# **INDONESIA-JAPAN JOINT SEMINAR ON MAPPING-OUT STRATEGIES FOR BETTER SEISMIC DISASTER MITIGATION**

**February 2007**

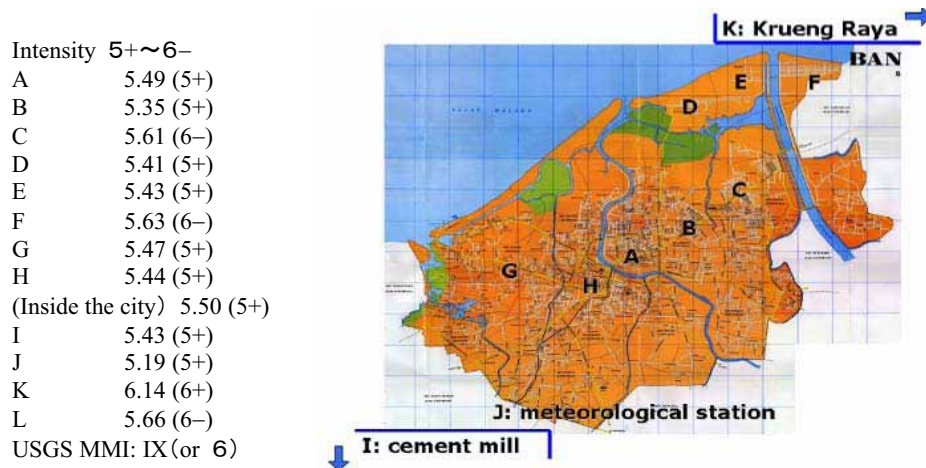
The seismic intensity was calculated based on questionnaires conducted in Banda Aceh. Professor Ota's method ([Ota, et al., 1979](#)) is used to calculate the local intensity. There are 35 questions such as: Feel the quake? Where? Duration? Could you move? Structures were damaged? Hanging stuff swinging? Unstable stuff falling? Heavy stuff moving? and other 27 questions. The results show the seismic intensity in Banda Aceh is around 5+ in Japan Meteorological Agency scale ([Figure 1](#)).

Figure 1. Seismic Intensity in Banda Aceh based on Questionnaires

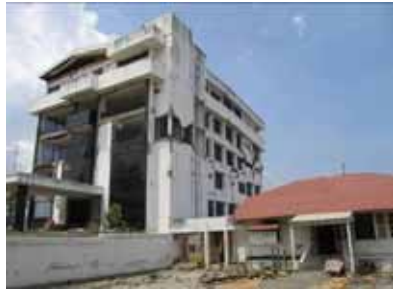
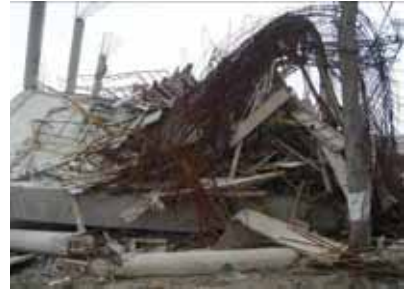
Figure 4. Structural Damages caused by Earthquake

The earthquake caused significant damages to structures, especially multi-story structures (structures with relatively long natural period). Examples are shown in Figure 4. Five-story Balai Gading Hall was significantly damaged, although nearby one-story wooden house was intact. Five-story Kuala Tripa Hotel was pancaking at the first story. Governor-office Annex which was under construction went down with soft-story mechanism of failure (see Figure 4).

(a) Balai Gading Hall

(c) Governor Office Annex

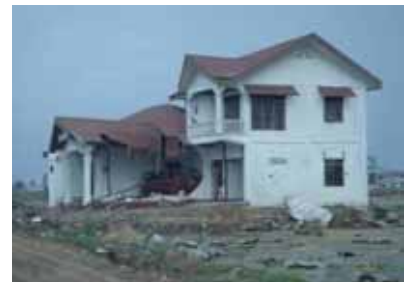
(f) House near Sea-shore

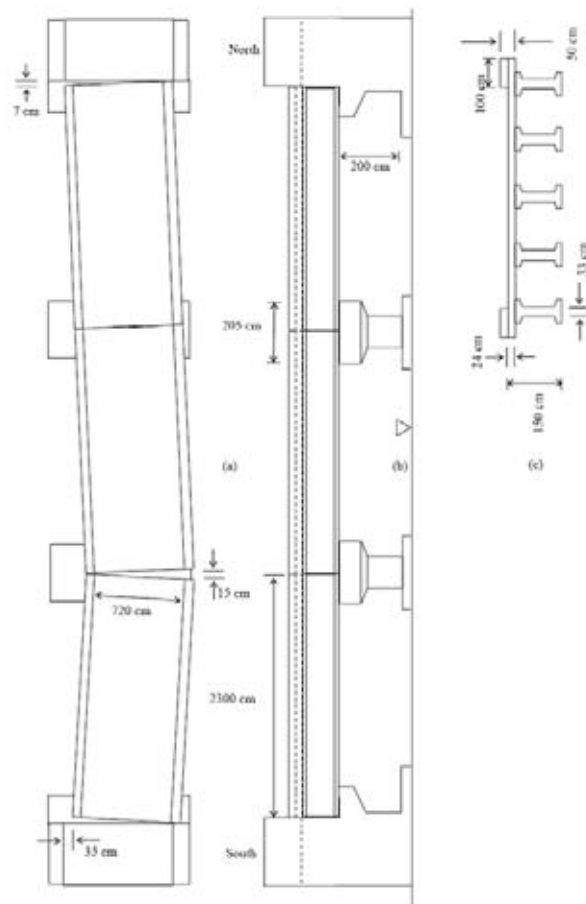
The condition of Bridge No.2, Ulee Lheue Bridge, is shown in Figure 6. It is a three-span bridge supported by two abutments and two piers. One span consists of a deck supported by five prestressed-concrete girders. From the plan view (Figure 6a), it is clear that the bridge decks were displaced in the direction of the tsunami water flow. The bridge is still functioning although some damages were clearly spotted. The bridge is located very close to the coast. The tsunami height in Ulee Lheue coast is estimated as 12 meter (Matsutomi, et al., 2006). Therefore, the bridge and its surroundings should have undergone severe hydrodynamic force by the tsunami.

Figure 6. Displacement and Dimension of Ulee Lheue Bridge after 2004 Tsunami

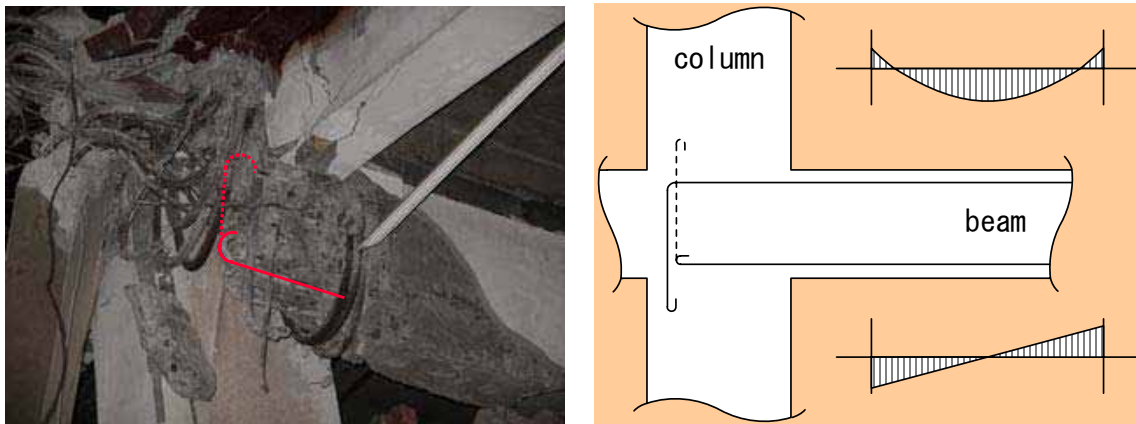
Note: Some beam bottom reinforcing bars were improperly detailed and pulled out of the beam-column joints. They had 180-degree hooks in the ends but were straightly terminated in the joints without bent anchorage into the joint core concrete. Rigid beam-column joints properly confined with lateral reinforcement and beam reinforcement bent into the joint core to develop its full anchorage are most essential for RC structures to perform successfully during earthquakes.

Photo 1 Pull-out failure of beam rebars at joint during 2006 Central Java Earthquake

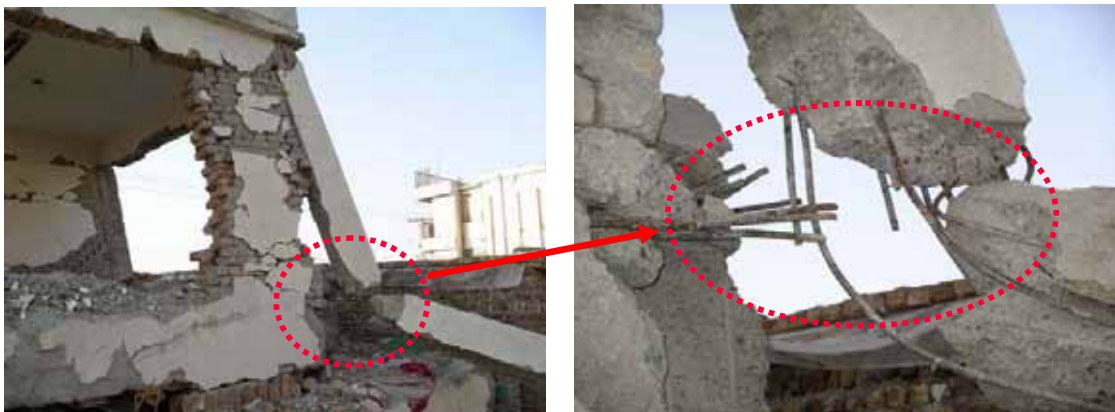
Photo 2 Collapsed 3 story building due to beam-column joint failure during 2005 Pakistan Earthquake

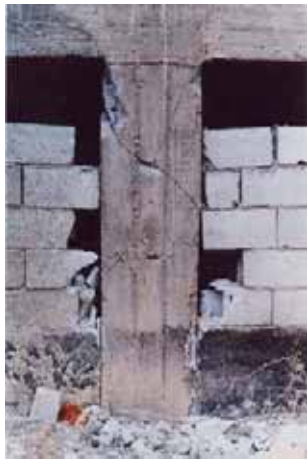
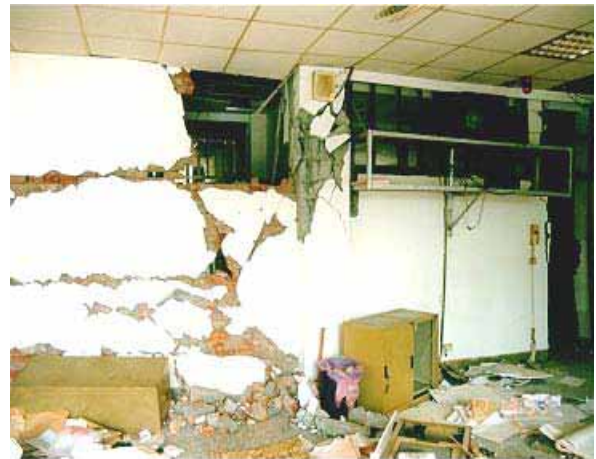
1992 Erzincan EQ (Turkey)

1999 Chi-Chi EQ (Taiwan)

Photo 3 Contribution of nonstructural elements to column shortening and damage

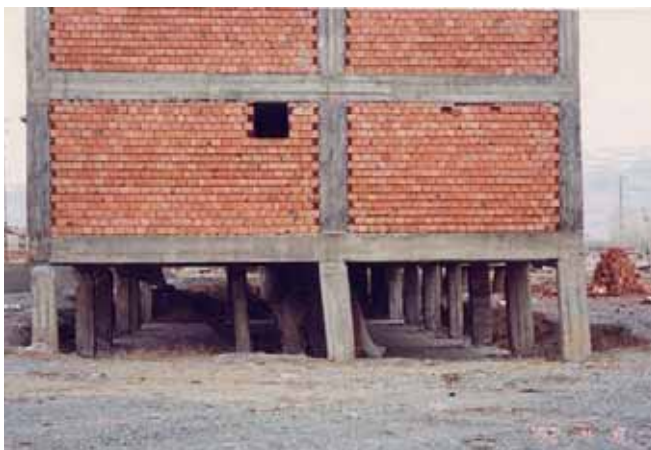
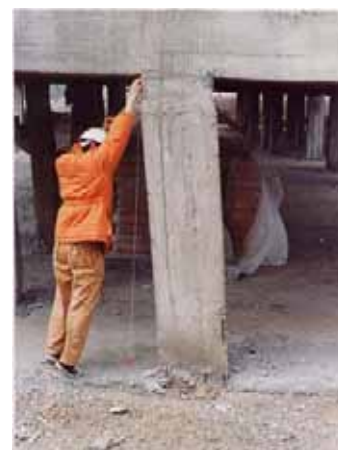
Photo 4 Contribution of nonstructural elements to soft first story (1992 Erzincan EQ)

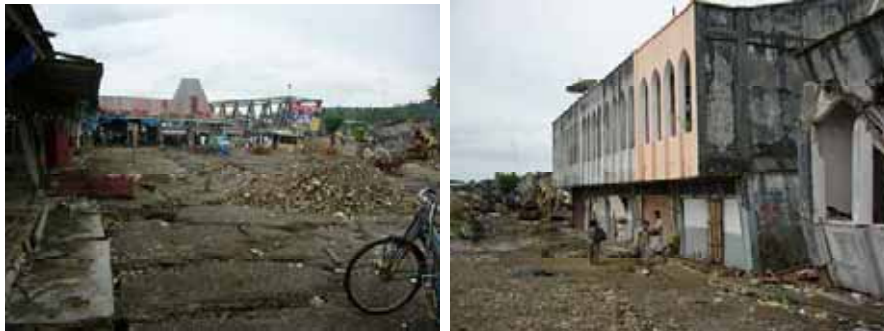
**Figure 6. Effect of liquefaction and lateral spreading on RC building and truss bridge**

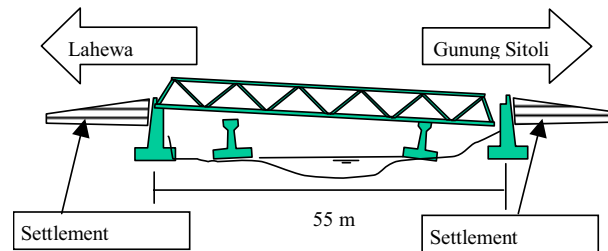
**Figure 4. Damage of Lafau Bridge**

The damaged bridges generally need to be re-constructed and It should be moved next to existing piers where geotechnical investigation of ground and its characteristics are necessary. The present truss decks can be used in the new-constructions with some replacement of damaged elements and bolts and bearings together with appropriate stopper against horizontal and vertical relative movements.

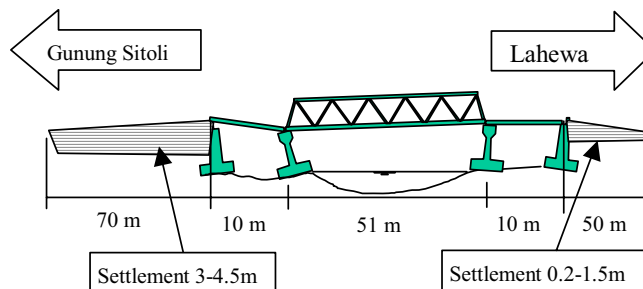
**Figure 5: Damage of Muzoi Bridge**

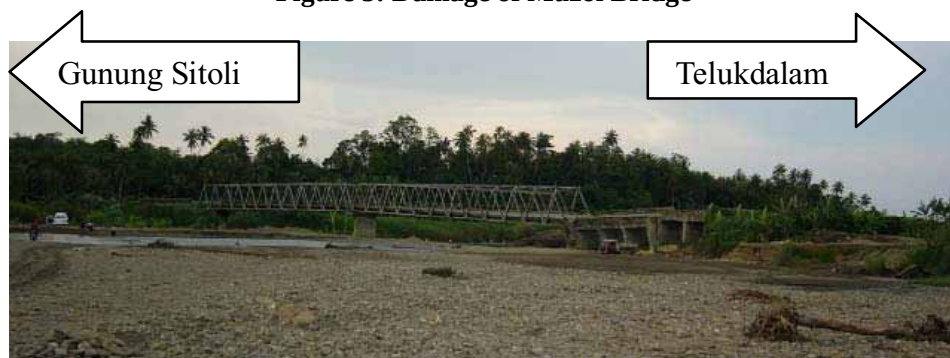
**Figure 6. Damage of Idano Gawo Bridge**

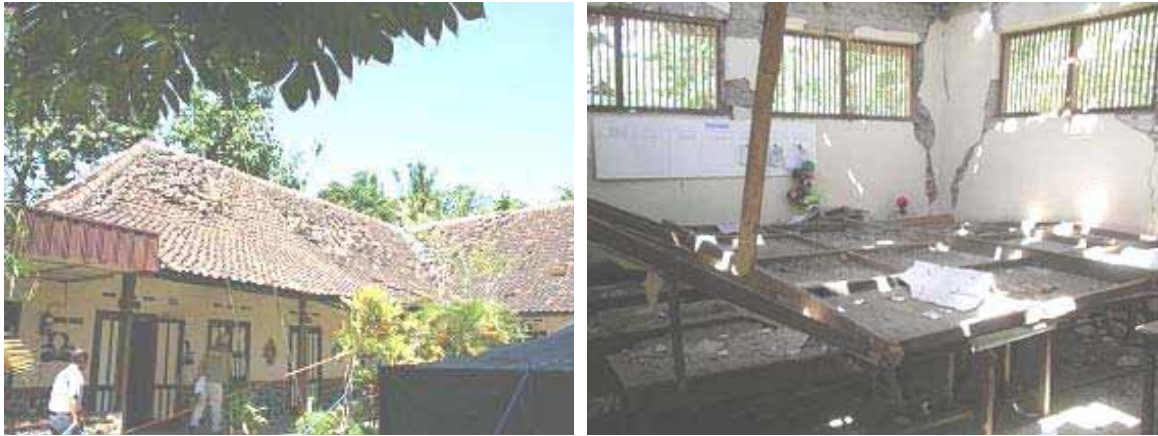
Photo 1 SD Tempel at Bambanglipuro, Kecamatan Baglipuro

No lintel beams were found and the roof truss was directly placed on un-reinforced masonry (URM) walls. Major damage was found in URM walls and the timber roof truss, and some ceiling boards fell down in the classrooms.

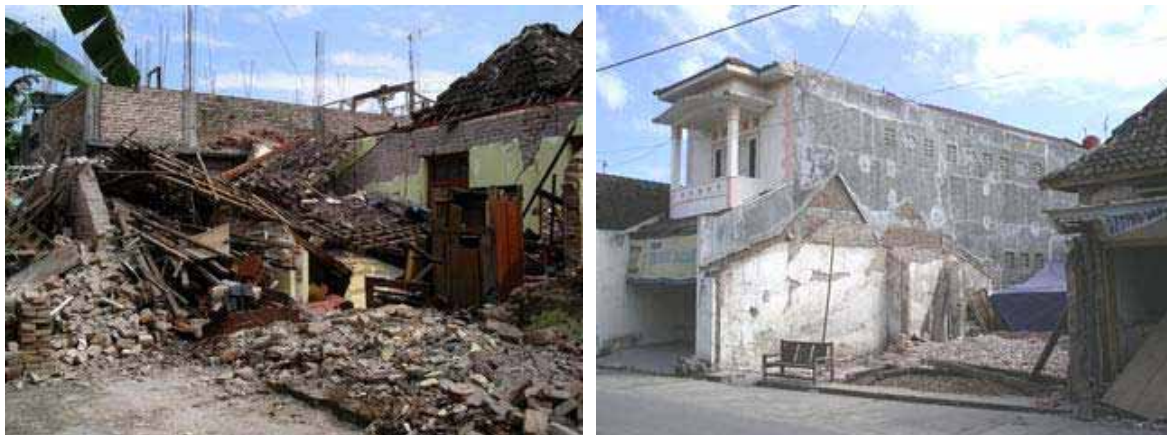
Houses in Imogiri were extensively devastated. They were URM structures with timber truss system and roofing tiles on it. URM walls were typically 20 to 25cm thick with 2 or 1.5 brick units, having a geometry size of 26cm x 12cm x 6cm. Since demolitions to reconstruct damaged houses had started in some damaged houses, it was not easy to identify which debris were due to shaking and which were not. Those with RC frames to confine URM walls often survived the shaking although they had some damage.

Photo 2 Devastated URM house

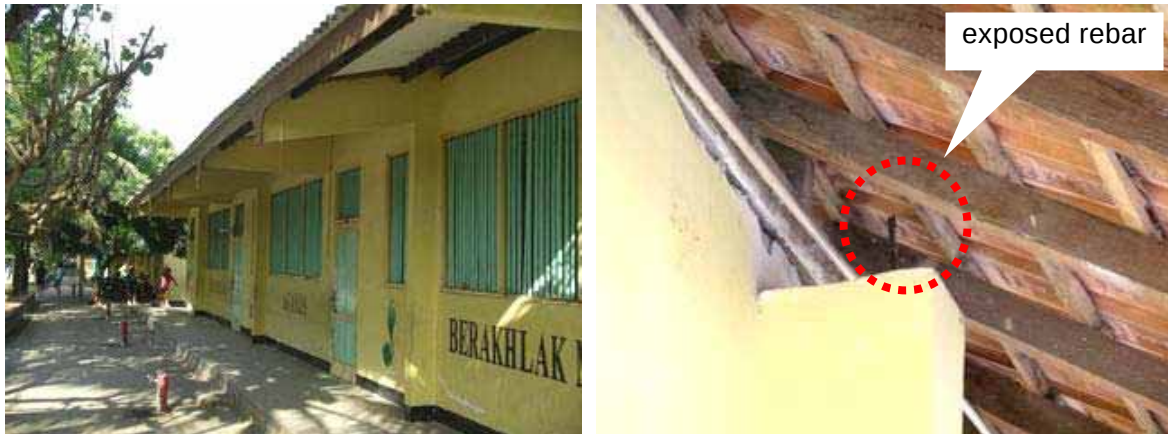
Photo 4 SD2 Parangtritis

Each class had 2 bays in the longitudinal direction. Each bay was 3.5m long and the column size in the middle was 175mm thick and 350 mm wide. The eaves were supported by  $\Gamma$ -shaped RC columns with cantilever beam. No major damage was found in the structure. Note that less damage was found in the coastal area around Parangtritis (to Opak River) than inland areas.

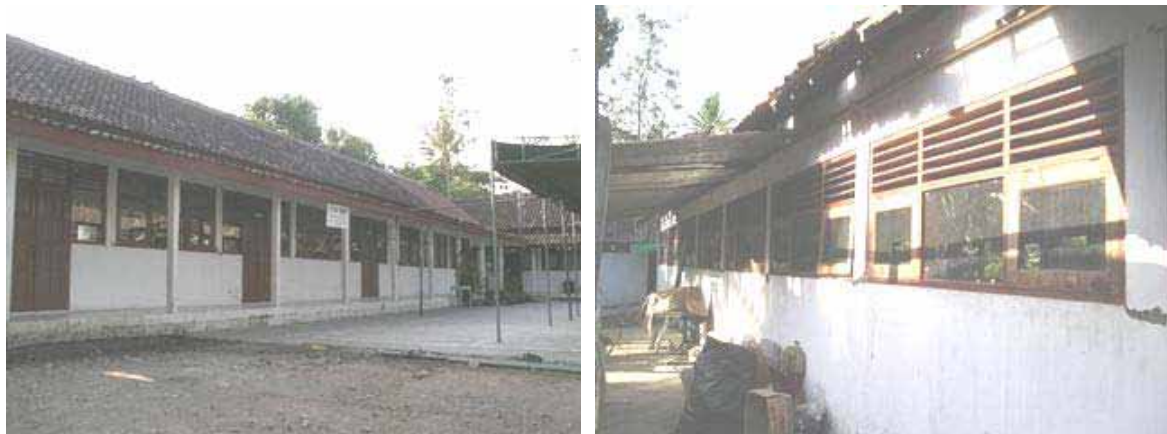
Photo 5 SLB-PGRI Trimulyo

Each class had 2 bays in the longitudinal direction. Each bay was 3.5m long. Columns had flexural cracks at both ends. The presence of reinforcing bars was not confirmed at the site since the building had minor cracks and rebars were not exposed.

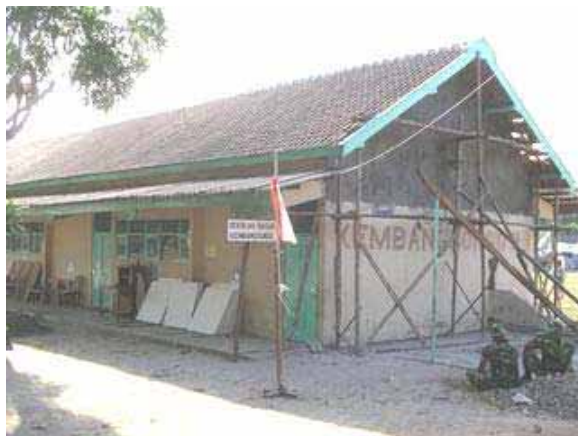
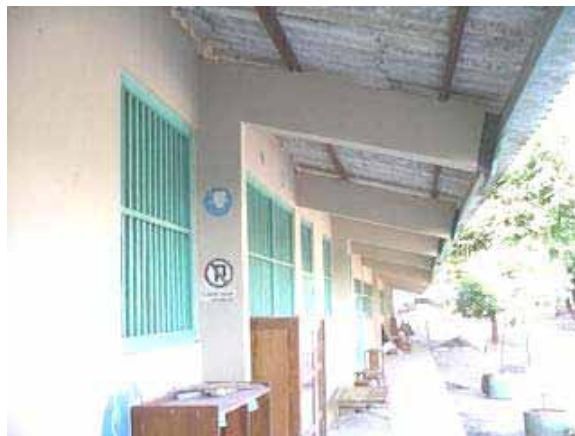
Photo 6 SD 2 at Kembangsongo

The school was located just north of the school at Trimulyo. The eaves were supported by  $\Gamma$ -shaped RC columns with cantilever beam, which was similar to SD2 Parangtritis. The exterior URM wall was damaged and repaired, but no other major structural damage was found in the structure.

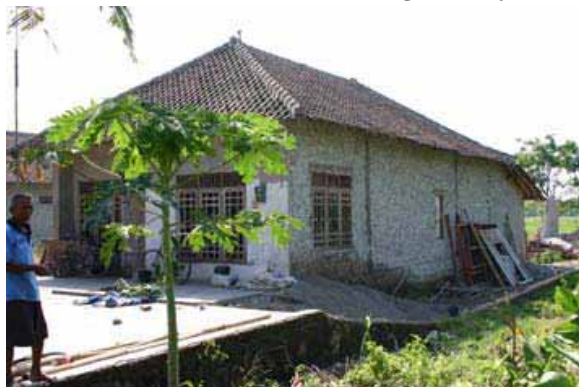
Photo 7 Stone masonry house

Traditional stone masonry houses in Gantiwarno Sub-Regency had some damage in masonry walls. They had some RC beams on the wall but no RC columns were provided in the house. Although they were heavy, the stone masonry walls were thick and long enough to resist and survive the shaking. Another traditional house older than the stone masonry construction had minor damage since they had light bamboo-net walls. The bamboo-net house investigated by the reconnaissance team was older than 70 years.

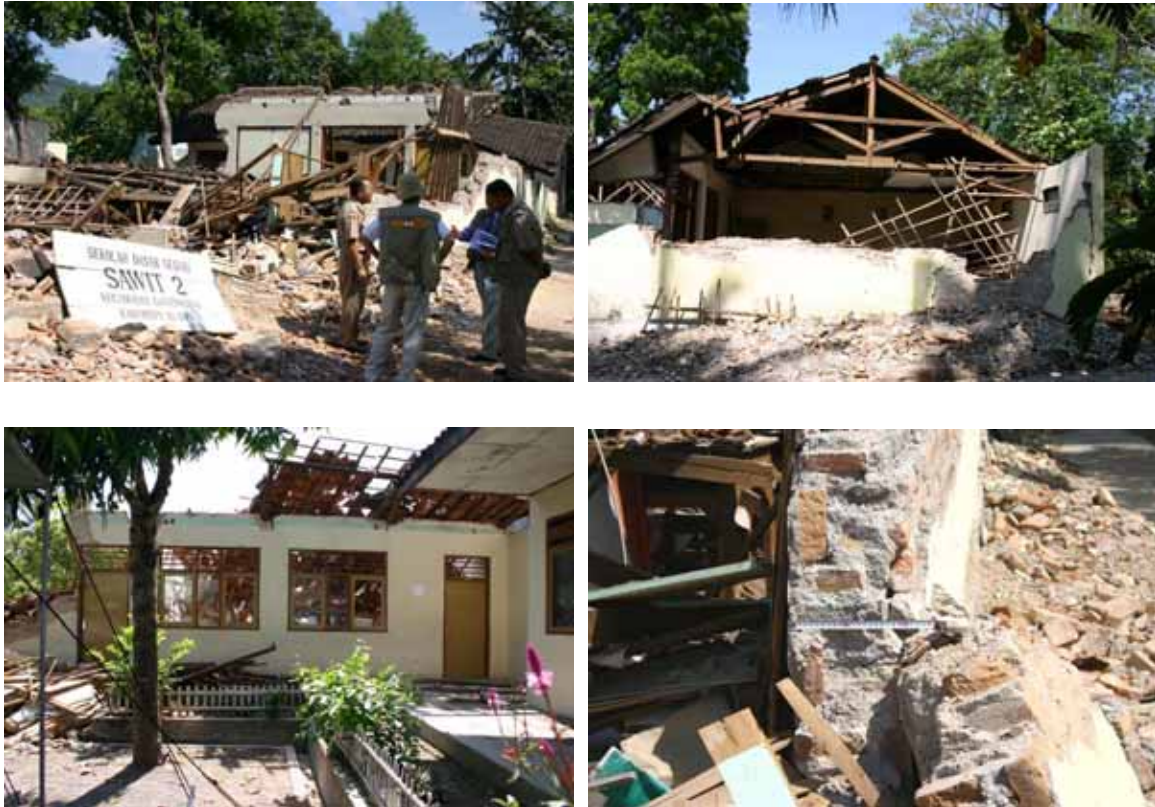
Photo 9 SD Sawit at Gantiwarno

The school building most probably had RC columns only at the 4 exterior corners but no columns in the middle of the structure. Each class had 2 bays and each bay was 3.5m long. Extensive damage was found in 20cm URM walls and the roof system.

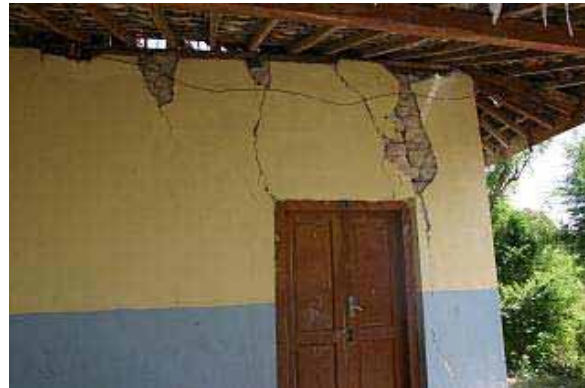
Damage to corner wall

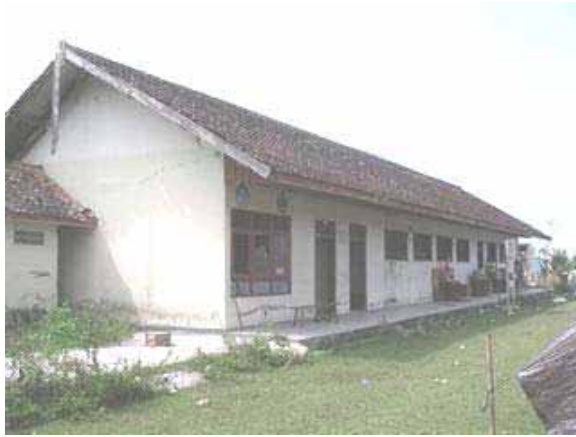
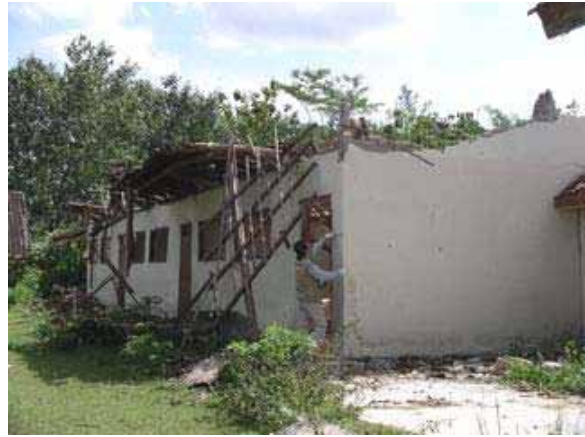
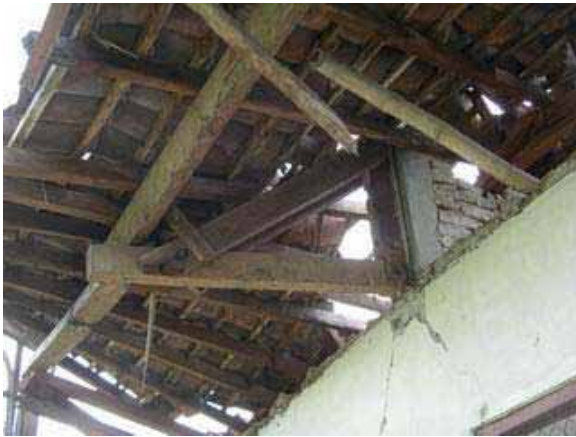
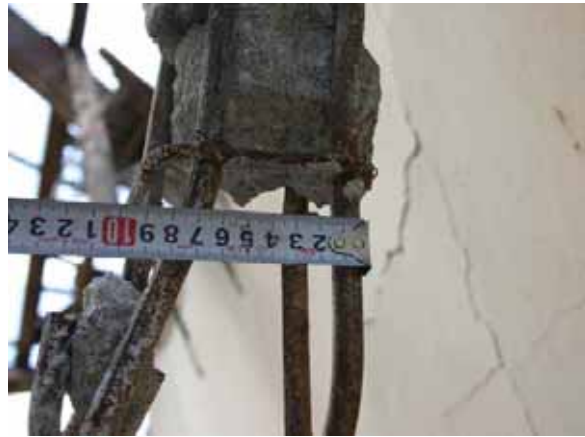
Photo 11 SD Pesu

The school had two buildings, one was seriously damaged in the roof system and the other survived the shaking. Columns having the 150mm x 150mm section with 4- $\phi$ 13 rebars and  $\phi$ 6 hoops were provided between classrooms. A mid-span wall was 150mm thick and 500mm wide. The roof was supported by the timber truss fastened to RC columns above.

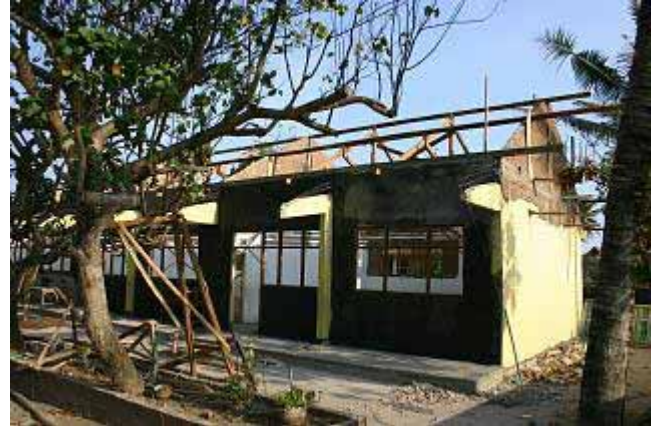
2006.09.16 Repairing. Top ends of walls are connected with RC beams

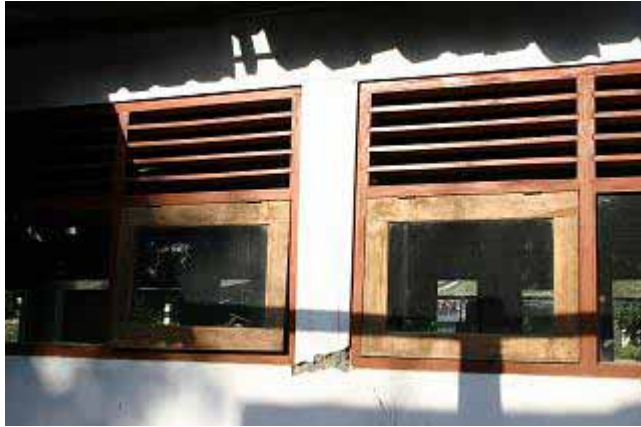
2006.06.12 cracks are found in the middle column

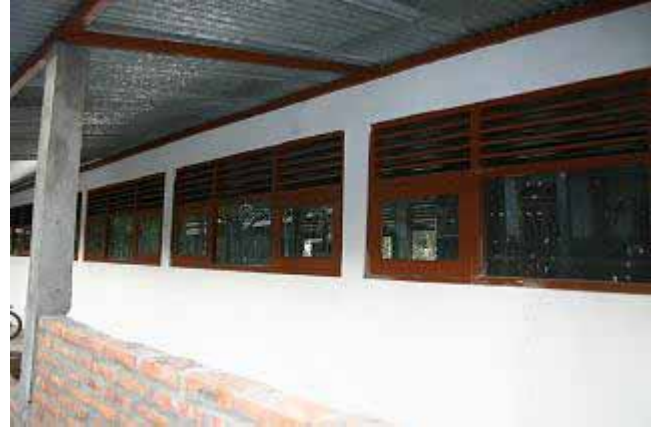
2006.09.16 Repaired, but method is unknown

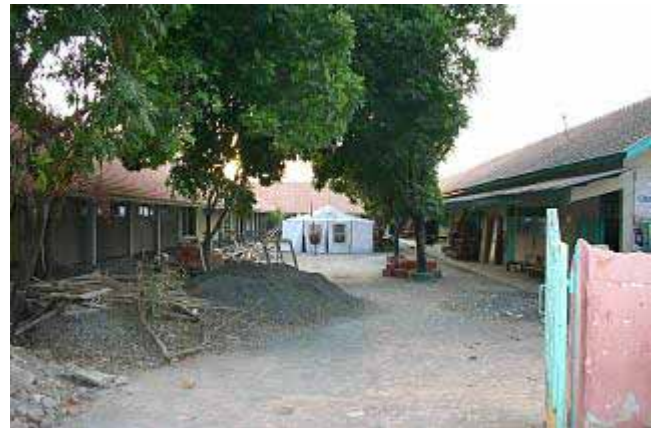
2006.09.16 New school on the left is under construction. The school on the right shows its original structure, No repair work has done yet.

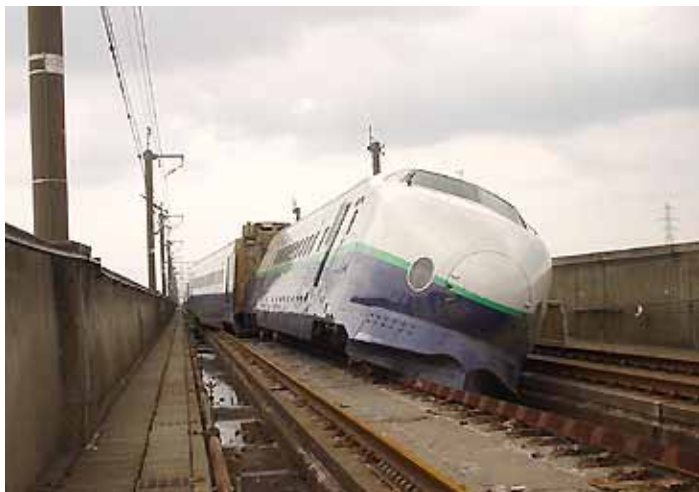
Fig. 2. Derailed train of Shinkan-sen in the Oct. 23, 2004, Chuetsu Earthquake.

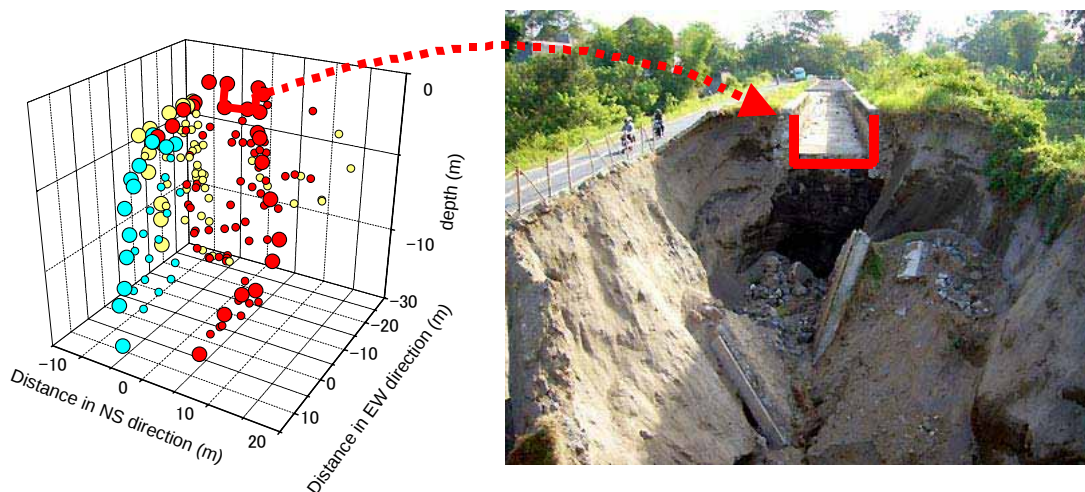
Fig. A1 Damaged embankment leading to Mataram canal bridge: The cave of the embankment was laser-scanned for its 3D image. Total soil volume about 2,000 m<sup>3</sup> has gone. Scar did appear immediately beneath the construction joint.
