A RECONNAISSANCE REPORT
ON
THE PISCO, PERU EARTHQUAKE OF AUGUST 15, 2007

2007 Pisco, Peru Earthquake Reconnaissance Team

Japan Society of Civil Engineers (JSCE),

October 2007

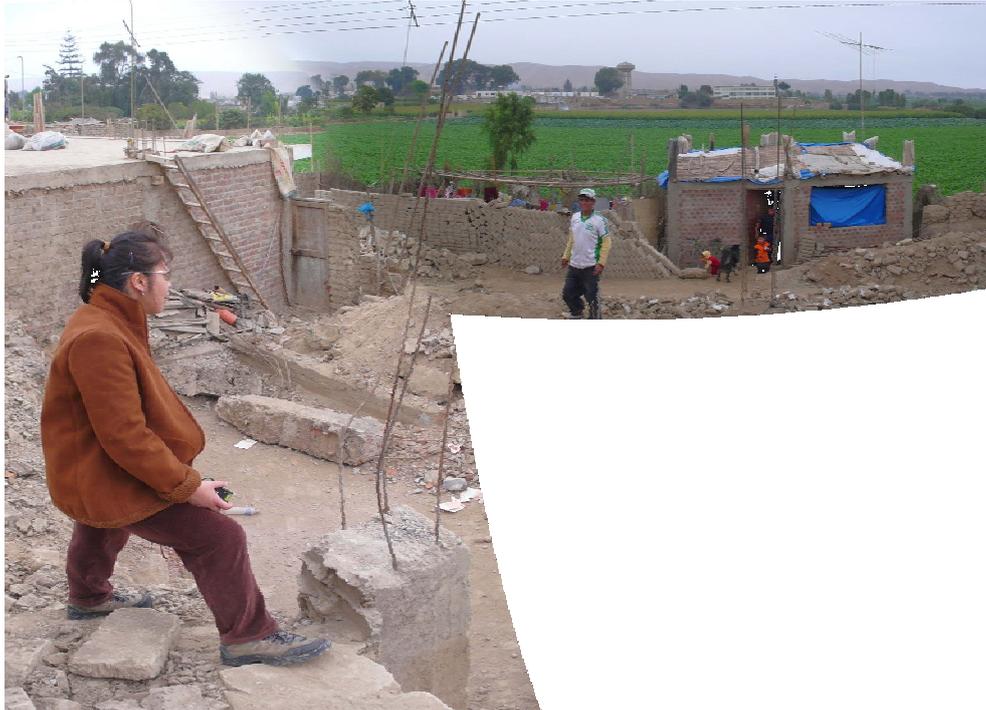
Fig. 3.12. Damage house located at point 79 in Fig. 3.6.

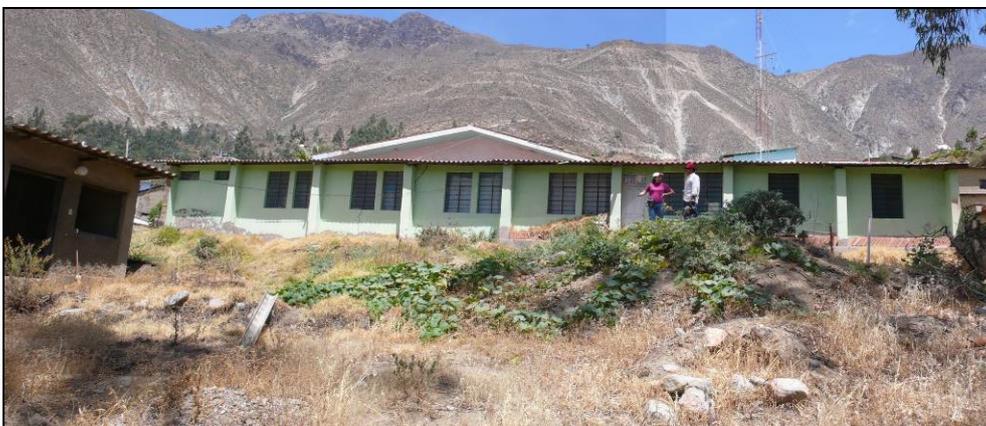
The health center in Huaytara suffered cracking of walls due to a foundation problem. At the construction there was a sewage canal, which is not in use any more, and on top of which an unreinforced foundation slab was placed. Due to the earthquake there was some soil movement around the canal and there was uneven settlement of the slab, causing it to crack as seen in Fig. 3.14.

Fig. 3.13 Health center in Huaytara with cracks in walls due to foundation differential settlement.

The health center was built on a slope, which likely exaggerated the soil movements and their effects on the slab foundation.

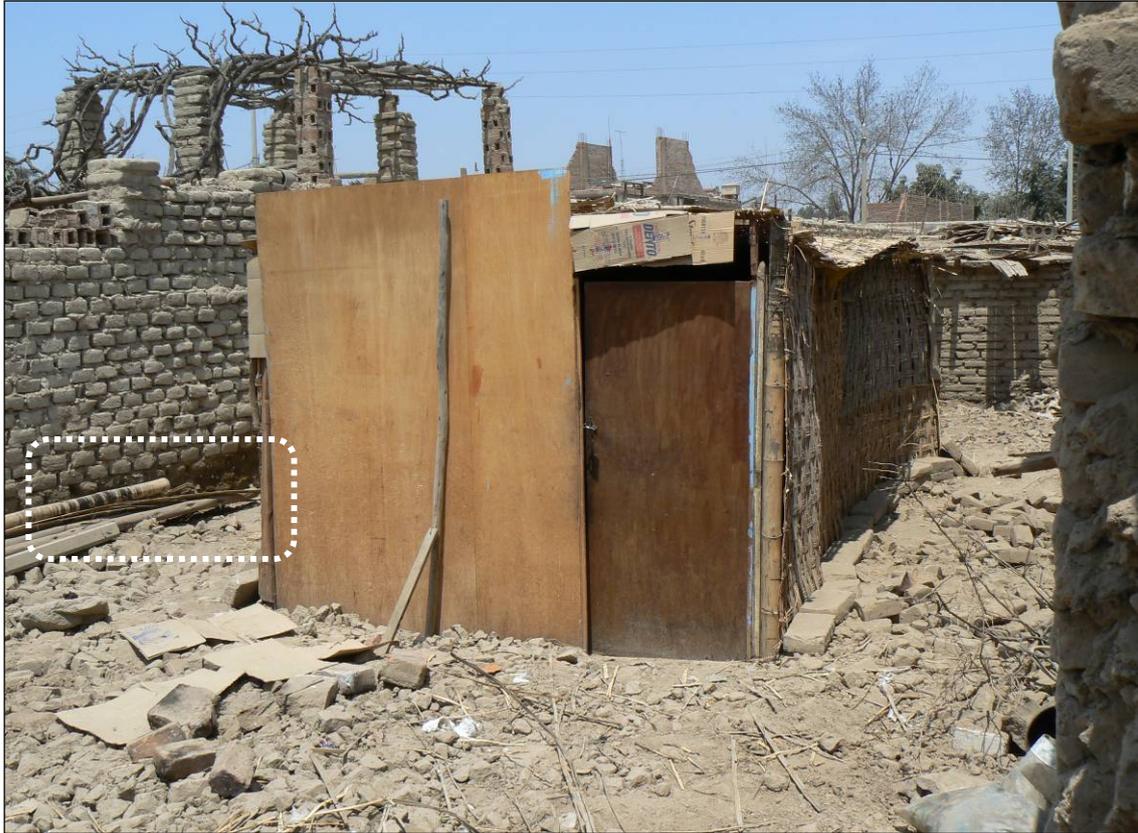
Fig. 3.16. Temporary self-built house. The original house collapsed in the earthquake. The dashed box shows how the lower part of the wall is darker due to moisture absorption.

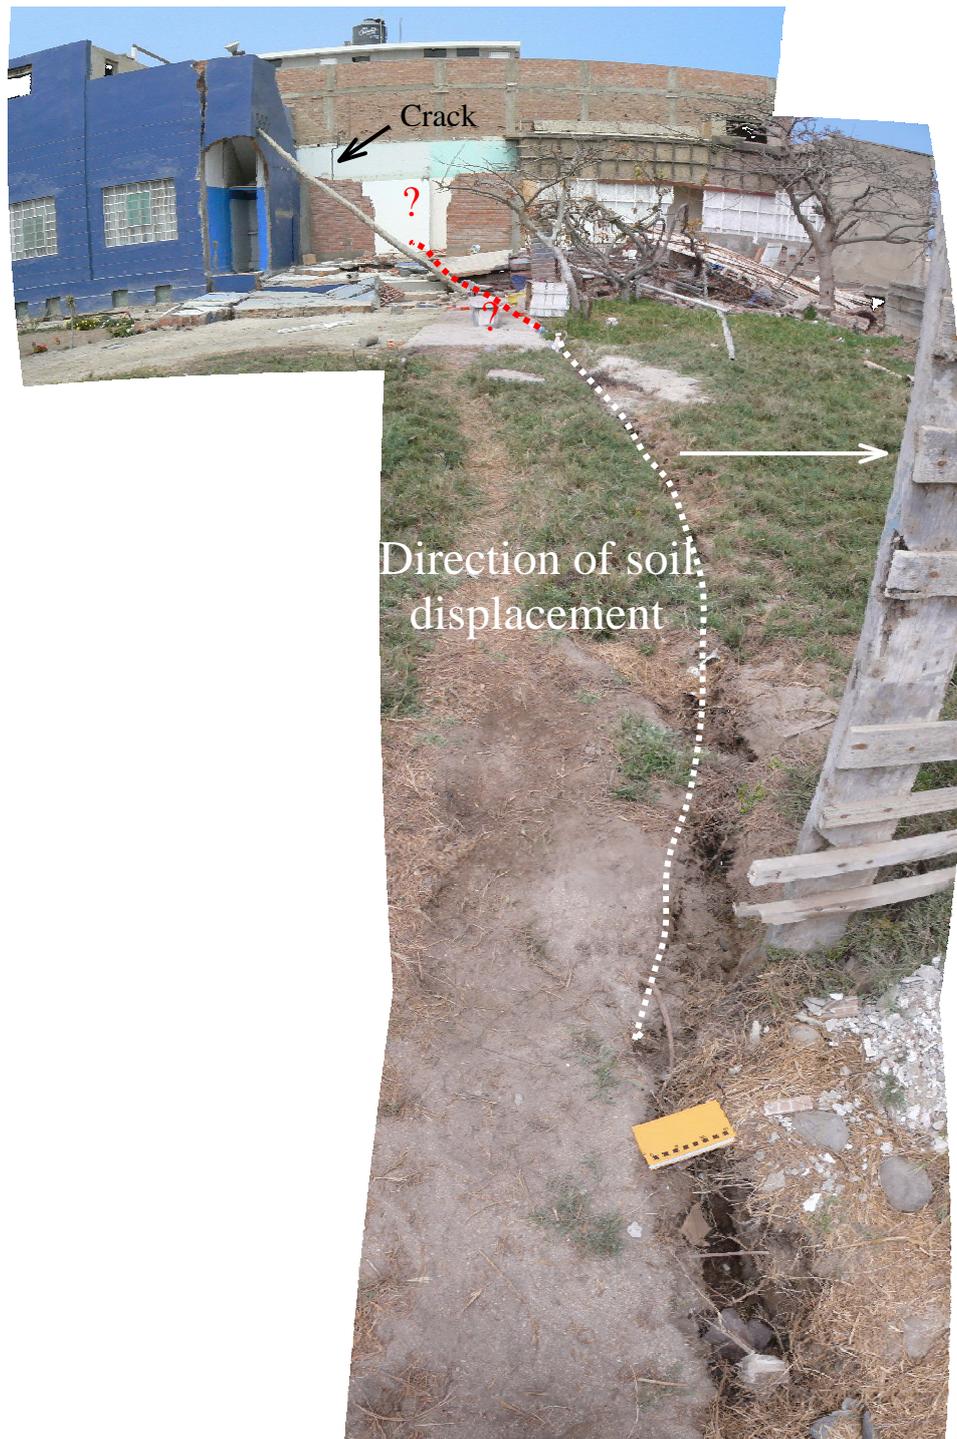
We found two buildings with good performance even though damage to buildings around them was severe. The location is indicated in Fig. 3.17. This area was severely damaged by liquefaction as seen in the ground cracks in Fig. 3.18. Lateral spreading caused the soil to displace towards the ocean and the creating some 10-15 cm wide cracks in the soil. The crack probably continues in front of and/or beneath the blue building and then up through the confined masonry wall as marked by the black arrow in Fig. 3.18. The soil settled some 10-15 cm next to the blue house as shown in Fig. 3.19.

Fig. 3.18. Soil displacement crack next to old building. (blue mark in Fig. 3.17). The crack probably continues in front of and/or beneath the building and then up through the confined masonry wall as marked by the black arrow. (The curvature of the building top is due image distortion, it should be a straight line.)

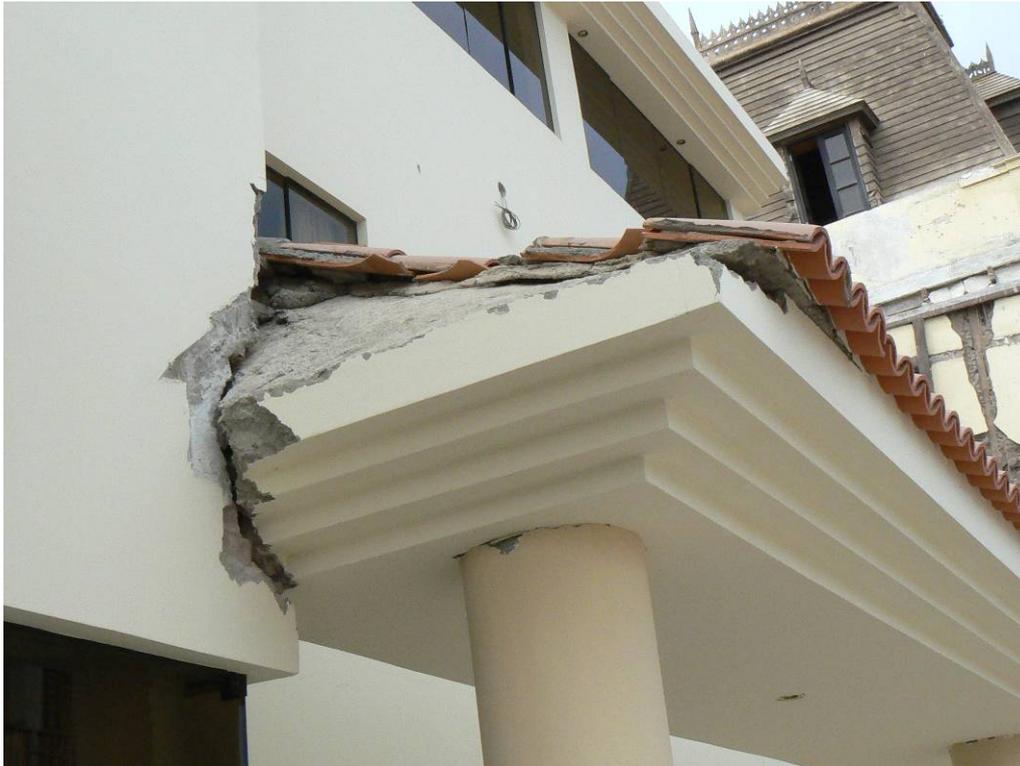
Fig. 3.23. Close up of hotel damage. Relative ground movement, due to liquefaction, between the columns of the exterior roof structure and the building, caused the cracks.

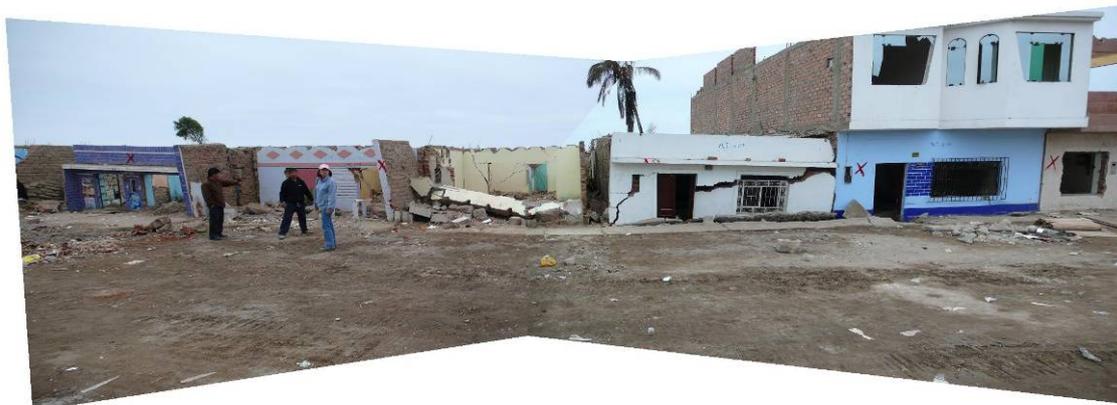
Severe settlement of buildings and foundation damage, due to liquefaction induced ground failure and lateral spreading, caused the collapse of adobe houses and severe cracking of walls of confined masonry buildings. The damage resulted in the death of 5 persons; Out of 1447 dwellings, 465 houses were completely destroyed, 308 were severely affected, another 467 were affected, and 121 were lightly affected [4]. This left only 121 unaffected houses.

Fig. 3.25. Settlement of 0.7 m of building in front of palm tree.

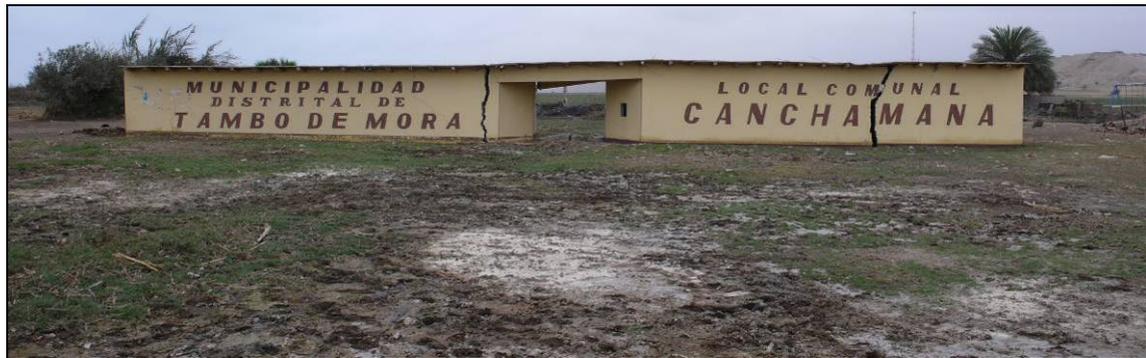
Fig. 3.26. Severely damaged community building in Canchamana, with liquefaction traces in the foreground.

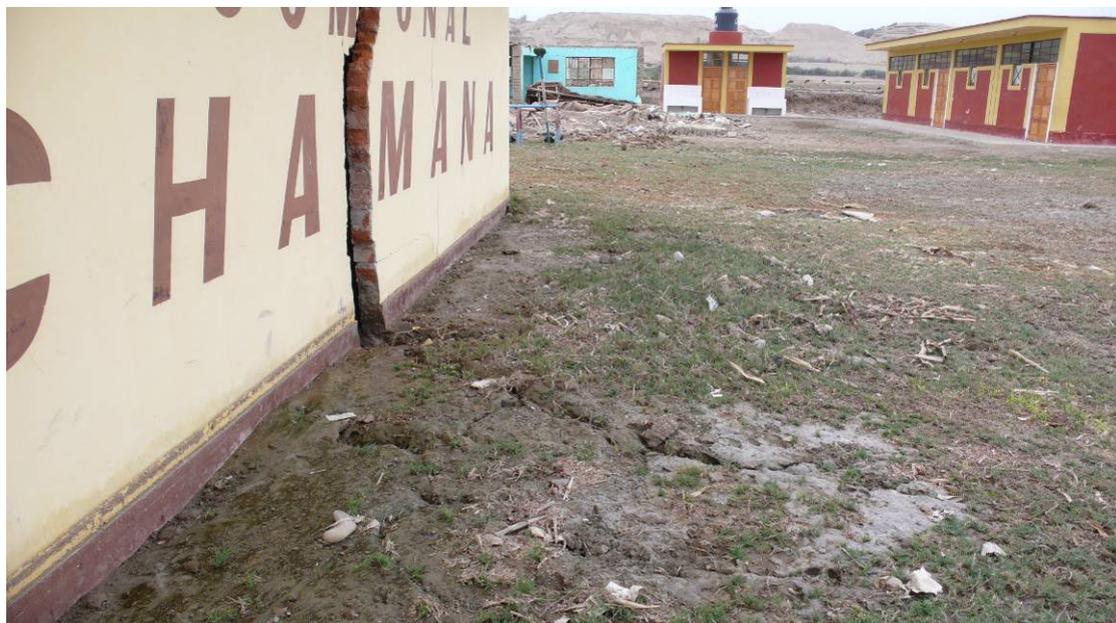
Fig. 3.27. Severely damaged community building in Canchamana, with liquefaction traces in the foreground and well behaved red school building in the background.

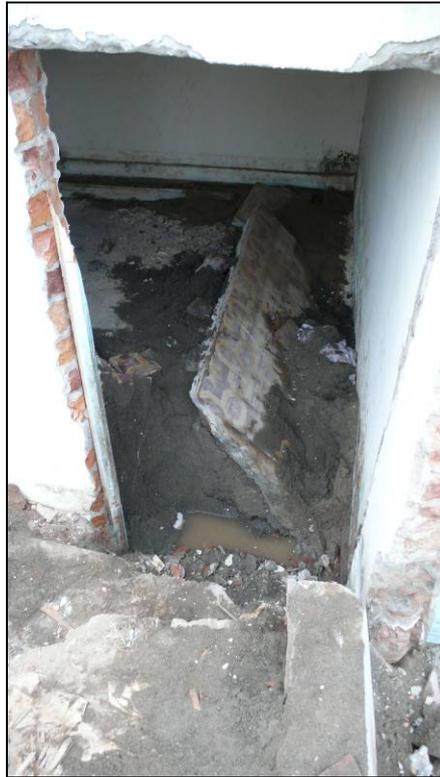
Fig. 3.28. Foundation pushed up due settlement the building.

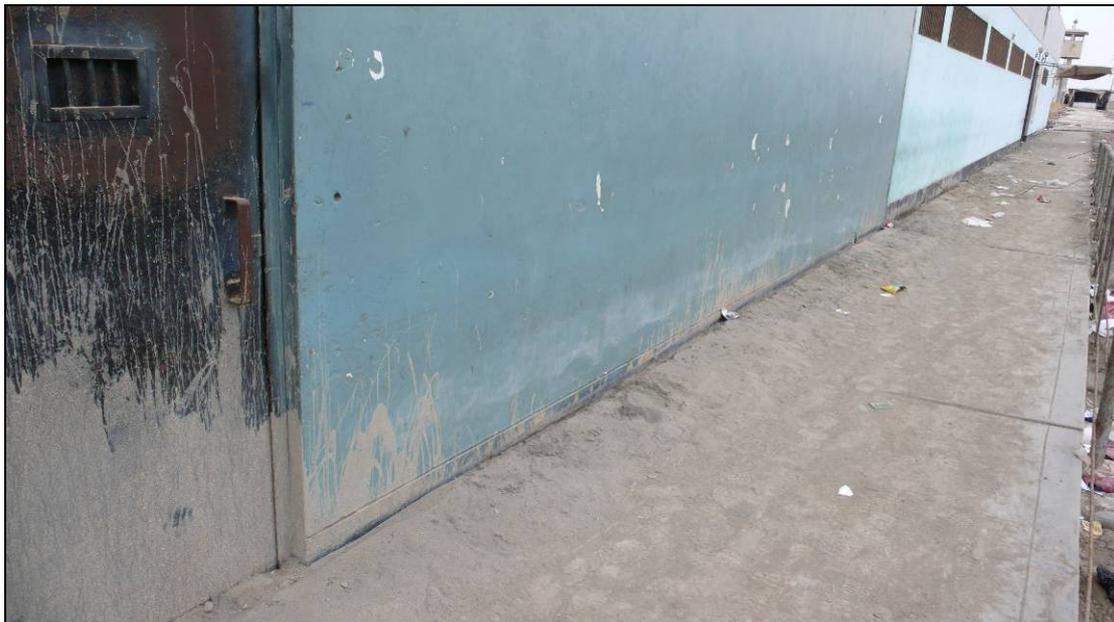
Fig. 3.29. Liquefaction splashed all the way to the top of Prison building door.

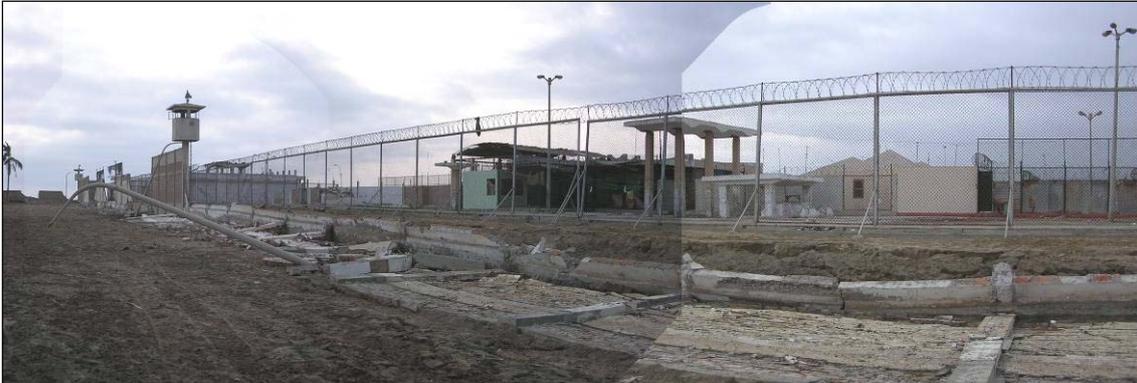
Fig. 3.30. Collapsed wall at Chinchá prison due to large ground deformation

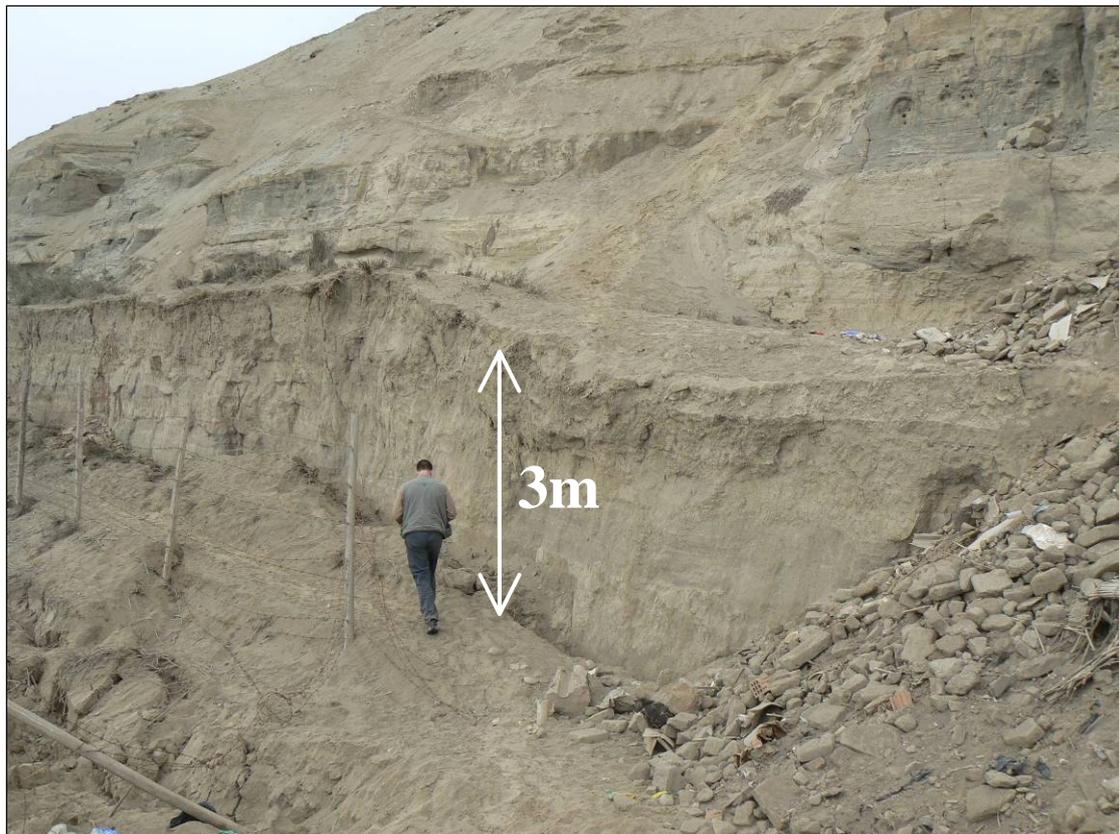
Fig. 3.33. On the border between the Canete formation and the marine deposit, there is a 3 meter differential vertical offset.

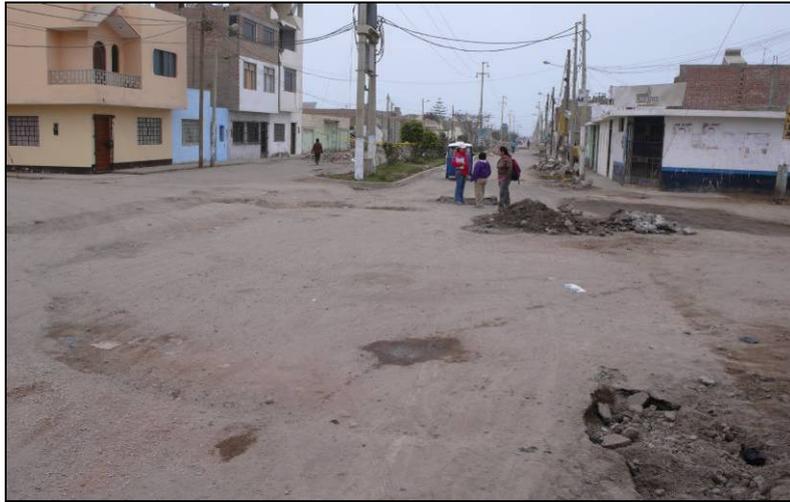
Fig. 3.39. Central Pisco (S13 42.542 W76 12.516). Settled ground as evidence of broken sewer pipes.

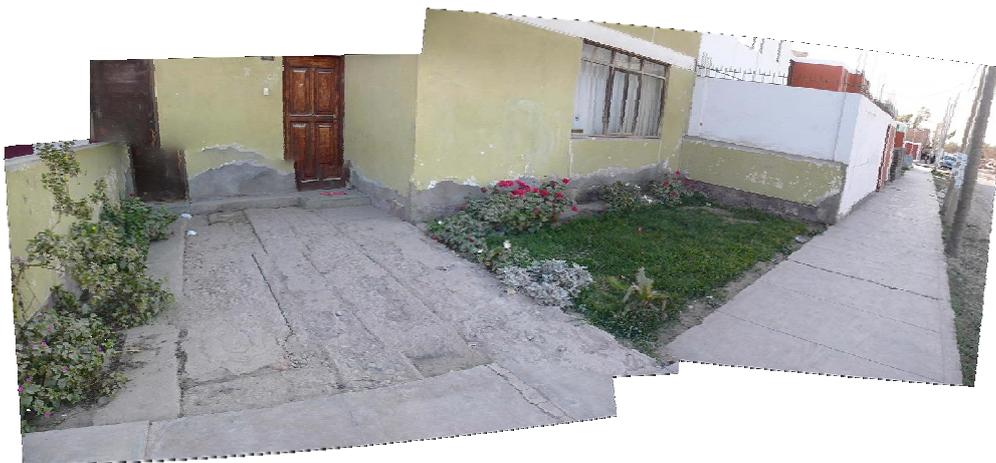
Fig. 3.42. Liquefaction traces were observed north-west of the intersection between Valdelomar Street and Las Americas Avenue.

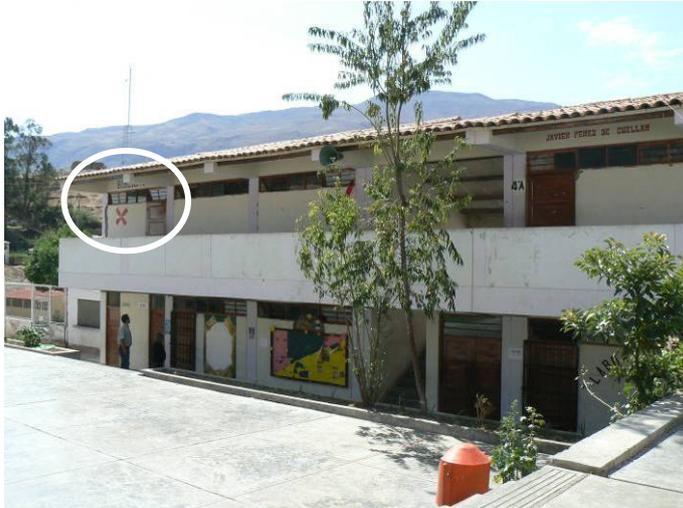
Fig. 4.42 Masonry panels in the second floor were damaged, (San Juan Bautista school, Huaytara)

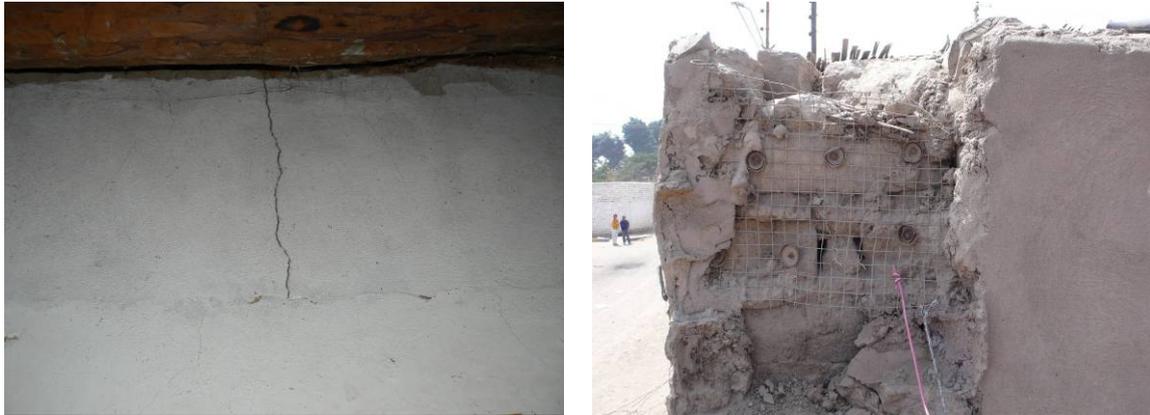
Fig. 4.68. Retrofitted house after the Pisco Earthquake

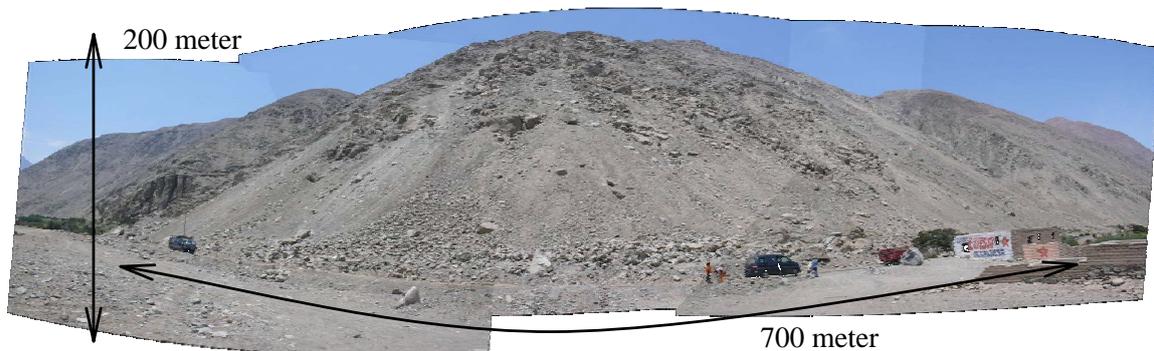
Fig. 5.10. Rock Fall. Canete-Yauyos Road, 60km from epicenter.

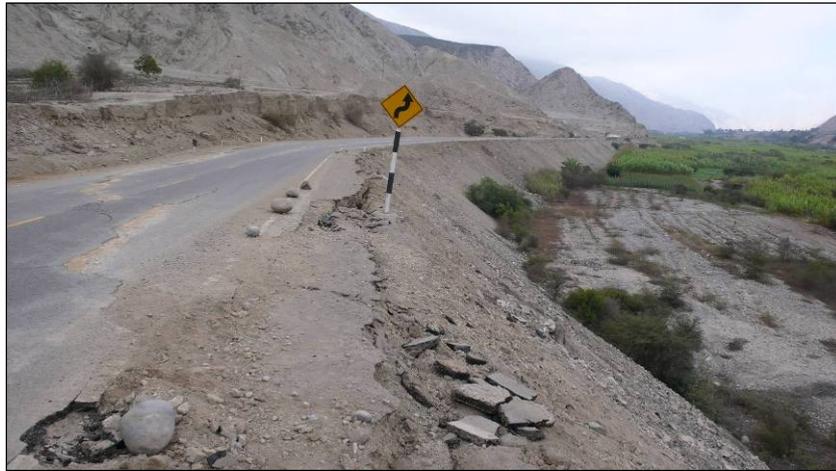
Fig. 5.12. Slope failure at Canete-Yauyos road (Km. 23)

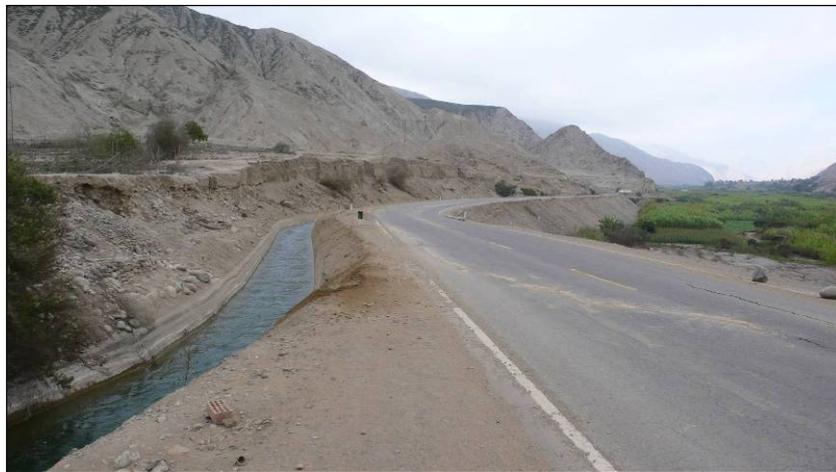
Fig. 5.13. Slope failure at Canete-Yauyos road (Km. 23)

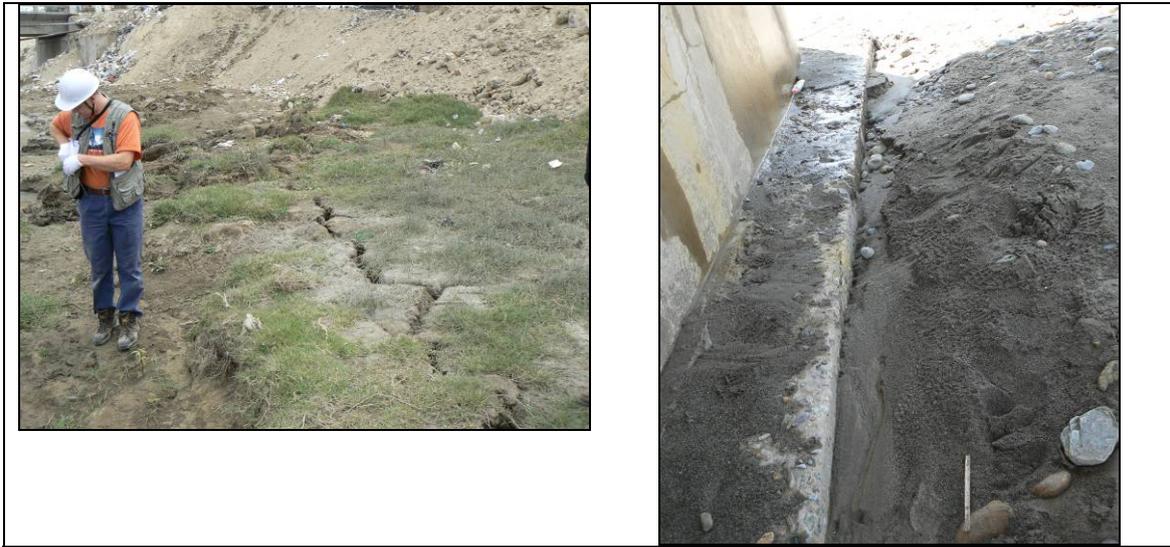
Fig. 5.18 Liquefaction induced lateral spreading (Pisco River north upstream pillar bank)

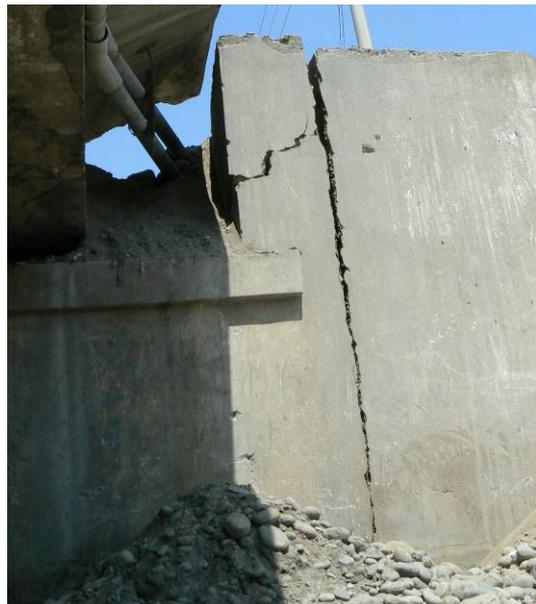
Fig. 5.21 South abutment, downstream

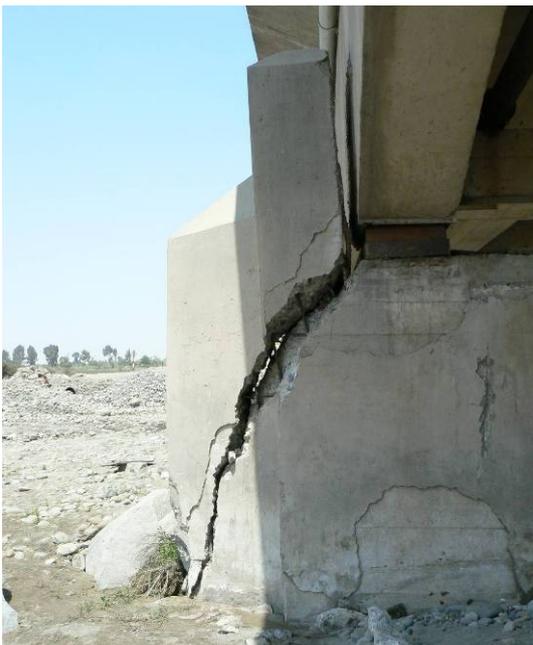
Fig. 5.27 Failed wing with poor reinforcement (pillar with movable bearing)

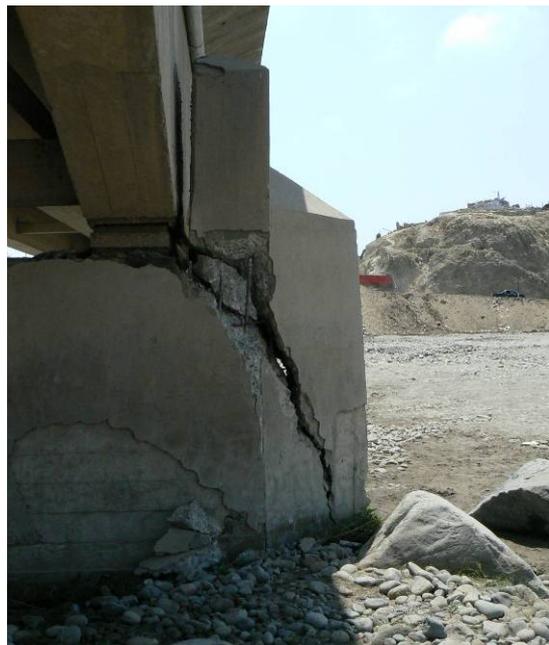
Fig. 5.28 Failed wing with poor reinforcement (pillar with movable bearing)
