A RECONNAISSANCE REPORT
ON
THE BENGKULU EARTHQUAKE OF SEPTEMBER 12, 2007

2007 Bengkulu Earthquake Reconnaissance Team

Japan Society of Civil Engineers (JSCE)

Japan Association for Earthquake Engineering (JAEE)

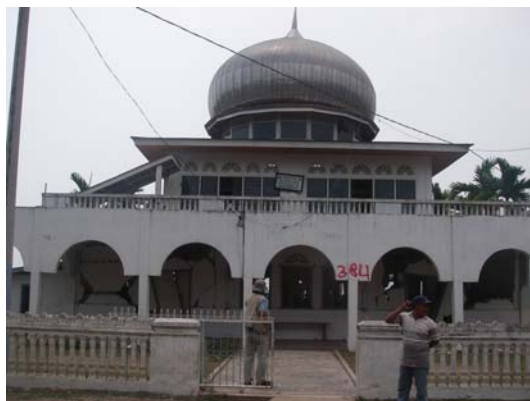
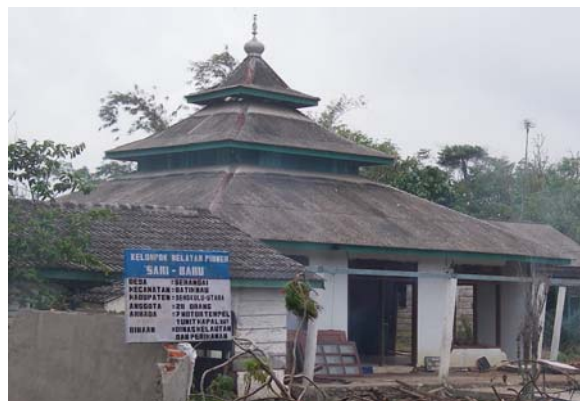
Mosques are semi-reinforced concrete structures. Although reinforced columns and beams are utilized, they are quite small in cross section (15x15 to 20x20cm) and they have 4-6 smooth steel bars with a diameter ranging between 8-12mm. The walls are either hollow cement blocks or bricks. The roof of mosques are generally light. The earthquake caused the failure of outer columns and load-bearing walls at corners and subsequent collapse of roofs (Figure 5.1).

Fig.5.1 Damage to mosques

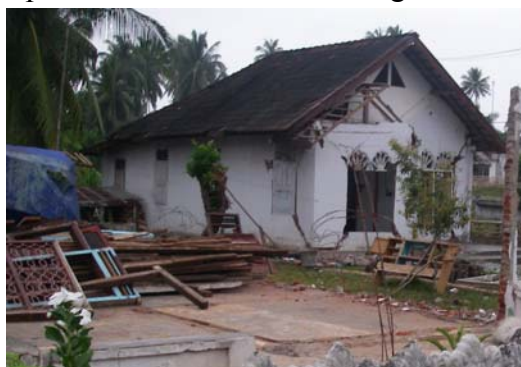
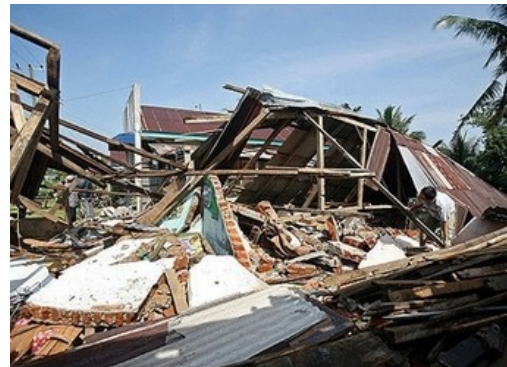
Masonry buildings are generally constructed with bricks and they are either one story or two story buildings. Old masonry buildings has no reinforced concrete lintels and/or columns. Such collapses were observed even in areas with high ground acceleration, (Figure 5.2) New constructions utilize reinforced concrete lintels and columns. There is no doubt that when such structural elements are integrated with masonry walls they perform better and they prevent the total collapse of the buildings in spite of some structural damage.

Fig.5.2 Collapsed or heavily damaged brick masonry houses

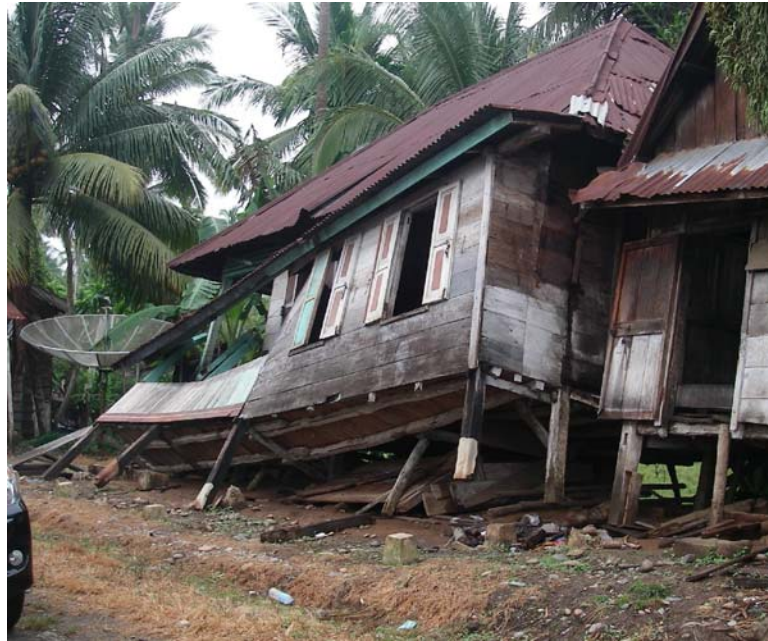
There are many wooden houses. Compared to brick masonry houses with or without RC lintels and/or columns, they performed better and there was almost no total collapse due to ground shaking. However, they failed due to the embankment failures as seen in Figure 5.3

Fig.5.3 Total collapse of a wooden house in Pasir Banting due to embankment failure

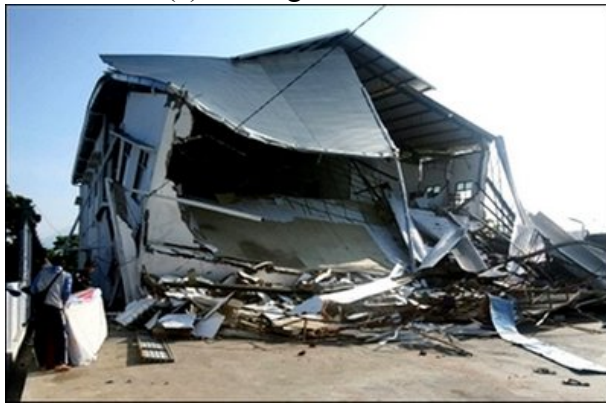
RC buildings with two or three stories suffered heavily from the earthquakes. Many RC buildings either totally collapsed or heavily damaged in Padang City even though they were about 400km away from the epicenter. The reinforced concrete structures are framed structures with integrated or non-integrated in-fill walls. The reinforcing bars are generally smooth and infill walls are built with red-burned solid clay bricks using mortar. The floor height in the region ranges between 3 to 4m. The inspections of the reinforced concrete buildings indicated that they are mainly failed in the pancake mode. RC buildings are generally found in cities and large towns. The concrete buildings having 2 or more stories were either collapsed or heavily damaged. The causes of damage to RC buildings are similar to those observed in other recent earthquakes in Indonesia and elsewhere (Figures 5.4). They may be re-stated for this earthquake as follows:

(c) Collapsed show room in Argamakmur

Fig.5.4 Examples of damage to RC buildings

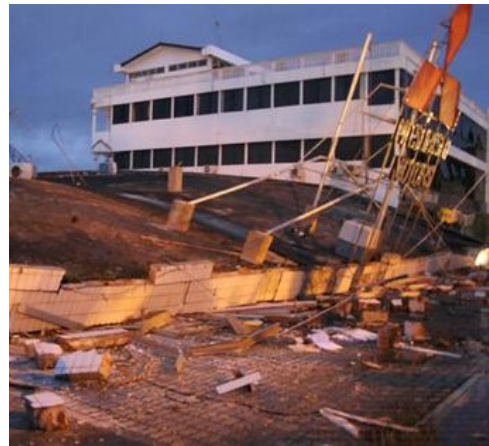
(d) Mitsubishi showroom

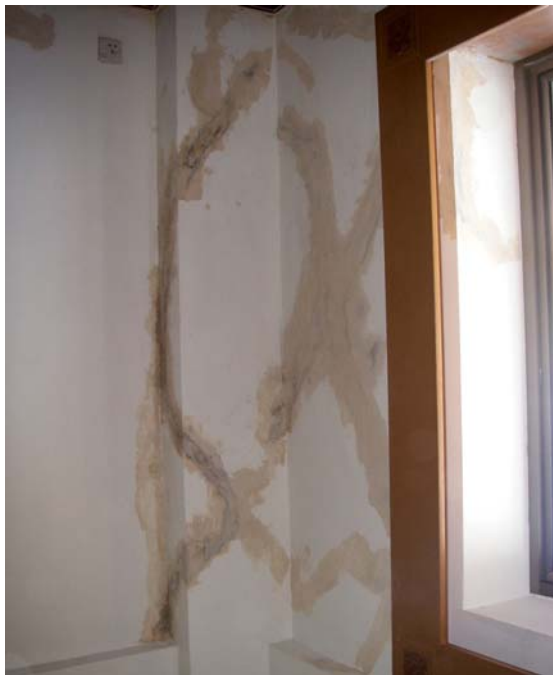
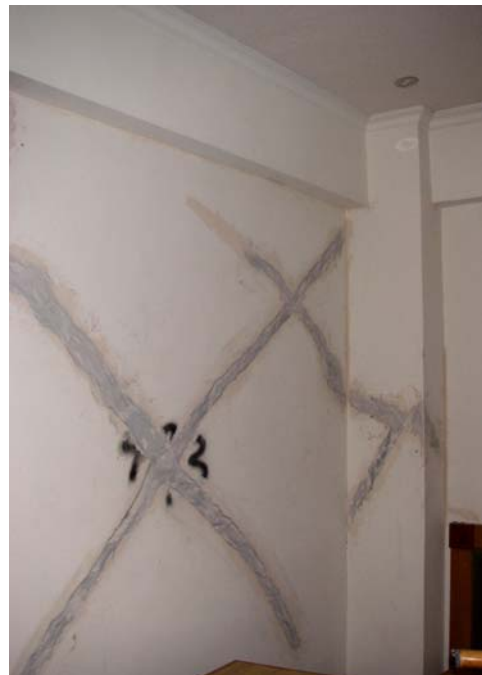
Many RC buildings suffered some damage and repairs implemented are just to re-plaster the cracks caused by the ground shaking (Figure 5.5). These buildings are probably the most vulnerable to collapse during a next strong earthquake.

Fig.5.5 Re-Plastered columns of an RC building used as an hotel in Padang

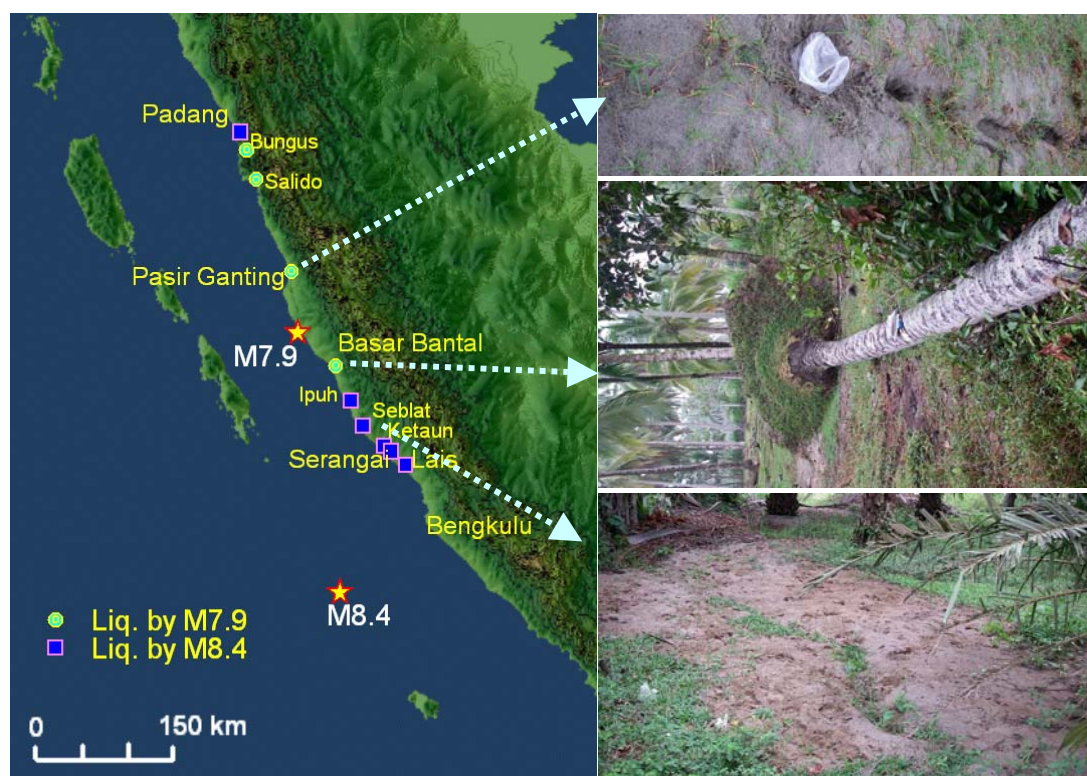
Ground liquefaction were observed in many places along the sea-coast and banks of major rivers (Figure 5.6). Except the heavy damage to a newly constructed 60m long arch bridge by ground liquefaction, the effects of liquefaction on structures such as bridges were quite small. However, the ground liquefaction did cause some damage to abutments of bridges and resulted in the non-uniform settlement of bridge foundations. Furthermore, lateral spreading was observed even in Padang City. The good engineering design bridges against ground failures and liquefaction could be a factor on the limited effects of ground liquefaction on super structure. Figure 5.7 shows the grain size distribution of soil samples from sand boils from Pasir Ganting, Basar Bantal and Seblat bridge.

Fig.5.6 Locations and views of sites where ground liquefaction were observed

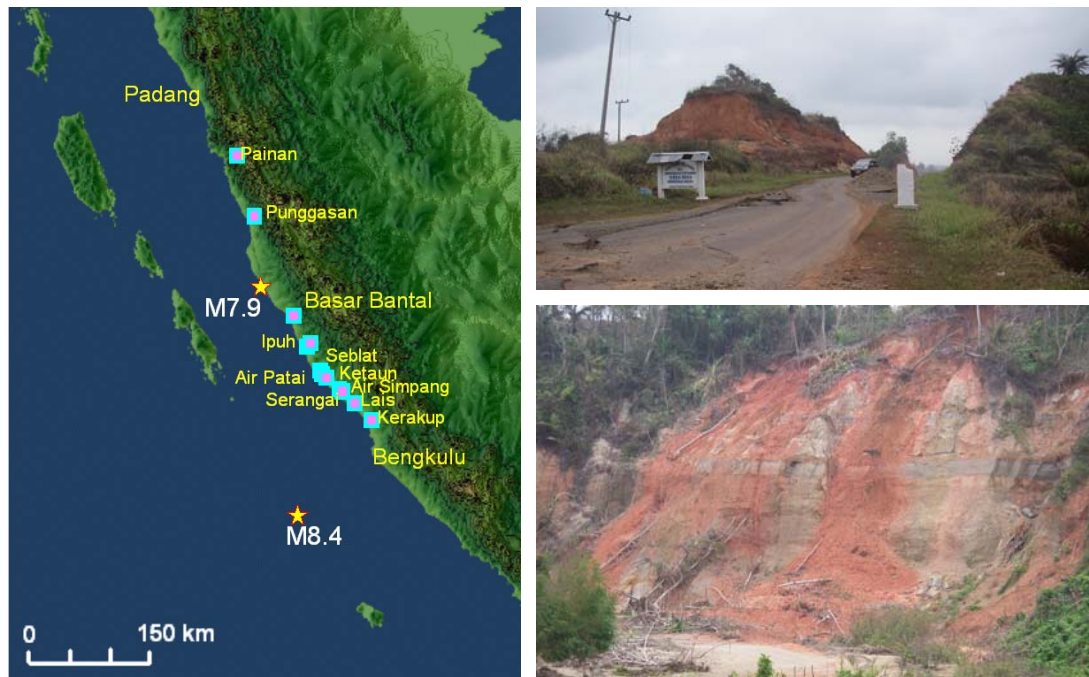
Extensive slope failures observed in along the coastal road between Padang and Bengkulu (Figure 5.7). The number of slope failures between Ketaun and Lais was much higher as compared with those in other areas. The slope failures took place within the volcanic sediments and volcanic sedimentary soft rocks. However, most of slope failures were shallow seated.

Fig.5.7 Locations and views of sites where slope failure were observed

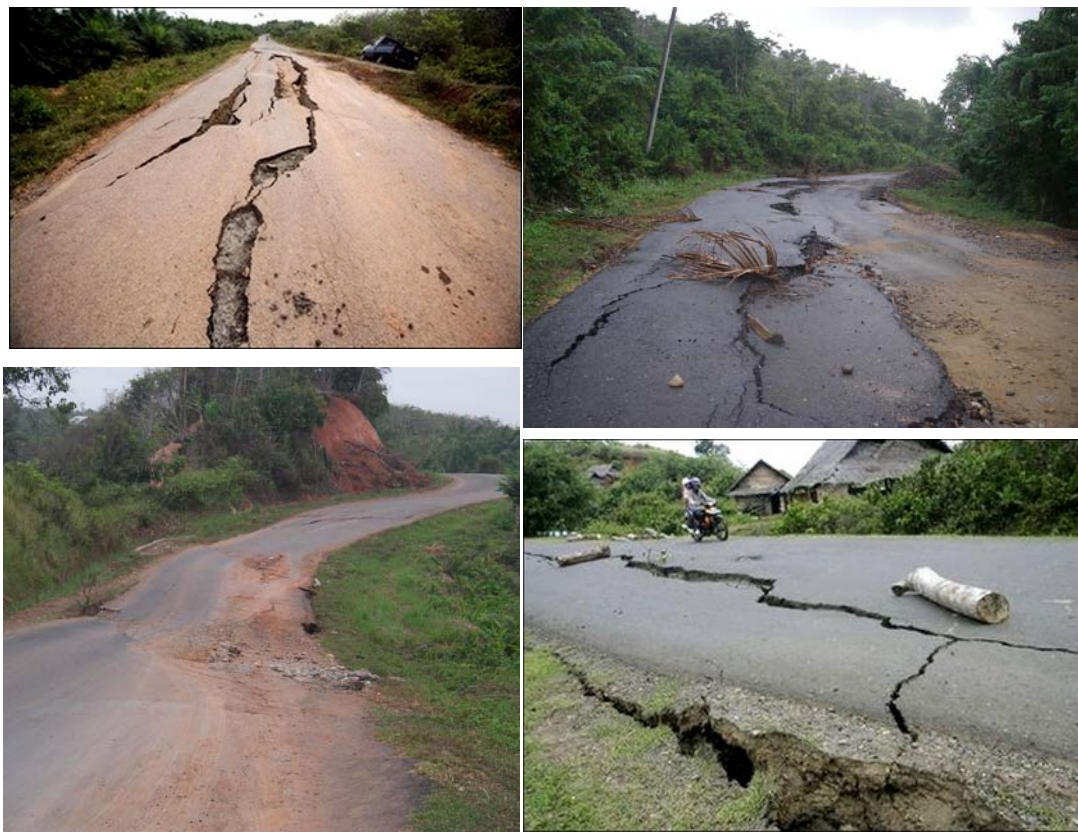
Embankment failures of roadways and rivers were also widespread in the area where the ground motions were high. The embankment failures at infilled sections of the roadways were quite severe and the general trend was quite similar to those observed in Noto Toll Road (Figures 5.8). Since the ground was more resistant and

ground shaking was mild, the translational movements did not cause the total collapse of the embankments. Furthermore, the approach embankments of bridges were severely damaged by settlement and lateral spreading of ground at their base.

Fig.5.8 Some examples of failures of embankments of roadways

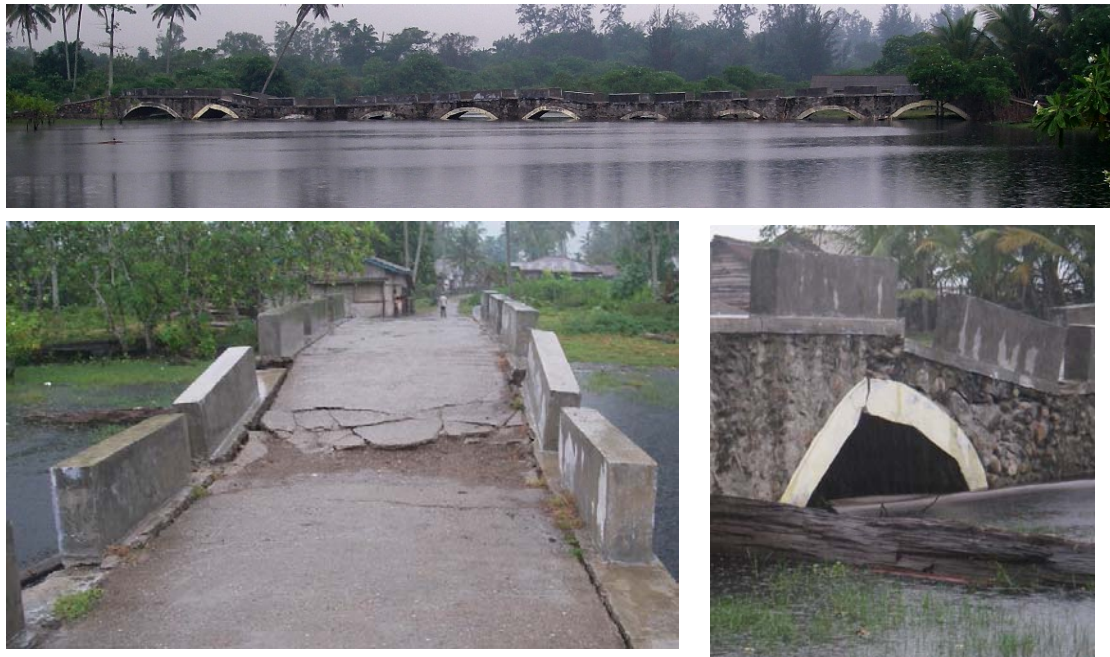
Fig.5.9 Damage to the arch bridge at Pasir Ganting due to ground liquefaction

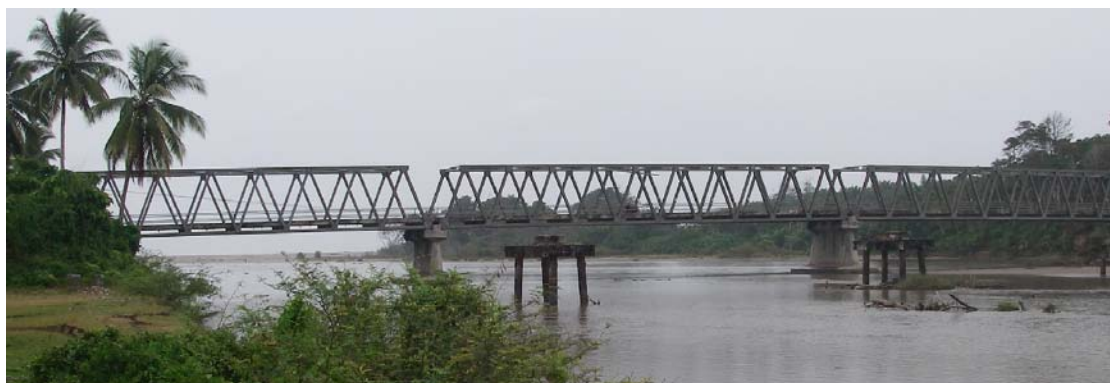
Fig.5.10 Slight damage to Seblat River Bridge due to uneven settlements

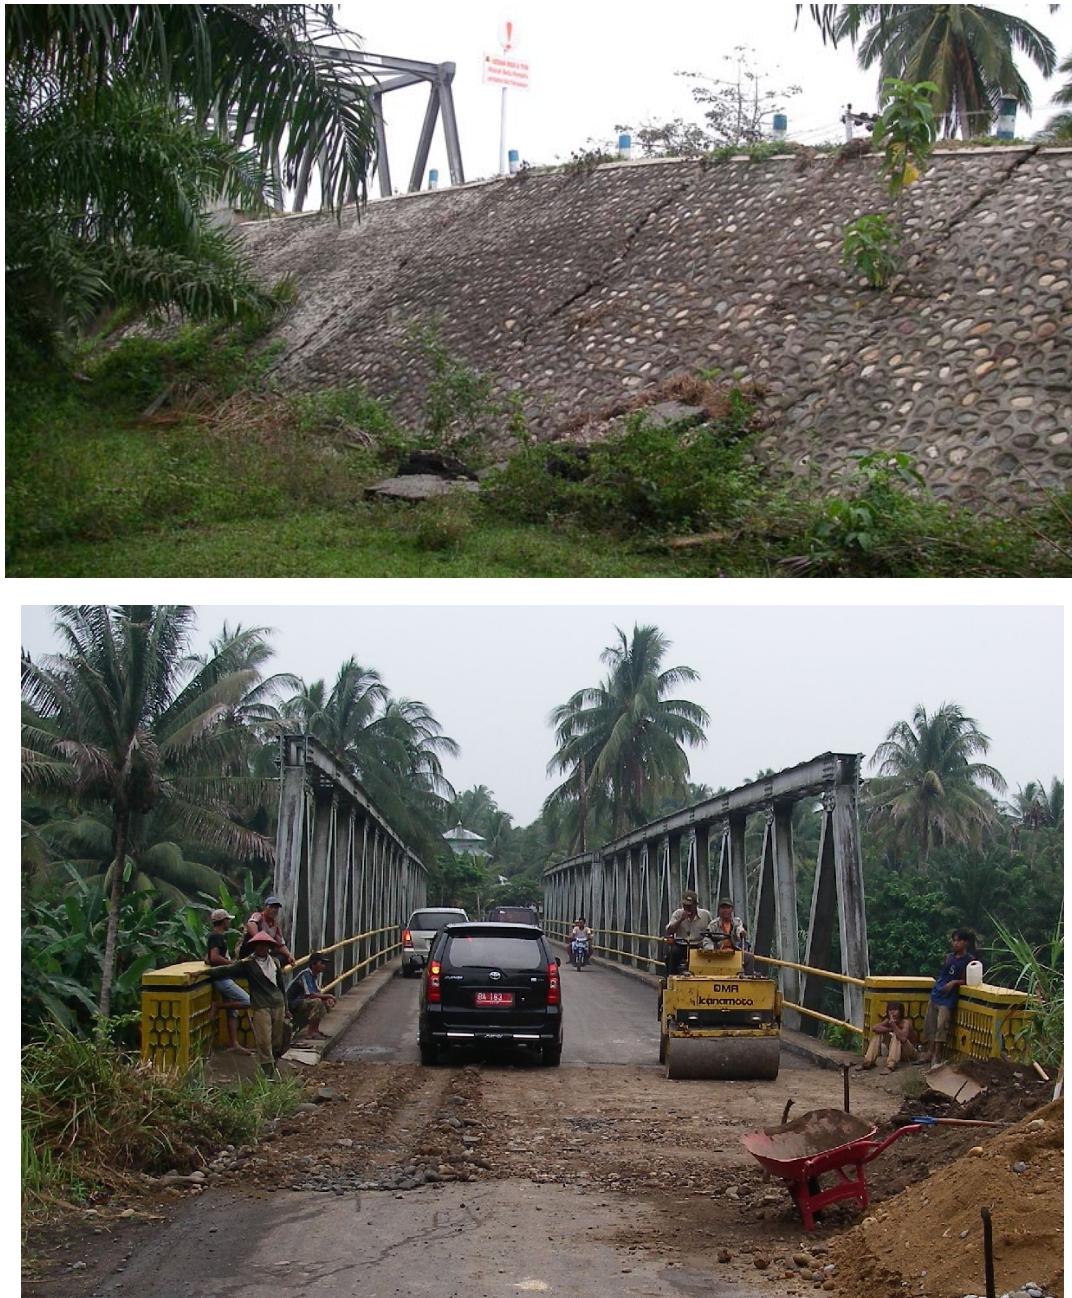
Fig.5.11 Damage to approach embankments of bridges

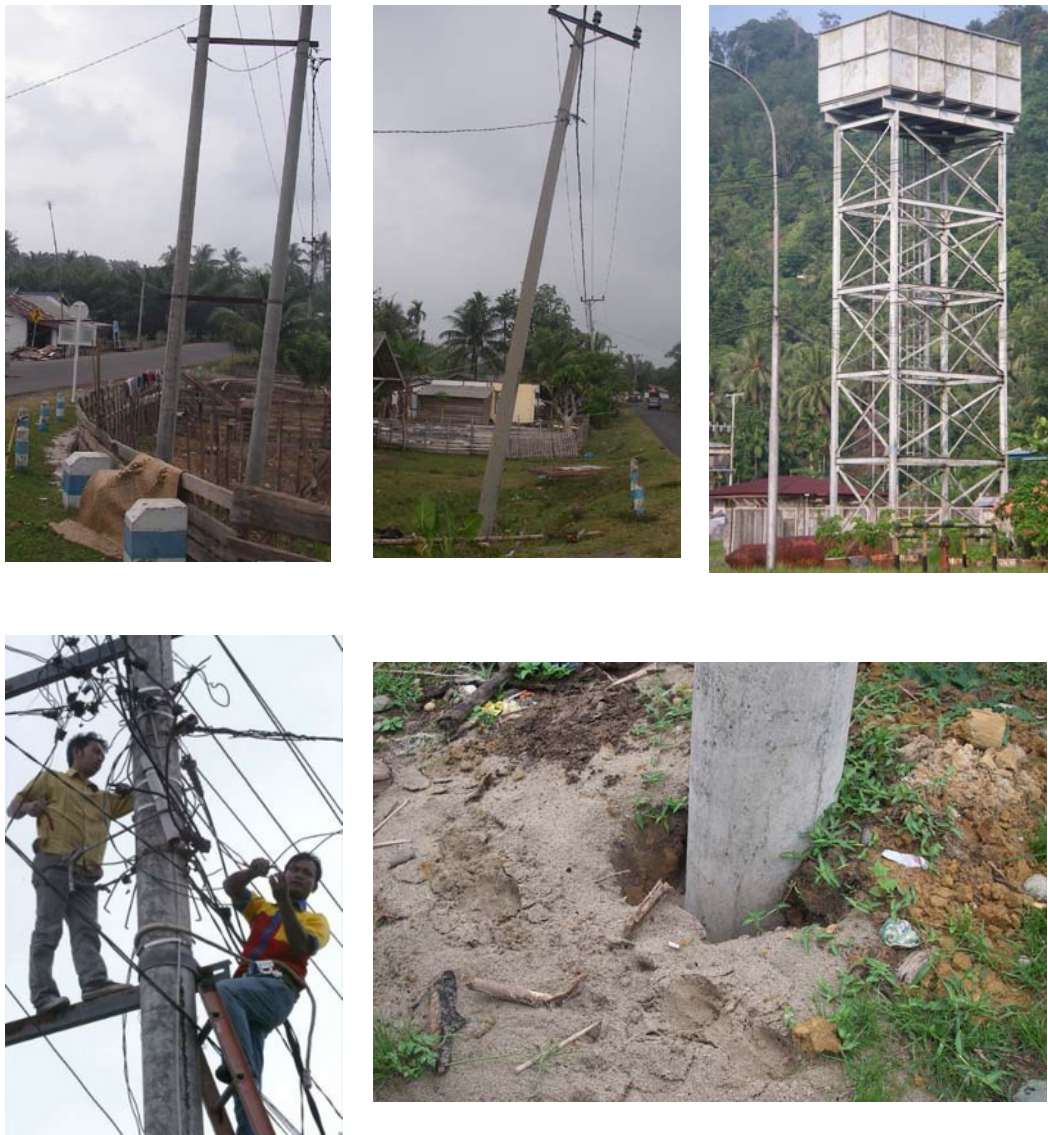
Power lines and communication were cut in the affected region following the earthquake (Figure 5.12). In some areas, electricity has returned to normal soon after the earthquake. At some locations, where shaking or geotechnical damage was heavy, some power lines were damaged. The electricity was fully recovered in the next day.

Fig.5.12 Views of some damage to utility poles and a non-damaged elevated water tank

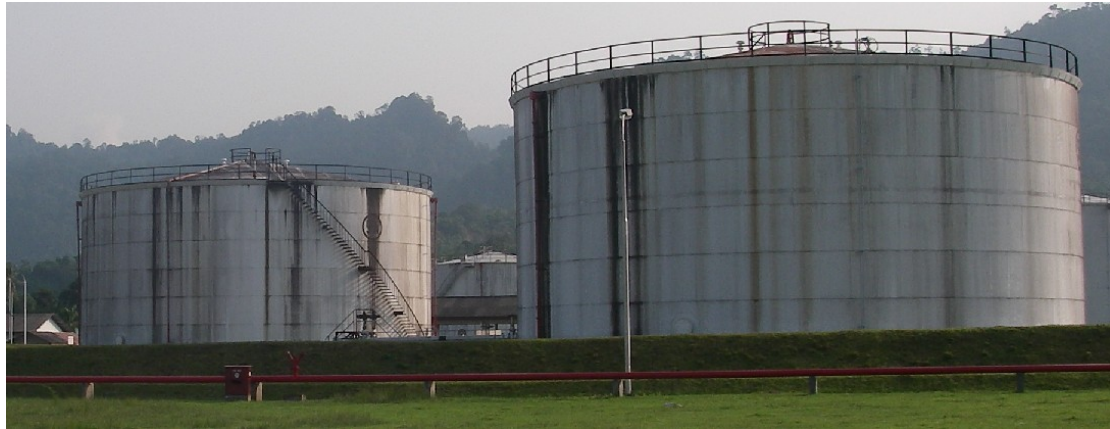
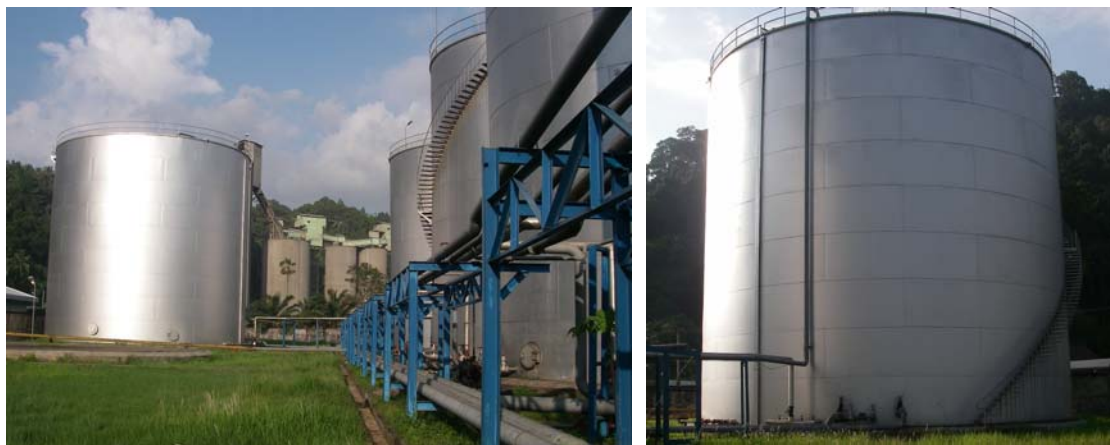
Most of industrial facilities are located in Bengkulu City of Bengkulu Province and in Padang City and Teluk Bayur Port of West Sumatra province. The inspection of some industrial plants between Padang and Bengkulu indicated that the earthquake did not cause any major damage to industrial facilities except some small scale damages to connections and rollers etc. (Figure 5.13 and Figure 5.14)

Fig.5.13 Tank yards in Teluk Bayur Port of Padang Ciity and Painan City

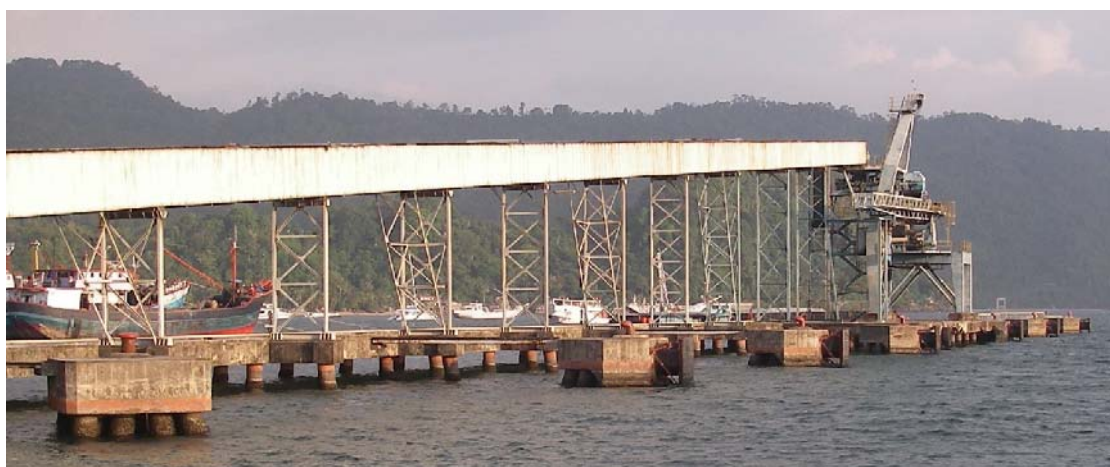
Fig.5.14 Slightly damaged Conveyor of loading facility at Teluk Bayur Port

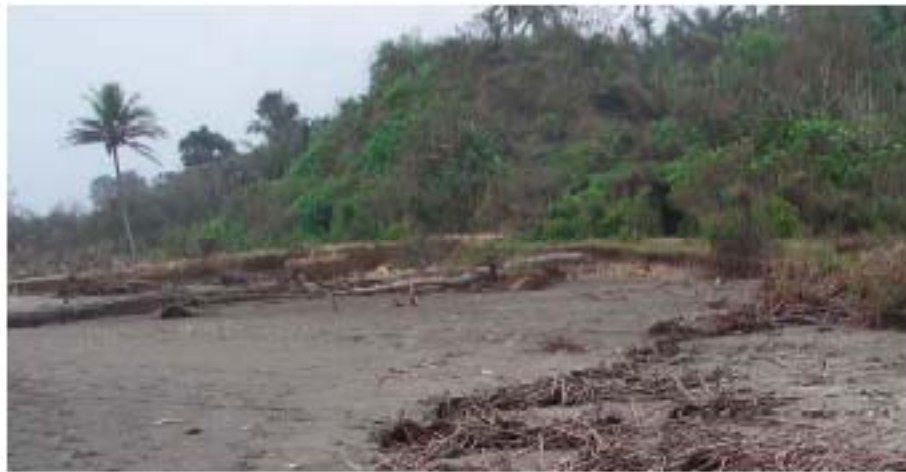
Fig.6.10 Example of tsunami erosion along the coast at Seblant, Koto-bani

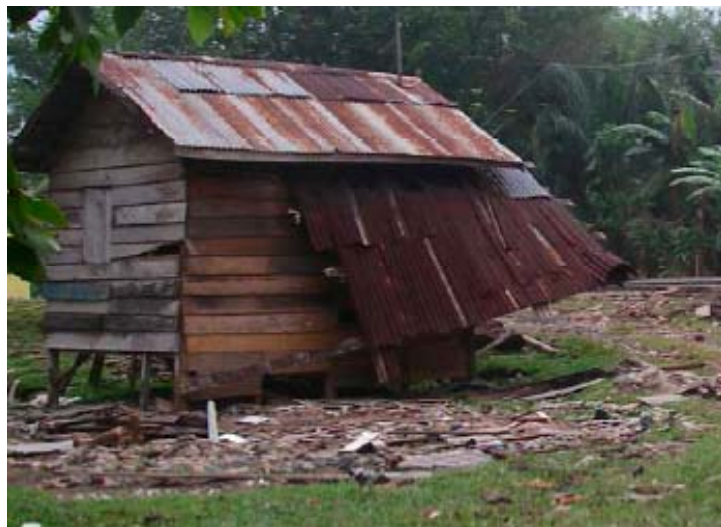
Fig.6.13 The house damaged and moved by the tsunami
