A RECONNAISSANCE REPORT
ON
THE BENGKULU EARTHQUAKE OF SEPTEMBER 12, 2007

2007 Bengkulu Earthquake Reconnaissance Team

Japan Society of Civil Engineers (JSCE)

October 2007

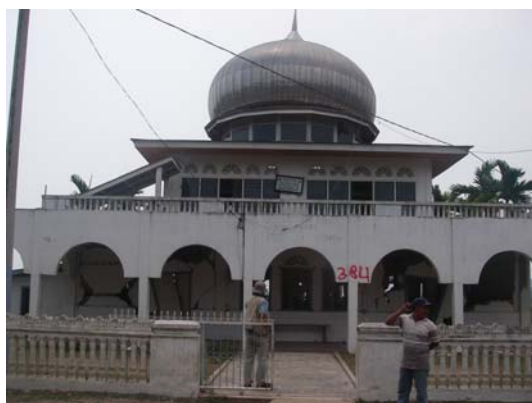
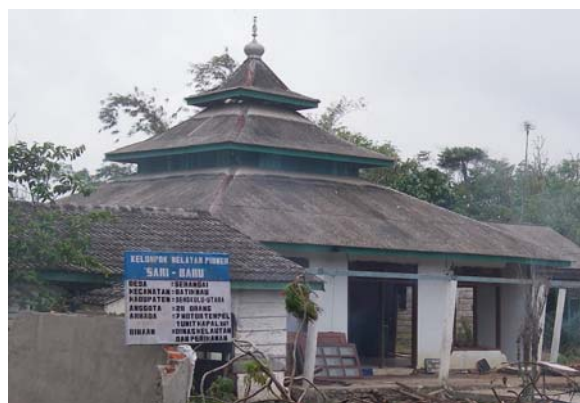
Mosques are semi-reinforced concrete structures. Although reinforced columns and beams are utilized, they are quite small in cross section (15x15 to 20x20cm) and they have 4-6 smooth steel bars with a diameter ranging between 8-12mm. The walls are either hollow cement blocks or bricks. The roof of mosques are generally light. The earthquake caused the failure of outer columns and load-bearing walls at corners and subsequent collapse of roofs (Figure 5.1).

Fig.5.1 Damage to mosques

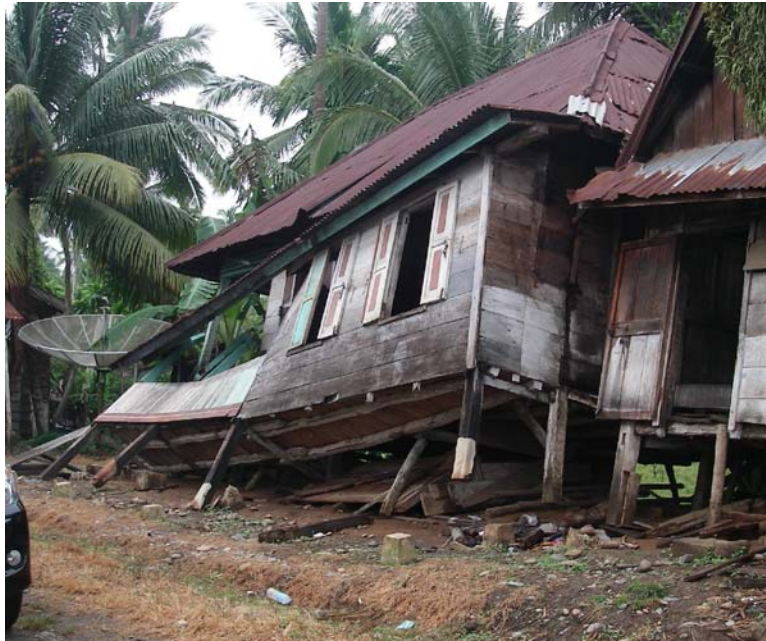
There are many wooden houses. Compared to brick masonry houses with or without RC lintels and/or columns, they performed better and there was almost no total collapse due to ground shaking. However, they failed due to the embankment failures as seen in Figure 5.3

Fig.5.3 Total collapse of a wooden house in Pasir Banting due to embankment failure

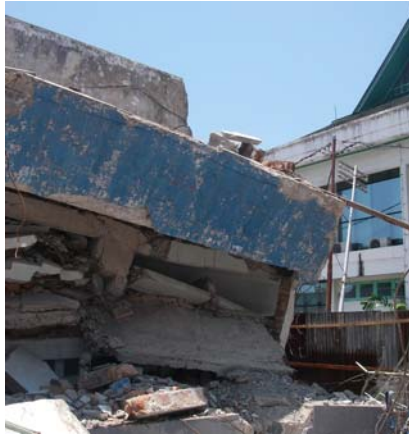
RC buildings with two or three stories suffered heavily from the earthquakes. Many RC buildings either totally collapsed or heavily damaged in Padang City even though they were about 400km away from the epicenter. The reinforced concrete structures are framed structures with integrated or non-integrated in-fill walls. The reinforcing bars are generally smooth and infill walls are built with red-burned solid clay bricks using mortar. The floor height in the region ranges between 3 to 4m. The inspections of the reinforced concrete buildings indicated that they are mainly failed in the pancake mode. RC buildings are generally found in cities and large towns. The concrete buildings having 2 or more stories were either collapsed or heavily damaged. The causes of damage to RC buildings are similar to those observed in other recent earthquakes in Indonesia and elsewhere (Figures 5.4). They may be re-stated for this earthquake as follows:

- a. Soil liquefaction and lack of the soil bearing capacity (particularly in Padang)
 - b. Large ground settlement of embankments nearby river banks
 - c. Fragile structural walls and lack of lateral stiffness,
 - d. Poor concrete quality and workmanship,
 - e. Plastic hinge development at the beam-column joints,
 - f. Lack of shear reinforcement and confinement,
 - g. Soft story,
 - h. Pounding and torsion and
- Ground motion characteristics (i.e. multiple shocks etc.).

Fig.5.4 Examples of damage to RC buildings

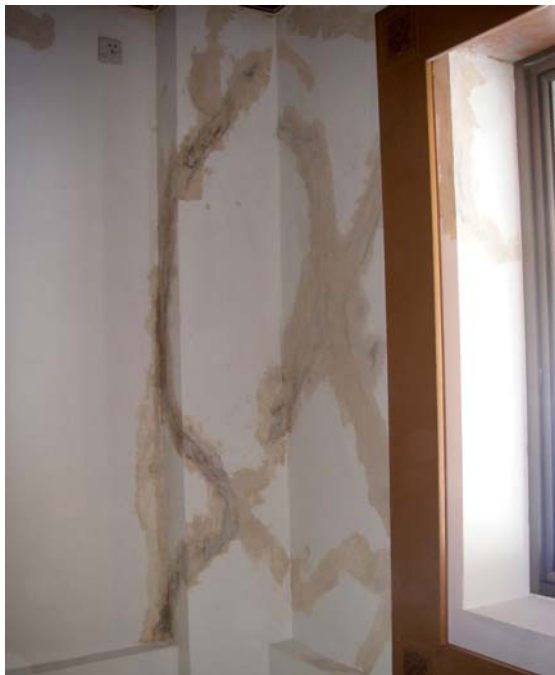
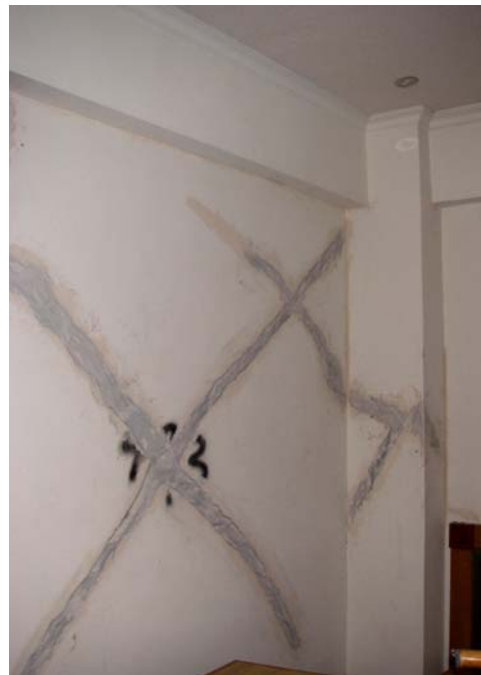
Many RC buildings suffered some damage and repairs implemented are just to re-plaster the cracks caused by the ground shaking (Figure 5.5). These buildings are probably the most vulnerable to collapse during a next strong earthquake.

Fig.5.5 Re-Plastered columns of an RC building used as an hotel in Padang

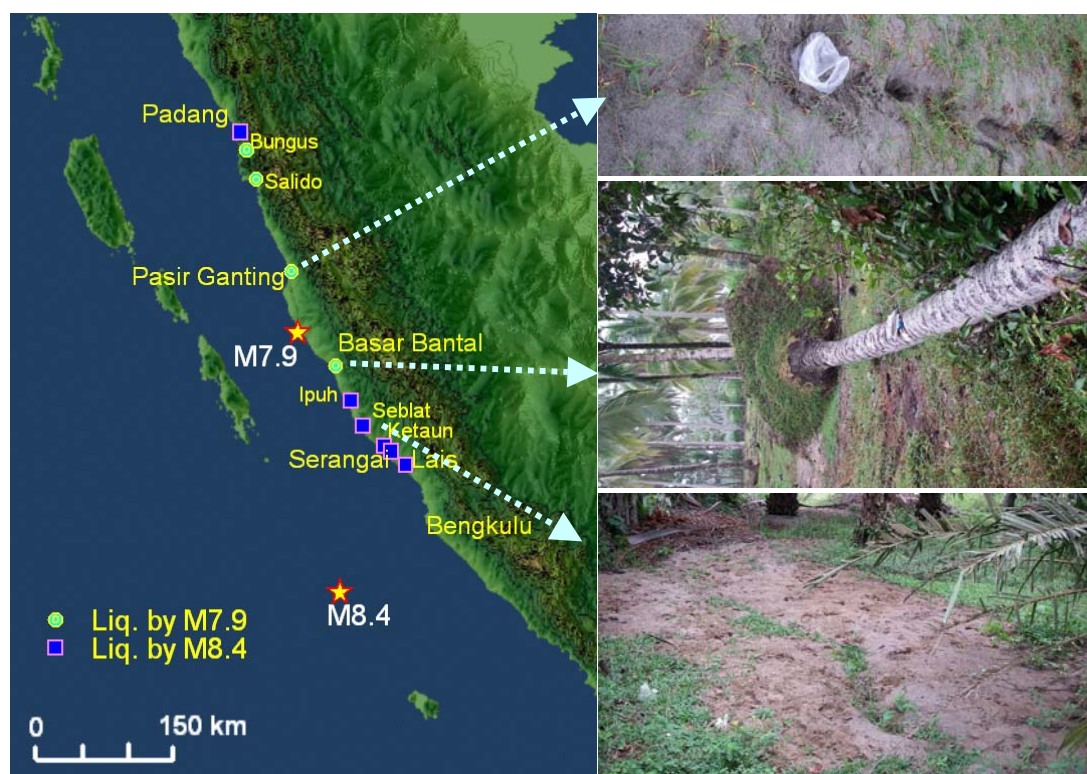
Ground liquefaction were observed in many places along the sea-coast and banks of major rivers (Figure 5.6). Except the heavy damage to a newly constructed 60m long arch bridge by ground liquefaction, the effects of liquefaction on structures such as bridges were quite small. However, the ground liquefaction did cause some damage to abutments of bridges and resulted in the non-uniform settlement of bridge foundations. Furthermore, lateral spreading was observed even in Padang City. The good engineering design bridges against ground failures and liquefaction could be a factor on the limited effects of ground liquefaction on super structure. Figure 5.7 shows the grain size distribution of soil samples from sand boils from Pasir Ganting, Basar Bantal and Seblat bridge.

Fig.5.6 Locations and views of sites where ground liquefaction were observed

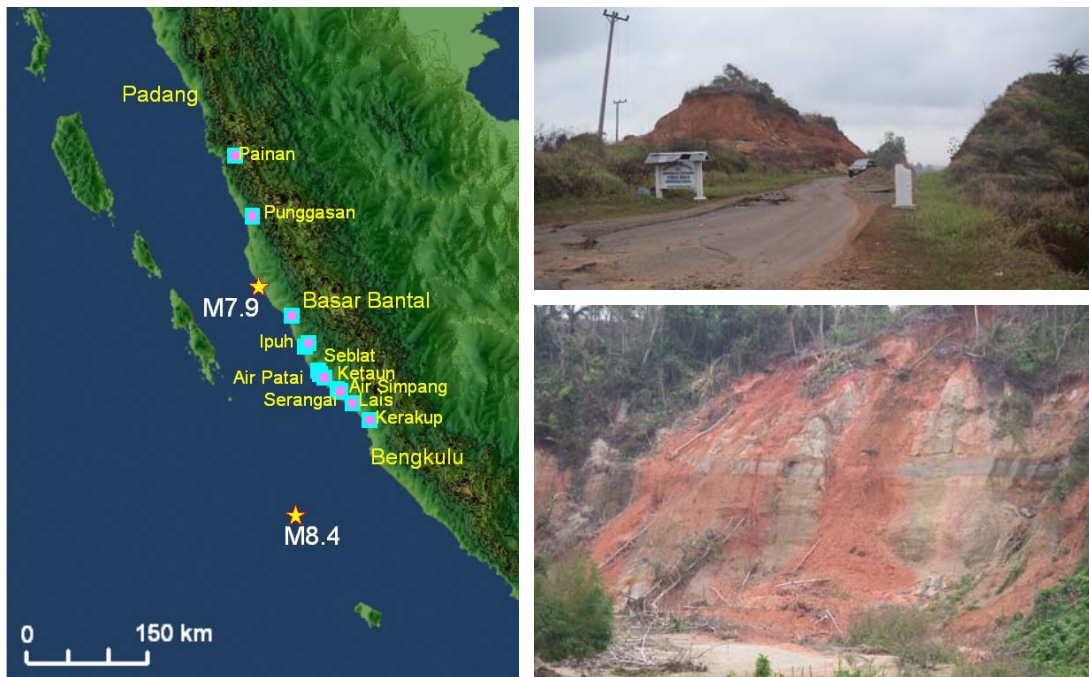
Extensive slope failures observed in along the coastal road between Padang and Bengkulu (Figure 5.7). The number of slope failures between Ketaun and Lais was much higher as compared with those in other areas. The slope failures took place within the volcanic sediments and volcanic sedimentary soft rocks. However, most of slope failures were shallow seated.

Fig.5.7 Locations and views of sites where slope failure were observed

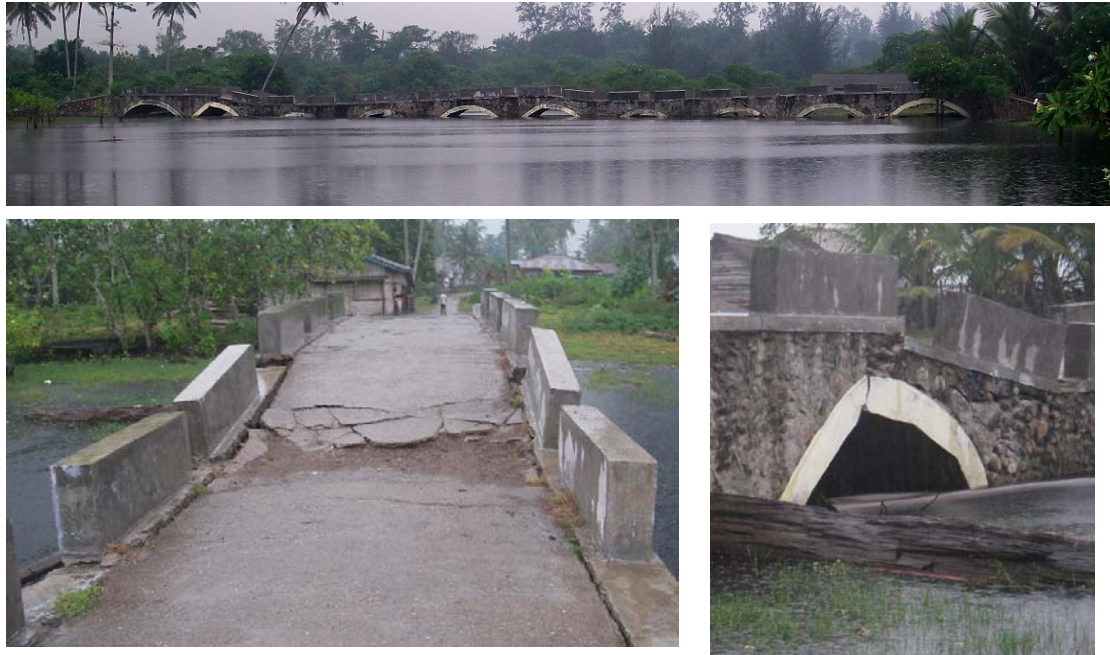
Fig.5.9 Damage to the arch bridge at Pasir Ganting due to ground liquefaction

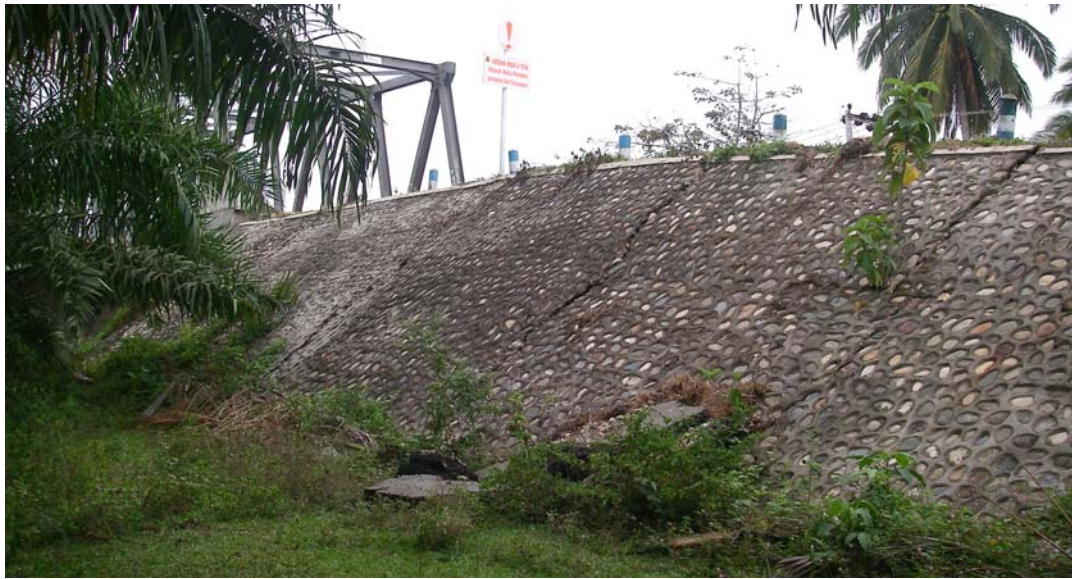
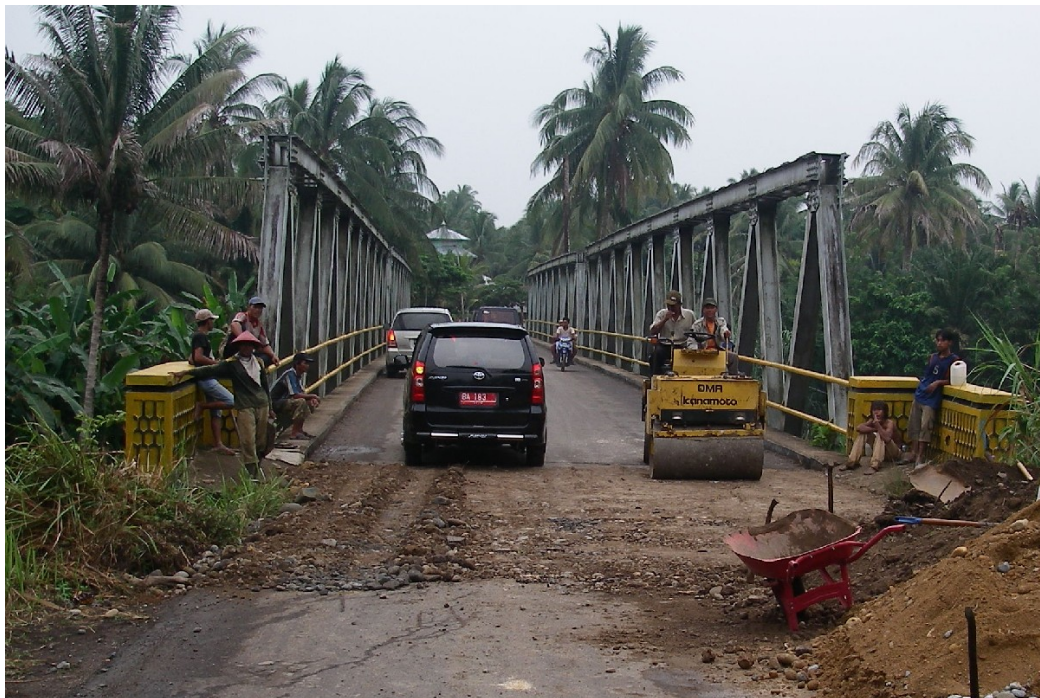
Fig.5.11 Damage to approach embankments of bridges

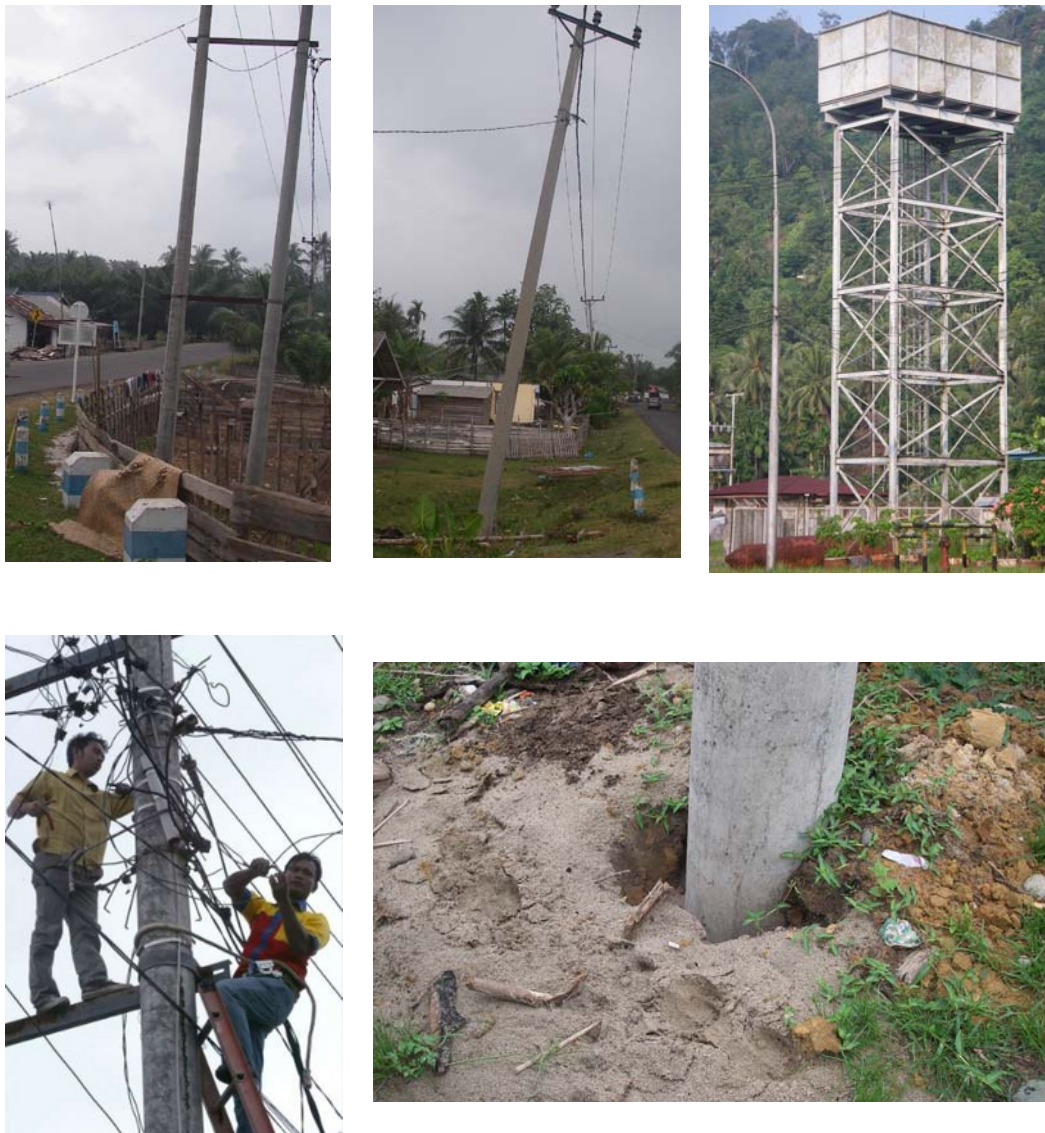
Power lines and communication were cut in the affected region following the earthquake (Figure 5.12). In some areas, electricity has returned to normal soon after the earthquake. At some locations, where shaking or geotechnical damage was heavy, some power lines were damaged. The electricity was fully recovered in the next day.

Fig.5.12 Views of some damage to utility poles and a non-damaged elevated water tank

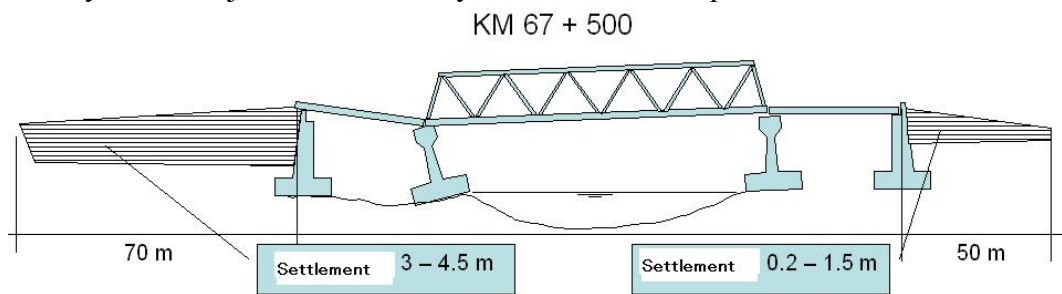
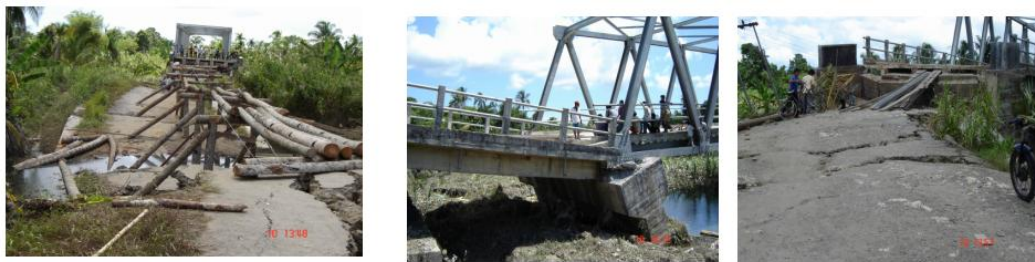
Fig.8.3 Liquefaction induced damage to Muzoi River bridge by 2005 Nias earthquake
