## **Chapter 12**

### **Damage to Lifeline Facilities**

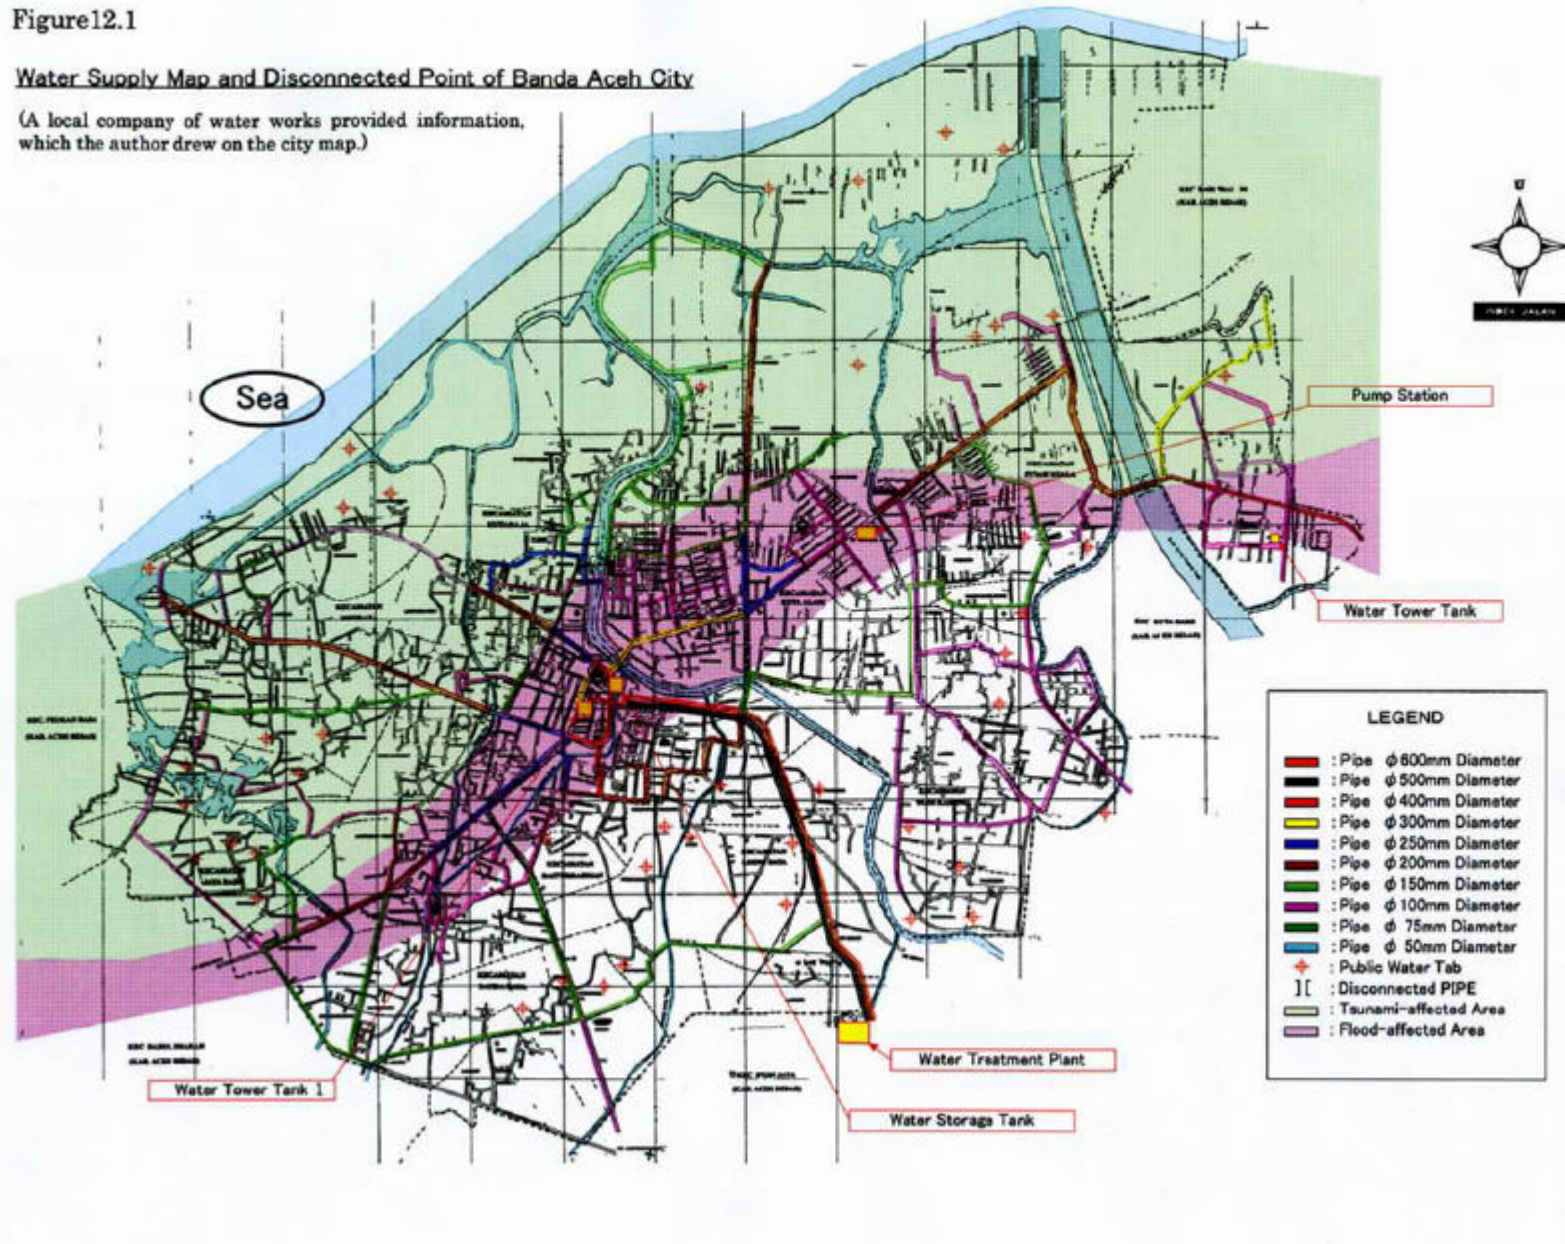
Figure12.1

The general plan of water distribution facilities for Banda Aceh city is shown in Figure 12.1. Major break places of the distribution network by the tsunami disaster are shown in the figure. Also in the figure, the tsunami-affected area and its run-up area are distinguished by different colors.

Water Supply Map and Disconnected Point of Banda Aceh City

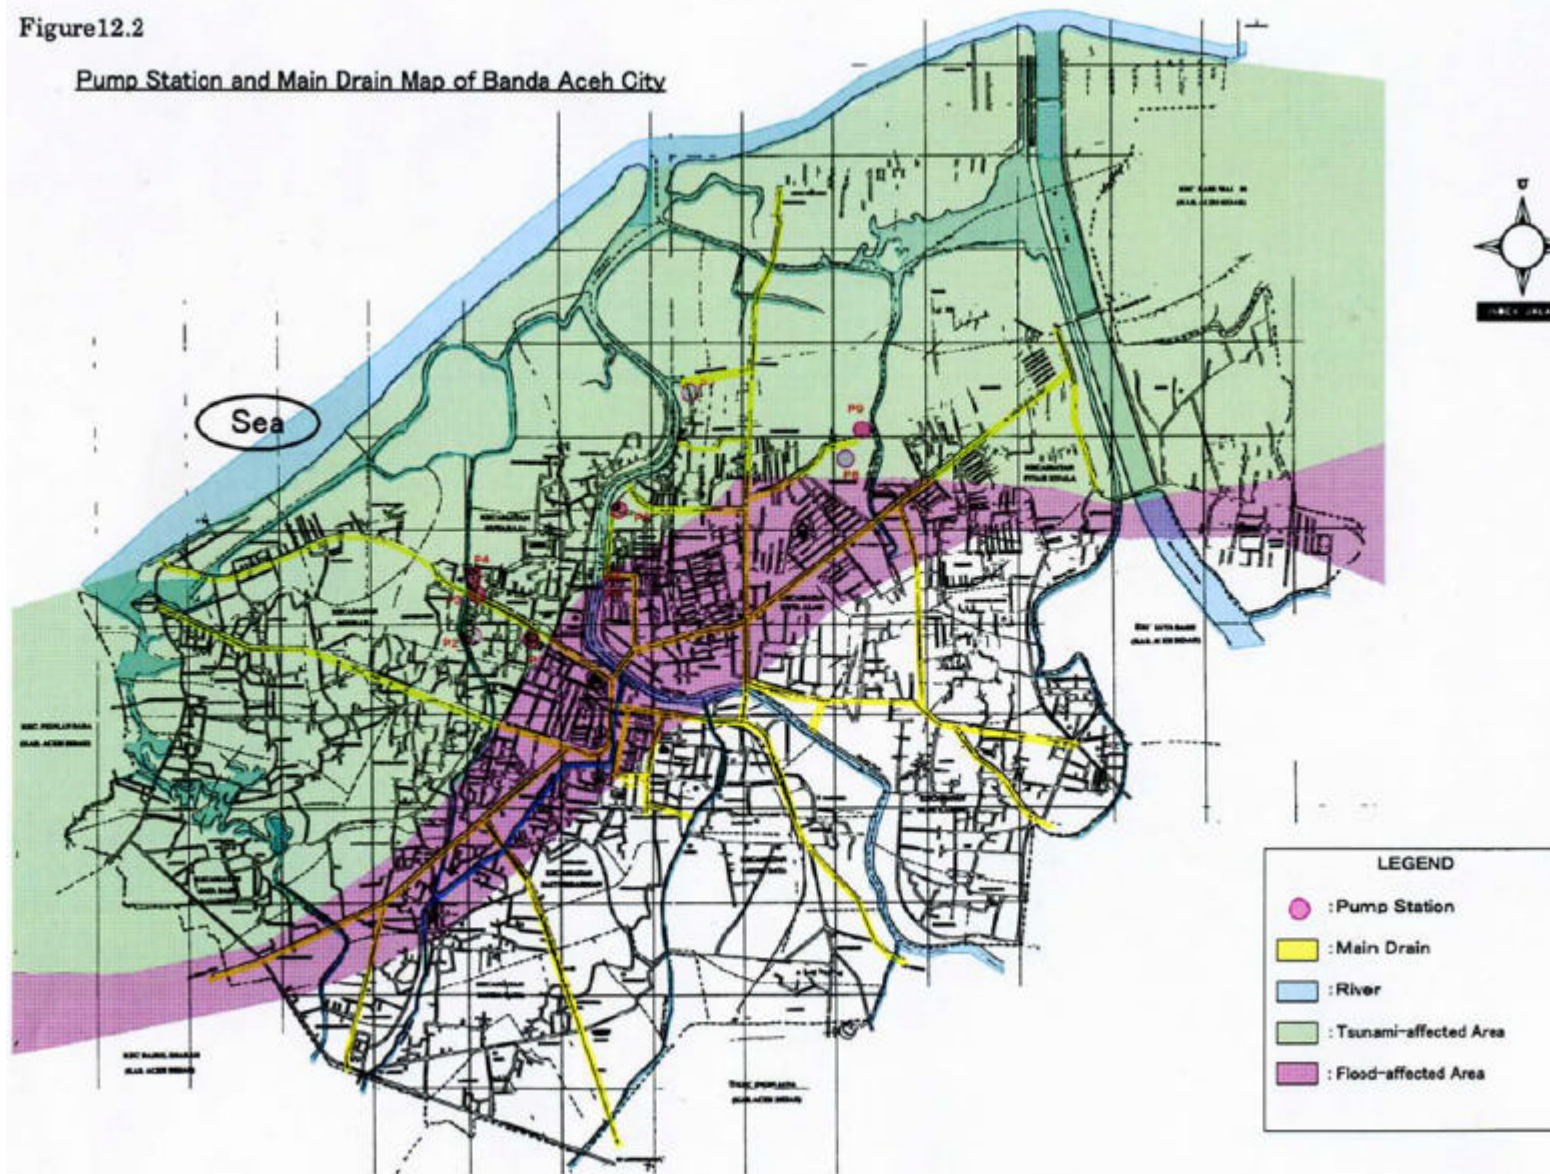
Figure12.2

Figure 12.2 shows the location of drainage pump stations and main drains in Banda Aceh City. The area, where the pump stations are located, is a low-lying urban area. The tsunami affected zone are back shaded in the same figure. All the pump stations from P2 to P9 except P1 were washed away by the tsunami and the drainage system is almost out of order. The drain ditch in the low-lying area has been clogged by debris, mud and sand carried by the tsunami, as shown in Photo 12.6. The backhoe during the cleaning work of debris is seen behind. The stocked water supply pipe has been scattered in mud at a water supply pump station as shown in Photo 12.7.

Pump Station and Main Drain Map of Banda Aceh City

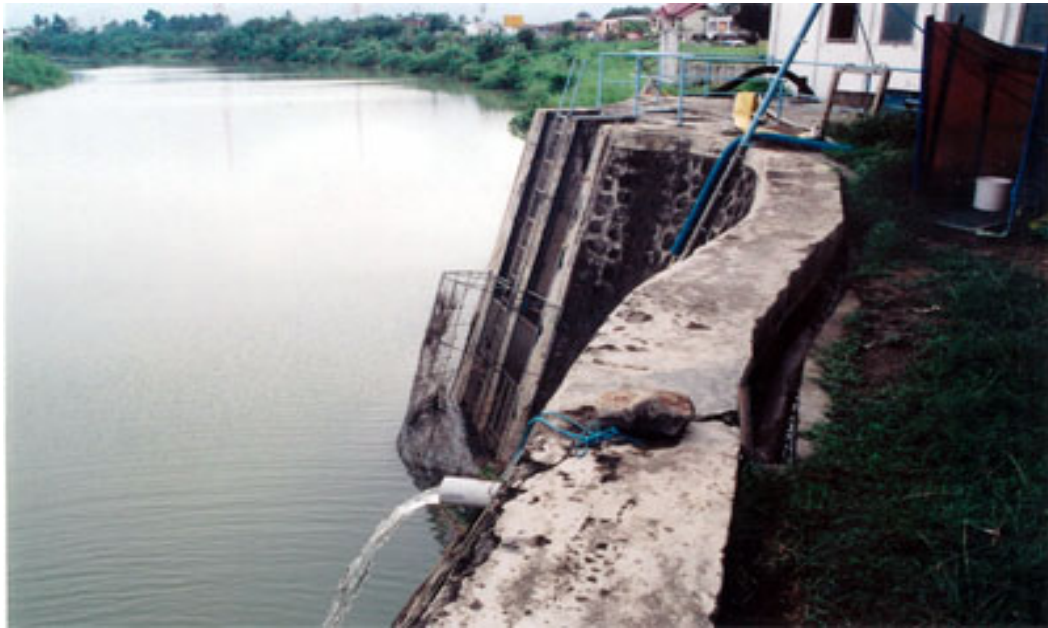
Photo 12.1 Intake site

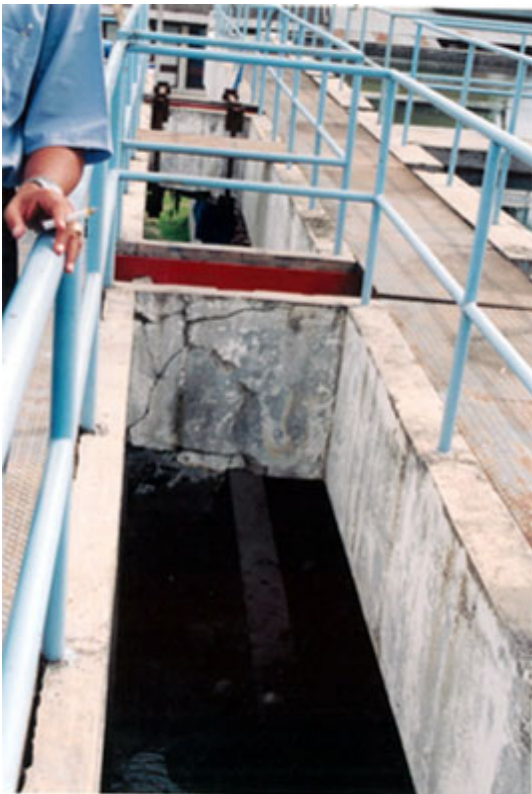
Photo 12.2 Emergency measure  
at the treatment plant

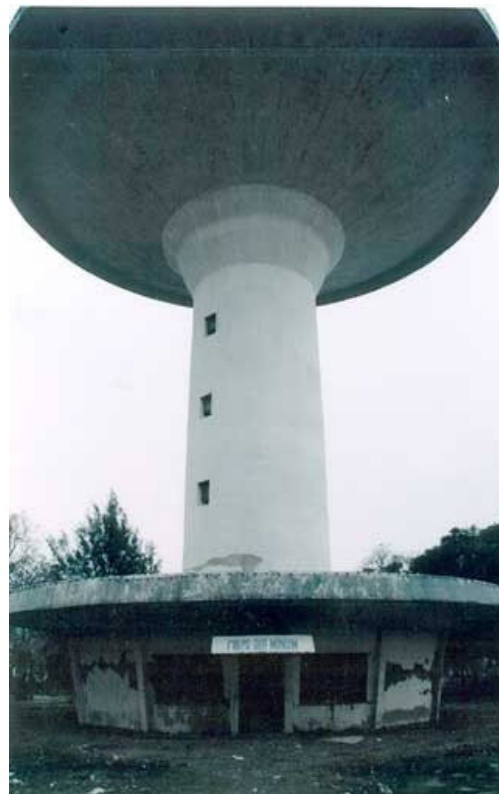
The elevated tank 1(2,000m<sup>3</sup>) of Photo 12.3 had not been functioning before the earthquake. However, the foundation of the tank was seriously damaged by the bending stresses caused by the earthquake. The tank should be demolished as soon as possible for safety reasons. The pipe next to the bridge nearby the Great Mosque crossing the Aceh River was washed away by the tsunami. As seen in the left picture of Photo 12.4, a rubber hose is temporarily installed on the river bed for water transmission to the other side of the river. The elevated Tank 2 of Photo 12.5 was also damaged with some minor cracks by bending stress in its foundation. Now the tank is used for emergency raw water supply from the nearby river. The water supply in the city is still critical now.

Photo 12.3 Water tower tank 1

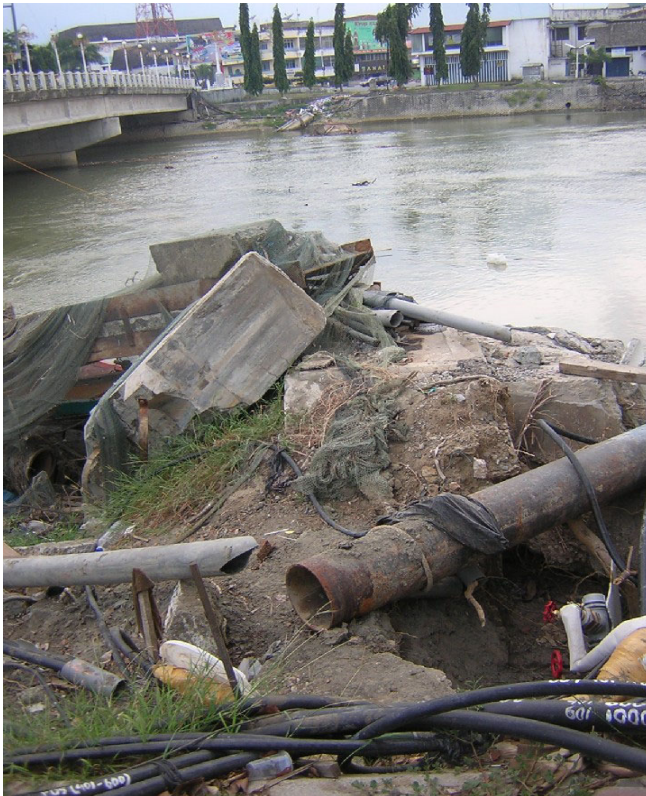
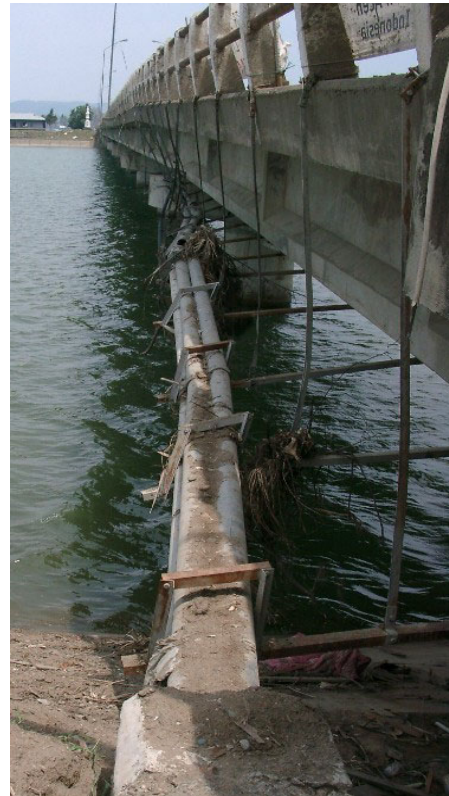
Photo 12.4 Broken water pipes nearby or attached to bridges

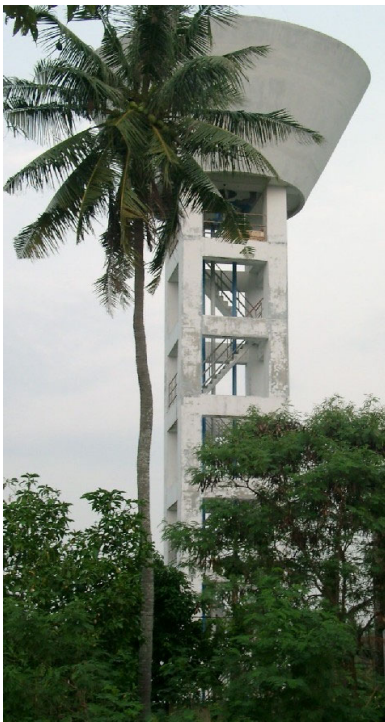
Photo 12.5 Slightly damaged elevated water tank 2

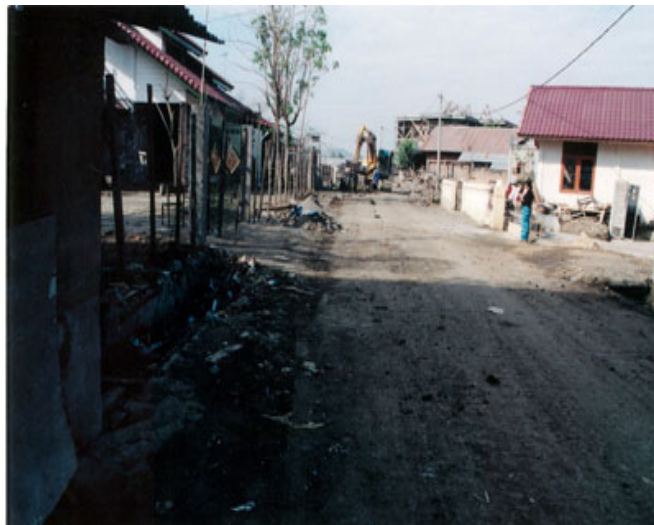
As domestic wastewater is flowing into the drainage system and water in the drains is stagnated at the moment, the hygienic environment is extremely poor. Immediate improvement is required.

Photo 12.6 Drain ditches are clogged with mud and debris. Backhoe is operating for removal of deposit of the flood.

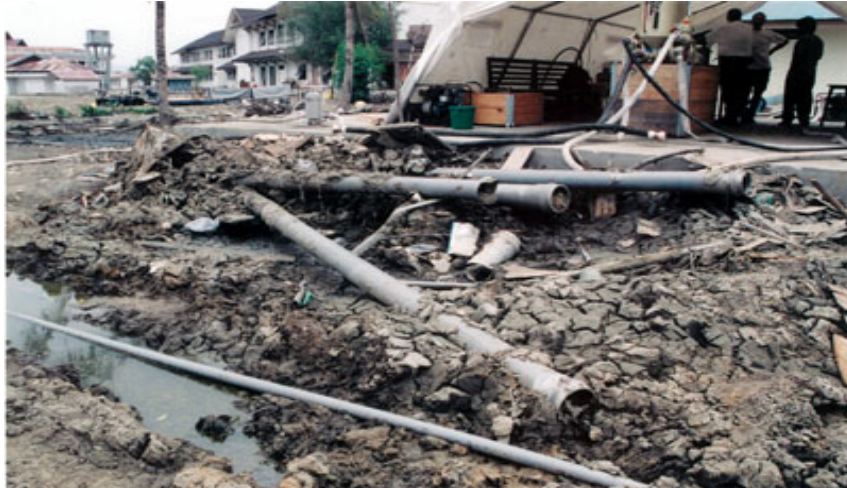
Photo 12.7 Scattered transmission pipe around pump station

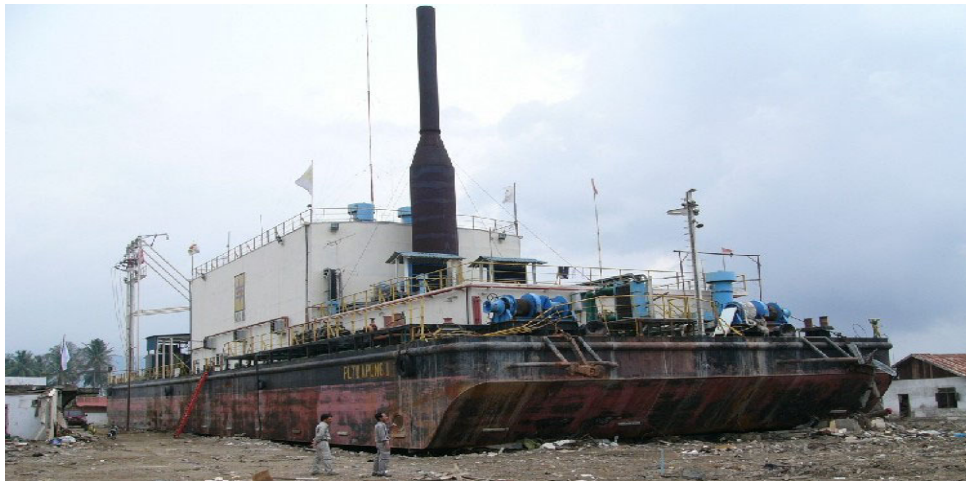
The power generation in the earthquake affected area is attained through thermo-electric power plants located on the land and on barges at the shore. The power generation plants (38MW) built on higher ground were not affected by the ground shaking, and they are operational. However, the power generators on barges at the seashore were displaced from their mooring wharfs into the land. For example, the barge with thermo-electric power generator (7.5MW) in Ulhe Lhee district was displaced 3km inland by the tsunami (Photo 12.8). Since almost one third of the city and its population were destroyed by the tsunami, the loss of power generators on the barges does not directly affect the excess supply capacity of electricity for Banda Aceh city.

Photo 12.8 Displaced barge with a thermo-electric power generator

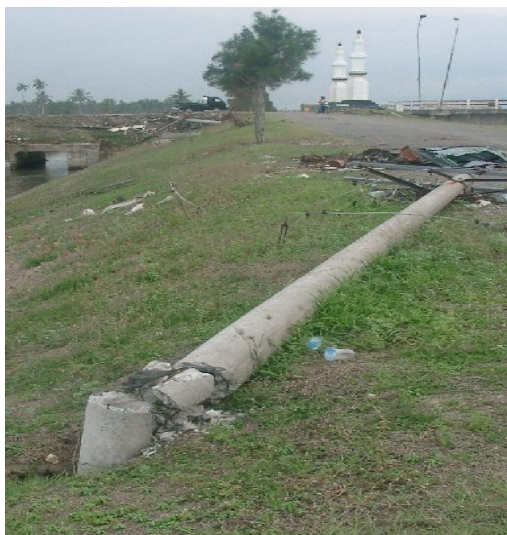
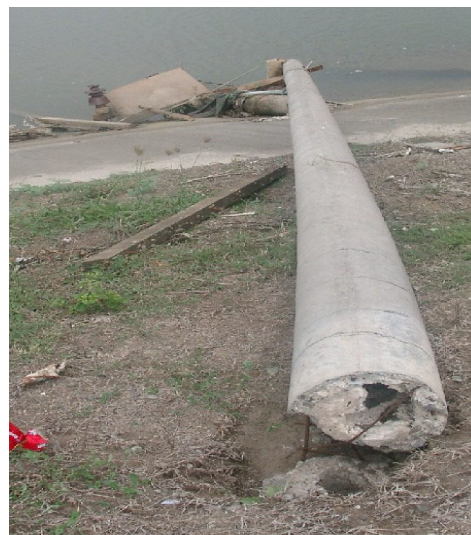
Many RC electric poles were broken in the area affected by the tsunami (Photo 12.9). However, either ground shaking or the tsunami did not damage transmission facilities from Medan (10MW).

Photo 12.9 Broken electric distribution poles
