Chapter 7

Damage to Buildings

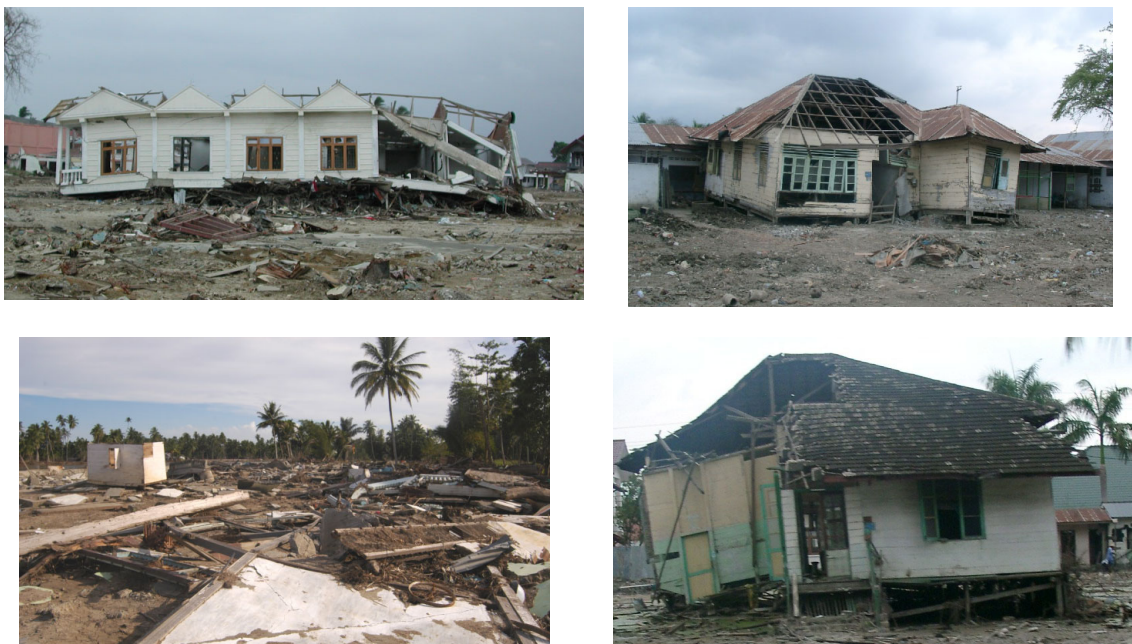
Wooden houses are generally single story or two story buildings. These buildings were almost non-damaged in the regions, which were not affected by the tsunami. Therefore the main cause of the damage was tsunami. The tsunami may impose at least four types of loading, namely, impact force, drag force, hydrostatic water loading and buoyancy (uplift) force on wooden buildings. While impact and drag forces directly related to the velocity of tsunami, the hydrostatic and buoyancy forces depend upon the tsunami height and relative density differences between the building material and tsunami waves. Photo 7.1 shows some examples of damage to wooden houses.

Photo 7.1 Damage to wooden houses

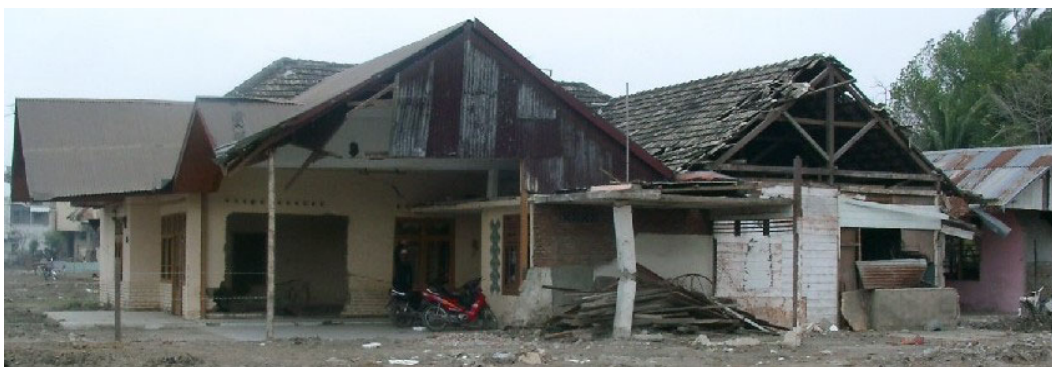
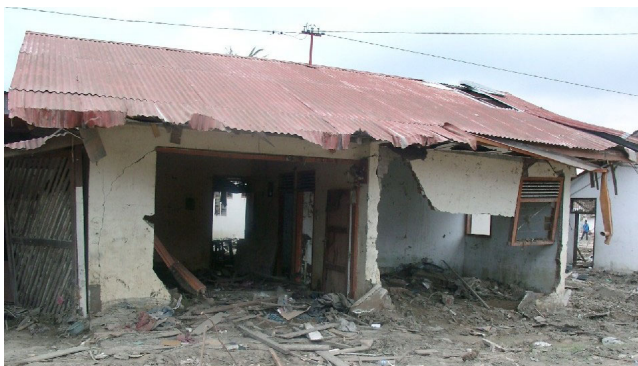
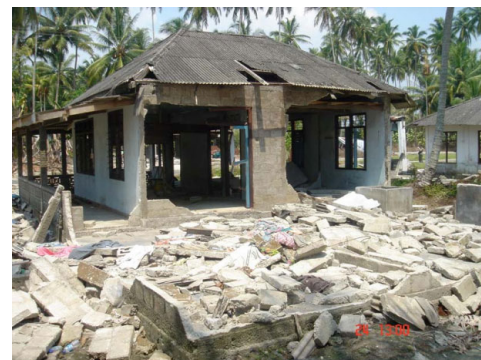
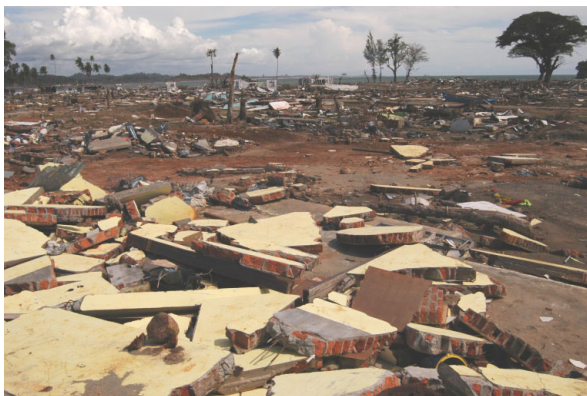
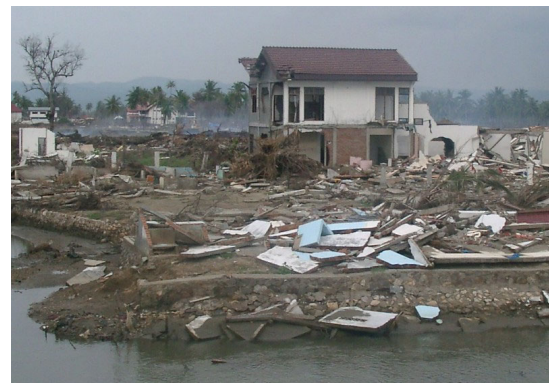
Masonry (brick) houses are generally single story buildings and some of them could be 2 story buildings. Solid red clay bricks or hollow concrete blocks were used for constructing the adobe houses. Although concrete column and slabs are utilized during the construction, they are merely used for achieving structural integrity. These buildings were not damaged in non-tsunami affected area. However, they were completely destroyed when the tsunami waves hit these structures. It seems that the impact force of the tsunami waves were quite high from the state of debris and the fallen tree trunks. The other force components of the tsunami waves could be drag forces and hydrostatic water loads. When the masonry (brick) houses are still standing, their walls were punched out. Photo 7.2 shows some example of damage to masonry (brick) houses.

Photo 7.2 Damage to masonry (brick) buildings

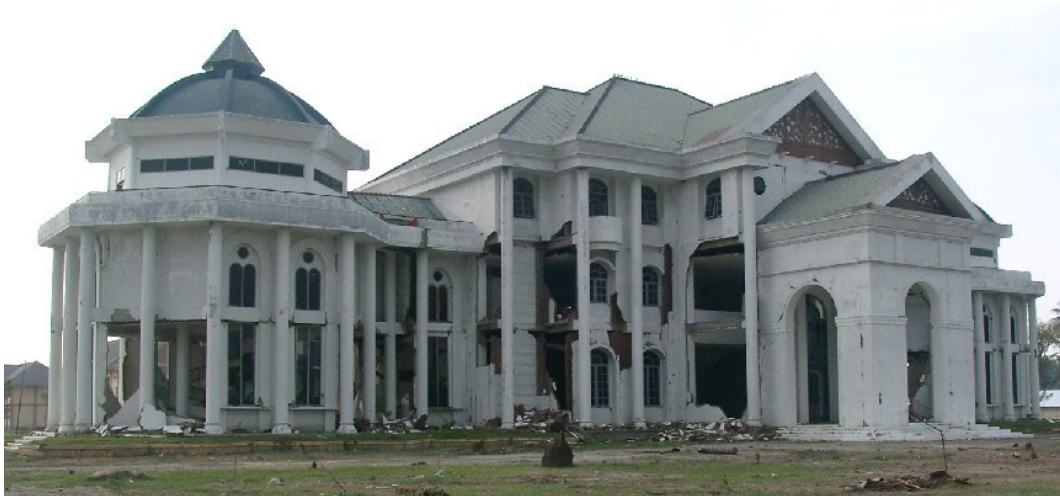
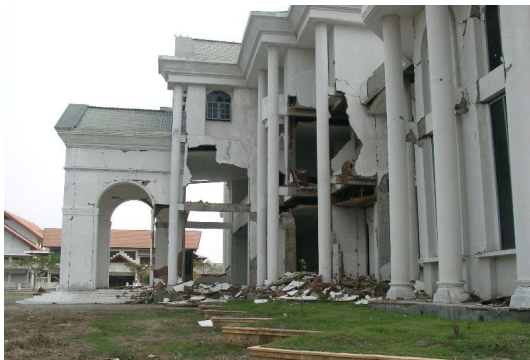
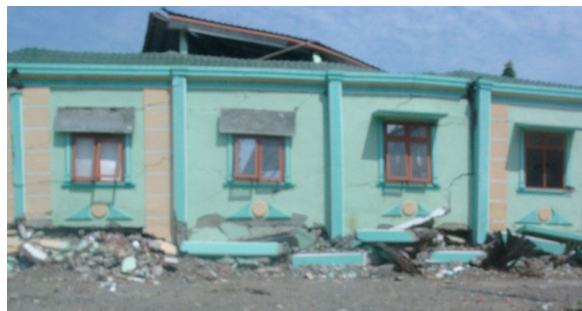
Most of RC buildings have 2 to 3 stories. Nevertheless, new buildings for governmental offices and shopping malls have more than 3 stories. Commonly their story number is 5. The common construction procedure for RC buildings is to construct the walls first and then cast the concrete columns and finally the slab concrete for a typical story and repeat the same procedure for the rest of stories. However, the new buildings are constructed as a frame structure by casting concrete columns and then slab concrete first and finally filling the space with solid brick in-fill walls. The floor height ranges between 3 and 4m. There was no structural damage to RC buildings having stories 3 or less than that in non-tsunami affected area. However, almost all new buildings having heavy weight on upper stories collapsed or heavily damaged in non-tsunami affected area (Photo 7.3). The collapses were mainly due to plastic hinging at column-beam connections due to the lack of required column size and stir-ups, hooking and confinement. Furthermore, the quality of concrete and workmanship were quite poor and the diameter of reinforcement bars was insufficient. The in-fill walls were too slender and they were easily separated from the concrete frame and came down by out-of plane failure mode. Besides the structural and constructional problems of RC buildings, the soft ground conditions may also play some roles on the collapses or heavy damage. The collapsed or heavily damaged RC buildings were constructed nearby rivers or swampy areas.

Photo 7.3(a) Collapsed or heavily damaged RC buildings

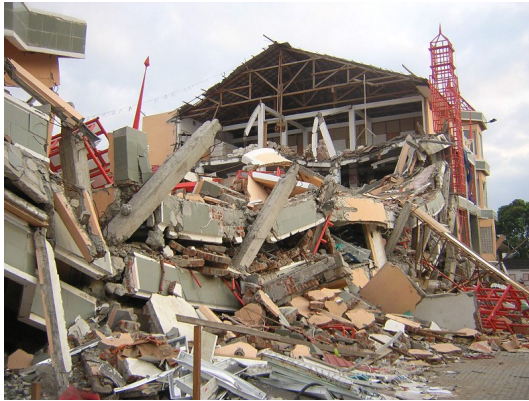
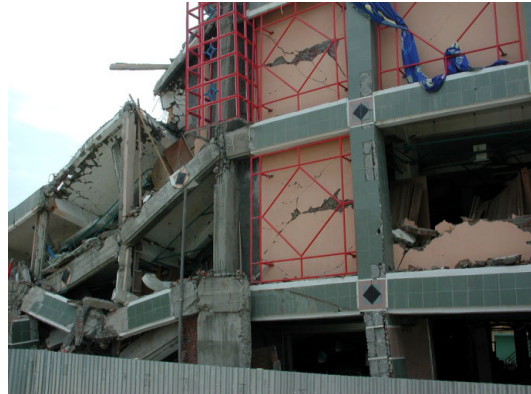
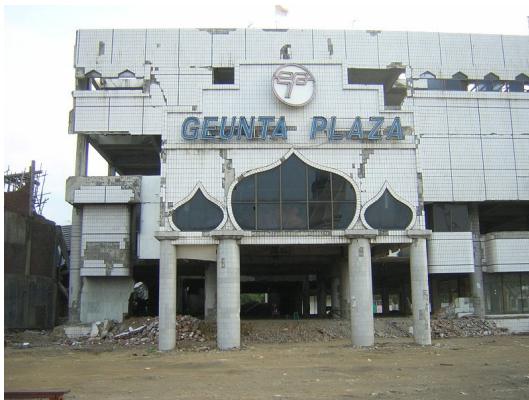
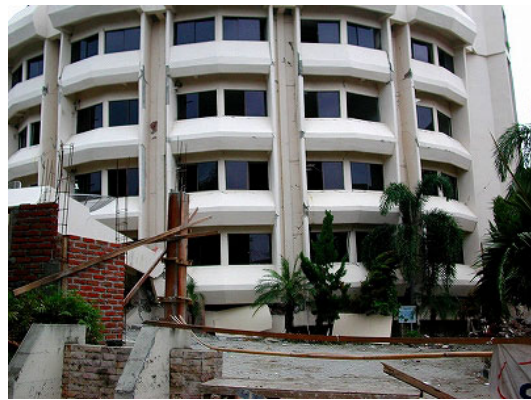
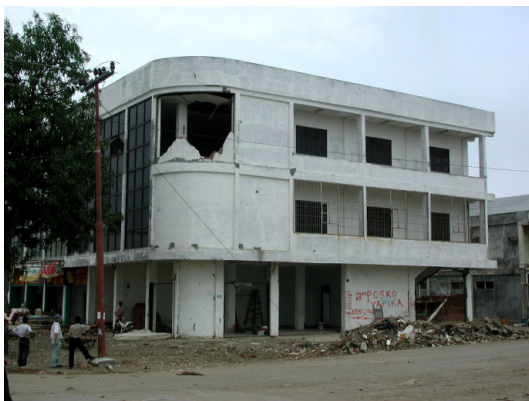
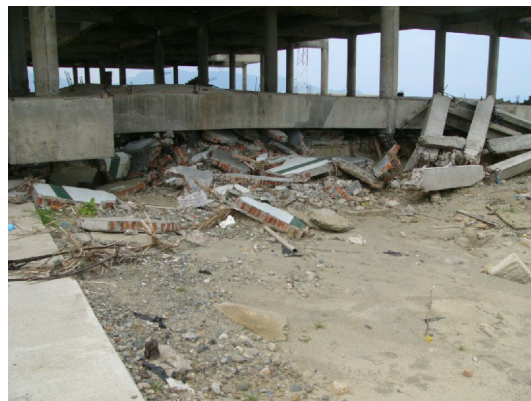
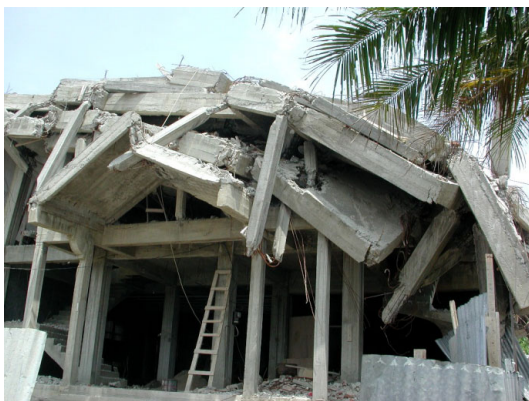
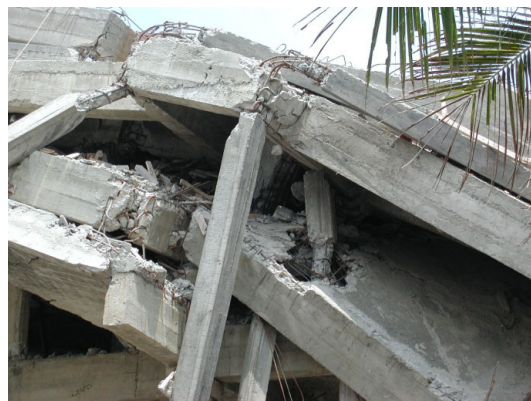
Photo 7.3(b) Collapsed or heavily damaged RC buildings

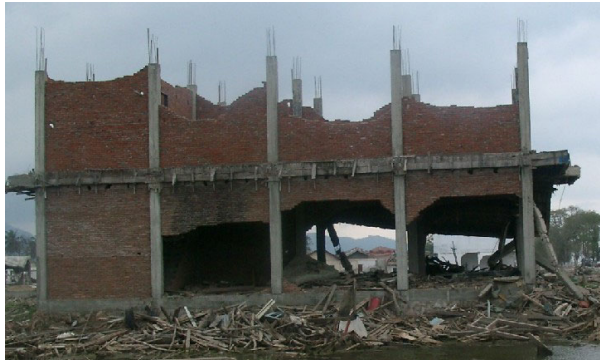
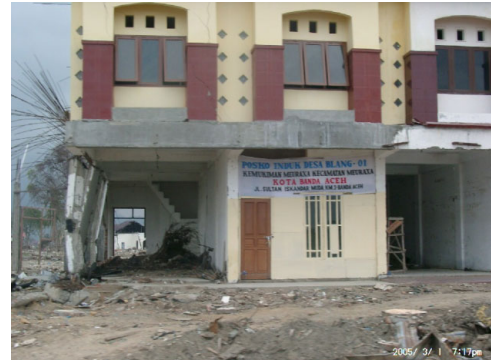
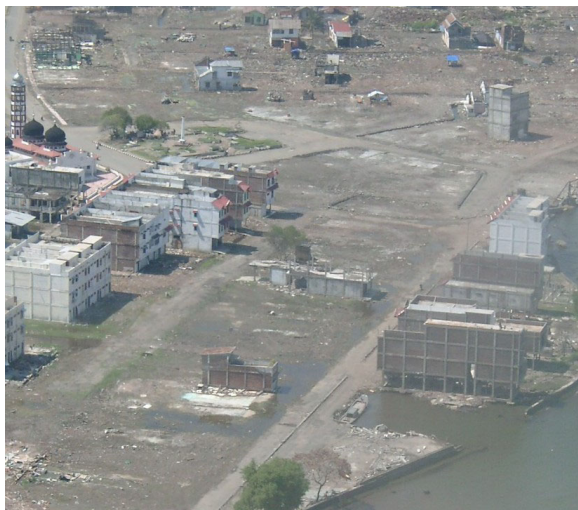
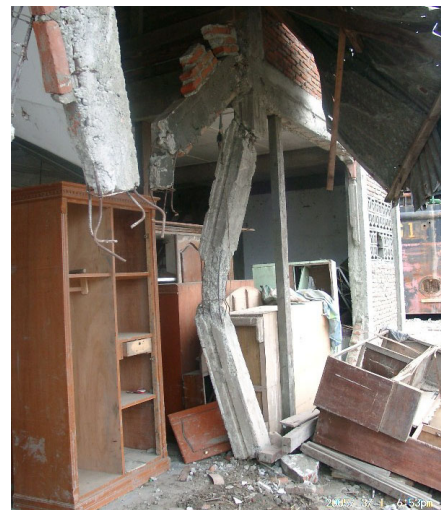
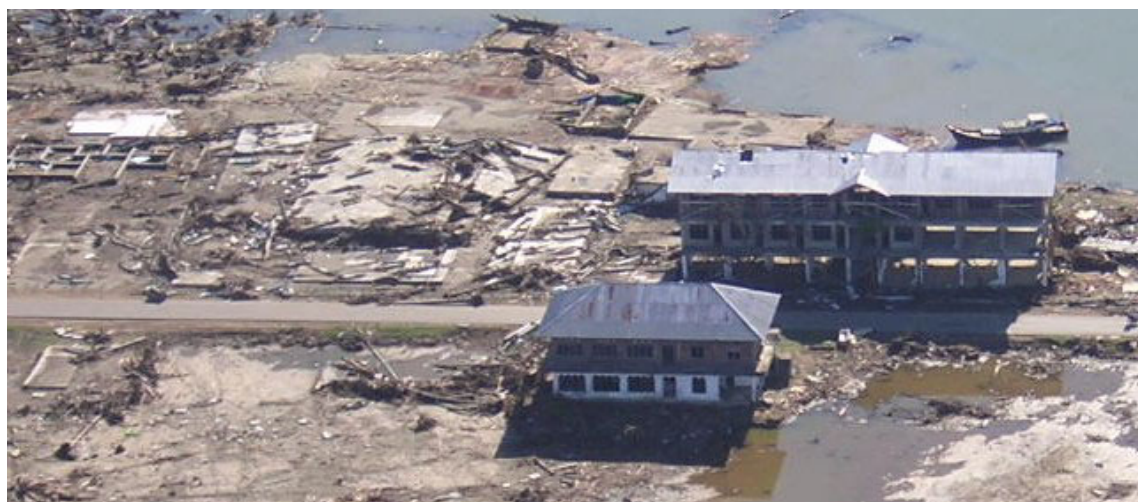
The RC structures in tsunami-affected areas have stories ranging between 2 and 3. Some of columns were broken and in-fill walls were punched out by the impact forces of tsunami waves and tsunami-dragged objects (Photo 7.4). Nevertheless, some of them survived against the ground shaking and also the forces resulting from tsunami waves. The columns were generally ruptured or fractured at their mid-height, which implies that there were subjected to high bending forces. Furthermore, the broken columns and punched-out walls were facing the direction of the in-coming tsunami waves.

Photo 7.4 Damage to RC buildings in tsunami-affected area

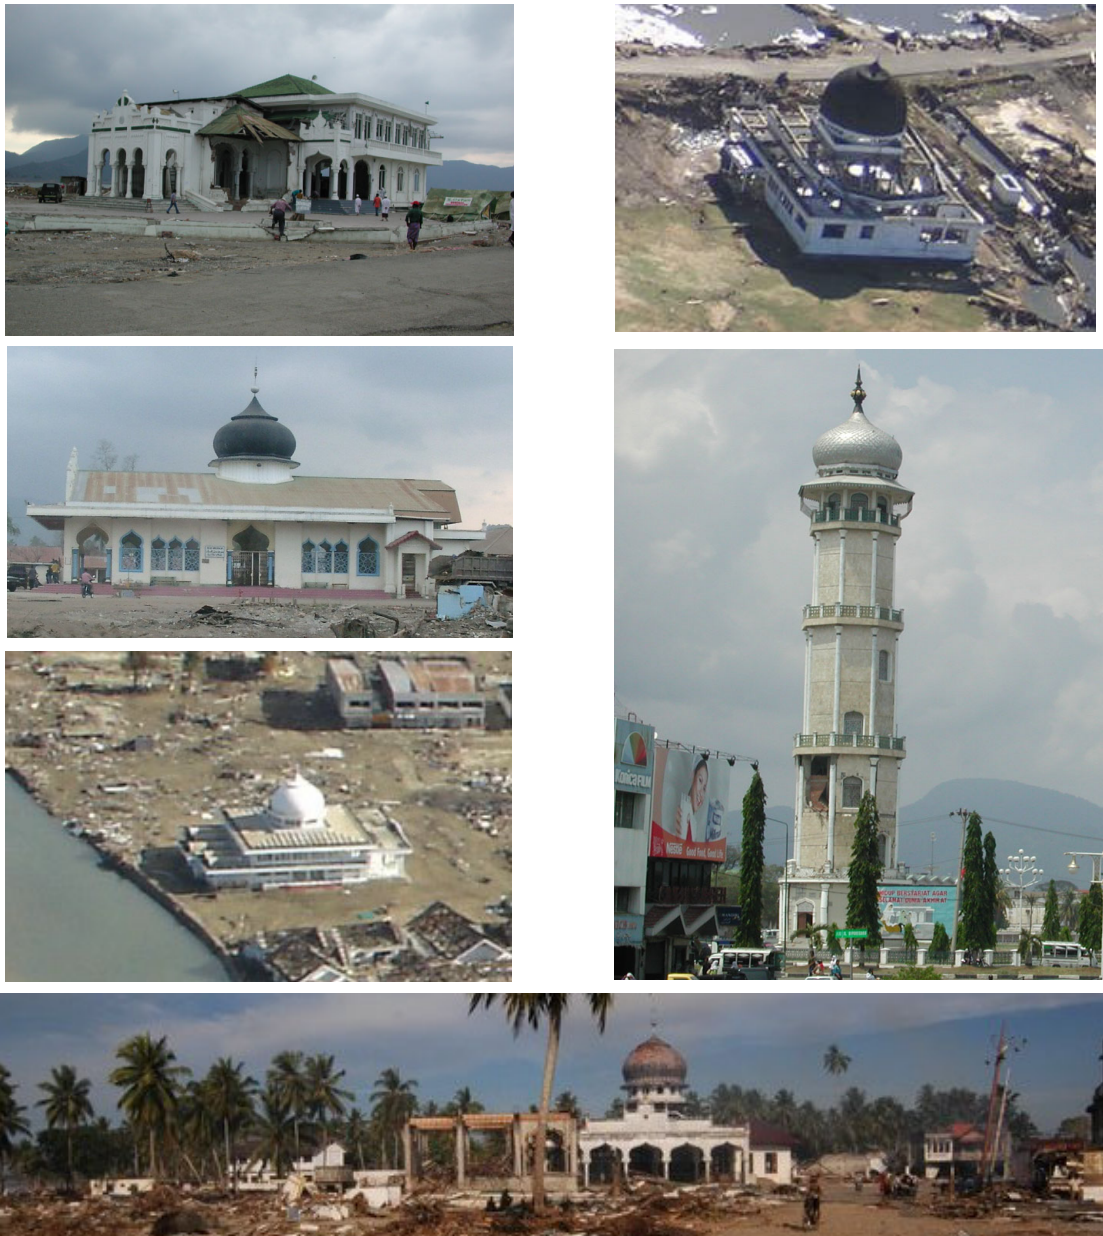
Mosques are generally built as single story RC structures. Due to tropical climate of the area, there are almost no in-fill walls. Most of the Mosques survived against the ground shaking and tsunami waves even in the severely hit areas (Photo 7.5). The possible reason for such a good performance against tsunami may be associated with its columnar structure without in-fill walls. One of the few mosques damaged in this earthquake is in Ulehle district. The central RC column of the wall facing the sea was fractured by bending at mid-height. Many mosques built as masjid having no minarets. The grand mosques in Banda Aceh and Meulaboh have only minarets. Their minarets were lightly damaged.

Photo 7.5 Damage to mosques and minarets
