Chapter 9

Damage to Industrial Facilities

9.1 Cement Plant

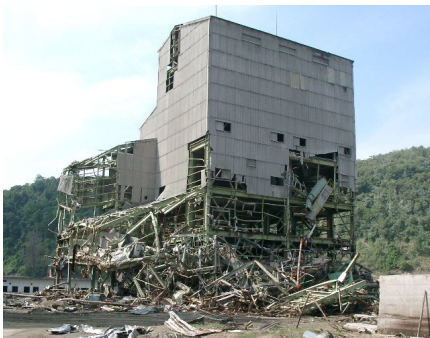
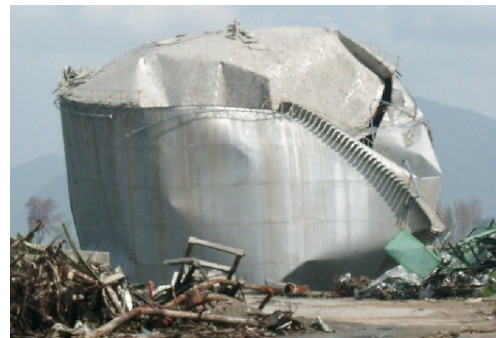
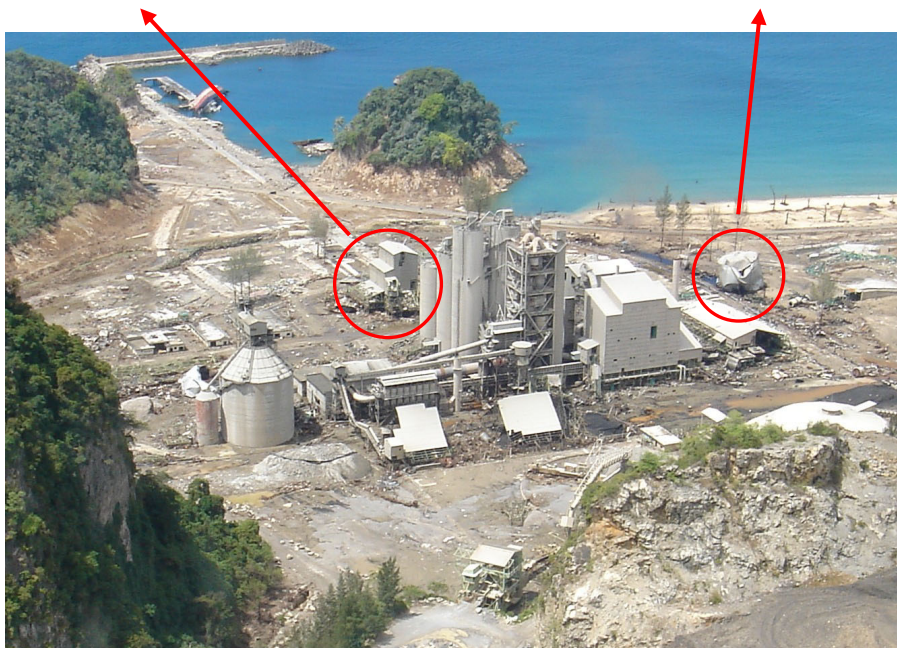
Aceh Province is one of the major oil and natural gas producing region in Indonesia. These facilities are on the east coast of province. None of these facilities were damaged either by ground shaking or induced tsunami. However, the cement plant at Lhonga was heavily damaged by tsunami waves. A French company originally built the plant and the subsidiary in Indonesian now operates it. The steel structure, kiln and fuel storage tanks were heavily damaged by tsunami while RC silos remained intact (Photo 9.1). It seems that tsunami waves reached a height of 15-20m in some sections and the steel beams and columns were either bended or buckled by the impact of tsunami waves and dragged objects. There were three cylindrical fuel tanks in the plant. Two of them were completely destroyed while the other one was buckled. All of them were offset from its original location.

Photo 9.1 An aerial view of the cement plant

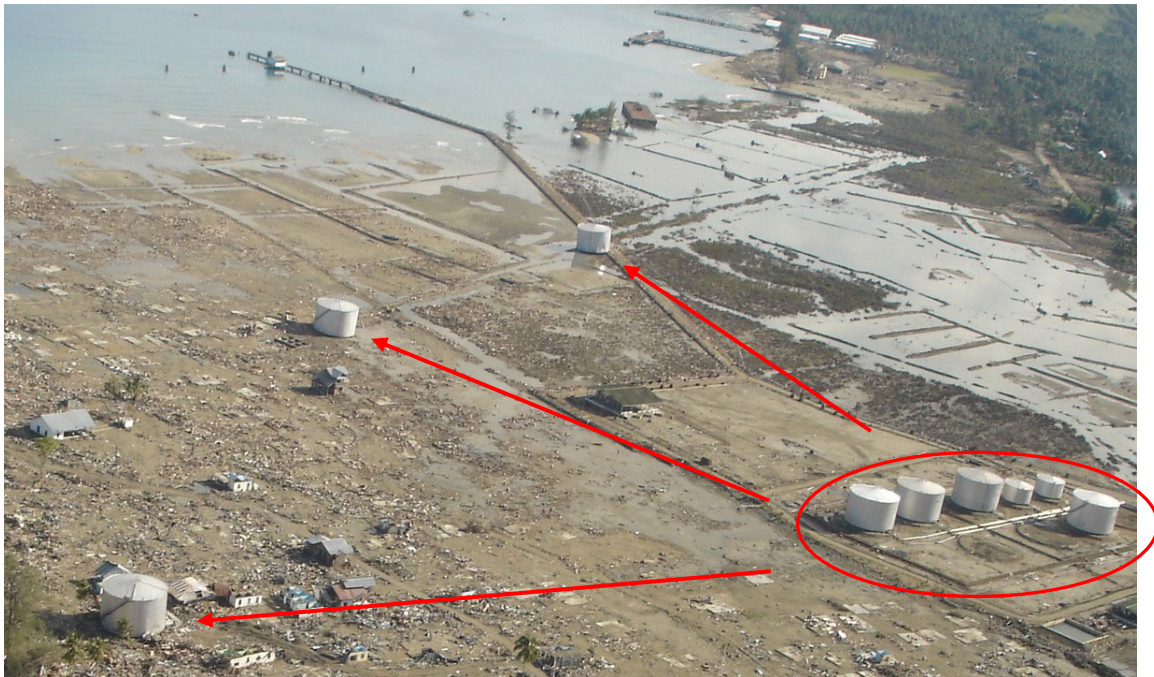
Storage tanks from an oil tank farm in the eastern part of Banda Aceh city (Krueng Raya, about 22km east of Banda Aceh) were displaced by the tsunami waves for a considerable distance from their original position as seen in Figure 9.2. The tanks were not fixed to the ground and some damage to piping did occur. Figure 9.3 shows a buckled tank along the seashore in Meulaboh. The tank was hit by tsunami waves and that side of the tank was buckled. Furthermore, some settlement of the tank occurred probably due to the liquefaction of foundation ground.

Photo 9.2 Displaced oil tanks by the tsunami

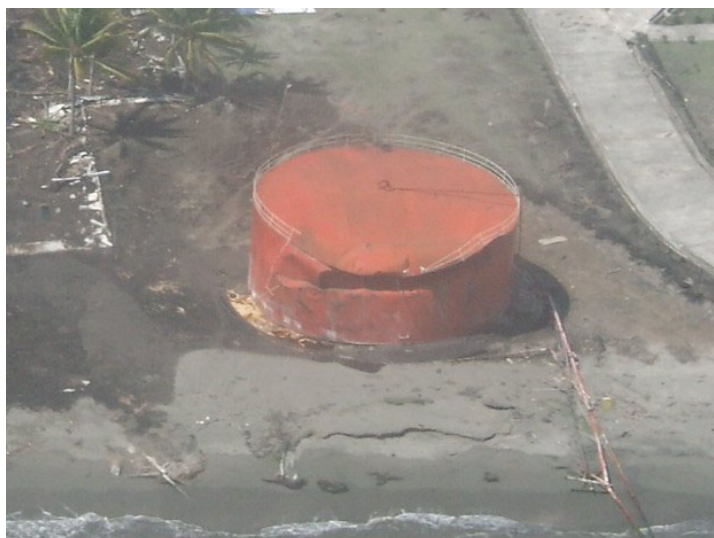
Photo 9.3 Buckled and settled tank at Meulaboh
