## Learning Map of the Mid Niigata Prefecture Earthquake in 2004

*The Sub-committee on Slope Engineering, Committee on Geotechnical Engineering, JSCE*

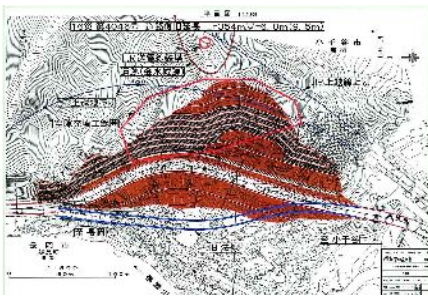
This landslide (bedrock collapse) struck three persons who were driving on a country road. Only the son was miraculously rescued. The sandstone slope inclined to the river forming a structure that could easily slip (called Nagare-ban in Japanese, it means “dip slope”). When the earthquake occurred, the layers slipped and part of the road was destroyed as the landslide slid towards the river. The JR Jyoetsu line tunnel was destroyed as it was partly submerged by the same deposits. Various methods for rebuilding tunnels and bridges were considered, but at present, the anchor method has been applied. A World War II underground tunnel was filled in to avoid having a weak zone below the ground surface that could collapse. Part of the destroyed road will remain a memorial to the tragic earthquake even though the rebuilding activities have been completed.

The plane chart and crossing chart of stabilized method. Unstable slope were reinforced with anchor method and slipped layers were removed.  
(Offered by Niigata prefecture )

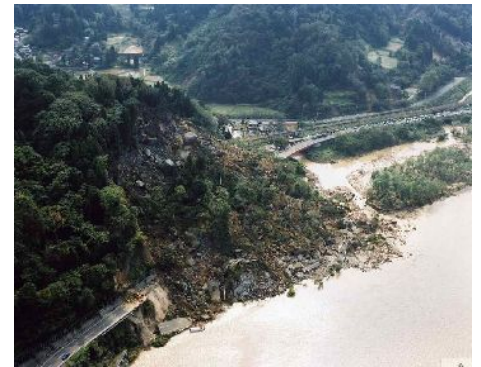
A view of the collapse situation from the sky over northern side  
(Offered by Niigata prefecture)

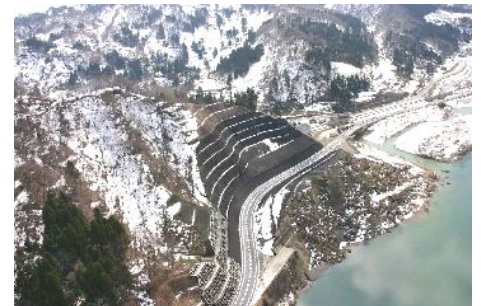
Stabilized slope and restored road  
(Offered by Niigata prefecture)

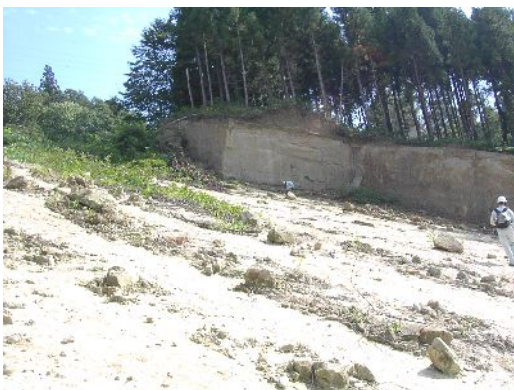
Slipped surface as smoothly (The mark of collapse) and rock layer remained at the side of the collapse

This field is very close to the Myoken field. The pictures show a surface as smoothly slipped looks like a skiing slope (inclination 22 degree). On the upper part of the surface there remains a sandstone layer with a thickness of about 3.0 m which can be clearly seen. The sandstone layer was shaken by an earthquake and collapsed along the slip surface. The tuffaceous sandstone measuring some millimeters thickness was found on the slip surface. Tuffaceous sandstone is a mixture of volcanic ashes and sand in sediment; this was the key answer as to why the high strength sandstone collapsed. Furthermore, this had the same white stone as the Myoken slope whose soil layer was “Naganre Ban” and thus formed a topography that easily slipped down. These two fields of “Nagare Ban” directly face a national route and train line, but fortunately no accident happened there.

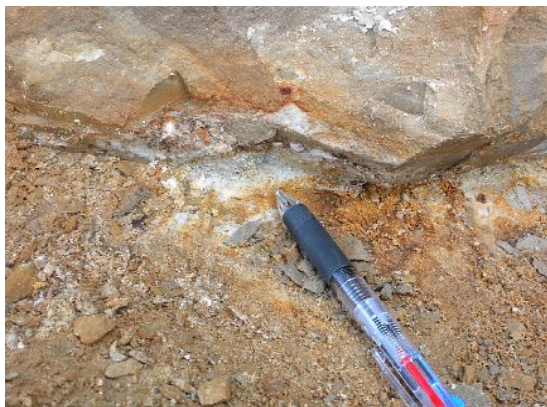
Tuffaceous sandstone of slipped surface

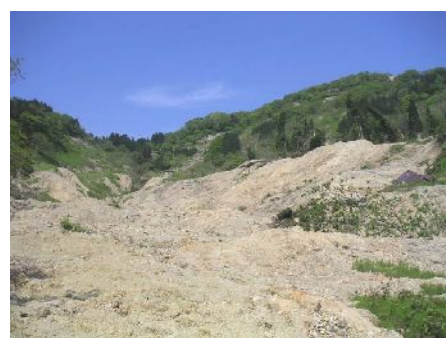
Chuetsu earthquake caused this landslide occurred at the foot of other old, large landslide. One part of the landslide deposit resulted in a debris flow that slid into swamp but the other part of landslide was stopped by a check dam (Sabo dam). There was no damage to the express train line or the road located at foot of this landslide. In this case, the Sabo dam effectively prevented a disastrous debris flow. In the Oguriyama landslide, flora such as Obakisumire (*Viola brevistipulata*), Nirinsou (*Anemone flaccid*), Tanukiran (*Carex podogyna*), and Kusasotetsu (*Matteuccia struthiopteris*), and rare flora such as Katakuri (*Erythronium japonicum*), Kibanaikarisou (*Epimedium koreanum*) grow from early spring to autumn and make the landscape of “Sato-yama” more beautiful.

Situation of landslide that mountain stream in end buries and is carried out.

The soil mass at the top of landslide was excavated and the slope surface was reinforced by a concrete frame to control soil erosion. In the lower part of landslide, an embankment was constructed and a drainage channel installed. Also, a Sabo dam was constructed. These structures were used rehabilitate the carp farm and protect the beautiful landscape. More study is needed concerning the harmonization between methods of controlling disasters and protecting the environment.

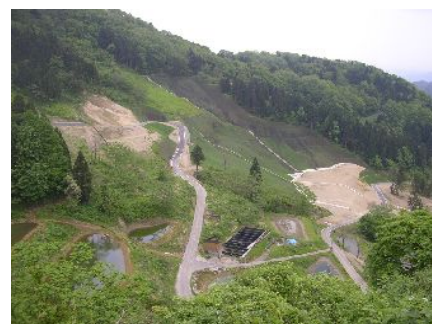
A view of the stabilized slope

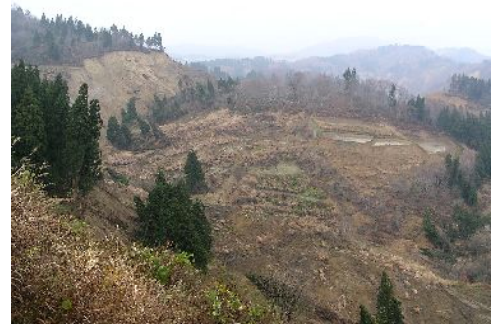
To go to the landslide zone, the group came to Siotani Village by a prefecture route. From there they walked northeast to a large landslide measuring 650 m in length, 450 m wide, and a volume of 7,500,00 m<sup>3</sup>. The scene is the right bank of the Kamisawa River, a branch of the Imo River, where an earthquake caused this large landslide. The landslide, located at Mt. Dainichi (390m high), was surrounded by a curved ridgeline (inclination 15°). The ground consisted of a weak plane with rice fields and fish farms. In the landslide, the soil/rock deposit displaced about 50 m, the upper part was a collapse zone, the middle part was a topsoil failure and crack zone, and upheaval occurred at the lowest part. The landslide moved in the southeast direction: the upper part was about 100 m wide, and the middle and bottom parts were about 40 m and 60 m wide, respectively. Boring data showed the depth of slip surface to be about 60 to 80 m. Fortunately, The debris flow did not occur downstream and thus no serious damage happened there. The reinforcement methods were: soil was removed at the upper part and embankment was established at the lower part, combined with drainage channels. These constructions prevented further effects from the landslide.

The cliff of left side were occurred by movement of soil mass

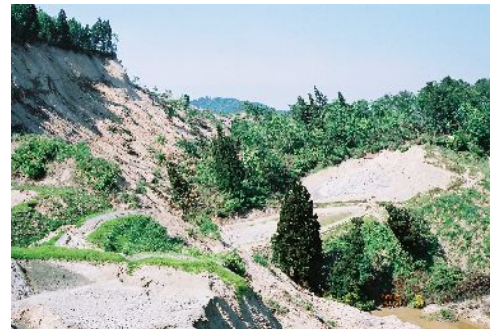
The cliff, inclined rice field and trees were occurred by landslide

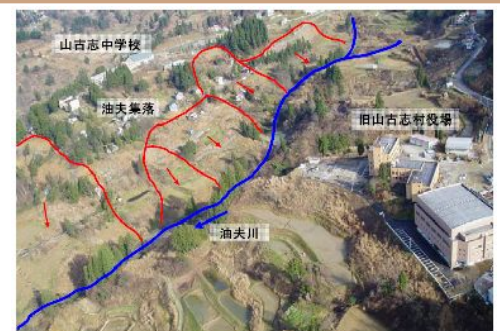
Yubu village is located on a rather gentle slope with rice terraces in the valley, this landscape is peculiar of landslide terrain. The Chuetsu earthquake caused the old landslide near Yubu village to reactivate. The soil/rock deposit of the landslide extended about 1.0 km along the Yubu River and restricted flow in the river. Half of the houses in Yubu village collapsed or were damaged by the earthquake and cracks in the upper portion of the landslide extended into the ground of Yamakoshi Junior High School damaging the third floor of the building. Many hillslopes within a large area near the Yubu River either failed or experienced extensive cracking. To stabilize these slopes anchor and facing concrete frame methods were used. Landslides were also stabilized by subsurface water drains (catchment wells) and Sabo dams and embankments were constructed in the valley. Of particular interest is an embankment constructed with soil/rock material of the landslide deposit at Yamakoshi to prevent reactivation of the landslide in Yubu.

Landslide of Yubu River from sky over  
(Offered by Niigata prefecture)

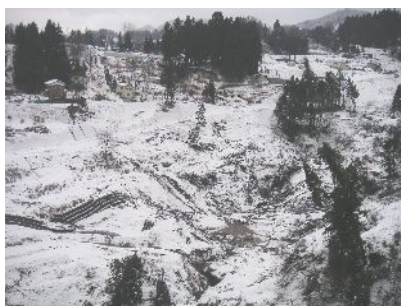
The snow fall collapse area in Yubu

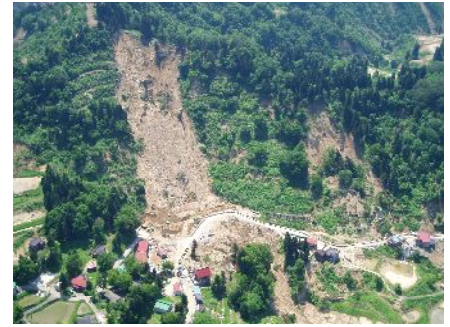
In the Takezawa area, close to the old city hall of Yamakoshi, there were many slope failures near the entry of Haguro Tunnel that connects Takezawa. A large slope failure of 200 m length and 80 m base occurred. The slope was strong weathered rock that collapsed under quake influences, and caused the prefecture route to be submerged in 5m of soil, and 3 houses to completely collapse. Around the landslide field, the steep slopes failed, and at the old city hall, a part of the old slope re-collapsed. In Takezawa, the average snowfall is about 3m per year, so many snow barrier were established on dangerous slopes. About half of the snow barriers were damaged by the earthquake. The weak sand was easily eroded, thus using the reinforcement method at the upper part was difficult. At the upper part of slope, the slope failure was reinforced by concrete frame. The snow shelter was repaired and restructured. At the lower part of slope, a retaining wall was constructed combined with 'green' methods.

The large slope failure near the Haguro tunnel (left side)  
(Offered by Forestry agency)

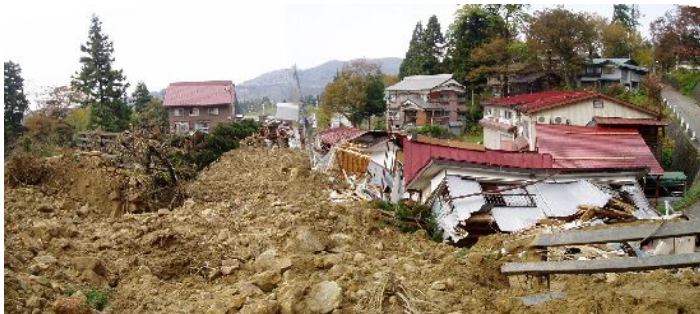
Collapsed houses by Landslide  
(Offered by Niigata prefecture)

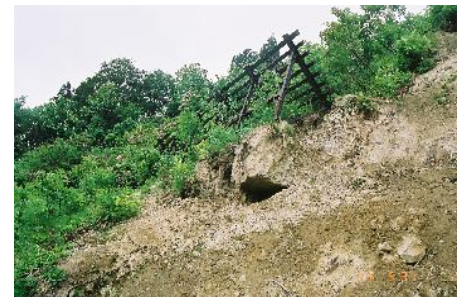
Damaged snow barrier

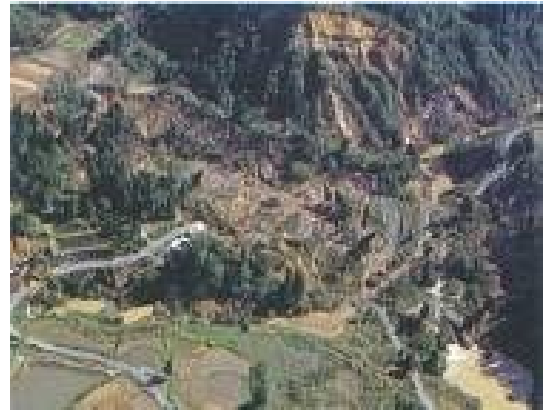
A 1.04 million m<sup>3</sup> landslide occurred along the left bank of the Imo River and a surface failure occurred along the right bank. The landslide confined Imo River by a natural dam (maximum length = 260 m, maximum base = 125 m, volume = 303 m<sup>3</sup>) and as a result, the nearby road was blocked. Similar to the Higashitakezawa site, the potential failure of this dam represented a major hazard to downstream areas, and thus a channel was quickly built to decrease the water level upstream. In 2005, three new Sabo dams were constructed, the slope failure was reinforced by concrete frames, and a new road was built opposite the landslide.

A view of the landslide in Terano area  
(Offered by Asia air survey co.ltd.)

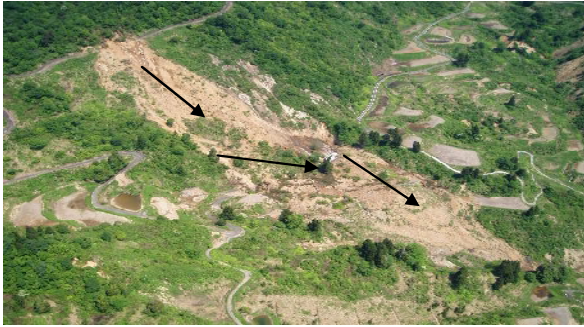
In the Tanesubara area, upstream on the Imo River, slope failures frequently occur. Near the Kazekuchi pass, a large landslide (length = 500 m; width = 100 m) cut through a forest road and another prefectural route. At the upper part of this failure, the weathered rock layer collapsed along 30–35 degree sloping bedrock. The lower part was an old landslide on a gentler slope with rice farms. One part of the landslide moved and deposited soil downstream to the Sabo dam. Solutions to this landslide problem included the rebuilding both the forest and prefectural roads. In the upper part of the landslide, the unstable mass was removed and reinforced by a concrete frame, while soil deposits were stabilized with retaining walls. In the lower part, the slope was reformed and some drainage channels were constructed.

The weathered rock layer collapsed in upper part, the lower part was an old landslide  
(The arrows indicates the direction where unstable mass moved) (Offered by Forestry agency)

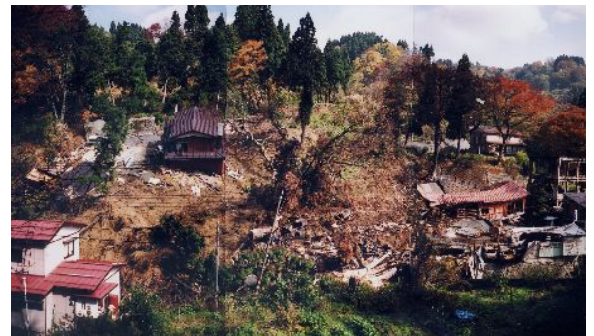
The slope of this landslide was the terminal portion of an old landslide. This recent landslide occurred due to the earthquake and even though it was only the terminal portion its length was 130 m and width was 70 m. The deposited soil struck homes, killed two people, cut through a prefectural road, and a portion reached the Ohta River. At upper part of the landslide experienced many cracks that clearly showed the movement of the failure.

Collapsed houses by landslide

Geology of the failed area consisted of weak weathered rock that could be penetrated by a knife. Because rainfall raised the ground water level rapidly after failure, a well and boring works were installed for underground drainage. At the terminal portion of the landslide, steel piles were installed to stabilize the slope.

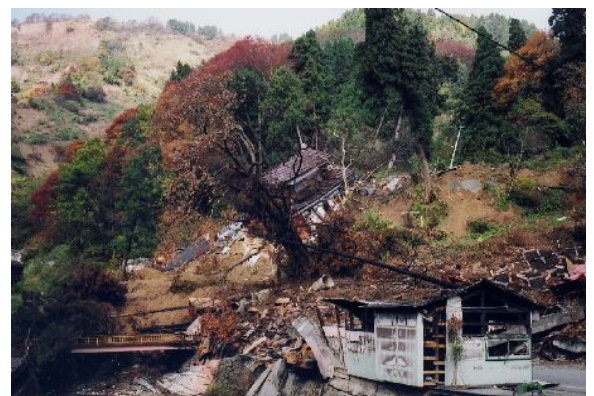
Damage situation by landslide

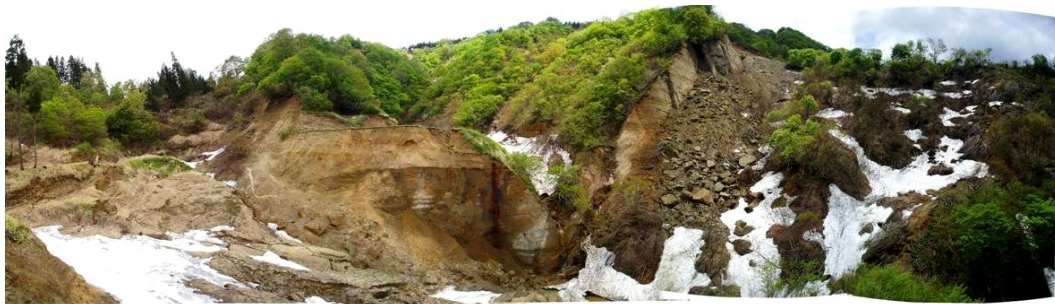
A rice farm on the slope was displaced by a large landslide and habilitation of the area became very complicated because the forest road was damaged. Thus, damages resulting from the landslide, such as avalanches, displacement of the rice farm, falling trees, ground cracking, and rock failures or compressions near the terminus were estimated. However, to better estimate damages, it is necessary for safety experts to go inside this landslide area.

In the landslide, the soil rock deposit displaced

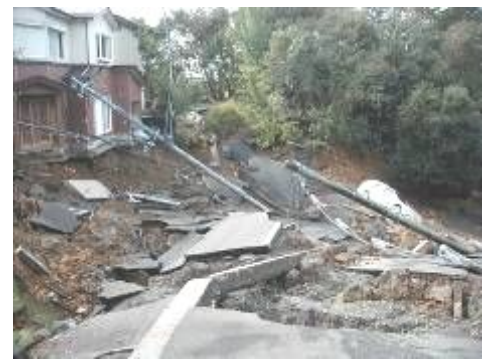
The slopes collapsed and there were a lot of ground movement in the residential quarters located on hill near Nagaoka City.

These were generated by the embankment that reclaimed from the valley and was made, and the damage occurred in the road and the house.
