# **Damage to Railway System**

## **East Japan Railway Company**

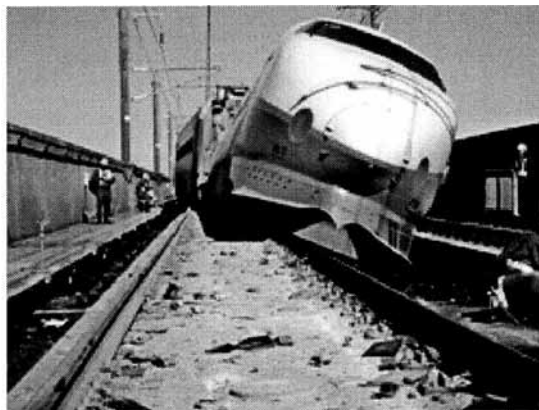
Photo 1 Last car of derailed bullet train Toki 325

Fasteners were damaged and the rails were displaced over a length of about 900 m near the point where bullet train 'Toki 325' derailed on the shinkansen line. (Photos 1 and 7) There were no damaged fasteners and no displaced rail ahead of the first car of the derailed train. The track slab was not heavily damaged, although the concrete has been chipped by the derailed cars.

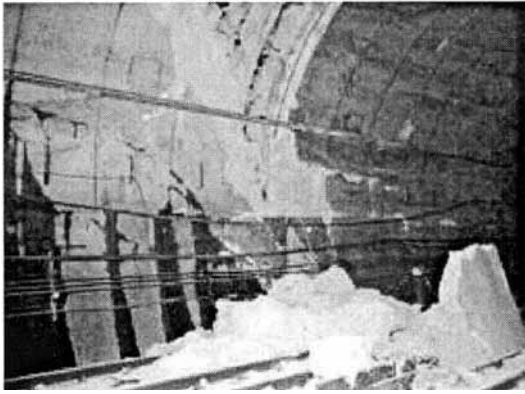
Photo 2 Uonuma tunnel between Urasa and Nagaoka

Badly damaged are the Uonuma and Myoken tunnels. Details of the damage are shown in Photos 2 and 3.

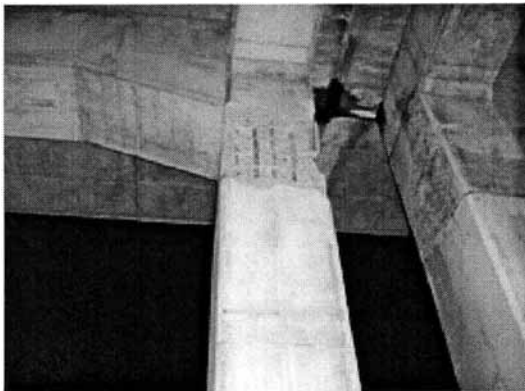
Photo 4 Muramatsu viaduct between Urasa and Nagaoka

Cover concrete fell away from the head of piers. (Photo 4) Of the eight piers of this viaduct, only one was heavily damaged while the seven others suffered light damage. (Photo 5)

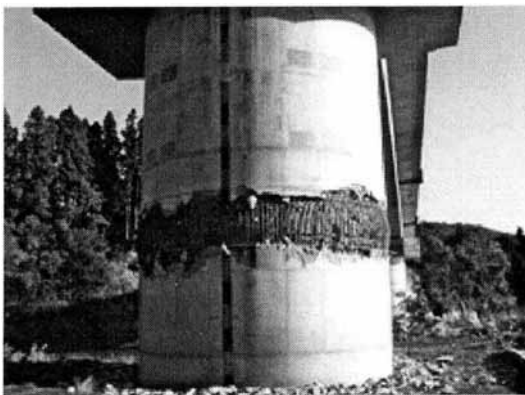
Photo 6 Uonogawa bridge between Urasa and Nagaoka

One bridge (Uonogawa bridge) (Photo 6)

Reinforcing bars bulged out and cover concrete fell away on the intermediate section (at the bar anchoring point) of the pier.

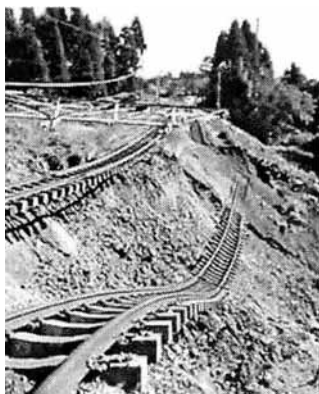
Photo 8 Joetsu line between Echigo Kawaguchi and Ojiya

Many structures related to local railway lines, including civil engineering structures and tunnels, were damaged in the vicinity of the seismic center. Damaged civil engineering structures included failed embankments and subsidence or outward flowing of base courses. (Photos 8 and 9)
