4. DAMAGE TO TRANSPORTATION FACILITIES

4.1 Overview

4.2 Highway Bridges

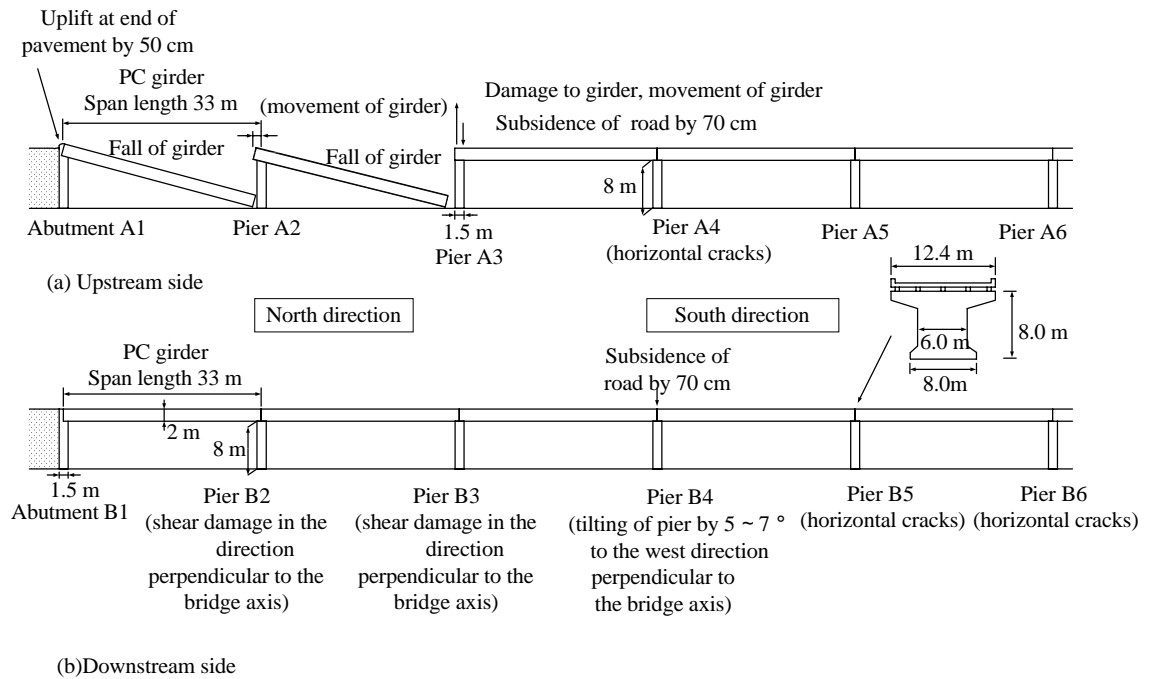
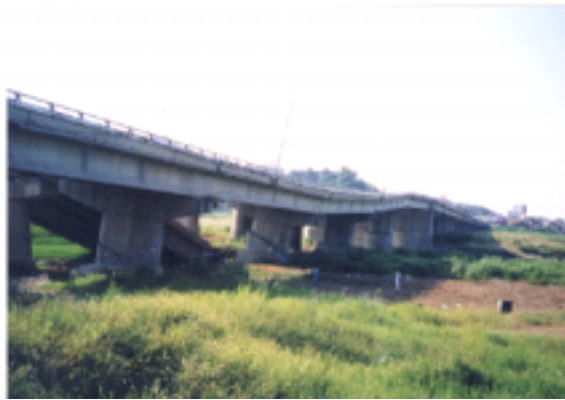
Figure. 4.3 Damage to WU-SHI Bridge

As shown in Figure. 4.3 and Photo 4.1 and 4.2, two girders towards the end of the bridge on the upstream side, namely girders between abutment A1 and pier A3 fell from the piers and a pavement around the abutment was lifted up by about 50 cm. Damage appeared to be caused by pounding observed at the end of the girder at pier A3. The road surface was subsided by approximately 70 cm at this location. This subsidence seemed to be too large compared with the behavior of the girders which fell from the bridge seats by 40 cm. It might also be affected by the vertical displacement of the piers and ground.

Regarding the damage on the downstream side of the bridge, the wall type piers B2 and B3 sustained serious damage in the bridge axis direction, with cracks penetrating through the piers. Pier B4 indicated no serious damage, but it tilted to the downstream side by approximately 5 ~ 7 degrees and its road surface subsided by about 70 cm. On piers B5 and B6, horizontal cracks of flexural type were observed at the mid-height. This portion is presumed to be the joint of the concrete.

- (a)Flexural and shear damage occurred on the piers due to large seismic forces or the movement of the ground. Although pier B3 and B4 seemed to be moved by 1 to 2 m in the direction perpendicular to the bridge axis, and girders on them didn't move to that direction. However, it is very unlikely that piers supporting simple girders, or unconfined piers fail by shear only by the movement of the ground. Therefore, to solve this contradiction, a detailed measurement of the movement of piers and girders is needed.

- (i)The damage patterns of piers and girders differ between those on the upstream side and those on the downstream side.
- (ii)On the upstream side, damage was caused by the crashing of the girder to the abutment which resulted in the falling of the girder.
- (iii)On the downstream side, shear failure was caused on the piers in the direction perpendicular to the bridge axis even though resistance of wall-type pier is greater in that direction.

Photo 4.1 Failure pattern of WU-SHI Bridge

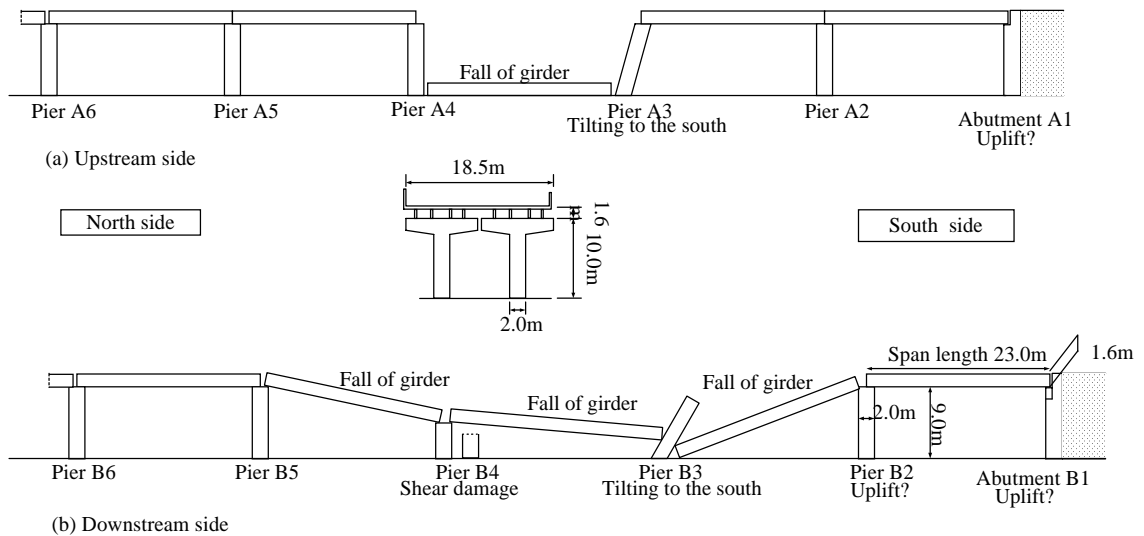
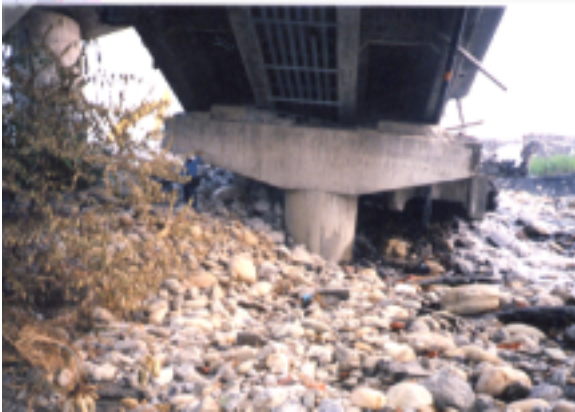
Figure. 4.4 Damage to MING-ZHU Bridge

The bridge is a four-girder simply supported bridge with a span length of about 23 m each. Regarding piers A3 and B3 and four girders existed between piers A2 and A4 and piers B2 and B4, a detail investigation was not feasible because they had already been dismantled. Therefore, press photos taken earlier were used instead for assessing the damage to those piers and girders. On the upstream side, pier A3 tilted significantly to the south direction and the girder between pier A3 and A4 fell down, as depicted in Figure. 4.4. On the downstream side, pier B4 suffered shear damage (Photo 4.3), pier B3 tilted seriously to the south direction, and girders between pier B2 and B5 were seen virtually to have fallen.

- (1)Shear damage which occurred on pier B4 at its upper portion might have caused the falling of girders existed between piers B3 and B4 and piers B4 and B5.

The strength of pier B4 obtained by the Schmidt hammer test was 260 kgf/cm² and the surface condition appeared to be sound, indicating that no problems existed in terms of quality.

- (1) Horizontal displacement to the level causing girders to fall occurred between piers A2 and A4 on the upstream side and between piers B2 and B4 on the downstream side.
- (2) Pier B4 showed shear damage at its upper portion where main reinforcement was probably partially terminated.

Photo 4.3 Failure of the Pier B4 of MINGZHU Bridge

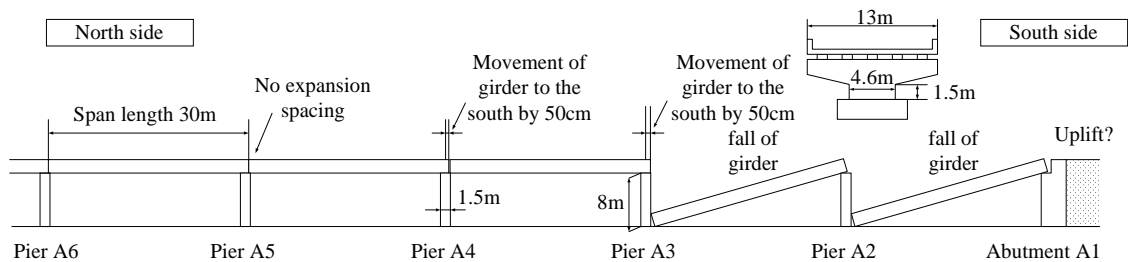
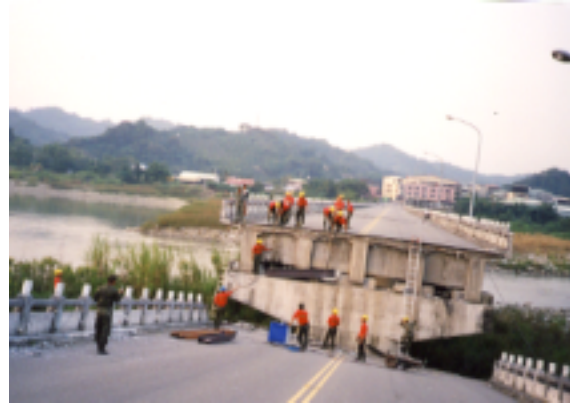
Figure. 4.5 Damage to CHANG-GENG Bridge

Figure.4.5 and Photo 4.4 show the damage situation of this bridge. As seen, piers indicated no obvious damage, but girders between piers A1 and A2 and piers A2 and A3 on the left bank side fell off the piers. The bridge is a five-girder PC bridge with a width of 13 m and a span length of 30 m each. The entire span length is approximately 400 m. The bridge seat to support the girder is only about 50 cm long.

- (1) Large horizontal forces or the shift displacement of the ground occurred in the direction from right bank to left bank (from north to south).
- (2) Girders on the right bank side were pushed out of the alignment in a phenomenon like a pileup car accident.
- (3) It was found that girder A4 moved by 50 cm and girder A3 by 70 cm (Photo 5). Also, no expansion spacing was found between girders. From this observation, it can be said that horizontal forces or displacement of the ground which caused significant movement of the girders were dominant in the direction from north to south.

- (i) The primary causes of the falling of the girders are presumed to be the movement of girders in a phenomenon like cars bumped in a pileup accident and the lack of the length of the bridge seat. Further investigations are needed to obtain the relationship between the amount of movement of the pier and the direction of fault movement.

Photo 4.4 Failure pattern of CHANGGENG BIG Bridge

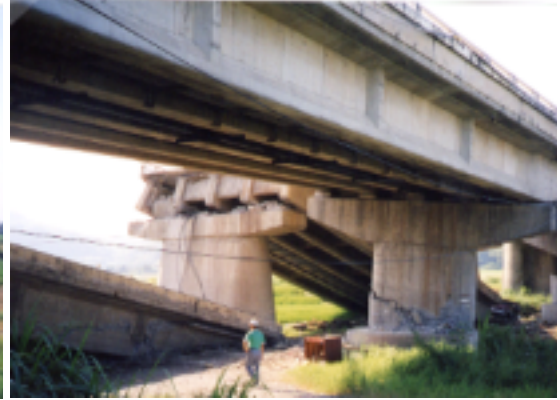
Photo 4.2 Shear failure of the wall-type pier

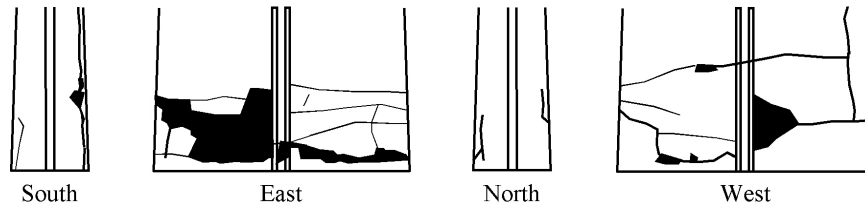
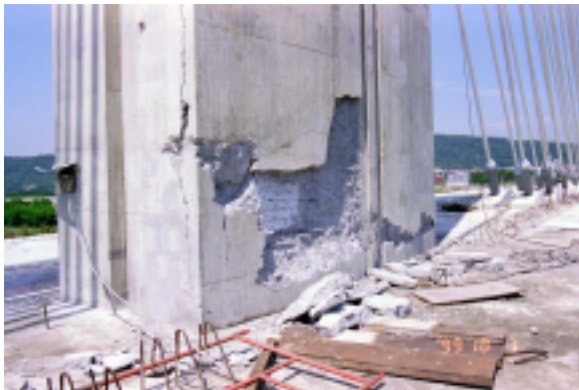
Figure 4.7 Crack Patterns of Main Tower

The main tower received flexural and torsional cracks. The cover concrete has been spalled and the hoop has been exposed at the bottom (Photo 4.6, Figure. 4.7). The hoops are the U-shaped type and the pitch is about 10 cm. The core concrete appear to sustain no severe damage.

Photo 4.6 Cracks of Main Tower

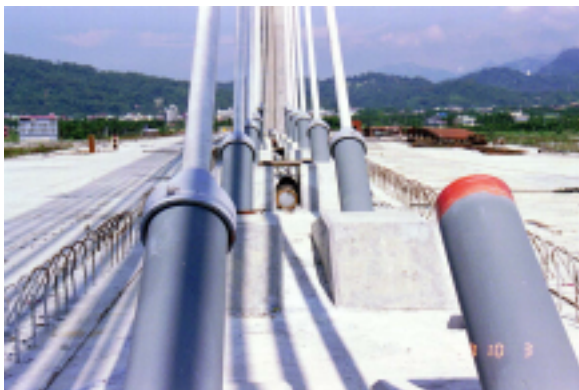
One cable in the south side east plane failed. At the connection between cable and girder, the coupler, made of the cast iron, broke and the cable escaped (Photo 4.7).

Photo 4.7 Breakage of Cable
(Damage Rank As)

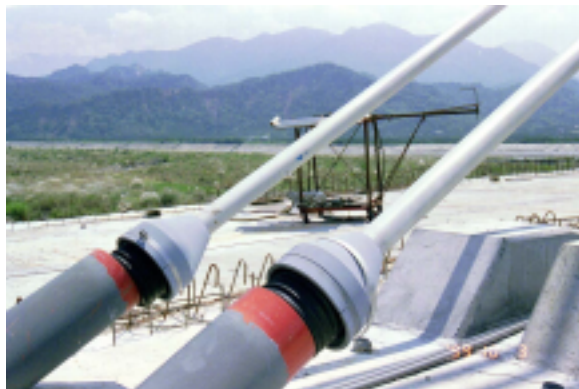
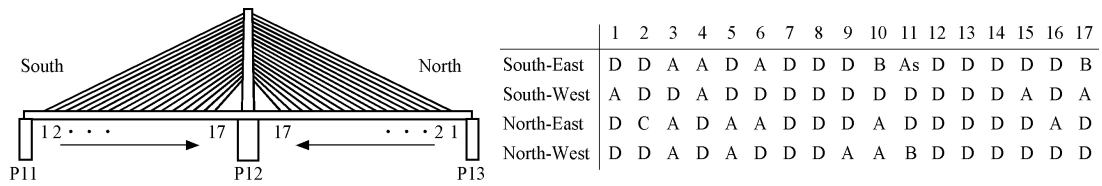
Figure 4.8 Damage Rank of Cables

Photo 4.8 Pull Out of Cables
(Damage Rank A)

Also, cable mounting couplers of other cables have pulled out from the girder (Photo 4.8). The detail investigation of the cable damage is shown in Figure. 4.8. Damage rank As shows the breakage, A shows severe damage (pull out of rubber gasket), B shows medium damage (pull out of coupler), C shows slight damage (crack of coupler) and D shows minor or no damage. As these data suggest, many cables seem to be loosened, and it is possible that the variation of cable tension occurs.

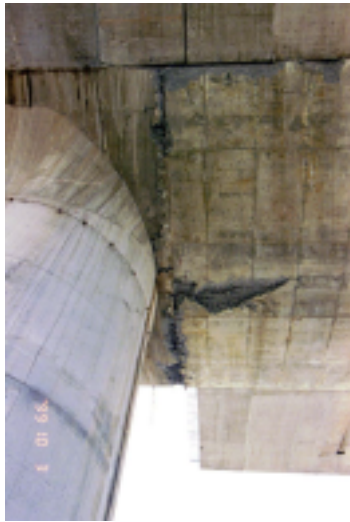
At the girder near the main tower, severe damage due to reinforcement buckling was observed (Photo 4.9). It is supposed that the girder vibrated due to the earthquake and at the fixed point, the connection between the tower and the girder, the damage had occurred by excessive moment and crushed by the compression force induced by the cables.

Photo 4.9 Buckling of Reinforcement

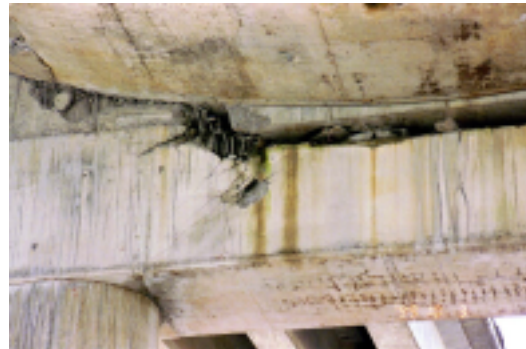
The rigid-frame piers at the end of the girder suffered severe damage. Shear crack penetrated the upper beam, and the shoes were broken (Photo 4.10). And the wall parapets were also broken because the girder moved laterally about 50 cm.

Photo 4.10 Shear Failure of Rigid-Frame Pier

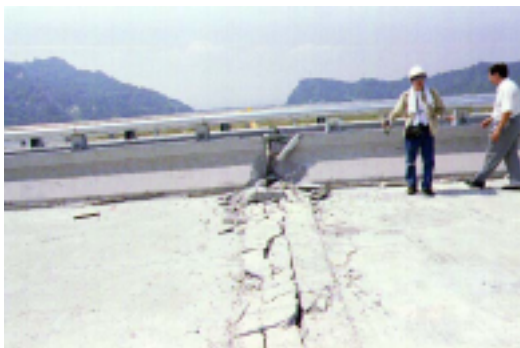
In the adjacent 8 span simply supported girder bridge, many ends of girders were broken by pounding (Photo 4.11). Some girders also moved about 20 cm in the transverse direction. And the wall parapets of pier P3 were broken (Photo 4.12). But for the T-shaped single column piers underneath seem to be no damage.

Photo 4.11 Pounding Failure of Girder

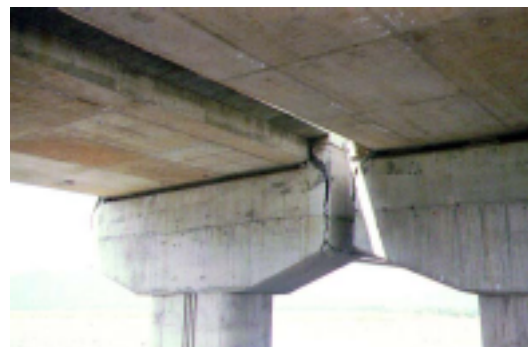
Photo 4.12 Failure of Wall Parapets

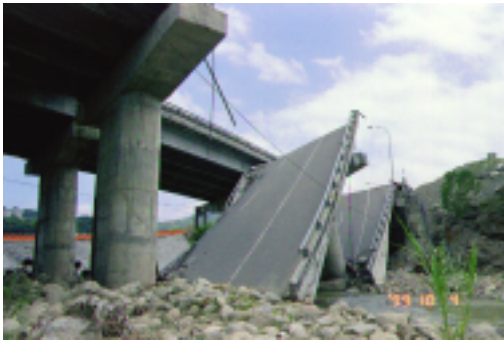
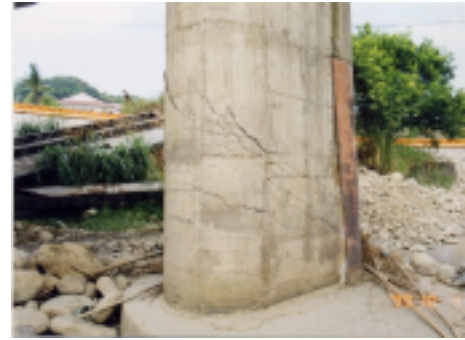
(a) SHI-WEI Bridge (Photos 4.13, 14)

Simply supported concrete girder bridge, which consists of structurally independent two neighboring bridges. Both bridges collapsed. Ground failure is observed at the adjacent bank and piers incline considerably. The main cause of this damage is the ground displacement due to landslide or fault. Development of shear cracks are observed at the bottom of piers.

Photo 4.14 Damage of the pier

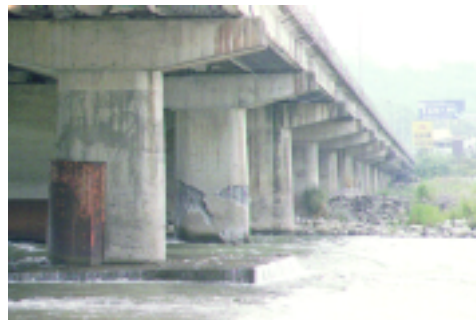
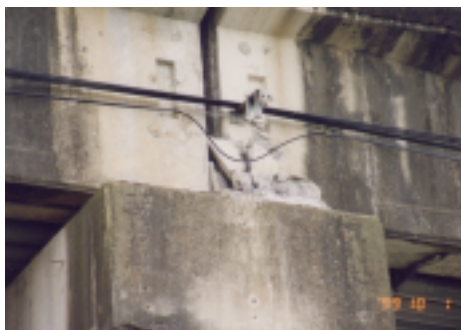
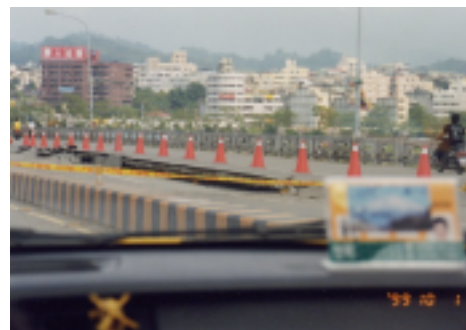
(b) DONG-FON Bridge (Photos 4.15-17)

Photo 4.16 Damage at girder edge

In simply supported concrete girder bridge, shear failure, and failure at the middle were observed at a group of three piers. All the damaged piers were damaged in transverse direction. Also, damage at girder edges (Photo 4.16) due to failure of bearing and/or

pounding is observed.

The bridge consists of three parts in transverse direction, i.e., central part, which is the original construction, and adjacent two parts which are the new extension of traffic lanes. Therefore, the bridge is made of three structurally independent parts in transverse direction, which are connected only at the slabs. Longitudinal crack on the lane (Photo 4.17) which is appeared to be caused by failure of bearings, three lanes were closed.

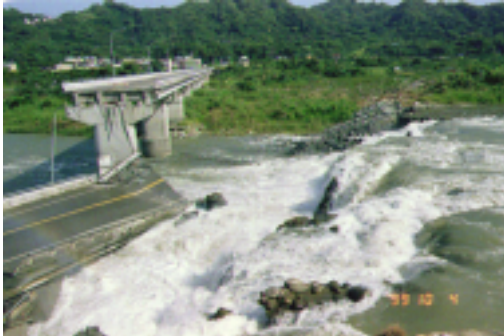
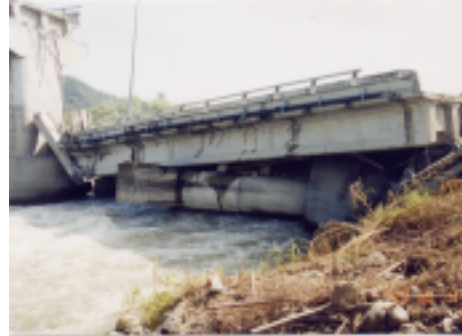
(c) BEI-FON Bridge (Photos 4.18,19)

Photo 4.19 Collapsed substructure

Simply supported concrete girder bridge. Fault run directly underneath the bridge, which is the major cause of this collapse.

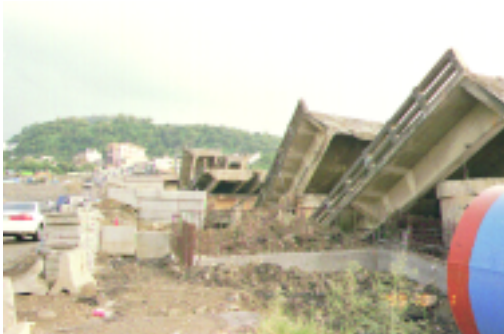
(d) II-JIANG Bridge (Photos 4.20-22)

Simply supported concrete girder bridge. Several spans fell off consecutively. The cause of this failure is shortening of a span by approximately 4m as shown in the photo. Other spans received relatively minor damage. Evidence of ground failure which appears to be related to fault action is observed around the region.

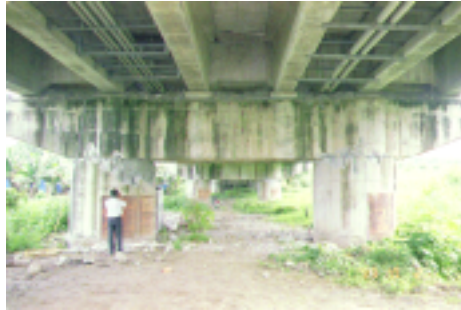
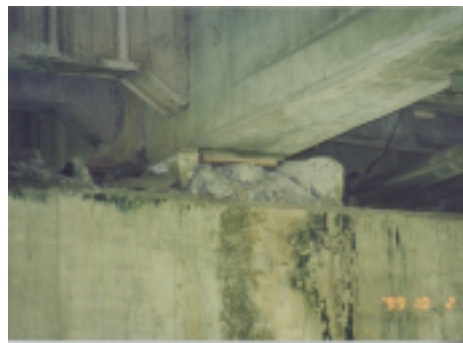
(e) EN FON Bridge (Photos 4.23-25)

Photo 4.25 Bearing and side stopper

Simply supported concrete girder bridge mounted on rigid frame type pier. One lane was closed due to expansion joint failure. The other lane also received damage at the expansion joint and had a step of 5cm, which forced the traffic to slow down. These expansion joint failure appeared to be caused by the failure at the bearings.

The pier failed at the connection of the vertical column and beam. The beam slides on the column and reinforcing bars received excessive deformation and rupture. All the beams slide to the transverse direction, to the north-east. The bearings are restrained by concrete block in the transverse direction, which supposed to have higher strength than the beam-column connection and caused this damage.

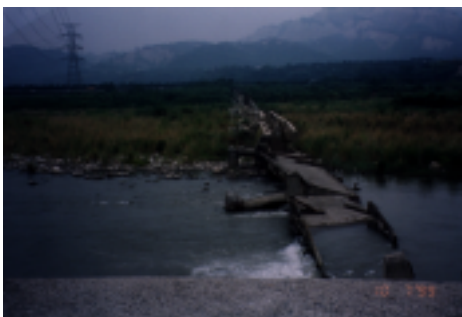
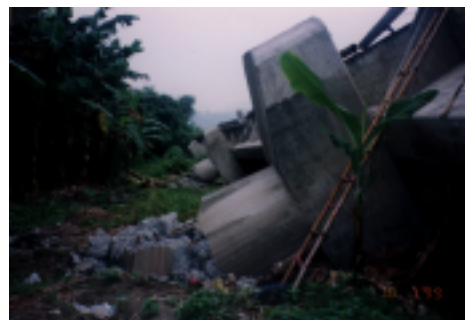
(f) PIN-LIN Bridge (Photos 4.26,27)

Simply supported concrete girder bridge adjacent to the En-Fon Bridge. Complete collapse of the bridge is observed which is caused by the failure of reinforced concrete columns.

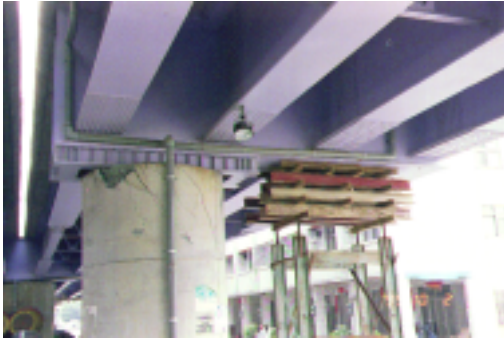
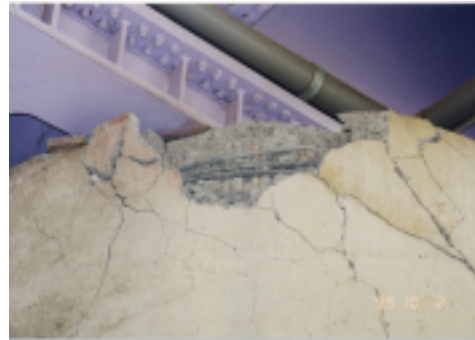
(g) MAO-LUOH-SHI Bridge (Photos 4.28,29)

The bridge is part of the bypass route of the State Route 3. Piers supporting the straight part of upper structure were not damaged. The piers have an elliptic cross section and are placed at the center of the width of upper structure. Some diagonal cracks were observed in piers at the junction where the highway branches out into two traffic lanes. Each branch is supported by circular sectioned piers. The piers at the beginning of branch are placed eccentrically to the width of the branch. After the earthquake, steel frames are erected as temporary additional supports of the branch.

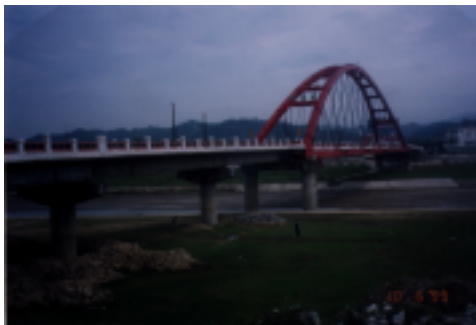
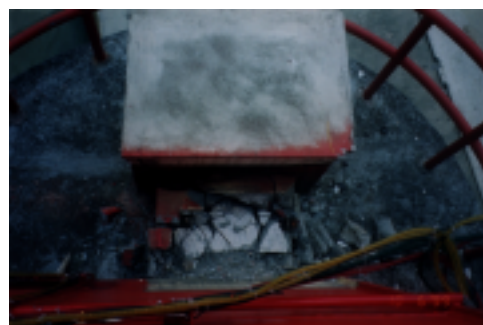
(h) LYU-MEI Bridge (Photos 4.30,31)

Photo 4.31 Failure of bearing

Steel arch bridge adjacent to Juin-Gong Bridge. Evidence of liquefaction is observed around this region. Damage to bearings associated with displacement of deck is observed (Photo 4.31). Failure of abutment similar to Juin-Gong Bridge is observed.

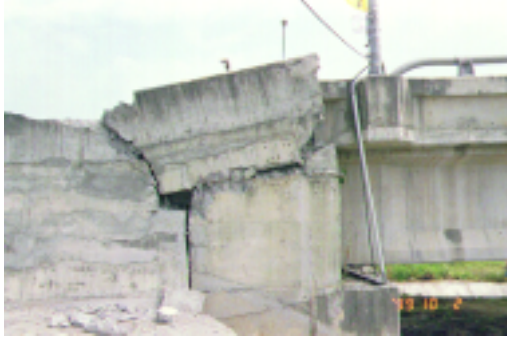
Photo 4.32 Abutment of Juin-Gong Bridge

Simply supported concrete girder bridge adjacent to Lyu-Mei Bridge. Clear evidence of liquefaction was observed. This would be the cause of the lateral settlement of the abutment along with the retaining wall to the river, which caused the failure of the abutment.

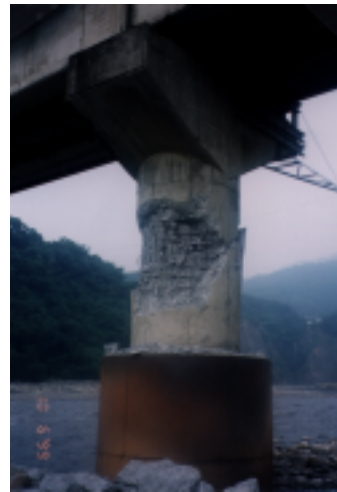
Photo 4.35 Damage of pier

Simply supported concrete girder bridge. Serious damage to reinforced concrete columns are observed. Lateral gap between adjacent girders and damage to abutment are also observed.

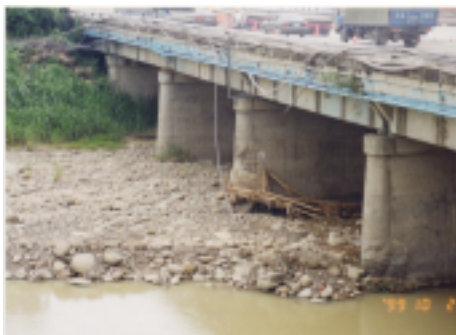
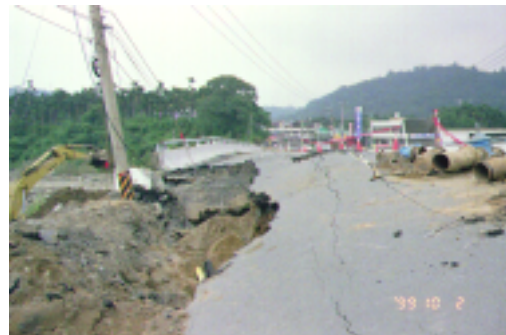
(k) YEN-PIN Bridge (Photos 4.36,37)

Simply supported concrete girder bridge mounted on wall-type piers. One lane was closed at the time of investigation due to failure of abutment caused by ground failure. Vertical through crack is observed at the center of the wall type pier.

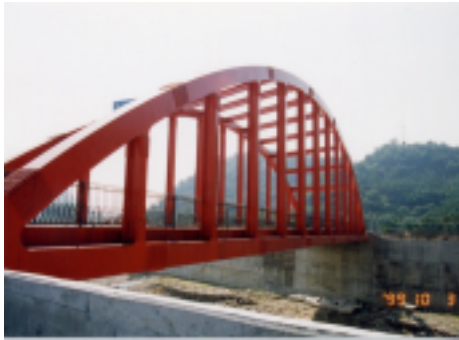
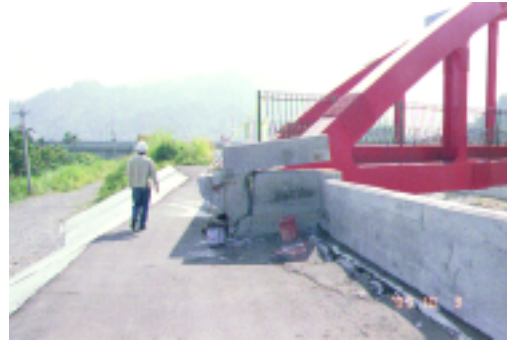
(l) LIN-WEI Bridge

Lin-Wei Bridge, which is a steel through type arch bridge with span length of about 60m under construction, is damaged at the abutment and bearing. All of the four bearings are failed, and the bridge is moved by 40cm to the east. Both end abutments are crushed by excessive motion of the girder and pounding.

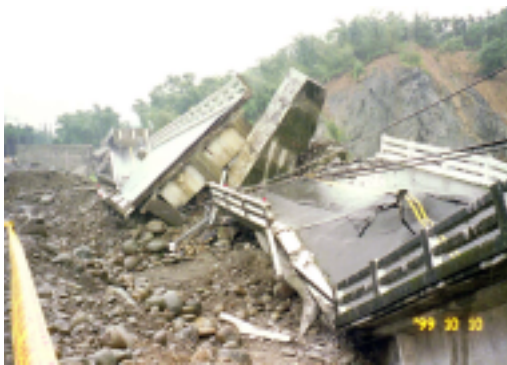
This bridge was completely collapsed (Photo 4.40). Two piers are failed in shear mode and one pier fall in the ground. All decks also fall in the ground. And the abutment suffered severe damage (Photo 4.41). Beside the abutment, a large-scale collapse of rock wall was observed. It is supposed that active faults exist around the bridge, because the piers, especially the abutment, were damaged severely.

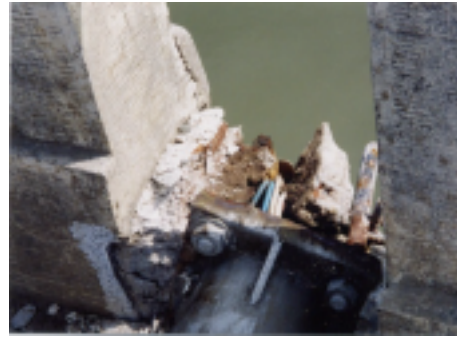
At the undamaged portion of bridges, several damages on secondary structures which affects the serviceability of highway are also observed. Photo 4.42 shows the highway on the Shi-Kan Dam. One of the lighting pole is overturned due to the failure of the anchor(photo 4.43).

Photo 4.43 Anchor of light pole

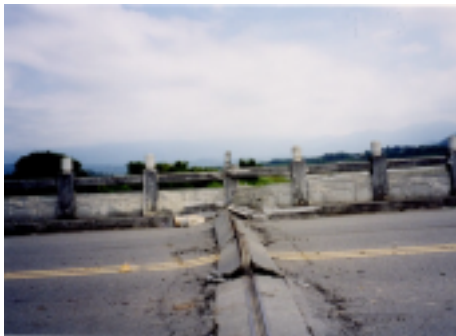
Photo 4.44 shows the compression failure of expansion joints at Chang-Geng Bridge, and photo 4.45 shows the stretching at Ming-Juu Bridge. Both appear to be due to the excessive ground displacement at the crossing of the fault. This kind of failure at expansion joints is also observed at other bridges such as Dong-Fon Bridge and En-Fon Bridge, which resulted in closure of several traffic lanes.

Photo 4.44 Compression of expansion joint

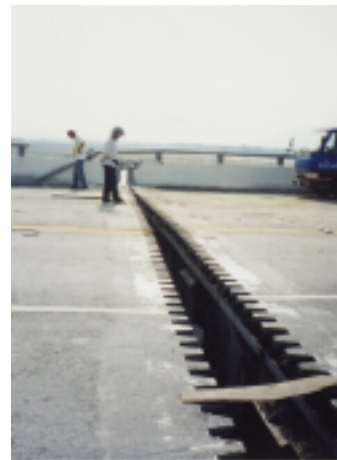
Photo 4.45 Gap at expansion joint

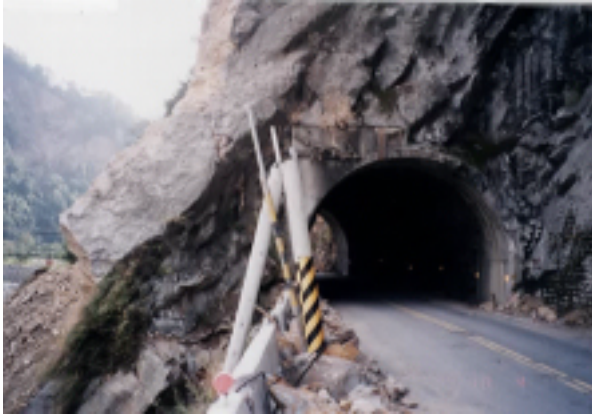
(a) Photo 4.51 shows the damage of The Li Leng mountain tunnel(Point 1) which is located near the Tienlun power plant. The landslide occurred in the basement rock around the tunnel, and the arch shoulder of portal suffered damages due to the landslide, but the inner part of tunnel suffered no significant damages.

Photo.4.51 Damage of Li Leng Tunnel
(Taiwan Road No.8)

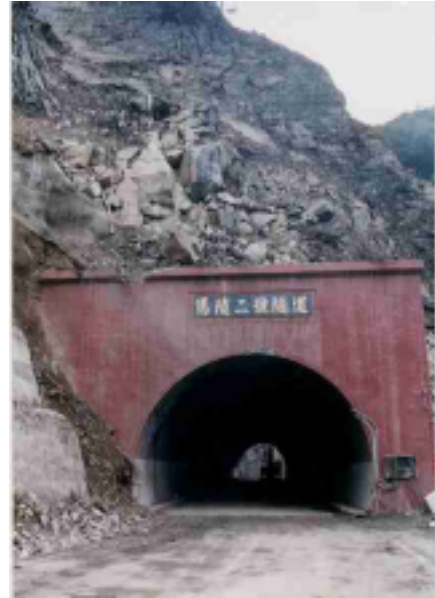
(b) Photo 4.52 shows the damage of the portal of The Ma Ling No.2 tunnel(Point 2) which located at Ma Ling due to the large landslide which occurred at the basement rock surrounding the tunnel.

Photo.4.52 Damage of Ma Ling No.2 Tunnel
(Taiwan Road No.8)

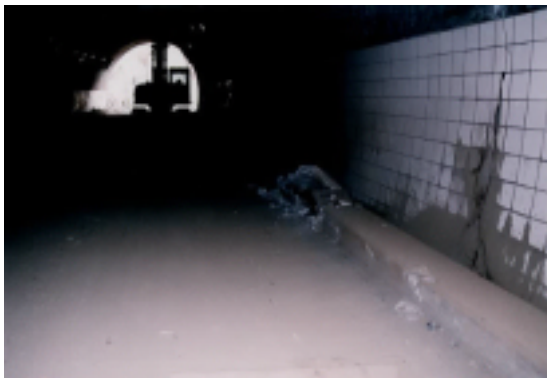
(c) Photo 4.53 shows the damage of the inner part of The Ma Ling No.2 tunnel. The cracks occurred in the circumferential direction on the side-wall due to the shear stress,

and the drain ditches of tunnel suffered severe damages, and the concrete cover was broken by the compressive stress.

Photo.4.53 Damage of Side wall at Ma Ling
No.2 Tunnel(Taiwan Road No.8)

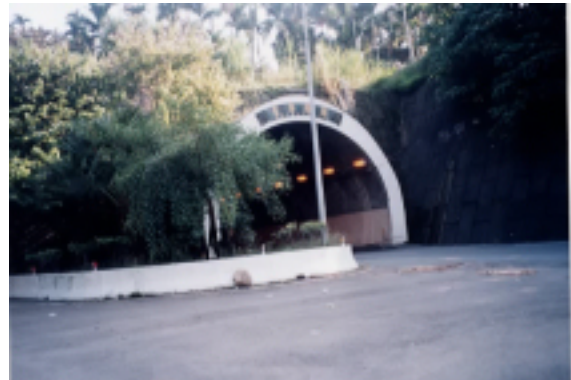
(a) Photo4.54 shows the Yu Le mountain tunnel (Point 3) located at Gan Zilin. The tunnel portal, inner part of the tunnel suffered no significant damage.

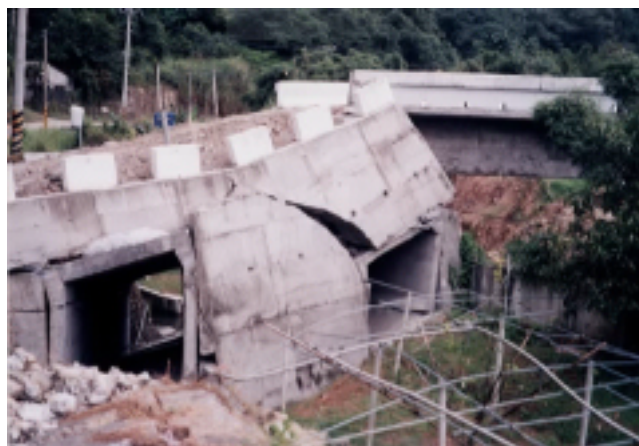
The unreinforced concrete underpass at Shishuikeng with dimensions of 5.0m in length, 2.0m in width, 2.4m in height and the thickness is 0.2m, suffered heavy damage by the fault. At this point, the riverbed upheaved about 3.0m-5.0m. The underpass collapsed by shear deformation of the surrounding ground, and the open cracks occurred in the longitudinal direction on the sidewalls of the underpass shown in Photo 4.55(Point 5).

(2)The underpass at Shishuikeng collapsed by shear deformation of the surrounding ground due to the fault.

Photo.4.55 Damage of Underpass at Shishuikeng

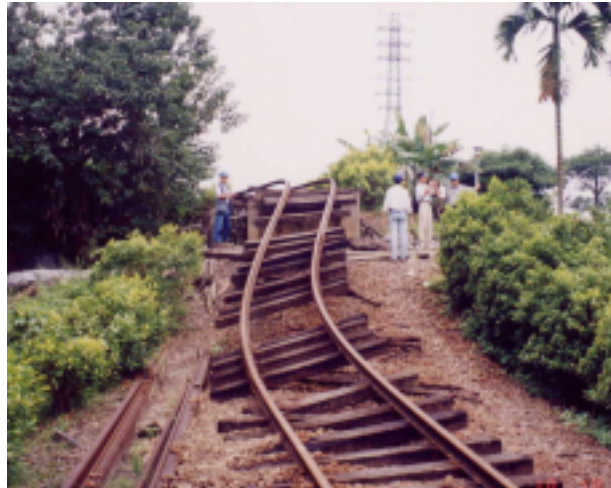
Photo 4.59 Damage in Chi-chi line (Mingchien)

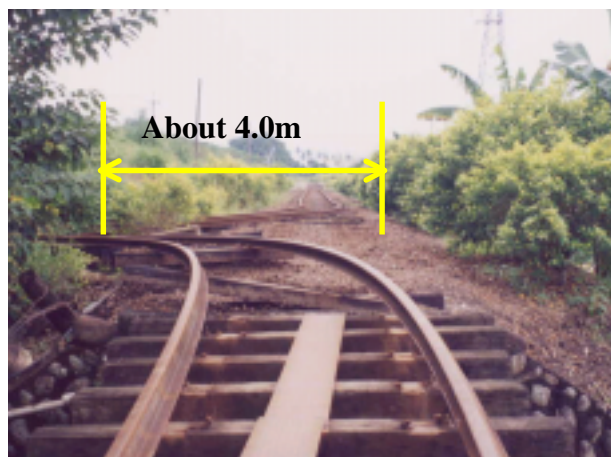
Photo 4.60 Rail buckling

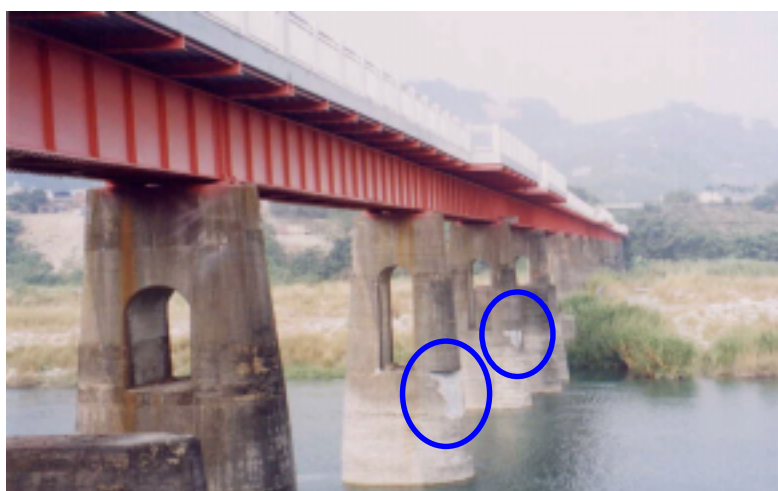
Photo 4.64 Damage of old railway bridge
