5. DAMAGE TO PORT AND HARBOR FACILITIES

5.1 Introduction

5.3 Damaged to port and harbor facilities

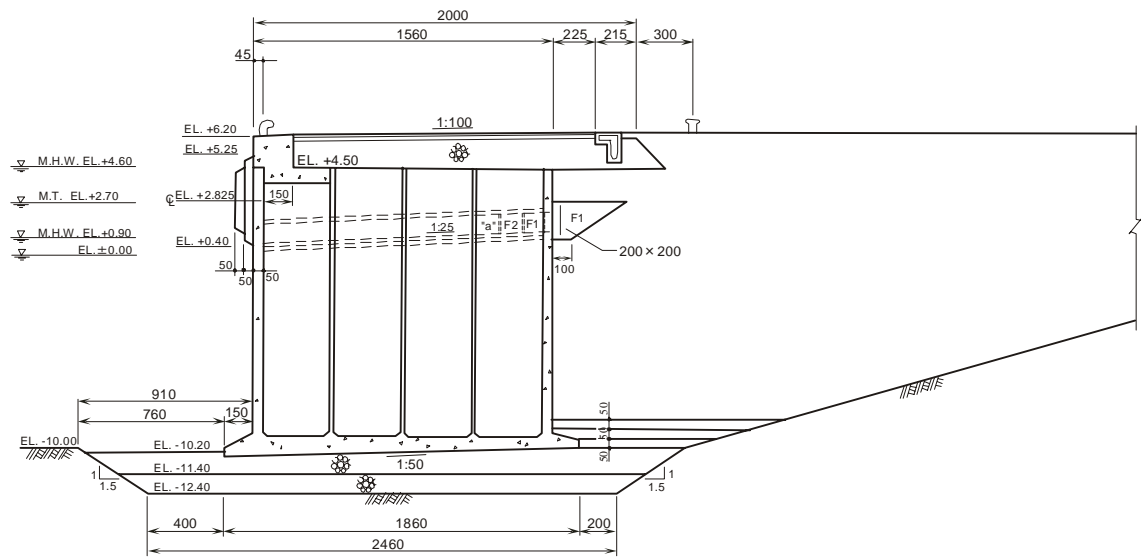
Figure.5.5 Cross section of No.4A berth

Typical cross section through No.1 to No.4 is shown in Figure.5.4. Figure.5.5 shows the cross section of No.4A which is different from an ordinary caisson quaywalls in Japan, i.e. It has no backfill rubble and has a pipe which penetrates from the back wall to the front wall of the caisson. It is supposed that the function of the buried pipe is dissipation

of the residual water pressure behind the walls due to the tidal level change.

The No.4A berth did not suffer any serious damage, while, No.1 to No.4 berths moved and inclined. The seismic coefficient is 0.15 for all the berths. The difference between No.1 to No.4 and No.4A is the existence of buried pipe for dissipation of the residual water pressure. Back analyses of seismic stability were conducted by taking the effect of the residual water pressure behind the caisson into the consideration. The astronomical tides around the time of the main shock(1:47am. Sept. 21) are shown as follows,

No.1 birth reaches 1.0 at the residual water level of EL+3.6m as shown in Figure. 5.7. If the residual water level is less than EL+3.6m, no damage occurs. It can be guessed that the boundary zone between backfill rubble and backfill sands should be stuffed up by fine contents of backfill sands, and the water level behind the quay walls could not follow the astronomical tidal level. This is one of the probable causes of the displacement and inclination of walls. On the other hand, the residual water level behind the No.4A quay wall was much lower because the dissipation of the residual water pressure by the buried pipe.

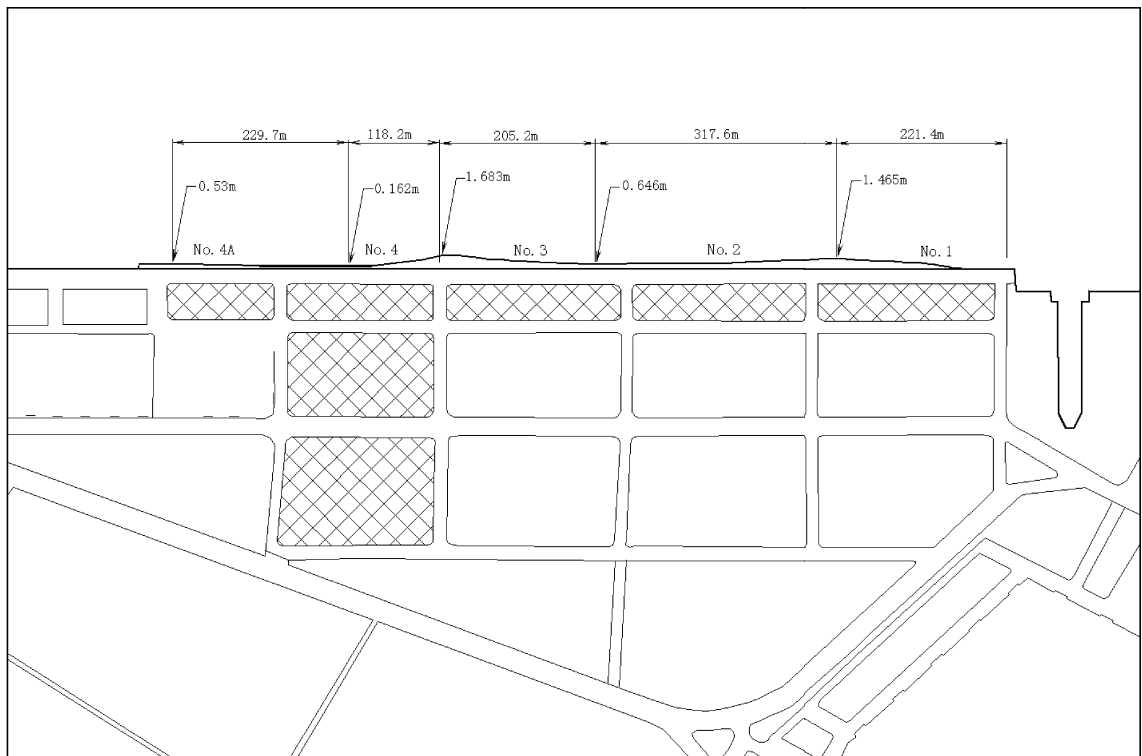
Figure.5.6 Horizontal displacement of quay walls

When the level of earthquake motion exceeds a specific limit of the earthquake resistant design, the caisson wall may displace toward the sea, causing settlement of the ground behind the wall. Typical example of the damage to the caisson quay wall(No.1) is shown in Figure.5.4. The relative seaward displacement of No.1-No.1A birth in the horizontal direction from the south west corner of No.1 birth, are shown in Figure.5.6. The maximum displacement of about 160cm occurred at No.3 birth, but the displacements of No.4 and No.4A berths are quite small. The face line of No.4A maintained straight. The settlement of quay walls is 0.1m to 1m and the angle of inclination of the caissons is 2 to 4 degree. A belt conveyor shown in Figure.5.4 was deformed due to the lateral movement of the caisson and ground surface settlement.

The ground settlements decreases with the distance from the quay wall. The sand boils due to liquefaction were observed within the area more than 40m far from the quay walls. Large ground depressions near the quay walls were observed periodically with about 26 m interval. It is supposed that the back fill sands penetrated into backfill rubble and drained away to the sea through the broken seal between caissons due to the movement of caissons and tidal water level change. The periodical ground depressions were significant at the No.3 birth.

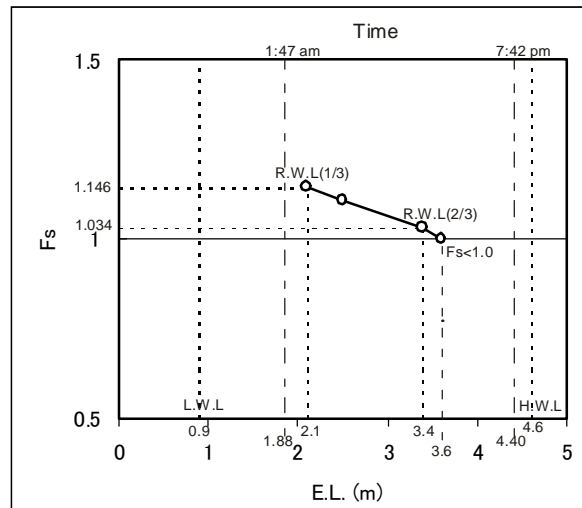
Figure.5.7 Relationship between safety factor and residual water level

The residual water level for design is EL+3.37m. The sliding safety factor for sliding of
