6. DAMAGE TO DAMS

6.1 Shih-Kang Dam

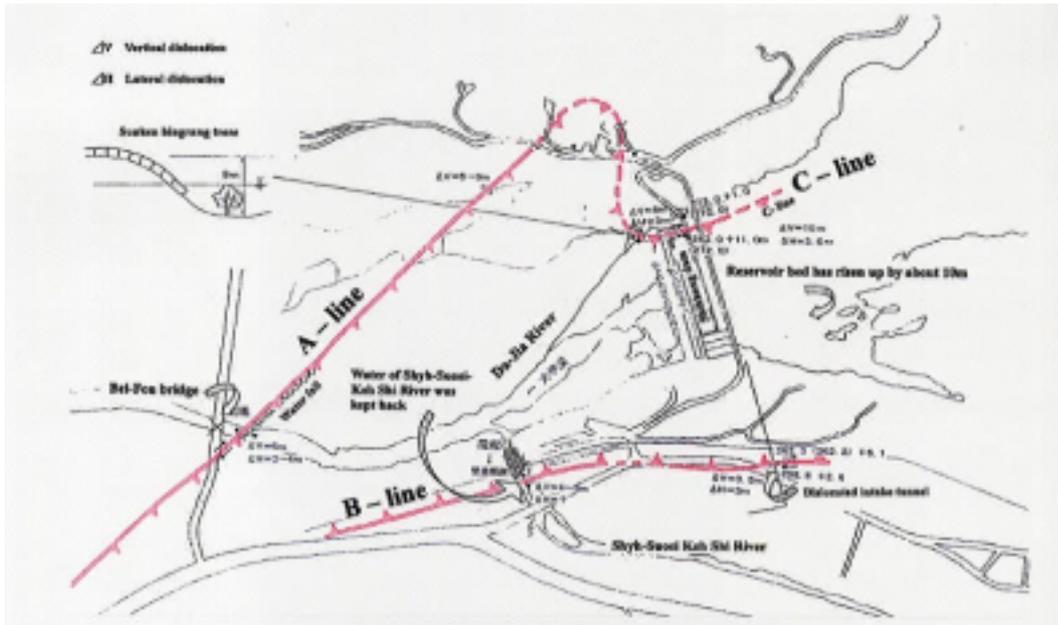
Figure 6.8 Shih-kang Dam and its vicinity

The complicated features of this fault emerge as the Shih-Kang area is zoomed in on. Figure. 6.8 shows the offsets that the authors have found during their reconnaissance. In this figure, the line, A, forms a part of the northeast extension of the Chelungpu Fault. The line, A, has crossed the Da-Jia river near the Bei-Fon bridge, where the southeast side of the fault has risen up by about 6 m with respect to the other side, causing a water fall to have appeared (Figure. 6.9). This line, however dies out as it climbs the north mountainside, and another line, C, appears abruptly a couple of hundred meters south off the line, A. This line, C, has crossed the northern end of the Shih-Kang dam causing three spillways of the Shih-Kang dam (No. 16-18) to be severely destroyed. The Water Resources Bureau, Ministry of Economic Affairs, who maintains and operates this dam, took quick action of surveying the damaged dam site and its vicinity for its retrofitting, and the elevations of a number of points were measured. Among them, two points were put side by side on the dam in such a way that the line, C, runs exactly through the two points, one on the pier No. 15 (Point *a*) and the other near by the gate No. 18 (Point *b*). Table 6.1 compares the elevations of these two points before and after the earthquake.

From this table, it is clear that the south side of the line, *C*, has risen up by about 10 m with respect to the north side. The entire picture of the fault line, *C*, however, is not clear yet, because the most part of the line lies under water. The estimated line, thus, is shown with the in-convincingly curved broken red line in Figure 6.8. The following findings, however, allow the authors to draw the broken line.

In addition to the faults *A* and *C*, another fault line, *B*, appeared on the south side of the Da-Jia River. As a whole, the north side of the line, *B*, has risen up by several meters, that is to say, the entire area surrounded by the lines *A*, *B* and *C* was relatively pushed up to that noticeable extent. This line, *B*, has crossed the intake tunnel of the Shih-Kang Dam, shearing the tunnel completely. Figure 6.10 shows the tunnel dug out after the earthquake. The tunnel has an oval cross-section, 4.1 m and 3.8 m in upright and transverse diameters, respectively. The roof line, which is clearly recognized with the steel timbers meeting together, was cut in half, showing the extent of the dislocation which the tunnel experienced. At this site as well, the Water Resources Bureau measured the elevations of some points around the sheared tunnel. Table 6.2 shows the comparison of the elevations of two points (Points *c* and *d*) arranged side by side on both sides of the fault.

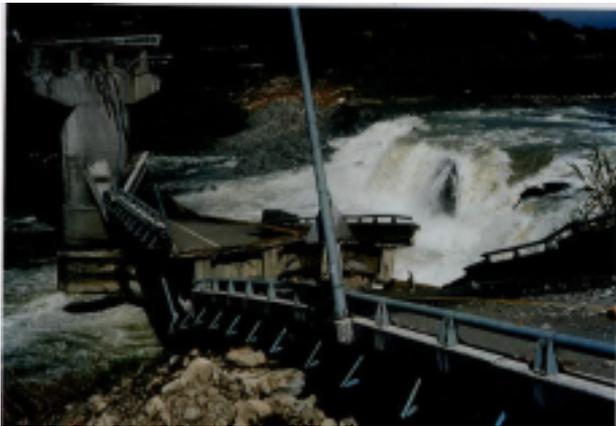
Figure 6.9 Bei-Fon Bridge and fault-created waterfall

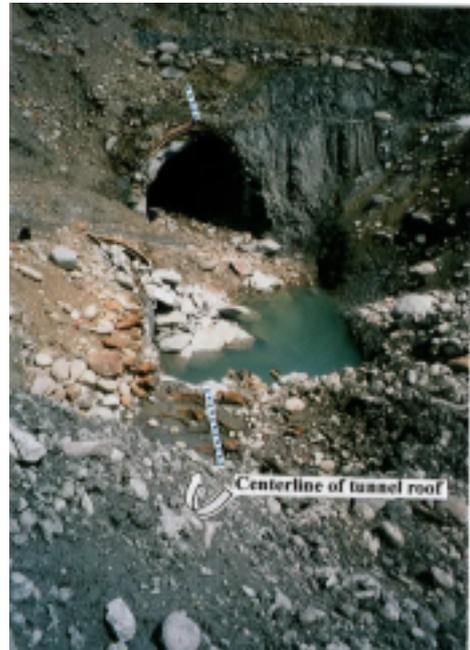
The vertical offset there is found to be about 3.5 m from the table, and judging from Figure 6.10, right lateral slip seems to be about 3 m. All tunnel joints cracked seriously (Figure 6.11). Large pieces and small fragments of concrete came off the tunnel wall, and the slack of the roof cable evidences that the tunnel has experienced a large axial force. The large axial force seemingly punched out the intake gate wall by about 20 cm (Figure 6.12).

Figure 6.10 Sheared intake tunnel

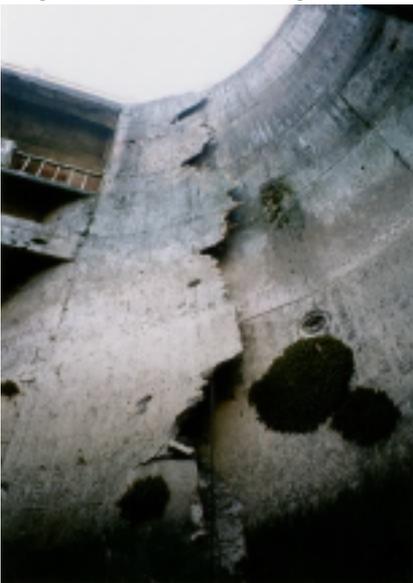
Figure 6.12 Intake gate wall

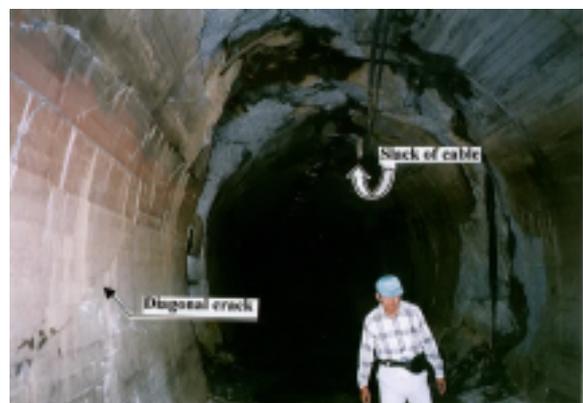
Figure 6.11 Cracked tunnel wall

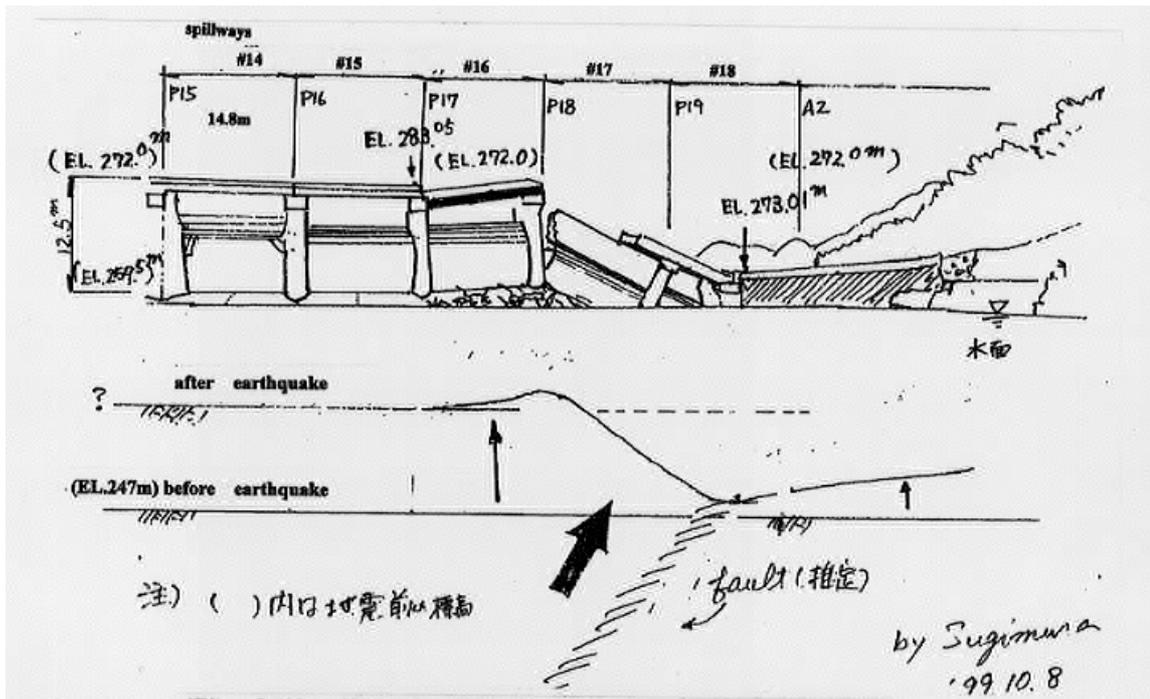
Figure 6.13 Sketch of Shih-Kang Dam from behind

As has briefly mentioned above, the Shih-Kang Dam has suffered serious damage mostly due to large dip-slip movement of the fault line, *C*. Figure 6.13, a sketch of the dam made from behind, shows slightly tilted spillways #15 and #16, seriously slanting spillways #17 and #18, the latter is deeply dipped in the water stopped behind. All these dislocated spillways allow us to figure out a possible shape of dislocation that happened immediately beneath the dam. It is noted in this sketch that spillways #16 and #17 slant to the left and right, respectively, indicating that the left side rock gradually rises towards the upper end of the fault-created steep scarp. Figures 6.14 and 6.15 were photographs taken from the downstream riverbed and the right abutment, respectively. From Figure 6.15, it is found that not only the large dip-slip movement but also a left-lateral movement reaching about 3m took place. The north part of the dam between the spillway #18 and the right abutment were cracked up along construction joints into several huge blocks, and a considerable amount of water was leaking out through the cracks.

Rock masses on both sides of a fault do not move as rigid bodies as was illustrated in the sketch (Figure 6.13). Since the dam was constructed directly upon the base sedimentary rock mass, the pattern of cracks on the dam body might indicate how the base rock was deformed during the earthquake. The cracks on the spillways and aprons were closely mapped (Sugimura and Jyh³), Figures. 6.16-6.22). Needless to say, cracks on such parts as those lying under water were excluded from these figures. Those excluded include the upstream slopes of spillways behind gates, and the spillways with their gates open. The completely destroyed spillways #16-18 were also excluded from this mapping.

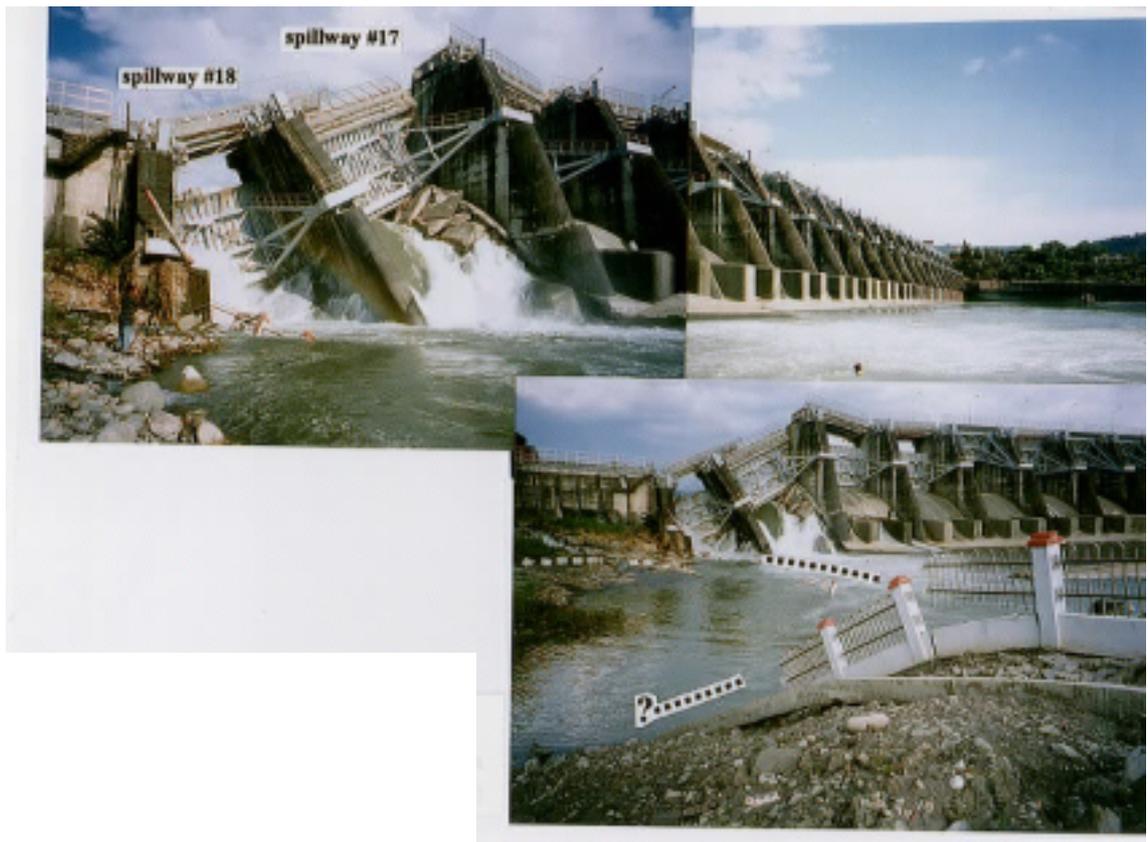
Figure 6.14 Broken spillways of Shih-Kang Dam
(Photos taken from downstream side)

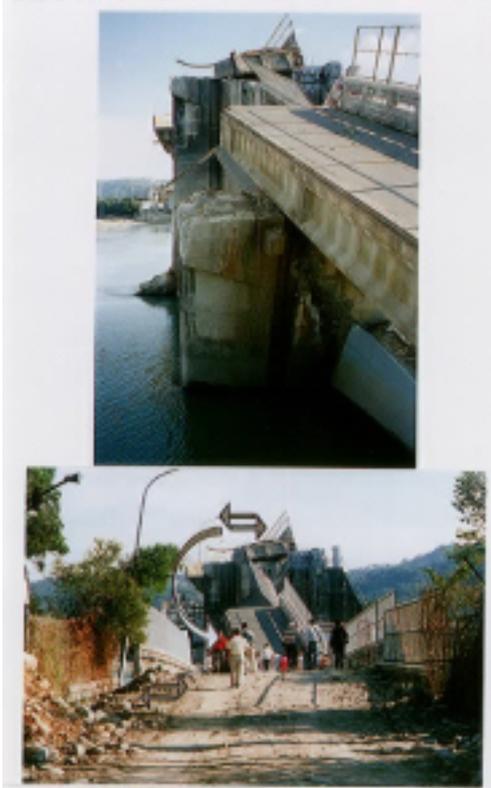
Figure 6.15 Broken spillways of Shih-Kang Dam (Photos taken from right abutment)

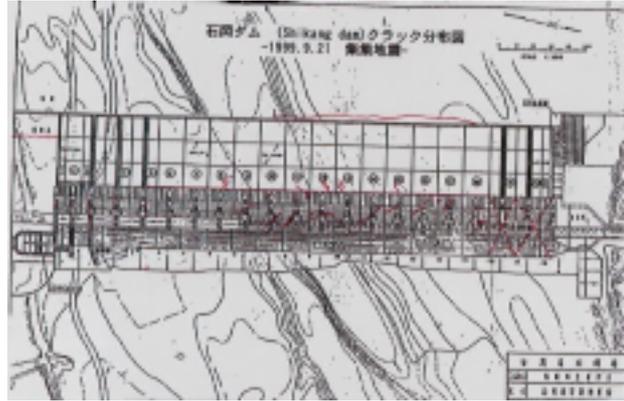
Figure 6.16 Crack map of Shih-Kan Dam

Figure 6.16 shows the distribution of cracks over the entire extent of the dam. The dam is made up of 21 blocks whose numbers are put in circles in Figure. 6.16. A pier sticks upright in the middle of a block, and a pair of blocks put side by side forms a spillway. Major cracks on spillways were found between the spillways #6 and #16, namely on blocks - . In general, diagonal cracks were found on most damaged spillways, and transverse joints between blocks were opened in such a way that the openings on the upstream side were wider than those on the downstream side (Figure 6.17). The entire dam body thus seems to have been slightly bent towards downstream side. The most diagonal cracks except those found on blocks and reached piers as shown in Figures 6.17 and 6.18. Cracks along horizontal construction joints were found on four piers #9, #10, #15 and #16 (Figure 6.19). No major cracks were found on blocks - , more than 160 m away from the fault, *C*. In this less-damaged part also, Piers #1-#5 were found cracked. The cracks on Piers #1-#5, however, have some different features from those found on the piers closer to the fault *C*. Some small fragments of concrete came off a jagged horizontal crack on Pier #2 (Figure 6.20), and the upper construction joint of Pier #3 was cracked as illustrated in Figure 6.21. A crack that has developed diagonally up through Pier #1 is illustrated in Figure 6.22 whereas the crack found on Pier #5 seems to have developed upright from the similar position. These cracks on the dam body have caused 6 gates not to be operable.

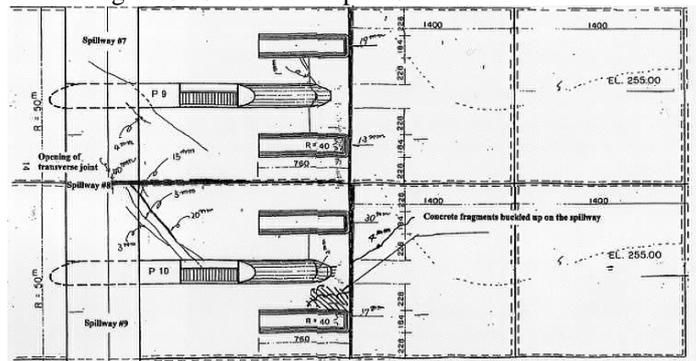
Figure 6.17 Crack on Blocks and

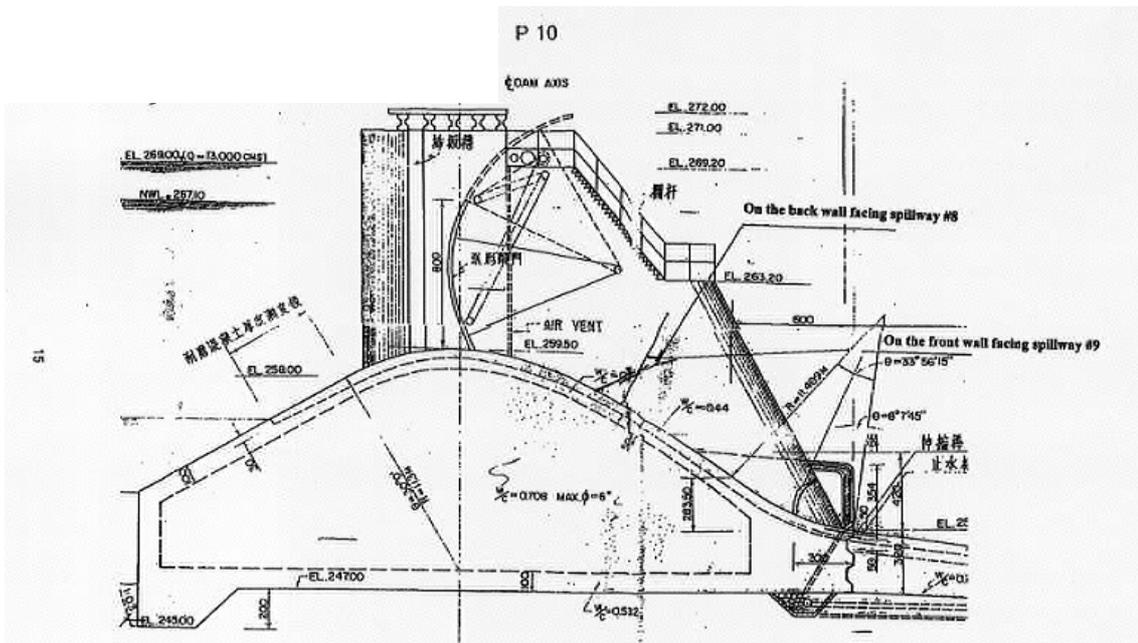
Figure 6.18 Cracks on Pier #10

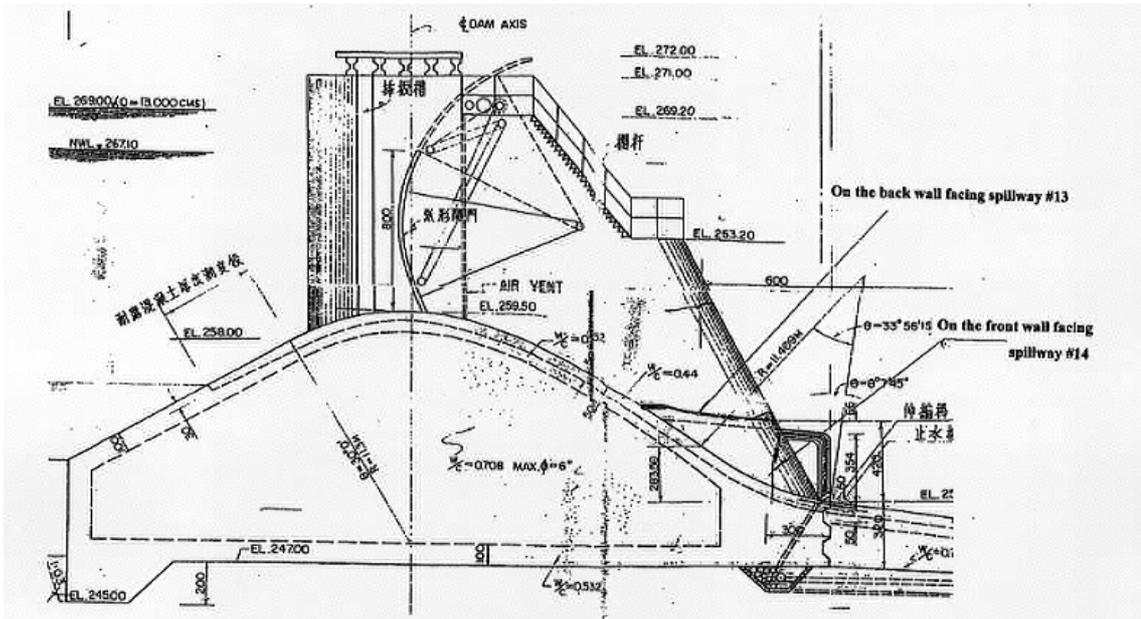
Figure 6.19 Cracks on Pier #15

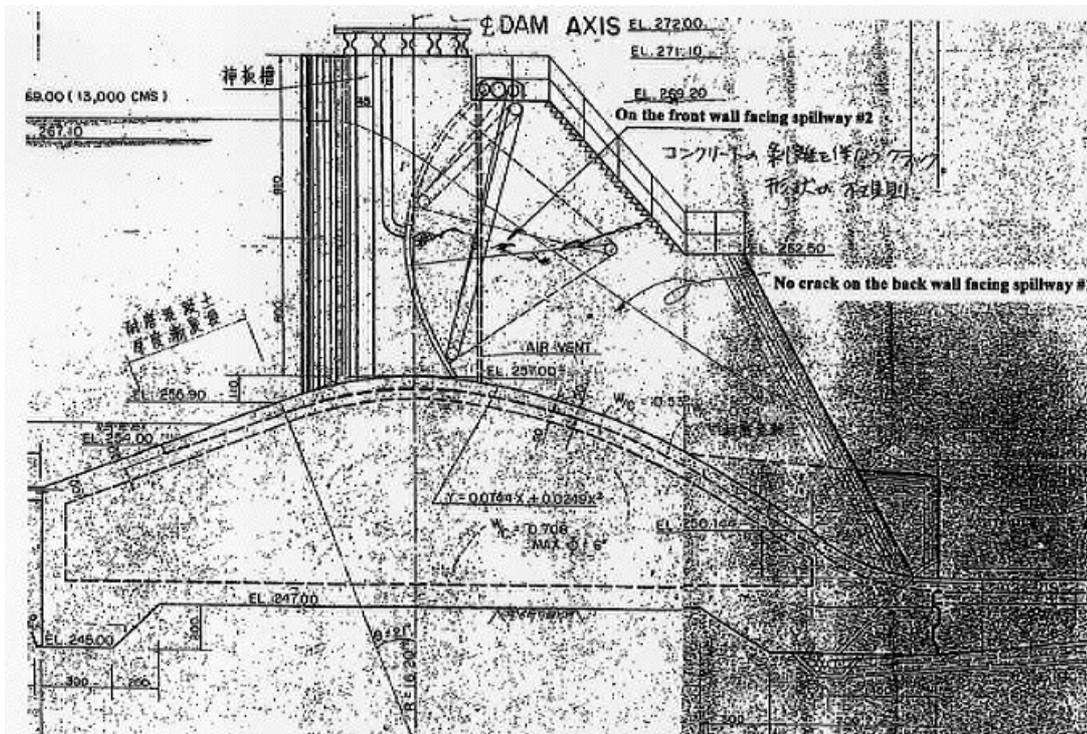
Figure 6.20 Cracks on Pier #2

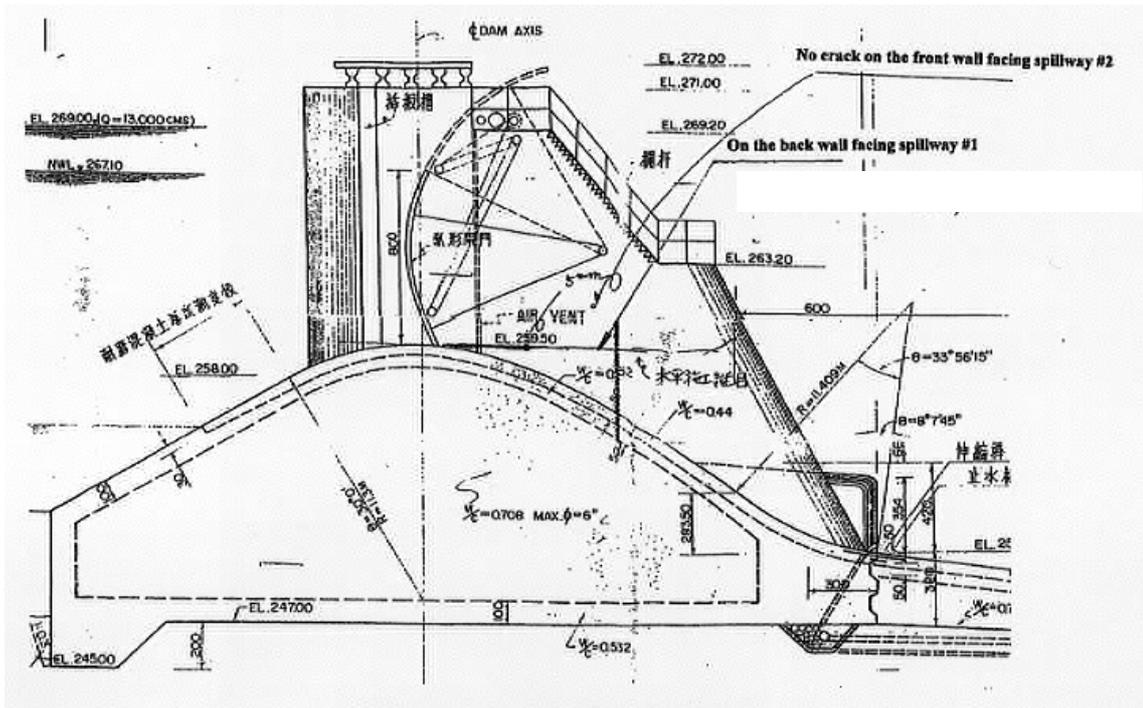
Figure 6.21 Cracks on Pier #3

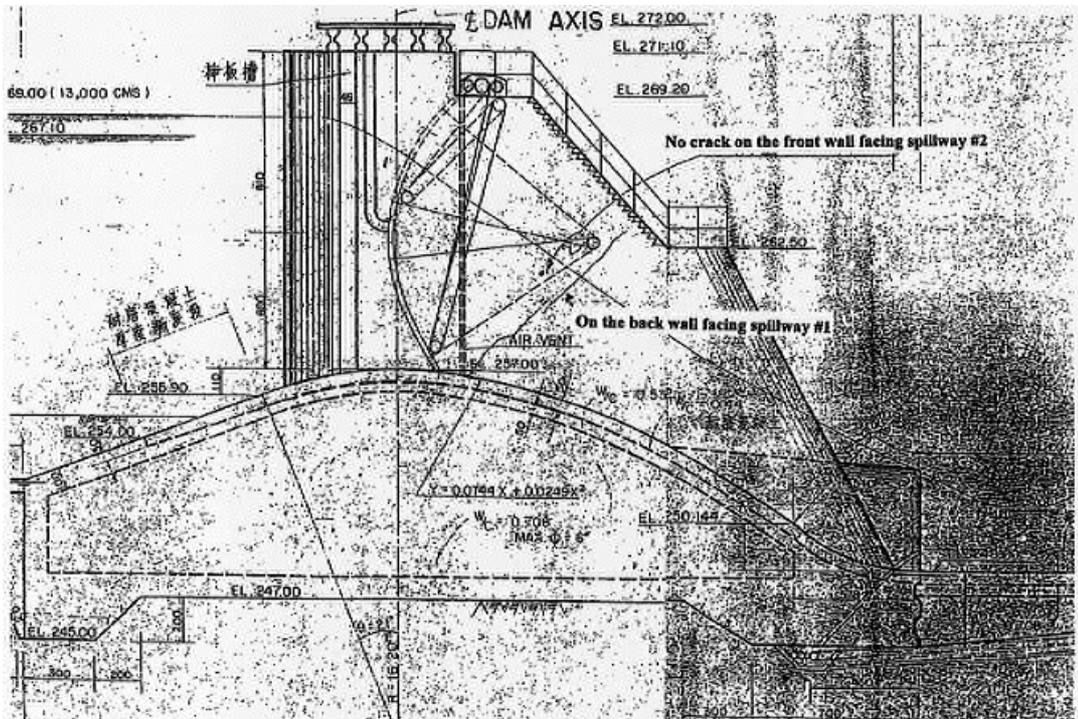
Figure 6.22 Cracks on Pier #1

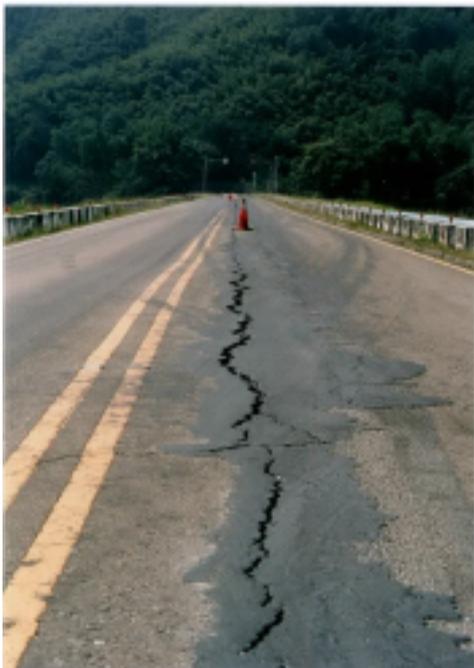
A longitudinal crack was opened over a 175 m distance on the crest of the dam (Figure 6.30). The maximum opening of the crack reached approximately 5 cm. The cracked crest was pitted to measure the crack depth, which was found to be about 40 ~ 50 cm deep. Concrete slabs covering up the upstream slope have been slightly slipped causing their horizontal joints to be opened by about 3 ~ 5 cm. A slight increase of water leakage of about 20 l/min reportedly followed the earthquake, but the leakage was recovered by reducing the water level to some allowable extent.

Figure 6.30 Longitudinal crack along the crest of Suei-Sheh Dam
