7. DAMAGE TO LIFELINE FACILITIES

7.1 Electricity

7.2 Gas

7.3 Water Supply System

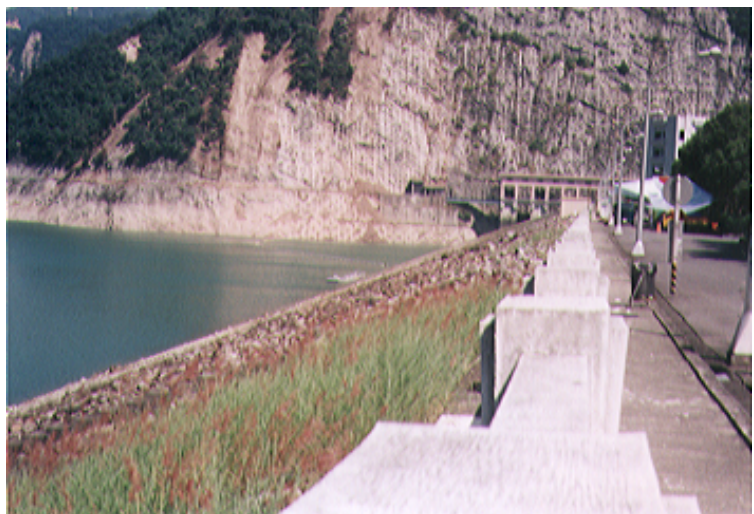
Figure 7.3 Mingtan Dam

Hydraulic power plants along the Juo-Suei-Shi River are located within an approximately 10 km section from the epicenter of Ji-Ji to Ru-Yue-Tan. Ru-Yue-Tan is the biggest man made reservoir in Taiwan. They include two pumped storage power plant, i.e. Mingtan and Takuan No.2. Ru-Yue-Tan is used as the upper reservoir for both power plants. They also include large-scale hydraulic power plants such as the Takuan No.1. Although a lot of dams are constructed along this area, damages on them were slight. The Suei-Sheh Dam of Ru-Yue-Tan is an embankment dam with a reinforced concrete core and an upstream side gradient of 1:3. It was reported that water level of Ru-Yue-Tan was lowered, by way of precaution, because of 5 cm of surface

settlement. TPC said that a survey conducted by an U.S. organization verified the structural safety.

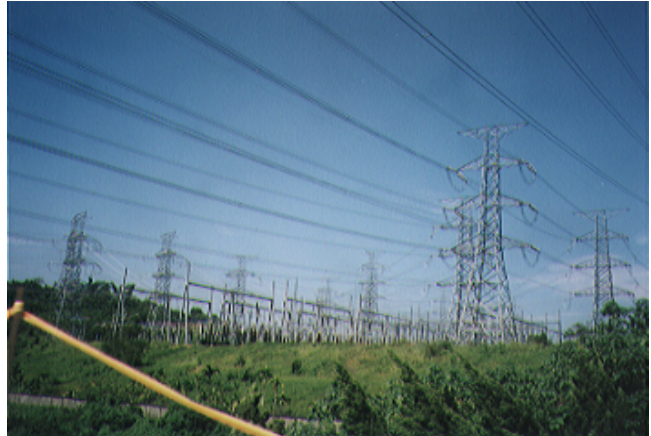
Figure 7.3 Photo of Chungliao switching yard

At the Chungliao switching yard (Figure 7.3, 7.4 and 7.5), insulators and bushings for the 345-kV extra-high voltage switching facilities were damaged. The probable causes of the damages are vibration and ground movement caused by collapse of the fault which diagonally crosses the switching station. The switching station consists of the northern and the southern parts (see the plan view for reference), with the former locating approximately 20 m higher than the latter. The whole area of the switching station also has a gentle north-south gradient of approximately 5 degrees and is provided with pile foundations because of its poor soil conditions. Therefore, there is a possibility that cracks observed in the ground of the site was caused by landslide of the lower southern part (Figure 7.6).

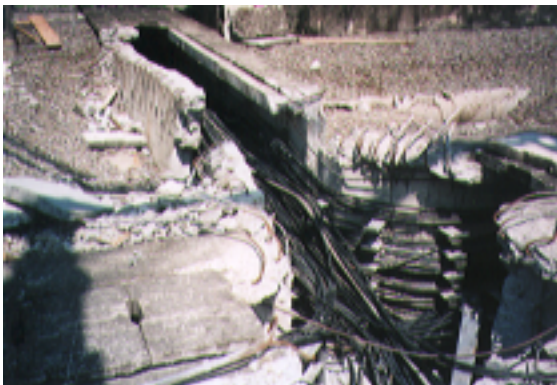
Figure 7.7 Damage of the Cable Ducts

There are reinforced concrete trench culverts (1 m wide by 1 m high) housing the underground cables for controlling switching devices. They are horizontally displaced by up to 1 m, due to which part of sections are completely closed (Figure 7.7) and shear failure (Figure 7.8) along the culvert axis occurred at other locations.

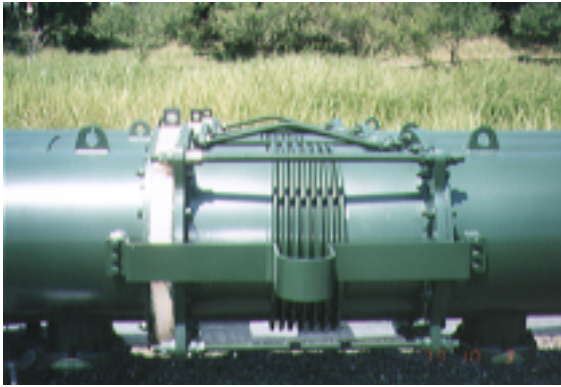
Figure 7.9 Flexible joints of Pipes

Six outdoor pipes located at southern part of the switching yard escaped fracture, due to flexible joints provided at mid sections of them (Figure 7.9). However, they were slightly bent and it has not yet been confirmed whether they are in working order. The gas insulated switchgears (GIS) are products of Mitsubishi and Hitachi and started operation 12 to 13 years ago (Figure 7.10). The local engineer of Mitsubishi said that since they are obsolete, there is no engineer in Japan who is well aware of the details of their mechanism. Checking on the GIS operation system was underway and efforts had been made to partially resume their operation from 5th October. The TPC said that for the time being, bypassing electric lines without using the switching facilities would directly transmit power. The Chungliiao switching yard is base of two north-south power transmission routes, so unless it is not rehabilitated, electric power cannot be transmitted from south to north; hence electric power failure in Taipei is not dissolved. Although some foundations for transmission towers were heaved, it seemed that it would not disrupt power transmission for the time being.

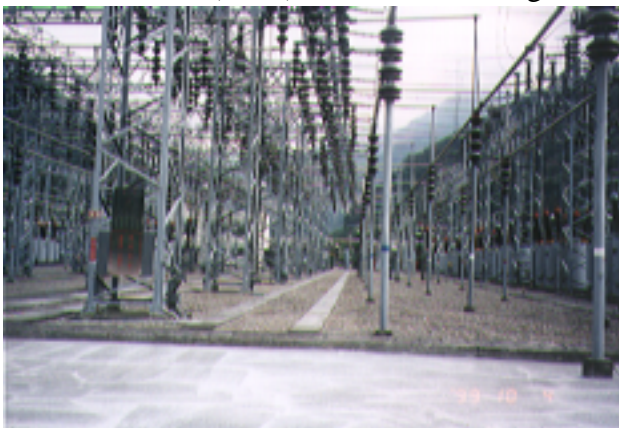
Figure 7.13 Overview of 161kv Substation

Extra-high voltage transformation facilities located adjacent to the Tienlun branch hydraulic power plant were damaged, including 161 kV and 345 kV devices. The 161 kV device has been repaired (Figure 7.13), and power generation and transmission have been resumed by using it.

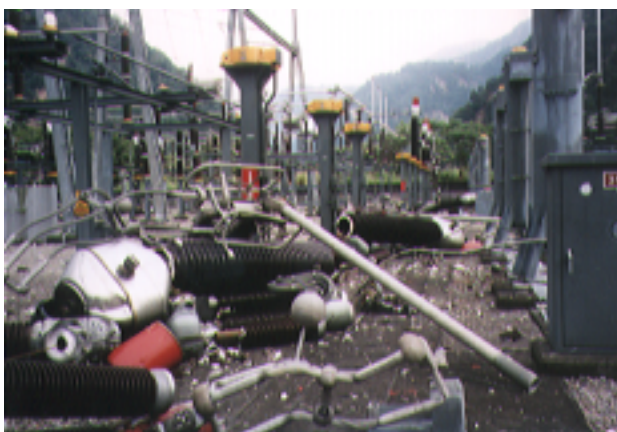
Figure 7.15 Damage of ACB at 345 kv substation

The 345 kV device was out of commission due to oil leakage caused by thermal expansion (boiling) of the oil, which arose from short circuit inside the transformer. A number of insulators were also damaged and almost all air circuit breakers (ACB) were broken (Figure 7.15). The 345 kV device was covering the first north-south route, which starts from Chungliao, runs through Tienlun and leads to Long Tan. Although the 161 kV device connected to neighboring areas such as Wu-Fong and Er-Mei was slightly damaged, it has already resumed power transmission after repairing; its oil circuit breakers (OCB) suffered no damage.

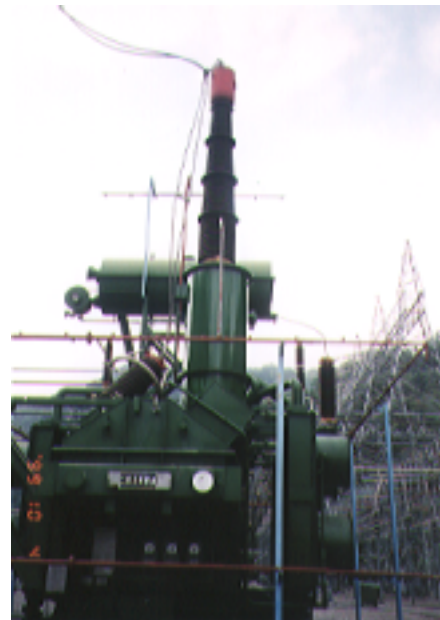
Figure 7.14 Damage of oil leakage at 345 kv Substation

Although the transformer station is located adjacent to the river-side power plant, no major ground movement was observed; only minor falls with a size of approximately 10-m from the slopes within the transformation station area occurred, but devices suffered no damage (judging from the nearly vertical slope, it is considered that the site was prepared by excavation, not by embankment, and the natural ground consists of rocks). It is therefore considered that damages on the transformation devices were caused by vibrations (Figure 7.14).

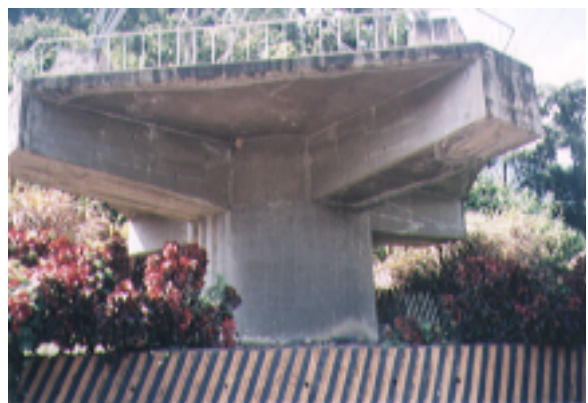
Figure 7.16 Well-type Tower Foundation

Tower foundations near rivers, mainly built by the well foundation (Figure 7.17) method (reinforced concrete footing, placed on a 6 m diameter well foundation with a depth ranging from 20 to 30 m, supports the four legs of the tower), were heavily damaged by ground deformation.

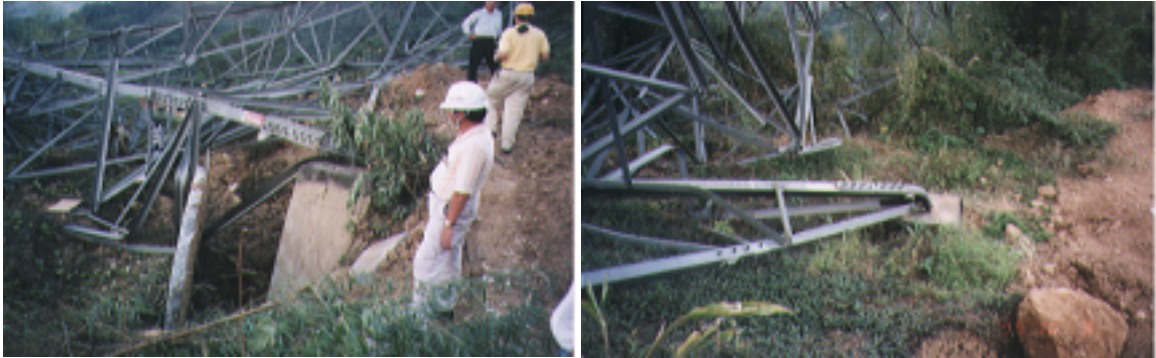
Figure 7.18 the collapsed tower # 203

We also surveyed the northern area from Ru-Yue-Tan, by way of Puu-Ri, to Kuo-Shing where a transmission tower collapsed. The collapsed tower # 203 (Figure 7.18) is

relatively close to the town of Kuo-Shing, about 20 minutes' by a 4WD vehicle, and located on the mountain slope. The suspended type tower collapsed at the bottom toward the valley side, perpendicular to the cable direction (Figure 7.19). The foundation level on the valley side was lower than the mountainside by approximately 10-m from the beginning (Figure 7.20). Electric cables were not disconnected and no visual damage was observed on the foundation concrete.

All four tower legs were bent inward at the bottom, which indicates that the two legs on the valley side had buckled. No major fissure, other than the one which runs through the center of the four legs in the mountain-valley orientation, i.e. perpendicular to the cables, was observed around the tower. Four foundations have a pyramid-shaped profile; about 2 m from the ground surface of one foundation on the mountainside was exposed, but other three showed no serious visual damage. While ground falls at the tower location were minor, prominent falls were observed everywhere near the tower.

Probably, the main cause of the tower collapse was displacement of the foundations due to ground deformation. However, judging from the fact that the foundations suffered only minor damage, it is also necessary to further investigate the causes in connection with the vibration of upper portion of the tower. The collapsed tower was left on the site and a temporary steel tower was being constructed on the mountainside approximately 10 m from the original position. It had no foundations and was supported in such a way that wires from upper and mid portions of the tower were fixed by anchors. 24 numbers of 10 mm diameter by 2 m long anchors per one direction were used. Test power transmission was scheduled to be started at 7:00 pm on 3rd October. Regular power transmission would be partially resumed from 5th October upon completion of rehabilitation work of the Chungliao switching yard (by-pass connection).

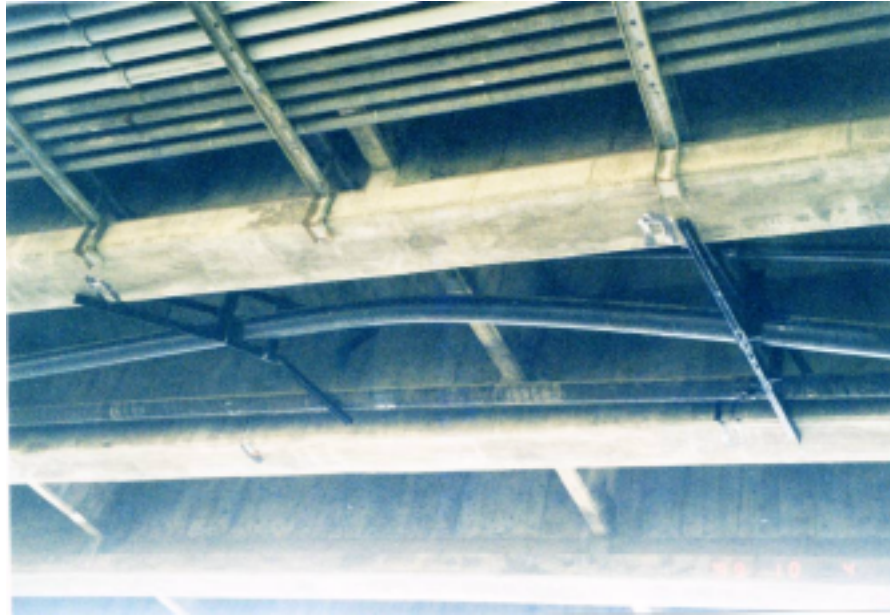
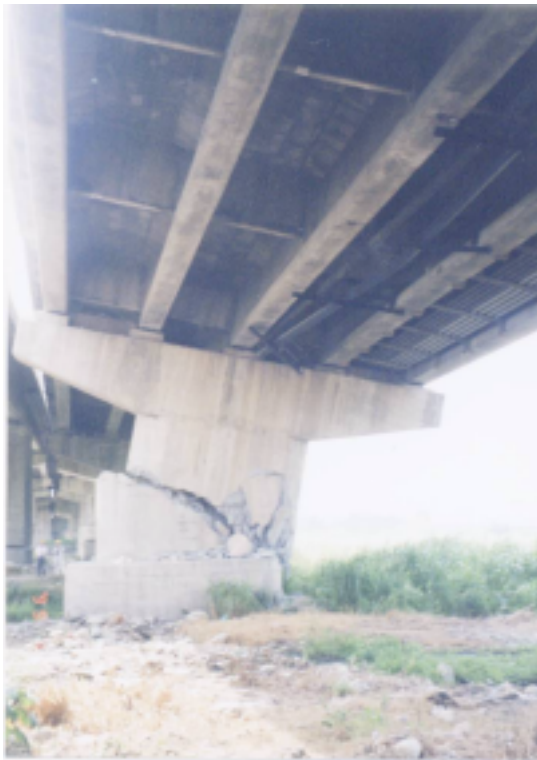
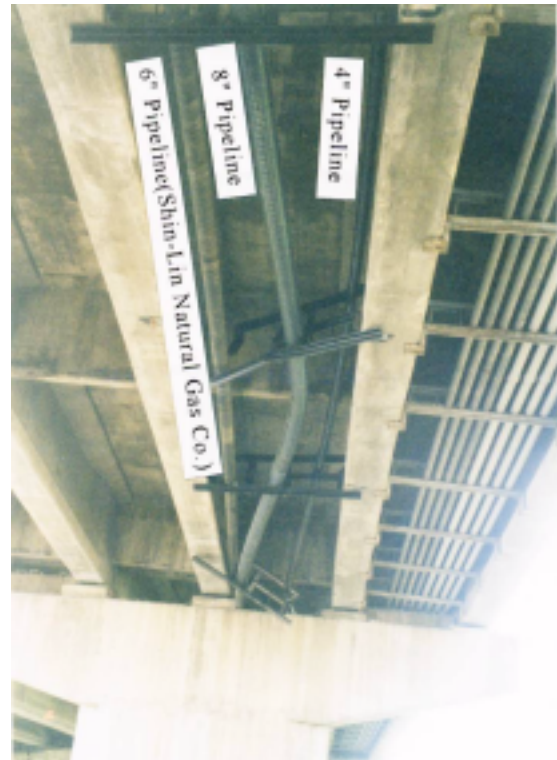
Figure 7.24 Bent pipelines at the Wu-Shi Bridge

The Wu-Shi Bridge consists of two adjacent bridges. In the earthquake, the bridge girders of the east bridge fell to the ground and the piers of the west bridge inclined. The 8" and 4" pipelines attached under the bridge girders of the west bridge were bent

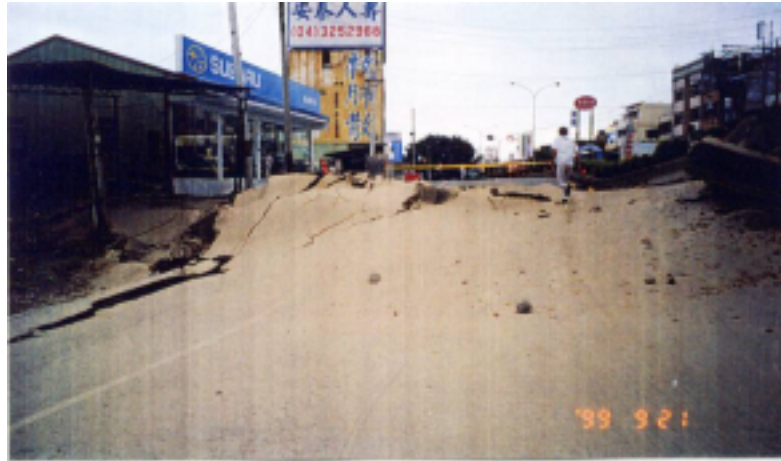
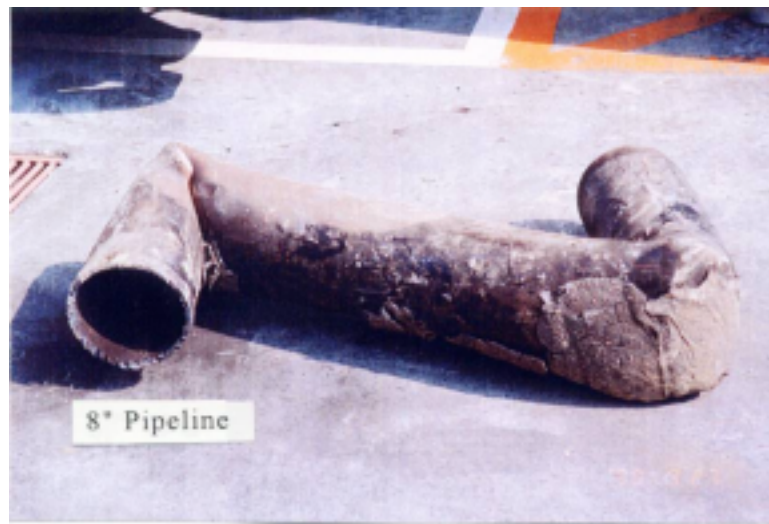
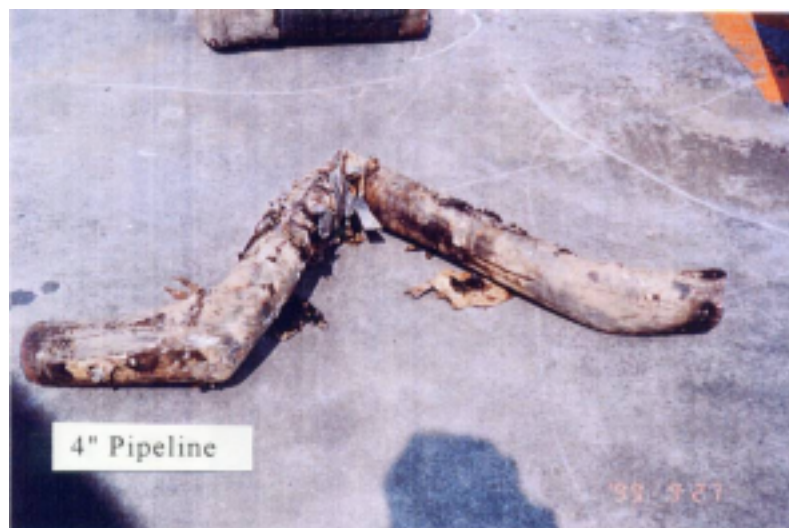
Figure. 7.25 The rising of the road surface and the deformed 8" and 4" pipes

At 30 m – 40 m south of the WU-SHI Bridge, the road surface rose 1m to 2 m due to buckling by compressive force. Although the 8"and 4" pipelines laid here were not cut off, they deformed into a "Z" shape at this site, as shown in Figure 7.25.

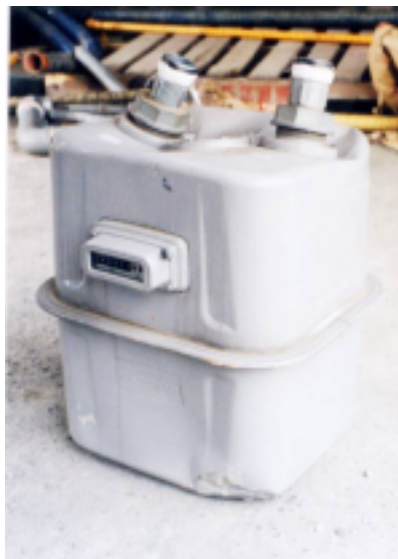
Figure 7.26 Damage to the gas meter

The elbows used in service pipes were heavily damaged at the point to rise up to gas meters. Gas meters were also damaged at many residences (Figure 7.26).

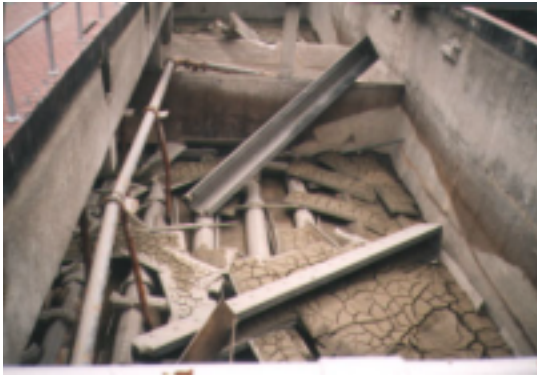
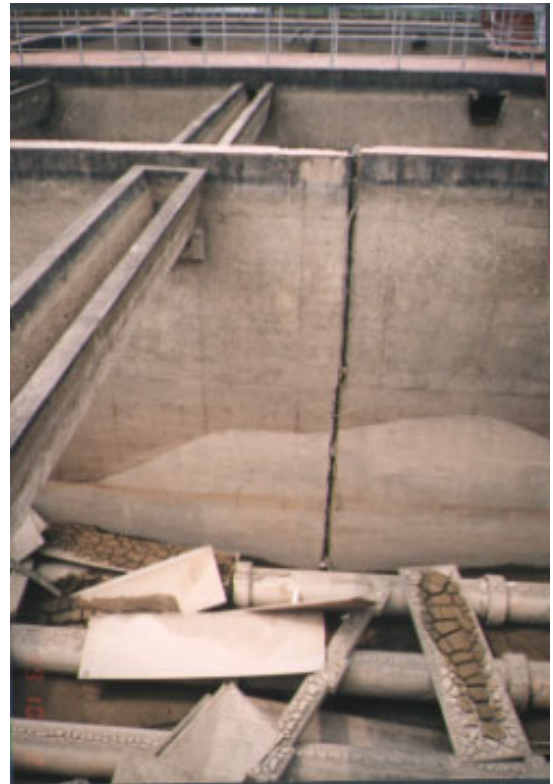
- a) Drop out of flocculator at flocculation basin
- b) Drop out and collapse of inclined plates and troughs at sedimentation basin
- c) Damage to liquefied chlorine injector
- d) Damage to buried pipelines
- e) Overturn of control facilities
- f) Damage to concrete pavement in buildings
- g) Fall of ceiling slab of service reservoir
- h) Damage to expansion joints

Figure. 7.34 Damage at suspended solid contact clarifier
(No. 1 Fon-yuan purification plant)

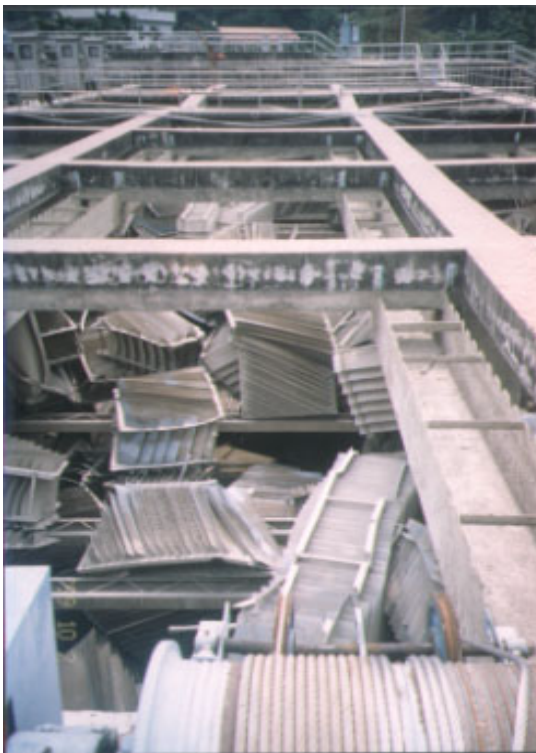
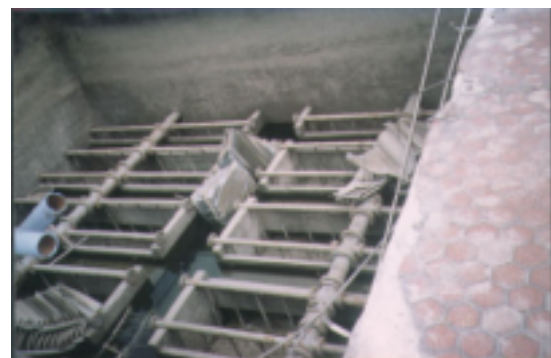
Figure.7.35 Damage at inclined plate clarifier
(No.1 Fon-yuan purification plant)

Figure.7.36 Jump out of inclined
plates(No.1 Fon-yuan purification plant)

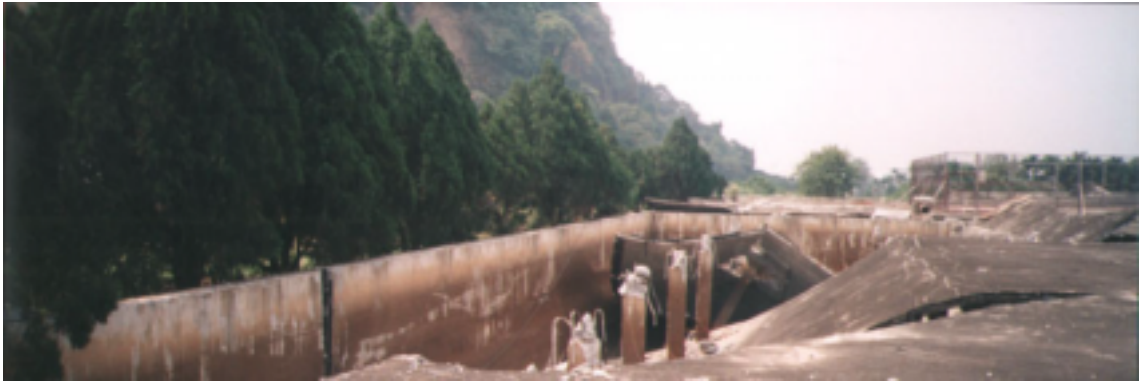
Figure. 7.37 Fall of ceiling slab of service reservoir
(No. 1 Fon-yuan purification plant)

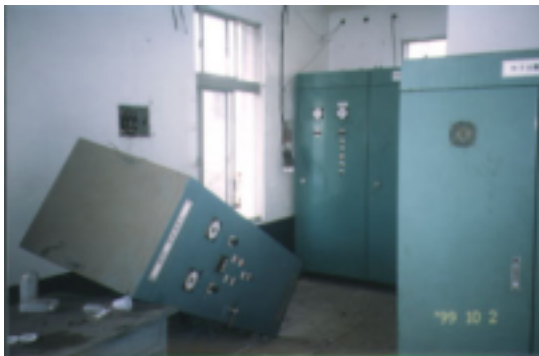
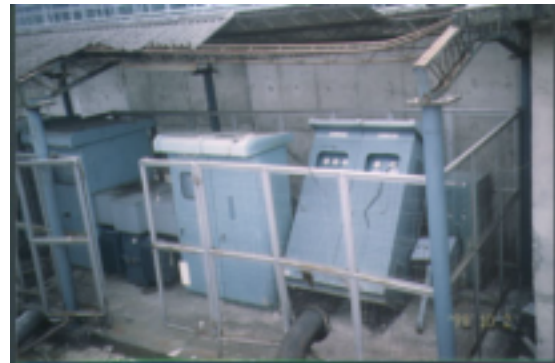
Figure 7.38 Overturn of control facilities(No. 1 Fon-yuan purification plant)

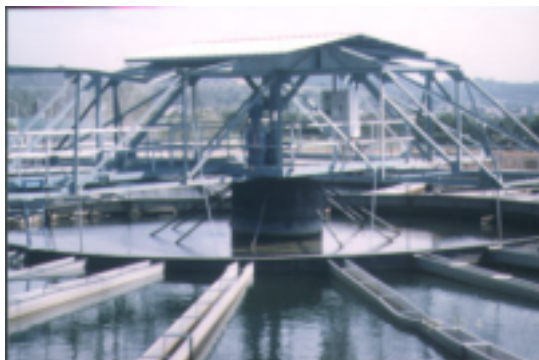
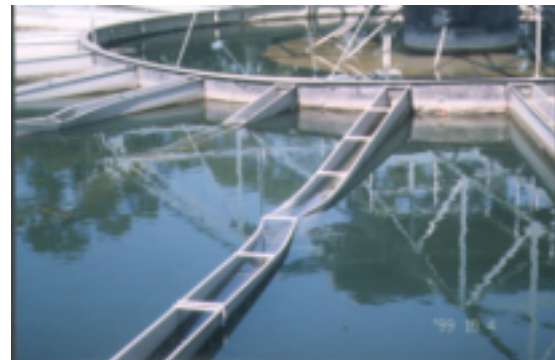
The capacity of the Rii-yui Tan purification plant is 750, 000 m³/day. The water resource is the Rii-yui Tan Dam (Effective storage: 122,776,000 m³). The treatment was done by the rapid coagulation-sedimentation and sand filtration method. Although there was no severe damage to the concrete structures, many steel troughs were bent and fell down at the rapid coagulation sedimentation basin.

Figure 7.39 Damage to troughs at suspended solid contact clarifier
(Rii-yui Tan purification plant)

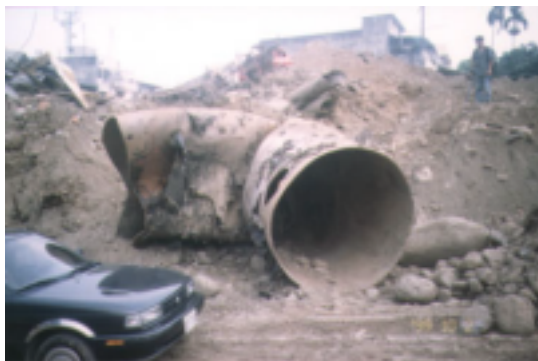
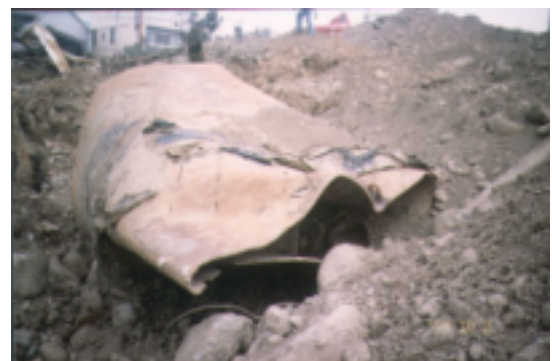
- a) Pull out and push in of pipes at joint were remarkably.
- b) Damage to pipeline concentrated at the areas close to the fault.
- c) Pipelines cross the fault were heavily damaged.

Figure 7.40 Damage to water conveyance pipe (Diameter: 2000mm)

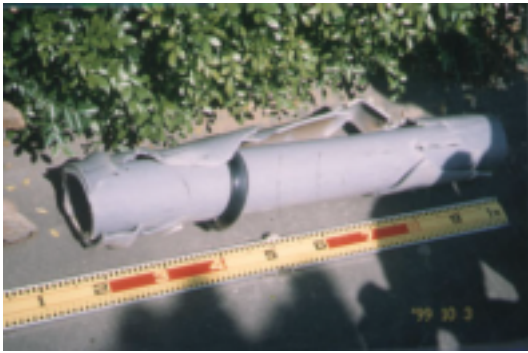
Figure.7.41 Push in each distribution pipe (vinyl pipe) at joints
(Displacement is about 0.8m)

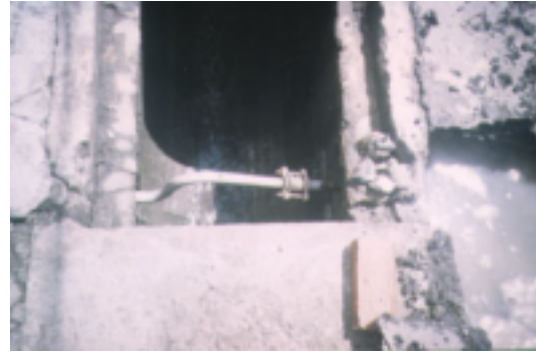
Damage to water service installation was investigated at Chunglia and Jong shing shin Tsuen. Service pipe is made up of polyvinyl chloride pipe and the pipe is installed as shown in Figure 7.42. Since the service pipe passes a concrete gutter shown in Figure 7.43, it was easy for the pipe close to the gutter to break during the earthquake. It was difficult to find the water leak because the water from the breakage permeated to gravelly ground.

Figure.7.43 Service pipe passing concrete gutter
