8. LANDSLIDE, SLOPE FAILURE AND LIQUEFACTION

8.1 Landslide and slope failure

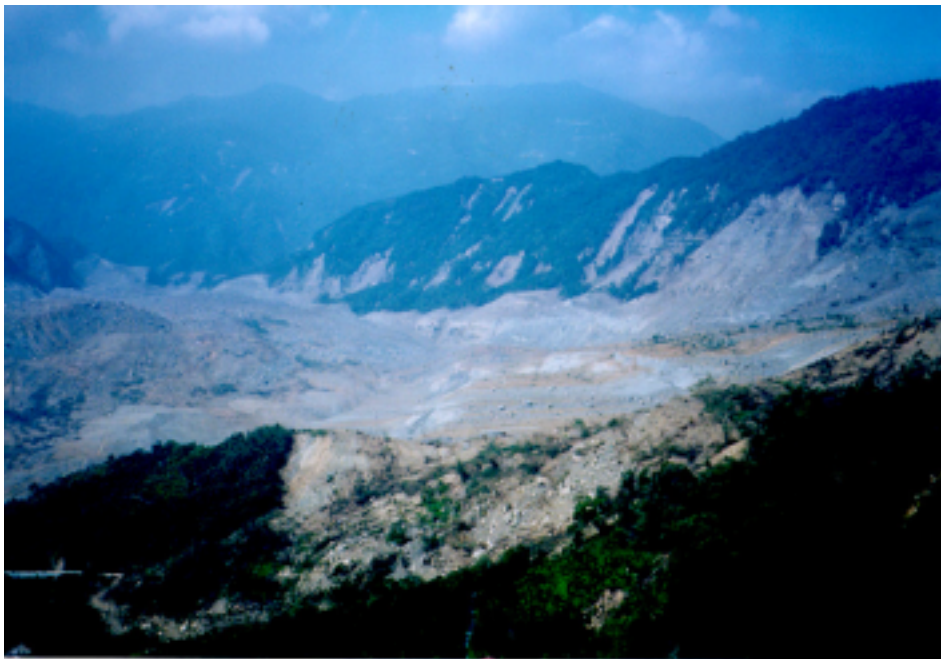
Photo.8.1 Landslide at Chao-Ling

Huge landslides occurred at Chao-Ling where was located along Ching-Shoei river around the border between Yui-Lin Shyuan and Chia-Yii Shyuan. Hence Ching-Shoei river is the branch of Juo-Suei-Shi river. The landslide as shown in Photo.8.1 generated around both sides of the mountains along the river and swallowed the village by the soil and gravel. The gross volume of the flow and the total length of the slide estimated to be more than 3 million m³ and 4 km, respectively. Furthermore, a river which has 80m width was filled with the soil and gravel, and a new lake was created.

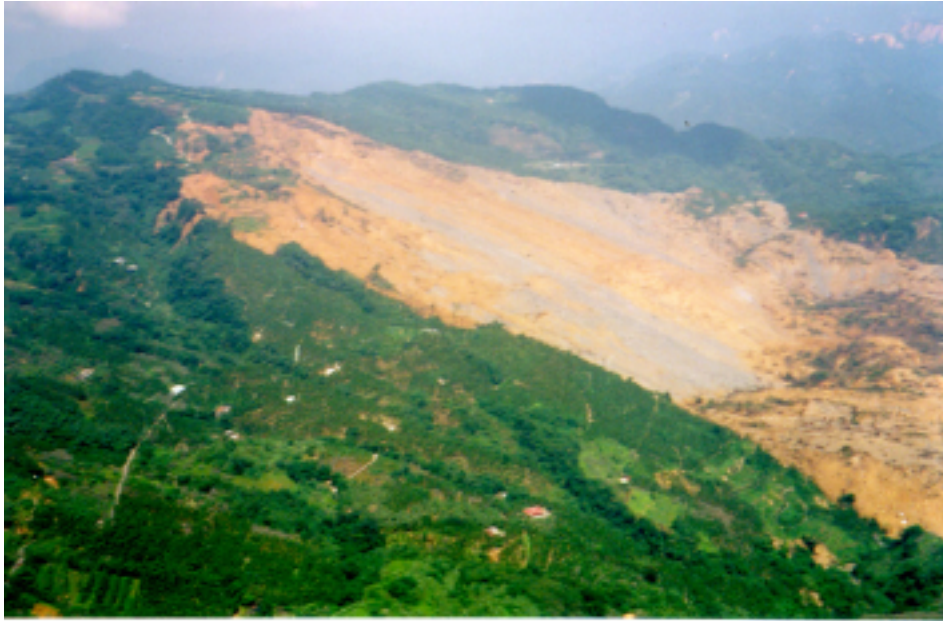
Photo.8.2 LandSlide at Jio-Fun-Ell-Shan Mountain

Huge landslides occurred at Mt. Jio-Fun-Ell-Shan where located about 3.0km west from Nan-Kan in Nan-Tou prefecture. The landslides were generated at the two mountains which were close to each other. Photo.8.2 shows the landslide occurred at one of the mountains. Due to the landslide, two villages were swallowed. Furthermore, the flow dammed up the river, and a new lake was created. The gross volume of the flow estimated to be more than 0.5 million m³.

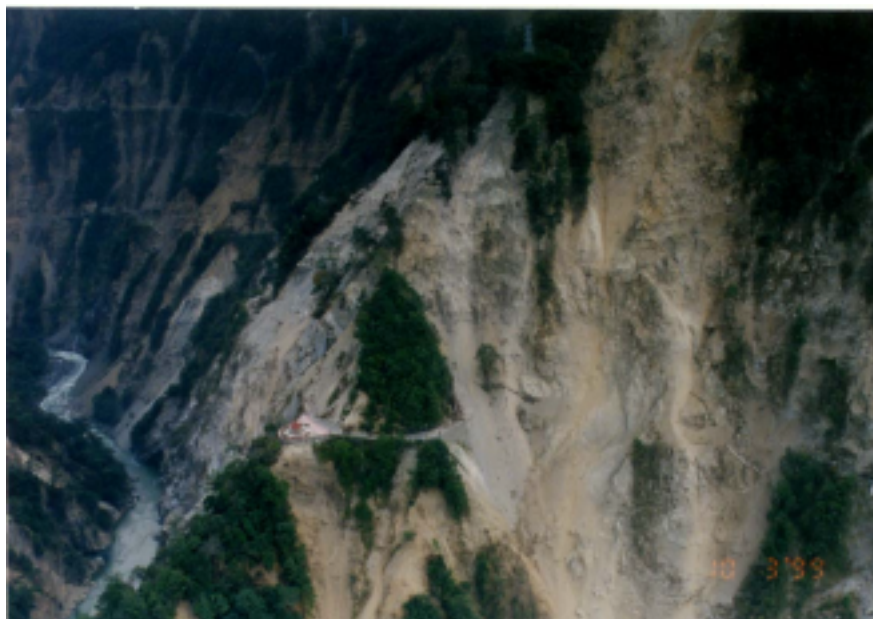
Photo.8.3 Slope failure at Gwu-Guan

A road(Jon-Buh-Heng-Guann-Gong-Luh) crossing the central part of Taiwan Central was interrupted at Gue-Guan due to a lot of large scale slope failures, one of example of which is shown in Photo.8.3. The road was constructed on the slope in the mountain range at upstream of Dai-An River and had an important role to connect between the eastern and the western parts of Taiwan. Many slope failures have also occurred during the aftershocks.

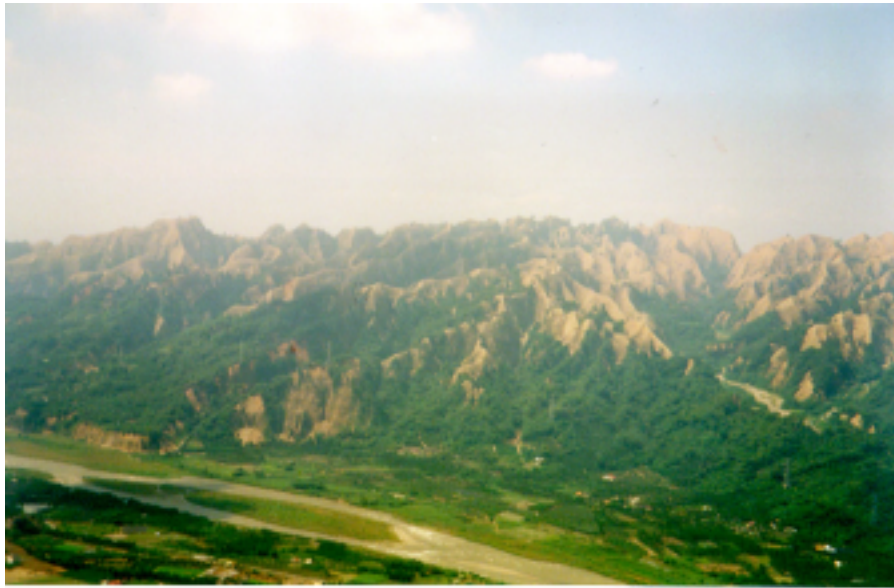
Mt. Hoyen-shan became bald as shown in Photo.8.4. due to the surface slope slidings. The mountain is located about 12 km east from Wu-Fong in Taichung County. The height of the mountains is 526 m and the slope is very steep. It had been all covered with trees up to the top before the earthquake. Cobblestones were observed around the top. The large scale slope failures resulted from the steep slopes and the unstable soil with cobblestones.

Photo.8.4 Whole view of Hoyen-Shan which became a bald mountaion

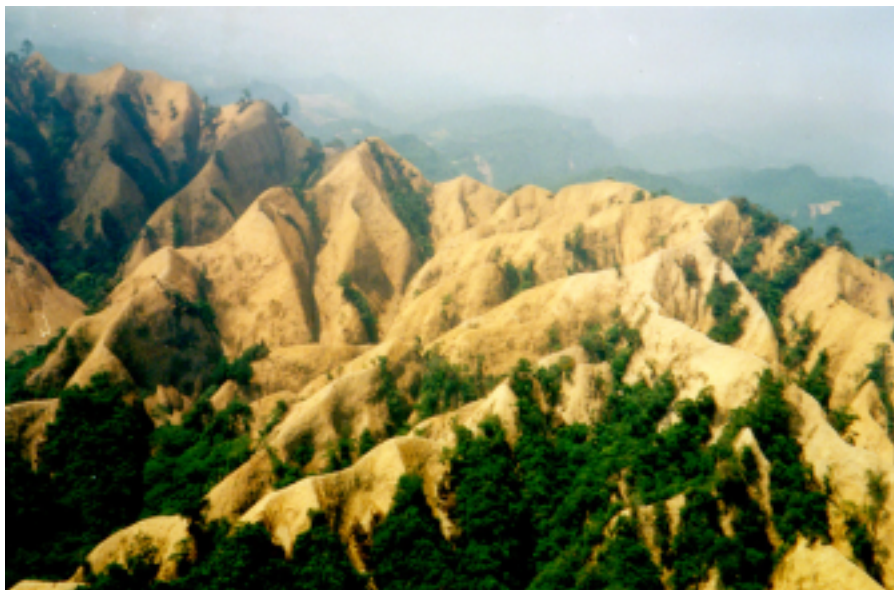
Photo.8.5 Close view of Hoyen-Shan which became a bald mountaion

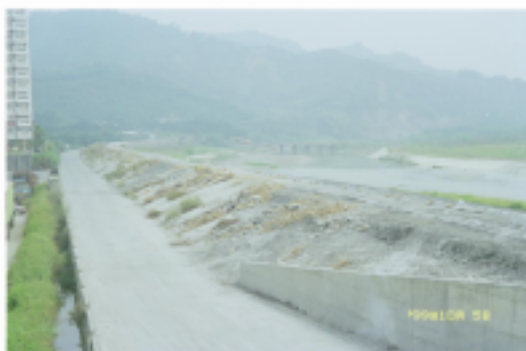
Damage due to liquefaction was observed at several places along the branch of Da-Jia river. The locations of the liquefied areas are shown in Figure.8.3. Among them, Both sides of the dike along Mao-Luoh river subsided to about 1m as shown in Photo.8. 6 and 8.7. The subsidence occurred to be about 5.0km long between Juin-Gong bridge and Nan-Gang. At Lyu-Mei Bridge, the dike of the river moved toward the river center due to liquefaction and the abutment of the bridge. Photo.8.8 shows the settlement of the approach road on the abutment. The total movement of the dike which was measured as the amount of crack width parallel to the river was reported as about 80cm. The similar damage was observed at Juin-Gong bridge which is close to Lyu-Mei bridge.

Photo.8.6 Settlement of River Dike

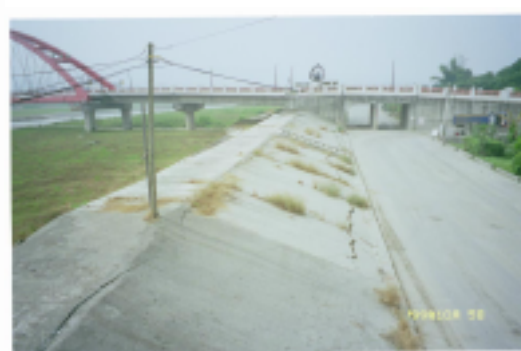
Photo.8.7 Crack along the facing of River Dike

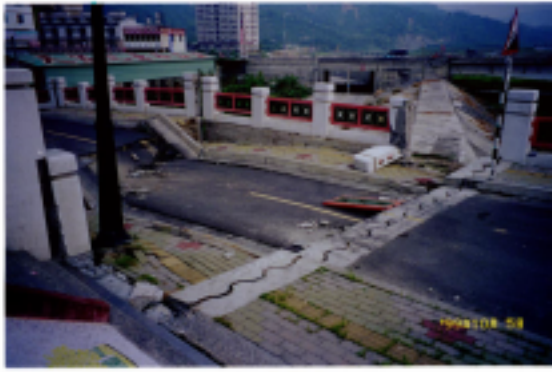
Photo.8.8 Failure of Abutment at Lyu-Mei Bridge(Provided from the investigation team for The 1999 Ji-Ji Earthquake by The Japanese Geotechnical Society)

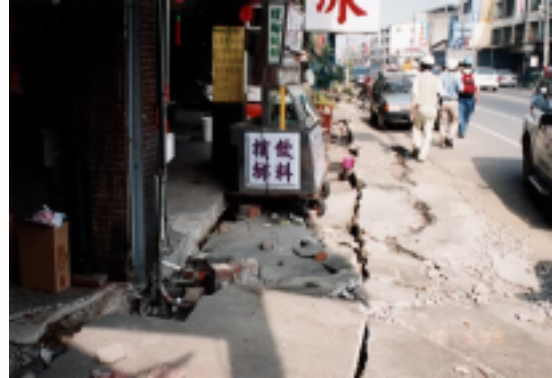
At Juin-Gong Lii about 200m north-west from the above-mentioned bridge, It was reported that many houses and side walks of a road were settled as shown in Photo.8.9 and a lot of sand boils were observed in a banana plant as shown in Photo.8.10. Sand boils were also found at a banana plant, south of Jenn-Shin bridge in Ping Ling lii.

Photo.8.9 Settlement of Houses and Side walk

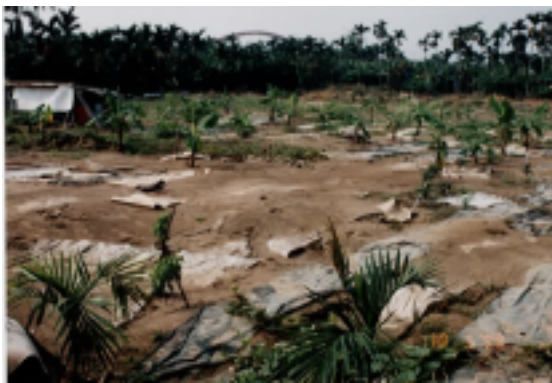
Photo.8.10 Sand Volcano in Banana Plant

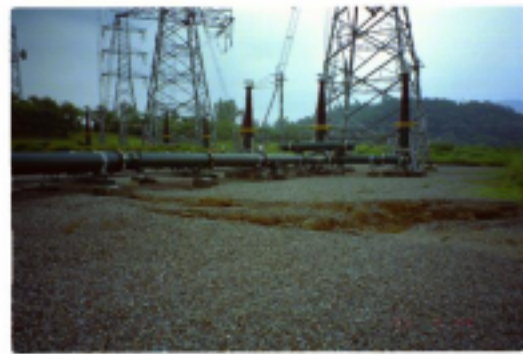
Chungliao switching yard of Taiwan Electric Power Company as shown in Photo.8.12 locates in the north from the epicenter. The switching yard was constructed on the top of a hill by cutting of the soil. Some fissures were observed around the filled area in the yard as shown in Photo.8.13. These fissures were supposed to be caused by the liquefaction, because a lot of sand volcanos were observed as shown in Photo.8.14. The erupted soils around sand volcano contains an amount of fine contents.

Photo. 8.13 Fissure generated by liquefaction

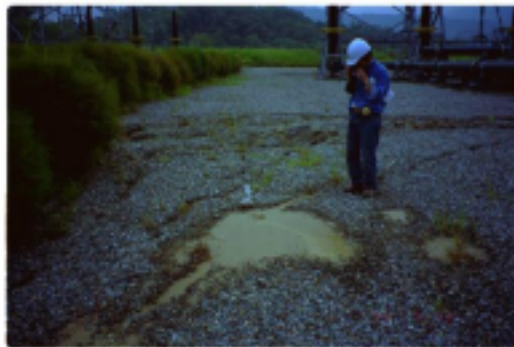
Photo. 8.14 Erupted soils on the lower site

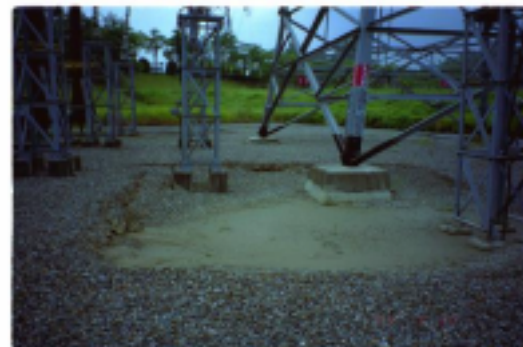
Ground around the foundation of a transmission tower subsided about 20 to 30 cm and sand boils were observed as shown in Photo8.15.

Photo. 8.15 Settlement of foundation of the transmission tower

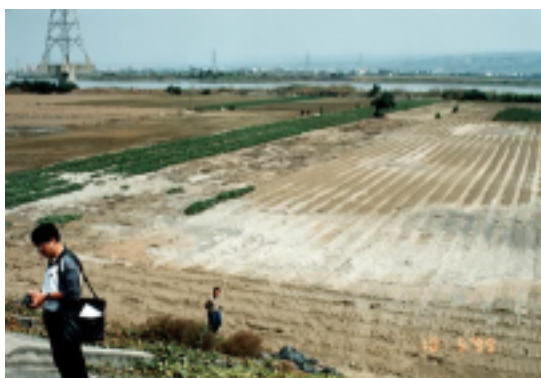
Ground fissures due to liquefaction as shown in Photos.8.16 and 17 were observed on the river front of the downstream of Da-Jia river around Chang-Hua city.

Photo.8.16 Fissure on the river front

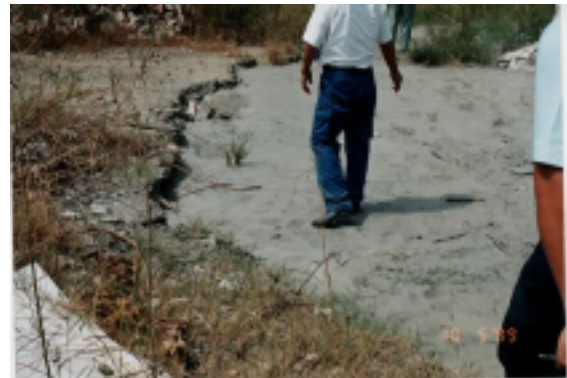
Photo.8.17 Boiled sand around fissure

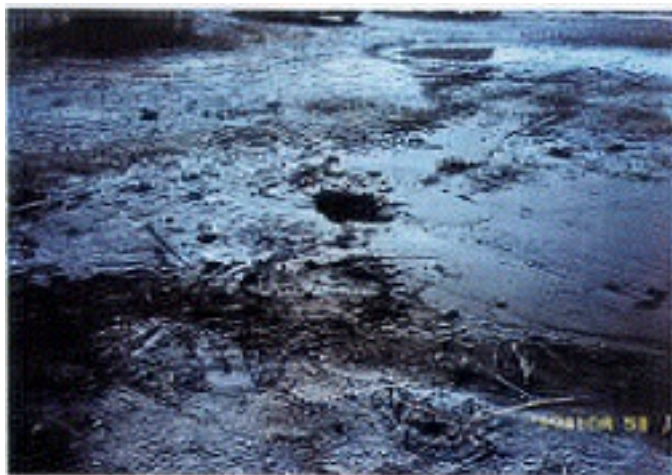
Sand boils due to liquefaction at Lu Gang which was under construction was observed as shown in Photo.8.18. However, the dynamic compaction method had been used in a part of the reclaimed land to improve the soil against liquefaction. Any sand boil was not observed in the improved area..

Photo.8.18 Sand Volcano in Lu-Gang

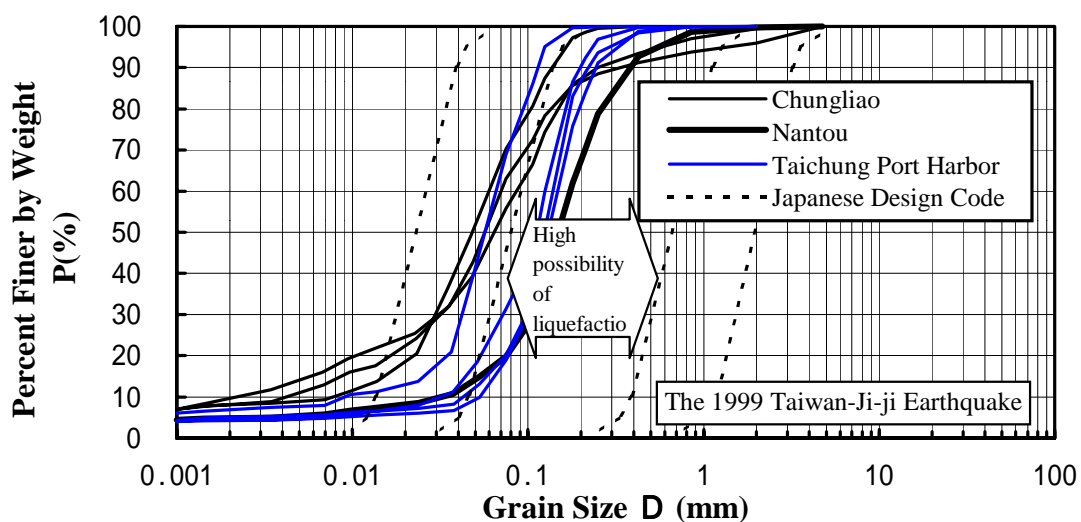
Figure 8.4 Grain Size Distribution of Liquefied

Figure 8.4 shows grain size distribution curves of the erupted soils. The ranges of high possibility of liquefaction, which is recommended by *the Technical Standard on Port Facilities and Its Explanation*(1989) is also shown in this figure. The grain size of the sand sampled at Nantou City and Taichung Port are in the range of "High Possibility of Liquefaction". The soil sampled Chungliao Switching Yard is classified to be silt because fine contents are more than 50%. The soil sampled soil at Taichung Ports is also classified to be silt.
