9. DAMAGE TO BUILDINGS AND HOUSES

During the 1999 Ji-Ji earthquake, more than 14,000 buildings suffered damage in the whole area of Taiwan. In Nantou and Taichung Prefectures in the epicentral regions, more than 12,000 buildings were damaged and about the half of which totally collapsed. Most of the buildings are constructed by reinforced concrete. Piles are not usually used even in the area of soft sediments. The damage to buildings in Nantou and Taichung Prefectures is briefly introduced and some findings from the investigation are described in this chapter. The investigation carried out by Japan-HongKong Joint Reconnaissance Team (<http://is-jack.archi.kyoto-u.ac.jp/taiwan/>).

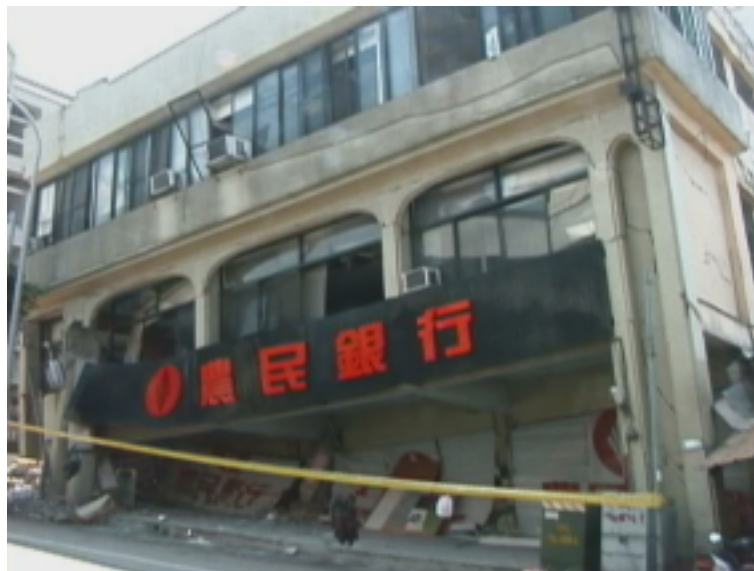
Ji-Ji locates about 3km southeast from the epicenter. Because of the short epicentral distance, many buildings in the city suffered severe damage including the total collapse of the building of Jiji station. Figure 9.1 shows the damage to 3-story RC building on Route 16. The building locates about 200m south of the station. The first story had few walls and two columns on the left-hand side collapsed. The building had been used for a bank.

Figure 9.1. Damage to 3-story RC building in Ji-Ji.

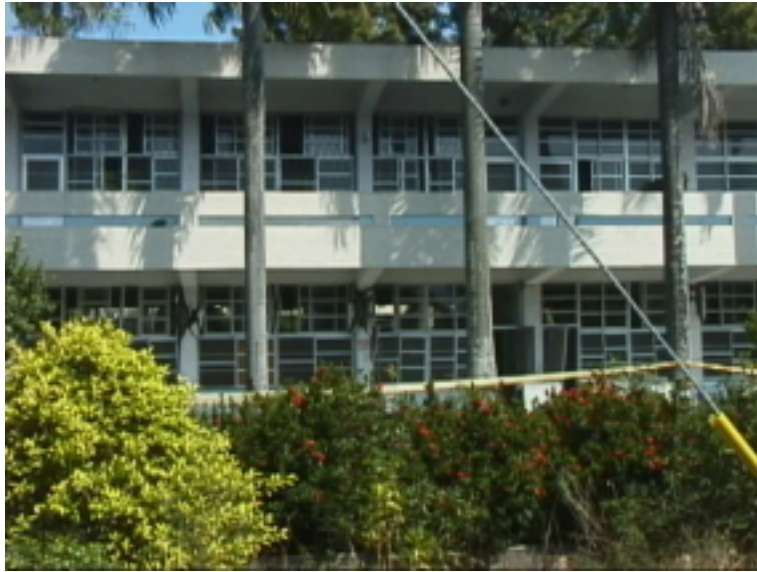
Figure 9.2 shows the damage to a 2-story RC school building (Ji-Ji Junior High School). The school locates about 600 m north from the station. The building is facing to the south. Figure 9.3 shows shear cracks in a column of the first story.

Figure 9.2. Damage to a 2-story RC school building in Ji-Ji.

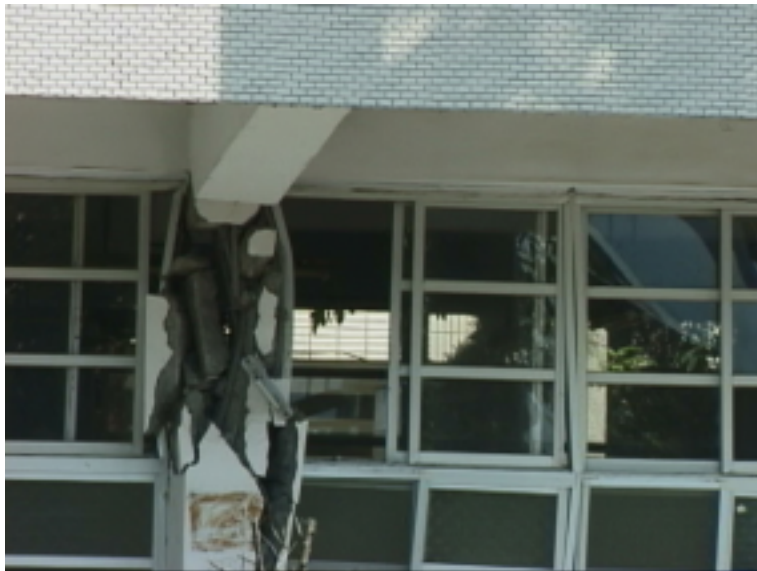
Figure 9.3. Shear cracks in a column of the first story of the building in Figure 2.

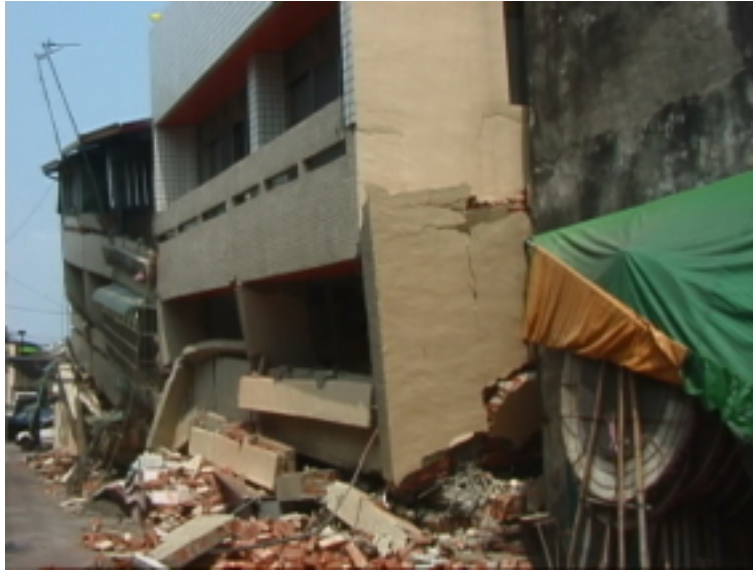
Nantou city locates about 10km northwest from the epicenter. Figure 9.4 shows damage to two 3-story RC apartment buildings with brick infill walls. The first story was used for a garage and had few walls. The collapsed columns and beams are shown in Figure 9.5.

Figure 9.4. Damage to two 3-story RC apartment buildings in Nantou.

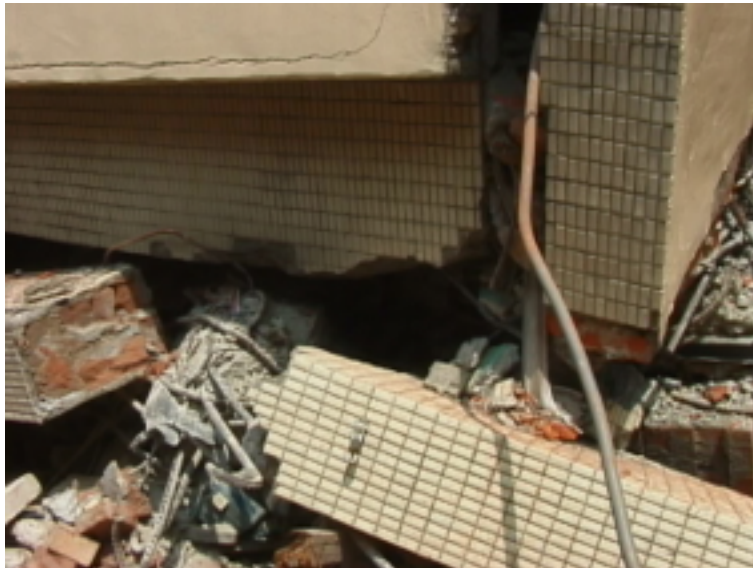
Figure 9.5. Collapsed columns and beams of the right building in Figure 4.

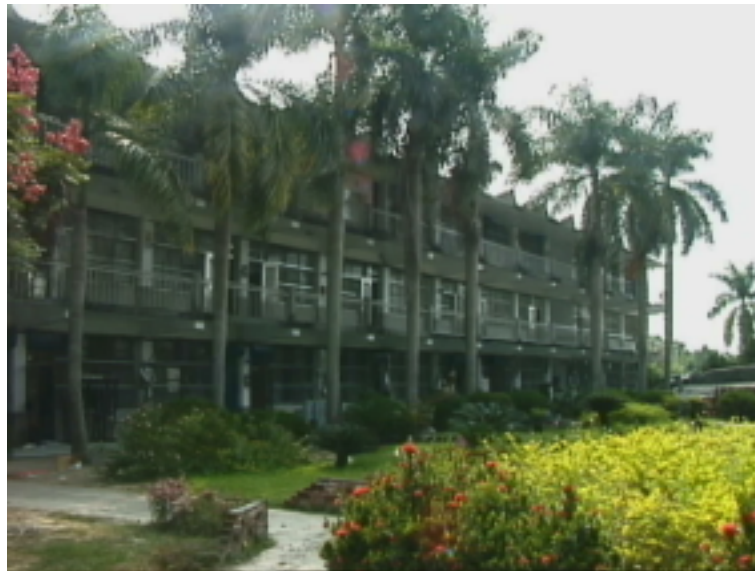
Figure9.6 shows damage to a 3-story RC school building (Guangfu Elementary School). The school locates in the south of the Wufung downtown and close to a vertical fault rupture which appeared on an athletics field. Figure.9.7 shows a collapsed column of the first story of

Figure 9.6. Damage to a 3-story RC school building in Wufung.

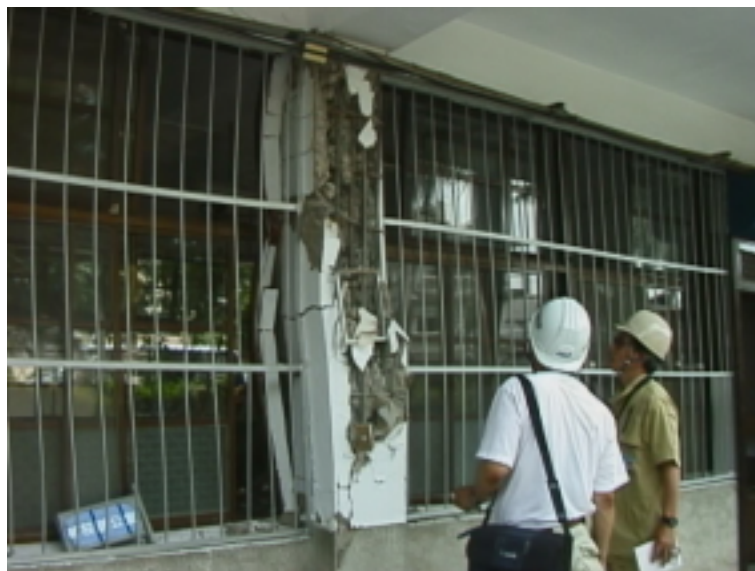
Figure 9.7. Collapsed column of the first story of the school building in Figure 9.6.

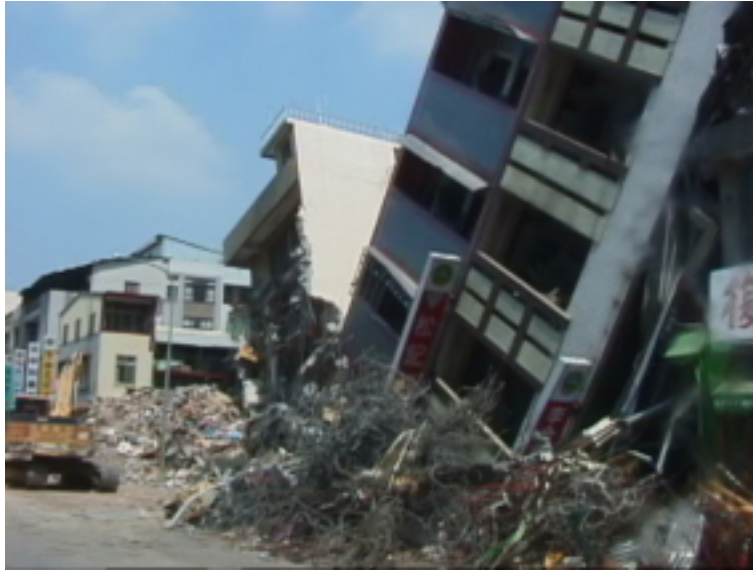
In Wufung, several buildings suffered severe damage due to land subsidences. Some buildings tilted due to differential settlements of foundations. Figure.9.8 shows an example of damage due to the differential settlement. The building on the right-hand side tilted but structural damage was small.

Figure.9.8. Damage to RC buildings due to differential settlements in Wufung.

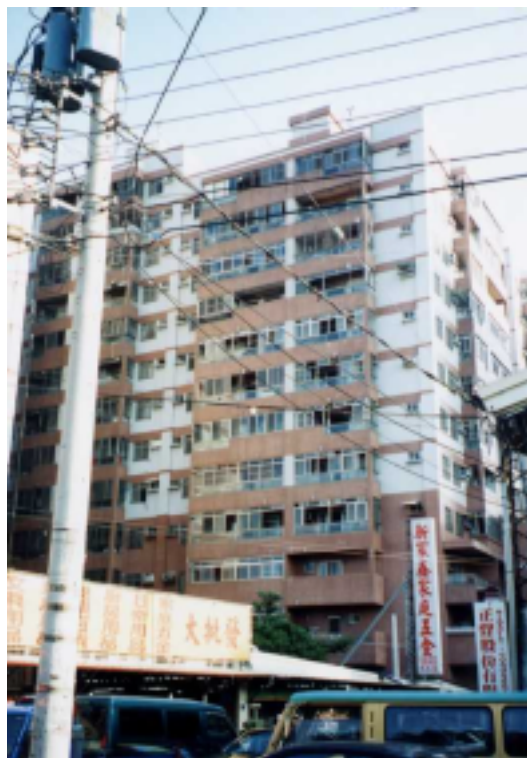
Figure.9.9 shows a 12-story RC condominium building in the center of the city. Non-structural damage was found on the outer wall, but the first story of the building was damaged as shown in Figure.9.10. Some fissures were found on the pavement around the building

Figure.9.9. Non-structural damage to a 12-story RC condominium building in Wufung.

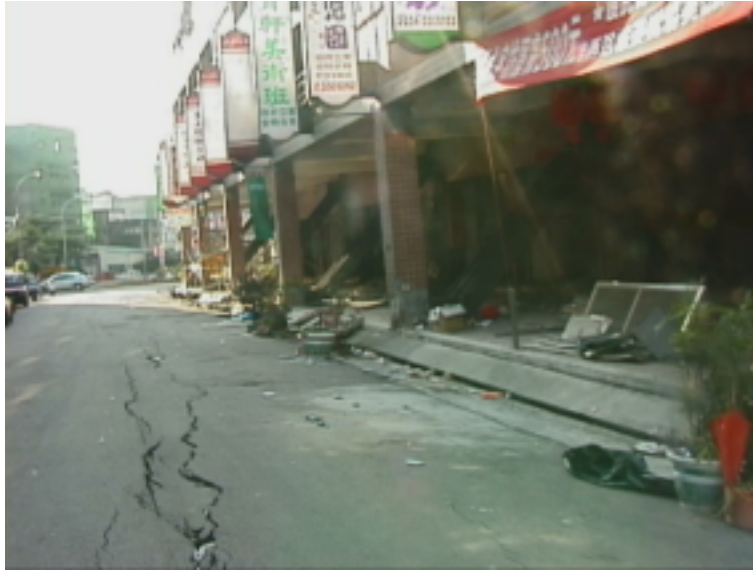
Figure9.10. Damage to the first story of the building in Figure 9.10

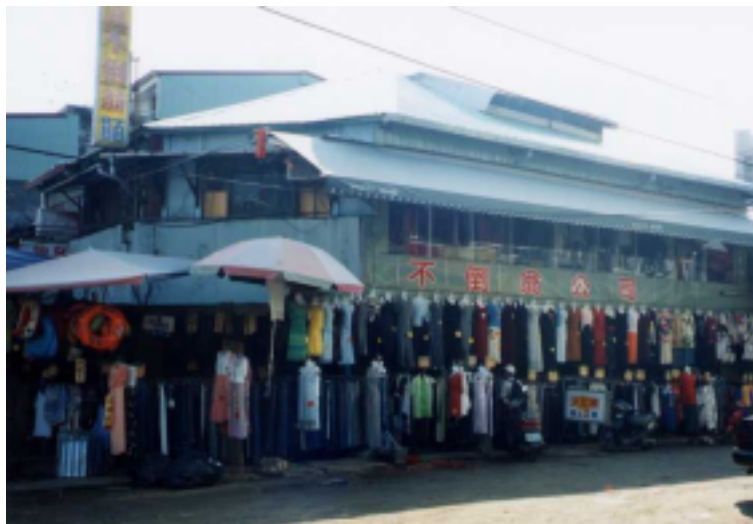
A numerous number of one-story houses which were constructed by sun-dried bricks completely collapsed. These houses were probably built before or just after the end of the World War II. On the contrary, wooden houses in the center of the district that had been built more than 60 years ago had relatively light damage. These wooden houses had mud walls reinforced with bamboo. Figure 11 shows an example of those non-damaged wooden houses.

Figure9.11. Wooden house with little damage in Wufung.

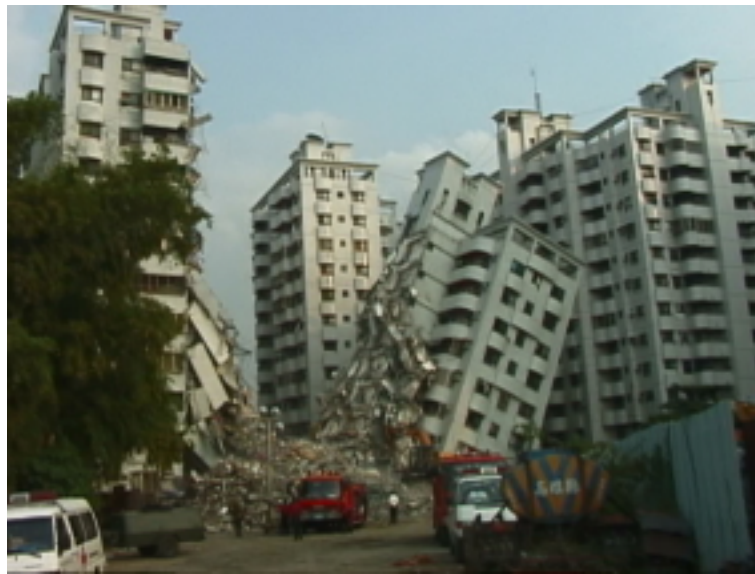
Dali is neighboring to Taichung City. Many condominium buildings had been constructed in the city and some of them seriously collapsed. Figure.9.12 shows damaged RC condominium buildings. The building in the center with L-shape plan totally collapsed in the first and second stories, and leaned on the adjacent building. Figure.9.13 shows a damaged column of a condominium building in the same site.

Figure.9.12. Damage to RC condominium buildings in Dali.

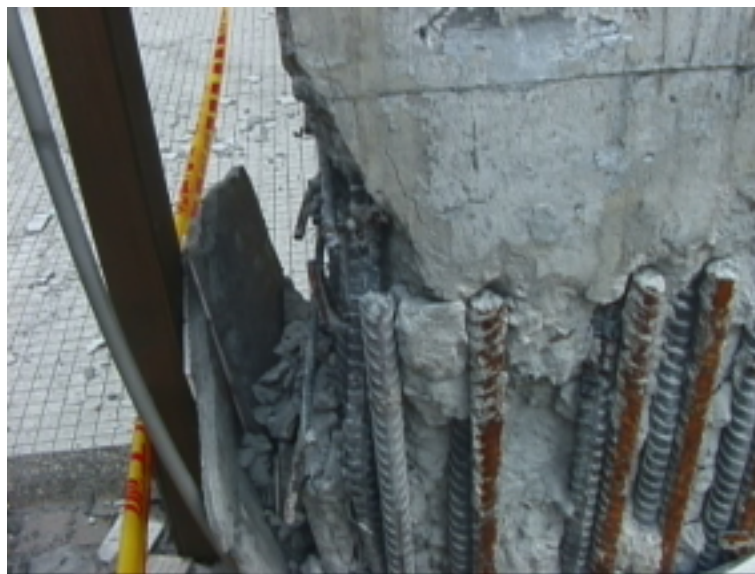
Figure.9.13. Broken column of a condominium building in Dali.

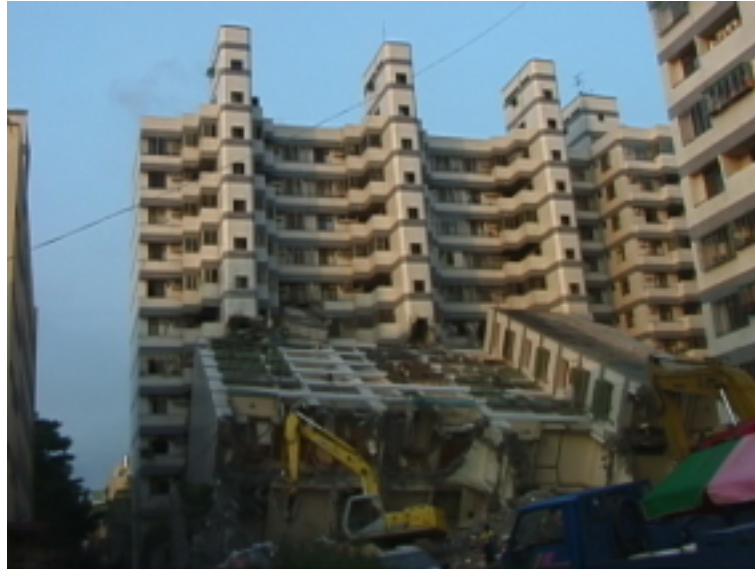
Figure.9.14 shows a RC condominium building in Dali. The location is close to the riverside of Dali River. The building had a parking spaces in the basement. Because the basement collapsed, the building leaned on a building behind it. Figure.9.15 shows another collapsed building in the same area. The building fell down with little structural damage and leaned on a neighboring building as shown in Figure.9.16.

Figure.9.14. Damage to RC condominium buildings in Dali.

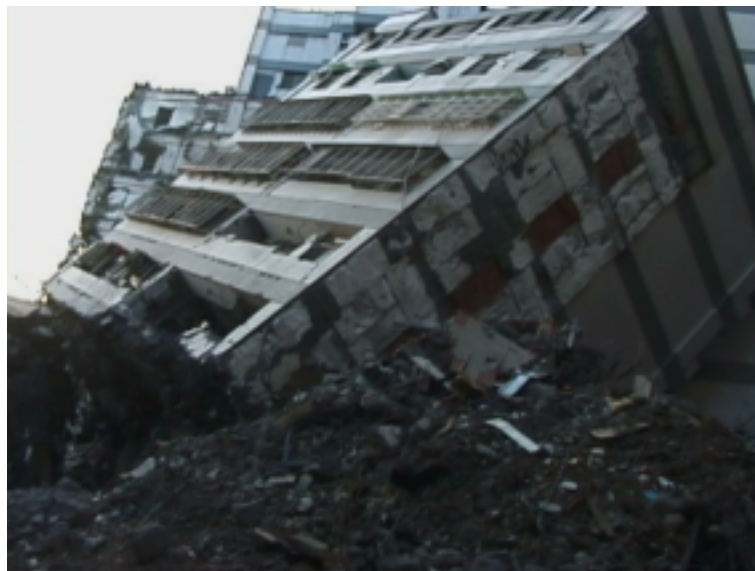
Figure.9.15. Collapsed building in Dali.

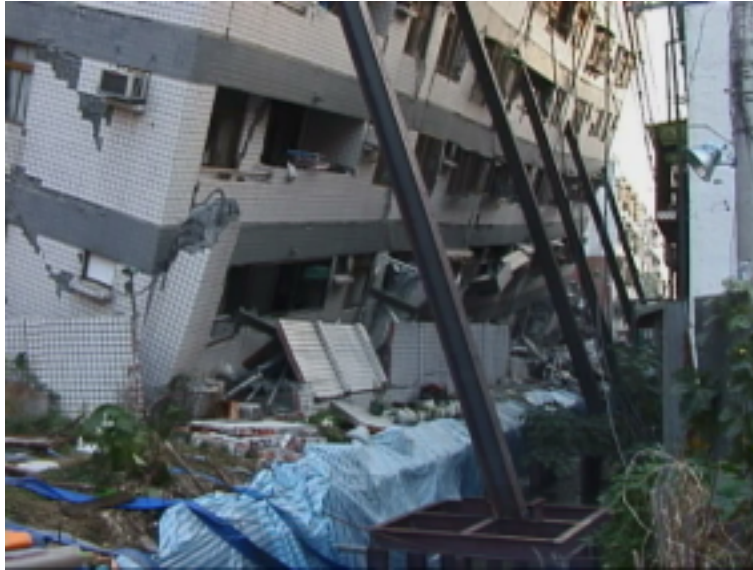
Figure.9.16. Serious damage to the building behind the building in Figure 15.

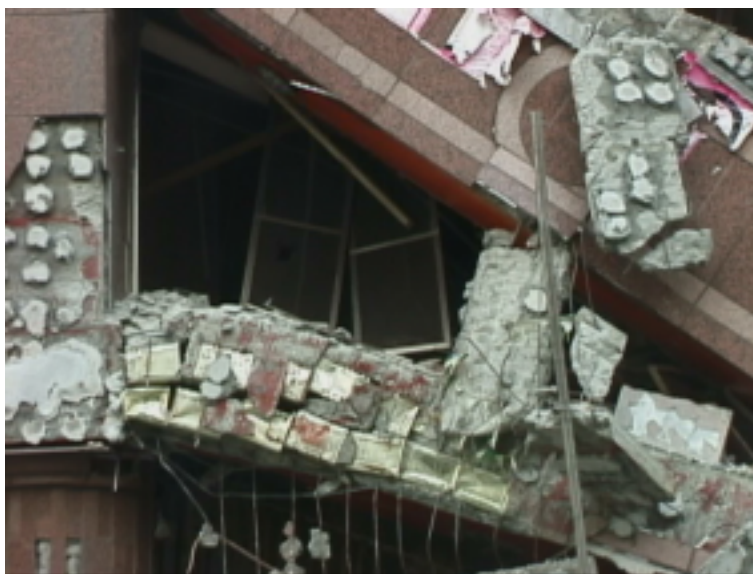
In Taichung City, more than 1000 buildings suffered damage, about the half of which totally collapsed. Figure.9.17 shows the collapse of a RC condominium building. Due to the failure of columns of the first story, the building totally collapsed. Figure.9.18 shows collapsed beams of the building. Can boxes were found in the broken beams and columns. Figure.9.19 shows a building neighboring which had a similar structure with the building shown in Figure.9.17.

Figure.9.17. Collapse of a RC condominium building in Taichung.

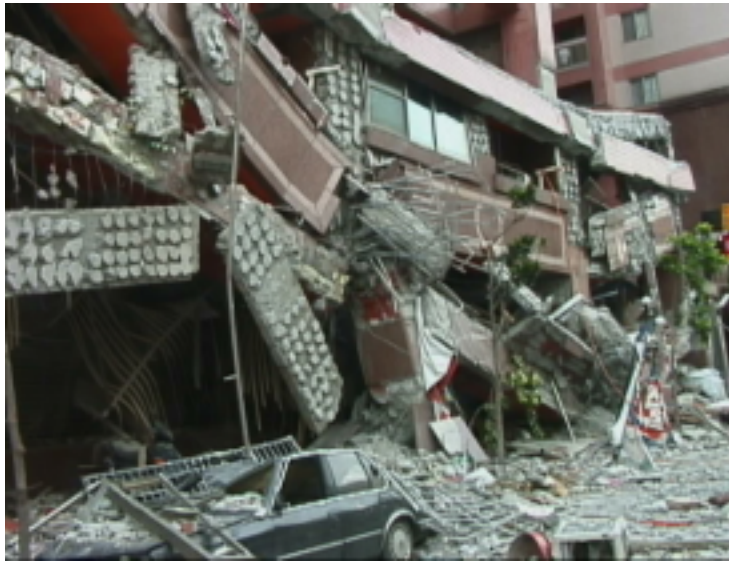
Figure.9.18. Collapsed beams of the building in Figure.9.17.

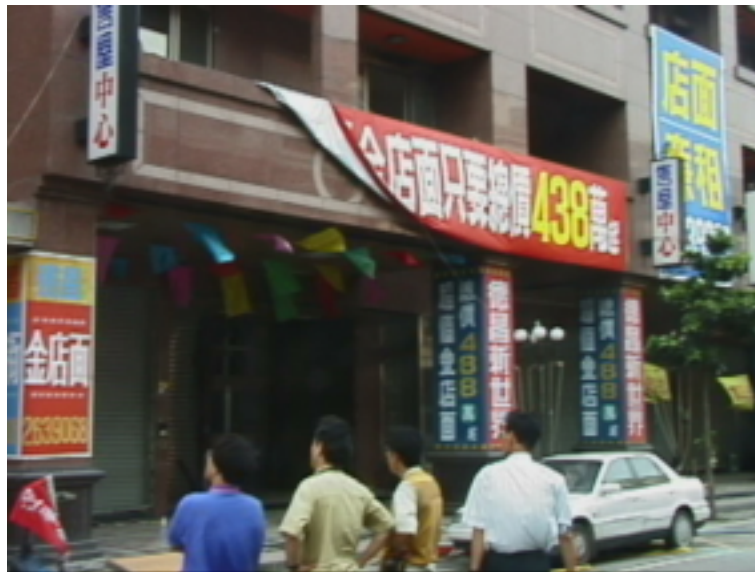
Figure9.19. Building directly right of the building in Figure.9.18.

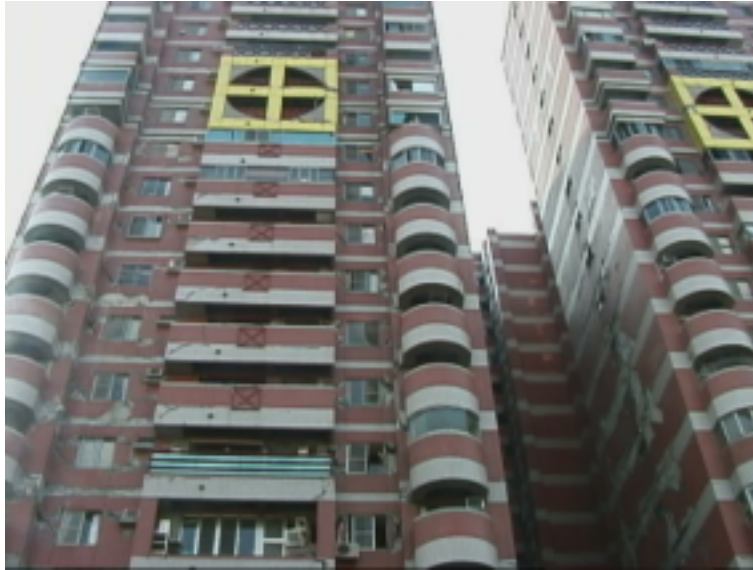
Figure.9.20. Shear cracks of a 22-story RC condominium building in Fengyuan.

Fengyuan locates about 15 km the north of Taichung City. Because the Chelongpu Fault runs through the city, many surface ruptures appeared in the city, some of which have vertical uplift more than 5 m. Figure 20 shows a 22-story RC condominium building in Fengyuan. The outer walls and columns of the building suffered extensive shear cracks.

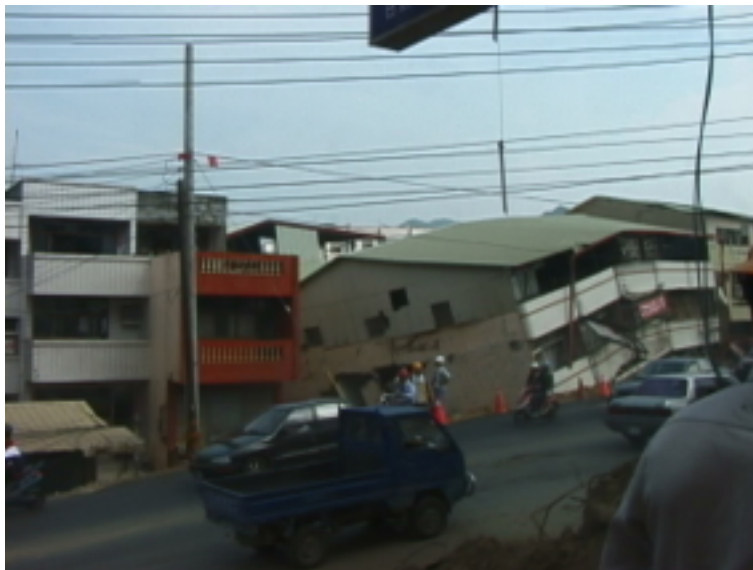
Figure.9.21 shows a collapsed building on a ground surface rupture on Route 3 in Fengyuan. Many buildings collapsed along the surface fault ruptures in Fengyuan and Neiwan. On the contrary the damage to buildings apart from surface ruptures was mostly light.

Figure.9.21. Collapsed building on a surface rupture in Fengyuan.

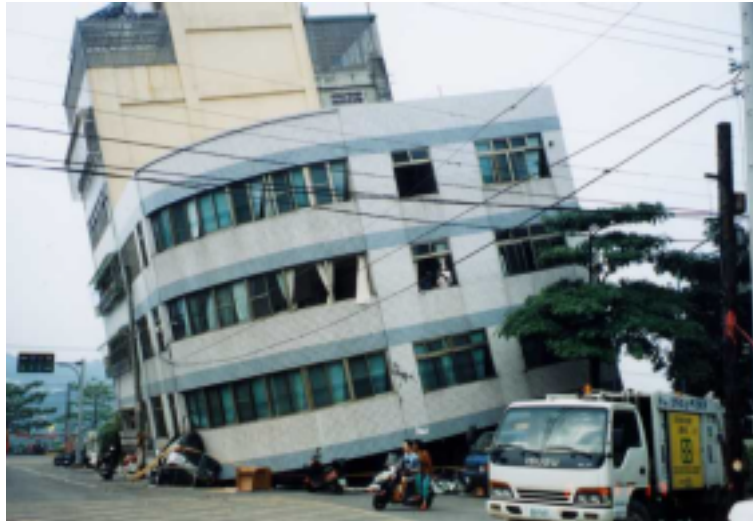
Tungshe locates about 25 km the northeast of Taichung City. This area also suffered serious building damage. Figure 22 shows a collapsed 4-story RC building. Due to the failure of the columns, the building largely inclined and crashed the car at the first floor.

Figure.9.22. Collapsed 4-story RC building in Tungshe.
