6 DAMAGE TO PORT FACILITIES

6.1 Damage State at Port Facilities around Eastern Marmara Sea

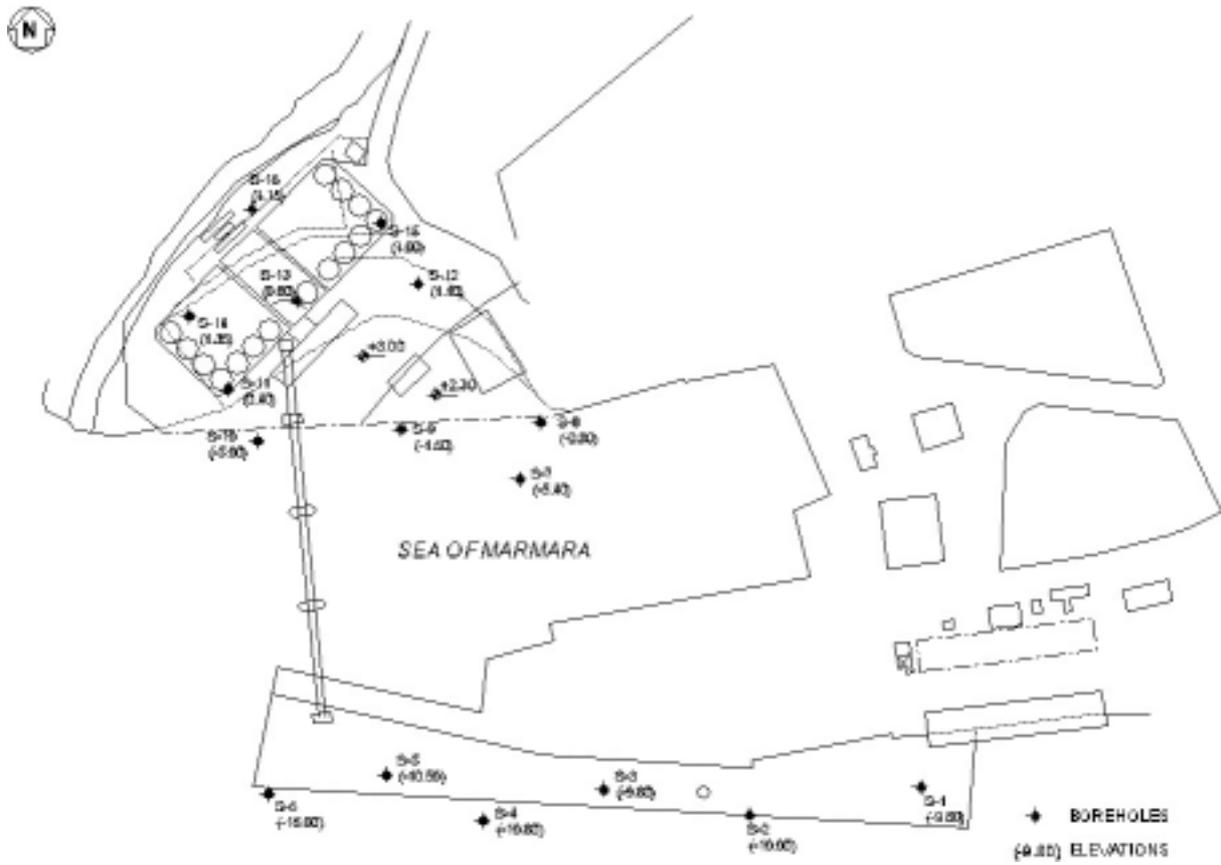
Figure 6.2 Plan of Derince port

Damage to quay walls were found at No.6 General Cargo Quay (-12m, 220m), No.7 Quay (-10m, 160m), and No.8 Quay(-6m, 120m). Concrete cellular block walls did not collapse but moved toward the sea 0.7m maximum. Large settlement (roughly 0.5m) the backfill occurred. Boiled fine sands were find around the warehouse located behind the No.7 Quay.

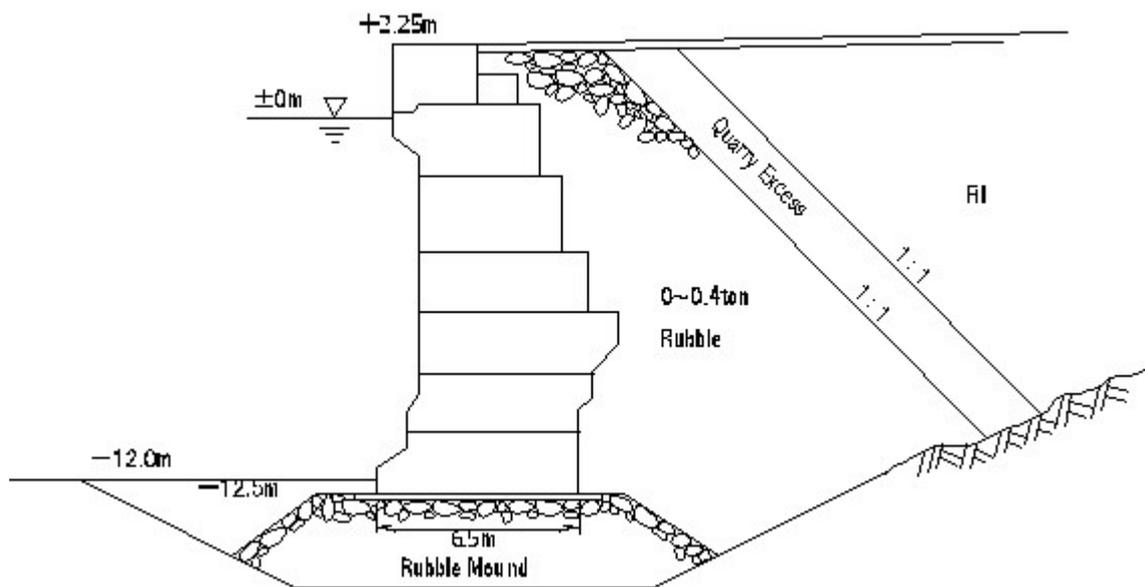
Figure 6.3 Cross section of quay wall at Derince port

block type as shown in Figure 6.1, with water depths ranging from -6 to -12 m. Damage to quay walls are generally minor.

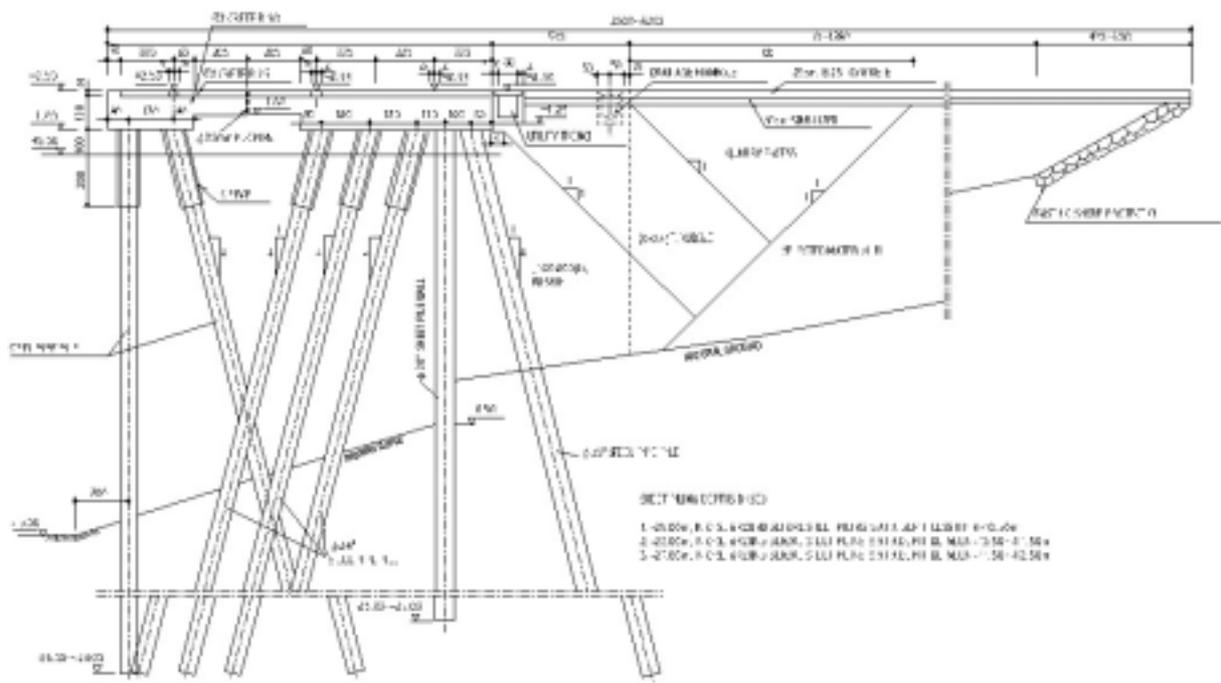
Figure 6.4 Cross section of the open type wharf with batter piles.

There was not significant damage to quay walls at Nos. 2 through 4 Quays (-7m, 82m; -15m, 400m) , the steel pile supported wharf with batter piles as shown in Figure 6.4. The general purpose crane on No.7 Quay which capacity is 5t, was overturned(Figure 6.5) due to the settlement of land side rail as 0.5m and earthquake motion. Other cranes were not overturned, however, suffered yielding of legs.

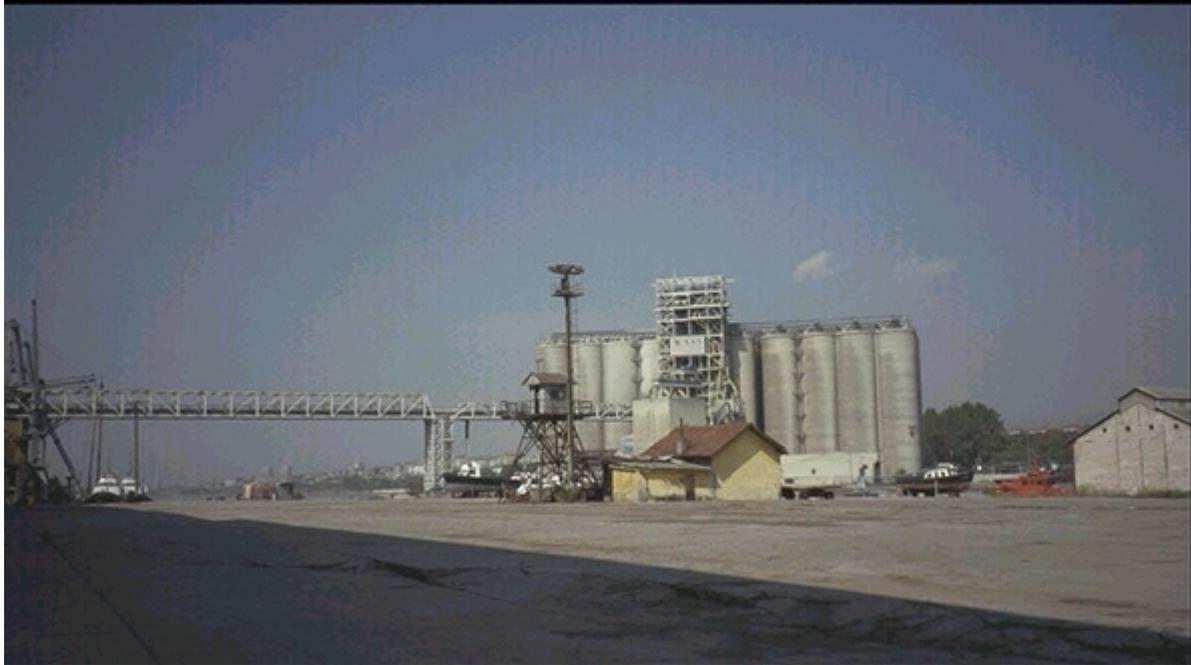
Figure 6.6 Grain silo

A grain silo of 95,000 tons capacity(Figure 6.6) supported by pile foundation were stable during the earthquake. The conveyer system between the silo and No.2 Quay had some damages due to the settlement of apron.

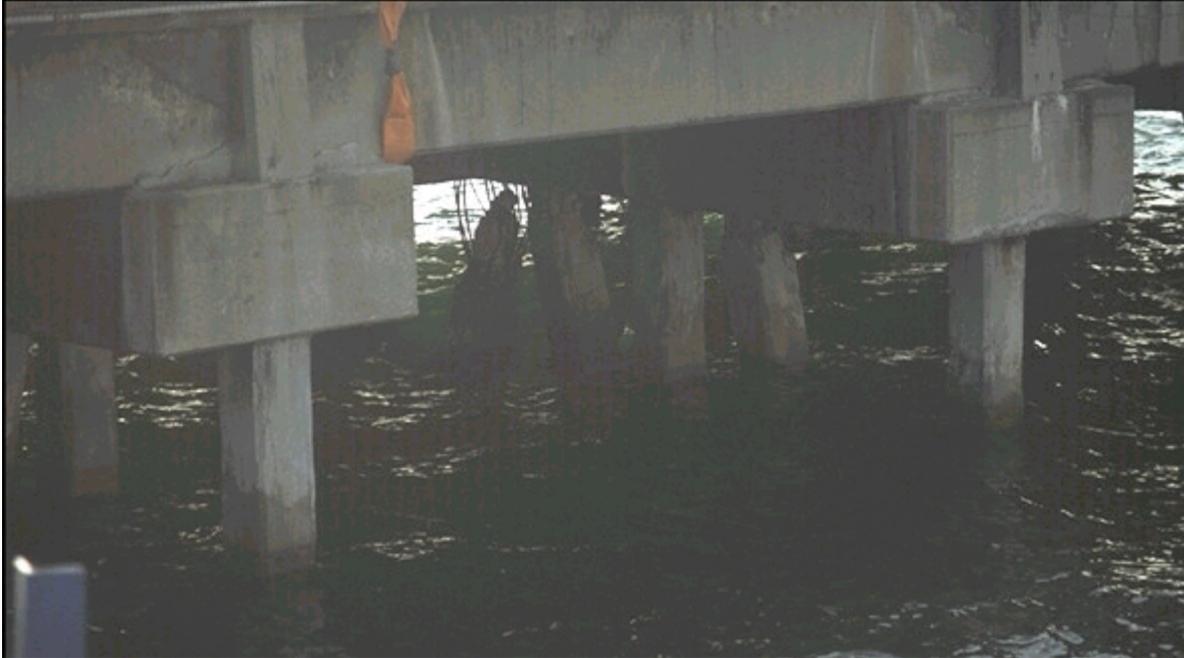
Figure 6.7 RC pile supported dolphine

Most of big factories such as chemical plant, have port facilities for load/unload chemical products. One of the most important function of the jetty is fire hazard prevention between ship and storage tanks during loading/unloading the products. Figure 6.7 shows the RC pile supported type dolphin (jetty) located near the Derince port. The upper top portion of pile show shear failure or corrosion. Generally speaking, the management of the factory is focused on the product section, however, it is strongly recommended that the inspection of residual strength of port facilities after the earthquake by port facilities design/construction specialists is needed.

- (6) Improvement of backfill soil is effective way to increase the performance of quay walls during earthquake
- (7) In case of private port facilities such as factory's port, the inspection of residual strength by specialists is needed.

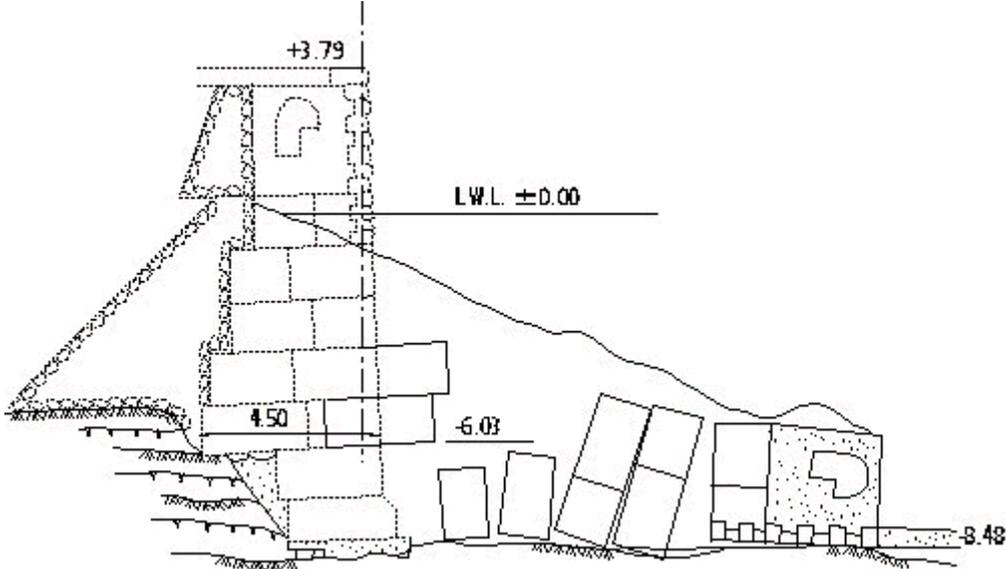
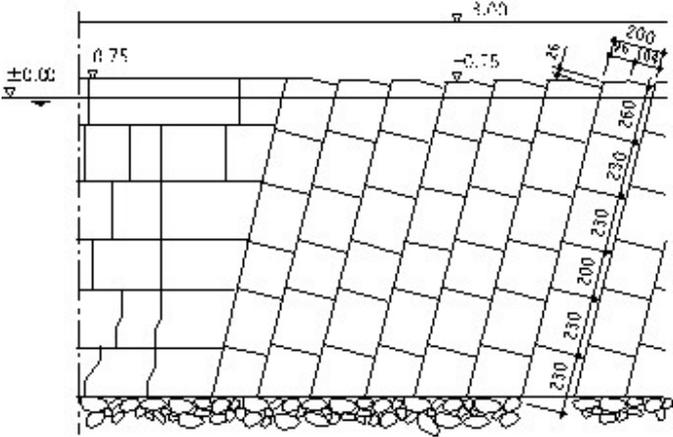
The major damage of port facilities during the Kocaeli earthquake is concrete cellular block type quay wall(Figure 6.8 and 9) moved toward the sea due to the liquefaction of backfill.

Figure 6.8 Cross section of quay wall at Derince port

Figure 6.9 Concrete cellular block stack design

Earthquake, improvement of backfill soil is effective way to increase the earthquake resistance of quay walls during earthquake.

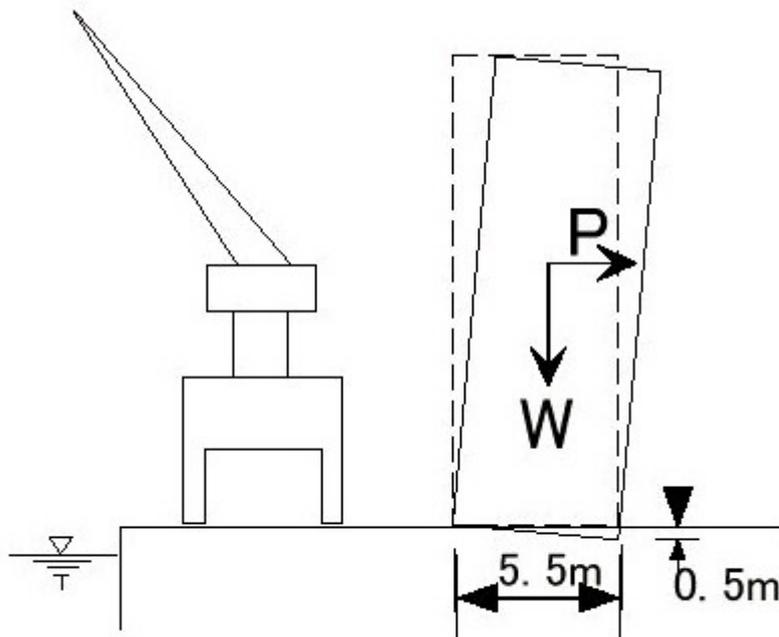
Figure 6.14 Schematic diagram of the crane overturn

$$2.75W=7.0P$$

$$P=34.38t$$

$$P=W/g*A$$

$$A=337.0 \text{ Gal}$$

In case of land side leg 0.5m settled condition,

$$P=29.22 t$$

$$A=28.0\text{Gal}$$

In case of standing crane next to the overturned crane with 0.5m settled condition, calculated in the same manner.

$$P=30.11 t$$

$$A=332.71 \text{ Gal}$$

From the simple analyses, the performance of two cranes located side by side during the earthquake can be estimated. However, the simple model analyses cannot treat the rocking effect as legs uplift. To clear the overturning phenomena of the crane, more precise analysis such as dynamic 3-D finite element method is needed.
