Tohoku Off Shore Earthquake & Tsunami,
Japan
 $M_w=9.0$ 11 March 2011

Lifelines Performance Assessment
Preliminary Summary

TCLEE TEAM MEMBER

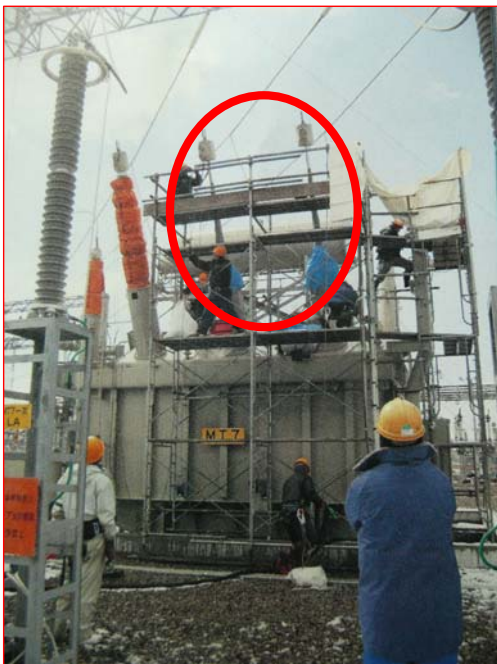
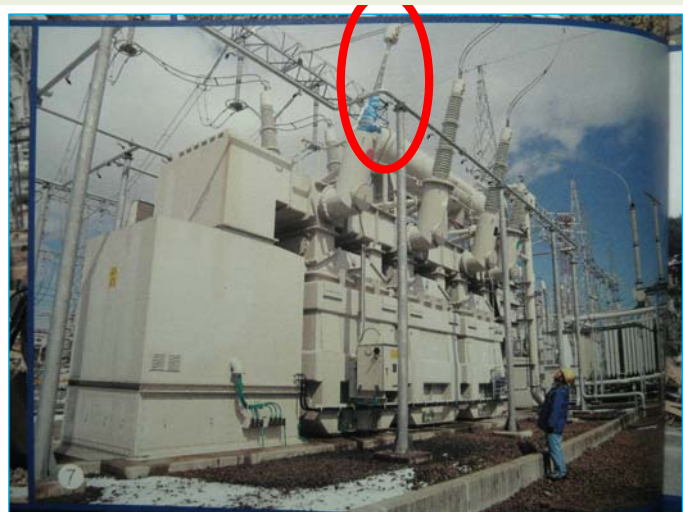
POWER TRANSFORMER FAILURES: Significant issue for transmission line system

M9	M7.2	M7.1/M6.3
(3/11/11)	(4/7/11)	(4/11-12/11)
47 Shaking	15 Shaking	1 Shaking
23 Tsunami

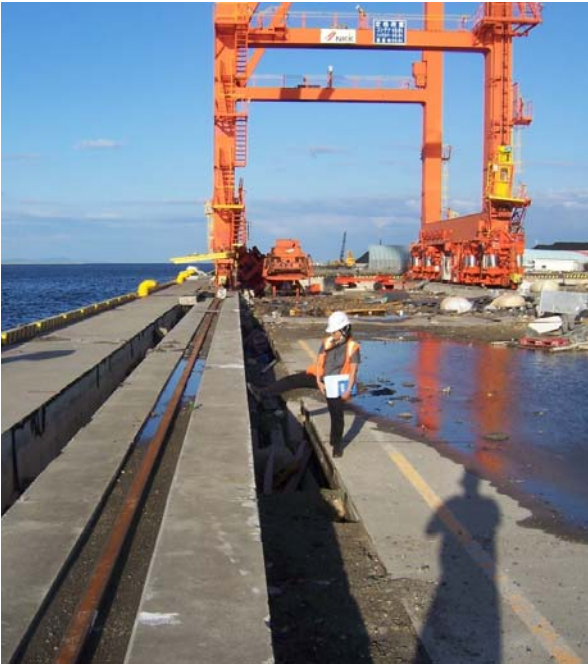
1. Shaking caused significant damage, lateral spread, and settlement in areas of poor fill
2. Important Equipment kept in non-waterproof areas
3. Poor performance of Fill Areas and Slopes
4. Significant losses due to tsunami damage
5. Lack of electricity is a major setback

1. Protect important equipment in watertight areas.
2. Test Important Equipment
3. Consider Ground Improvement in Fill Areas
4. Significant losses due to tsunami damage

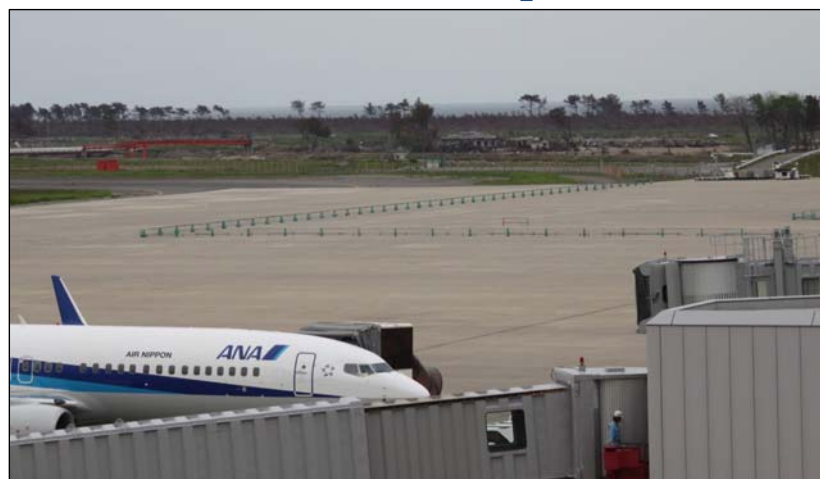
1. Good Performance
2. Ground Improvement Worked Well
3. Electricity Loss Paramount

1. Protect Emergency Generators from Water Damage
2. Consider Ground Improvement for Rehabilitated Areas to prevent repeat liquefaction damage

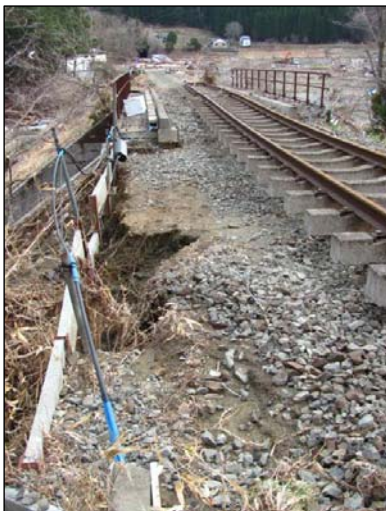
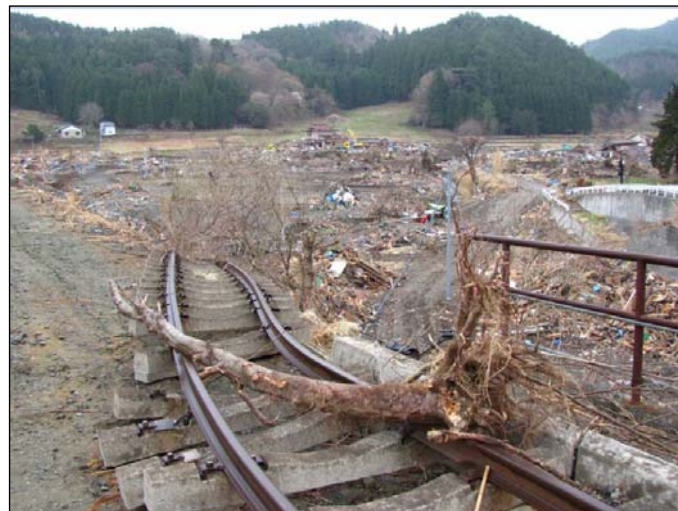
Sanriku

- 4 central offices lost service due to isolation from the rest of the network caused by severed transmission links caused by destroyed bridges.
- Restored with new by-pass transmission routes.

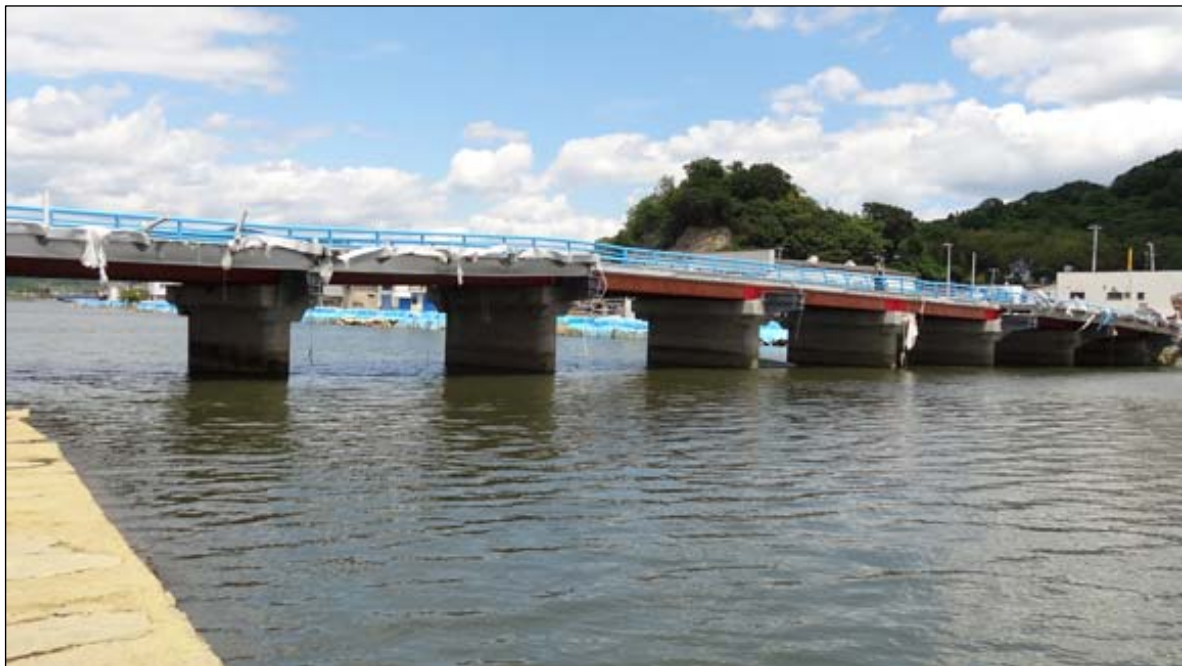
During tsunami why do a few spans get knocked off bridges but most spans stay on bridges?

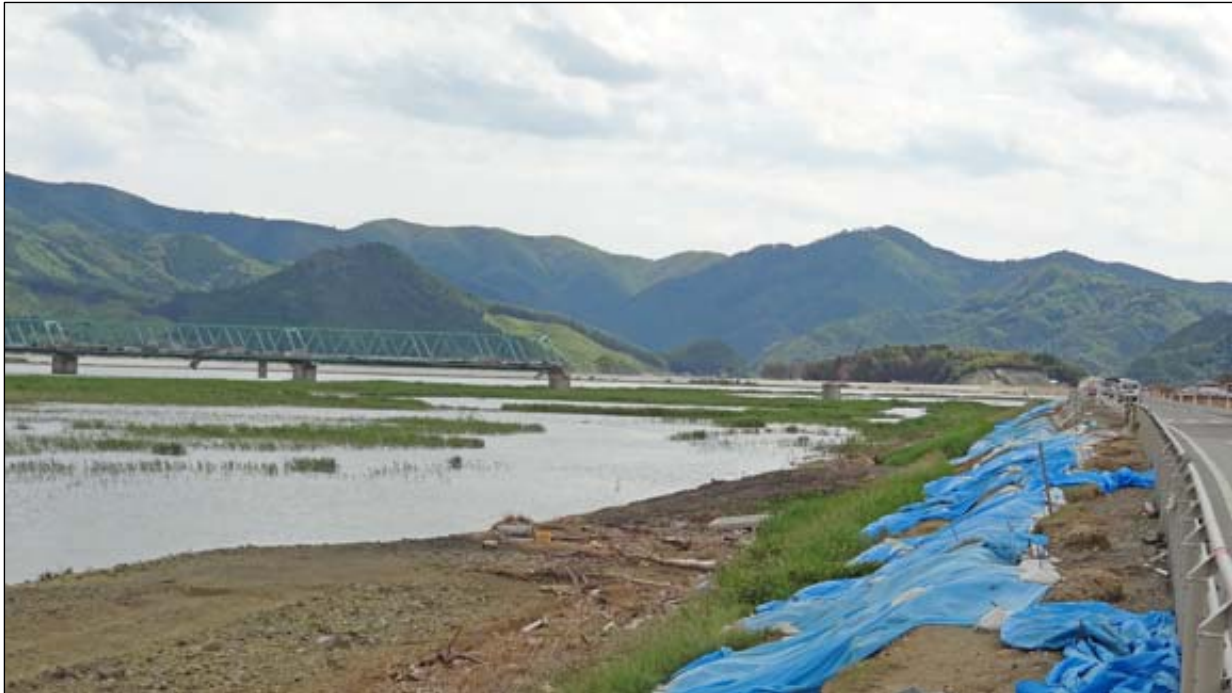
Is it better to tie the girders to the piers or will that just cause the piers to be damaged during tsunami ?

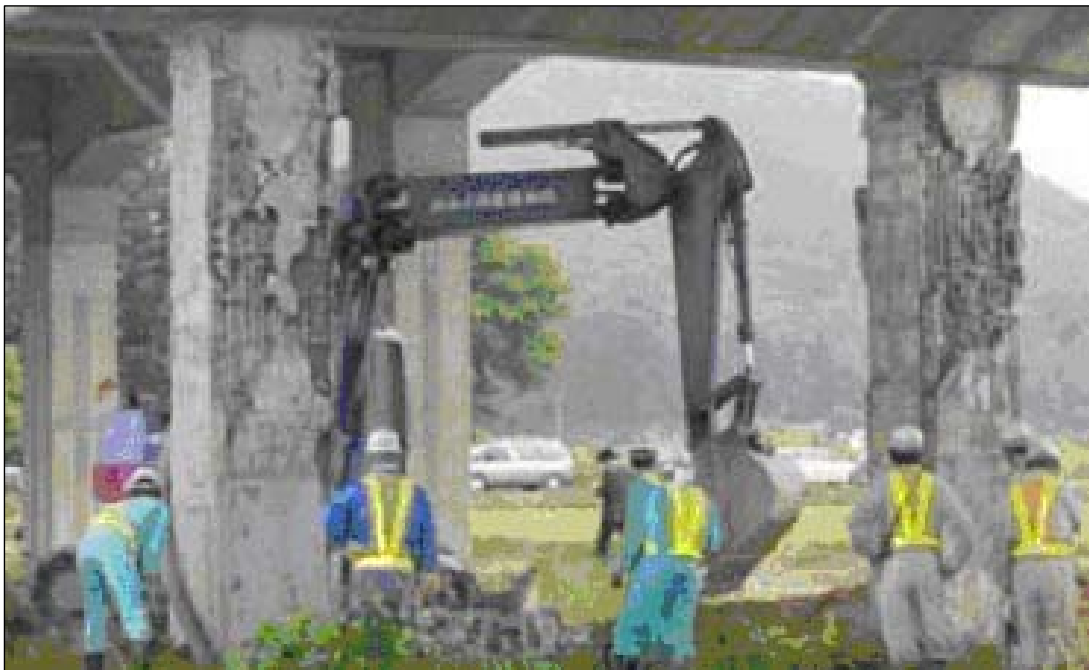
Is it better to retrofit Shinkansen viaducts or just repair them after each earthquake?

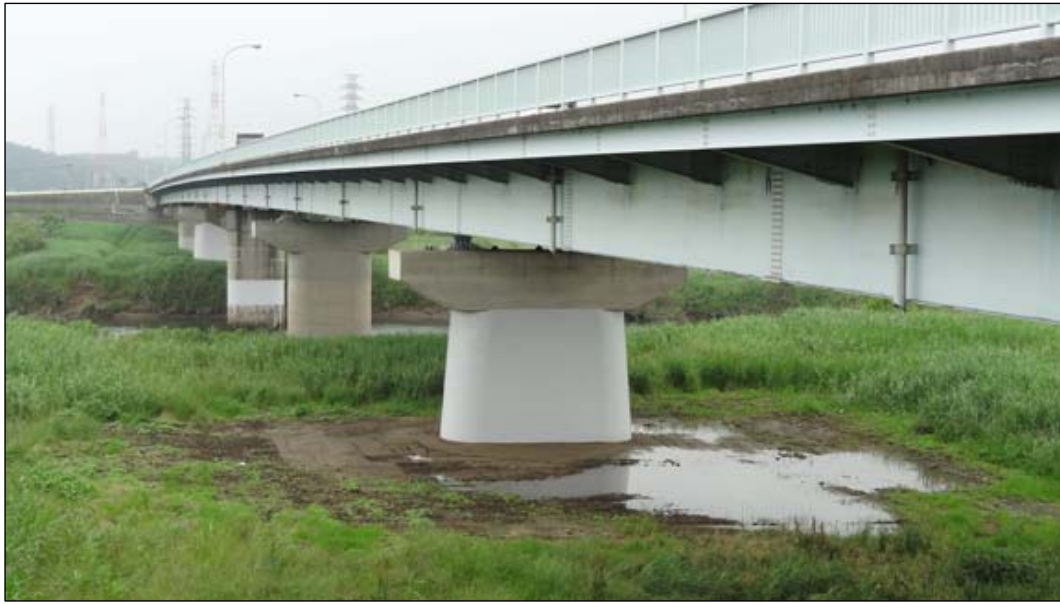
What are the consequences of designing tall columns and short columns on the same bridge?

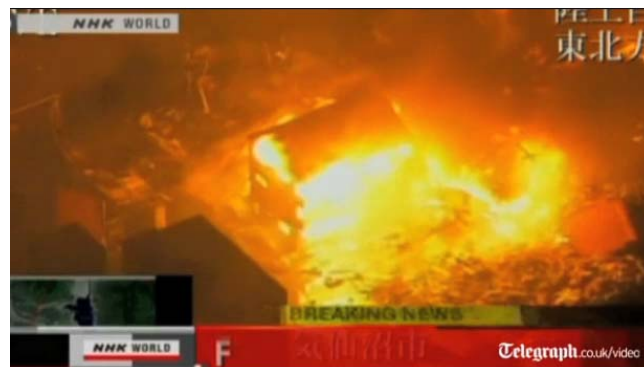
Kesennuma Fire

- 300 miles Northeast of Tokyo
- Pre-earthquake population 74,000 people
