付録 4 DAMAGE TO HIGHWAY STRUCTURES DUE TO THE HYOGOKEN-NANBU EARTHQUAKE

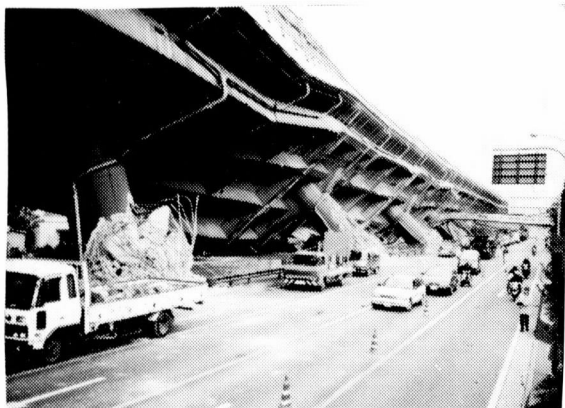
- Roll-over of concrete girder viaduct in Fukae area, Higashi Nada-ku (Photo 1)
- Collapse of two spans in Hamawaki, Nishinomiya (Photo 2)
- Collapse at Takashio, Nishinomiya (Photo 3)
- Collapse of steel pier at Tateishi Intersection
- Buckling of Steel Piers (Photo 4)
- Buckling of box steel girder at Hamanaka Intersection
- Collapse of Ramp Structure at Minatogawa

Photo 1. Roll-over of Concrete Girder Viaduct
(Hanshin Expressway, Route No.3)

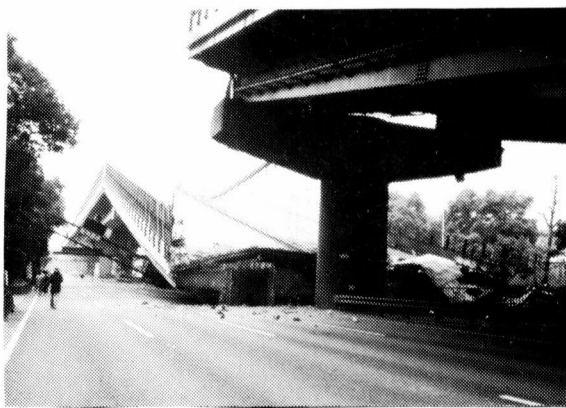
Photo 2. Fall-down of Girder
(Hanshin Expressway, Route No.3)

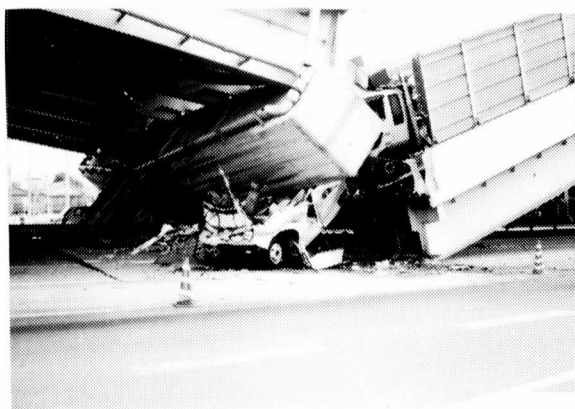
Photo 3. Collapse of Concrete Pier
(Hanshin Expressway, Route No.3)

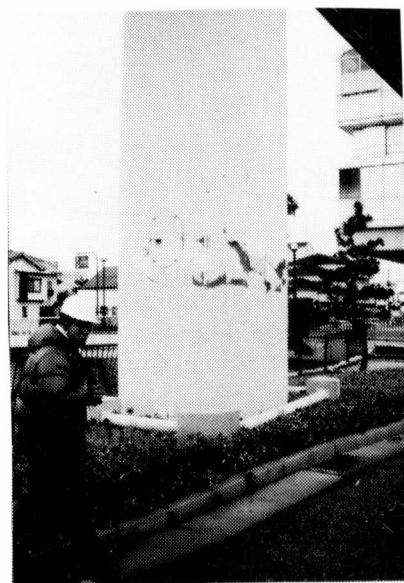
Photo 4. Buckling of Steel Pier
(Rokko Liner)

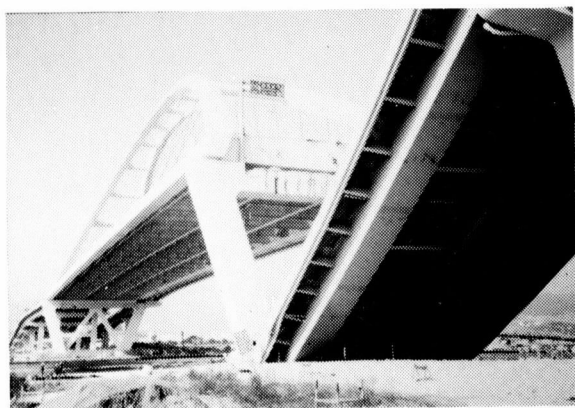
- Collapse of a side span of Nishinomiya-ko Bridge (Photo 5)
- Failure of bearings and cable anchor of Nishinomiya-ko Bridge
- Failure of bearings and transverse movement of the girder of Rokko Island Bridge (Photo 6)
- Failure of bearings and collapse of the girder of Nagigawa Bridge

Photo 5. Fall-down of Girder,
Nishinomiya-ko Bridge
(Hanshin Expressway, Route No.5)

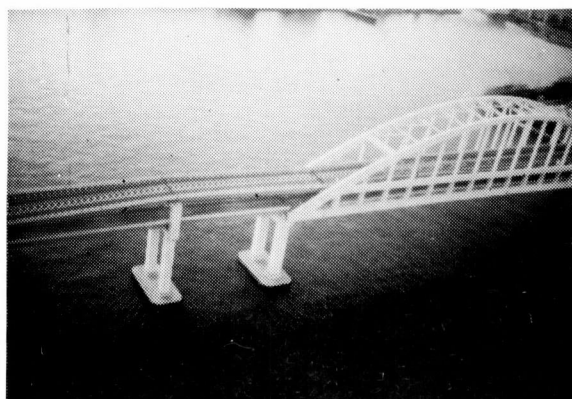
Photo 6. Failure of Bearing,
Rokko Island Bridge
(Hanshin Expressway, Route No.5)

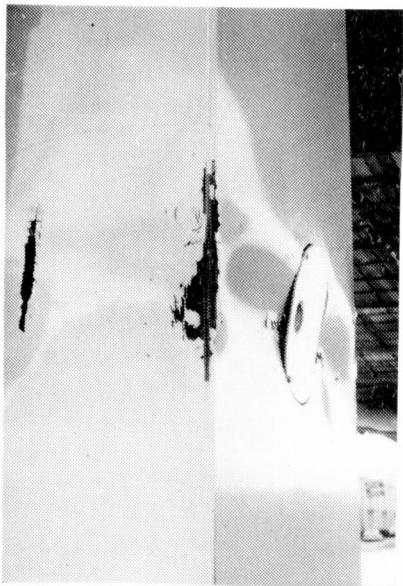
Damage of RC piers, fracture of steel piers, buckling of columns near inspection holes

(Photo 7) were found. RC piers of Second Maya bridge suffered severe damage.

Photo 7. Elastic Buckling of Steel Pier
(Harbor Highway)

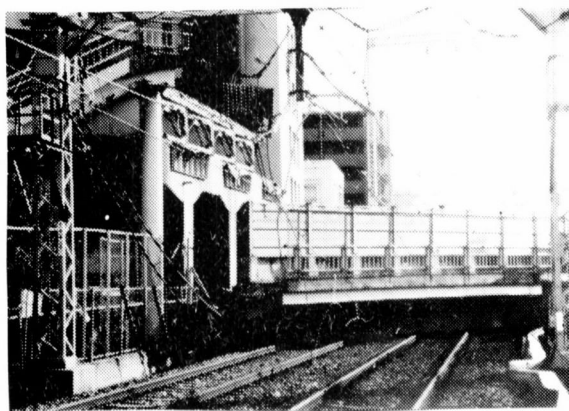
- Mondo Viaduct: Collapse of the roadway deck onto a Hankyu Railway line (Photo 8).
- National Highway Route 2, Hamate Bypass: transverse movement of double-deck girders.
- Iwaya Junction Overpass: Collapse of the upperstructure caused by steel pier collapse.

Photo 8. Fall-down of Overpass Bridge
(National Road Route 171)

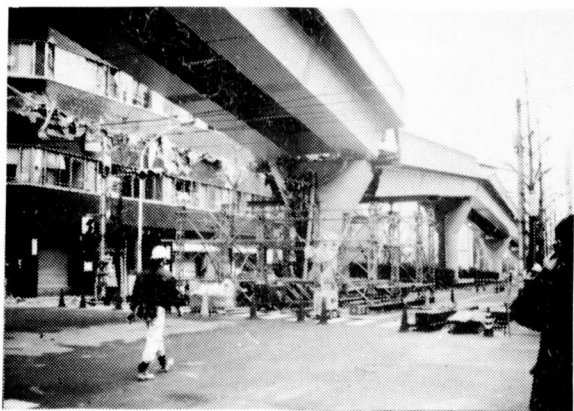
Port Island Line suffered damages including failure of RC piers in Chuo-ku (Photo 9), downward displacements of girders, and unseating of a continuous beam from the bearings. A girder of Rokko Island Line collapsed in the Rokko Island side of Rokko Bridge (Photo 10). Horizontal movement of the pier seems to have caused the damage.

Photo 9. Collapse of Concrete Pier
(Port Liner)

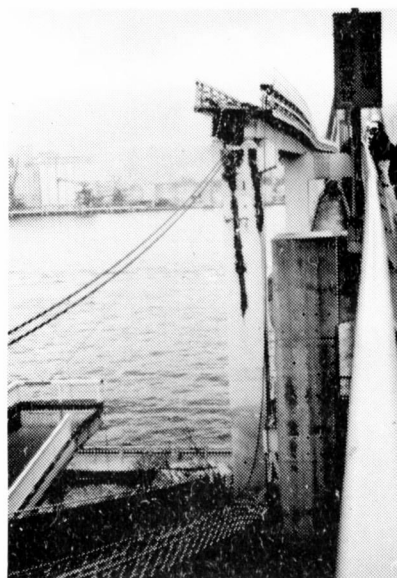
Photo 10. Fall-down of Steel Girder
(Rokko Liner)

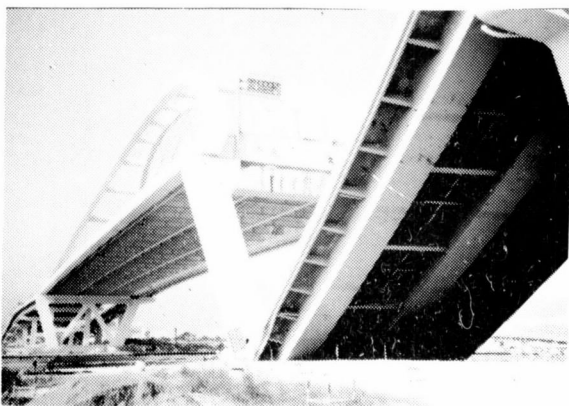
- Nishinomiya Bridge: Fracture of RC Piers in the middle of the height (Photo 11)
- Kobe Bridge: Damage to bearings and considerable movement of girders

Photo 11. Collapse of Concrete Pier
(Harbor Highway)

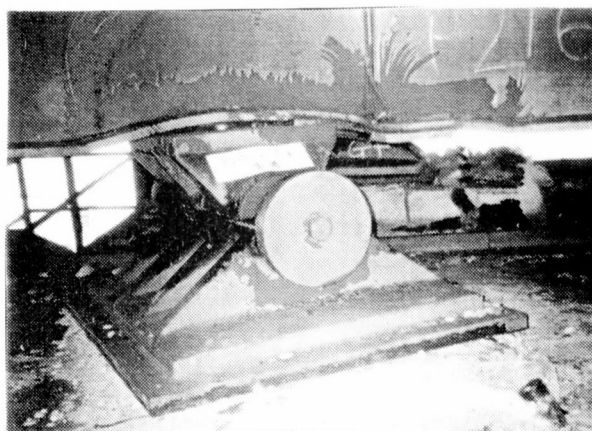
Steel bridge girders are supported by steel bearings which are sitting on top of piers. Half of them are so called "fixed hinges" which allows only rotation of girder ends. Extremely large and shock-type seismic force worked at the "fixed hinge" and broke them (Photo 12). For repair and retrofit of damaged bridges, more flexible rubber type base isolation bearings are recommended.

Photo 12. Failure of Steel Bearing

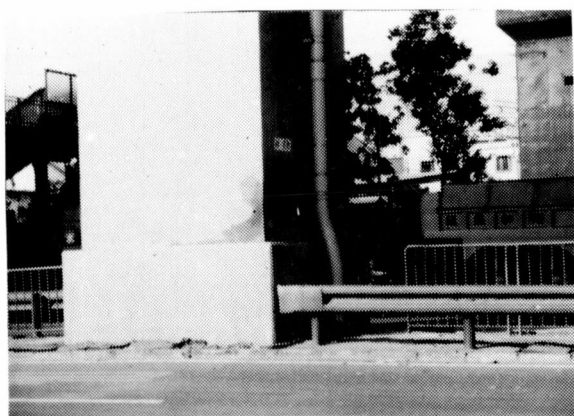
Due to strong earthquake force and, consequently large deformation of steel piers, buckling behavior is observed at the bottom of piers where maximum bending moment is expected (Photo 13). At the most of the buckled part, paint on the surface of piers is off and change of the color is observed. The reason of off-paint seems to be repeated inelastic strain experienced on the flange and web of the piers. So buckling with off-paint can be judged as inelastic buckling which gives more ductile restoring force characteristics. Most of observed buckling are of this type with moderate damage.

Photo 13. Buckling of Steel Pier
(Hanshin Expressway Route No.3)

Hybrid structural systems with use of both steel and concrete material are recommended to avoid buckling behavior and enlarge deformation capacities.

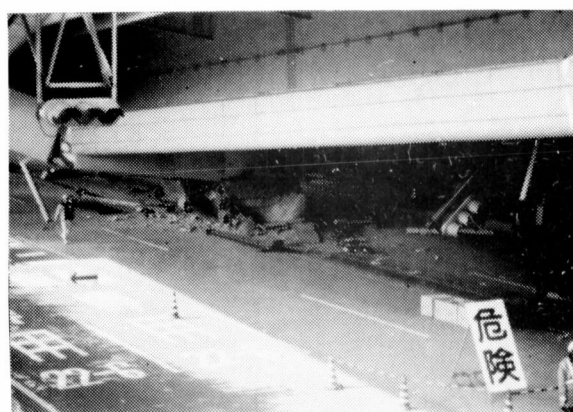
However, a few of steel piers collapsed due to breakage of the corner of rectangular section which is caused by excessive buckling (Photo 14). In some steel piers, elastic buckling without off-paint is observed especially around the inspection hole. The elastic buckling may introduce sudden collapse of structural system, which shall strictly be avoided.

Photo 14. Collapse of Steel Pier,
Tateishi Intersection
(Hanshin Expressway, Route No.3)

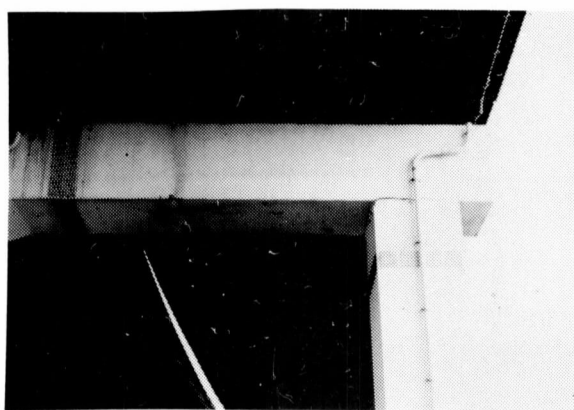
In a few bridge frame piers, cracks are found at beam-column connection (Photo 15). Complete brittle failure of a steel pier is also observed (Photo 16). The reasons of cracks and brittle failure of steel piers are due to impulse type structural deformation caused by the direct hit by the fault. The damage can be compared interestingly with the cracks at beam-column connections of the buildings observed at the time of the Northridge Earthquake.

Photo 15. Crack of Beam-Column
Connection (Harbor Highway)

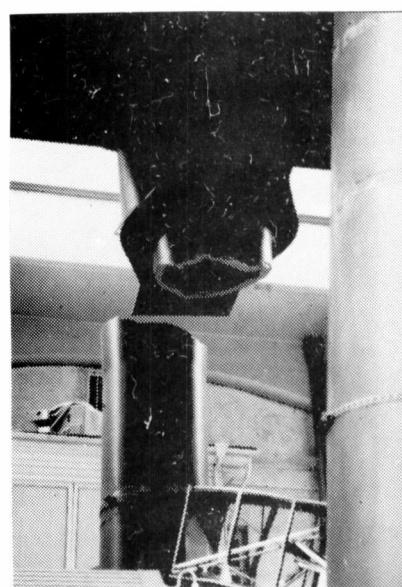
Photo 16. Brittle Failure of Steel Column
(Kobe Rapid Railway)

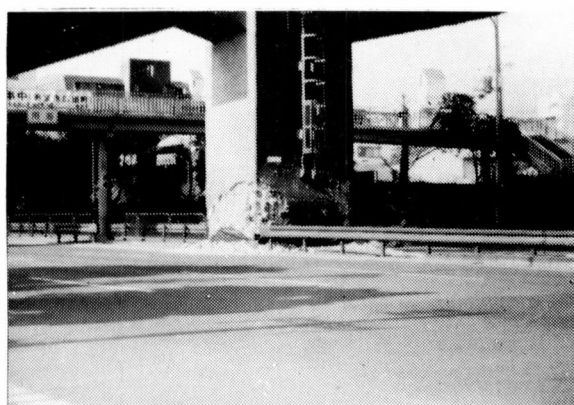
a) Flexural or flexural-shear failure at the bottom of pier (Photo. 17)

This failure mode is more ductile than the another two ones described below. In this case, spalling of cover concrete, buckling of longitudinal steels and unfastening of transverse hoops were observed in the bottom of the piers.

Photo 17. Flexural-Shear Failure at the
Bottom of Concrete Pier
(Hanshin Expressway, Route No.3)

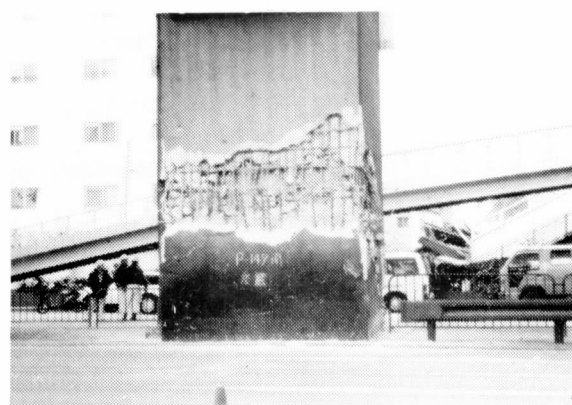
b) Flexural-shear failure at cut-off zone of longitudinal steels (Photo. 18)

Many piers were damaged due to this type of failure. Extending cracks were generated in cut-off zone of longitudinal steels due to insufficient transverse hoops and development length of cut-off steels, resulting in the flexural-shear failure. In some piers, rupture of longitudinal steels at the weak weld was observed.

Photo 18. Flexural-Shear Failure at Cut-off
zone of Longitudinal Steel
(Hanshin Expressway, Route No.3)

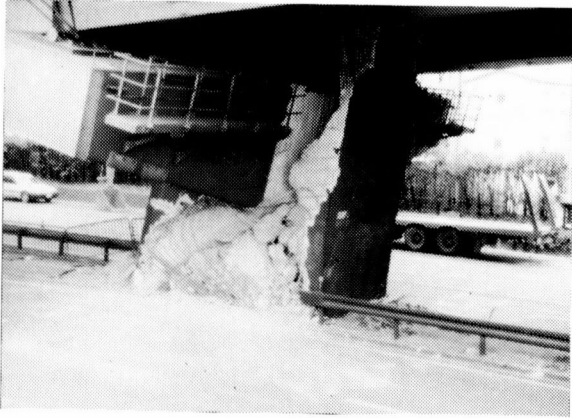
c) Shear failure (Photo. 19)

Relatively short piers often collapsed by shear failure due to large seismic force caused by high stiffness. This type of failure was very brittle and the weight of superstructures could be carried no longer after the failure, resulting in the falling down of girders.

Photo 19. Shear-Failure of Concrete Pier
(Hanshin Expressway, Route
No.3)

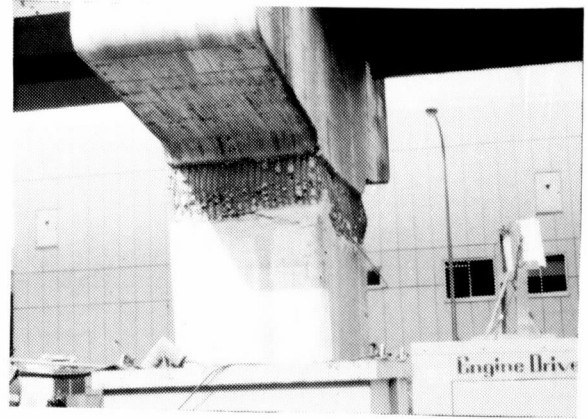
RC piers in Meishin Highway and others (Harbor Highway, National Road Route 2, 43 and so on) were also damaged during the earthquake (Photo.20). The failure mode of the damaged single column piers are almost the same as that observed in Hanshin Expressway. In Meishin Highway, however, a lot of damage of wall-type piers were observed near Amagasaki Area (Photo. 21). In these piers, longitudinal reinforcement buckled outside without crushing of concrete at the end of diagonal cracks.

Photo 20. Damage of Concrete Pier
(Harbor Highway)

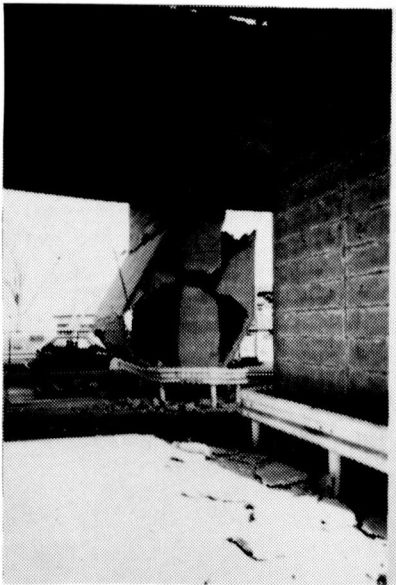
Photo 21. Damage of Wall Type RC Pier
(Meishin Highway)

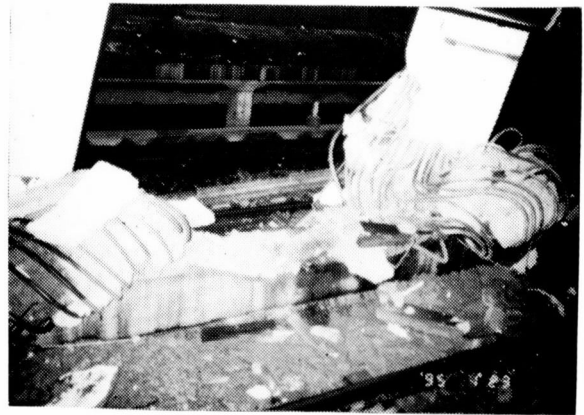
In addition, a lot of RC columns supporting the subway platforms, for example at Daikai station of Kobe Kosoku Tetsudo Line, collapsed (Photo. 22) and a big settlement more than 2m was caused in the above National Road Route 2.

Photo 22. Failure of Center Columns
(Kobe Subway)
