# THE BEHAVIOUR OF STRUCTURES BUILT ON ACTIVE FAULT ZONES : EXAMPLES FROM THE RECENT EARTHQUAKES OF TURKEY

Reşat ULUSAY<sup>1</sup>, Ömer AYDAN<sup>2</sup> and Masanori HAMADA<sup>3</sup>

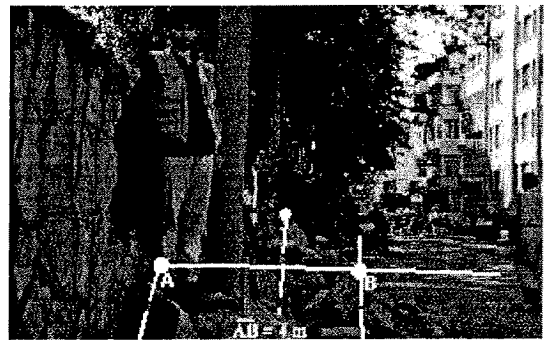
From the surveys of offset fence lines, roads and tree lines, the maximum offset along the surface rupture was measured about 4.5-5 m (Fig.3). General trend of the surface rupture has an orientation of NE-SW in the east between Gölyaka and Akyazi and then it appears with a general trend of E-W in the western part of the earthquake region. Width of the primary surface rupture traces varied from 5 to 20 m with little or no secondary deformation. However, broad zones of primary and secondary deformation up to 200 m wide were evident. The fault rupture produced typical examples of strike-slip offset, including well-formed moletracks, left-stepping en-echelon fault traces in various scales, uplift of pressure ridges and subsidence (Fig.4). Furthermore, the observations of striations on the existing fault rupture near Arifiye (Adapazari) and Tepetarla (between Adapazari and Kocaeli) imply that the vertical component of the fault motion has a normal fault sense with vertical offsets of 10–20 cm in these parts of the fault segment. This may be a further evidence of trans-tensional nature of the western part of the North Anatolian Fault.

Fig.3 A typical view from the right lateral offset during Kocaeli earthquake (western wall of the Naval Command Center in Gölük / slip: 4–5 m)

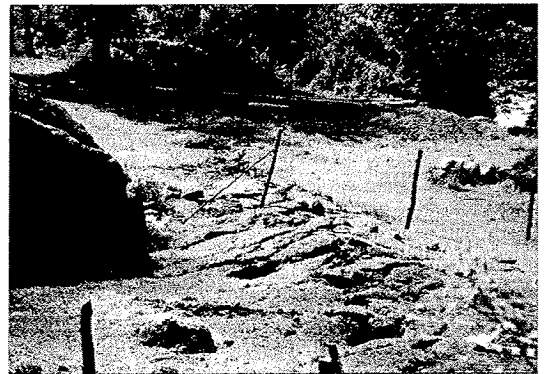
Fig.4 Moletrack between Gölyaka and Akyazi in Aksudere valley (Kocaeli Earthquake).

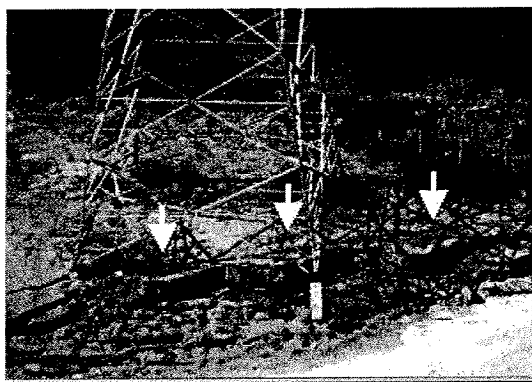
with any other earthquake break. This fault caused rotation of a pylon of a power line (Fig.6) near the Ford automobile factory construction site about 10 degrees and global subsidence of the basin with local submergence of the coastline and inundation of the

**Fig.6** The fault with a normal component which caused rotation of a pylon of power line at the south of Ford automobile factory construction site.

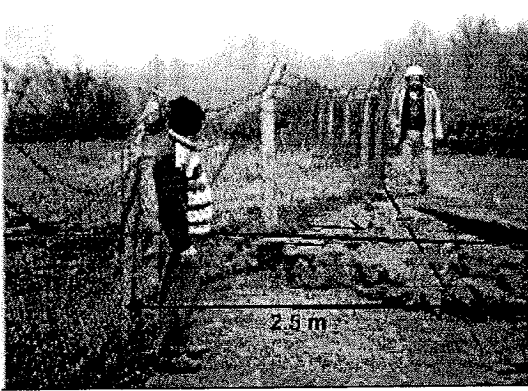
The maximum lateral offset is about 5 m. As seen from Fig.9, the amount of right-lateral offsets, clearly observed on roads, fences and tree lines (Fig.10), in-

**Fig.10** A typical right lateral offsets from the surface fault rupture resulted from the 1999 Düzce earthquake.

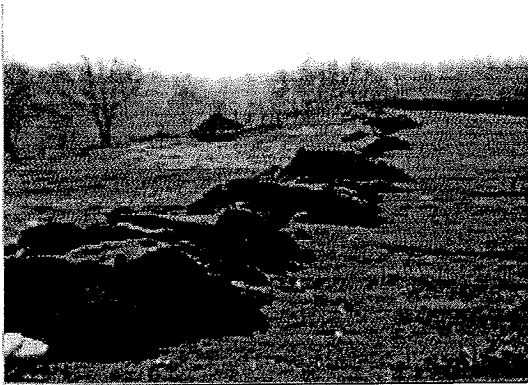
**Fig.11** A typical view from the surface rupture and pressure ridges at the eastern part of Cinarli village (view from east to west).

E-W. Due to left stepping observed at some locations, pressure ridges were evident (**Fig.11**). In this zone, in addition to Riedel fractures crossing the main rupture surface with angles between  $25^\circ$  and  $60^\circ$ , en-echelon fractures were also well developed. The direction of fault scarps coincides almost with those obtained from the fault plane solutions. The surface rupture seems not to follow the depicted fault segment that passes through the boundary between the alluvial sequence and rock units at the southern edge of Düzce Plain. It should be remembered that such traces of rupture observed along the south of the Düzce plain are just the products of flowering phenomenon during the motion of strike-slip faults as a result of reduction of vertical stress near the ground surface.

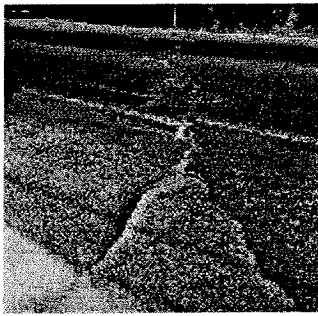
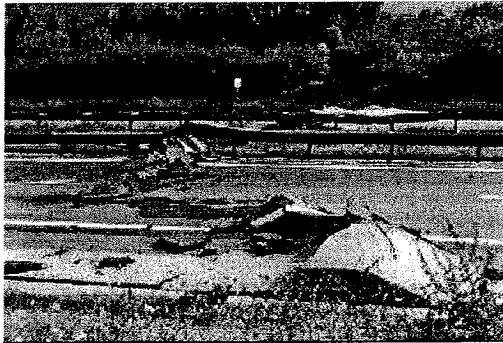
The E-5 (D-100) highway and TEM, connecting Ankara to Istanbul, also pass through the region affected by the Düzce earthquake. The fault break observed in this earthquake crossed the E-5 highway in Kaynasli town between Bolu and Düzce cities (**Fig.13a**). In addition to these, several country roads were crossed by the fault break (**Fig.13b**) and easily levelled with the dirt available on the site. The surface of the roadway directly built on existing ground surface was buckled since the maximum compres-

**Fig.12** (a) Damaged D-100 highway, and (b) buckling of roadway surfacing on the motorway between Adapazari and Kocaeli.

From these examples it is clear that some damage to roadways could not be prevented where the relative movement of the ground occur due to faulting and non-elevation of roadways in fault zones is a key element to deal with the negative effects of faulting on roadways. There is a very important engineering decision, that is, the highways should be directly built over the existing ground surface in active fault zones.

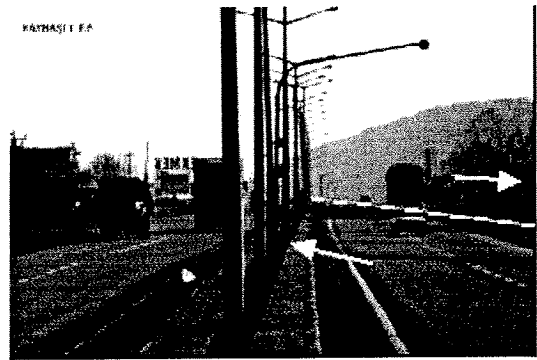
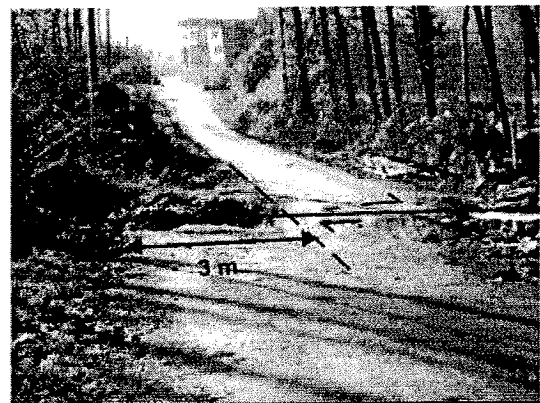
**Fig.13** (a) Damaged and repaired location of the E-5 highway in Kaynasli and (b) a displaced local road at Kaynasli.

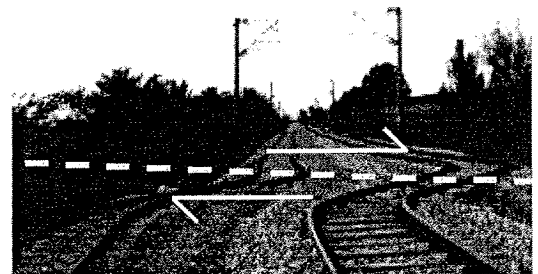
**Fig.14** Buckled railway near Tepetarla station.

rail with an angle of 60°. The right lateral offset was 2.5 m near this station. This direction is almost parallel to the maximum compression of the ground due to faulting and an approximately 200 m section of the railways was damaged. The ground was also heavily deformed by faulting for a length of 700 m resulted near the Kurtköy (close to Arifiye). The railways, however, were operational within three days after the earthquake by replacing buckled rails and damaged traverses, and the railways were completely repaired together with the correction of displaced alignment in 20 days after the earthquake, so that trains began to

Although the damage to the railways could not also be prevented, even they are directly built on the existing ground surface where the railways must pass through an active fault zone, the recovery of railways is very quick.

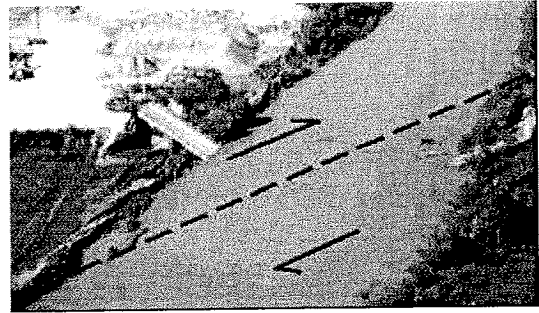
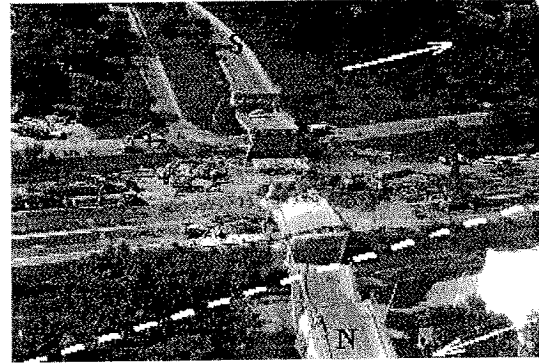
Bridges and viaducts are elevated structures. Since roadways and railways were not elevated structures, no viaducts existed in the region of the fault breaks resulted from the Kocaeli earthquake. The bridges of highways and railways over Sakarya River were intact and no direct faulting event occurred at these localities. However, the YSE bridge spanning over Sakarya River for a service road collapsed as a result of relative motion due to faulting between its abutments (Fig.15a). Along the damaged section of the motorway, there were several overpass bridges. Among them, a four span overpass bridge at Arifiye junction collapsed as a result of faulting (Fig.15b). The girders collapsed onto the motorway killing more than 10 people in a bus who were just happened underneath the overpass bridge at the time of collapse. The fault rupture passed between the northern abutment and the adjacent pier. The overpass was designed as a simply supported structure according to the modified AASHTO standards and girders had elastometric bearings. However, the girders were connected to each other through pre-stressed cables. The angle between the motorway and the strike of the earthquake fault was approximately  $15^\circ$ , while the angle between the axis of the overpass bridge and the strike of the fault was  $65^\circ$ . The measurements of the relative displacement in the vicinity of the fault ranges between 330 and 450 cm. Therefore, an average value of 390 cm could be assumed for the relative displacement between the pier and the abutment of the bridge. The girders of the bridge rotated and pulled so that the fall of the girders between the north abutment and the adjacent pier could not be prevented. However, the collapse of the other girders of the remaining part of the bridge might have been prevented if the girders were not connected to each other through the pre-stressed cables.

**Fig.15** (a) A view from a collapsed bridge on Sakarya River at 5 km of SE of Adapazari due to faulting (view from south to north), and (b) an aerial view from the collapsed overpass bridge onto the motorway near Arifiye.

The examples mentioned above indicated that it is not desirable to elevate the roadways in fault zones where permanent deformation of the ground may take place during earthquakes. If they have to be elevated for some important reasons, such as floods or landslides, the limitation of roadway inclination, etc., as being in the case of viaducts in Asarsuyu valley, it seems better that the girders should be designed as redundant structures, and simply supported structures must be avoided as much as possible. Furthermore, T-type piers should be generally avoided as this type piers result in top-heavy situations.

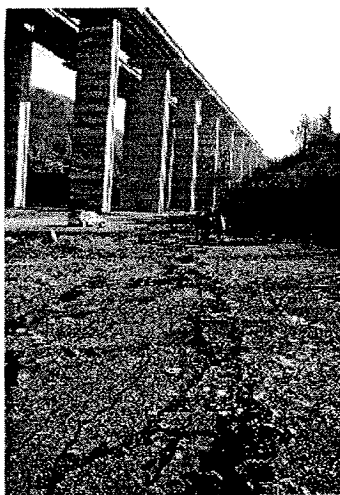
diameter of 180 cm. The elevated section is divided into to large segments, namely East viaducts and West viaducts. Although the viaducts exhibited a well performance in the Kocaeli earthquake, the fault break passed through the elevated section of the TEM in Asarsuyu valley at an angle of  $20^\circ$ – $30^\circ$  and caused the rotation and tilting of some of piers during the Düzce earthquake (Fig.16). As a result of that, the simply supported girders of the viaducts were displaced from their supports. Although no girder was fallen off and piers performed very well during the earthquake, some of the girder were very close to fall.

**Fig.16** (a) The surface rupture of the Düzce earthquake appearing below the viaducts of the motorway, and (b) a view from displaced girders of the viaducts.

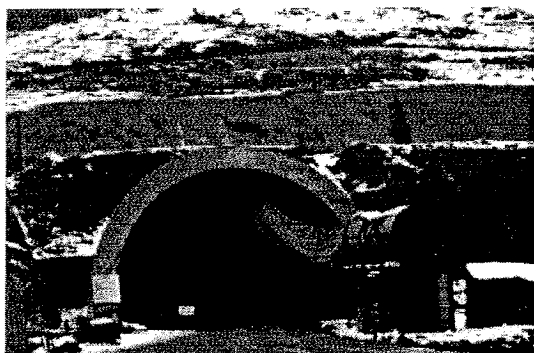
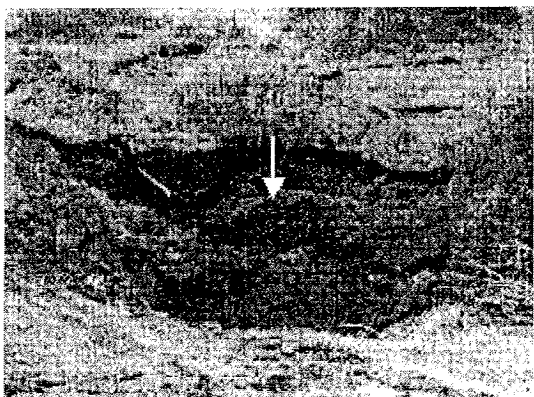
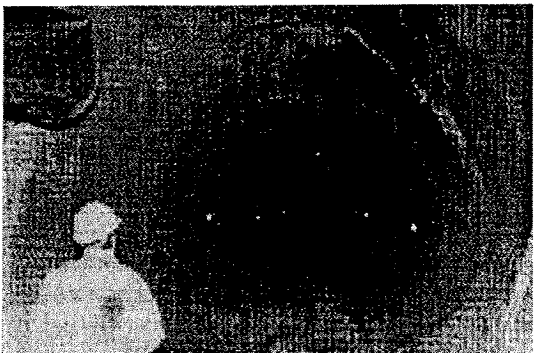
**Fig.17** (a) View from the Elmalik portal of the Bolu Tunnels, (b) surface crater above the collapsed main tunnel on the Elmalik side<sup>9)</sup>, and (c) damages to pilot tunnels<sup>9)</sup>.

After a certain period of time, it was reported that a collapse occurred in an unfinished portion of the tunnel in the fault gauge zone on the Elmalik side where the major difficulties had previously been experienced<sup>9)</sup>. The collapse on the Elmalik side occurred about 50 m beyond the end of the completed inner lining section. Cracks and craters could be observed on the surface (**Fig.17 b**), although the overburden is more than 50 m at this location. This section is located at the transition from fairly good ground into a major fault zone. Damage can be observed at the inner side drift shotcrete structure. The 30 cm thick shotcrete shell was fractured in the invert and the shoulders (**Fig.17c**). The causes for this behaviour still have to be determined. It is also noted that accelerations of 0.6 to 0.8 g were measured at the stations in the vicinity of the site, far in excess of the 0.4 g design with the preliminary assessments arisen from the authors about the possible damage to the tunnel.

As understood from these examples, it is difficult to prevent the rupturing of tunnel linings at locations where the fault cause relative movements. Nevertheless, this type of damage is quite localised and it does not cause any danger to the overall stability of tunnels. Therefore, the current seismic design concepts for tunnels can be safely used and design should also be based on dynamic numerical calculations.

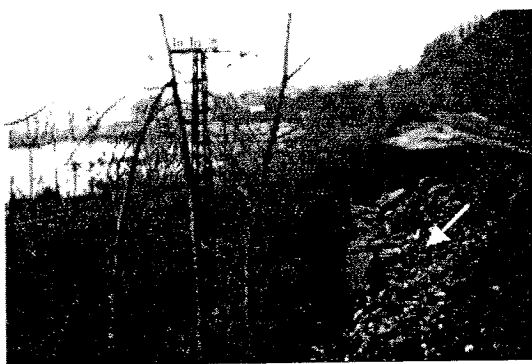
During the Düzce earthquake, the fault break induced damage to a minor energy transmission line occurred near Cevizli village as shown in **Fig. 18a**. The roadway embankment failure induced by the fault break nearby Efteni Lake caused the steel pylons sank to the lake and electricity cables were subsequently cut off.

**Fig.18** (a) Damaged to a minor energy transmission line due to fault break induced embankment failure of a roadway on the shore of Efteni Lake, and (b) ruptured plastic pipe in Findikli village (Düzce earthquake).

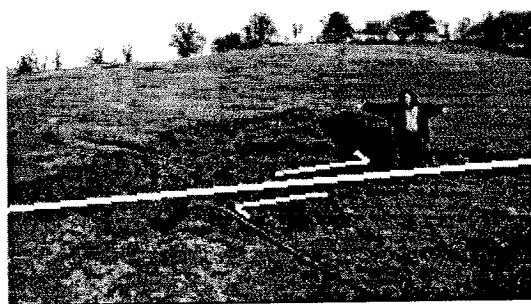
(b)

No damage to the wells, pipes and pumps of the water supply systems during the Düzce earthquake was reported. Nevertheless, it is reported that the water supply system of Düzce city was heavily damaged as a result of breaks at pipe joints due to ground shaking and probably lateral spreading. The damage to the water supply system of Kaynasli town was quite heavy since the water pipes were damaged by either buckling or breaking as a result of ground shaking and faulting. The damage to asbestos or plastic pipes and was quite heavy (Fig.18b).

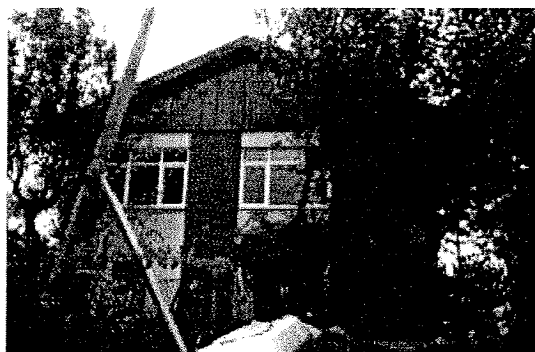
The first example from the Kocaeli earthquake is a two-story reinforced concrete house with a raft foundation in Tepetarla village. The fault passed just underneath the foundation of the southern side of the building (Fig.19a). The relative displacement of the fault break was about 200 cm. Since 70% of the foundation of the building was on the stationary northern side of the fault and the southern side of the fault had a very small amount normal component, no damage to this building was observed. In other words, this implies that if the fault just slides beneath a structure with a raft foundation in the case of strike-slip faulting, no damage could be caused to the structure, provided that the structure is strong enough against shaking.

**Fig.19** (a) The behaviour of a two-storey reinforced building at Tepetarla; (b) the collapse of apartment block at Kullar, and (c) rotated buildings due to strike-slip faulting in Gölçük (Kocaeli earthquake).

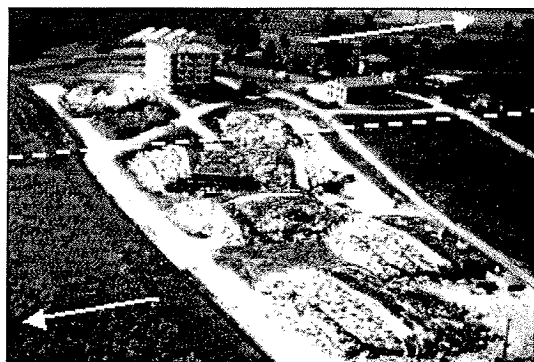
(b)

A very peculiar behaviour of an apartment complex consisting of 8 five-story apartment blocks was observed in Kullar village (Fig.19b). Seven apartment blocks failed in a pancake mode while one apartment block remained self-standing. One of the failed apartment blocks just crossed by the fault break that has a relative horizontal displacement of 240 cm and 20–25 cm vertical throw (north side down). The ground surface was sloping to north. One of two apartment blocks on the southern side was damaged while the other one collapsed towards east in a pancake mode in accordance with the movement of its foundation. The 5 blocks on the northern side were completely collapsed in a pancake mode towards west in accordance with the direction of shaking. Except the apartment block over the fault break, the failure of 5 blocks on the northern side of the fault break may be con-

sidered to be purely due to shaking. Although the intensity of shaking on the southern side of the fault break should be the same, the damaged self-standing apartment block should deserve some special consideration. The simplest explanation may be just a slight variation of the ground condition if the apartment blocks are assumed to be structurally identical. Whatever the reason is, it is of great interest that the most vulnerable buildings may also survive within a distance of 5 to 6 m to the fault break during the inland earthquakes.

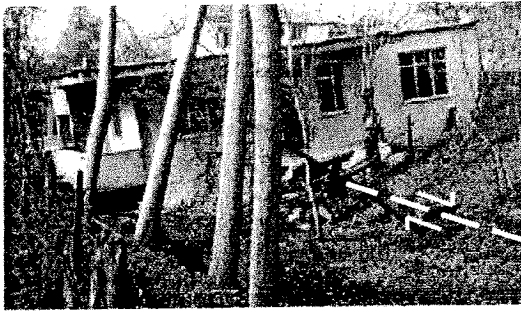
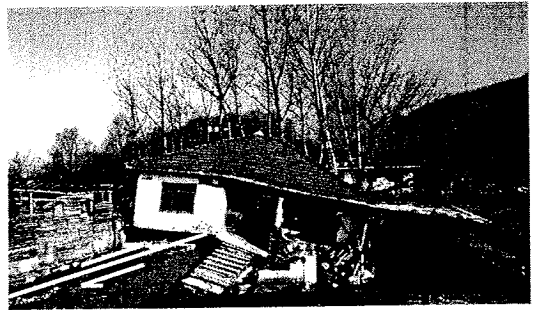
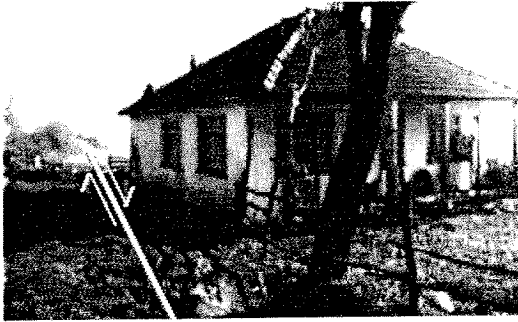
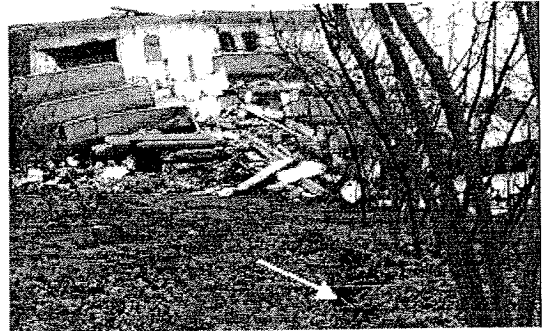
The reinforced concrete buildings with 4 stories or more on the alluvial plain collapsed. **Fig.20d** shows a totally collapsed 5-story reinforced concrete building in Kaynasli, beneath that the fault break passed. Of course, one may easily think of the fault break as primary culprit for the collapse of this building. Considering other totally collapsed similar type buildings, which were not directly crossed by the fault, it should be plausible to put the blame directly onto the fault break.

**Fig.20** (a) Tilted and rotated one-story reinforced concrete building in Findikli, (b) one-story himis building in Çakirbrahim village, (c) a brick masonry house in Findikli village, and (d) a totally collapsed 5-story reinforced concrete building in Kaynasli (Düzce earthquake).

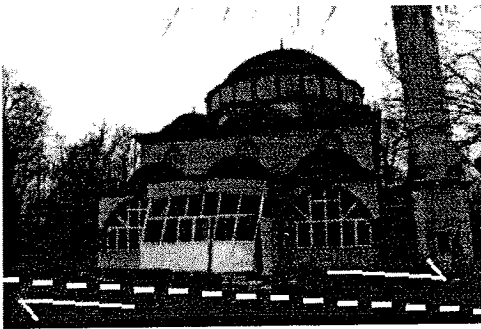
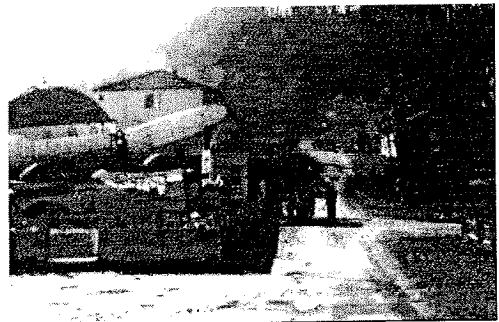
**Fig.21** (a) Partially damaged mosque in Dariyeri Hasanbey village due to fault break passing beneath the left corner of the main compound, and (b) a collapsed mosque in Kaynasli due to fault break passing beneath the main compound (Düzce earthquake).

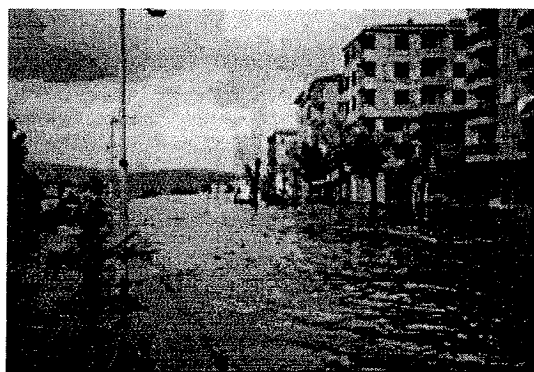
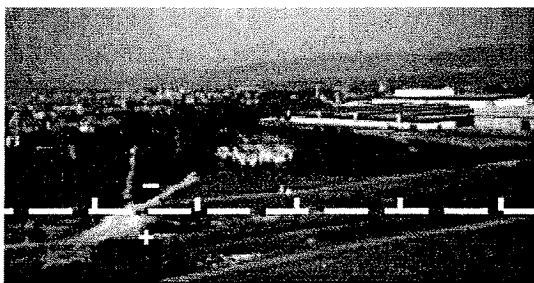
the Izmit Gulf during the 1999 Kocaeli earthquake. This ground failure was typically observed between Kavakli district of Gölcük town (**Fig.23 a**) and Seymen at its east. As previously discussed in 3.(1), the ground subsidence took place as a result of secondary normal faulting associated with the main lateral strike-slip event (see **Fig.5**). The land on the overhanging block of the fault subsided with a gradual tilt towards the sea with the northern tip submerged into the sea. In other words, a huge land has moved as a whole towards the sea with lower relief. A large industrial plant under construction for Ford Otosan was on the overhanging wall of the fault. It was undamaged except where ground settlement and trace of the normal fault with a vertical throw of 240 cm intersected one corner of the 50.000 m<sup>2</sup> building (**Fig.23b**). At this location the building (steel roof trusses on concrete columns with metal cladding) experienced settlements that pulled the columns over several tens of centimetres. Particularly at Kavakli, fine sand was ejected as a result of liquefaction (see **Fig.23a**). However, the subsidence was mainly associated with the ground settlement due to normal faulting and partly lateral spreading induced by liquefaction.

**Fig.23** (a) Submerged Kavakli district of Gölcük town due to normal fault induced ground subsidence, and (b) a view of Ford-Otosan factory with the normal fault scarp.

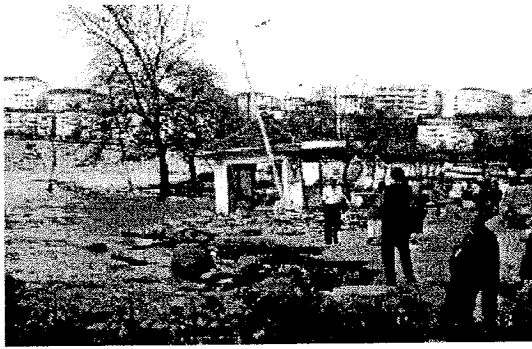
**Fig.24** Coastal land chopped away into the sea due to submarine landslide at Degirmendere during 1999 Kocaeli earthquake.

liquefaction has also some roles in submarine slides. The most publicised submarine slide took place at Degirmendere where a 5-story hotel slid into the sea together with two adjacent buildings (Fig.24). The site investigations showed that there were tension cracks extending into the land at a distance of 75–80 m from the post failure seashore. The spacing of these tension cracks was quite consistent. The coastal land about 250 m long was chopped away into the sea (Fig.25).
