DAMAGE OF BRIDGES RESULTING FROM FAULT RUPTURE IN THE 1999 KOCAELI AND DUZCE, TURKEY EARTHQUAKES AND THE 1999 CHI-CHI, TAIWAN EARTHQUAKE

Kazuhiko KAWASHIMA¹

This paper describes the damage of bridges resulting from the fault movements in the 1999 Kocaeli and Duzce, Turkey, Earthquakes and the 1999 Chi-Chi, Taiwan, Earthquake. Effect of the fault displacement on the seismic performance of bridges is presented with an emphasis on the mechanism of failure.

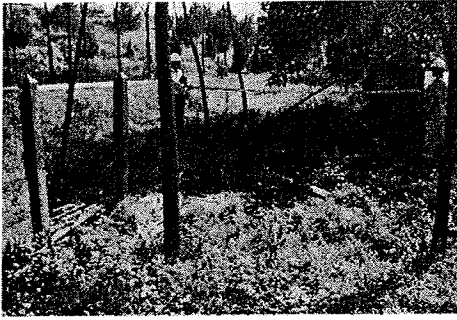
Various evidences of the right-lateral strike slip rupture were observed in the area (refer to Fig. 3)^{1), 2), 3)}. A 4.3m offset of a concrete fence occurred at an automobile factory (Arbas Arac Kadlama Fabrikasi) at its northeast corner (Point D) as shown in Photo 1.

Photo 1 4.3m Offset of a Concrete Fence at Automobile Factory (Point D, refer to Fig. 3)

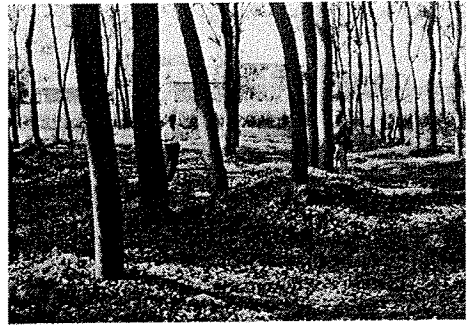
In a poplar grove at Point G, the fault offset measured from the displaced poplar trees was as large as 4.3m, as shown in Photo 2. The fault resulted in an offset of a 1m-diameter sewer pipe embedded at Point H, as shown in Photo 3. The offset appeared to be in the order of at least 3m and probably 4m. The fault rupture continued further west parallel to the Motorway

Photo 2 4.3m Offset of Poplar Trees at Point G (Refer to Fig. 3)

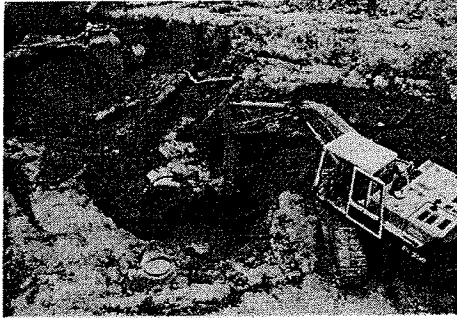
Photo 3 Offset of a Sewage Pipe at Point H (Point D, refer to Fig. 3)

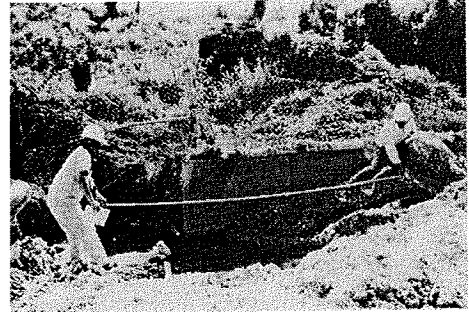
Photo 4 3.6m Offset of a Drainage Pipe at Point H (Refer to Fig. 3)

and resulted in a 3.6m offset of a 1.4m-diameter drainage pipe at Point I, as shown in **Photo 4**. The Points G, H and I were close to Arifiye Bridge that collapsed in the earthquake.

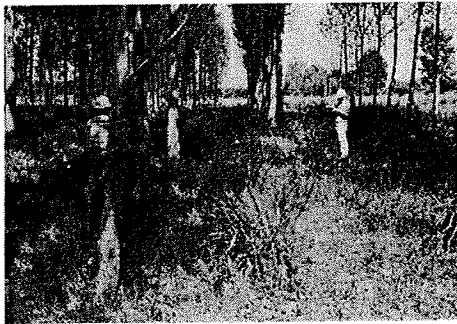
Photo 5 2.5m Offset of Poplar Trees near Tepetarla Station (South side (bottom in Photo) was about 1m lower than the north side (top))

Near Tepetarla Station (refer to **Fig. 2**) where a large offset of railways occurred, an offset of the poplar trees of about 2.5m occurred as shown in **Photo 5**. As well as the right lateral slip, a vertical offset occurred (south tip of the fault was about 1 m lower than the north tip).

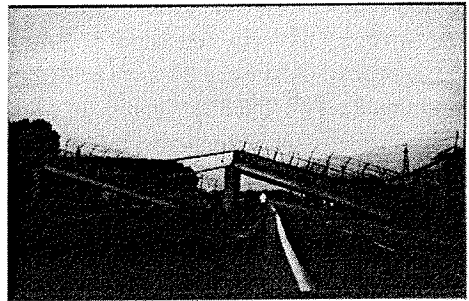
Photo 6 Collapse of Arifiye Bridge H

The Arifiye Overpass consisted of four span simply supported prestressed concrete bridge (No. 3, refer to Fig. 3). Two abutments and three wall-type reinforced concrete piers supported the deck. It was a skewed bridge with an angle of 65-degree. The substructures and the decks are denoted herein as A1, P1, P2, P3 and A2, and D1, D2, D3 and D4, respectively, from the north to south (refer to Fig. 5). As shown in Photo 6, D2, D3 and D4 fell down at their south ends with the north ends still being supported by the piers.

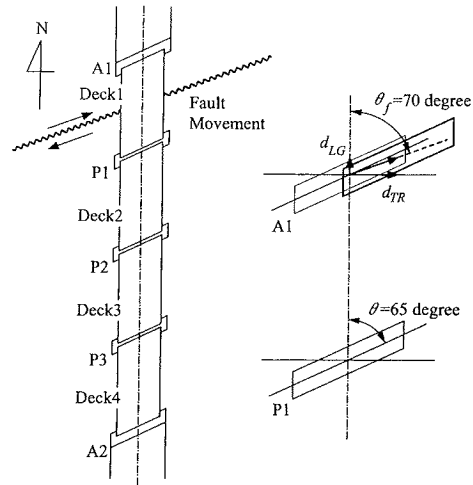
Fig. 5 Arifiye Bridge

As shown in Fig. 5, the fault crossed the bridge between A1 and P1 at an angle θ of 70-degree. The right-lateral strike-slip fault dislocated A1 in northeast direction relative to P1-P3 and A2. If one idealizes the ground displacements as shown in Fig. 8 (a), the ground displacements at north and south

relative displacement between A1 and P1 in the longitudinal direction, d_{LG} , was 1.37m, which was much larger than the seat length of 0.6 m at A1 and 0.45 m at P1. It seemed that D1 dislodged from their supports resulting from such a large relative displacement between A1 and P1. On the other hand, the foundations of P2, P3 and A2 were dislocated in south direction. It appeared that such a southward movement of the foundations resulted in the dislodgments of D2, D3 and D4 from their supports at the north end.

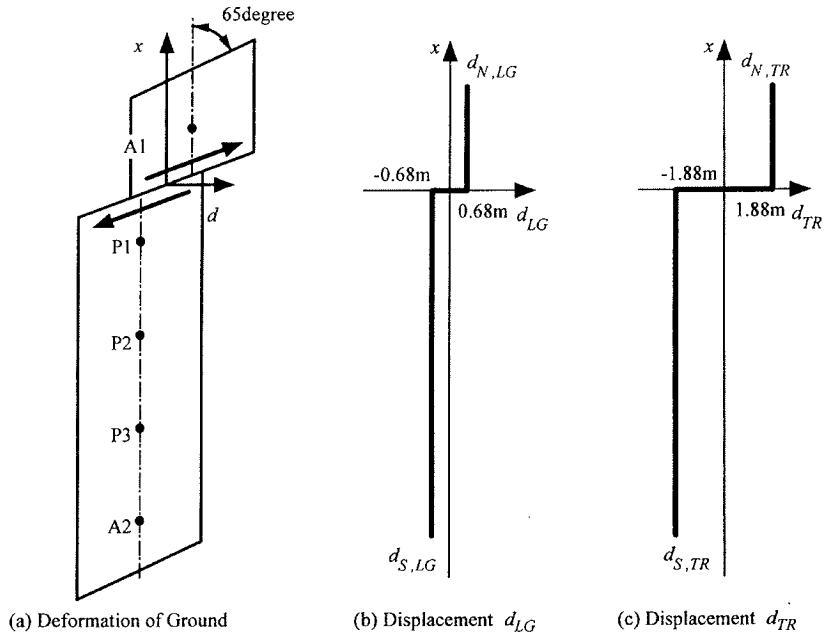
Fig.8 Effect of Fault Movement

tips, d_N and d_S , may be obtained as $d_N = d_S = D_0/2$, in which D_0 is the displacement of the fault dislocation. Hence, the ground movement in the transverse and the longitudinal directions of the bridge axis may be represented

Assuming $D_0 \approx 4\text{m}$ and $\theta \approx 70\text{-degree}$, the ground displacements may be evaluated from Eqs. (1) and (2) as shown in Fig. 8 (b) and (c). The

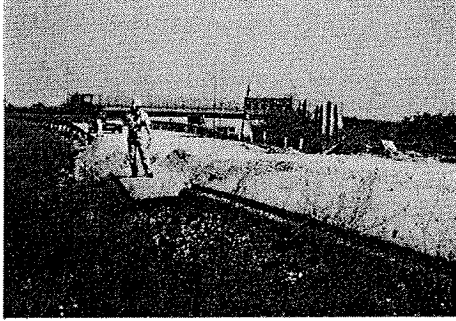
Photo 7 Minor Damage in an Overpass where the Fault Crossed the Overpass at the Abutment

Near the Arifiye Overpass, there existed several overpasses that had the decks and the substructures similar to the Arifiye Overpass. In general, their seismic performance was satisfactory. For example, the fault crossed a two span simply supported prestressed concrete overpass (No. 1 Overpass, refer to Fig. 3) at its south abutment, after crossing the Motorway at about 50 m west of the overpass as

shown in Photo 7. However, the damage was limited, i.e., only about 50mm-shear deformations of elastomeric bearings occurred resulting from the fault movement.

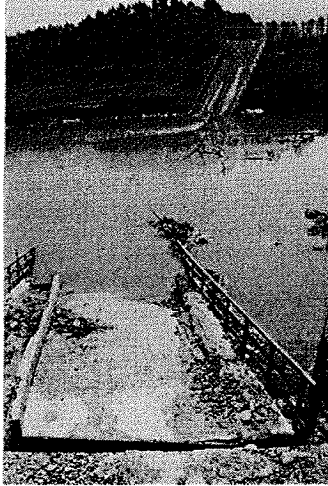
Photo 8 Collapse of Sakarya Central Bridge

Sakarya Center Bridge, crossing Sakarya river, on a regional road (No. 5 bridge, refer to **Fig. 3**) collapsed as shown in **Photo 8**. The bridge consisted of eight span simply supported girders with two internal hinges (Gerber hinges) at the center. It was 92m long (10m+6x12m+10m). Steel bent piles as shown in Fig. 10 supported them. It was constructed 30-35 years ago. The fault crossed the north abutment.

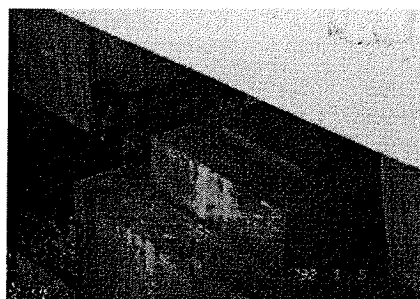
Photo 10 Girder Offset from the Pier

Most decks moved in the longitudinal and the transversal directions. At several piers, the girders offset from their pedestals, and were hung only by the concrete slabs as shown in **Photo 10**. Consequently, the concrete slabs suffered extensive shear failure as shown in **Photo 11**. Some decks were about to collapse. Based on the site inspection, it seemed that the most decks in the west from the fault rupture moved in the west direction while the most decks in the east of the fault moved in the east direction. If this is correct, the direction of the movements of the decks was not consistent to the right lateral slip. This requires more detailed survey of the damage.

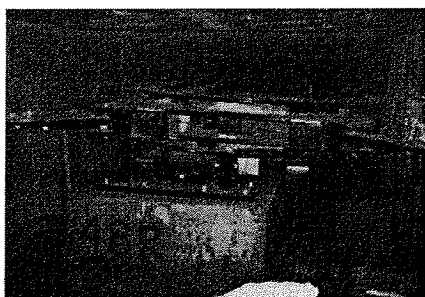
Photo 12 shows a damage of the energy-dissipating unit and the viscous damper stopper at Pier 48R. The C-shaped energy dissipating elements suffered damage, as shown in **Photo 13**, due to an excessive movement of the deck. 30mm diameter bolts that connected the elements to the frame ruptured. **Photo 14** shows a set of cable restrainers at a deck end. It seemed that the cable restrainers were effective to prevent collapse of the Viaduct

Photo 12 Damaged Energy Dissipating Unit and Viscous Damper Stopper

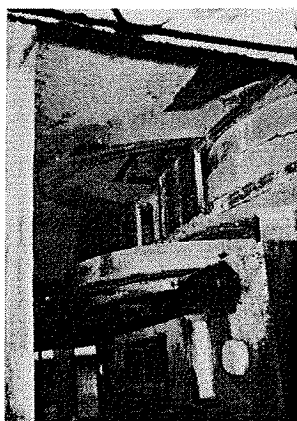
Photo 13 Energy Dissipating Elements that suffered Damage resulting from Excessive Movement of the Deck

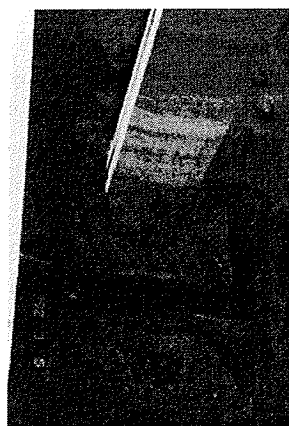
Some pile foundations where the fault crossed the Viaduct rotated⁹⁾. **Photo 15** shows the damage investigation of piles by removing the soils.

Photo 15 Damage Evaluation of Pile Foundation

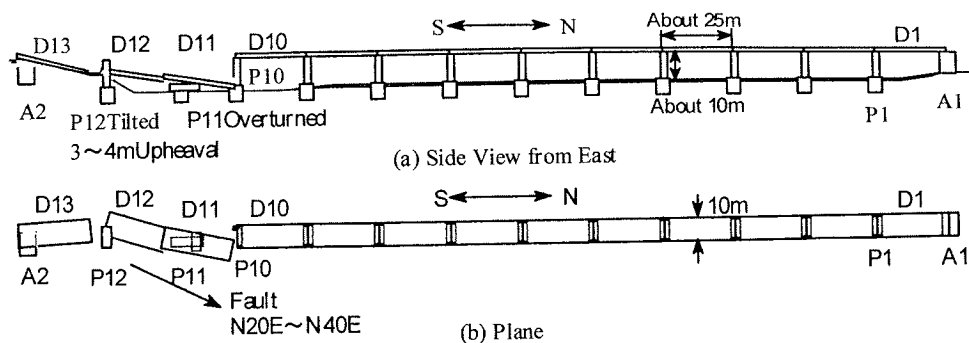
Fig.17 Damage of Bei-Fong Bridge

Bei-Fong Bridge was located downstream of the Shikhekang Dam. Resulting from the fault rupture, a waterfall was created about 100m upstream of the bridge. It was a 13-span simply supported I-beam girder bridge constructed in 1991. The south most three spans collapsed as shown in **Fig. 17** with other spans being free from damage. The abutments, the

piers and the decks are numbered herein from the north to the south. A2, P12 and P11 up-heaved about 3-4m, and P12 and A2 were laterally displaced about 3.5m and 4m, respectively, in the downstream direction (west) as shown in **Photo 16**. D13 was resting on the slope of the river embankment with the north end being dislodged 6.6m south from the original alignment.

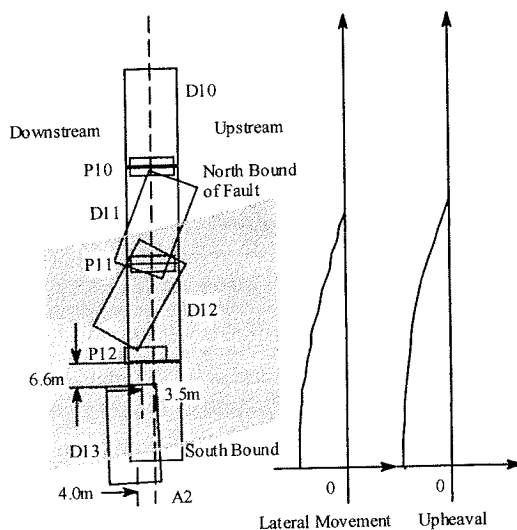
Fig.19 Fault Movement and Ground Movement, Bei-Fong Bridge

Fig. 18 shows the location of fault investigated by the Taiwan Geological Survey and Otsuki, K., Tohoku University. It seems that the fault crossed the bridge between A2 and P12 at an angle of about 42-degree. From the fact that P12 was laterally displaced in west, and that D11 and D12 clockwise rotated (20-40-degree), it appeared that the fault rupture crossed the bridge between A2 and P11 as shown in **Fig. 19**.

in which D_0 is the fault displacement. Substituting $d_{TR} \approx -4\text{m}$ and $\theta \approx 42\text{-degree}$ into Eq. (3), one obtains $D_0 \approx -6\text{m}$ and $d_{LG} \approx -4.5\text{m}$. Although the longitudinal displacement $d_{LG} \approx -4.5\text{m}$ is not large enough to the above-estimated southward dislodgment of D13 at the north end (6.6m), they are not too much different.

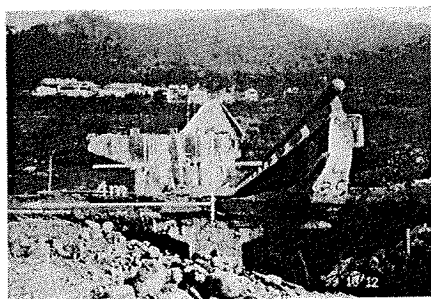
Photo 16 Lateral Movement of A2 and P2, Bei-Fong Bridge

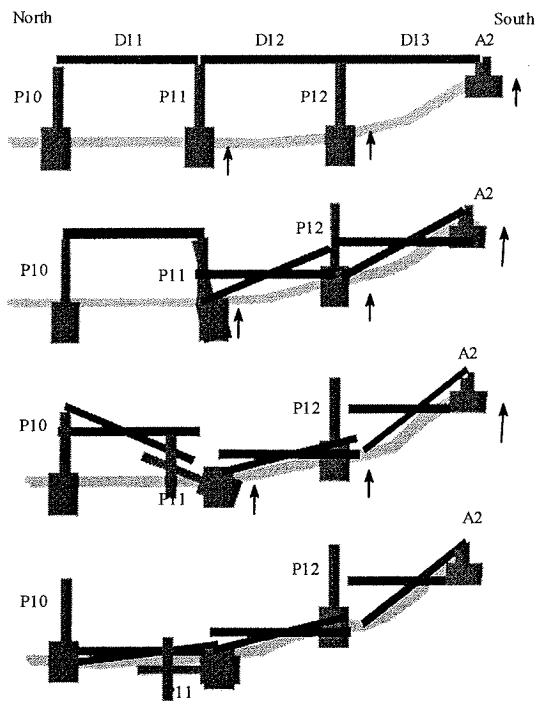
Fig.21 Collapse Mechanism, Bei-Fong Bridge

Based on the above facts, it seems that the collapse of the bridge resulted from a large tilting of P11 in the north direction, which was caused by the fault movement as shown in **Fig. 21**. D12 dislodged

from P11 first at its north end, followed by the dislodgment at the south end. This resulted in the complete collapse of D12. D12 finally fell on P11 at the north end with the clockwise rotation resulting from the right-lateral fault. The collapse of P11 resulted in the dislodgment of D11 at its south end. The south end of D11 thus finally collapsed on the north end of D12. Increased distance between P12

and A2 resulted in the collapse of D13.

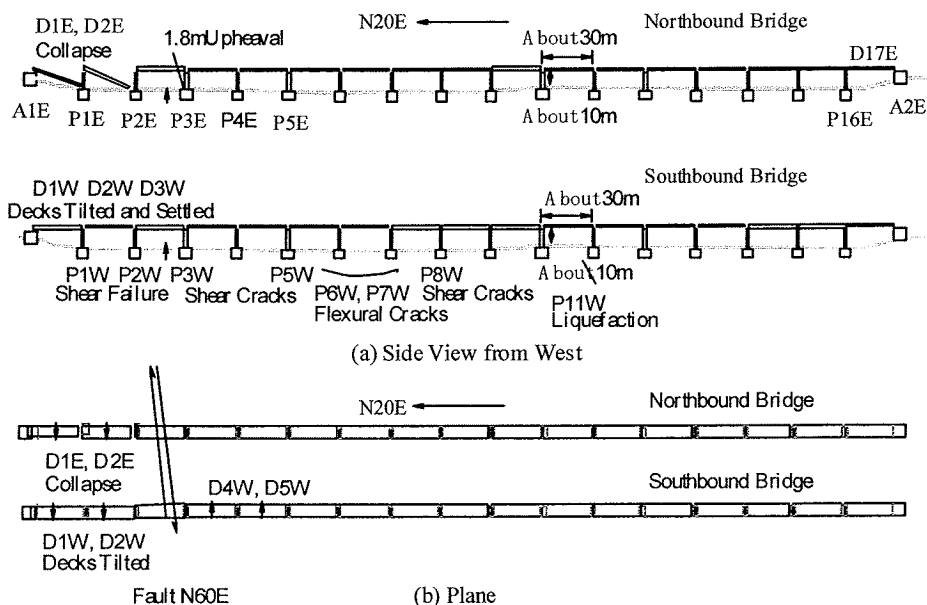
Fig.22 Damage of Wu-Shi Bridge

D1E and D2E collapsed (refer to **Fig. 22**), while D1W and D2W tilted and settled extensively. **Fig. 23** shows the damage of piers in the southbound bridge. P1W and P2W failed in shear from the east to the west. The caisson foundation at P3W suffered shear failure from the east to the west as shown in **Photo 18**. Nearly all piers in the westbound bridge suffered damage. In particular, P1W and P2W suffered extensive damage.

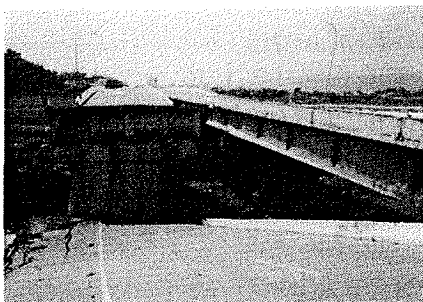
while the southbound bridge was newer than the northbound bridge. As shown in **Photo 17**, the northbound bridge was supported by 8.5m wide and 3m long wall piers, while the southbound bridge was supported by 5m wide and 2m long rectangular reinforced concrete piers. For example, in P1W (P1 at the southbound bridge), 32 deformed 22mm diameter bars were placed around the pier, and deformed 12mm diameter tie bars were placed at 200mm interval. They were supported by caisson foundations with a diameter of 6m. Deformed 22mm bars from the caissons were spliced with the bars from the piers at 1m above the bottom of piers. The concrete strength measured by the author using the Shumit hammer was about 24MPa.

Photo 17 Collapse of Wu-Shi Bridge

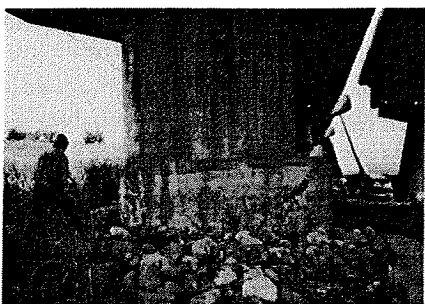
Photo 18 Shear Failure of Caisson Foundation Resulting from Fault Movement, Wu-Shi Bridge

It seems that the failure of the caisson foundation at P3W (refer to Photo 18) resulted from the fault movement.

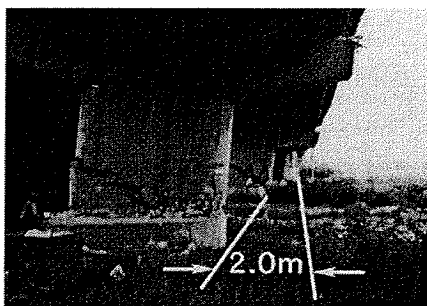
Photo 19 Lateral Movement of P1 and P2, Wu-Shi Bridge
