**A PRELIMINARY REPORT ON SULTANDAĞI-AFYON  
EARTHQUAKE OF FEBRUARY 3, 2002\***

**Ömer Aydan**

**Tokai University  
Department of Marine Civil Engineering  
Shimizu, Japan**

**February 7, 2002**

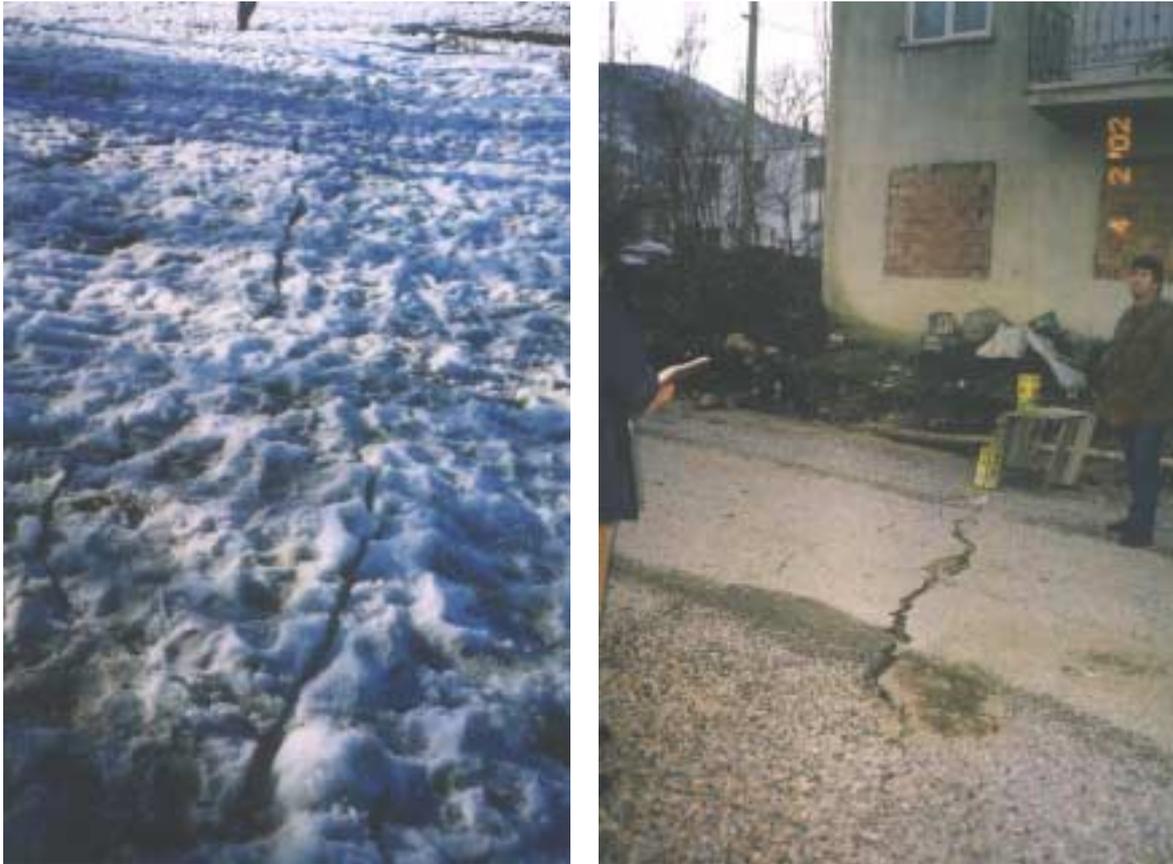
Figure 10 Ground breaks observed at Maltepe (pictures by H. Kumsar of Pamukkale University)

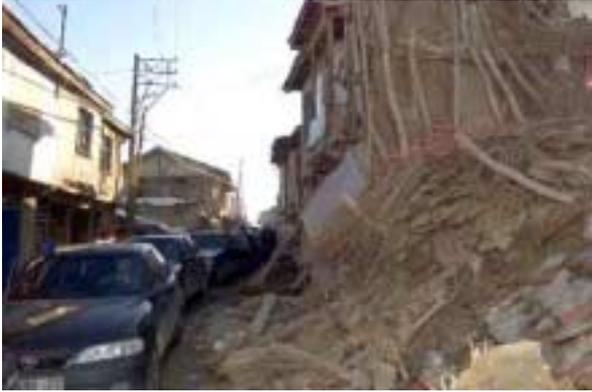
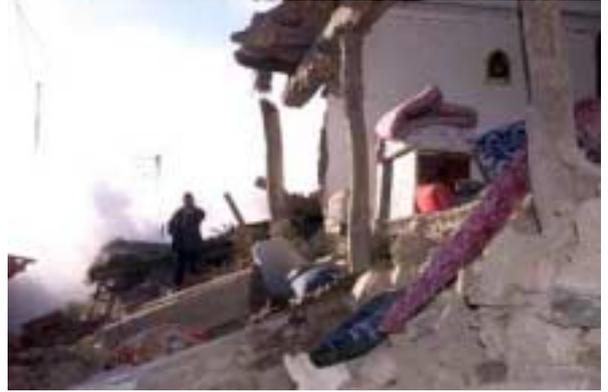
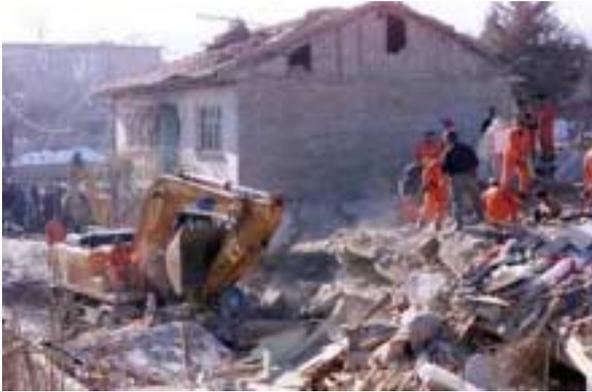
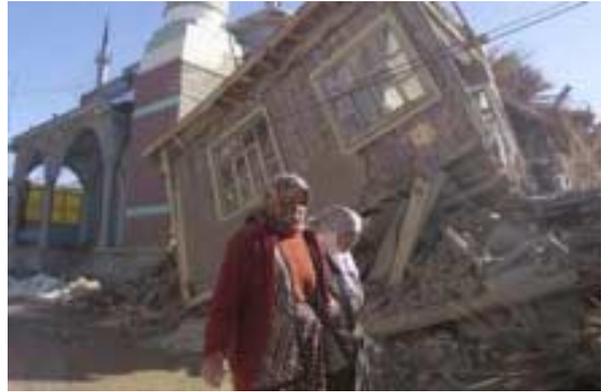
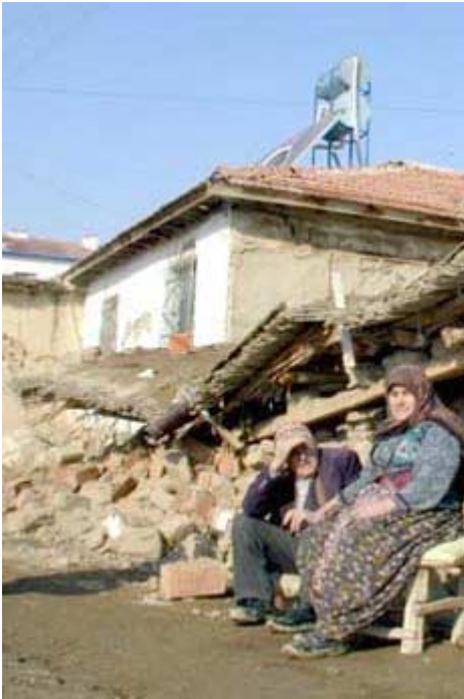
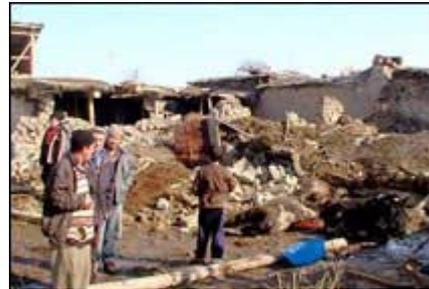
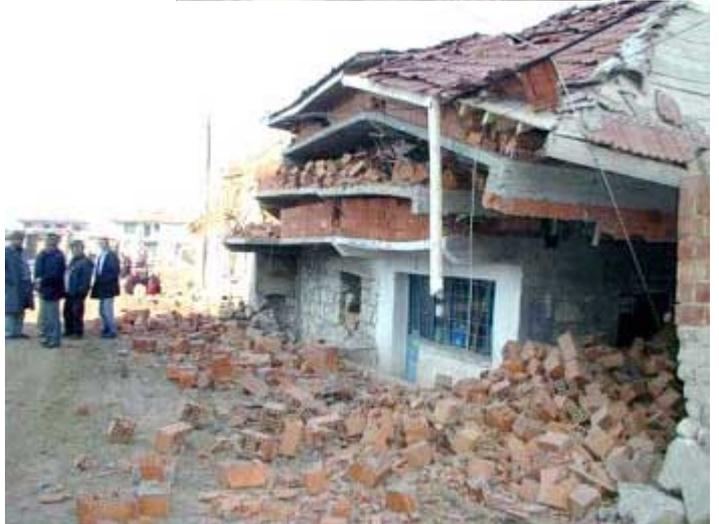
According to preliminary reports, the heaviest damage occurred in the towns of Sultandağı and Çay and their villages. Figure 22, 23, 24 and 25 show some examples of structural damage. The pictures are taken from the web-page of Milliyet daily newspaper. It seems that the old wooden houses of Bağdadi type and kerpiç (adobe) type masonry houses collapsed. These houses are either single story or two-story structures as seen in Figure 22. Some masonry structures with delikli tuğla (hollowed bricks) without appropriate concrete slabs for structural integrity also collapsed as seen in Figure 22. The reinforced building having 3-8 stories failed either by toppling or collapsed due to the weak-floor effect as commonly observed in other Turkish earthquakes (Figure 23). As seen in Figure 24, minarets of some mosques toppled during the earthquake. Since these structures have long shaking periods (0.7 seconds), their failure implies the existence of some long-period waves.

Figure 22 Damage and collapses of wooden and masonry structures (pictures by Milliyet)

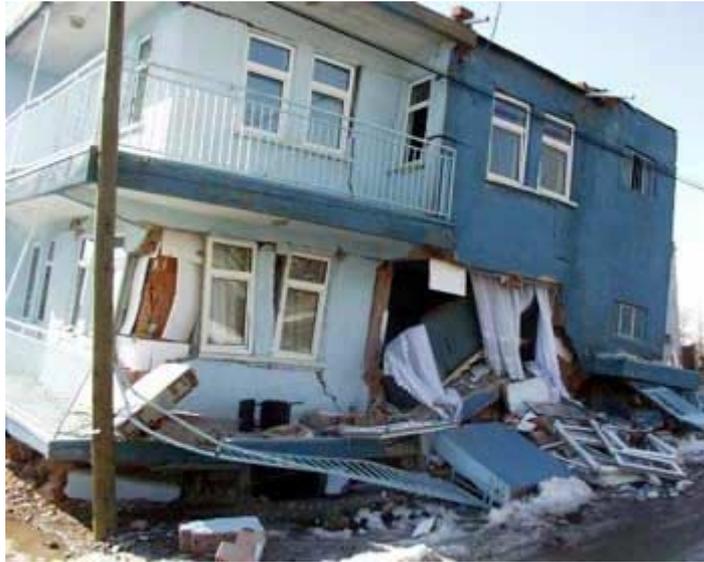
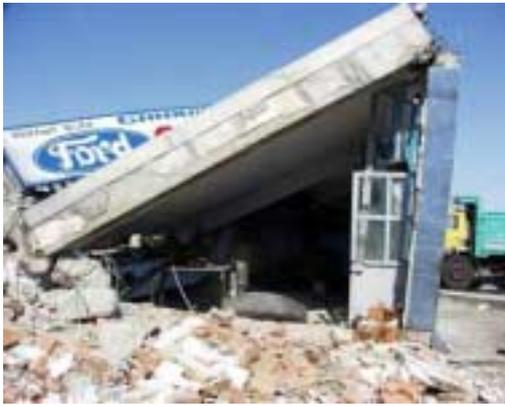
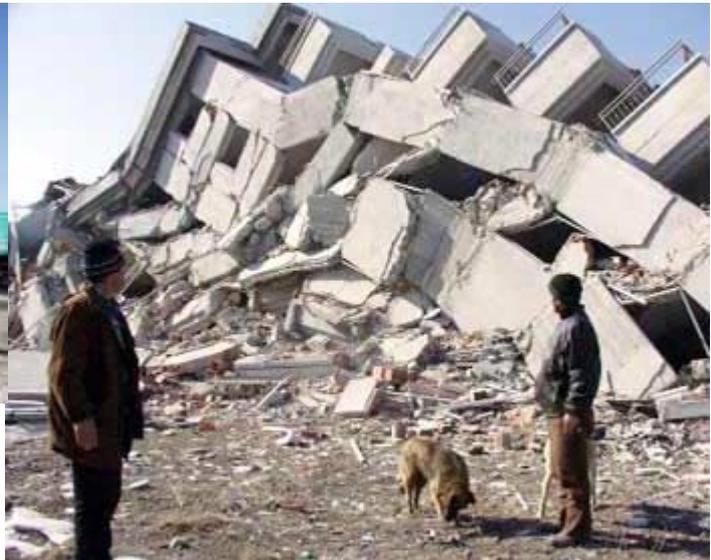
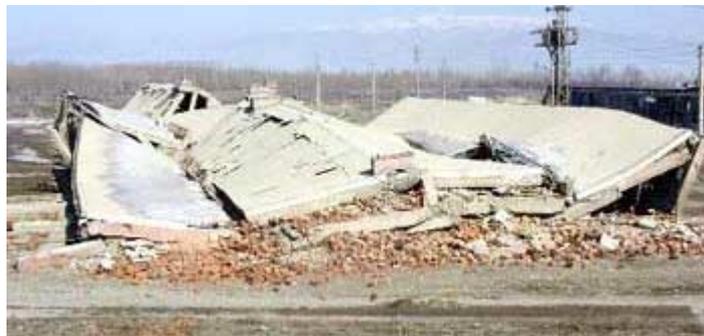
Figure 23 Damage and collapses of reinforced concrete structures (pictures by Milliyet)

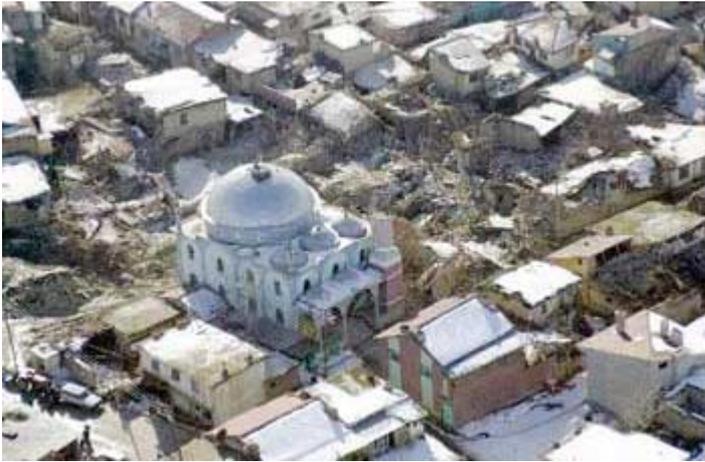
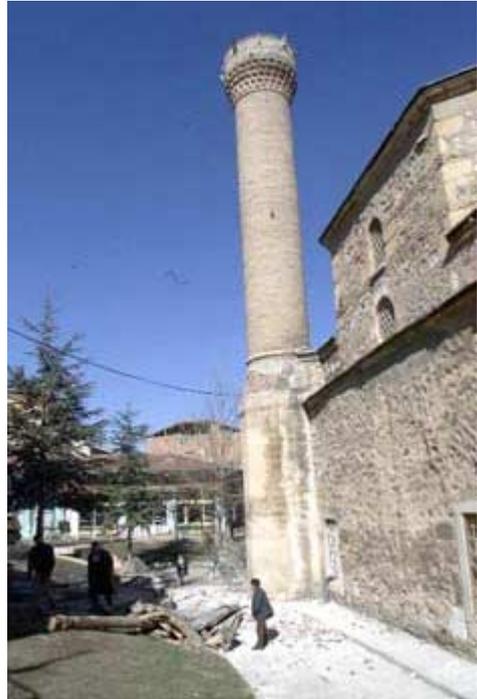
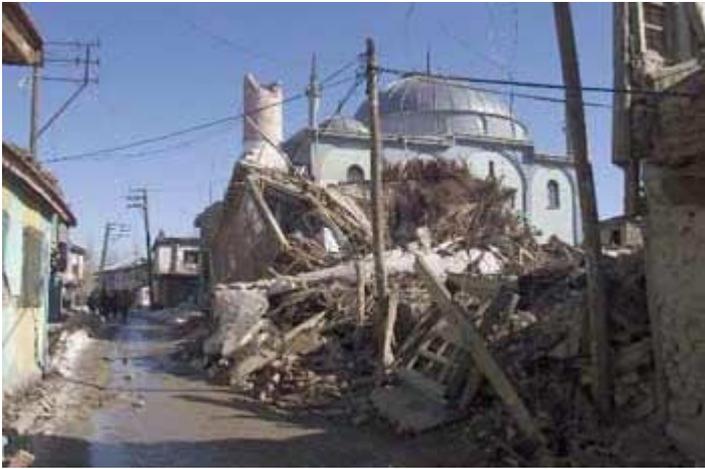
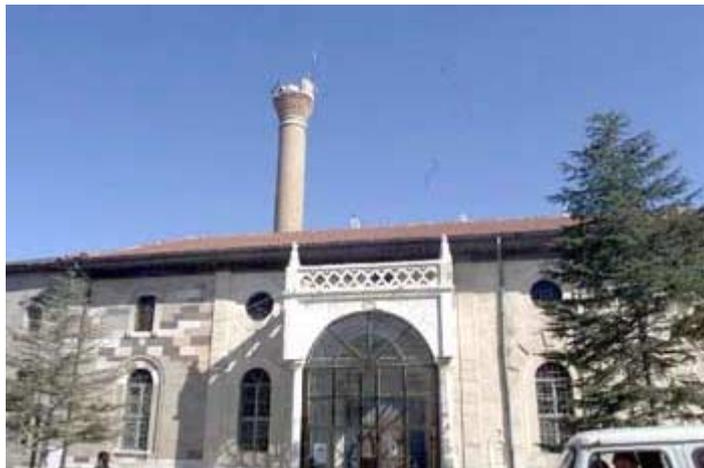
Figure 24 Damage to mosques and collapses of their minarets (pictures by Milliyet)

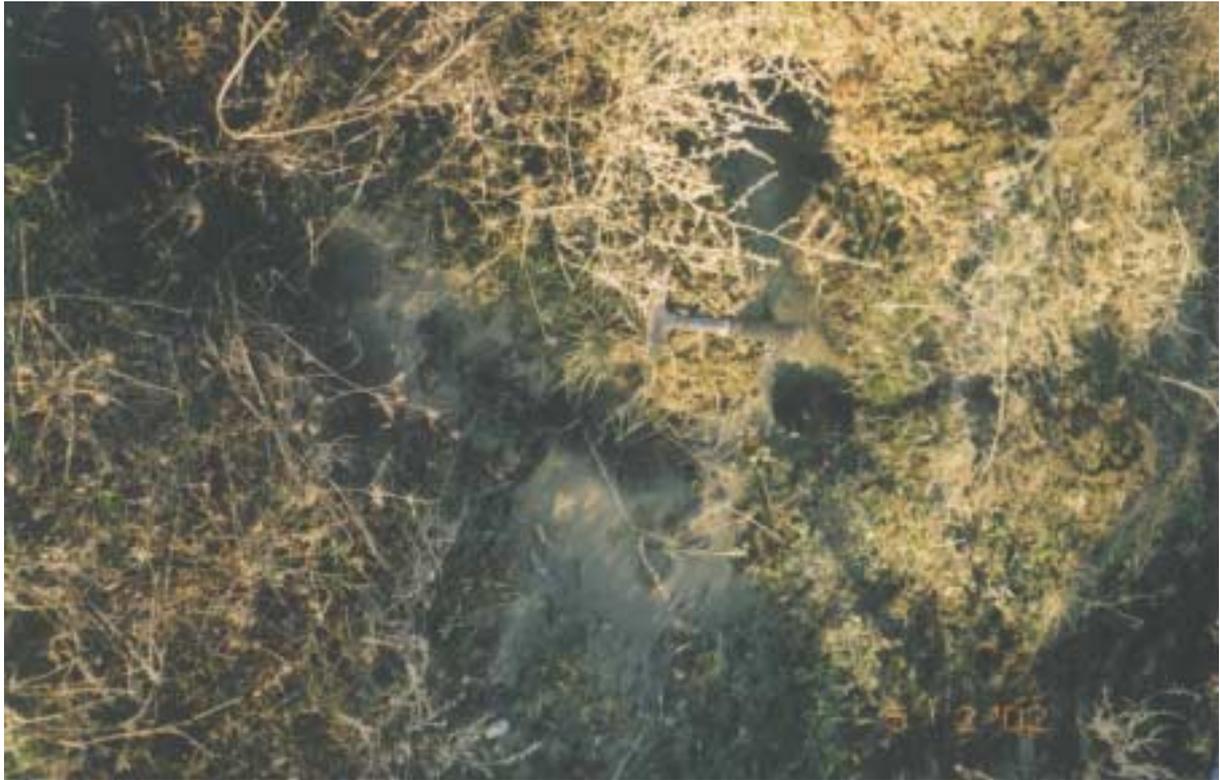
There are a few reports on ground failures. The cause might be the hinderence of the thick snow cover in the region at the present time of the year. It is also reported that the area is covered with thick clayey or silty deposits. It seems that some ground failures occurred along the shores of Eber lake. At some parts of its shore, it is reported that some liquefaction also took place. H. Kumsar of Pamukkale University reported that liquefaction observed in Maltepe and Kadıköy villages and also in the river course of Gani çayı (creek). Figure 26 shows an example of liquefaction reported by Kumsar of Pamukkale University.

Figure 26 Ground liquefaction (picture by H. Kumsar of Pamukkale University)
