THE 1999 QUINDIO EARTHQUAKE, COLOMBIA

- Investigation into Damage to Civil Engineering Structures -

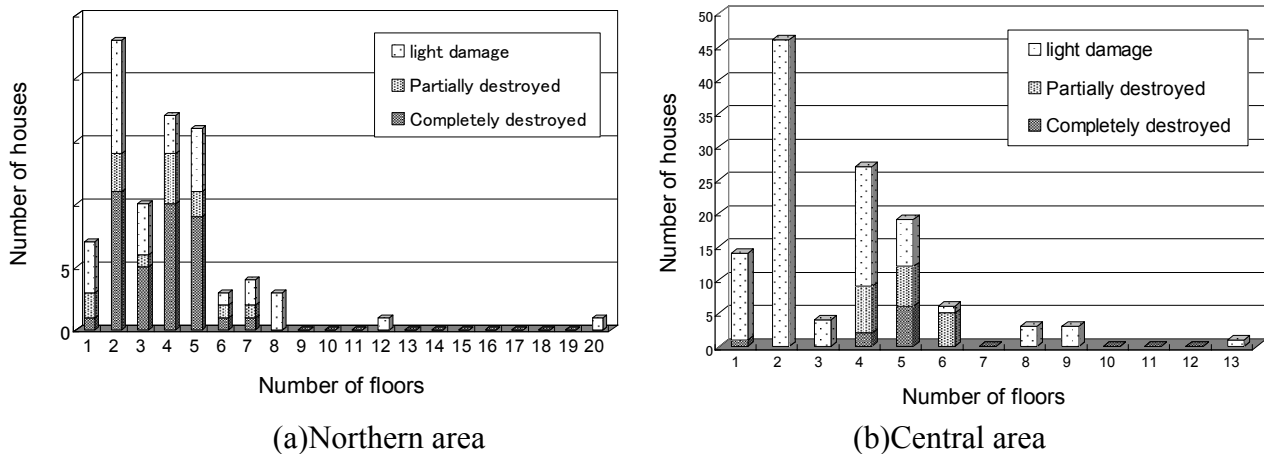
Fig.3. Damaged houses in northern and central parts of Armenia City

Foundation soil in Armenia City includes a soft foundation layer sandwiched between finger-like formation of hills which is a typical representation of the topography of the city. Fig.3 makes a comparison of architectural damage, in terms of damaged buildings, encountered in the central and northern parts of the city. (INGEOMINAS [1999b] Terremoto del Quindio (entro 25 de 1999) Informe Tecnico Preliminar, No.2, Armenia-Quindio.) In the northern area, where most buildings conform to the building standards of 1984, only 8 buildings were completely destroyed in the earthquake, whereas in the central area that has so many old buildings suffered severe damages. Provincial government buildings, city government buildings, hospitals, fire department headquarters, police department headquarters, and shopping district all suffered heavy damages due to the earthquake. Out of the extent of architectural damage, 10% were completely destroyed, 40% were severely damaged but not completely destroyed, 30% suffered medium level damages, while the rest of 20% had minor damages. To the west of this area, the Armenia Fault runs from north-northeast to south- southwest, and although the fault did not move itself, the weak foundation area to the west of the fault was associated with indicated the greatest degree of damage. In the southern area, where low-income dwellers are concentrated and the buildings are old, due to the poor foundation soil, the amount of architectural damage was in the range of 40-70%(see photo 1). Most of these low rise structures were self-constructed with bricks, but among them were some houses made of thick bamboo reinforcements called *Gaudoa*; the low-cost single story structures were not severely damaged due to their light weight. However, in the northern Lobidensia, the damage rate was 30%, the central Centro area this was 90% while the southern Brazilia area had 95% damage ratio.

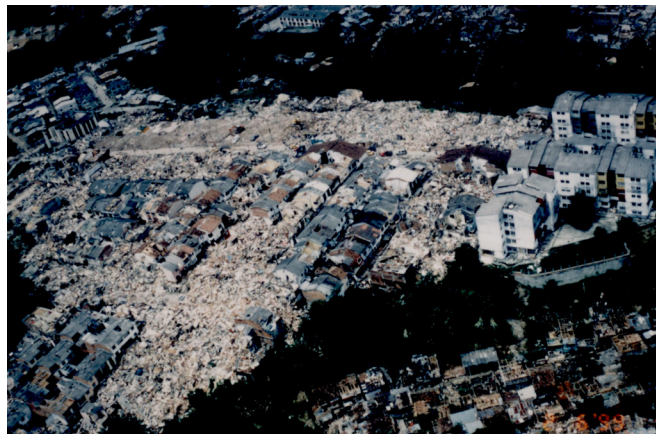
Photo 1. Worst damaged area of Armenia City (Courtesy: by E.Rodriguez Grandos)

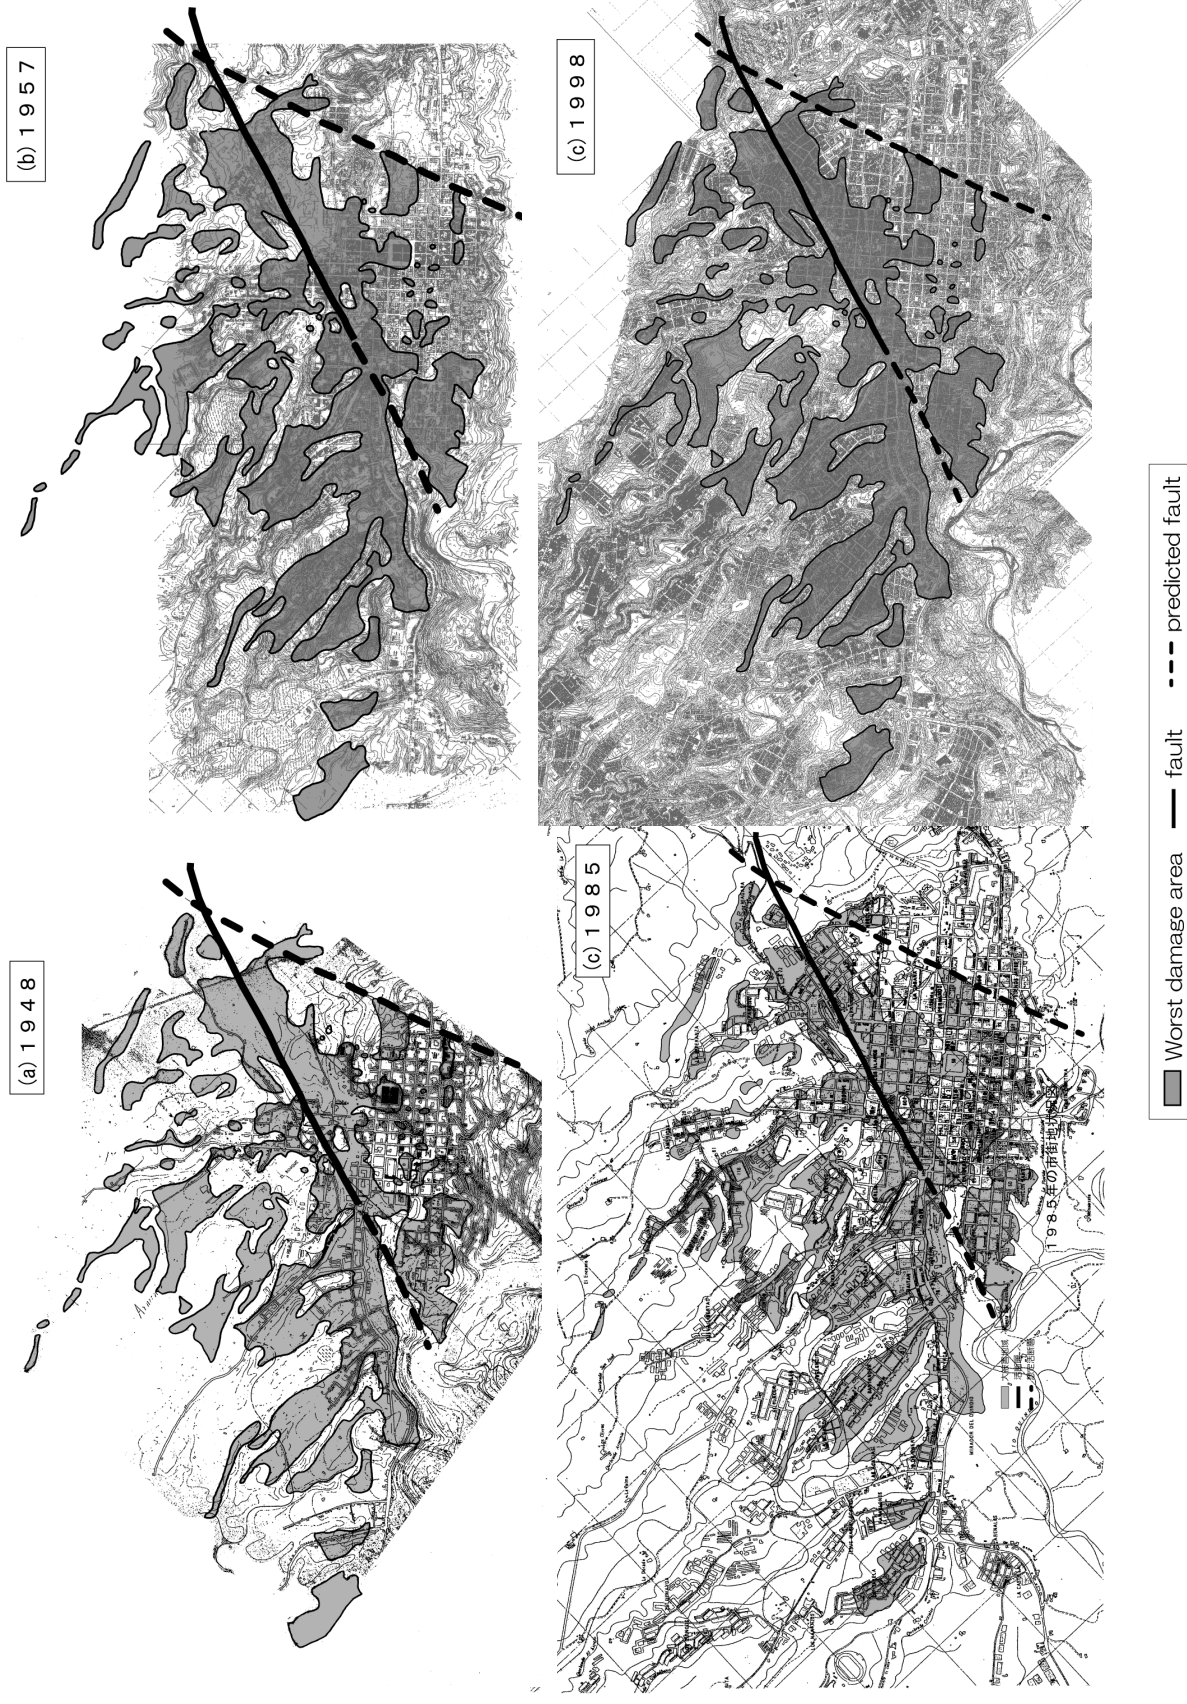
Fig.4. Evolution of urban area of Armenia City 1948-98.

Fig.4 shows a comparison of urban growth of the central area in which the damage due to the earthquake was most severe, from 1948 to 1998. In 1948, the urban area was only a small but high plateau, which would have had minimal damage due to an earthquake. In the course of the city growth to 1998, it is observed that urban sprawl has set in here. It accelerated in 1957, causing urbanization up to the areas of cliff slopes and those of soft soils. The urban area of 1985 quite resembles that of 1957. And urban sprawl has shown a tree-like growth. As a result, the area of growth within this period has matched that of the area of damage in this earthquake. Thereafter, since the urban growth was in the direction of southwest towards hills,

the damage in this area was minimal. In the central and southern parts of Armenia City, there was a good correlation between the filled area and disaster damage. In the filled area, the damage was great, and this included the fire department as well.

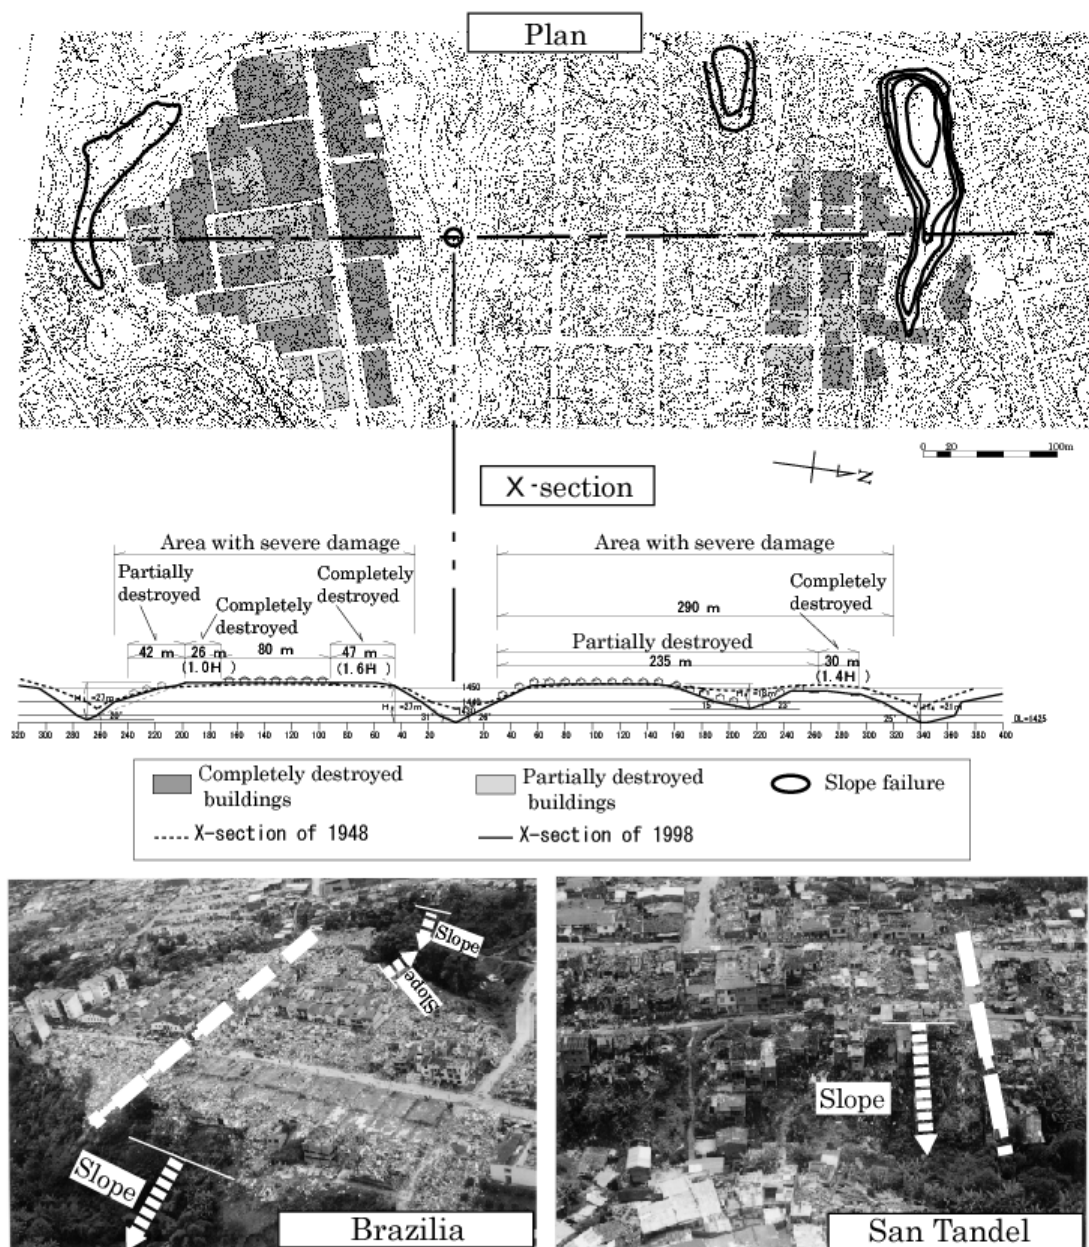
Fig.5. Cross-sectional topography and building damage distribution of Brazilia and San Tandel

Fig.5 shows cross-sectional topography and architectural damage distribution of Brazilia and San Tandel, where the most severe damage was reported. This figure revealed that the building located up to a distance of 1.0-1.5 times the height of slope, from the foot of it, were completely destroyed. This will be discussed in the next chapter.

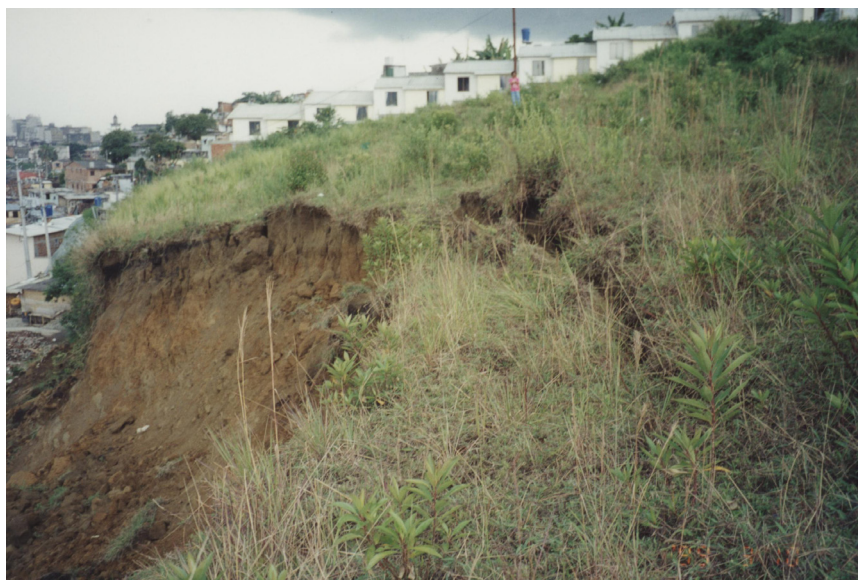
To analyze the damage in the worst affected areas, the effects of topography (①~⑥) and foundation soils (A to J) were investigated. Lines of cross-sections considered are shown in Fig.6 In areas where severe damage occurred slope failure and tension cracks etc. were observed due to topography of slopes (see photo 2). In Fig.7, cross-sections at slope failure locations are shown. These locations were affected severely by the topographical conditions. Fig.8 shows relation between width of damage area and height of cliff. Damage area is defined as the places where severe damage to houses and buildings was caused in this paper. According to distribution map of damage level presented by INGEOMINAS [1999b], all areas of the Armenia City are classified into severe and moderate damage levels. The severe damage level area is adopted here as the maximum damage area. Therefore, there was no big difference in the damage level in the area. It was possible to observe that an upper boundary of L is 1.0 to $1.5H$, where L and H are width of maximum damage area and height of cliff respectively. In locations like cross-section ⑤ where it is surrounded by a valley, the damage was observed to be $L > 1.5H$. Fig.9 indicates relation between slope and L/H . L/H increases in an increase of slope and the upper boundary of L/H is 1.5 . There is almost no study that investigates width of damage area during earthquake with respect to the height and/or angle of cliff. Hirai et al. investigated the damage to building foundation in relation to an angle, height (H) and distance from the edge of cliff (D) in the 1995 Kobe Earthquake. They clarified that the number of damaged buildings increased when the slope exceeded 30% and no building damage occurred in the areas of $D > 1.5H$ (Hirai et al. 1996). These show good agreement with our observation in Colombia. Since the soil type is, however, different in each site, further study is needed.

Photo 2. An example of slope failure

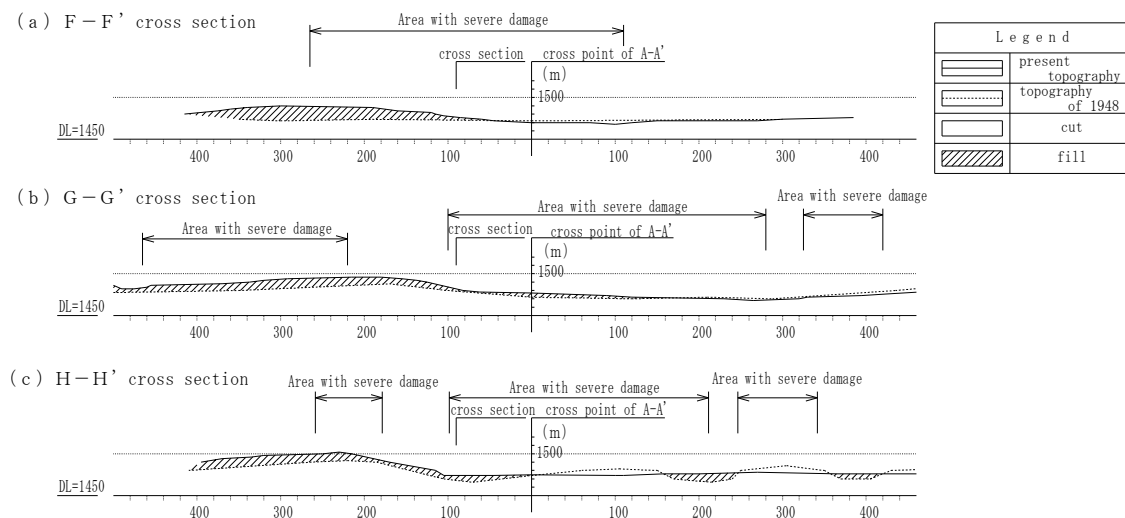
Fig.10. Effects of foundation soil condition

Since soil investigations have not been conducted, maps of 1948 and 1998 were overlapped as shown in Fig.10. It was observed that urban sprawl was quite minor in the area illustrated in Fig.10 during this period, therefore assuming that this difference in topography is fills, each cross-section was analyzed. This fill area, as seen in typical cross-sections from F to H, is in the western (left) part, including the fault.

In cross-section H, a damage area exists in the eastern (right) part including the fault. According to the soil maps of INGEOMINAS [1999b], large deformations in cross-sections were observed and in comparison to the upper western part, the eastern part has considerable sediments of loam, which are as thick as 50 m approximately at the fault. Therefore, it is concluded that (right) areas east of the fault have been affected by fill while western (left) areas have been affected by soft loam. Further, it is considered that ground motion amplification could have occurred on either side of the fault owing to the soft soils.

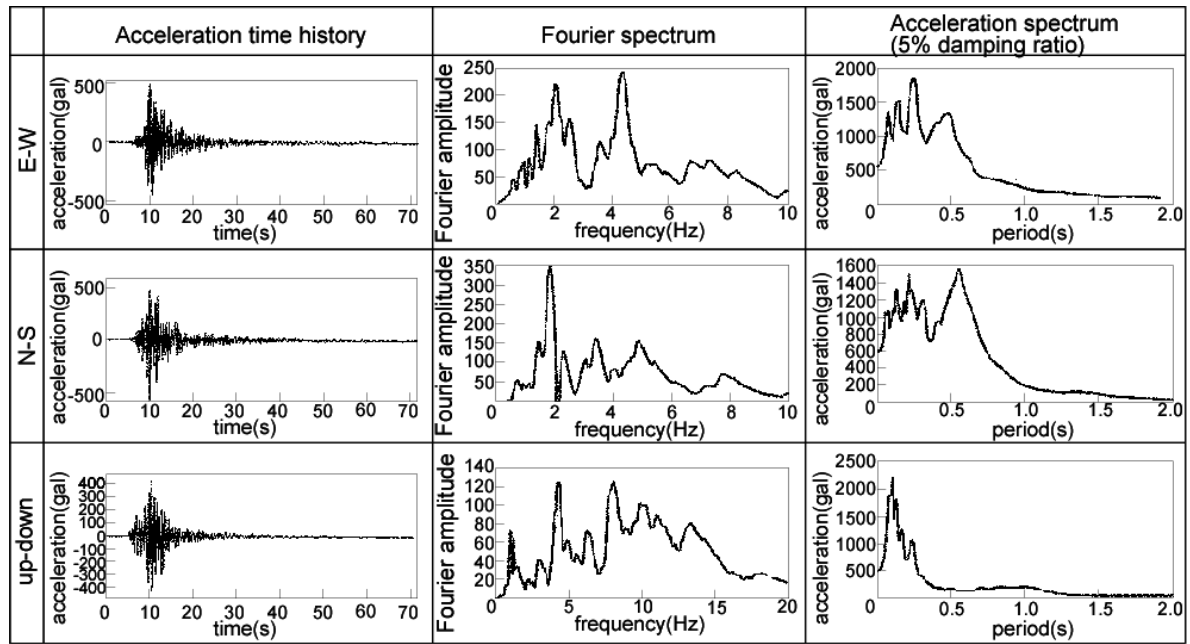
Fig.11. Acceleration time histories, Fourier spectra and acceleration spectra of main shock in Armenia City

In Armenia City, INGEOMINAS has installed an accelerometer in the Quindio University located at the north of the city. Fig.11 shows the time histories, Fourier spectra and response acceleration spectra of the accelerographs of the main shock. The details of stratigraphy of this site were evaluated by the CRQ and the Los Andes University (1997) survey as listed in Table 4. The natural period of ground vibration was evaluated as a function of the thickness of the soil deposit, the soil density and shear modulus by using Table 4. According to this evaluation, the natural period of this site was obtained as 0.68 sec. This period coincides with the peak of response acceleration spectrum in N-S component as shown in Fig.11.

Although the natural periods of buildings in this area were not determined, they can be roughly estimated from a function of the number of stories (n) as $0.1 \times n$. When the natural period of building is close to the peak period of the response acceleration spectrum, the resonance effect is strong. The five to seven story buildings are likely to be affected by resonance effects in the north of the city where the accelerograph was obtained. According to Fig.3(a), the number of completely destroyed buildings was greatest in five stories. The resonance effect seems to be one of causes of building damage in this area. Only a preliminary investigation was conducted here, more detailed soil data are needed for proper study of the amplification of ground motion.
