Chapter 1

Purpose, Members and Itinerary of the Reconnaissance

The purpose of the reconnaissance was to investigate damage to civil engineering structures caused by the earthquake shaking as well as by tsunami, for the progress of disaster mitigation and earthquake as well as tsunami resistant design and construction.

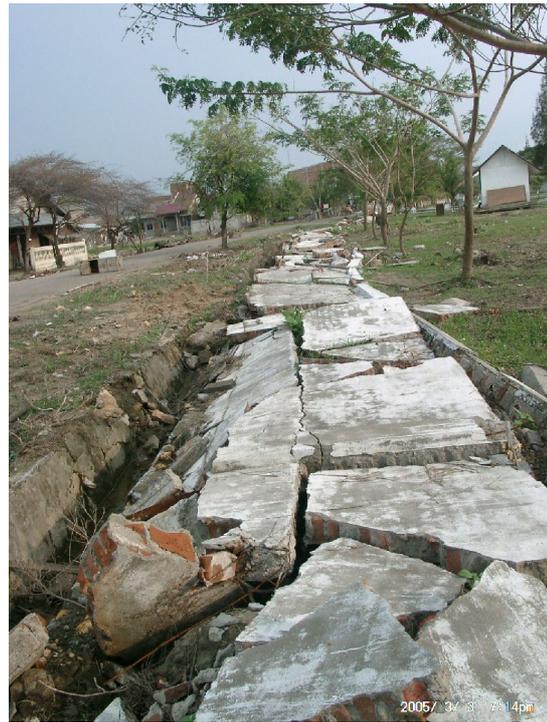
Photo 6.1 Earthquake induced wall failure

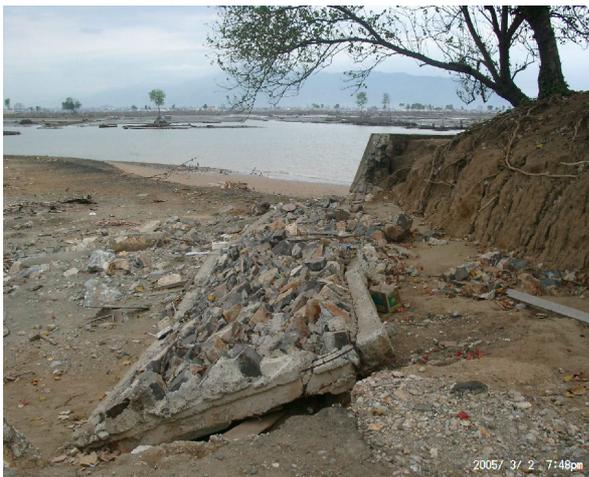
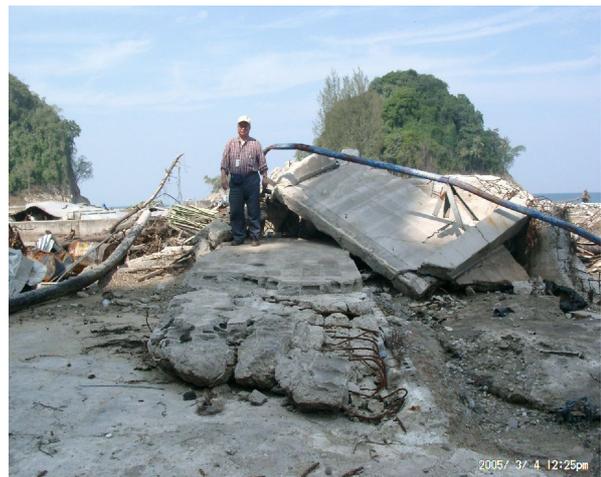
The walls shown in Photo 6.2 were toppled by the tsunami waves. Through some mechanical considerations, these walls may be useful for inferring the impact force of tsunami waves. Photo 6.3 shows pictures of collapsed RC buildings. These buildings were collapsed mainly in NS direction. Although the details of the reinforcement of these columns are not known, a rough estimation would indicate the ground acceleration should be greater than 100gal for the failure of the columns of these buildings.

Photo 6.2 Tsunami induced wall failures

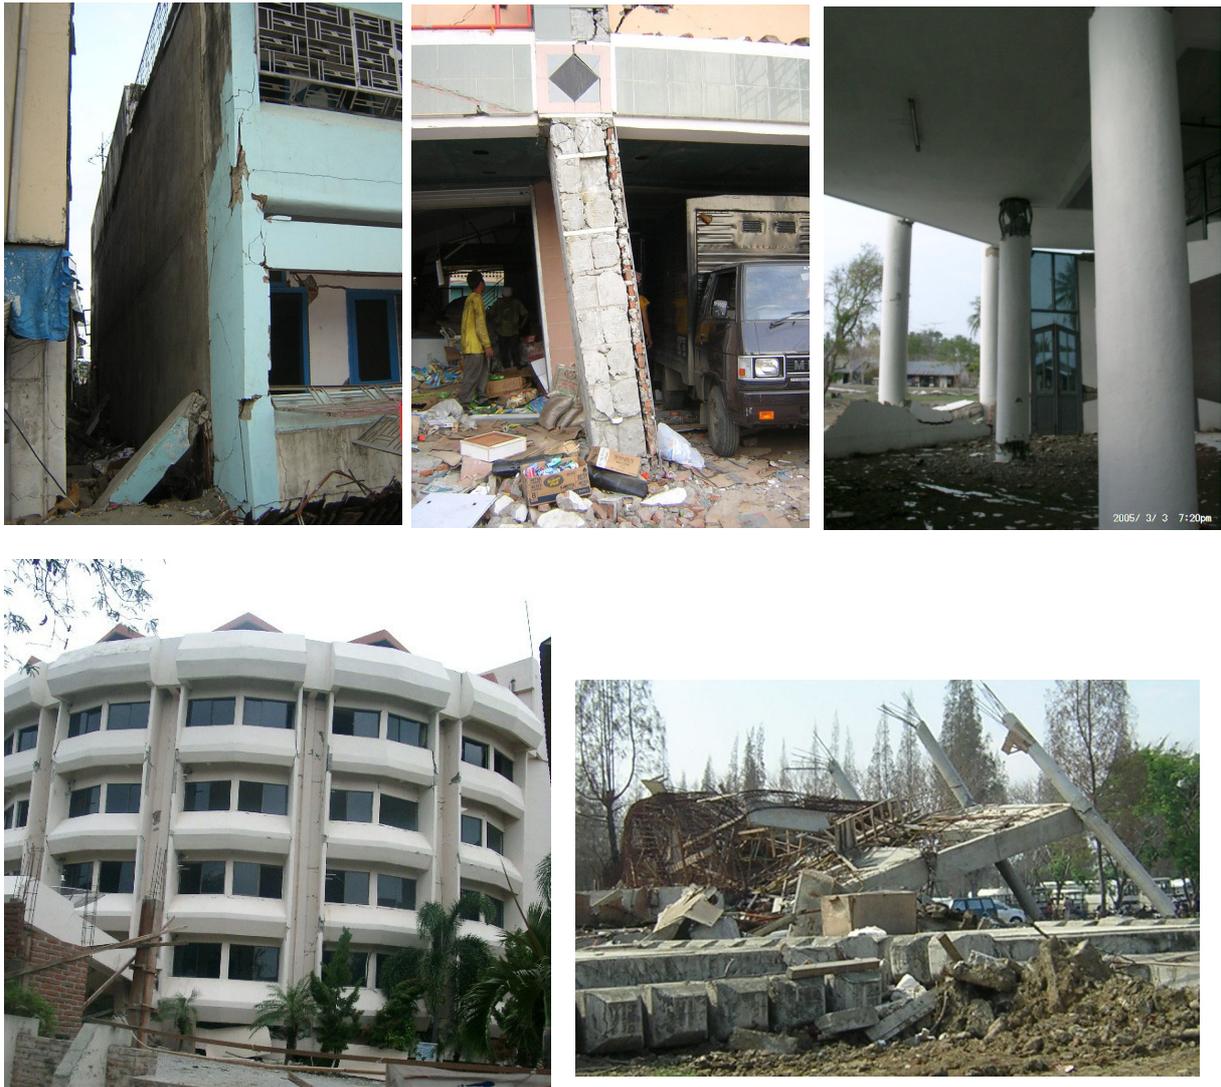
Photo 6.3 Collapsed reinforced buildings in Banda Aceh

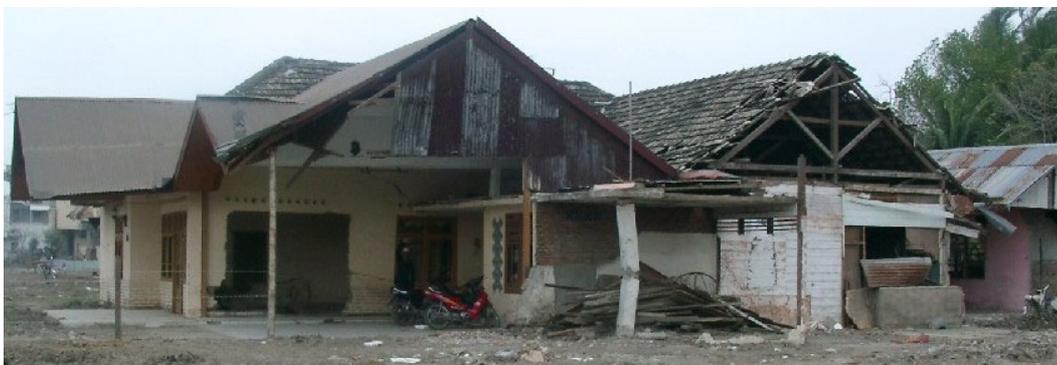
Masonry (brick) houses are generally single story buildings and some of them could be 2 story buildings. Solid red clay bricks or hollow concrete blocks were used for constructing the adobe houses. Although concrete column and slabs are utilized during the construction, they are merely used for achieving structural integrity. These buildings were not damaged in non-tsunami affected area. However, they were completely destroyed when the tsunami waves hit these structures. It seems that the impact force of the tsunami waves were quite high from the state of debris and the fallen tree trunks. The other force components of the tsunami waves could be drag forces and hydrostatic water loads. When the masonry (brick) houses are still standing, their walls were punched out. Photo 7.2 shows some example of damage to masonry (brick) houses.

Photo 7.2 Damage to masonry (brick) buildings

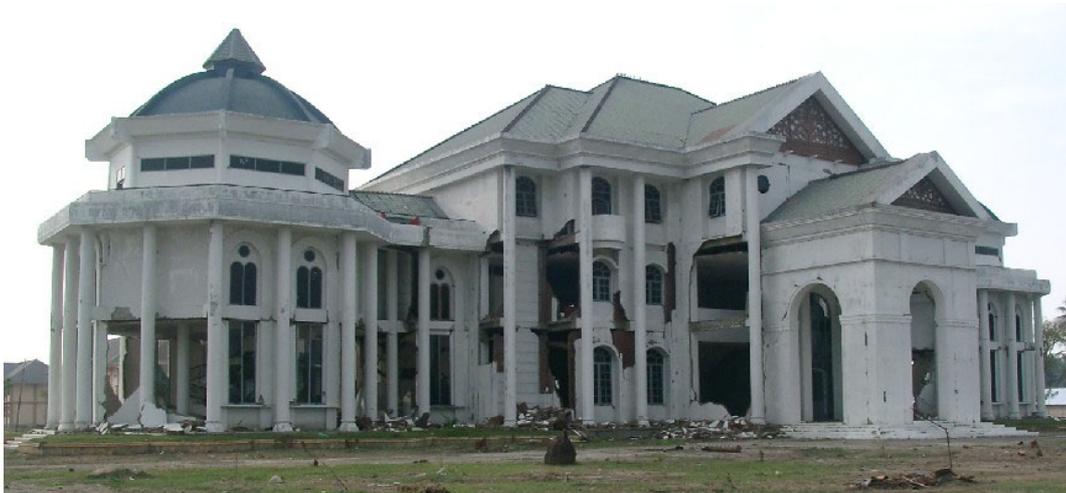
Most of RC buildings have 2 to 3 stories. Nevertheless, new buildings for governmental offices and shopping malls have more than 3 stories. Commonly their story number is 5. The common construction procedure for RC buildings is to construct the walls first and then cast the concrete columns and finally the slab concrete for a typical story and repeat the same procedure for the rest of stories. However, the new buildings are constructed as a frame structure by casting concrete columns and then slab concrete first and finally filling the space with solid brick in-fill walls. The floor height ranges between 3 and 4m. There was no structural damage to RC buildings having stories 3 or less than that in non-tsunami affected area. However, almost all new buildings having heavy weight on upper stories collapsed or heavily damaged in non-tsunami affected area (Photo 7.3). The collapses were mainly due to plastic hinging at column-beam connections due to the lack of required column size and stir-ups, hooking and confinement. Furthermore, the quality of concrete and workmanship were quite poor and the diameter of reinforcement bars was insufficient. The in-fill walls were too slender and they were easily separated from the concrete frame and came down by out-of plane failure mode. Besides the structural and constructional problems of RC buildings, the soft ground conditions may also play some roles on the collapses or heavy damage. The collapsed or heavily damaged RC buildings were constructed nearby rivers or swampy areas.

Photo 7.3(a) Collapsed or heavily damaged RC buildings

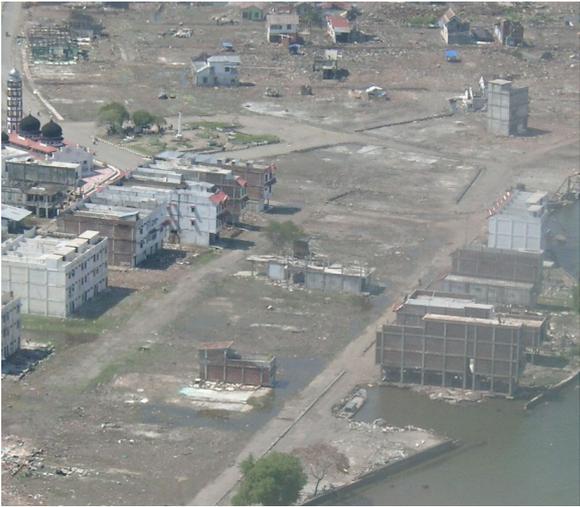
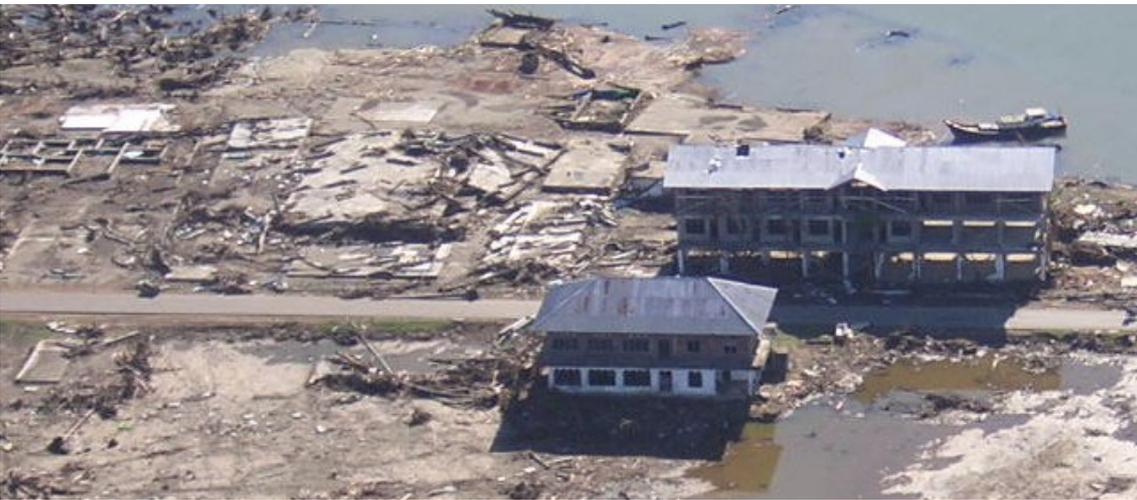
The RC structures in tsunami-affected areas have stories ranging between 2 and 3. Some of columns were broken and in-fill walls were punched out by the impact forces of tsunami waves and tsunami-dragged objects (Photo 7.4). Nevertheless, some of them survived against the ground shaking and also the forces resulting from tsunami waves. The columns were generally ruptured or fractured at their mid-height, which implies that there were subjected to high bending forces. Furthermore, the broken columns and punched-out walls were facing the direction of the in-coming tsunami waves.

Photo 7.4 Damage to RC buildings in tsunami-affected area

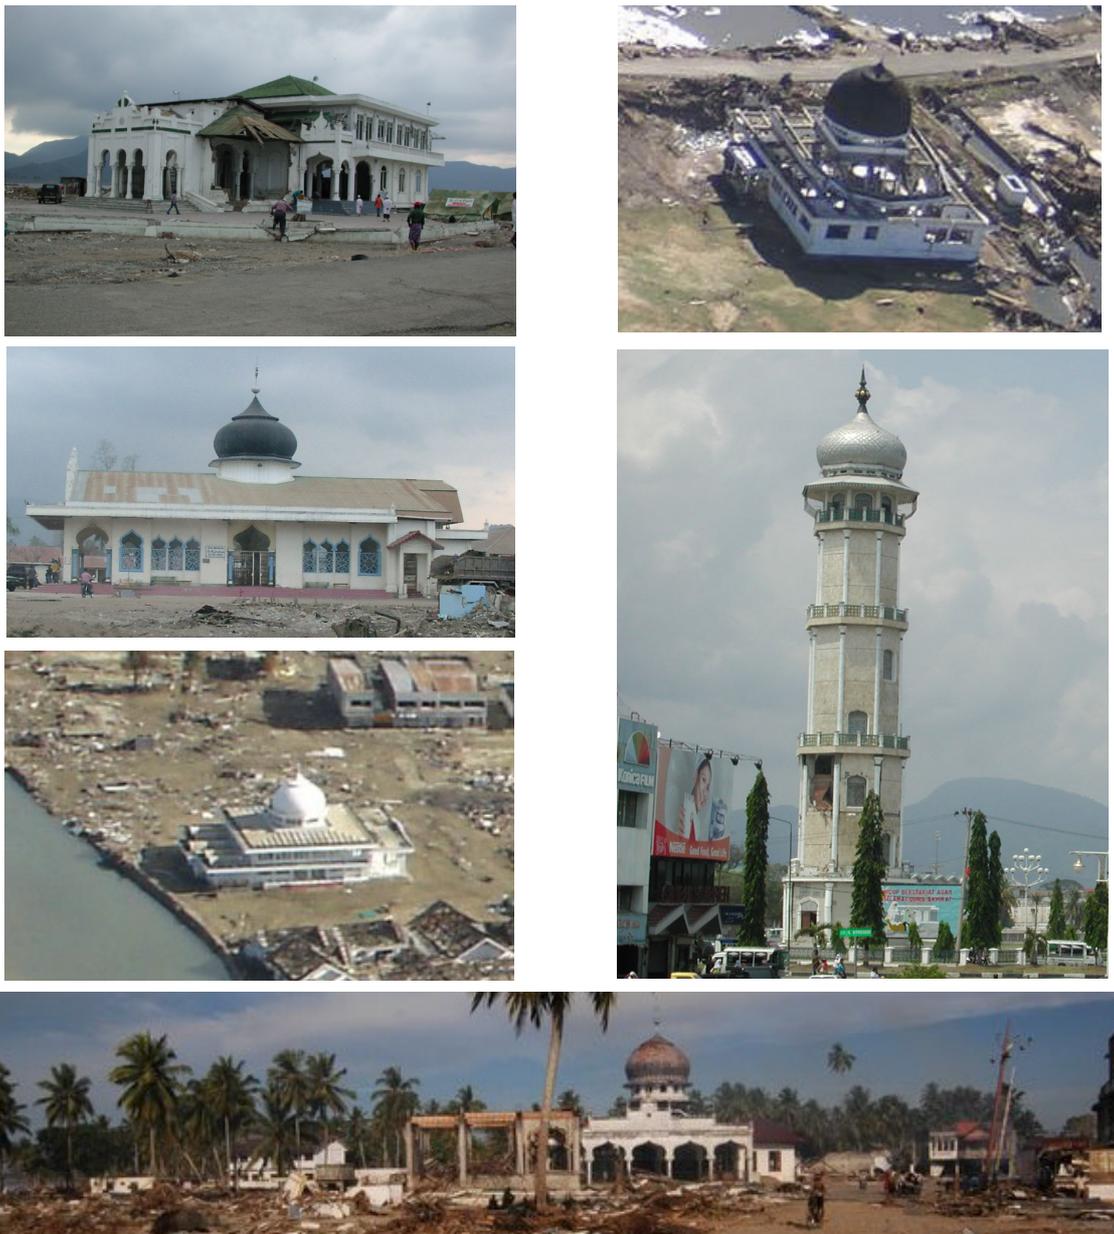
Mosques are generally built as single story RC structures. Due to tropical climate of the area, there are almost no in-fill walls. Most of the Mosques survived against the ground shaking and tsunami waves even in the severely hit areas (Photo 7.5). The possible reason for such a good performance against tsunami may be associated with its columnar structure without in-fill walls. One of the few mosques damaged in this earthquake is in Ulehle district. The central RC column of the wall facing the sea was fractured by bending at mid-height. Many mosques built as masjid having no minarets. The grand mosques in Banda Aceh and Meulaboh have only minarets. Their minarets were lightly damaged.

Photo 7.5 Damage to mosques and minarets

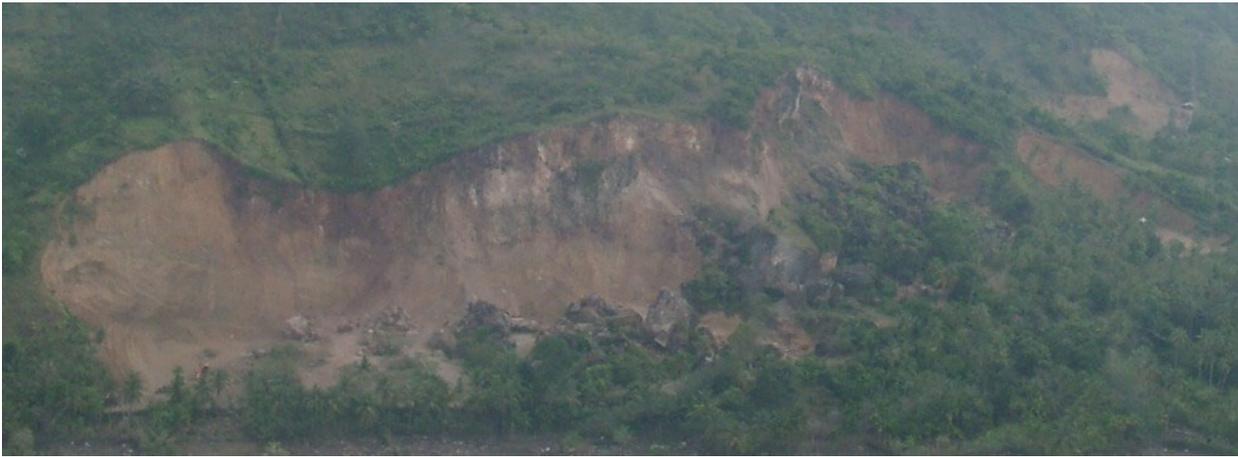
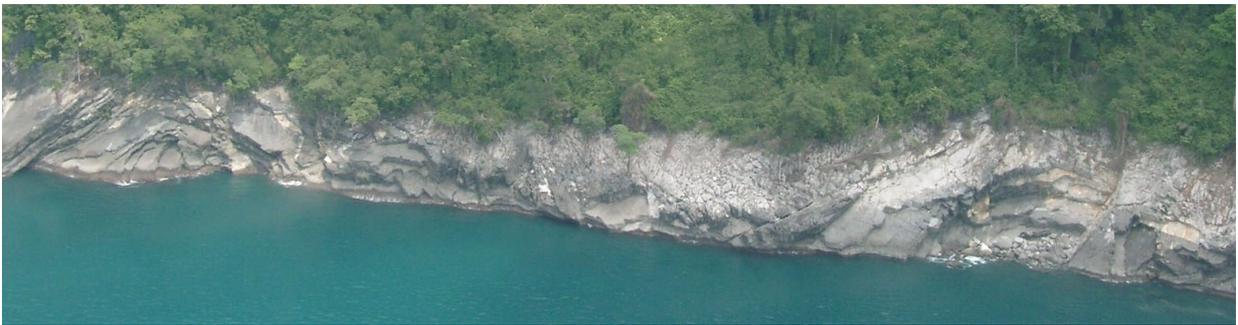
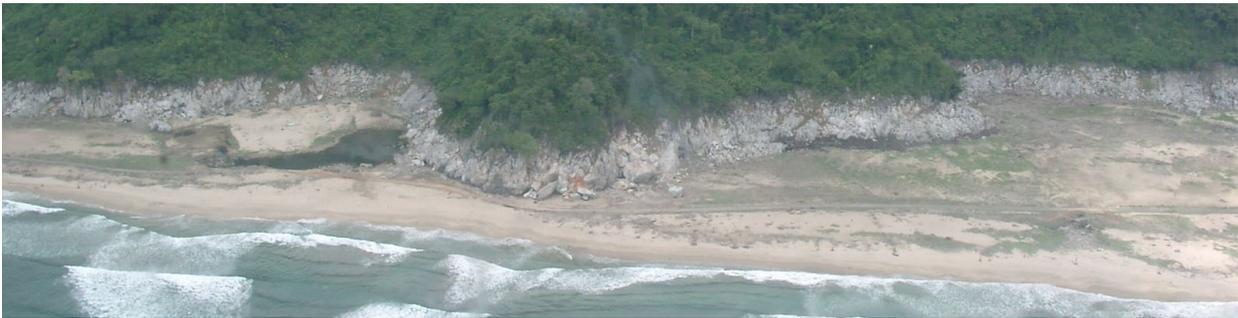
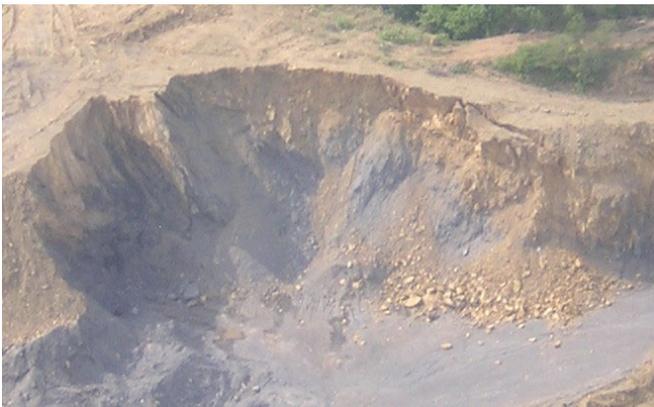
Slope failures were mainly observed in the areas of stone quarries, along roadways and seashores. The seashore between Banda Aceh and Lamno is particularly mountainous and slopes are steeply inclined. Furthermore, the rock layers are folded and are inclined towards the sea. The failure of rock slopes was mainly due to sliding on bedding planes of hard sedimentary rocks and the slopes facing the causative fault plane (Photo 8.1). It is therefore thought that the ground shaking was the main cause of rock slope failures. The weathered material on the rock slopes along the seashore was stripped away for a height of 10-20m by the tsunami waves as seen in Photo 8.2. Rock falls were observed in stone quarries in Lhonga area nearby the cement factory.

Photo 8.1 Rock slope failures and erosion by tsunami

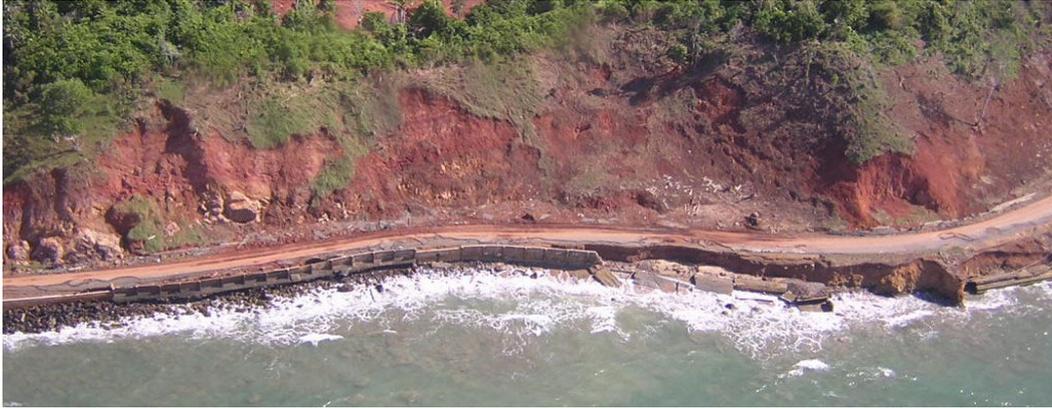
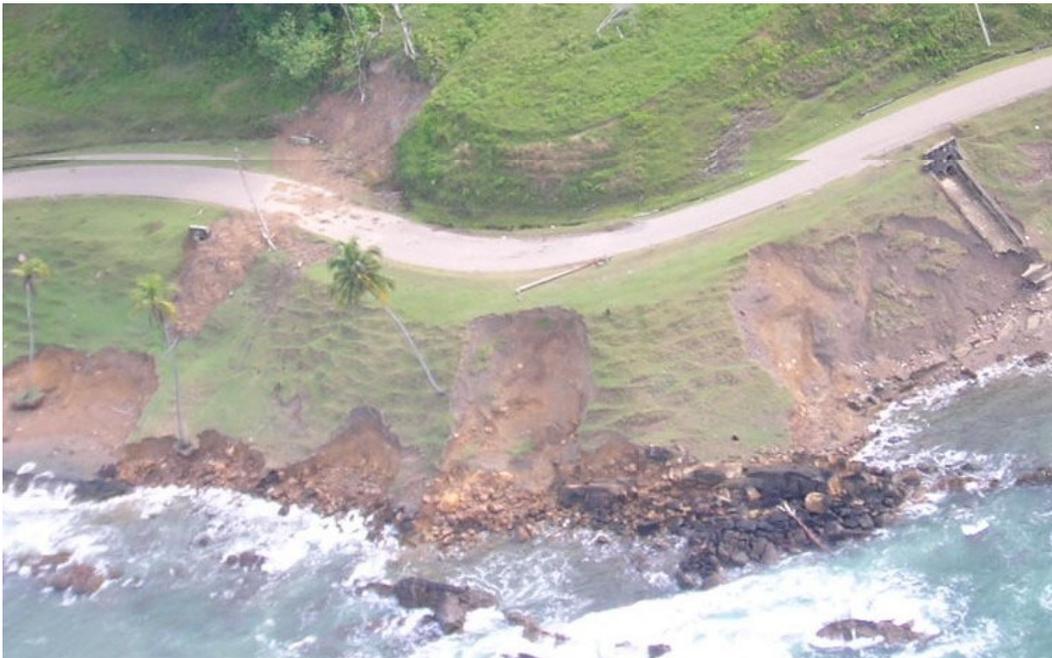
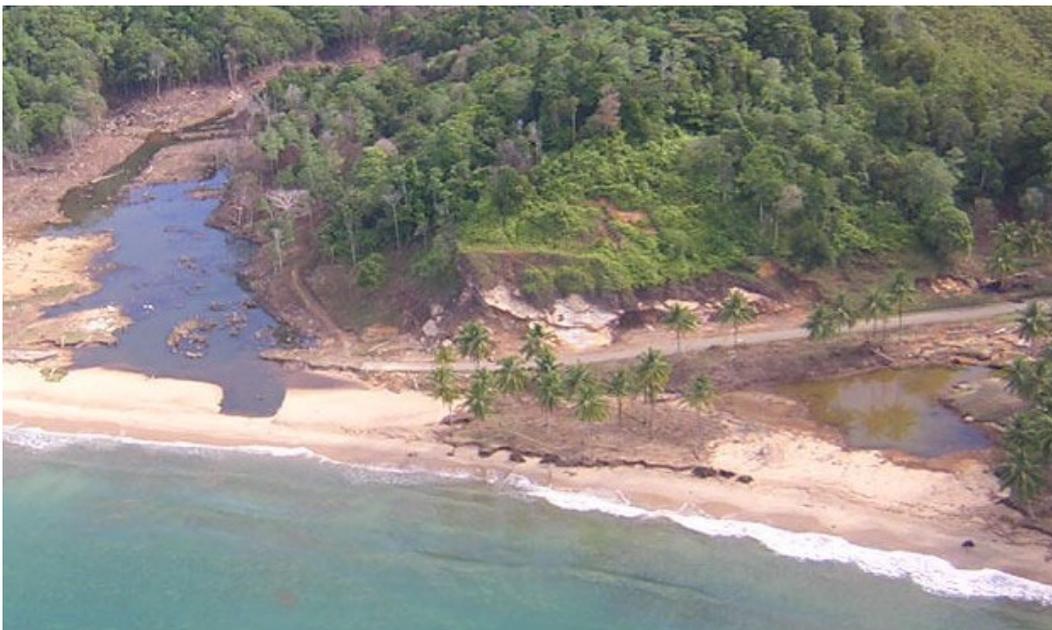
Slopes involving residual soils or highly weathered volcanic rocks were failed in the form of circular sliding. Such failures are observed on slopes on headlands as seen in Photo 8. 2.

Photo 8.2 Soil slope failures and erosion by tsunami

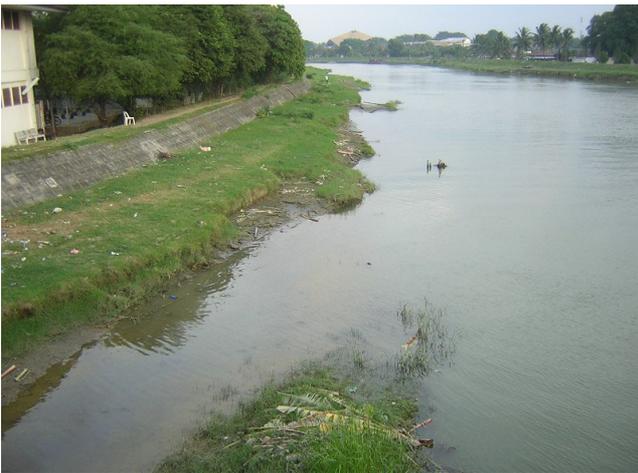
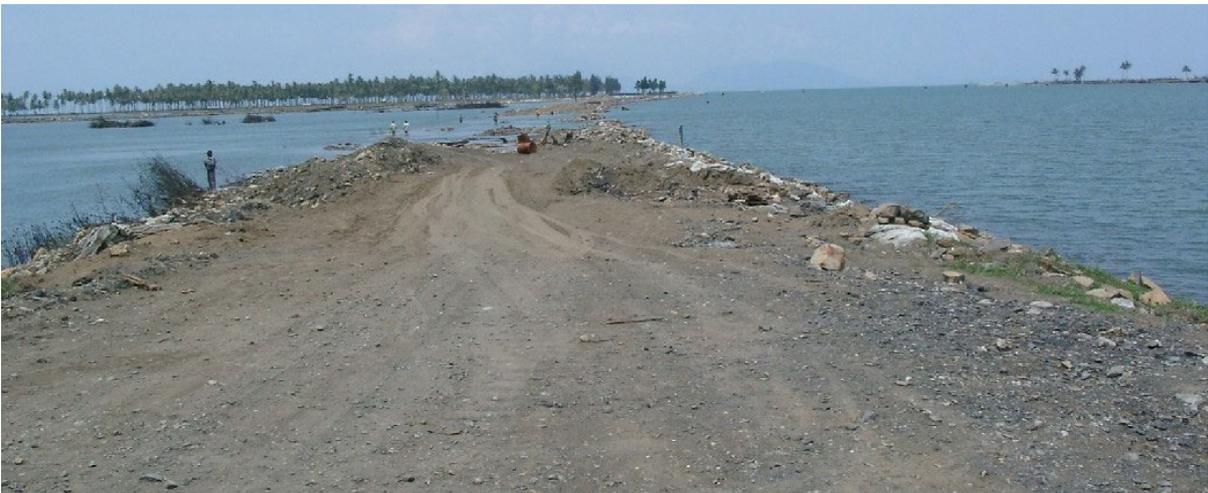
Embankment failures were observed along seashores, rivers and canals and roadways. Some of failures were in the form of typical circular sliding, erosion and liquefaction associated lateral spreading. Photo 8.3 shows some examples of embankment failures.

Photo 8.3 Embankment failures

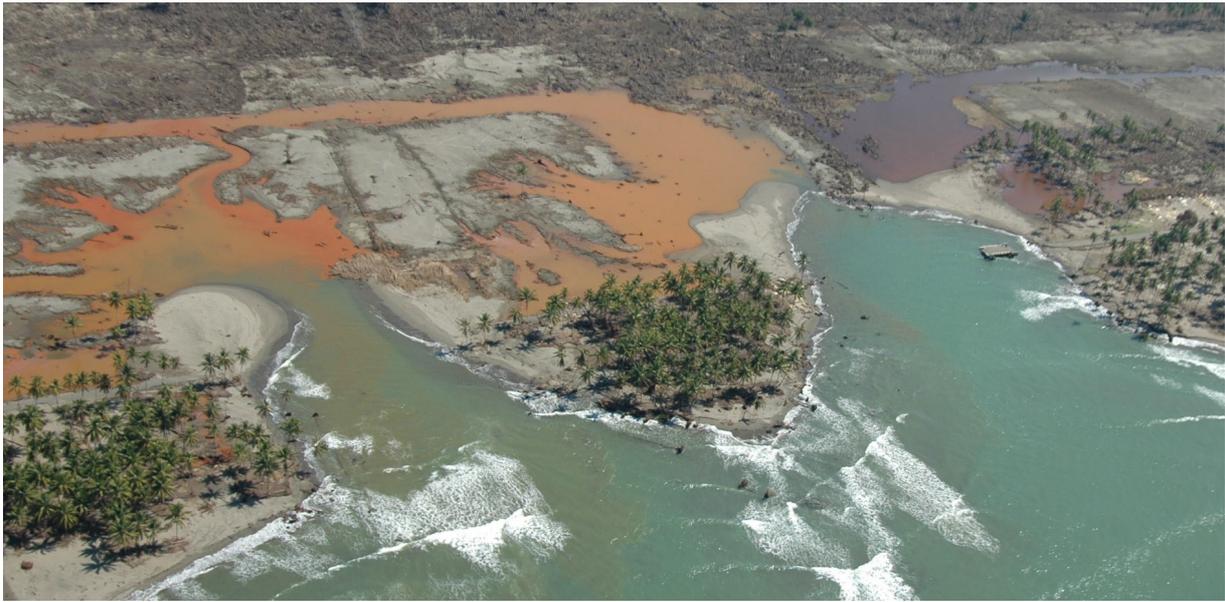
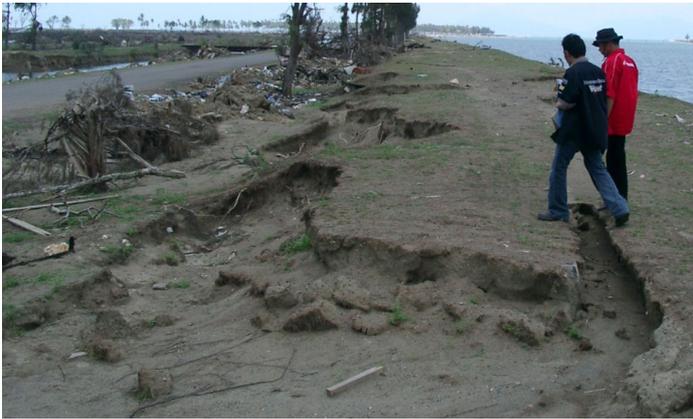
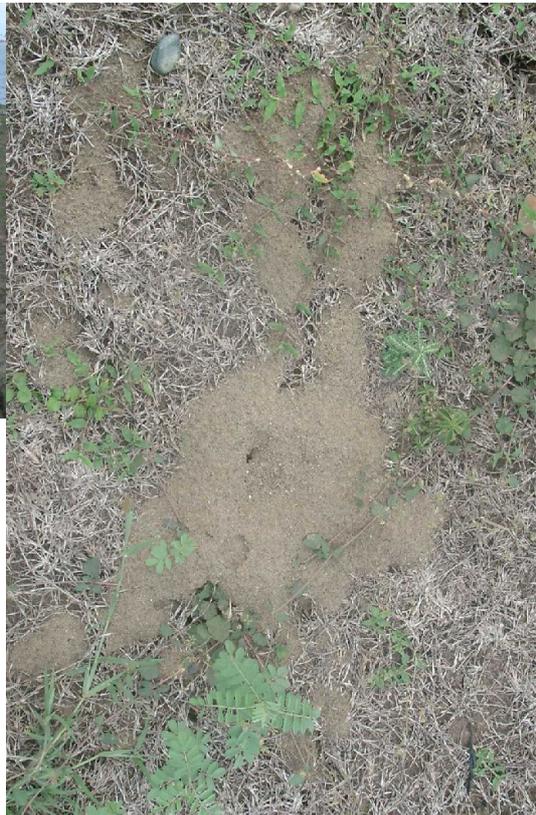
Ground along the western coast of Sumatra Island is mostly sandy soil. Liquefaction can be induced by ground shaking as well as by tsunami. The effects of liquefaction would be ground settlement, lateral spreading and erosion by retreating tsunami waves. The coastal area seems to be settled down and or topsoil is eroded. Photo 8.4 shows some examples of failures induced by liquefaction.

Photo 8.4 Effects of ground liquefaction and erosion

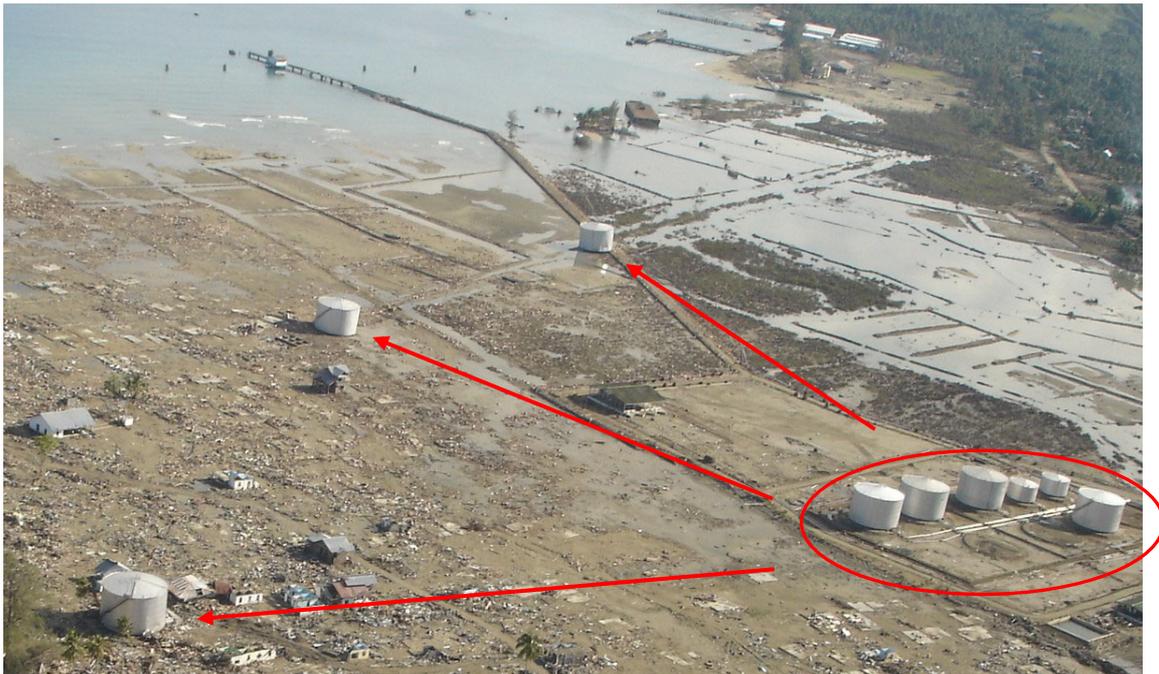
Storage tanks from an oil tank farm in the eastern part of Banda Aceh city (Krueng Raya, about 22km east of Banda Aceh) were displaced by the tsunami waves for a considerable distance from their original position as seen in Figure 9.2. The tanks were not fixed to the ground and some damage to piping did occur. Figure 9.3 shows a buckled tank along the seashore in Meulaboh. The tank was hit by tsunami waves and that side of the tank was buckled. Furthermore, some settlement of the tank occurred probably due to the liquefaction of foundation ground.

Photo 9.2 Displaced oil tanks by the tsunami

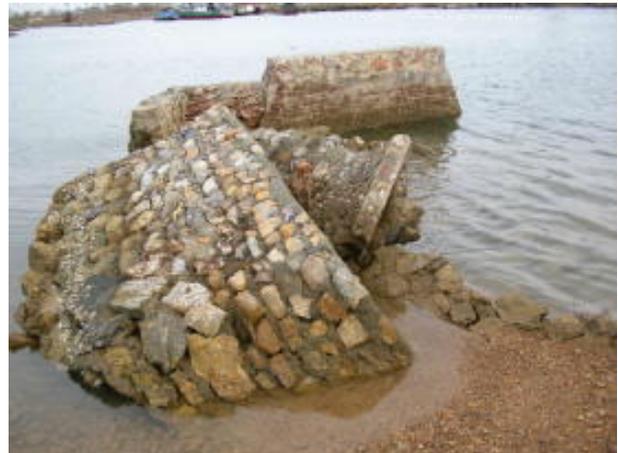
Photos 11.3 and 11.4 show another bridge where the superstructures were completely washed out. It was reported that the bridge had a relatively shallow superstructure made of wooden materials. Substructures were made of masonry materials connected with concrete.

Photo 11.4 Masonry Substructure and
Washout Effect of Surrounding Soils

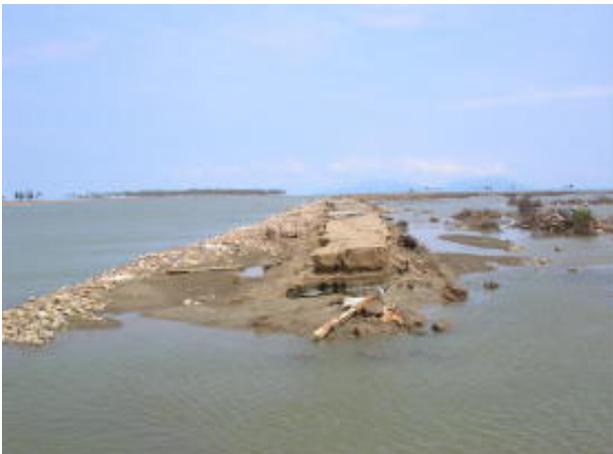
Photo 11.17 Washout of River Dike

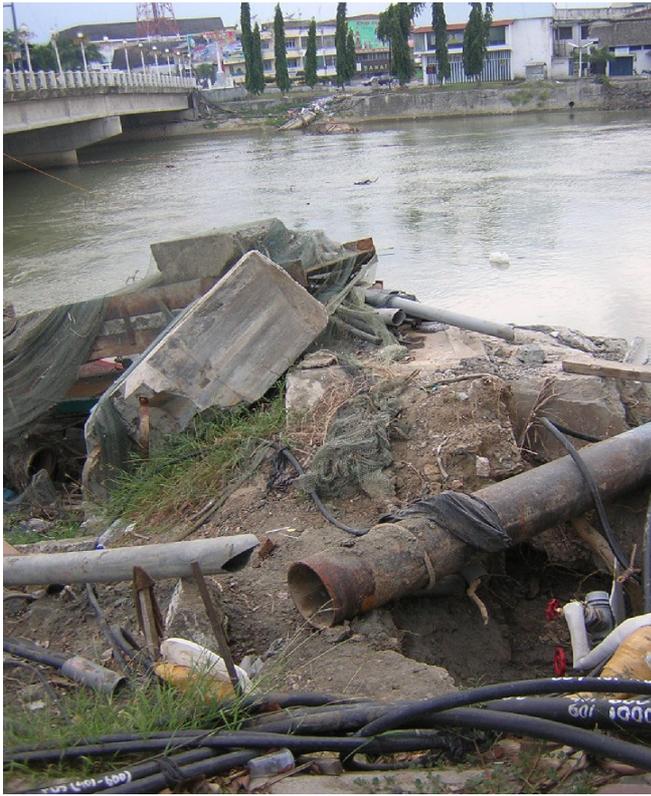
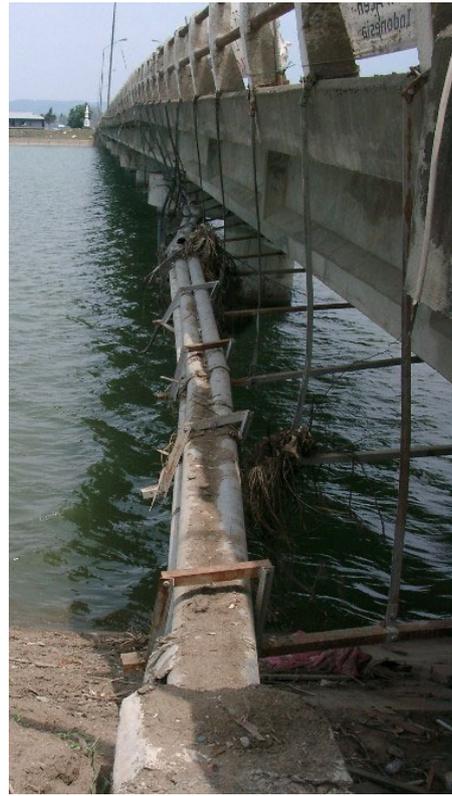
Photo 12.4 Broken water pipes nearby or attached to bridges

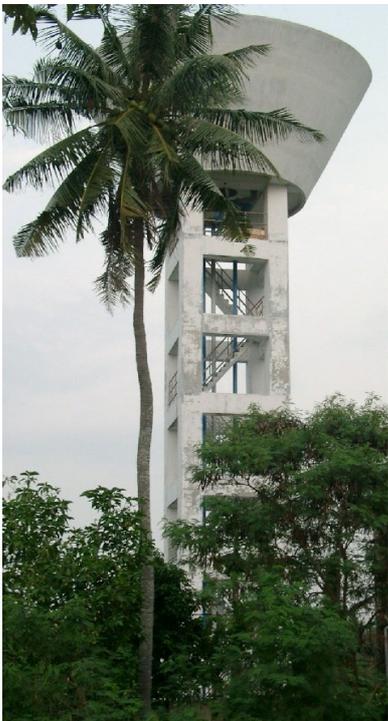
Photo 12.5 Slightly damaged elevated water tank 2

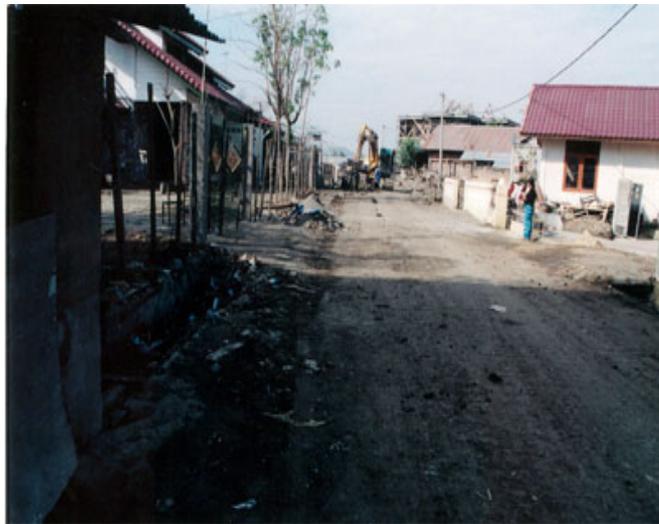
Photo 12.6 Drain ditches are clogged with mud and debris. Backhoe is operating for removal of deposit of the flood.

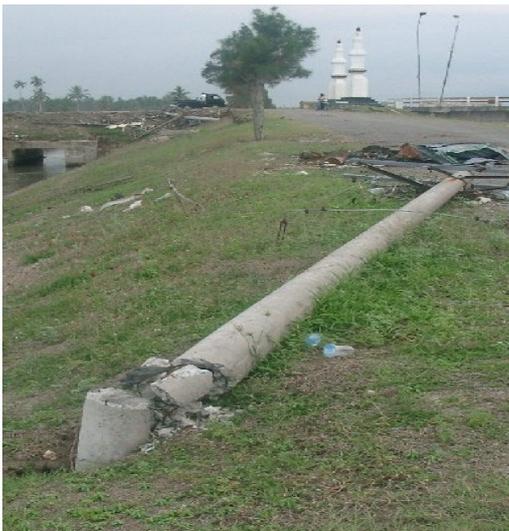
Photo 12.9 Broken electric distribution poles
