A RECONNAISSANCE REPORT
ON
2008 WENCHUAN EARTHQUAKE*

Japan Society of Civil Engineers
Earthquake Engineering Committee
Earthquake Disaster Investigation Sub-Committee

May 19, 2008

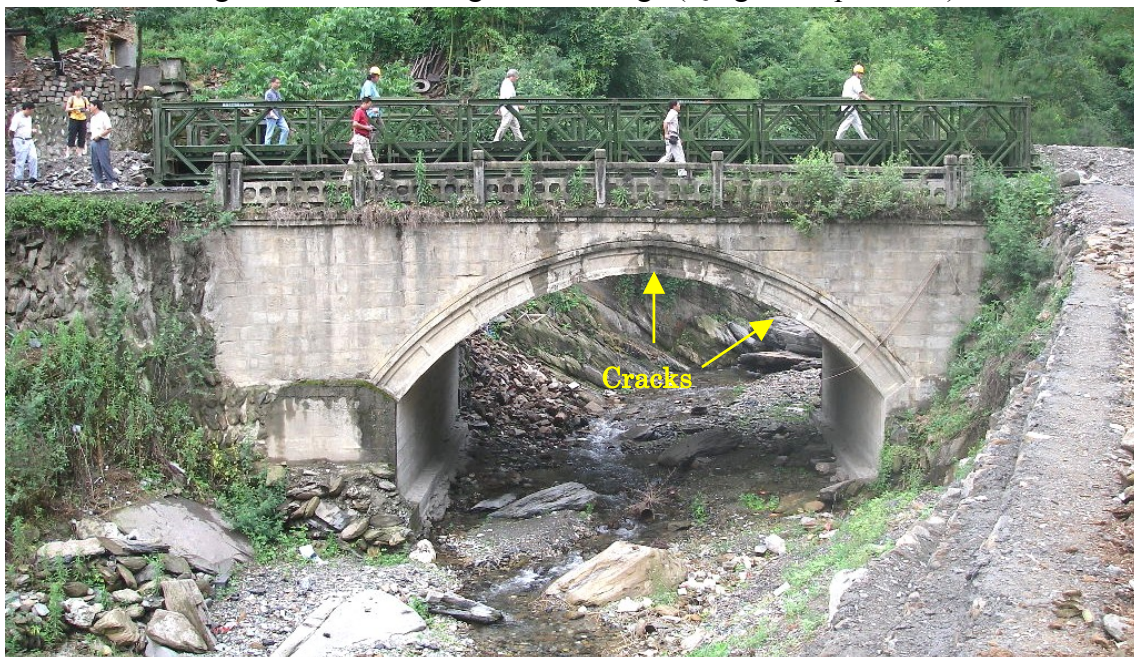
Figure 8.5. Slightly damaged reinforced concrete arch bridge (32.43049N,105.23746E)

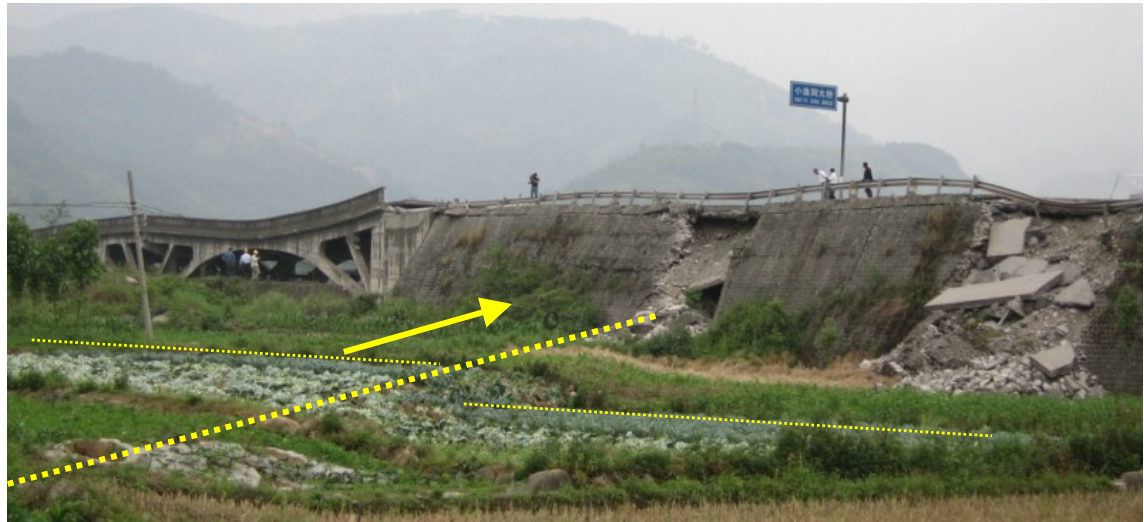
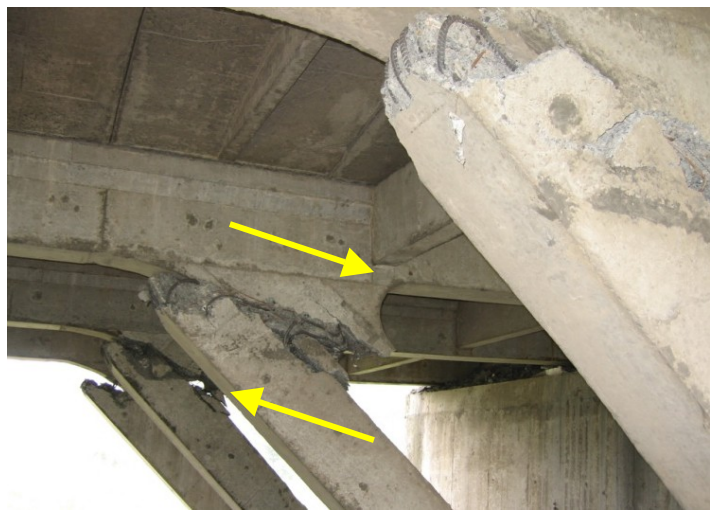
The heaviest damage occurred at the four span reinforced arch Hsiaoyudong bridge in Longmenshan town (Lin, 2008), from which the Longmenshan fault zone was named. The arch sections of the bridge were sheared as shown in Figure 8.6. Besides high ground motions in the vicinity of the bridge, the shearing of arched section in the longitudinal axis of the bridge implies permanent ground movements, which may result from thrust faulting and ground liquefaction beneath the riverbed.

Figure 8.6. Collapsed Hsiaoyudong bridge in Longmenshan town (pictures and figure from NRCEE, 2008)

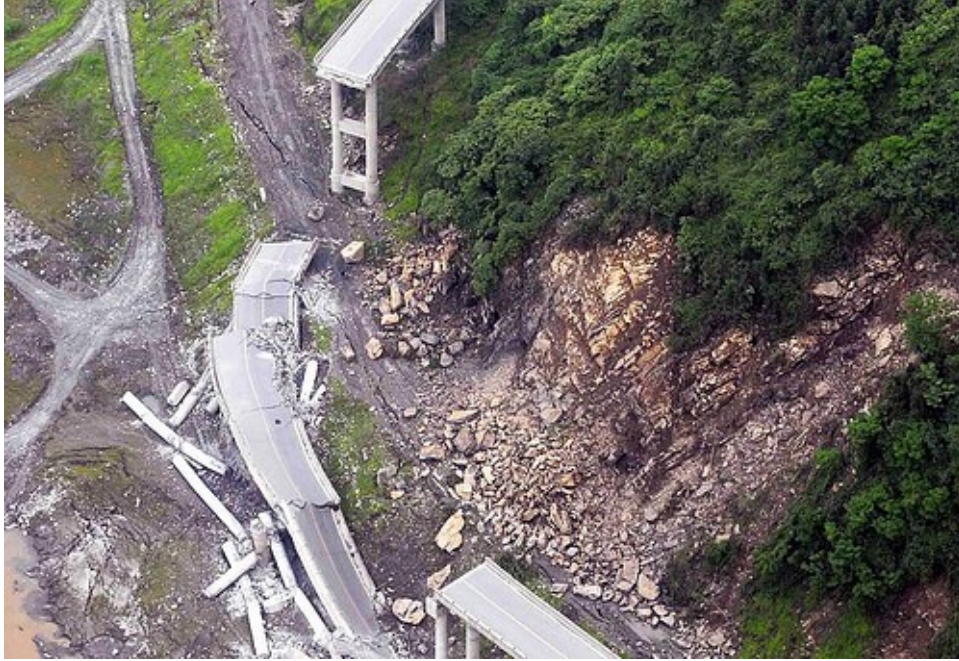
(a) Aerial view

One section of the highway named as Baihwa Bridge between Wenchuan and Dujiangyan, is a 500m long viaduct with a 30m height (Figure 8.7). The three-span convex part of the bridge collapsed during the earthquake. The girders were fallen towards the slope side while the columns were broken and fallen towards the river side. Although the authors did not visit this side yet, the impressions such that the permanent ground movements can be the key-factor besides the close proximity of the Baihwa bridge to the epicentral area.

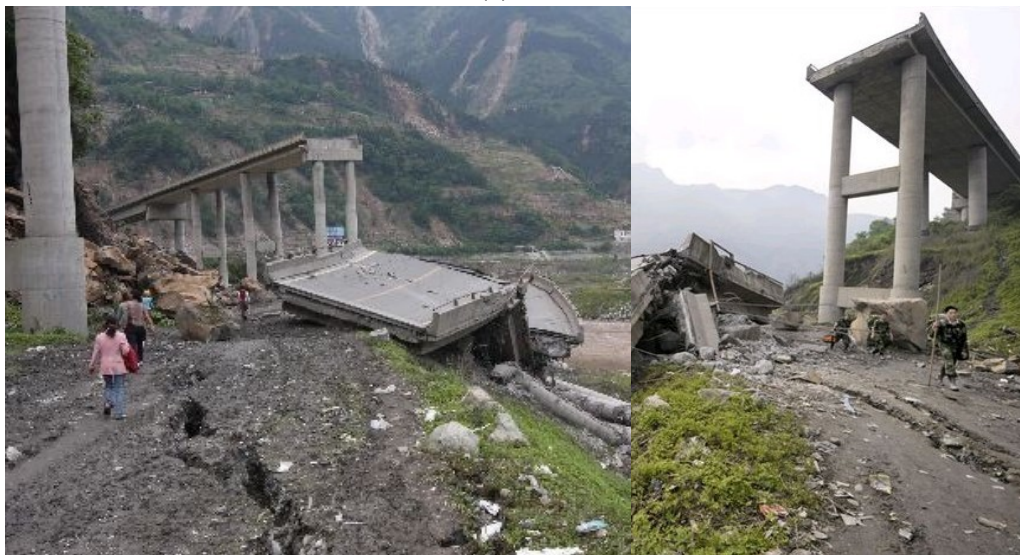
(b) views of the collapsed sections (note the ground ruptures in foreground)

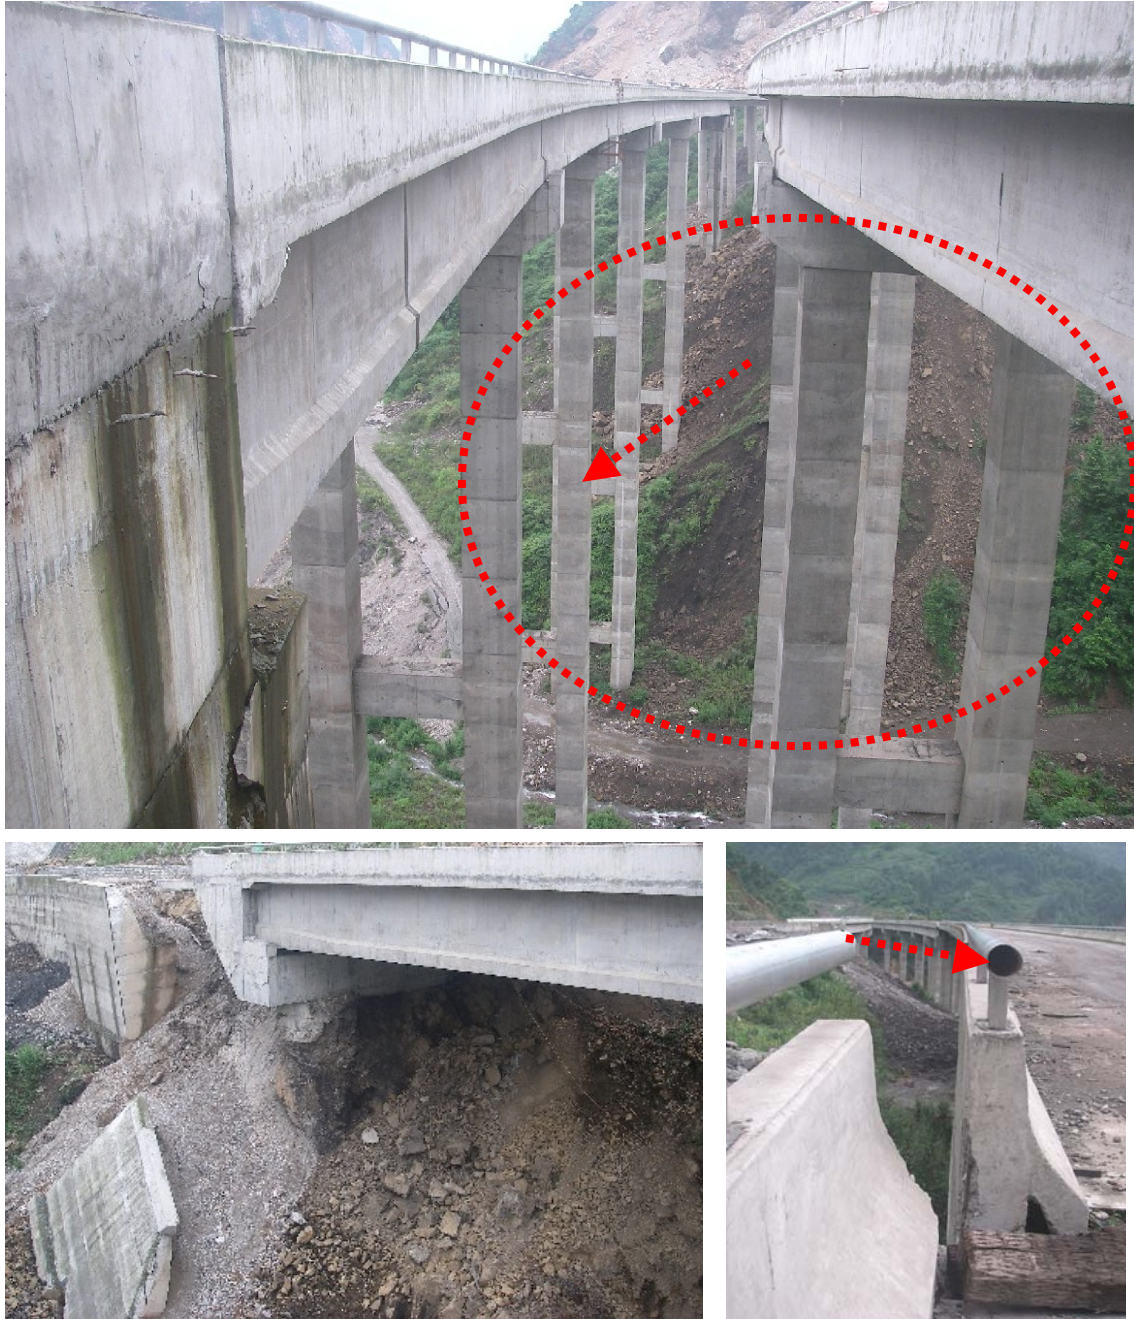
Another section (N31.04392,103.52891, 15.4km away from the epicenter) of Wenchuan-Dujianyang expressway nearby the Miaoziping bridge was also damaged by the permanent movement of foundation ground resulting from earthquake induced slope movements (Figure 8.10). The foundation ground consist of debris material consisting of sandstone and shale. In the west abutment, the debris material is a thick deposit. Furthermore, there were also toppling and planar sliding of steeply inclined intercalated sandstone and shale depending upon the orientation of slope.

Figure 8.10. Damage to viaducts due to permanent displacement of foundation ground

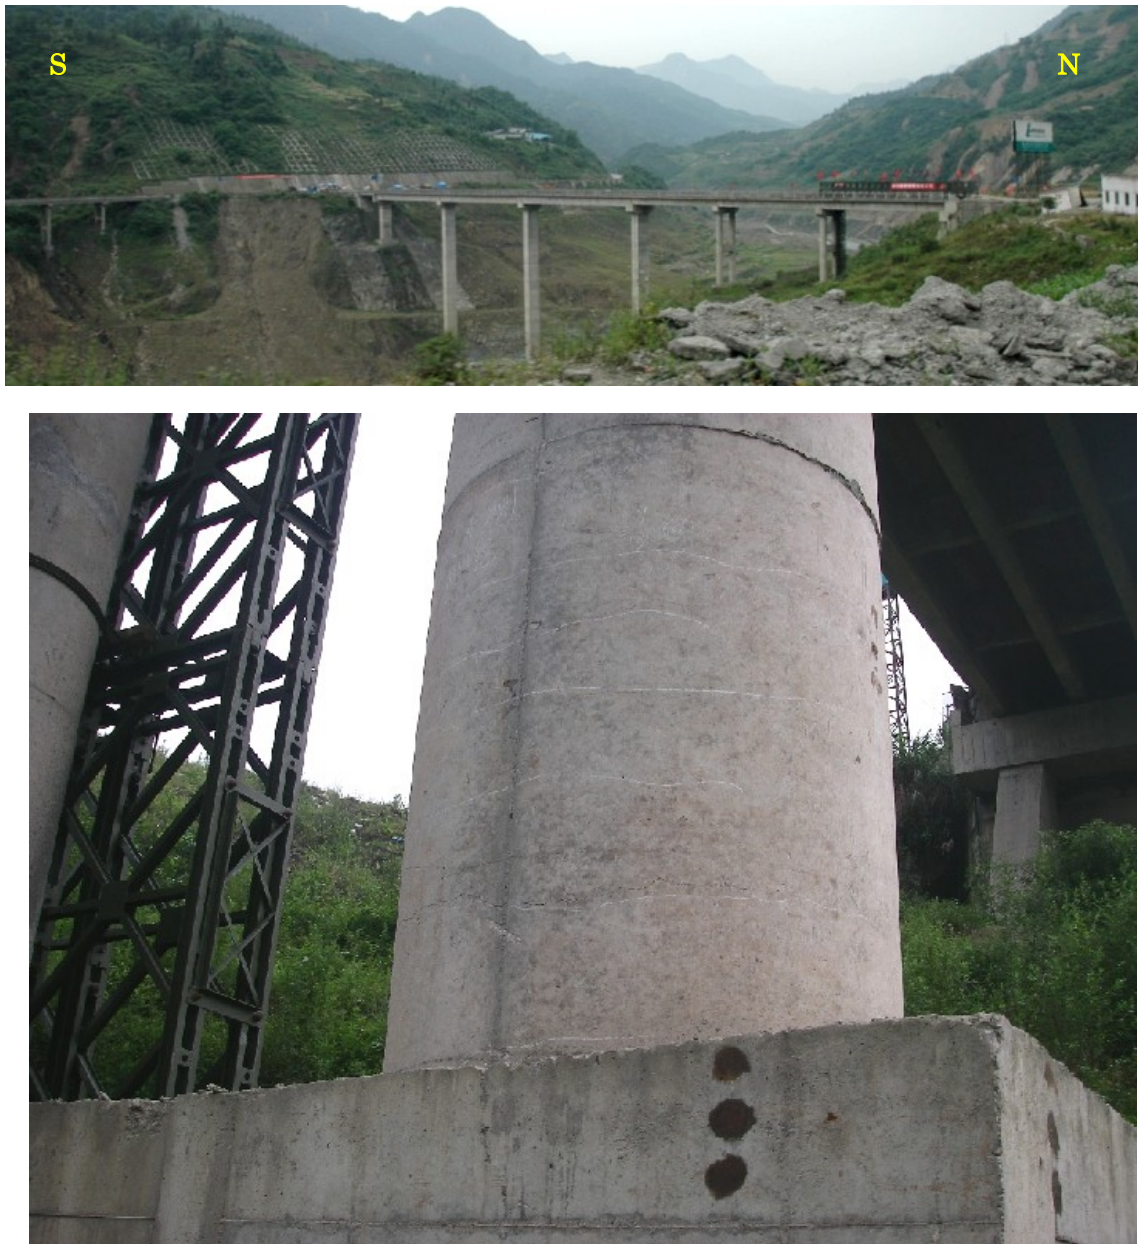
The girder of the north approach of the Shoujiang bridge, which is about 9.8km away from the earthquake epicenter, was partially shifted and rotated (Figure 8.11). The south of the side of girder was offset from its pedestal and supported by a temporary scaffold. The site inspection of cracks of piers indicated that the foundation ground has moved towards south. In other words it moved towards the river. As a result of that movement, the bending cracks appeared on the southern side of two piers on the northern abutment. Nevertheless, No cracks were observed at the rest of other piers.

Figure 8.11. A view of damaged Shoujiang Bridge

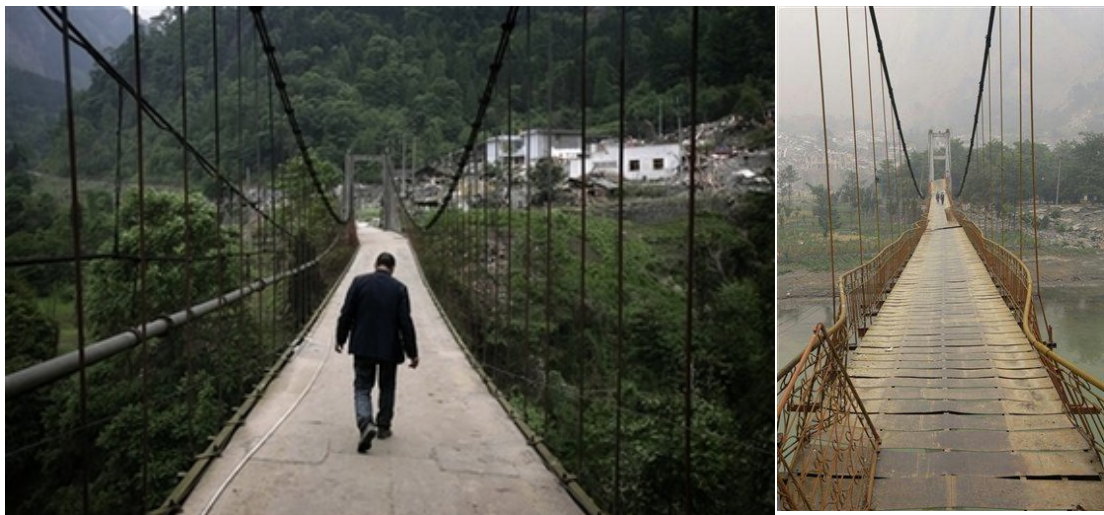
The forth bridge type is suspension bridges. There is a cable stayed bridge near Jiangyou on the expressway between Chengdu and Guanyuan. There was no visible damage to this bridge (Figure 8.12). However, There were some damage to suspension bridges for pedestrians due to the movement of anchorage blocks (Figure 8.13).

Figure 8.13. Damage to some pedestrian suspension bridges (from Xinhuanet)

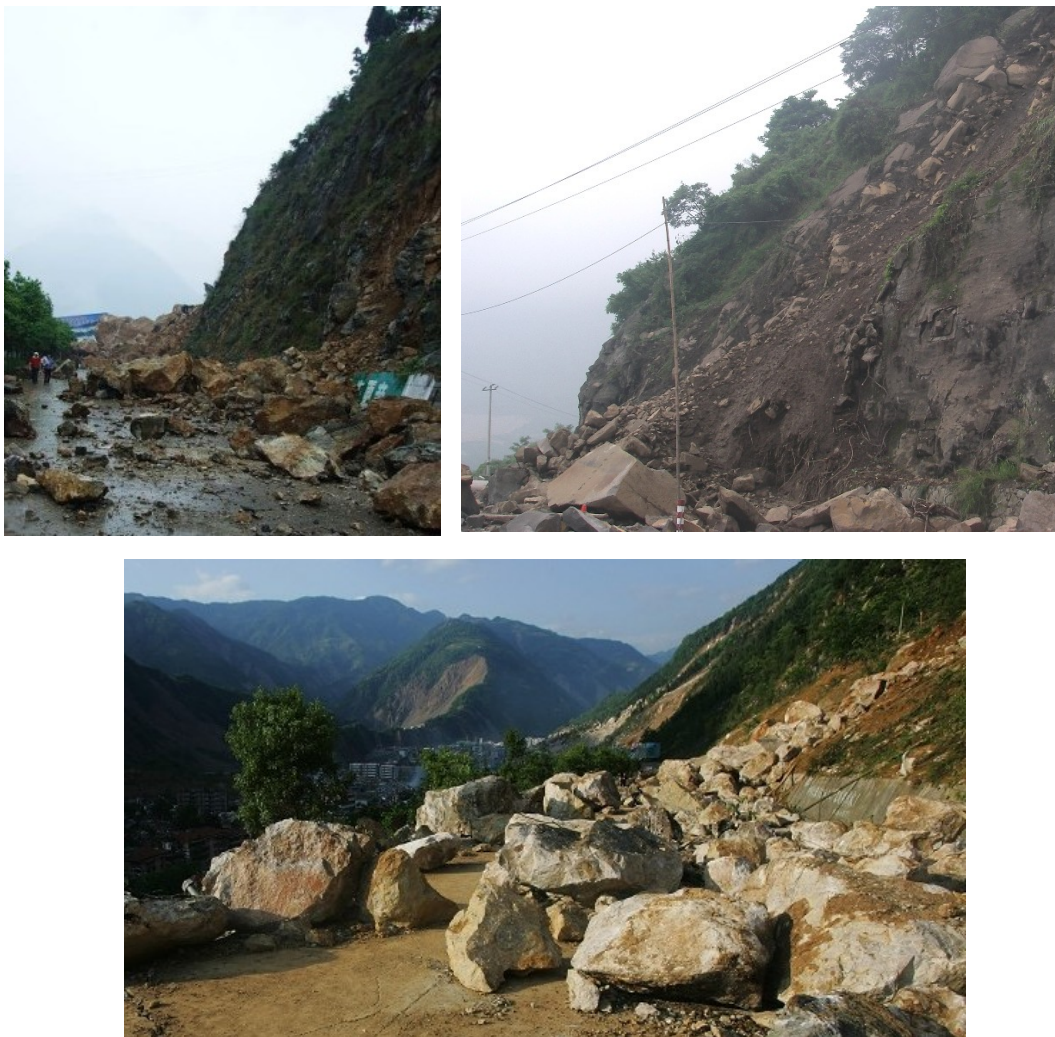
Damage to roadways was mainly caused by slope and embankment failures and rock falls (Figure 8.14, see Figure 7.1 for locations). In some places such as Yingxiu, Beichuan and Qingchuan, the damage to roadways and railways was caused by faulting (see Figure 5.3). The highways G213 and G317 were obstructed at numerous locations. The damage to the pavements of roadways by ground shaking could not be observed. The damage to Chengdu-Guangyuan expressway was observed in the section between Deyang and Mianzhu junctions due to the embankment failure. Nevertheless, the damage was limited and the expressway was open to traffic soon after the earthquake. One of the distinct characteristics of this earthquake is too many crushing of vehicles by the rockfalls, which probably deserves further detailed studies as a lesson of this earthquake.

Figure 8.14. The obstruction of roadways due to rock slope failures

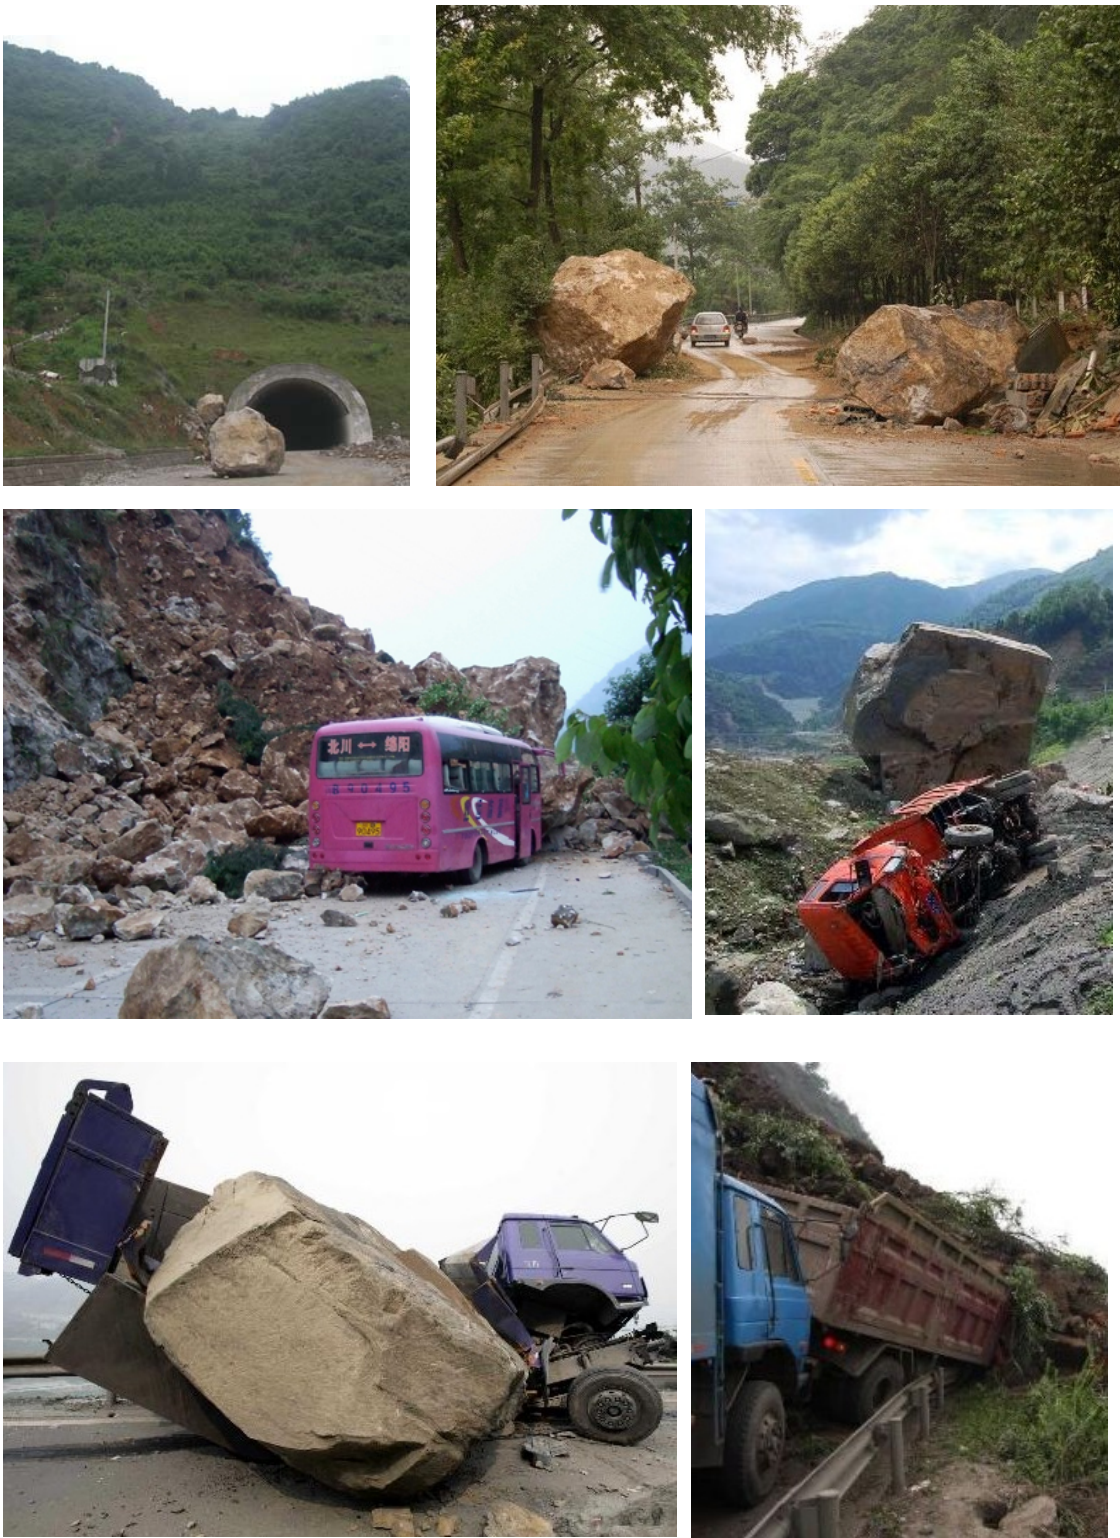
Figure 8.15. Rockfall induced damage and vehicles crushed by rockfalls (partly from Xinhuanet)

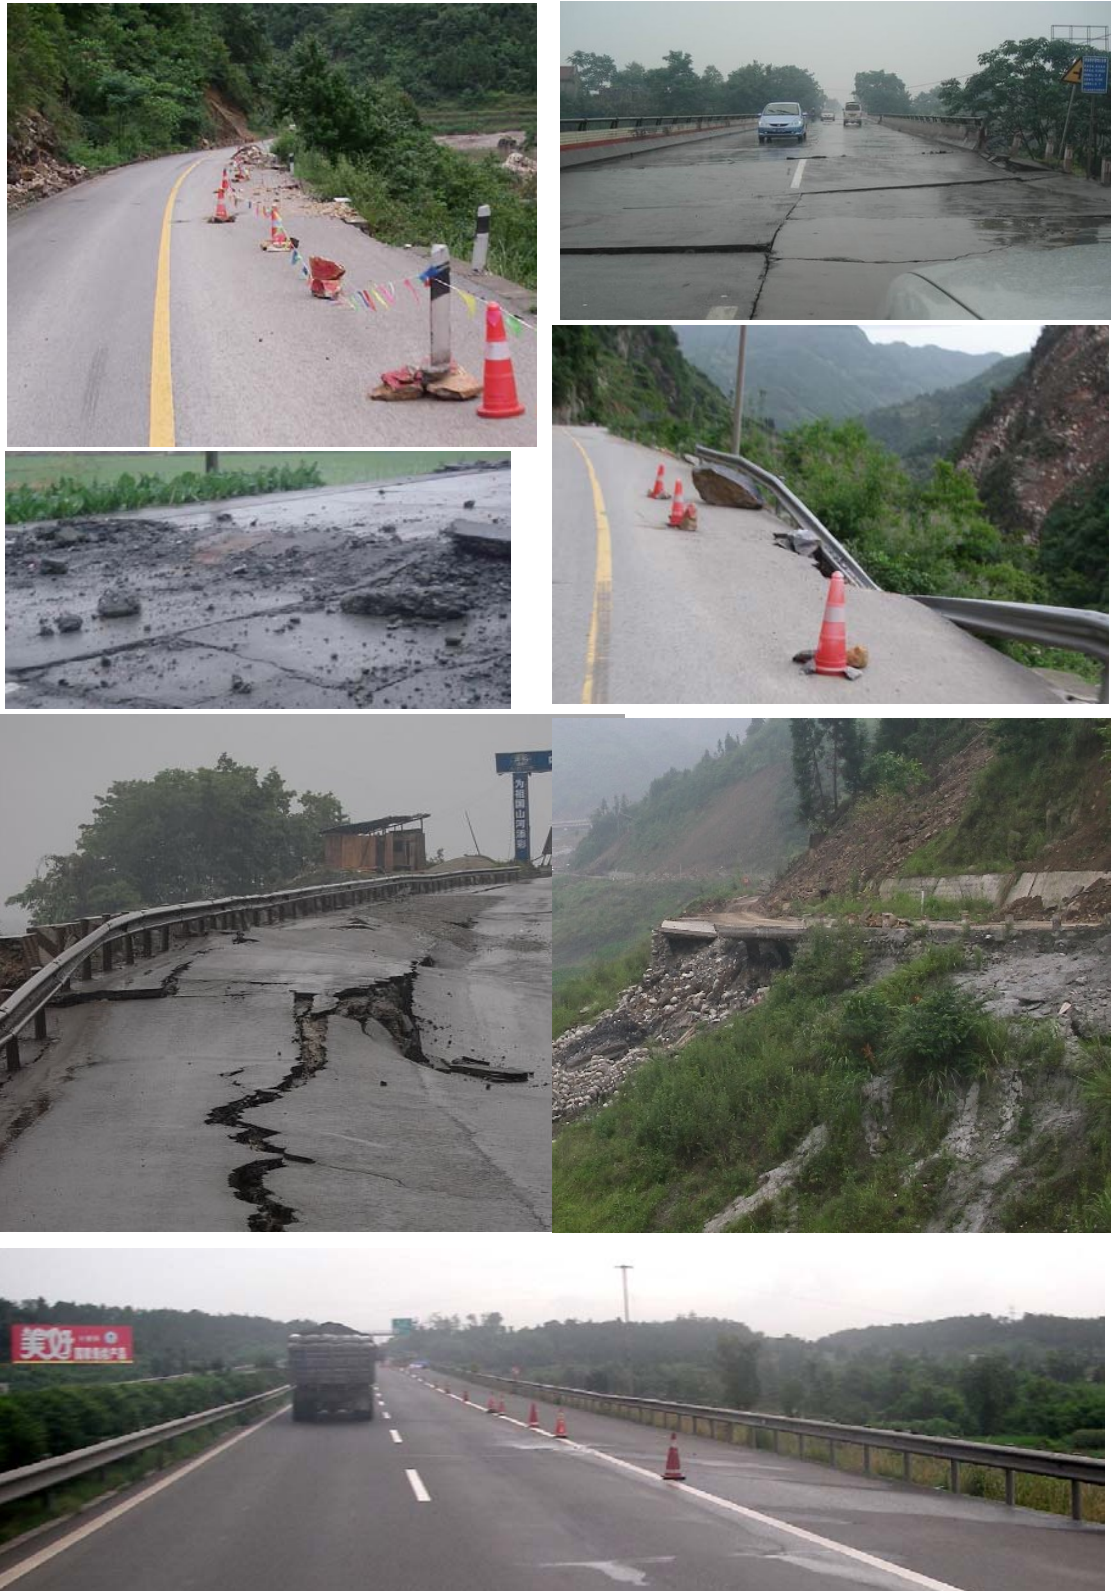
Figure 8.16. Views of damage to highways due to embankment failures (partly from Xinhuanet)

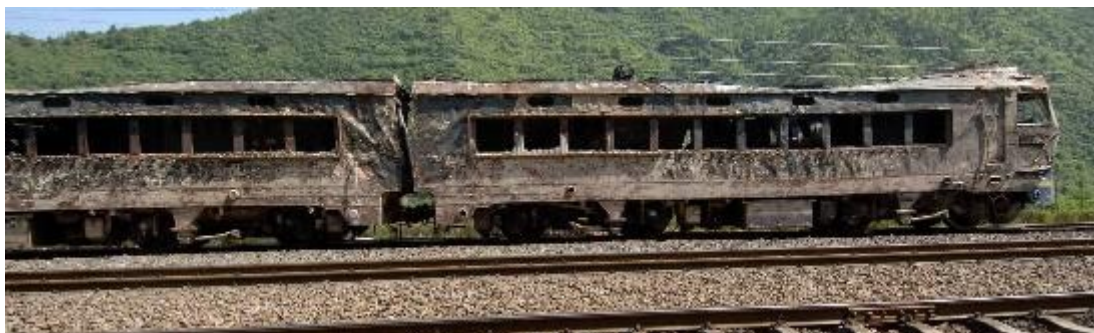
Figure 8.16. Views of damage to railways ,(from Xinhuanet)

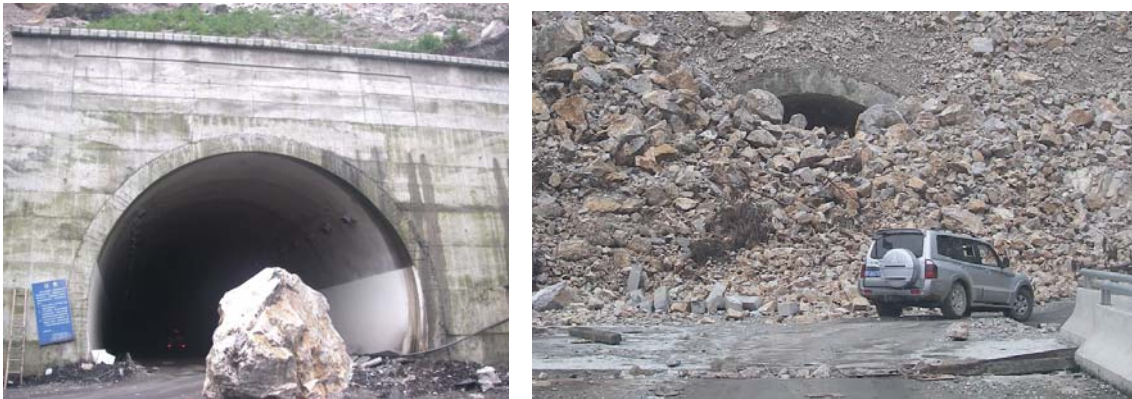
There are many roadway and railway tunnels. Some of them are under construction. It is well known that the underground structures are earthquake-resistant compared to surface structures when ground shaking is concerned. The damage to tunnels are generally limited to portals, which are mainly caused by slope failures and rockfalls. Several examples of portal damage are shown in Figure 8.17. Similar damage to portals of railway tunnels were also observed. Nevertheless, such damage are light in scale and did not cause any major structural stability problems so far.

Figure 8.17. Damage to tunnel portals

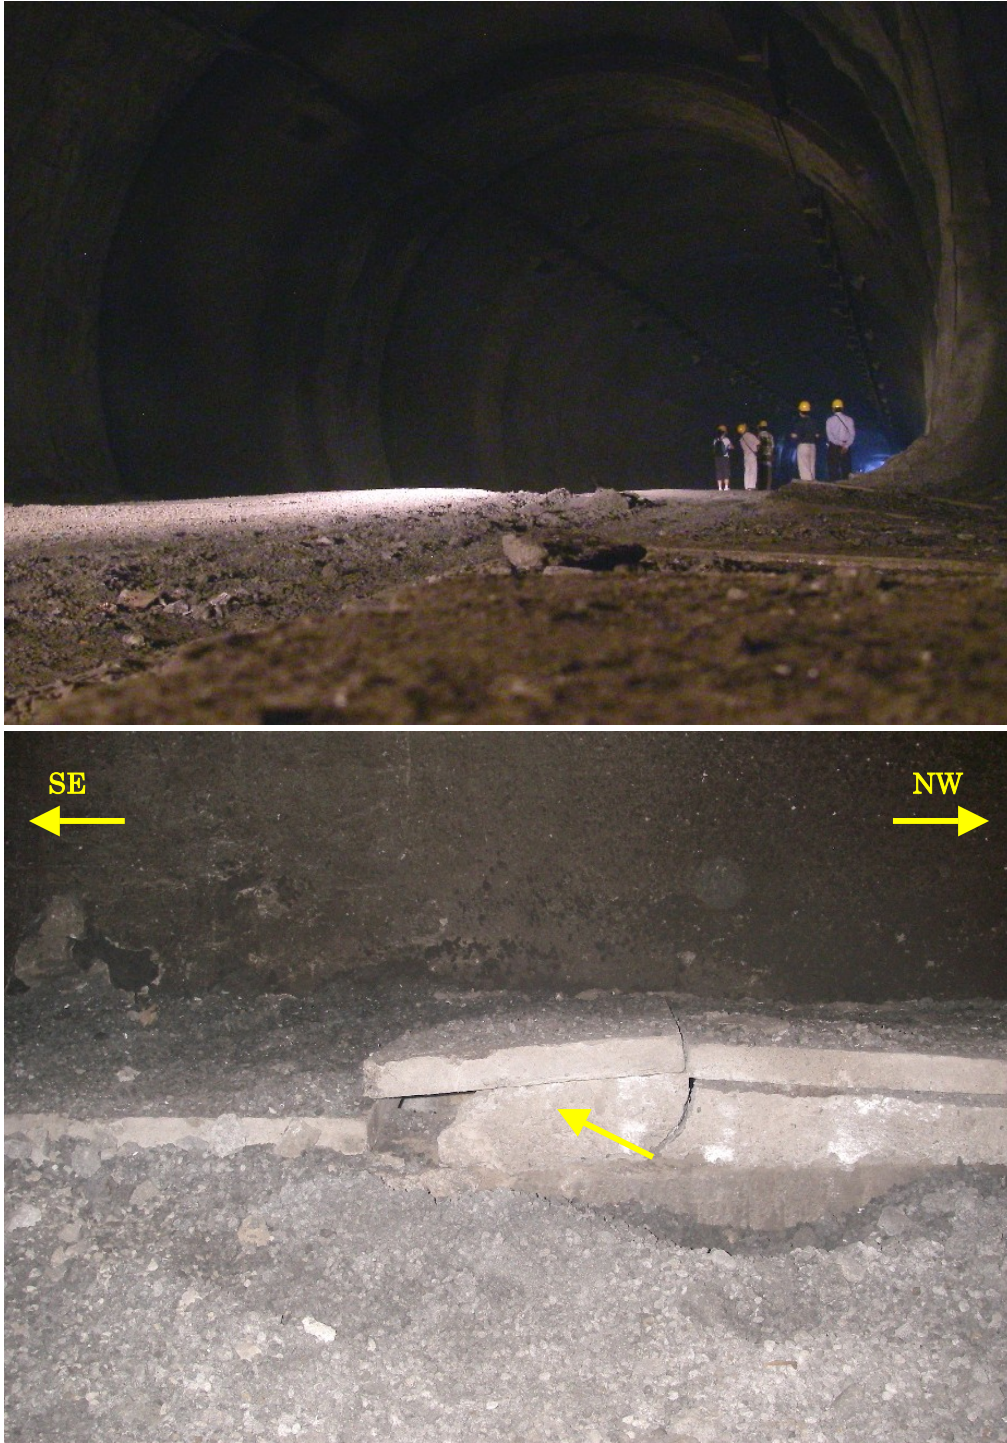
The authors had the chance to visit five tunnels, three of which were under construction and suffered heavy damage during the earthquake. The tunnel nearby Zipingpu dam (N31.04888,E103.56463) is a two lane tunnel with a length of about 1000m. The lining was damaged at several locations perpendicular to its longitudinal axis, which is aligned NW-SE direction. This tunnel was already repaired at the time of the investigation (June 21, 2008) (Figure 8.18). The tunnel is about 18.5km away from the earthquake epicenter and it is very close to the Yingxiu-Beichuan fault. The tunnel floor was stepped at the damaged zones implying the NW side is moved upward. Since this earthquake is of great scale and its relative slip was presumed to be about 7m, it is very natural to expect a diluted deformation zone as the fault approaches the ground surface due to the reduction of vertical stress. The damaged section of the tunnel rebolted and shotcreted.

Figure 8.18. Views of repaired damaged section of the tunnel nearby the Zipingpu dam

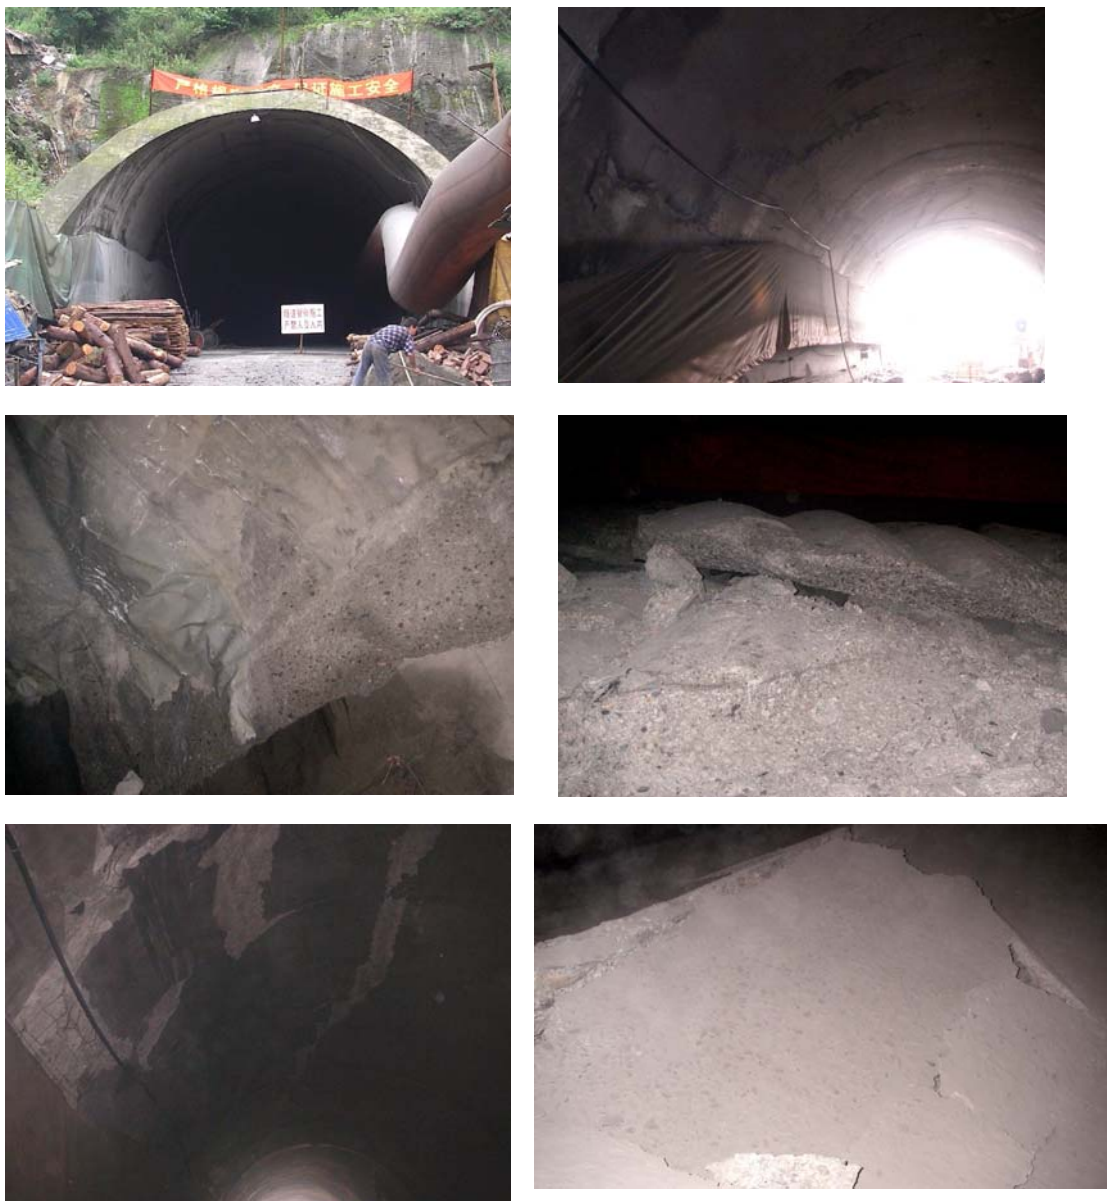
The tunnel was excavated using the rockbolts and shotcrete as an initial support and then the unreinforced concrete lining was constructed. The concrete lining was ruptured and the crown concrete was fallen down (Figure 8.19). However, the overall rupture

trace dips NW. The floor of the tunnel is also ruptured and uplifted by buckling. The tunnel collapsed at the location where the overburden is about 70m. The collapse may have created a sinkhole at the ground surface, which should be checked. The similar type of the collapse occurred at the Elmalik section of Bolu Tunnel during the 1999 Duzce-Bolu earthquake (Aydan et al. 2000). As the ground conditions at both tunnels remarkably similar to each other. The engineers still did not checked the zone beyond the collapsed section of the tunnel. The fundamental causes of the damage to this tunnel is probably the permanent ground deformations along the fault zones as well as high ground shaking.

Figure 8.19. Views of earthquake damage at Longxi (Longqi) Tunnel

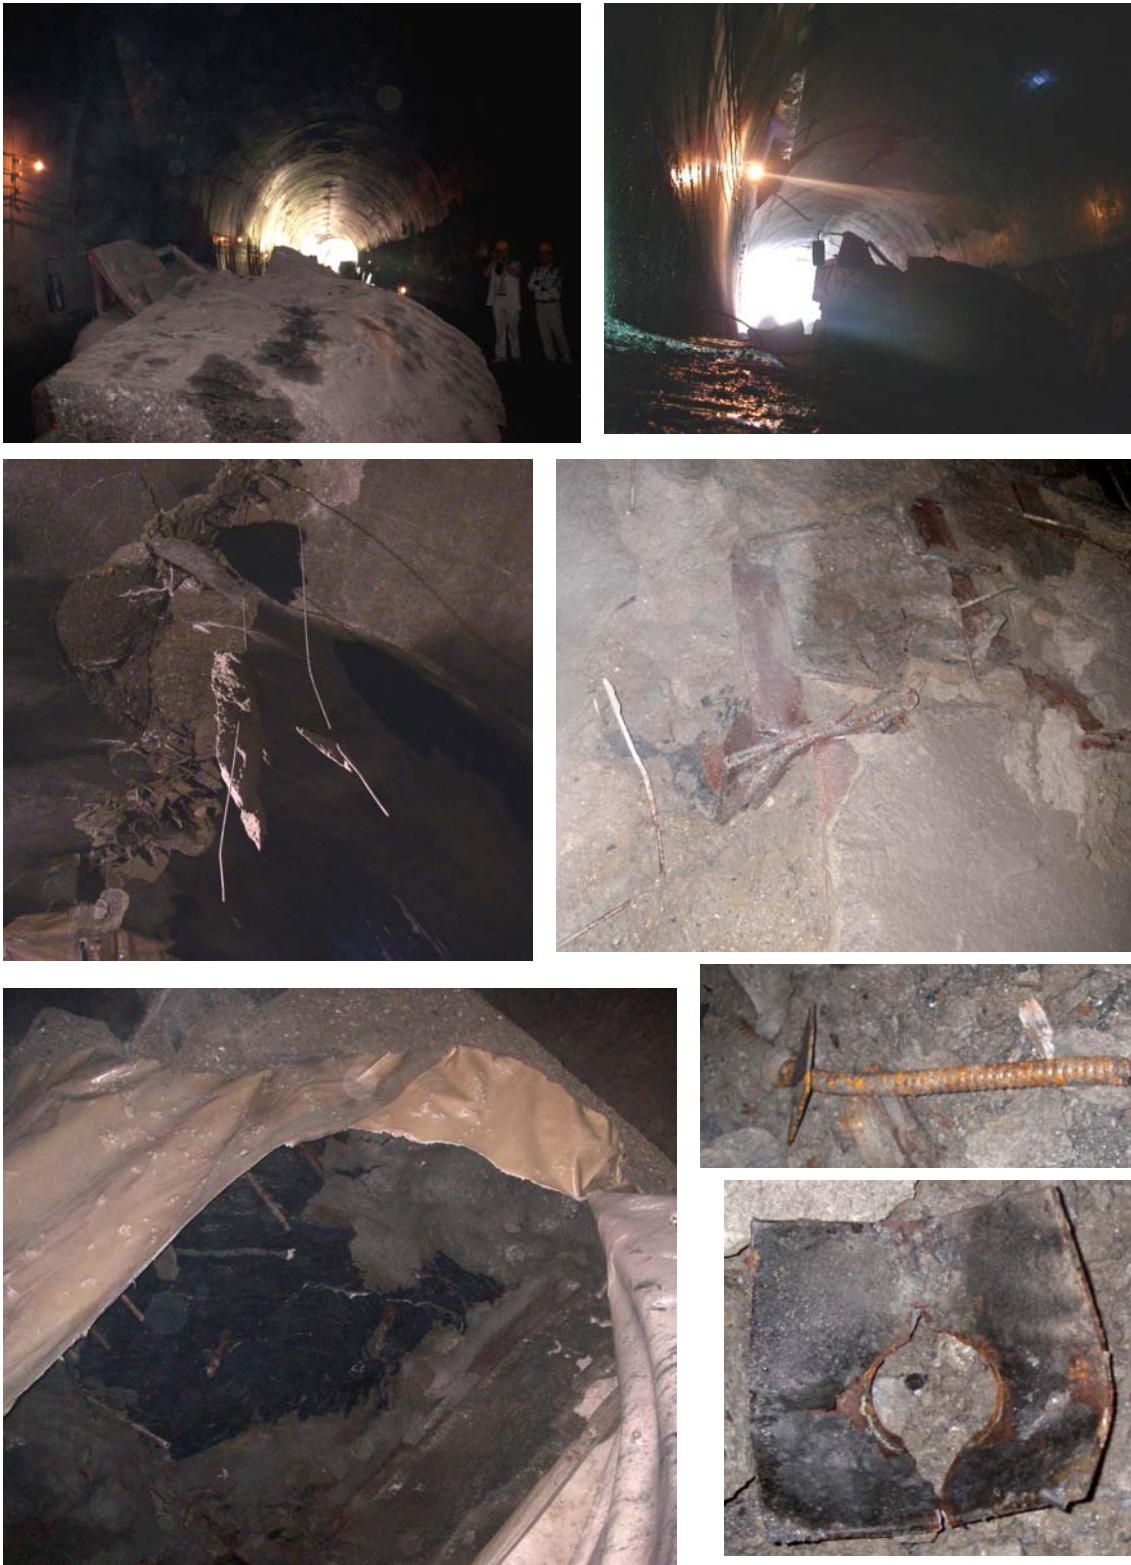
Jiujiaya Tunnel is a 2282m long double lane tunnel and the coordinate of its south portal is N32.41288 and E105.12046. The tunnel is 226.6km away from the earthquake epicenter and it is about 3-5km away from the earthquake fault of Wenchuan earthquake. The tunnel face was 983m from the south portal at the time of the earthquake (Figure 8.21). The concrete lining follows the tunnel face at a distance of approximately 30m. The tunnel suffers from metan gas problem due to coal seams below the tunnel. The rock consists of phyllite with intercalations of dolomite. The bedding planes has the orientation of NW50/64, which is roughly similar to that of the Longmenshan fault zone. The geological investigation indicated that the tunnel pass through several fracture zones. The engineers informed the authors that 30 workers were working at the tunnel face and one worker was killed by the flying pieces of rockbolts, shotcrete and bearing plates caused by intense deformation of the tunnel face during the earthquake. The concrete lining was ruptured and fallen down at several section (Figure 8.22). However, the effect of the lining rupturing was quite large and intense in the vicinity of the tunnel face. The rupturing of the concrete lining generally occurred at the crown sections although there was rupturing along the shoulders of the tunnel. Furthermore, the invert was uplifted ue to buckling at the middle sections. Sometimes, the whole invert was pushed upward. The authors noticed that the tunnel heading was offset in a dextral sense with an upward with respect to the rest of the tunnel. The lateral and vertical offset displacements are approximately 100mm. This sense of deformation is very similar to that of the Longmenshan fault zone, which probably cuts through the tunnel with an acute angle of 50-60°. Besides the high ground shaking, the permanent ground deformations definetly played an important role on the damage observed in Jiujiaya Tunnel.

Figure 8.22. Views of damage at Jiujiaya Tunnel

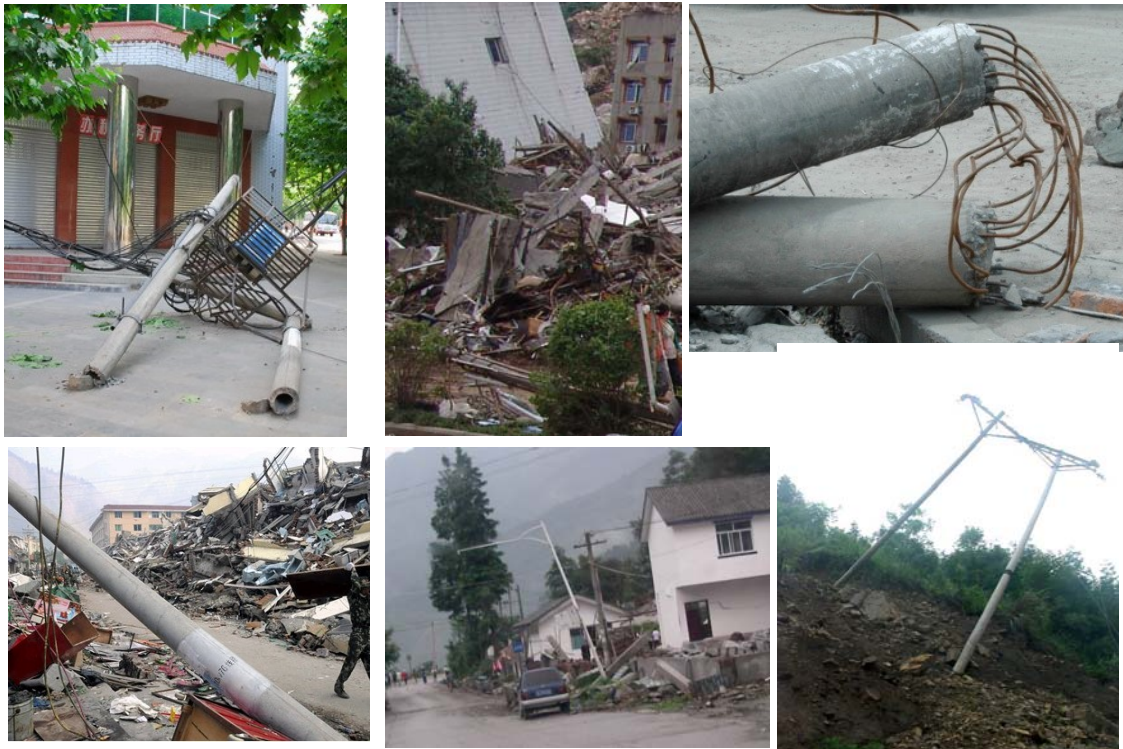
The preliminary site investigations and additional data and information other sources clearly indicated that the damage to pylons and poles were either caused by the collapse of buildings, slope failures or faulting. The effect of ground shaking on the damage to pylons and electricity poles seems to be small (Figures 8.22 and 8.23. Particularly the selection of foundation ground for high pylons and their structural design and construction should have been very carefully implemented.

(a) Damaged or broken utility poles

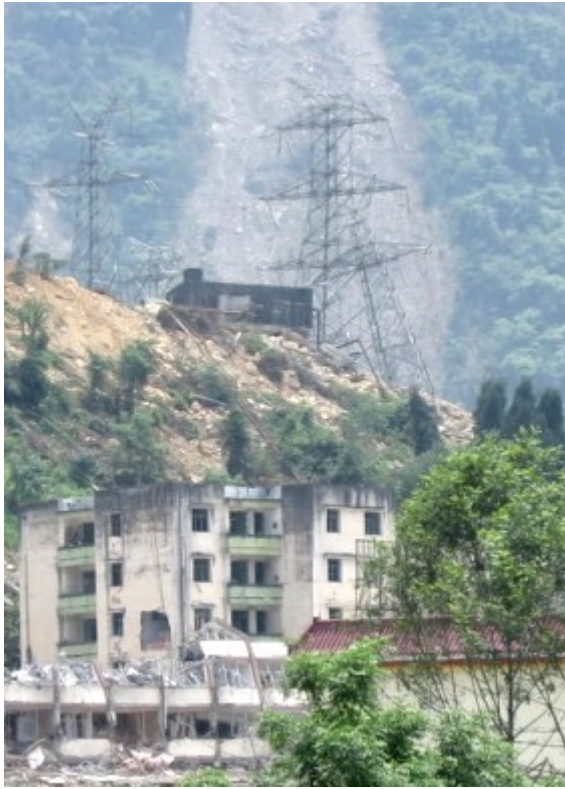
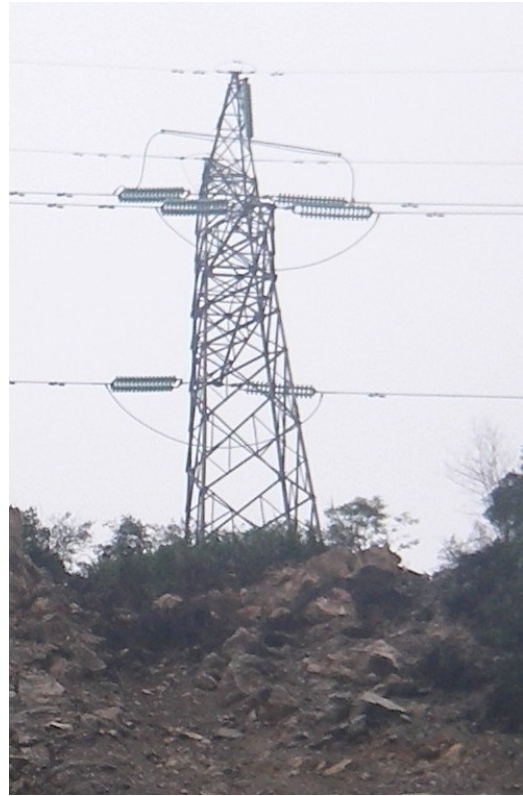
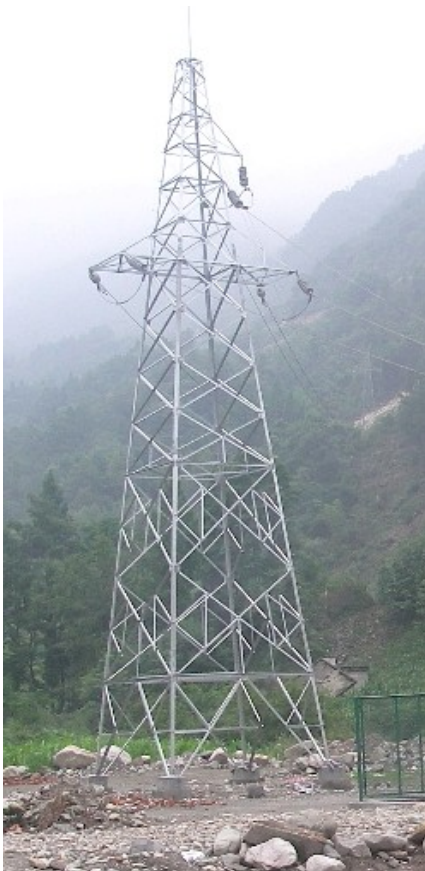
Figure 8.23. Views of damaged and non-damaged pylons

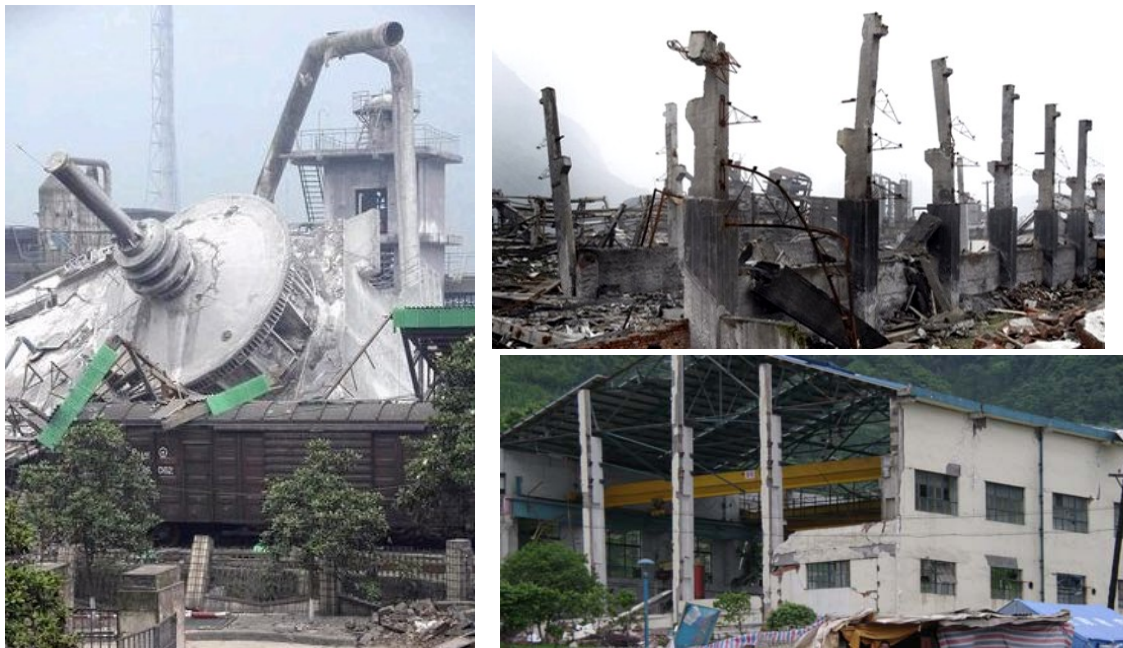
The heavy damage to industrial facilities were observed in Hongbai and Hanwang towns near Shifang, where ground accelerations up to 632 gals were recorded. These towns are 75km away from the epicenter. However, they are in the close proximity of the earthquake fault (within 15-20km). The reports indicated that two chemical plants were heavily damaged in Hongbai town (Figure 8.26 and 8.27). These plants released more than 80 tons of liquid ammonia. There are also some damage to industrial facilities in Yingxiu and Wenchuan (8.28).

Figure 8.26. Some examples of damage to industrial plants in Hongbai

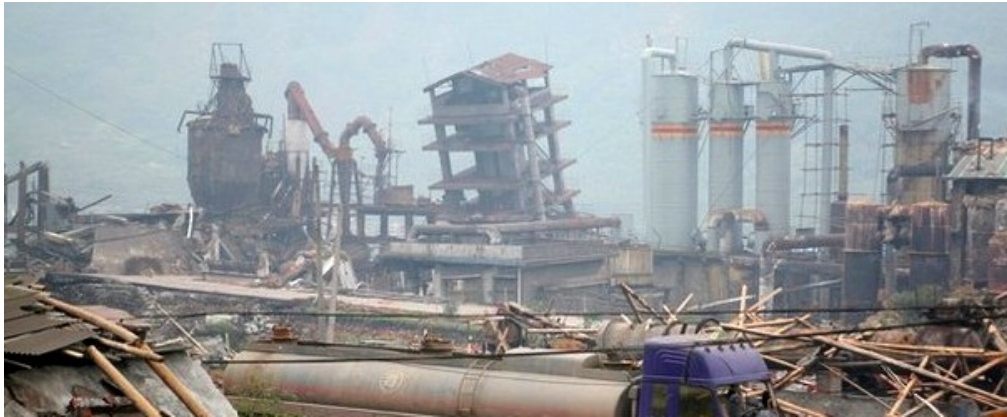
Figure 8.27. Some examples of damage to industrial plant in Hanwang

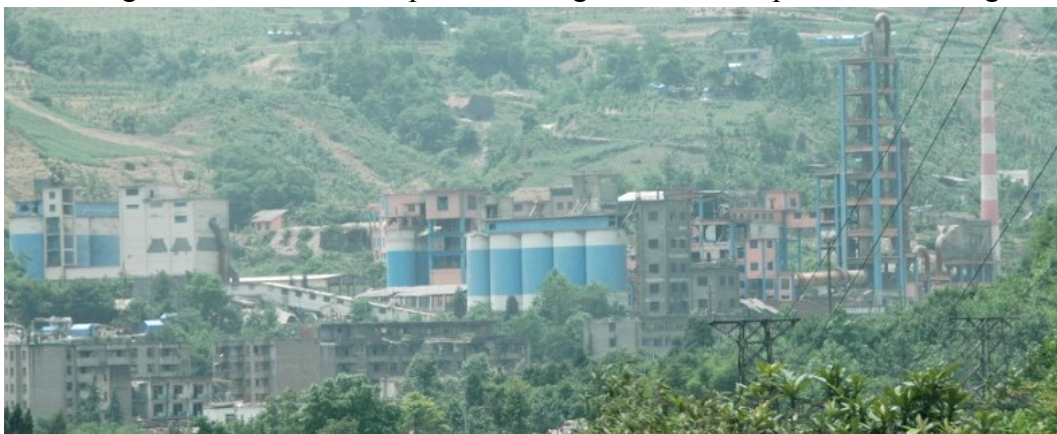
Figure 8.30. Views of damage to industrial facilities at Yingxiu town
