A RECONNAISSANCE REPORT
ON
2008 WENCHUAN EARTHQUAKE*

Japan Society of Civil Engineers
Earthquake Engineering Committee
Earthquake Disaster Investigation Sub-Committee

May 19, 2008

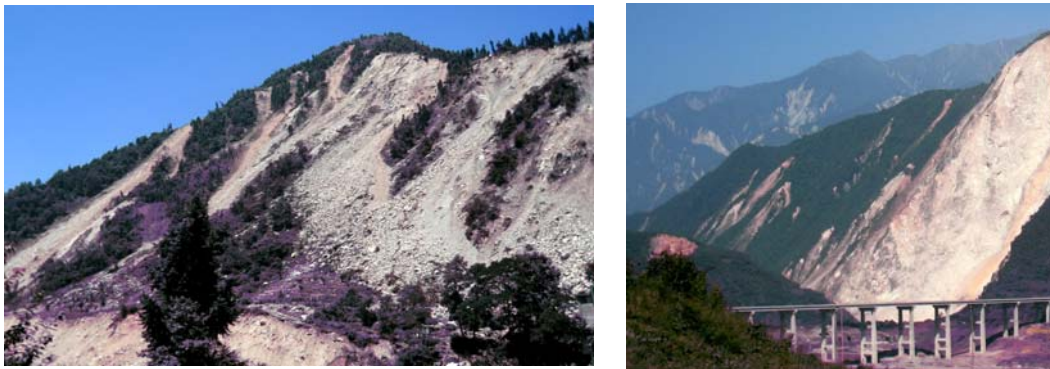
Rock units in the epicentral area are phyllite or slate, sandstone, mudstone, shale and limestone. Particularly reddish mudstone and brackish shale are very prone to weathering. Furthermore, the rocks at higher elevations are also subjected to thawing and freezing as well as other atmospheric conditions. Most of these rock units contain joints, bedding or schistosity planes as well as fracture zones due to intense tectonism associated with Longmenshan fault zone. In addition, the limestone is very prone to solution by percolating ground water along fractures and they contain many solution cavities. Figure 9.3 shows several surficial slope failures in limestone unit in the vicinity of the Weizhou and the Zipingpu dam site. The surficial slope failures in limestone unit was spectacular and continued for several kilometers as they are clearly noticed in satellite images.

Figure 9.3. Spectacular surficial rock slope failures

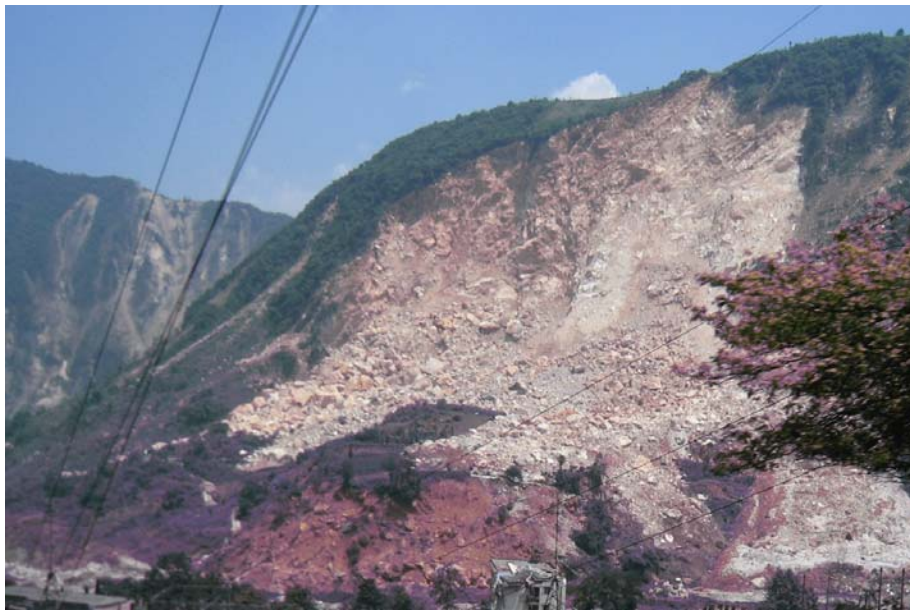
Figure 9.5. A view of the Yingxiu landslide

The Yingxiu landslide (Figure 9.5) involved mainly limestone, which dips to the valley side with an inclination of $20-25^{\circ}$. Furthermore, there is a fault dipping parallel to the failure surface within the rock mass. The angles of the lower and upper parts of the failed slope are 60° and 30° , respectively. In addition to this new landslide, one can

easily notice the existence of a paleo-landslide in the fore-ground. The failure plane of this slope failure or landslide is bi-planar and it involved the fault and bedding plane. The fault plane probably assisted the separation of the failed body from the rest of the mountain. The in-situ tilting tests on the limestone joint surfaces yielded the friction angle as $38-42^{\circ}$. If the resistance is purely frictional the expected lateral horizontal seismic coefficient should be greater than $0.36g$. Since Yingxiu town was heavily damaged by this earthquake, it is more likely that such a high ground acceleration did act on this slope.

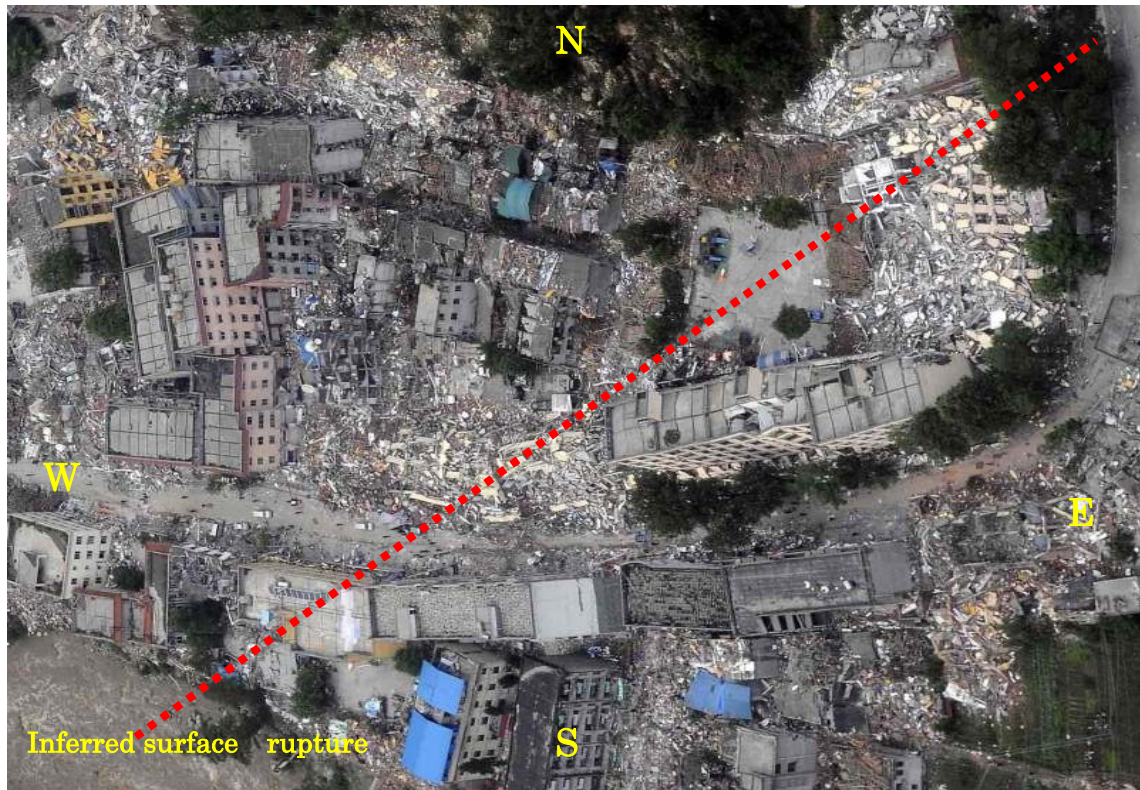
Figure 9.1. An aerial view of a heavily damage section of Yingxiu town

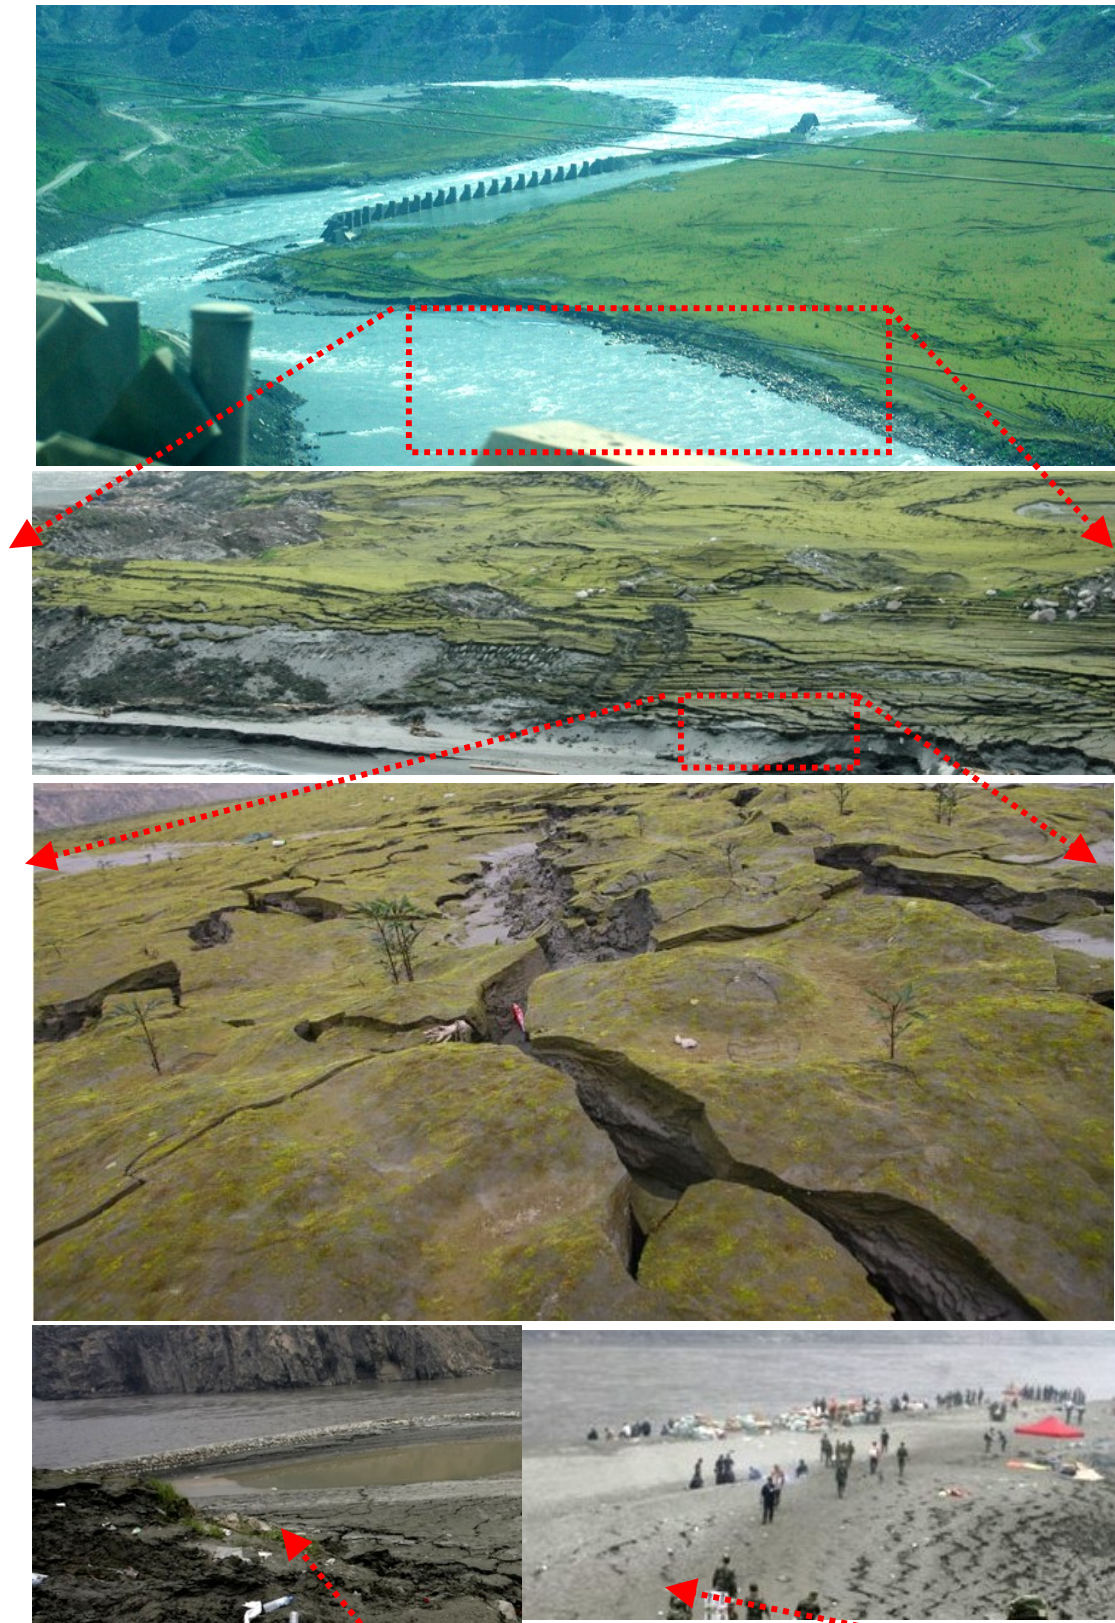
Figure 9.2. Effects of ground liquefaction and lateral spreading in the vicinity of Yingxiu of WenchuanCounty

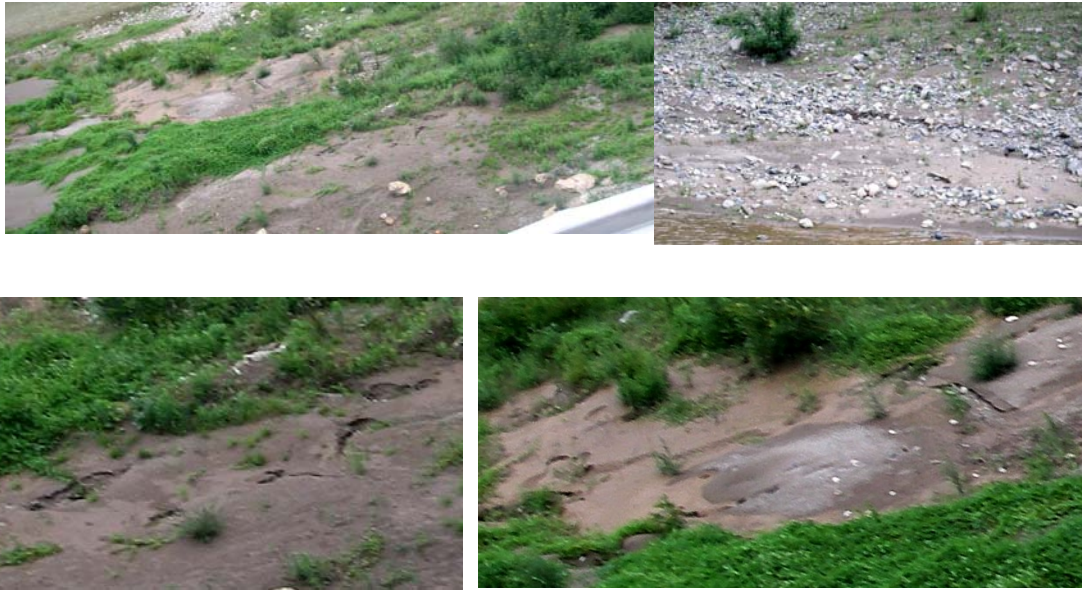
Figure 9.3. Sandboils and surface ruptures in Qingchuan County

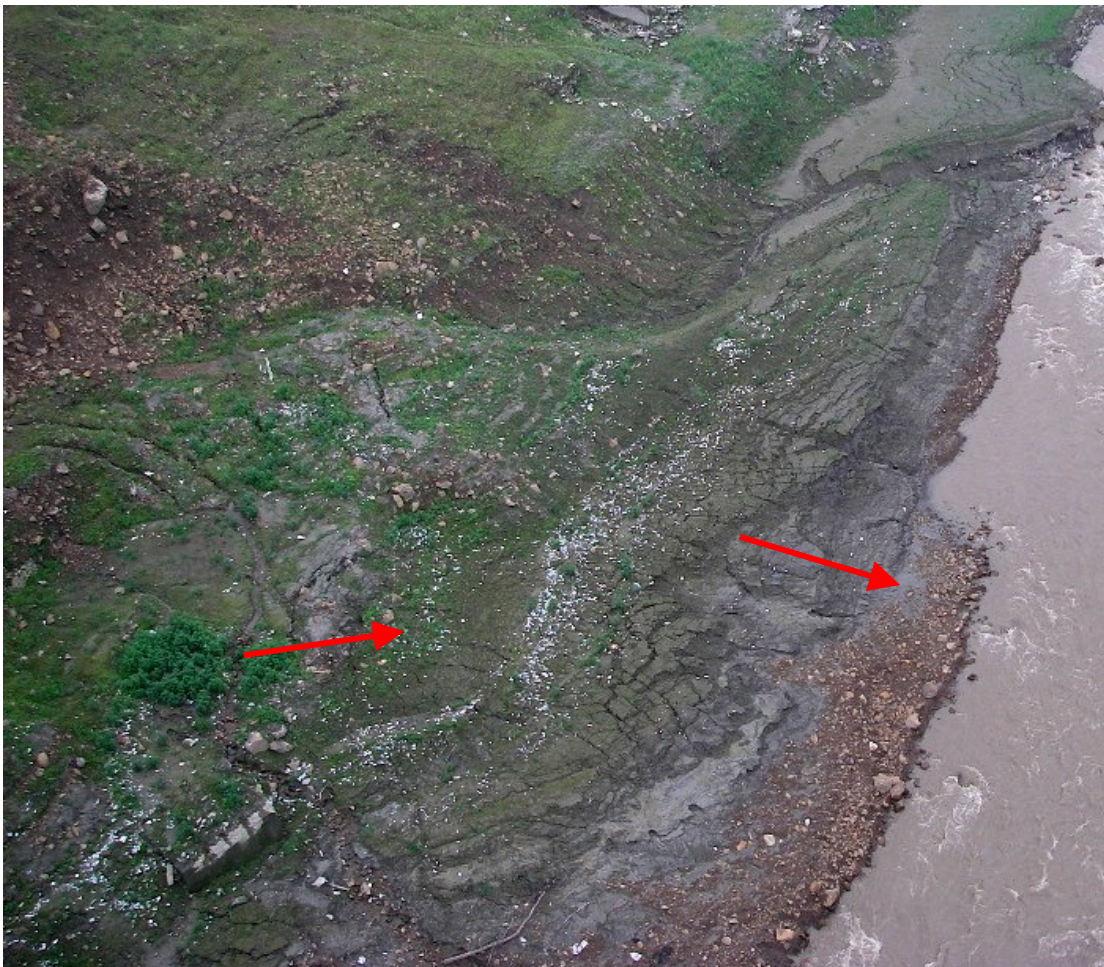
Figure 9.4. Lateral spreading of ground in the vicinity of Shoujiang Bridge

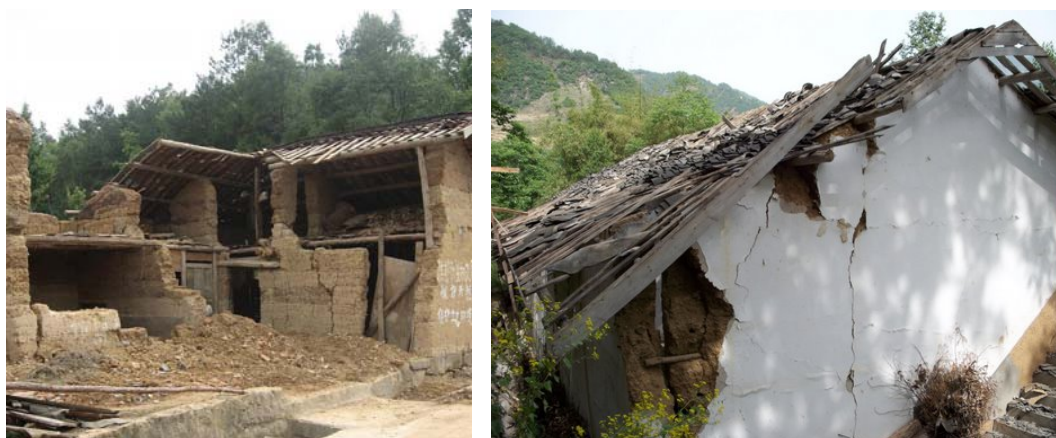
Figure 11.1. Damaged or totally collapsed adobe buildings

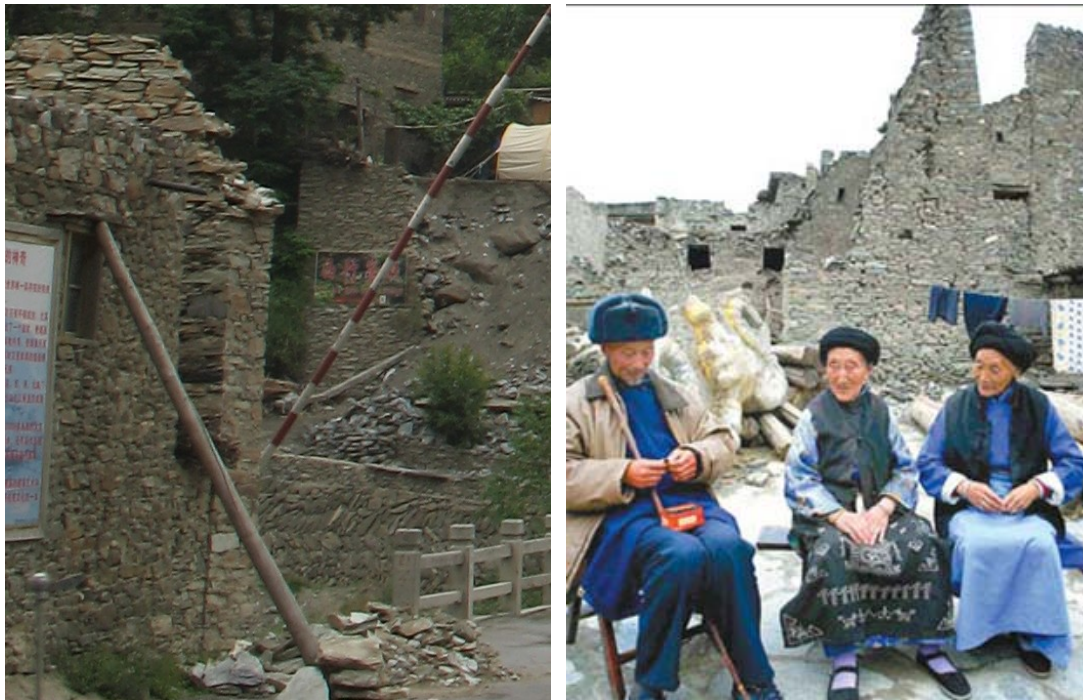
Figure 11.2. Damaged stone masonry buildings in Taoping village in Aba region

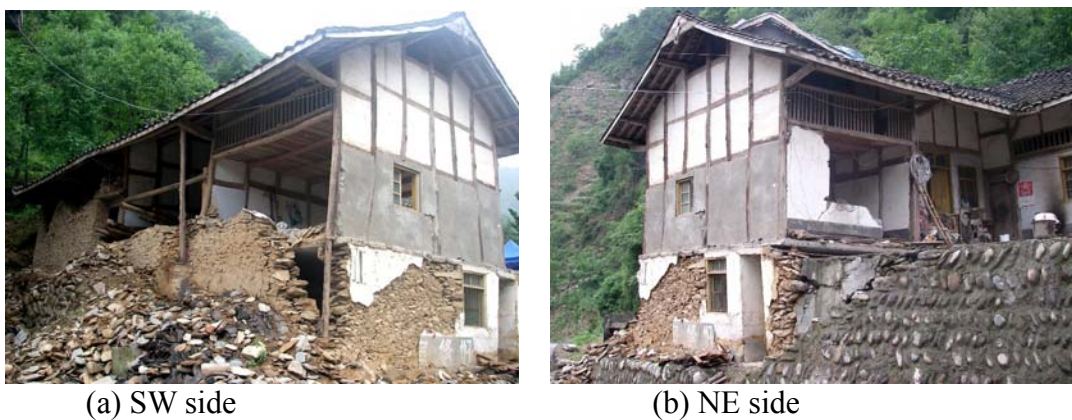
Figure 11.3. Toppled walls of a wooden framed house in Xiao village in Qingchuan

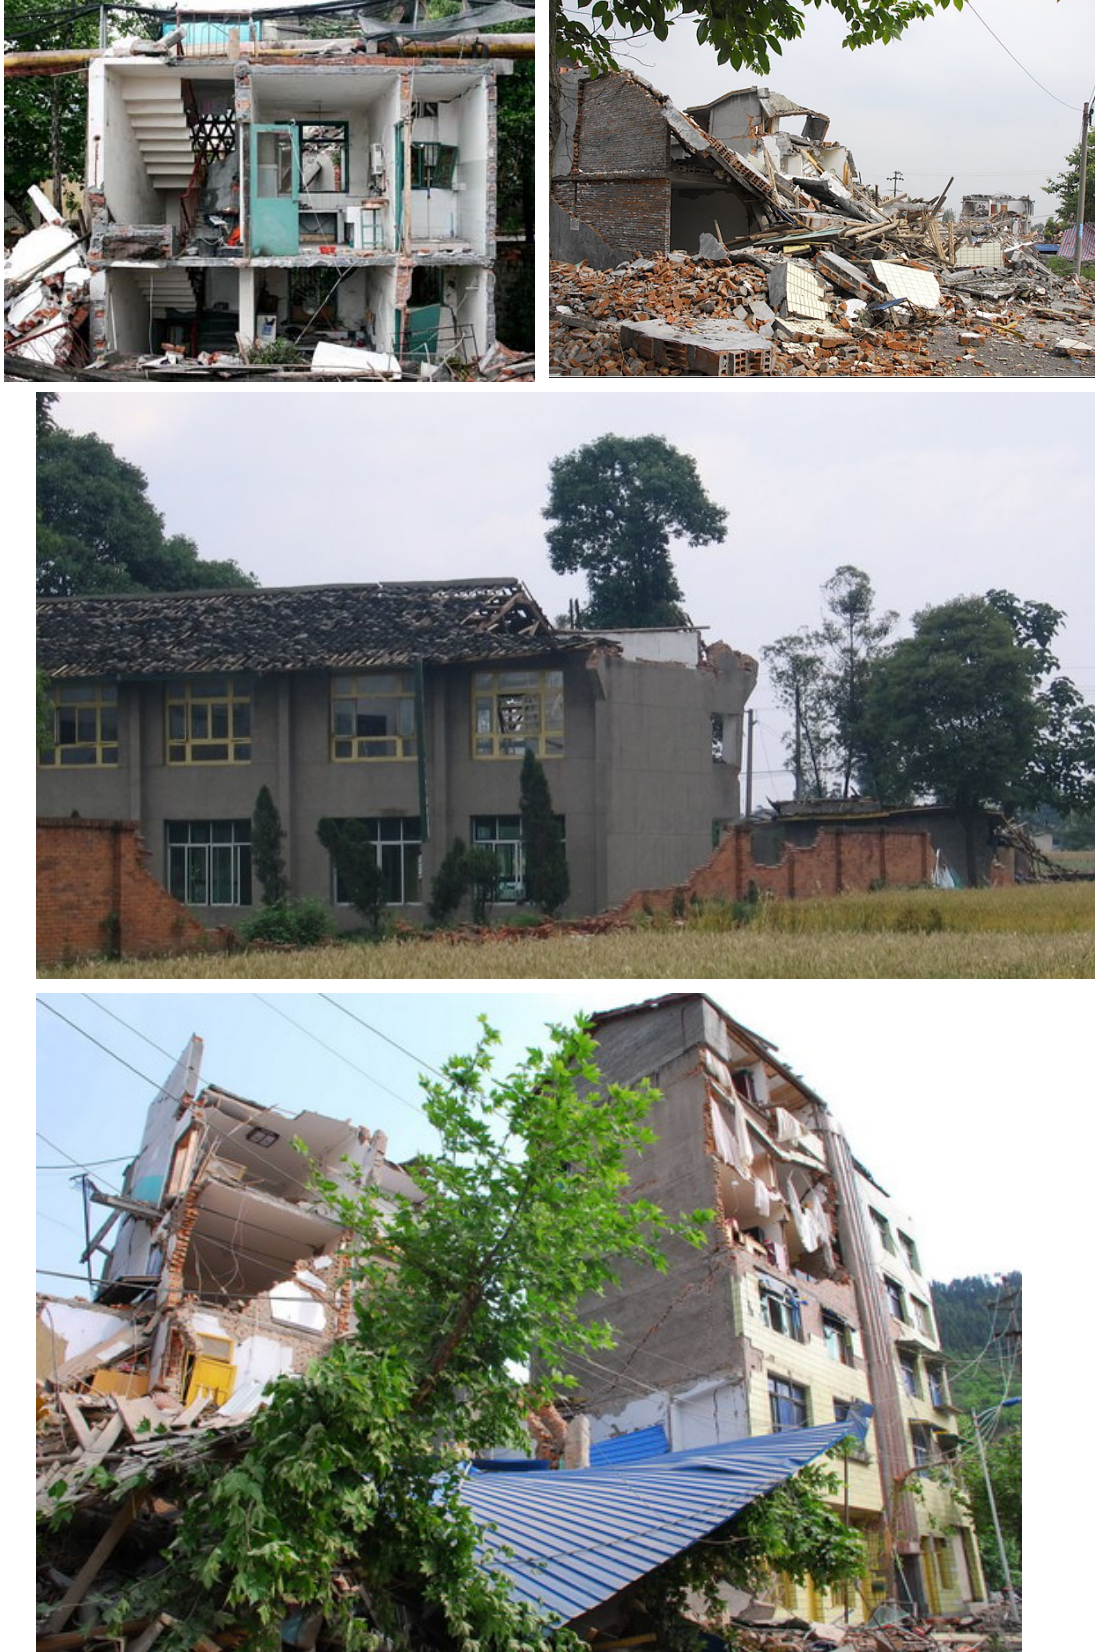
Figure 11.4. Damage to brick masonry buildings in the epicentral area

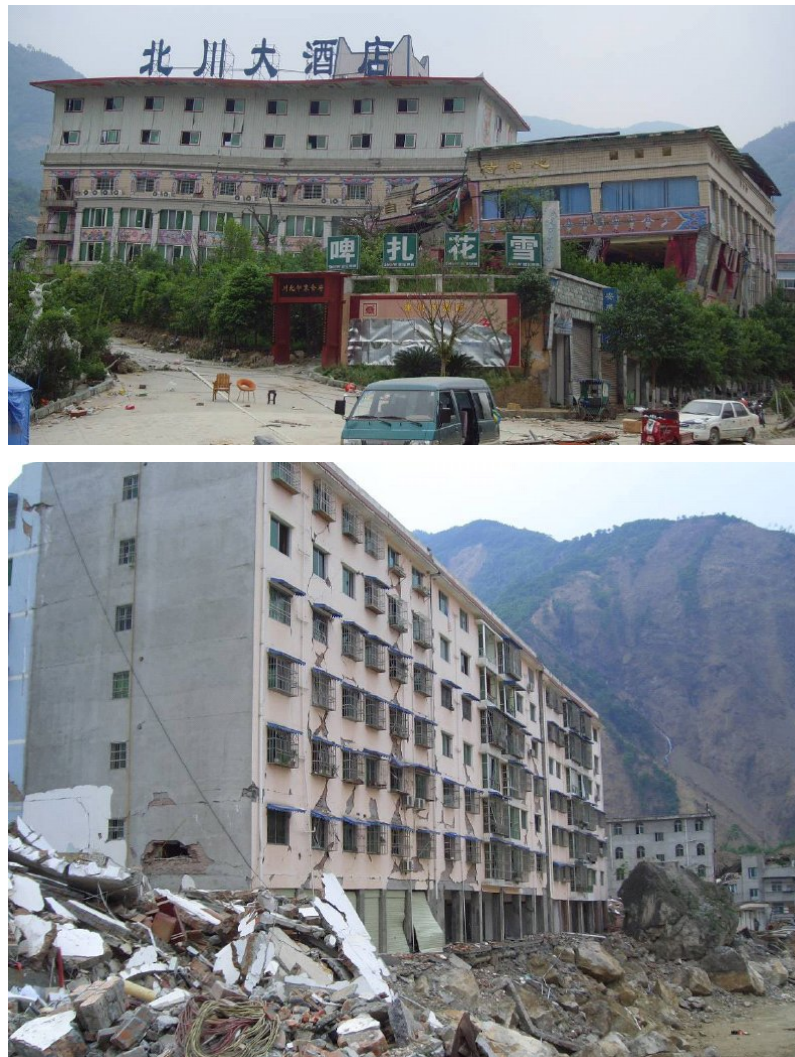
Figure 11.11. Damage to structures due to forced displacements induced by faulting in Beichuan

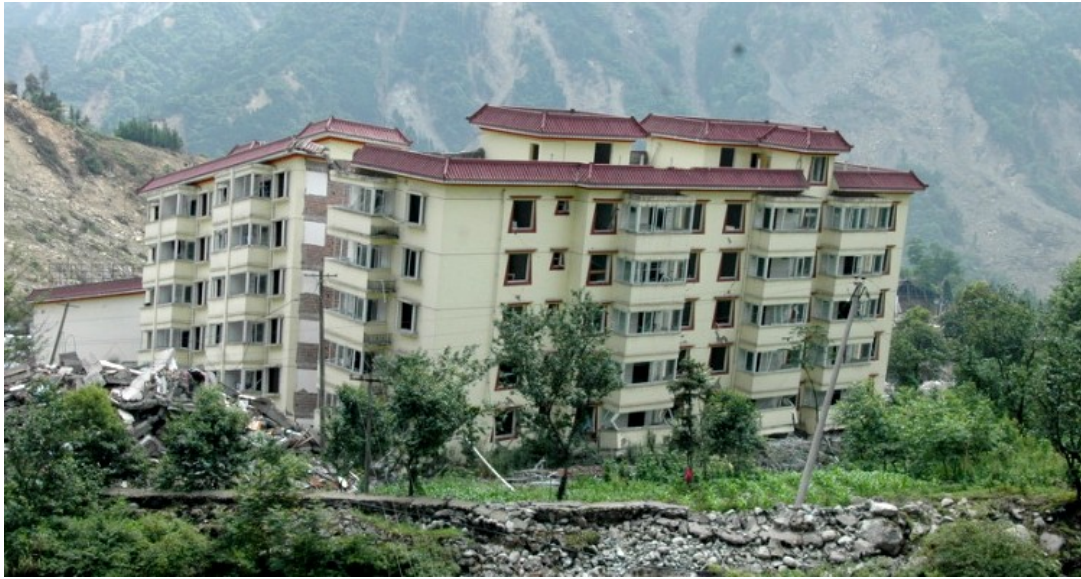
Figure 11.13. Damage to structures due to forced displacements induced by faulting in Yingxiu

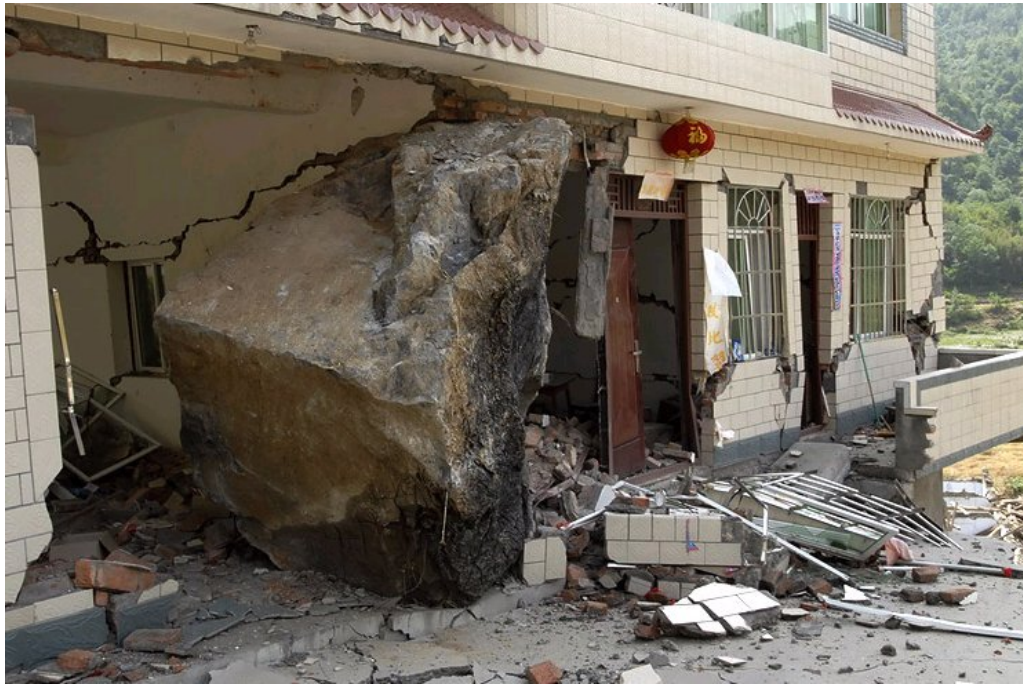
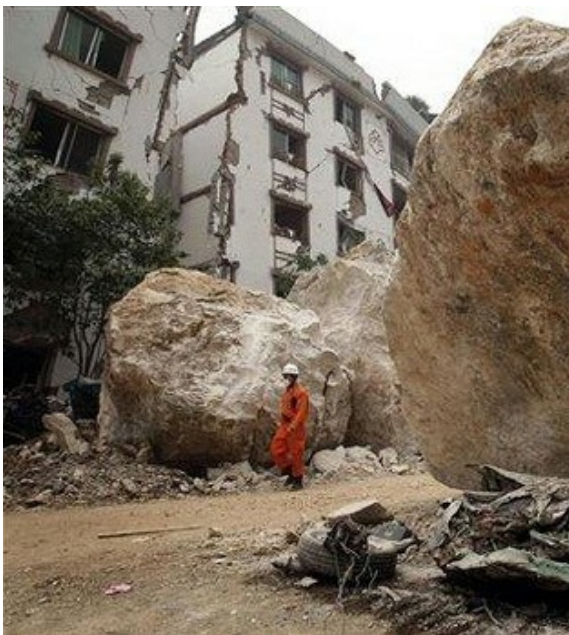
Figure 11.17. Rock fall induced damage on buildings
