Japan Society of Civil Engineers
Yotsuya 1, Shinjuku-ku, Tokyo 160-0004
<http://www.jsce.or.jp/>

3. BUILDINGS AND DWELLINGS

The January 13, 2001 Off the Coast of El Salvador Earthquake

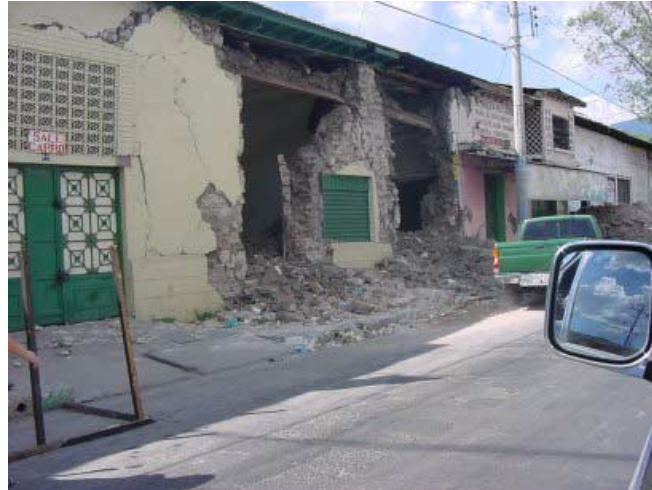
Figure 3.2. Typical adobe house that was damaged by the earthquake

Adobe buildings have poor seismic performance. They are massive and heavy, which attracts high levels of seismic forces, and the material is brittle and has almost no tensile strength by itself. Poor construction practices often decrease the bond between adobe and mortar. Although there are techniques to provide internal reinforcement to the adobe structures in order to improve their seismic performance, those techniques are not in practice in El Salvador.

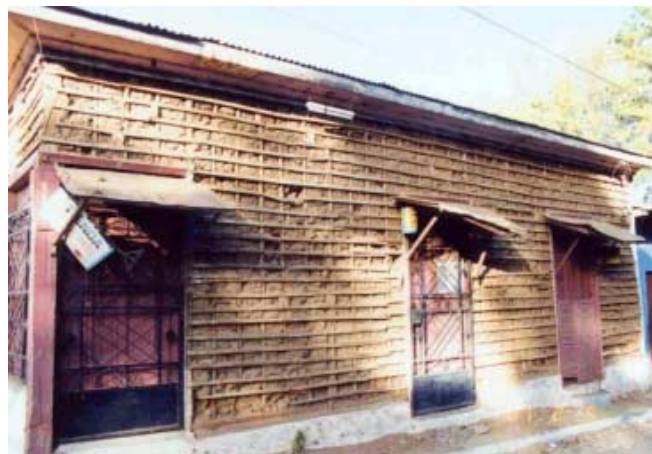
Figure 3.3. Bahareque structure which suffered mud cover spalling.

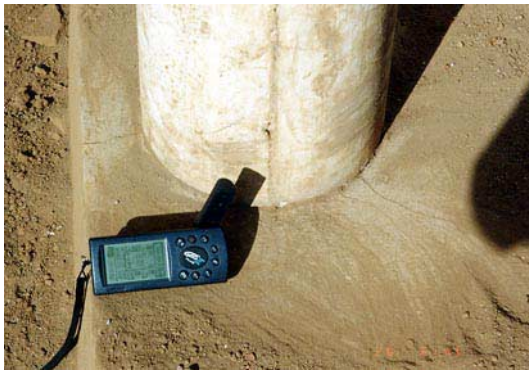
Pole #1

Utility poles (5m tall) are embedded upright in concrete-paved sidewalk in this town (**Figure 3.10**). Cracks developing outwardly on the pavement from these poles suggest possible directions in which ground motions were intense (**Figure 3.11**). Some poles (**No. 6** and **7**) are very close to the step-shaped edge of the sidewalk. The thin cover concrete thus might have affected the crack pattern. Though the number of the examined utility poles is not sufficient for thorough statistical manipulations, some poles seem to have been forcibly shaken in about N-S direction.

Figure 3.11. Cracks appearing around utility poles

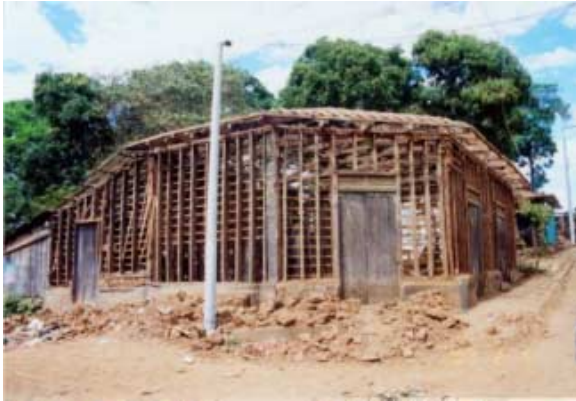
Figure 3.12. Bahareque structure that suffer mud spalling.

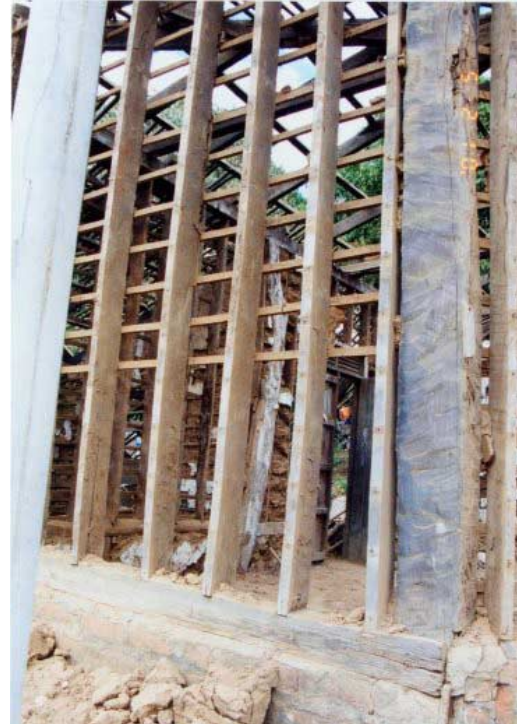
Figure 3.13. Detail of the connection between studs and foundation of the house in **Figure 3.12**. The foundation extends above the ground level protecting the wooden members.

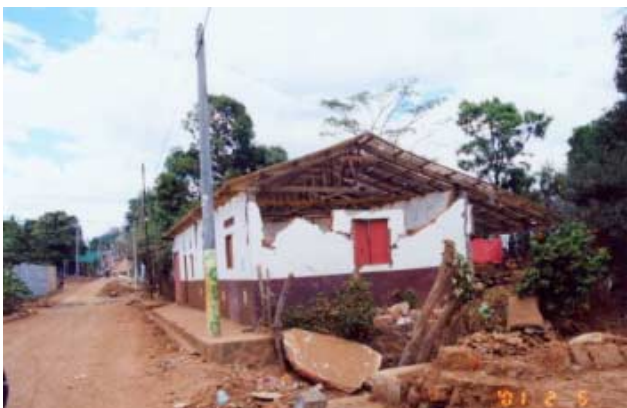
Figure 3.14. Unreinforced masonry house partially collapsed. The walls perpendicular to the street (~NE-SW direction) failed out-of-plane. The roof restrained the displacements of the top of the wall parallel to the street.

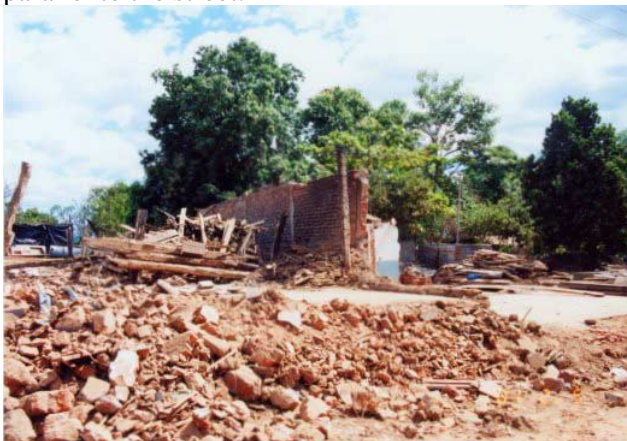
Figure 3.15. Completely collapsed adobe house.

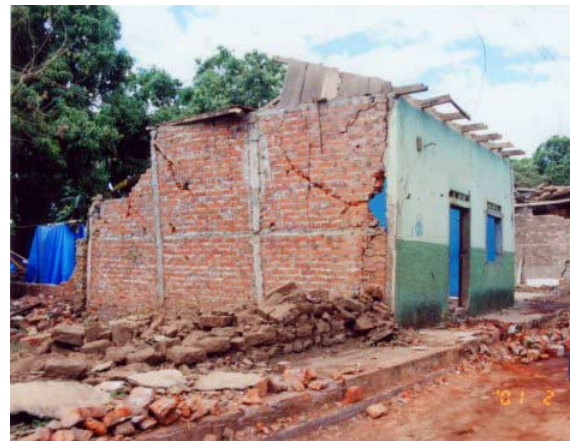
Figure 3.16. Collapsed reinforced masonry wall. The separation of the walls from the transverse walls can be observed in the two buildings shown in the photograph. The street direction is approximately NE-SW.

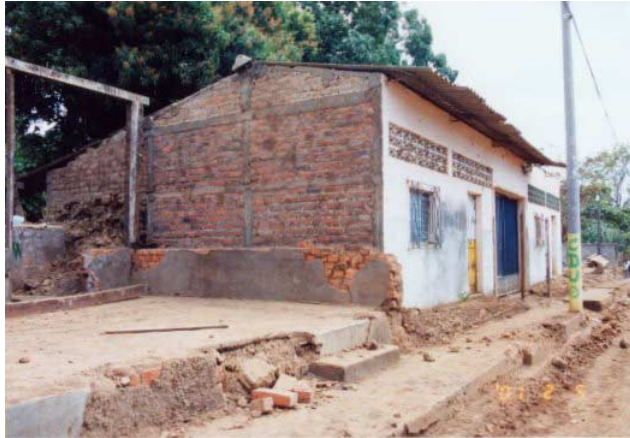
Figure 3.17. Adobe house completely flattened next to a reinforced masonry structure that did not suffer any damage.

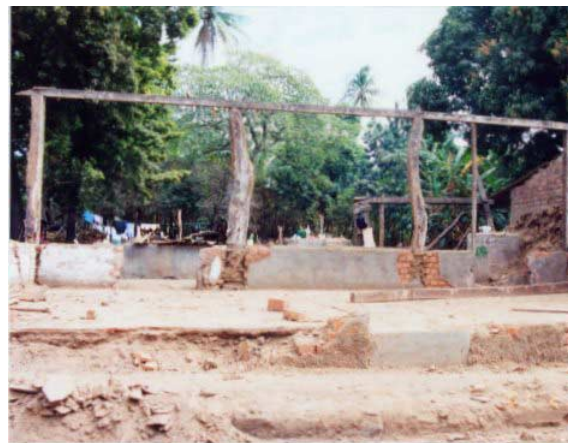
Figure 3.18. Detail of the adobe house in **Figure 3.17**. Just the confining wood of one wall remained.

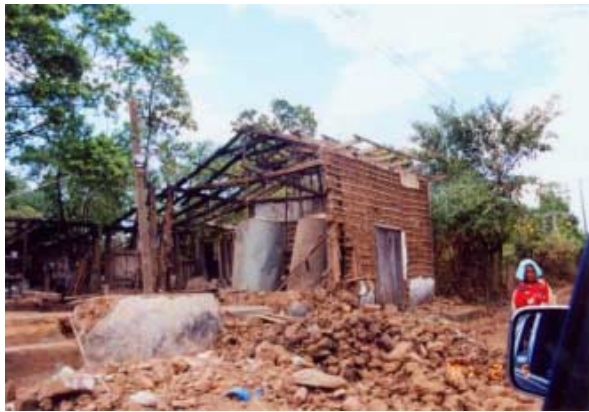
Figure 3.19. Collapsed bahareque house.

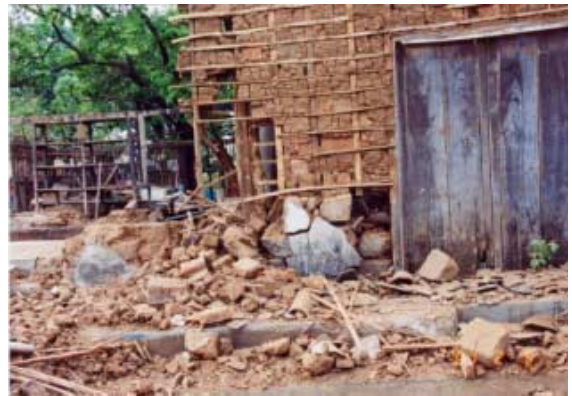
Figure 3.20. Detail of the poor foundation of house in **Figure 3.19**.

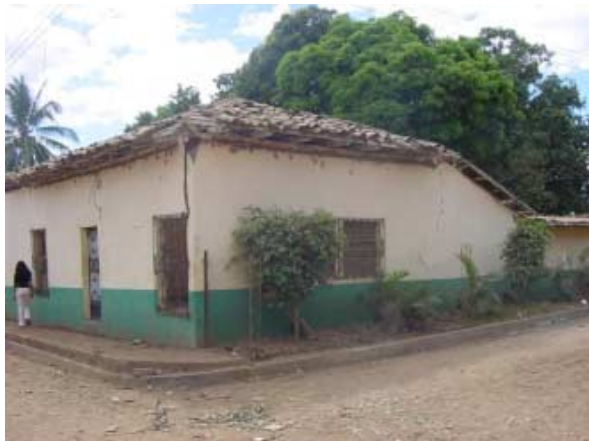
Figure 3.21. Unreinforced masonry structure. A vertical crack is observed at the connection between walls.

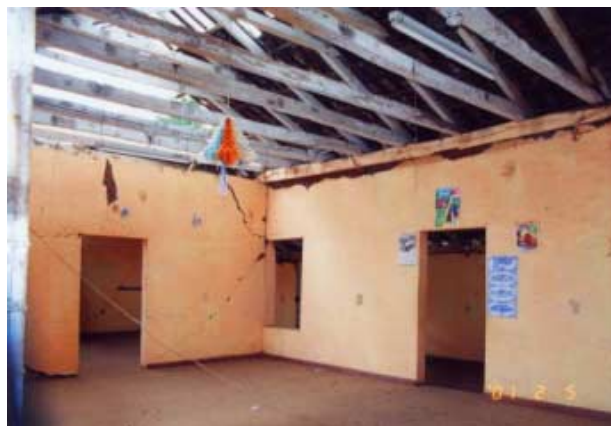
Figure 3.22. Interior of the building shown in **Figure 3.21**. The wall exhibits diagonal cracking.

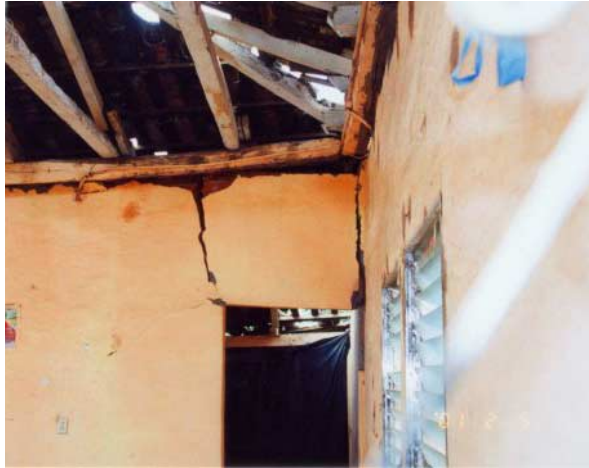
Figure 3.23. Interior of the building shown in **Figure 3.21**. Vertical cracking of spandrels over the door head can be observed.

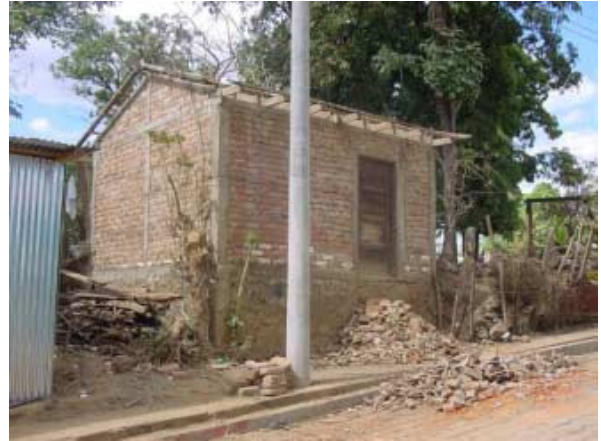
Figure 3.24. Reinforced masonry structure that did not suffer damage. However, the roof tiles felt down.

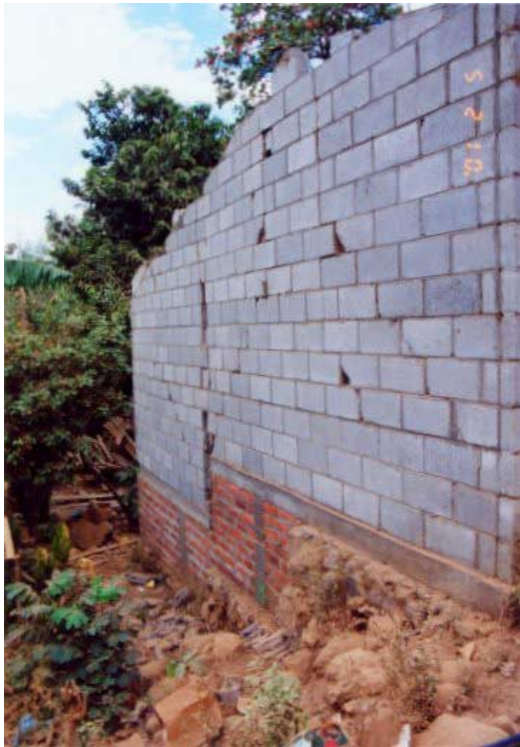
Figure 3.25. Masonry wall with clay bricks and concrete blocks. A diagonal crack crosses the concrete portion

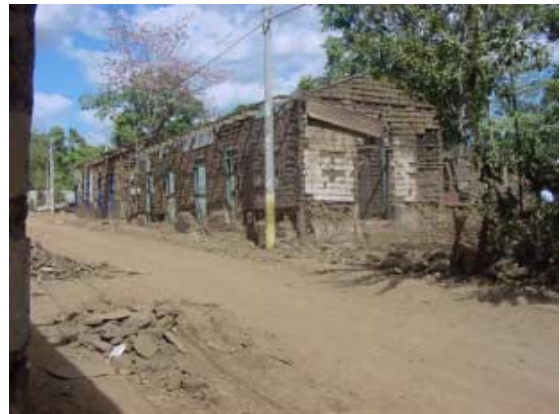
Figure 3.26. Bahareque structure damaged by the earthquake.

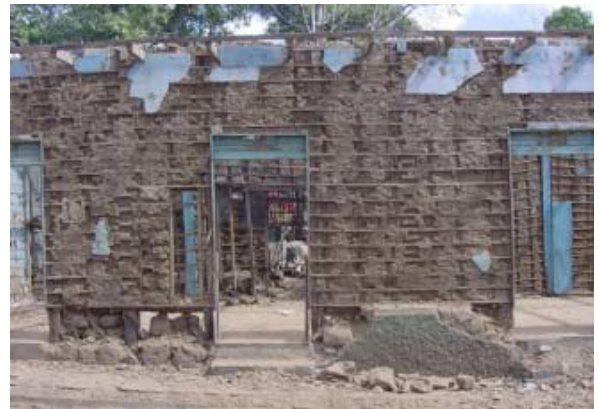
Figure 3.27. Details of the walls of the house in **Figure 3.26**. Notice the poor foundation detail.
