4. LIFELINES AND CRITICAL FACILITIES

The January 13, 2001 Off the Coast of El Salvador Earthquake

4.2 ELECTRICITY

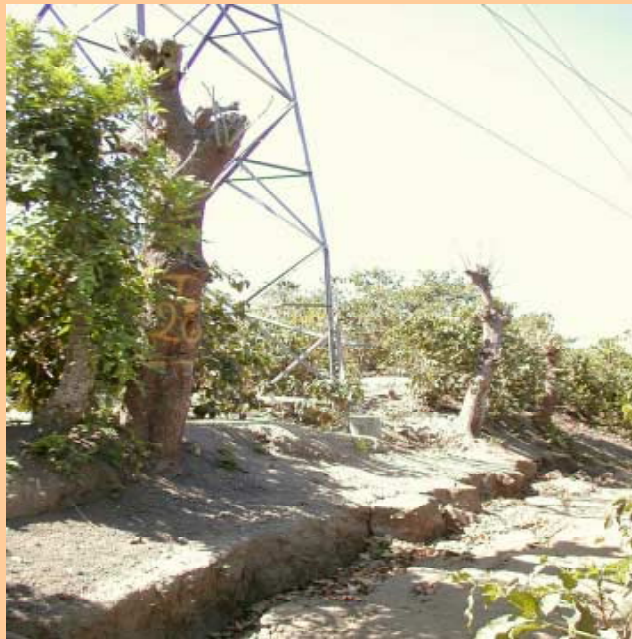
A slope failure slightly off a transmission tower:
Foundations of the tower narrowly escaped from
being carried off (Sonsonate -Nuevo Cuscatlan, 115 kV
Line).

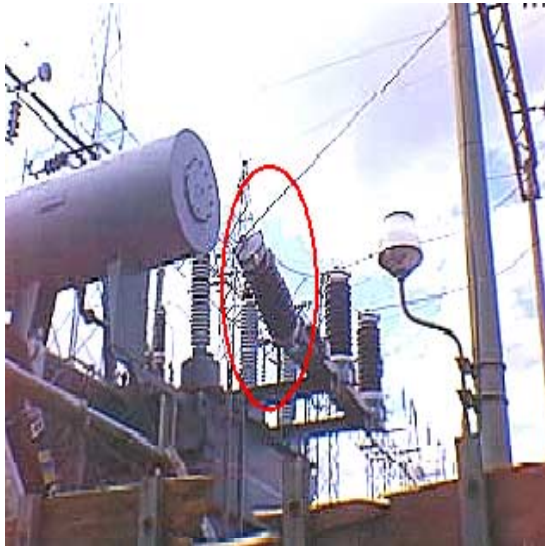
Shortly after the earthquake, functioning installations in some damaged substations were brought in full operation to make up for the drop in power supply caused by damage to their transformers, bushings, interrupters, connectors, radiators, and circuit breakers. At Soyapango and Nejapa substations, some insulators and bushings for lightning rods and transformers (30/40/50 MVA and 110-46/23 kV) were broken (**Figures 4.2 and 4.3**). Heavy equipments such as power transformers and their radiators were broken, and oil leaked from their bottoms (“15 de Setiembre” substation, **Figure 4.4**). Supporting rods of interrupters were broken at their bottom ends (Nejapa Substation, **Figure 4.5**). For interrupters, the intense shake was not the sole cause of the damage to them. Flashovers (electric arcs) around or over the surfaces of insulators and/or short-circuits damaged equipments at Nejapa Substation (**Figure 4.6**). At Tecoluca Substation, short-circuit in a circuit breaker caused the damage to the main switchboard of an isolator (**Figure 4.7**). Obviously, porcelain insulators and/or bushings for substation equipments were quite susceptible to intense shakes and easily broken during the strong shaking. In addition to the abovementioned substations, major damages to porcelain devices were reported at Nuevo Cuscatlan, San Martin, Ateos, San Antonio Abad, but less at other substations.

Figure 4.2. Broken bushing for a transformer (Soyapango Substation)

Surface configurations and soil profiles are often responsible for noticeable amplification of seismic ground motions. Substations with equipments with fragile bushings and insulators are thus desirable to be well located on stable soils. As for transmission lines, it is recommended to avoid constructions of towers and poles on the edges of unstable slopes. If unavoidable, constructions should involve some necessary slope stabilizations. Single upright poles or plane frames with two upright poles are conveniently used because they do not require much space for their foundations. It is however desirable to have more stable space frames (towers) for important transmission lines.

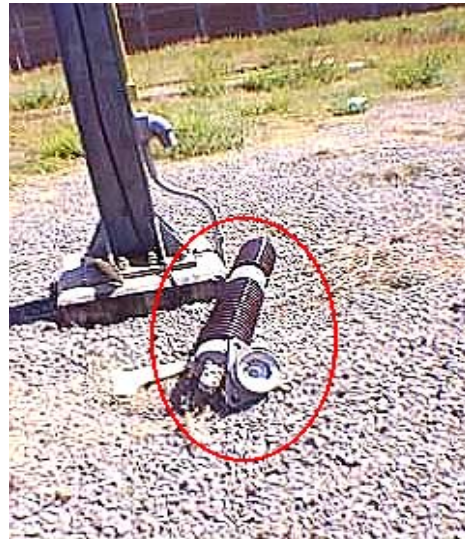
Figure 4.3. Broken bushing for a lightning rod (Nejapa Substation)

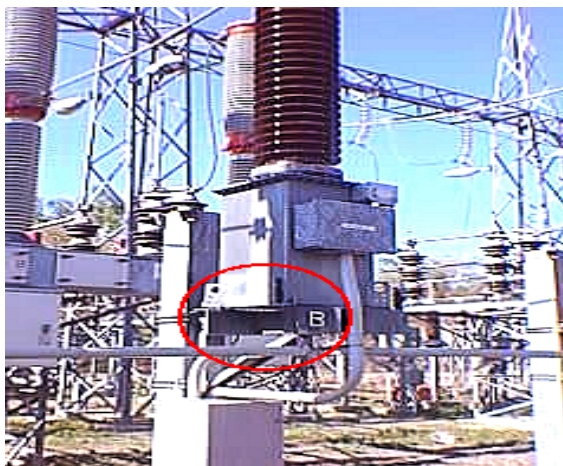
Figure 4.4. Oil leakage from the bottom end of radiator

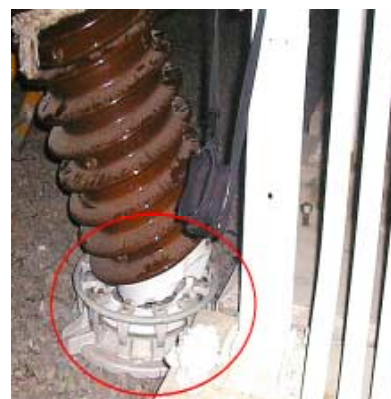
Figure 4.5. Broken support of interrupter (Nejapa Substation)

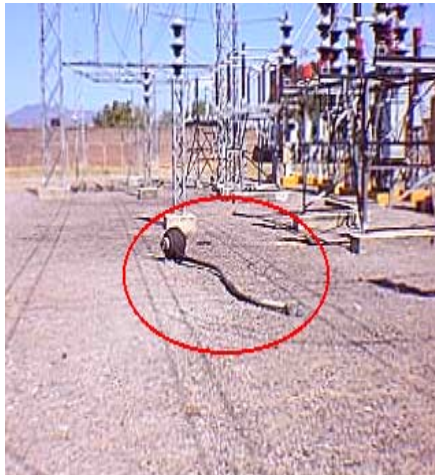
Figure 4.6. Broken insulator

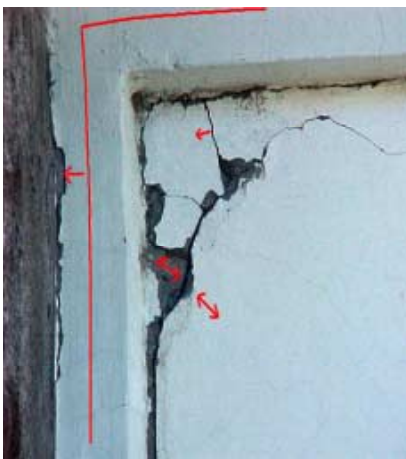
The intense ground motion was also responsible for damage to some substations buildings. Temporary supports were needed in some buildings under some damaged structural members so that the functioning equipments could be fully operated. At the switchyard of Nuevo Cuscatlan substation, the upper corner of a wall cracked due to the confining frame deformation (**Figure 4.8**), and concrete beams were spalled (**Figure 4.9**).

Figure 4.8. Cracked corner of a wall

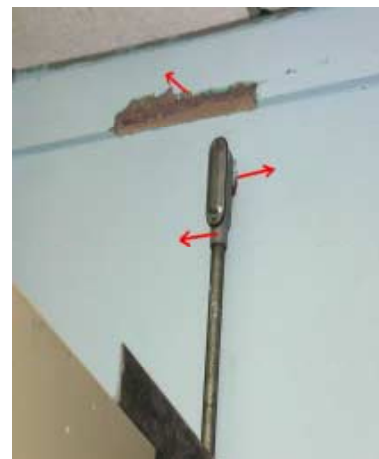
Figure 4.9. Spalled concrete beam

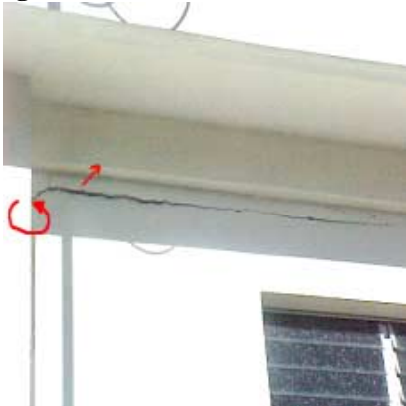
Figure 4.10. Lateral crack beneath a beam
(Switchyard, Santo Tomas Substation)

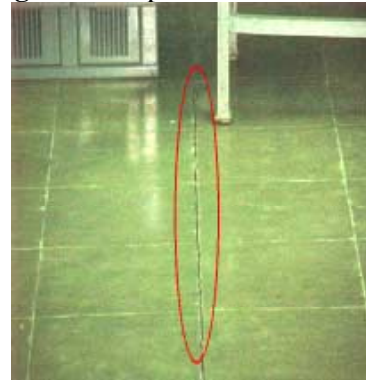
Figure 4.11. Tension crack along a joint between
tiles (Switchyard, Sonsonate Substation)

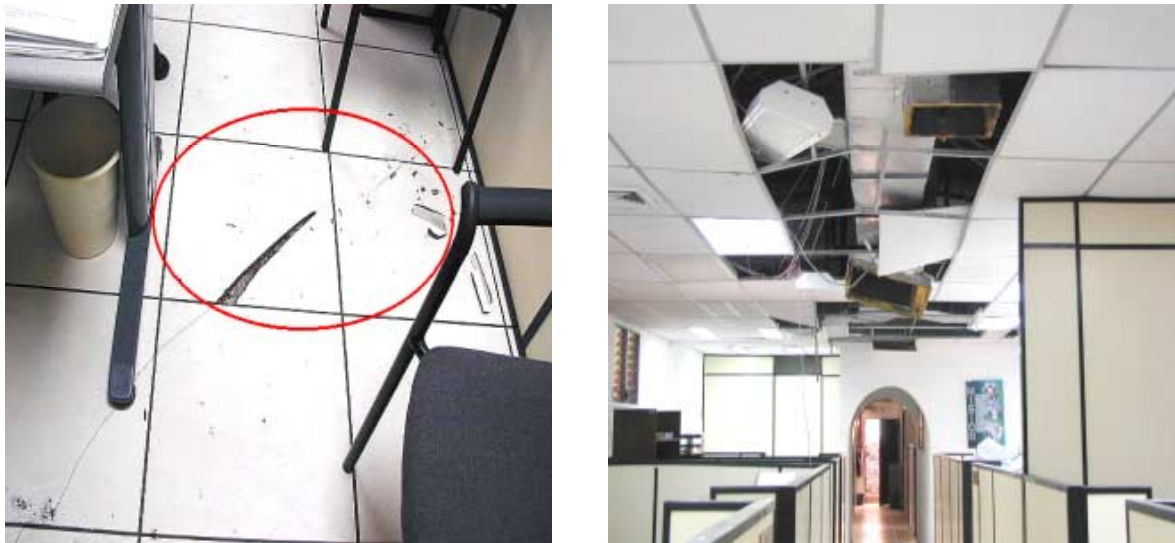
The headquarters of the “El Salvador Electricity Transmission Company” (ETESAL) was forced to evacuate its building because of the serious structural damage. Some joints of walls were opened widely. A floor suffered some shear cracks when it was forcibly compressed (**Figure 4.12** left), and some ceiling panels came off (**Figure 4.12** right).

Figure 4.12 Damage to the headquarter building of “El Salvador Electricity Transmission Company” (ETESAL)

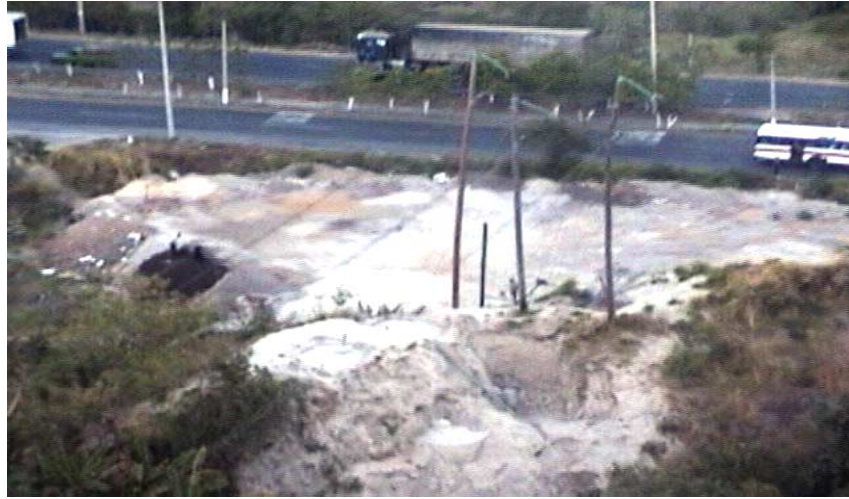
Wooden poles are mainly used for lower voltage lines, and since they do not need much space for their foundations, they are often constructed along thin mountain ridges (**Figure 4.13**), on the edges of natural or artificially cut slopes (**Figure 4.14a** and **b**) and so on. Two or more poles are often joined together to make up a plane frame for suspending several cables. At some damaged plane frames, foot soils do not equally subside causing some noticeable tilt of the frames (**Figure 4.15**). Slope failures were found not only in loose soils but also on weakly cemented volcanic products. A slope-failure took place about 4m off a transmission tower of the “Nuevo Cuscatlan–Santo Tomas” 115kV Line (**Figure 4.16**). The exposed slip surface shows an arrangement of volcanic products in strata of varying thickness. Weak layers bedding in the strata seem to have slipped.

Figure 4.13 Damage to wooden poles for transmission cables.
(San Martin– Nuevo Cuscatlan Transmission Line)

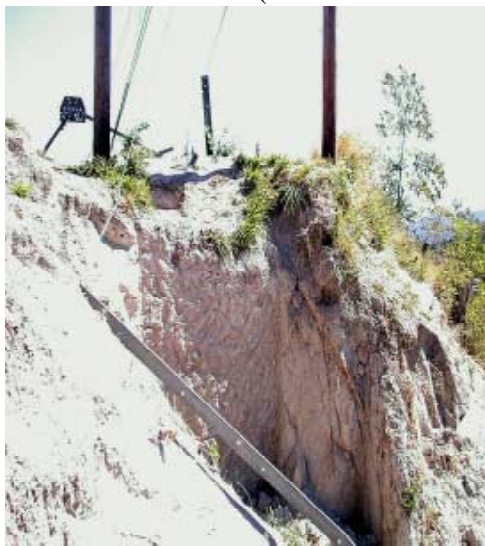
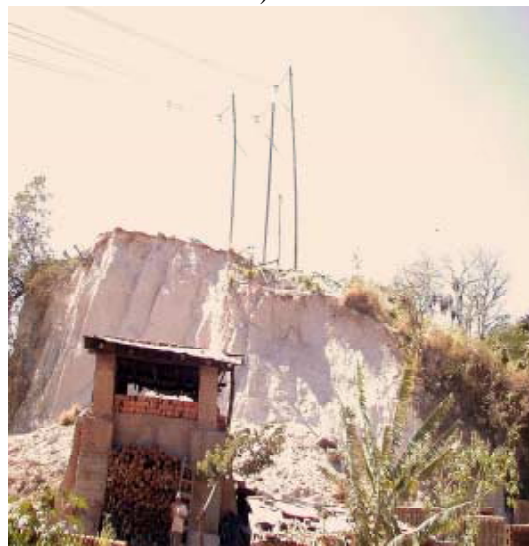
Figure 4.14. Poles on the edge of unstable cut
(Nuevo Cuscatlan-Santo Tomas Line)

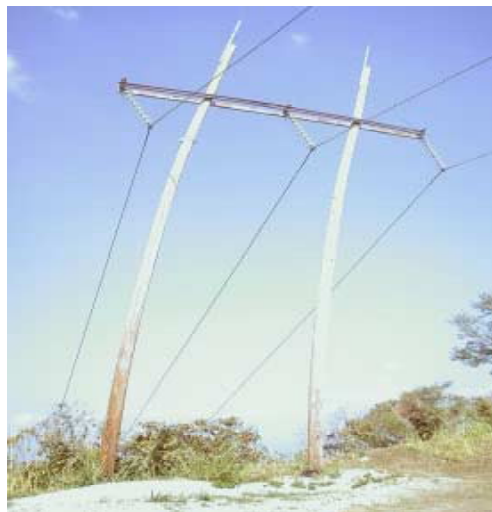
Figure 4.15. Tilted plane frame of the Nuevo Cuscatlan–Santo Tomas 115 kV line

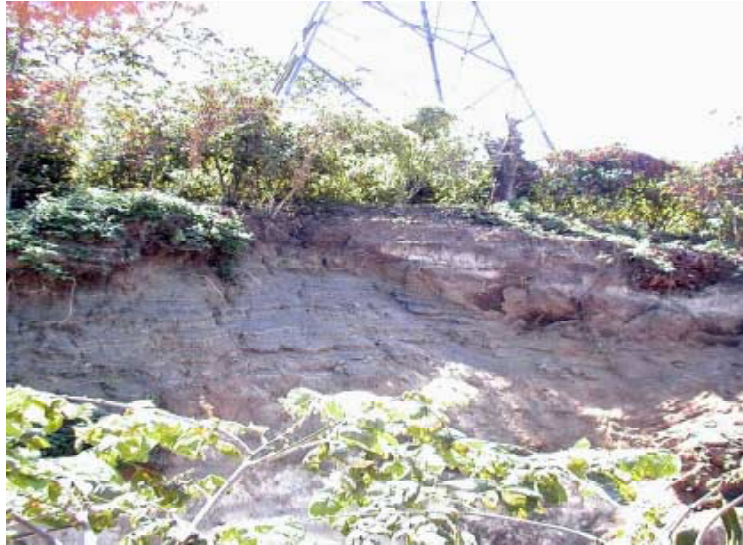
Figure 4.16. A slope failure about 4m off a transmission tower: Foundations of the tower narrowly escaped from being carried off. The failure surface extended over 8 meters height and 12 meters wide (Nuevo Cuscatlan-Santo Tomas Line)

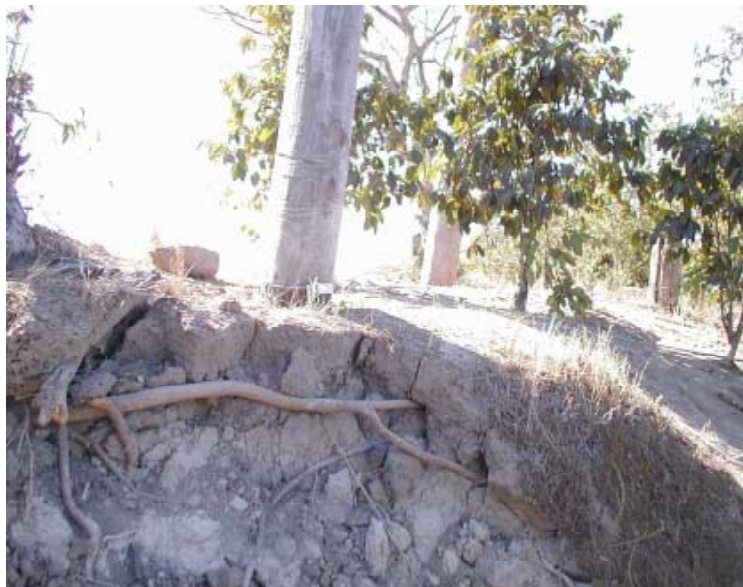
Some trees thrust their roots far and wide laterally, cracking cemented soils, and thus causing some soil blocks to come off (**Figure 4.17**).

Figure 4.17 Roots cracking soils (Nuevo Cuscatlan-Santo Tomas Line)
