Summary of Las Colinas Landslide

2.6 OTHER LANDSLIDES

2.7 SUMMARY AND RECOMMENDATIONS

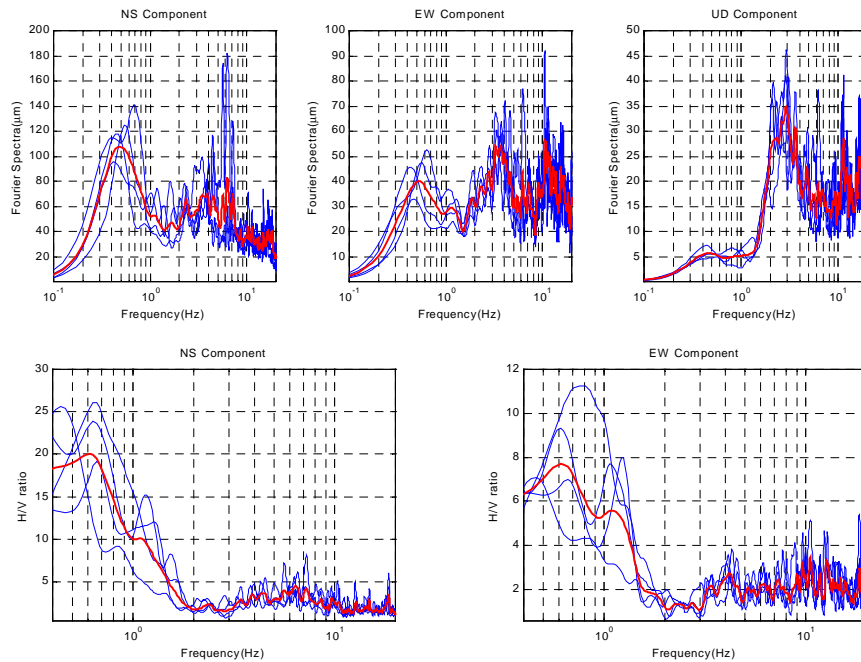
Figure 2.47. Fourier spectra of microtremors at the top of El Balsamo ridge

Fourier Spectra of three components of the tremor as well as the H/V ratios are shown in **Figures 2.47** and **2.48**. Thin (blue) lines correspond to four separate windows of 40.96sec opening and the thick (red) lines show the averages. At the top of the ridge, two peaks at 0.6 and 1.1Hz (on the H/V diagram) are distinguished for the EW and NS components, while 0.75Hz component in NS direction is predominant at the toe, and no clear peak is observed for the EW component there.

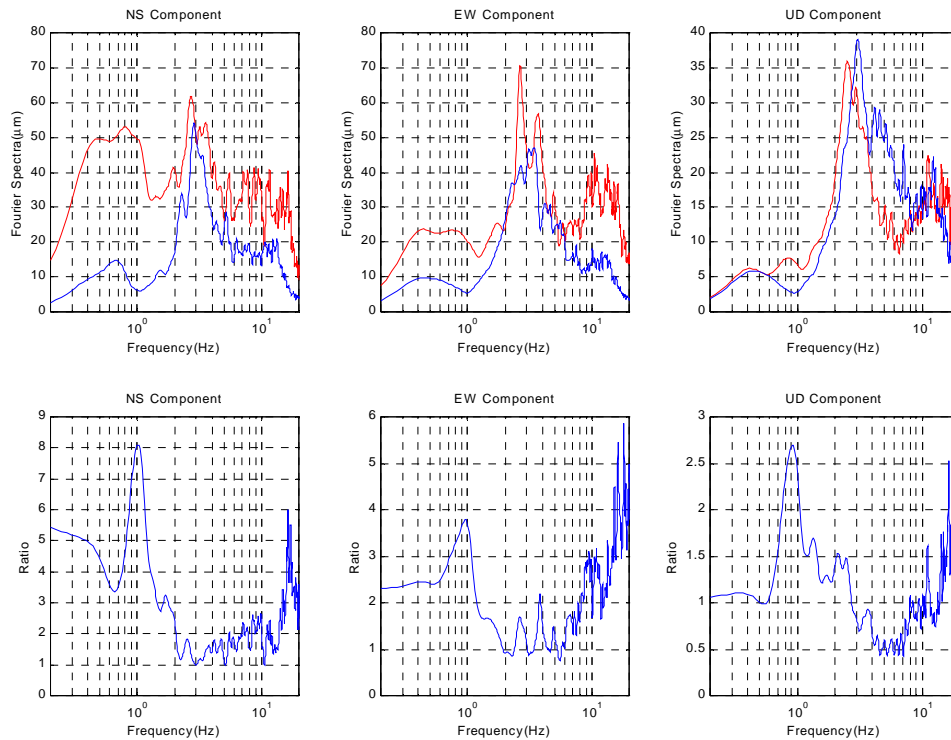
Figure 2.49 Ratios of Fourier Spectra (top of the ridge / toe of the ridge)

In order to evaluate the topographical effect at Santa Tecla, the microtremors at the top and toe of the El Balsamo ridge were compared. The Fourier Spectra of the three components at the top of the ridge were divided by the corresponding components at the toe. The results are shown in **Figure 2.49**. The three upper graphs depict the average of the Fourier Spectra at the top (red) and the toe (blue) of the ridge, respectively. The three lower graphs show the ratios of the Fourier Spectra (top of the ridge /toe of the ridge).

1. Fourier Spectra of the horizontal components at the top of the ridge are larger than the corresponding components at the toe of the ridge.
2. Fourier Spectra of the UD components at the top and the toe of the ridge are generally similar to each other. A slight shift of the latter towards higher frequencies can be observed.
3. NS components below 1.5Hz are about twice as large as the EW components at the top of the ridge. This is not the case for the rest of the frequency range.
4. The spectral ratio of the NS, EW and even UD components show a clear peak at around 1Hz.
5. For NS, EW and UD components, another peaks at around 18Hz can be identified.

Findings 1 and 2 suggest that lateral components of the ground motion have been amplified at the top of the mountain ridge due to the topographical effect, and from **Finding 3**, the effect was more pronounced in the transverse direction of the ridge. The fundamental resonance frequency of the ridge is considered to be about 1Hz judging from **Finding 4**.

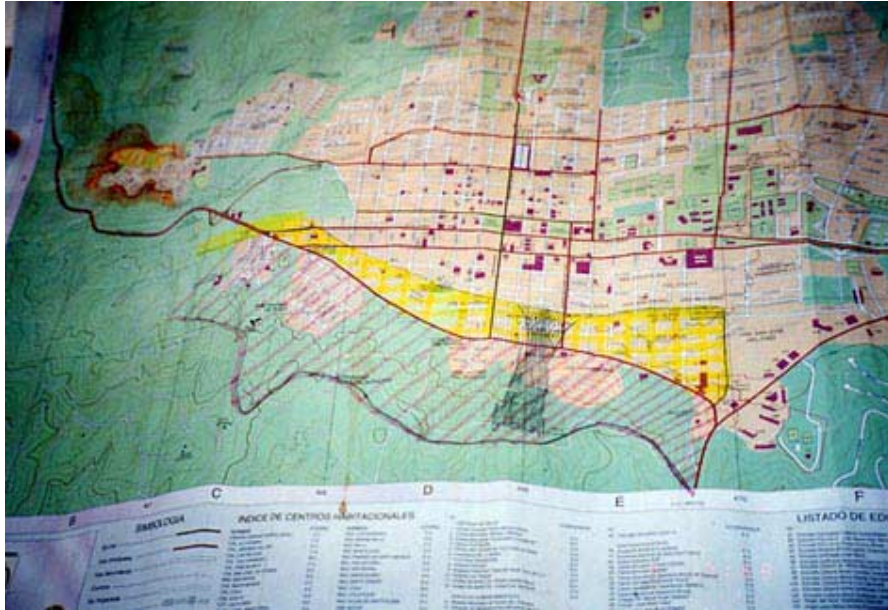
Figure 2.50. Zones of potential risk

Extensive cracks remaining along El Balsamo ridge are certainly the serious threat of further slides. The city of Santa Tecla was controlling the potential hazard zones, the red zone with the highest risk and the yellow zone of slightly less danger (**Figure 2.50**). A week after the earthquake, the number of residents evacuated from the zones exposed to the menace of possible landslides reached 14,000, and as of Feb. 3, about 4,000 refugees were still being forced to live in tents (**Figure 2.51**). Since the rainy season starts in April or May, necessary countermeasures should be taken because even flat-lying areas away from sudden changes in slope angle may be still within the possible reach of the soil mass. Recommendations will be given in Section 2.6.

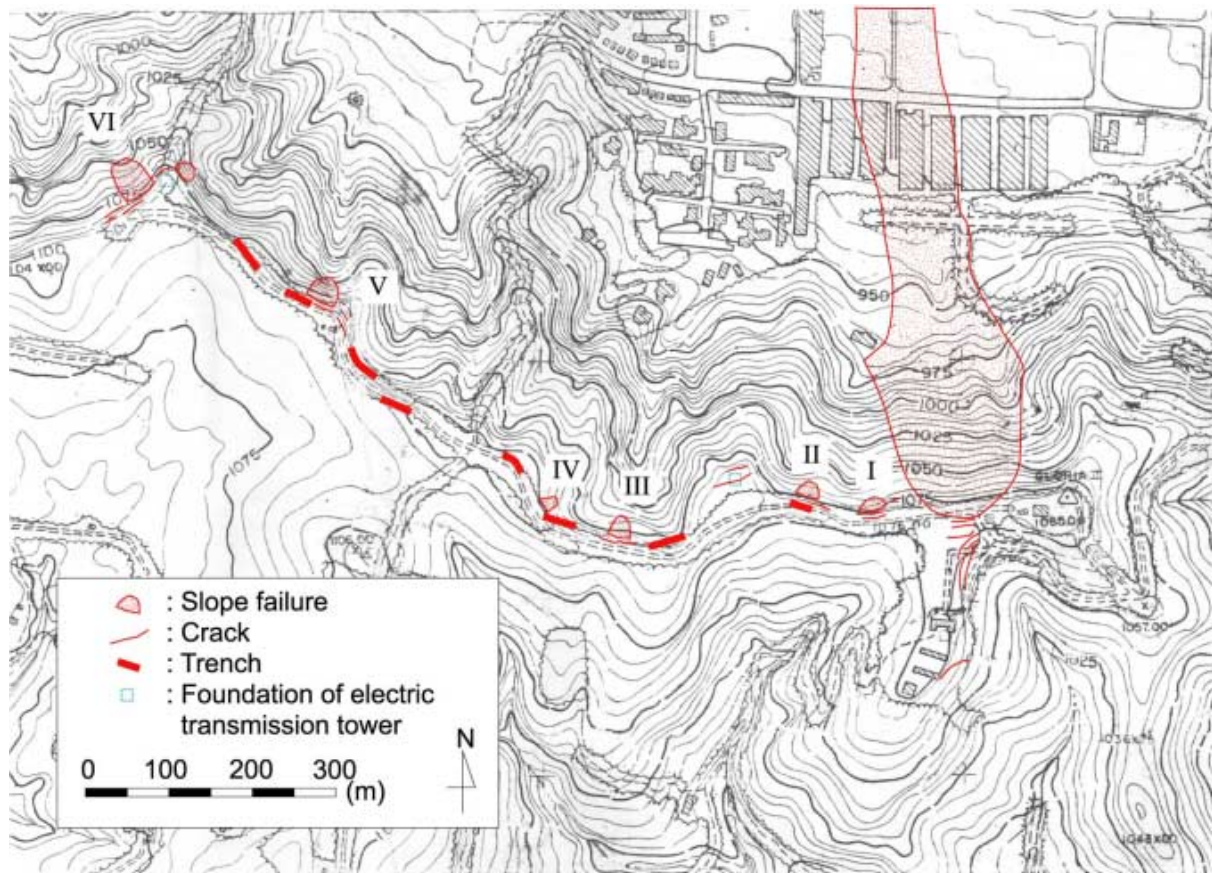
Figure 2.53. Slope failures along El Balsamo ridge (Topographical map: Ministerio de Obras Públicas, 1970)

El Balsamo ridge rising south behind Neuva San Salvador is shown in **Figure 2.53** (Ministerio de Obras Públicas, 1970). Red spots and lines at the top or along the nose of the ridge show landslides and cracks. The largest red zone is the Las Colinas landslide. Since the north slope of the ridge is much steeper than its south side, slope failures were found on its north side. Salvadorian army took a quick action of excavating trenches (thick red lines in **Figure 2.53**), and they were all grouted with soil cement to stop water soaking into the soils. The sizes of these slope failures are roughly described in **Table 2.6** in terms of their heights and widths measured by using a laser rang finder.

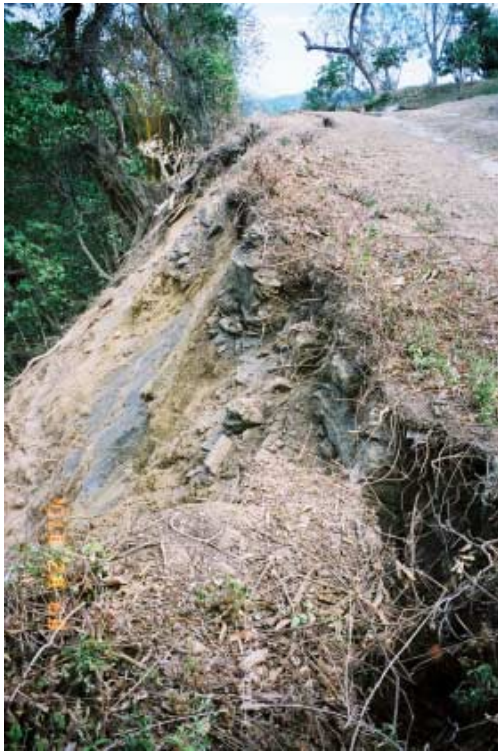
Figure 2.54. Slope failure at **Site III**

Figures 2.54-2.56 show a slope failure at **Site III**, 22.3 m wide, and 32 m long, on a steep slope of about a 45degrees inclination. A longitudinal crack was open wide and deep along the nose of the ridge (**Figure 2.55**) The slope shows a stratified soil arrangement with a top lapilli tuff layer (dark bluish gray) of about 90 cm thickness overlying a pumice soil deposit (grayish ocher: see **Figure 2.56**). A couple of thin lapilli tuff films were bedded in the pumice. The pumice grains that came off the intact surface are rather coarse (1.2 mm×2.3 mm×3.5 mm, 1.3 mm×2.3 mm×3.5 mm, e.g.). The stratified soil arrangement with the inclusion of weak pumice might be the cause of this slide.

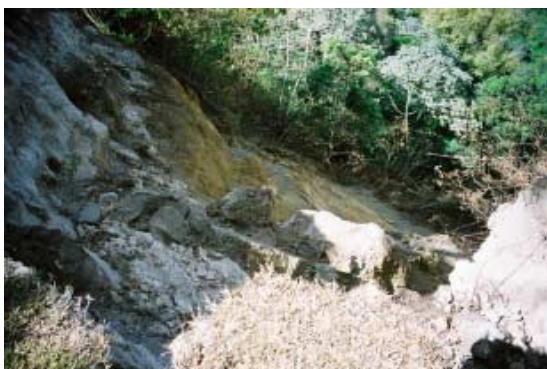
Figure 2.57. Slope failure at **Site VI**

Figures 2.57-2.58 show an about 30 m wide and 51 m long slope failure at **Site VI**. The soil exposed on the top terrace is a pyroclastic flow sediment of 2.5 m thickness overlying a pumice sediment. The stratified structure is about the same as those abovementioned. Some cracks appearing close to the nose of he ridge were 1.3 m wide and 1.0 m deep e.g. (**Figure 2.58**).

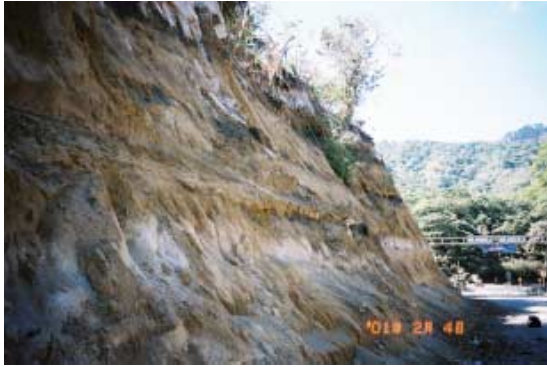
A number of slope failures occurred on slopes excavated for the Pan-American Highway in Los Chorros area. The exposed failure surfaces are classified in the following three geological categories: 1) stratified arrangement of lapilli tuff and pumice (**Figure 2.59**), 2) pyroclastic flow sediment (**Figure 2.60**), and 3) fresh volcanic rock (**Figure 2.61**).

Figure 2.59. Failure surface exhibiting an arrangement of volcanic products in strata. Two lapilli tuff layers (dark gray) lie between the loose pumice soil sediment (ocher).

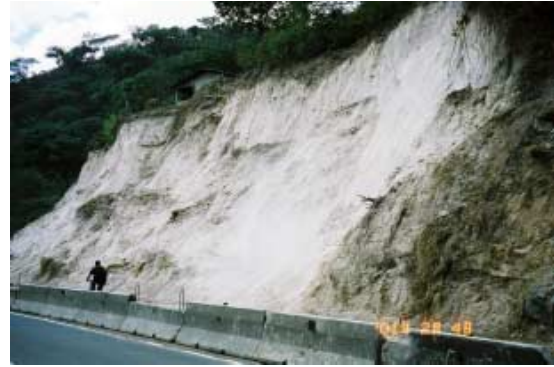
Figure 2.60. Exposed failure surface of pyroclastic flow sediment.

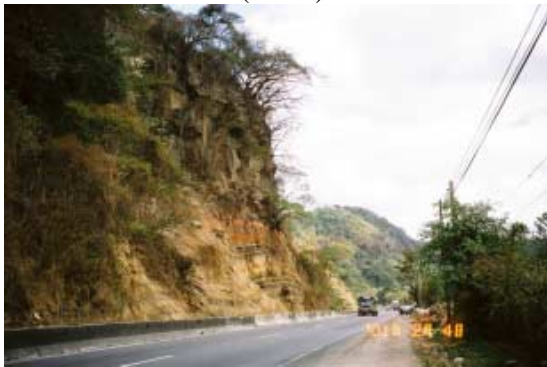
Figure 2.61 (left) Slope failure on fresh volcanic rock

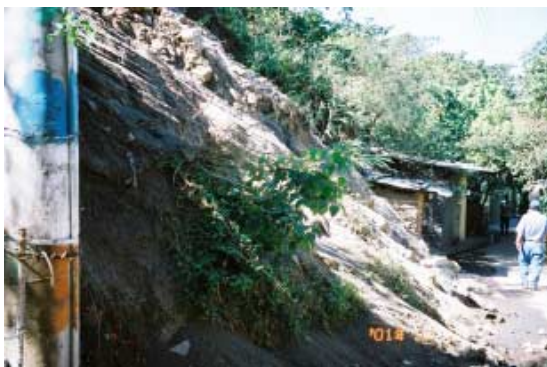
Some slope failures took place at Nueva Cuscátlan. **Figure 2.62** shows the largest one among them, 19.5m wide and 6 m high, on an about 50 degrees slope of weathered lapilli tuff (dark gray). Two adobe houses were broken under the slid soil mass. Some cracks were found wide open along the nose of the mountain ridge cutting roots of coffee trees, while a pressure ridge of about 22 cm high was found around the toe of the slope (**Figure 2.63**).

Figure 2.62. Slope failure on weathered tuff

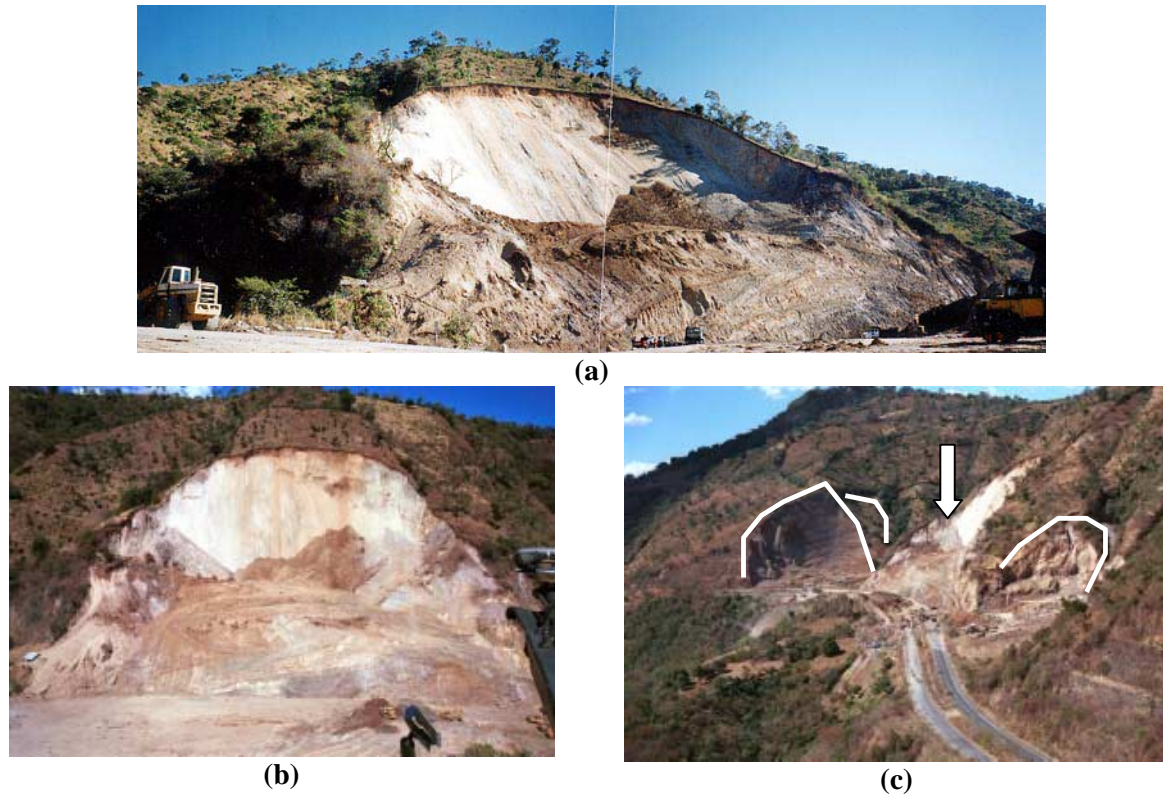
Figure 2.64. San Vicente landslide

At the 53rd km of the Panamerican Highway, in San Vicente, a slid soil mass blocked the road (**Figure 2.64 (a),(b) and (c)**). Three-dimensional shape of the slip surface (hollow) was measured by using a laser-rangefinder (**Figure 2.65**), and the volume of the slid soil mass was roughly estimated to be about 300,000 m³. A dipping joint surface seems to have served as a slide plane. It is noted in **Figure 2.64(c)** that there are some suspect old scarp-like marks (white curves) recognized on both sides of the slide. Some cracks were found further above the upper end of the scar.

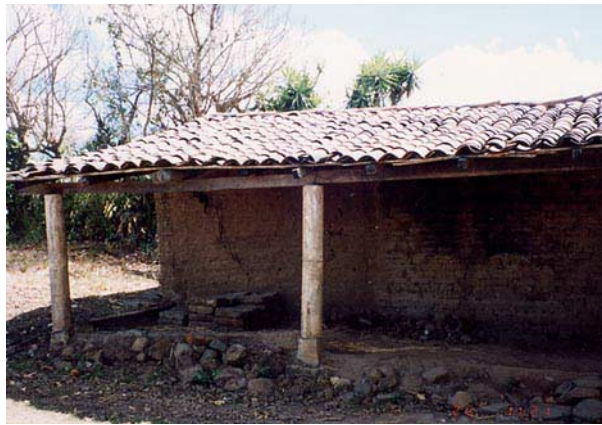
Figure 2.66. Bahareque house near San Vicente landslide

Figure 2.66 shows bahareque house near San Vicente landslide. This bahareque house, standing on the terrace high above the headscarp of the slide, performed quite well, though it suffered some diagonal shear cracking.
