5. TRANSPORTATION FACILITIES

5.1 Railways

5.2 Roadways and Highways

5.3 Railway and Roadway Bridges

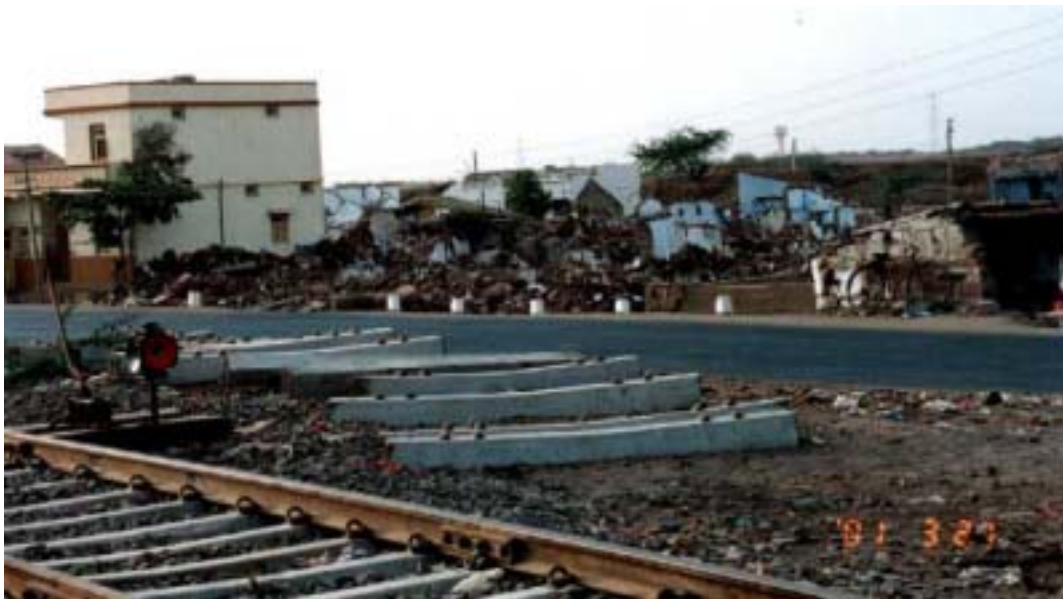
Damage to railway tracks was observed in the form of bending and distortion of rails and tracks due to ground shaking and deformation (Figure 5.2). This situation could be clearly observed at Gandhidham railway station (Figure 5.3). There were three railway lines at this station. Two of them were under construction. It was apparent that some rails were bent or were offset although they were repaired after the earthquake. The restoration of tracks of railway segments are as follows:

Figure 5.2 Restored railway line in Ratnal (note the damaged railway ties)

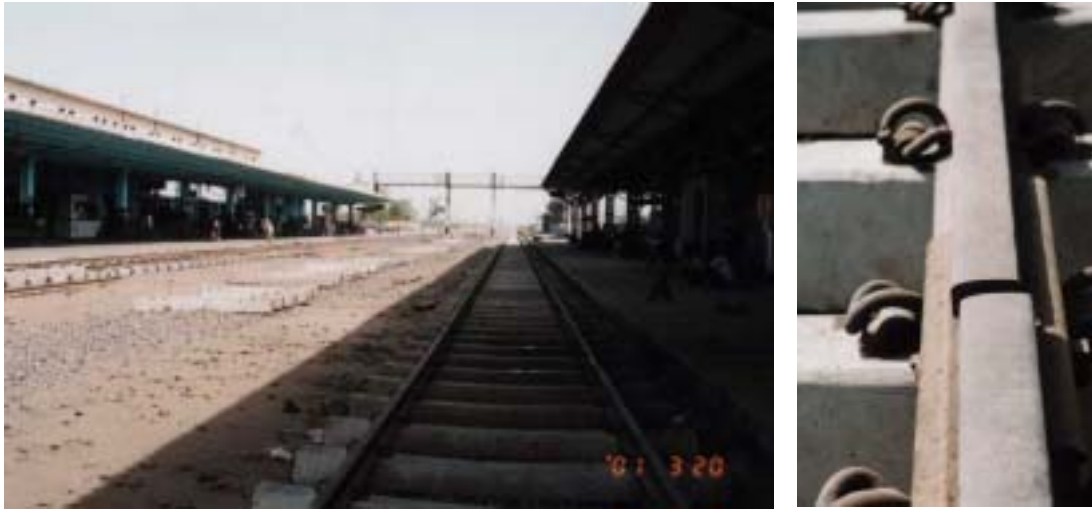
Figure 5.3 Railway lines in Gandhidham station and a close-up view of distorted rails

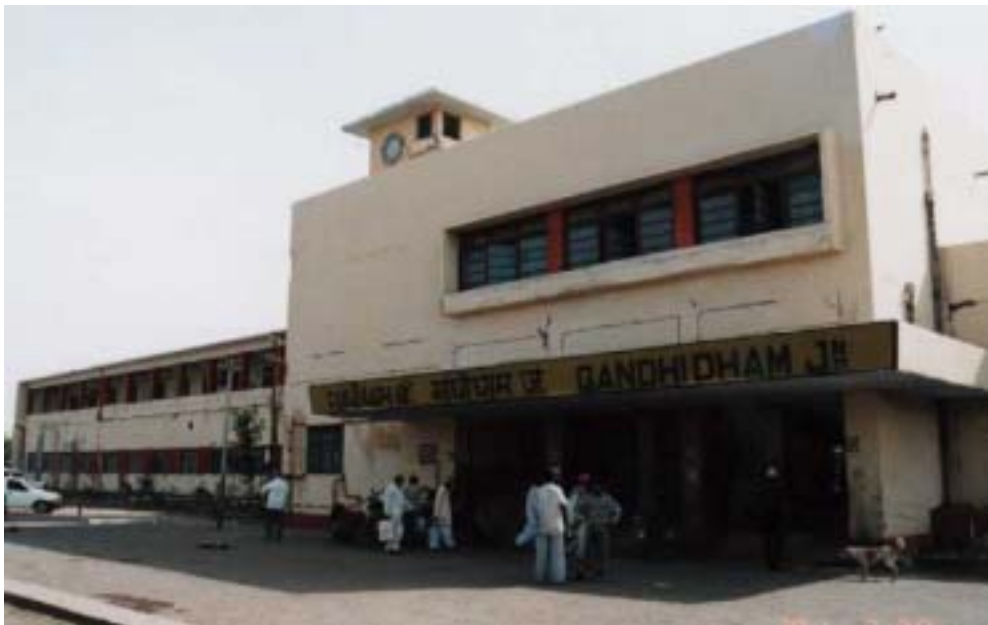
20 railway stations across Kutch were damaged as a result of the earthquake. Gandhidham station was the worst-hit. Gandhidham railway station was an RC structure and some structural damage was observed (Figure 5.4).

Figure 5.4 Damaged Gandhidham railway station

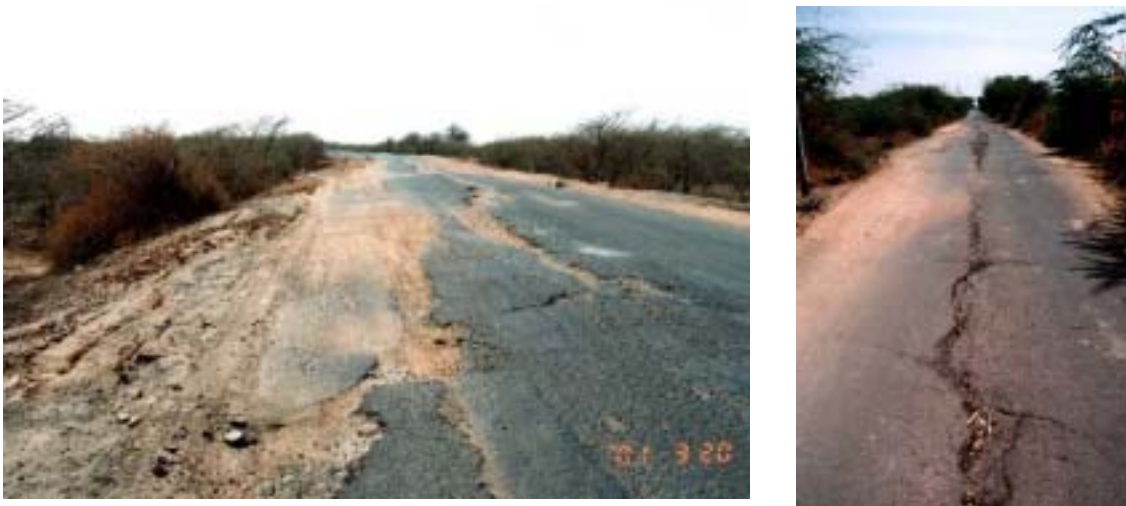
Figure 5.6 Damaged roadways due to ground deformation

Figure 5.5 shows roadways and highways in Kutch region. Out of 650 Kms of highways, 100 Kms severely damaged. Most of roadways had to be re-surfaced due to extensional and bulging type cracking (Figure 5.6). Furthermore, the settlement of embankments of bridges caused differential settlement and slow down of the traffic (Figure 5.7). In some places, the traffic had to be diverted for the repairment of embankments. The toll-gate buildings of the highway 5A were broken at their base columns (Figure 5.8).

(a) Bachau-Bhuj roadway

(b) Roadway to Manfera

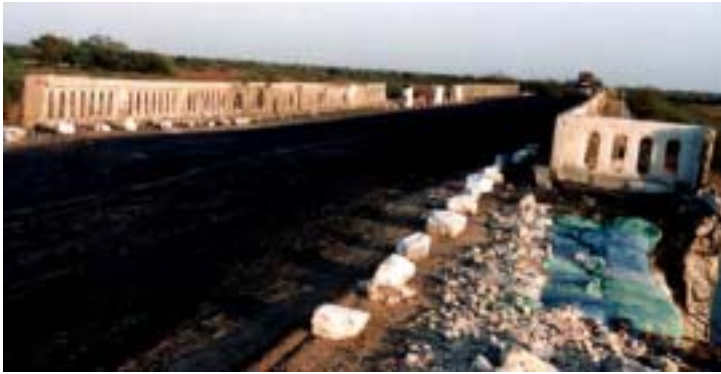
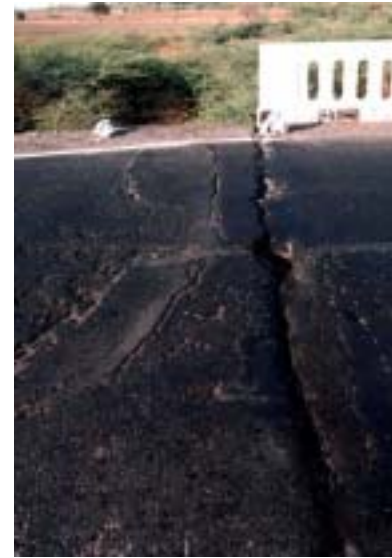
(a) Damaged bridge on Kankawati River

(b) Settlement

Figure 5.7 Settlement of roadway at a bridge on Kankawati River (7km to halvad)

The bridge has 10 span and each span is 6m wide. Piers are masonry (Figure 5.7). Each pier is 1.3m thick and 7.3m wide. The girders moved in the direction of N75E.

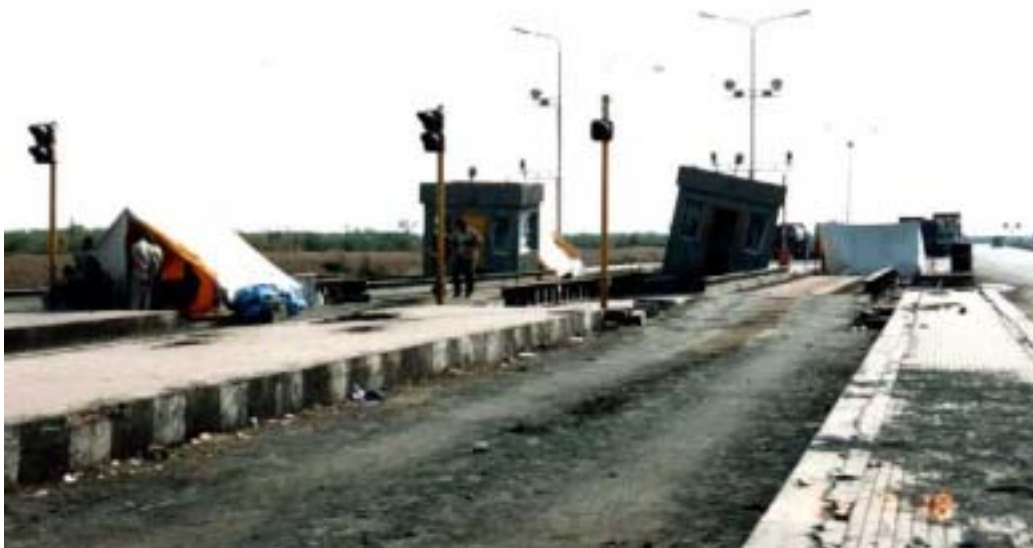
Figure 5.8 Collapsed toll gate of Highway 5A nearby Bachau

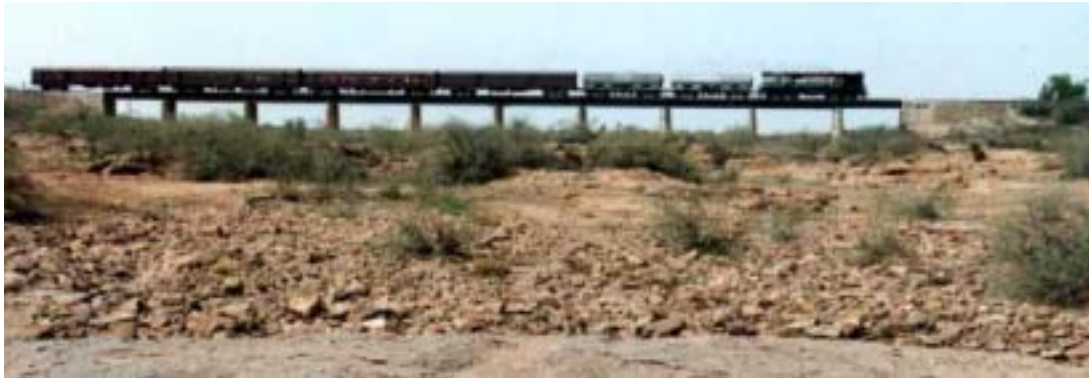
Except a few bridges, railway bridges were almost not damaged. At a railway bridge 7km from Halvad (100km from the USGS epicenter) there was no visible damage while some damage to roadway bridges at the same location was observed (Figure 5.9). The direction of the bridge with 10 spans was EW. Its height was 5m with a span of 12m. The piers were concrete with dimensions of 1.5m in thickness and 7m in width. The only reported damage occurred at Bridge No.45 between Kukma and Bhuj and it was restored on 3rd Feb., 2001.

Figure 5.9 Non-damaged railway bridge on Kankawati River (7km from Halvad)

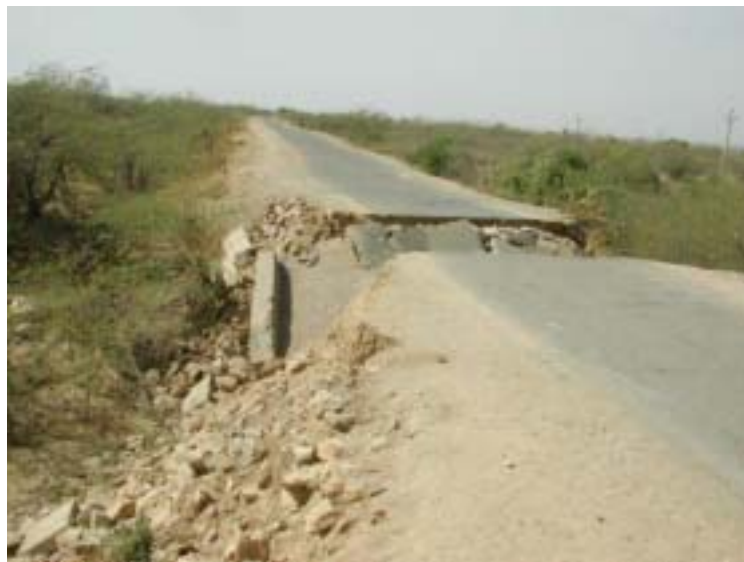
Most of the minor/major roadway and highway bridges in Kutch region were damaged (Figure 5.10). Paraphets of the minor and major bridges were totally or partially toppled or displaced in the entire region affected by the earthquake.

Figure 5.10 Collapse of a minor roadway bridge (Oyo corporation)

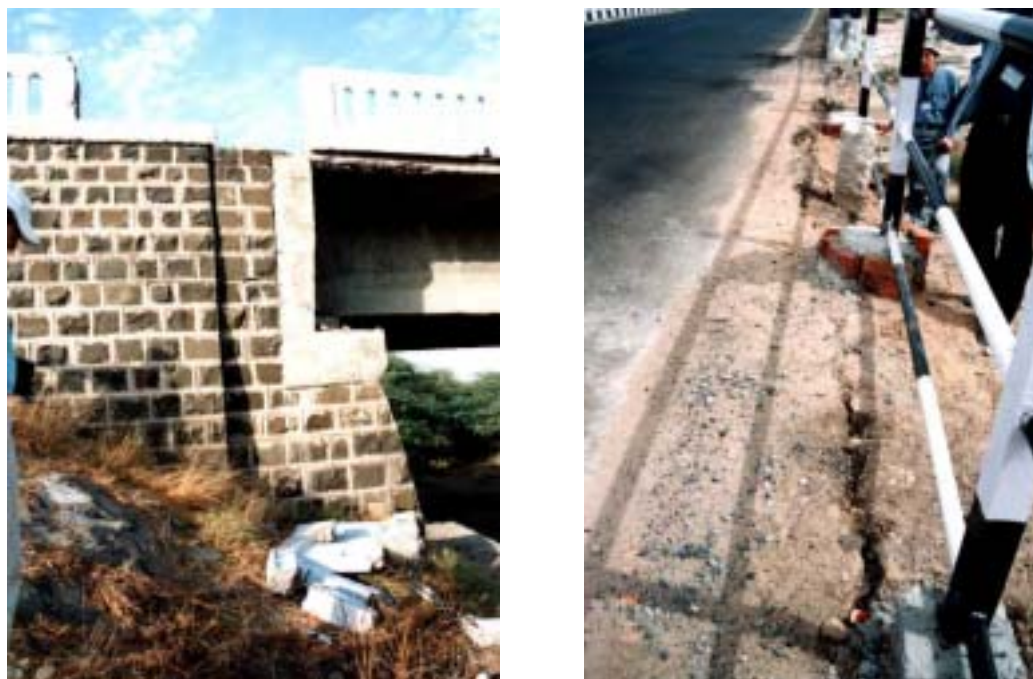
The bridge has 3 spans which are 25m wide. The embankment failure occurred and liquefaction and lateral spreading of ground nearby the bridge were observed (Figure 5.11).

Figure 5.11 Damage to parapets and settlement of bridge over Macchu River

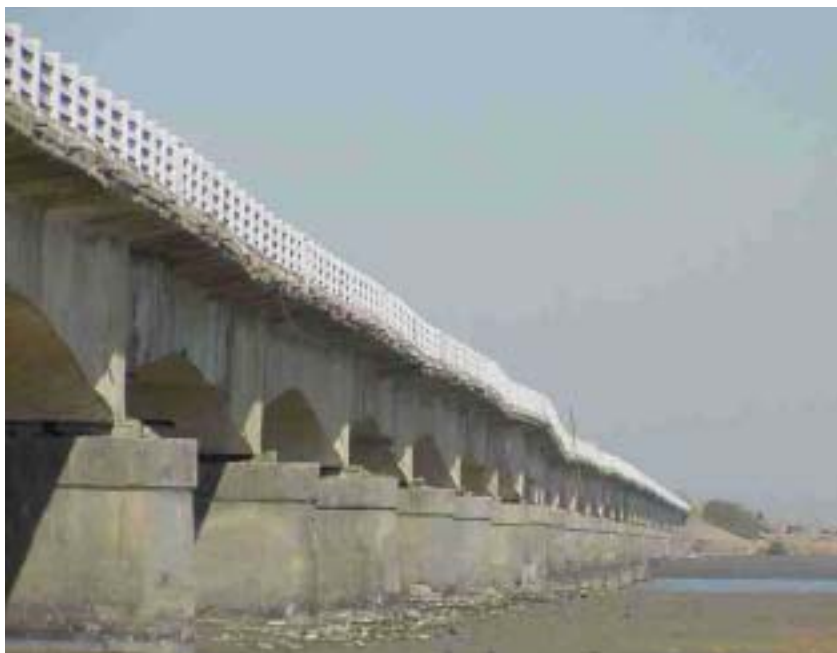
The bridge has 30 spans and is of Gerber type. The length of each span is 32.2m. The bridge has caisson type foundations over the Little Rann. The bridge is either uplifted or its northern embankment settled by 60cm. The bridge seems to be subjected to

compression along its longitudinal axis which is aligned in the direction of almost NS. Extensive liquefaction and lateral spreading were observed and a very long ground rupture with a strike of N50E was observed in the ground on the western side of the bridge.

Figure 5.12 Damage to Hadakiya Bridge (Suraj Bari)

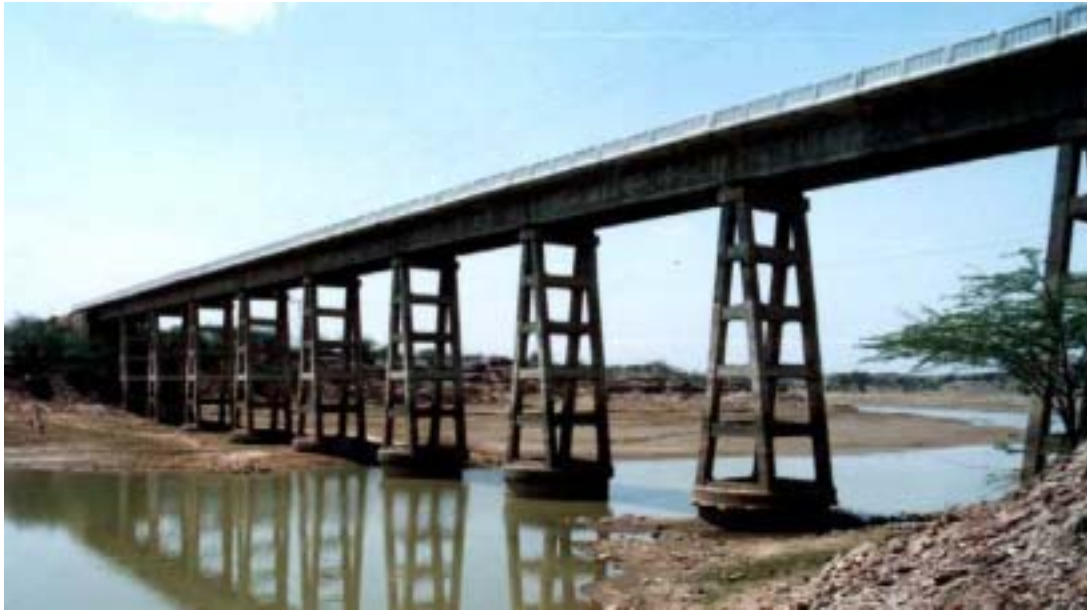
This bridge spans over the reservoir of Rudramata earth-fill dam. Its total length is about 120m and it consisted of 10 spans (Figure 5.13). Bridge footings were placed on piles. The length of piles are not known. The soil at both sides of the settled and spread towards the center of the valley (Figure 5.14). Linear cracks run along the longitudinal axis of the valley. Many rock slope failures observed next to its northern embankment. Nevertheless, the bridge was structurally safe although some visible cracks on its piers and girders were observed. The quality of the concrete was poor and the corrosion of reinforcement bars were visible. In addition, some damage to girders due to collision during shaking and rupturing of parapets were observed.

Figure 5.13 Rudramata bridge

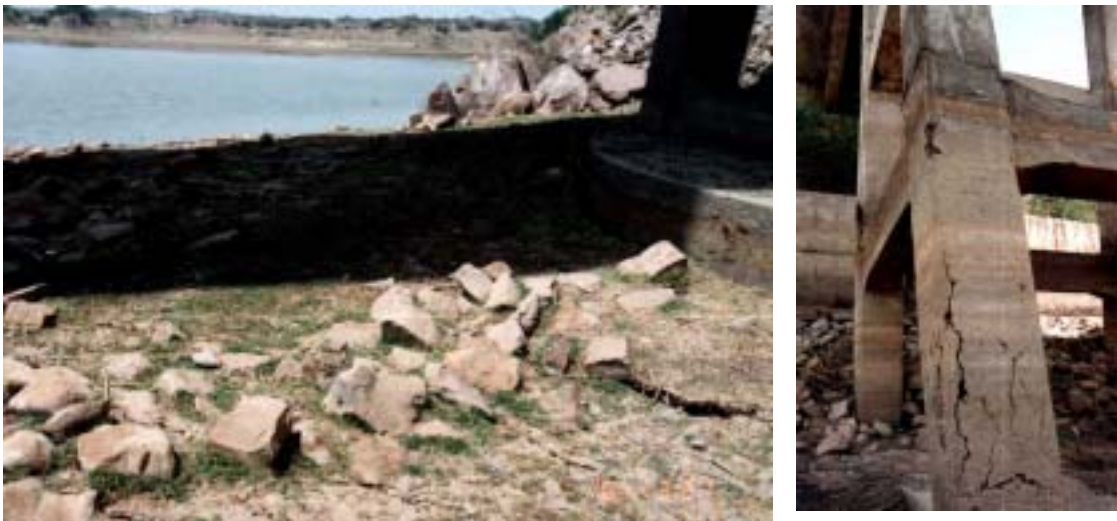
Figure 5.14 Settlement of ground around a pier of Rudramata bridge and its damaged state (note also the fallen rock blocks in the vicinity of the pier)
