5. GEOTECHNICAL HAZARDS

5.1 ROCKSLIDE

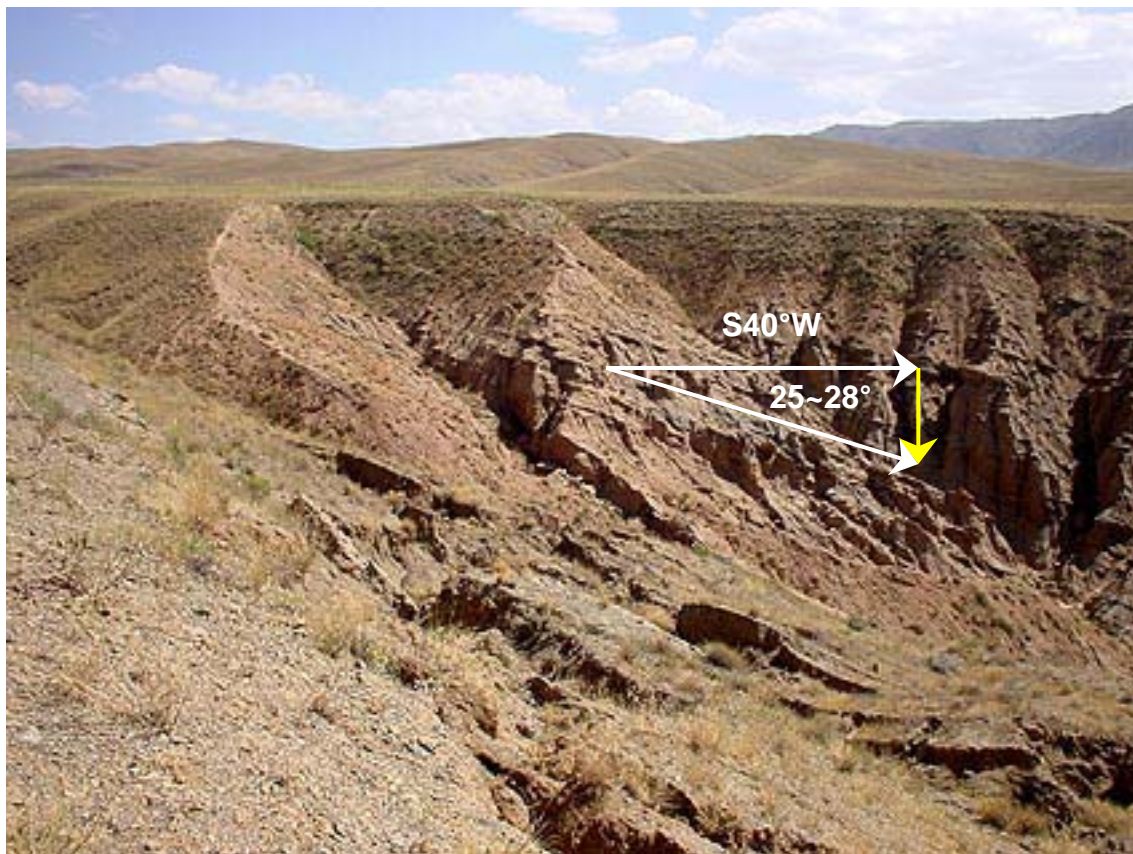
Several gorges cut deep in a terrace of silt rock, and Changureh village that has been flattened in this earthquake spreads along a rim of the terrace. On the other side of the gorge, a thin mountain ridge dips gently towards north. A rockslide took place on its west slope (**Figure 5.1**). The stratified silt rock mass with a cap rock covering its top dips about 25-28 degrees S40°W as shown in **Figure 5.1**, and the slide seemingly took place along layer boundaries.

Figure 5.1 Rockslide in the foreground and Stratified structure of the rock

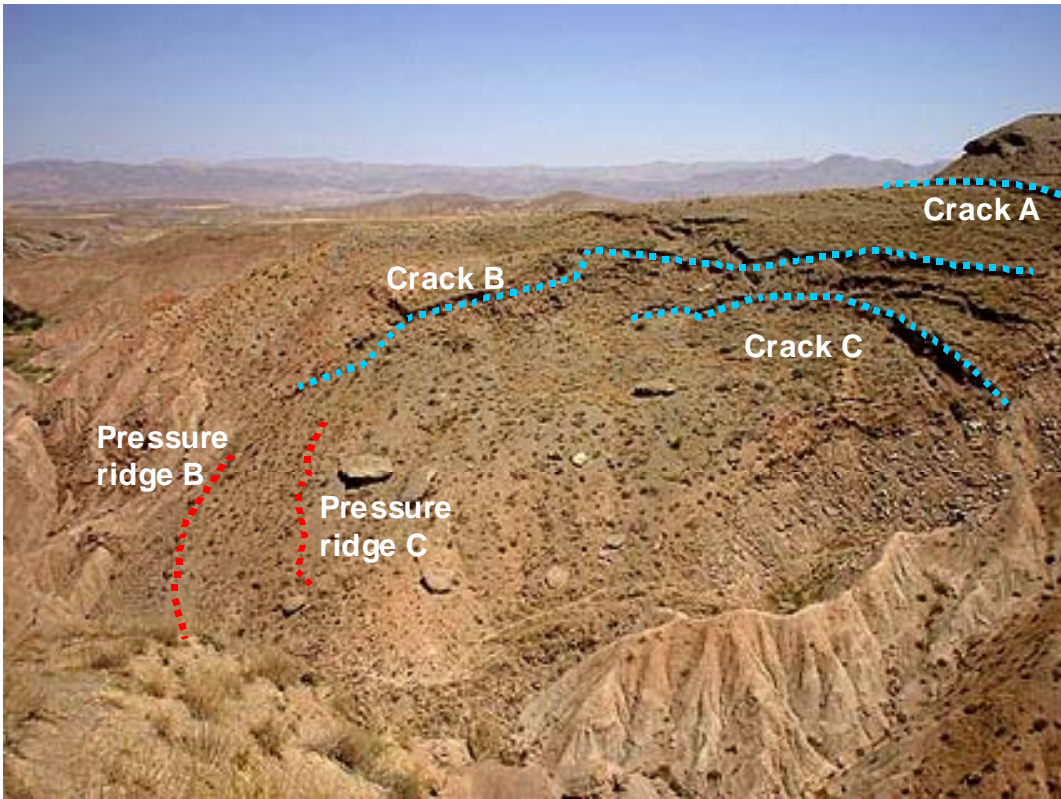
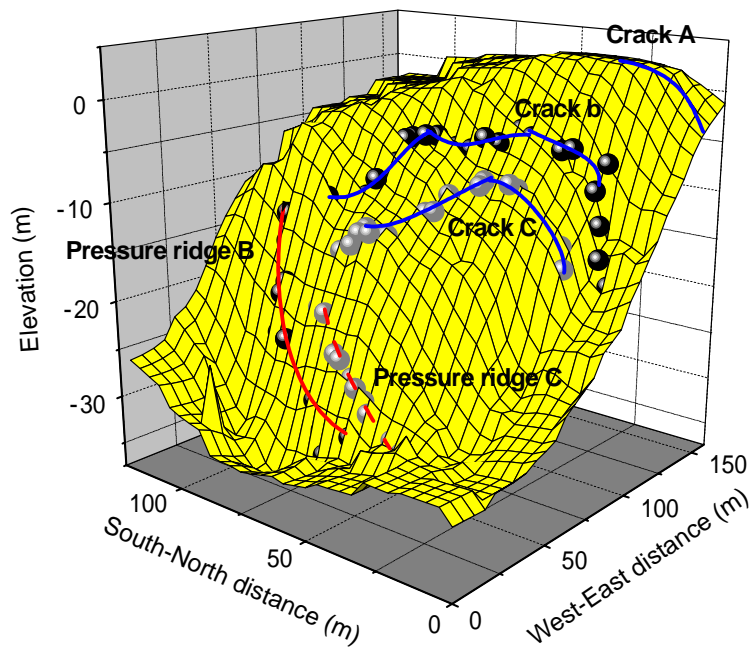
Figure 5.2 Slipped rockmass

The slid rock mass of about 150m long, 100m wide and 30m high is barely caught on the slope, and its configuration was measured by using a laser theodolite (**Figure 5.2**). The upper part of the rock mass was cracked along the perimeter of the slipped mass, and major cracks were mapped on **Figure 5.2**. The opening of cracks became wider as we came closer to the top, and the maximum opening and depth of 3.5-4 m and 5m were reached at **Point A** on Crack A (See **Figure 5.3** showing the plan of Crack A). It is noted in **Figure 5.3** that there was little difference between elevations of both sides of this crack; this fact suggests that the failure surface geometry could be planar.

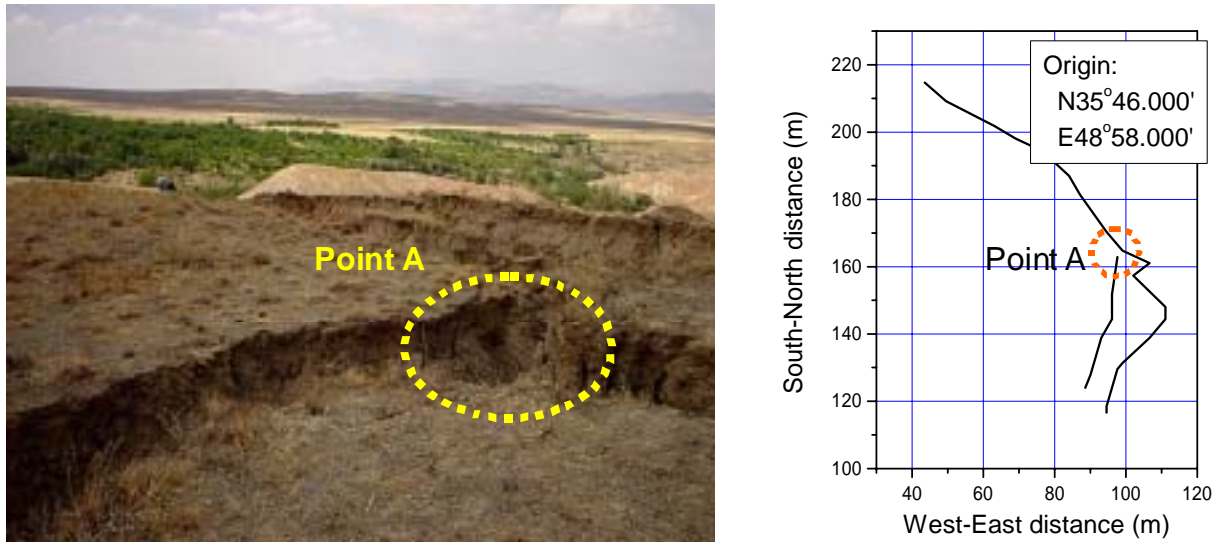
Figure 5.3 Crack A and its plan

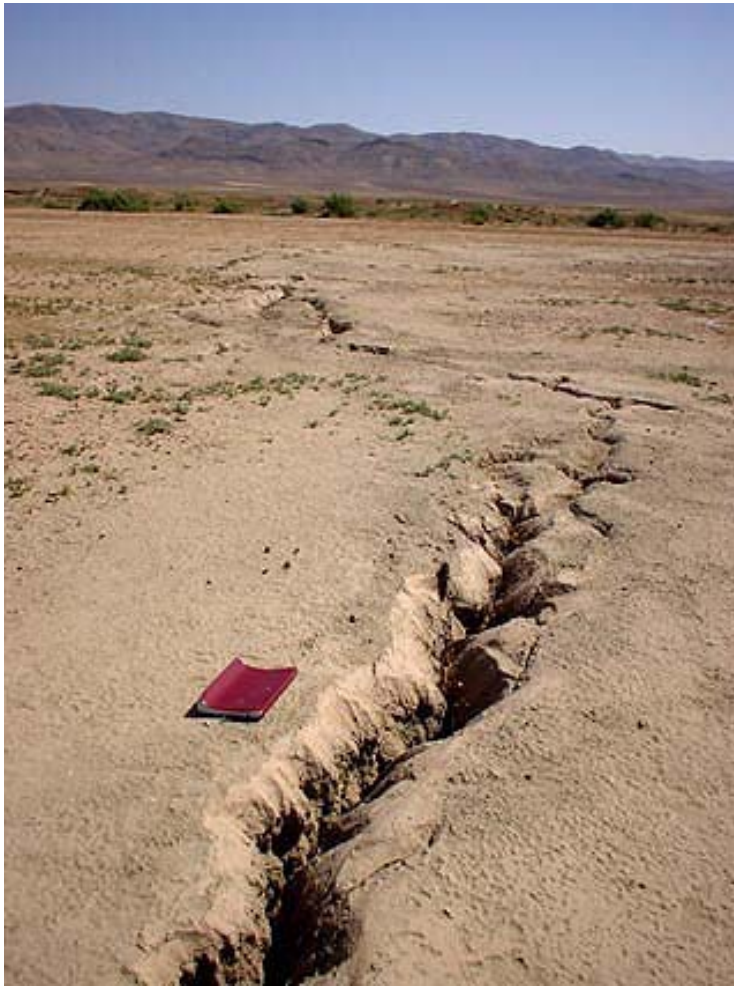
Hesar, about 5km north of Abdarreh, lies in the middle of a valley of about 15km wide extending in NW-SE direction. A liquefaction took place in a flat area of a little grassy land about 2 km northwest of Hesar (**Figure 5.4**). **Figure 5.5** shows the traces of liquefied sand. The bunch of cracks appearing across the area seems to be winding along a small river trace, which is dried up in hot weather. Soils along the crack at **Point A** are covered 5-10 cm thick with fine sand (about 0.5 mm in diameter, **Figure 5.4**), while gravels were found at **Point B** (**Figure 5.6a**). The flat mass of gravel stopped there was cut upright (**Figure 5.6b**) to discuss its possible sedimentation process. The bottom part was full of middle size grains of about 3-5 mm diameter, which was then covered thick with finer sand. And lastly, a number of bigger grains (5-15 mm) were found all over the sand mass. This fact suggests that the liquefied matter was forcibly spouted twice.

Figure 5.4 Liquefied sand at Point A

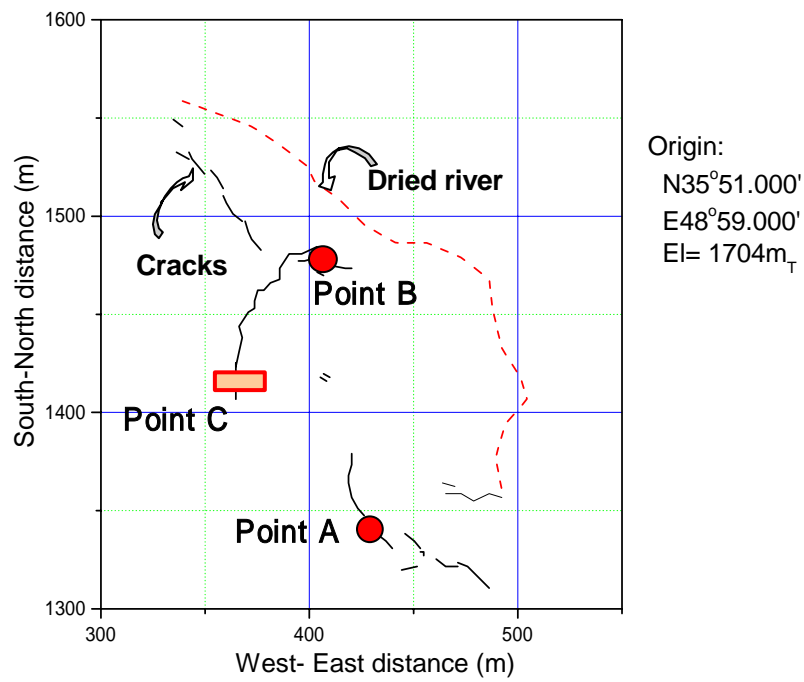
Figure 5.5 Crack mat at the liquefied area, Hesar

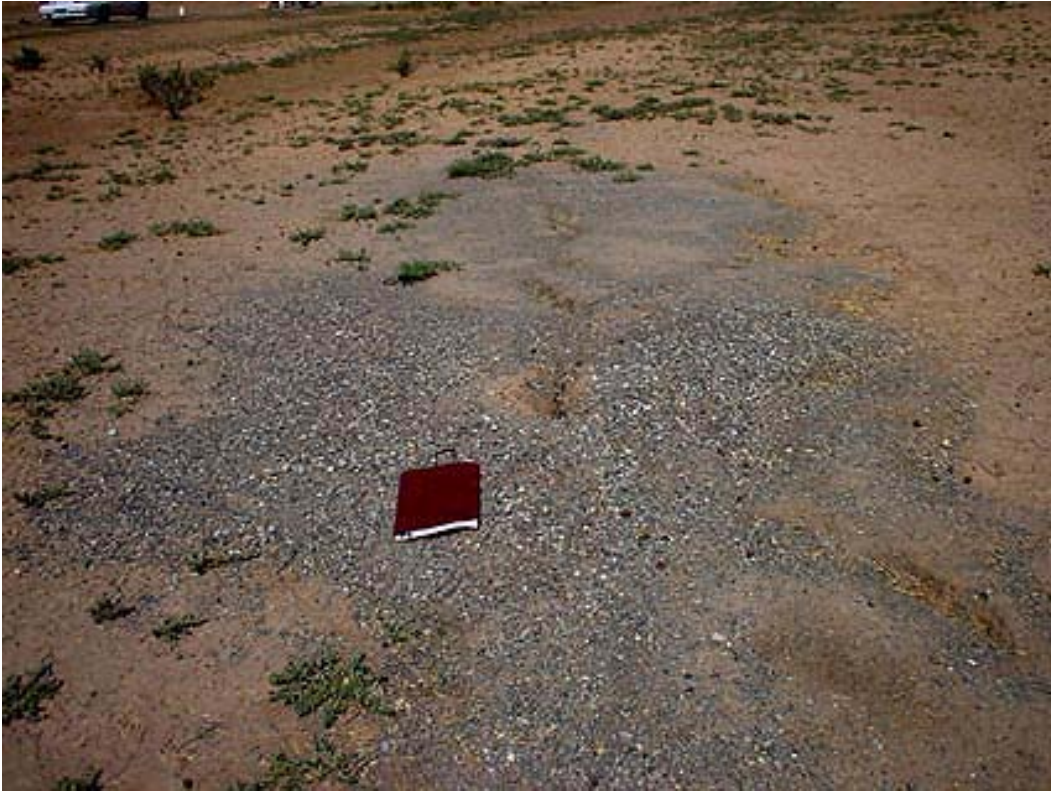
(a) Liquefied gravels

Figure 5. 6 Gravels liquefied at **Point B**

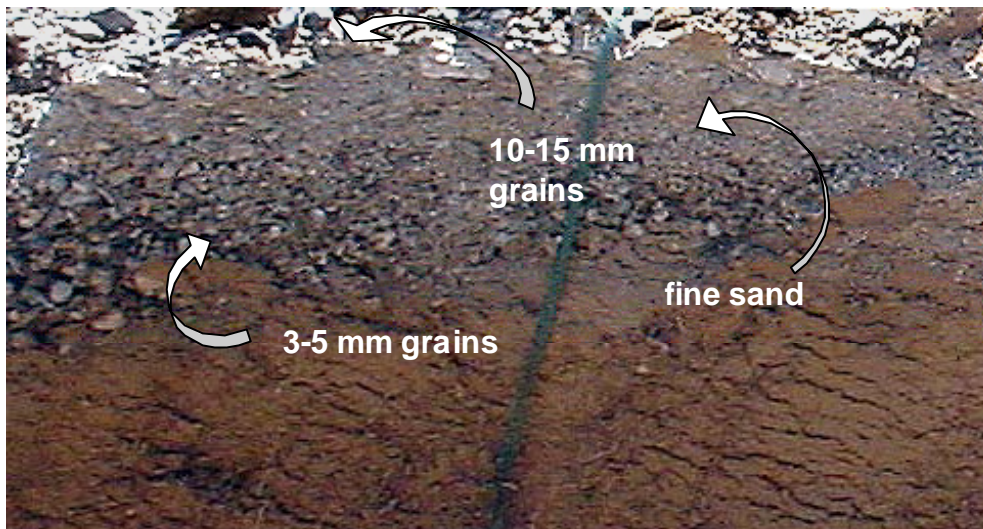
(b) Cross-section of flat mass of liquefied matters

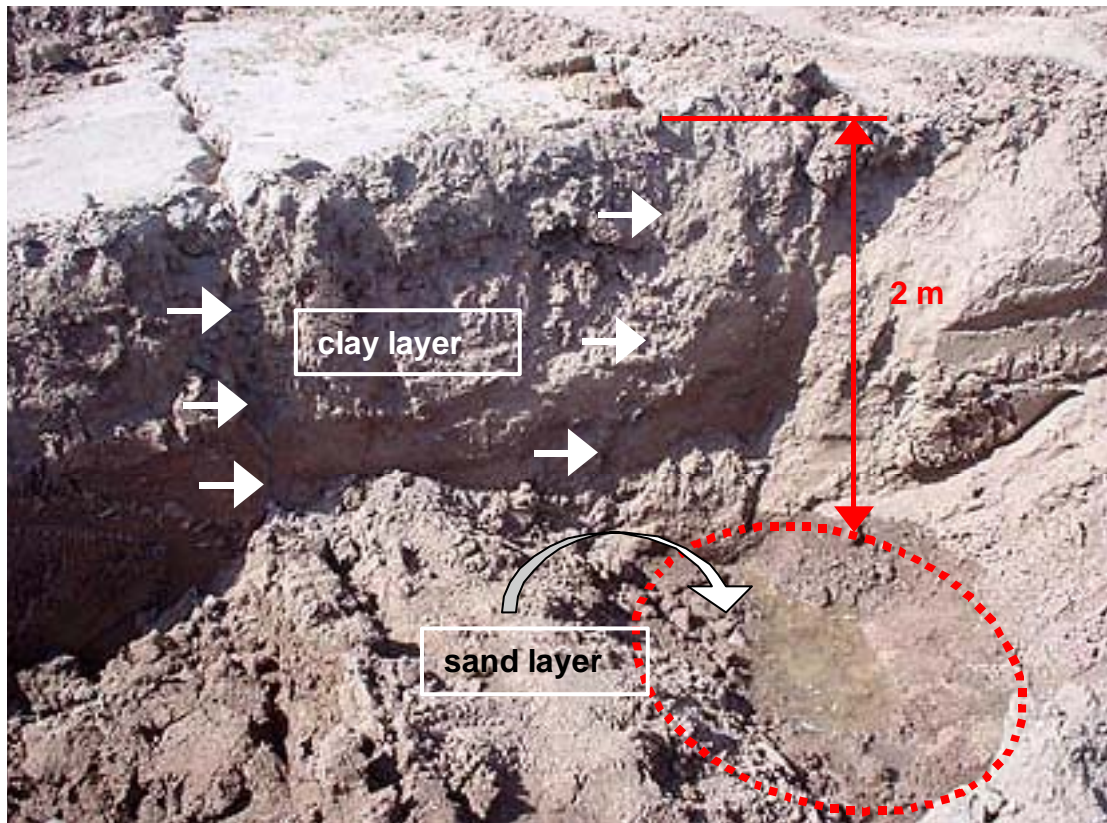
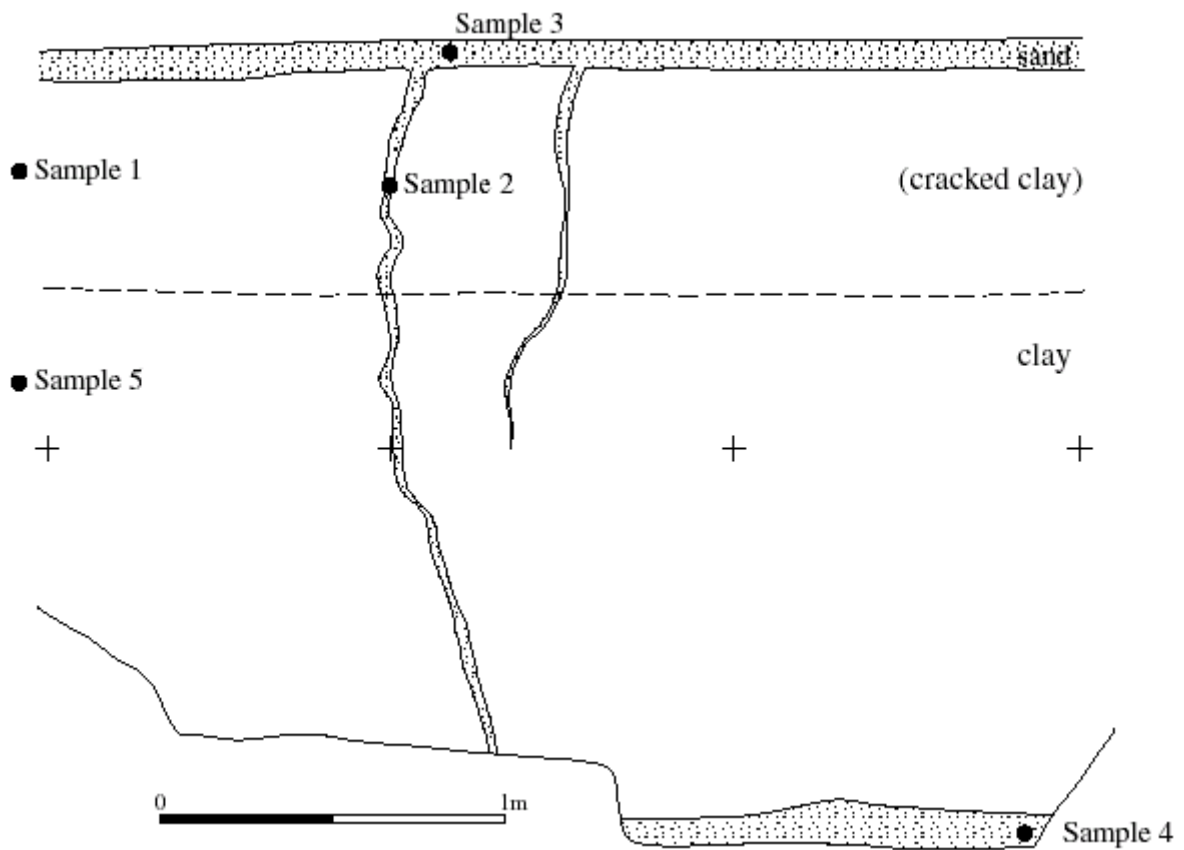
A trench was excavated at **Point C**, where the surface soil was covered thick with fine sand (0.5 mm in diameter). Several cracks were found almost upright on a stiff clay wall of the trench through which liquefied sands forced their ways up (**Figure 5.7**). There were several cracks appearing upright on the clay wall of the trench, through which liquefied sands forced their ways up. The clay layer was 2m thick lying over the completely wet sand layer.

Figure 5.7 Liquefied sand channels through clay layer

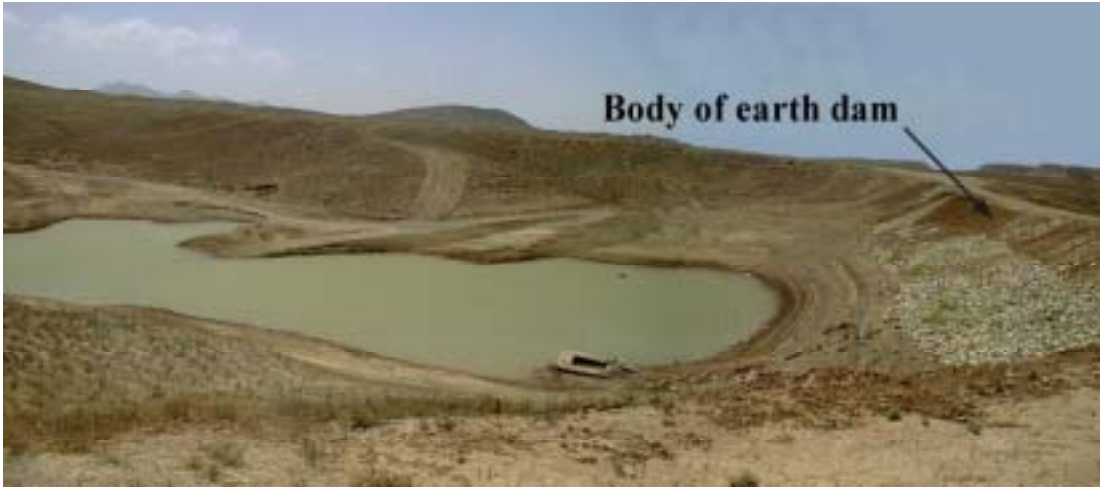
A small size earth dam, located at northwest of Abdarreah village experienced the strong ground motion caused by Changureh earthquake (**Figure 5.8**). The height of dam is approximately 10 meter. The body of this dam consists of clayey soil with no core section constructed inside. The upstream side is covered by rock fill material. Approximate cross section and layout of the dam is shown in **Figure 5. 8**.

Figure 5. 8 General view of the small earth dam located northwest of Abdarreah village

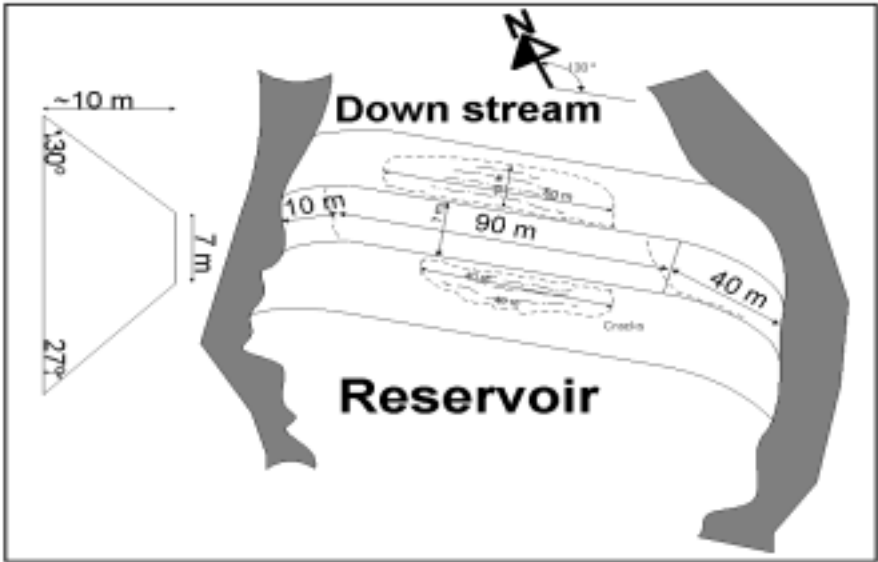
Figure 5.9 shows the general view of this dam. As it can be seen in this photograph the dam reservoir was not full at the time of earthquake. For this reason the body of dam was not water saturated. In contrast the ground at upstream and downstream sides seems to be wet and probably saturated due to the certain level of water in the reservoir. This condition can well explain the damage pattern of the mentioned dam and adjacent ground.

Figure 5. 9 Layout of the earth dam and the crack distribution on its body

The instabilities appeared in the form of some longitudinal cracks indicating failures of upstream and downstream slopes of the dam. Some minor cracks which cross the body at both end of the dam were also appeared. Figure 5.-5-1 shows the distribution of these cracks. **Figures 5.10, 11, 12, 13 and 14** also show the cracks at both sides of dam and at its two ends.

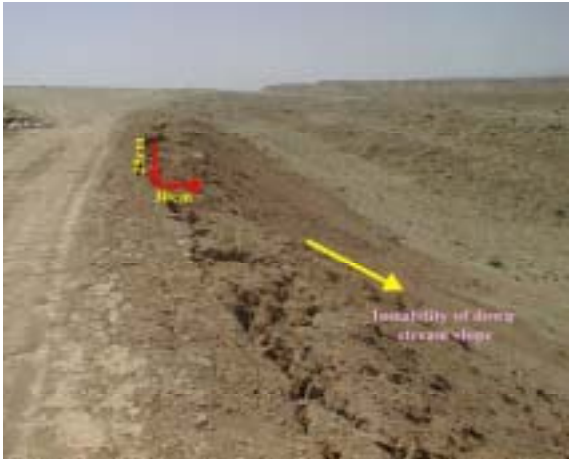
By measuring and summation of the width of all longitudinal cracks the total permanent displacement of both upstream and downstream slopes were estimated to be 56 cm and 87 cm respectively. These amounts represents the deformation of the displaced ground, whereas the amount of horizontal permanent displacements were 10 cm and 30 cm for upstream and down stream slopes as shown in photographs 4-5-2 and 4-5-3. As it is shown in Figure 5.-5-1 the size of dislocated zone at downstream side is almost 60 m in length and 10 m in its width. To estimate the maximum acceleration at the position of the dam a simple analysis based on Seed-Makdisi method is conducted. By measurement of internal friction angle of almost 30° and cohesion of ~25 KPa, using remolded soil samples obtained from the body of dam and selecting an average shear wave velocity of 400 m/sec, the maximum acceleration is approximated to be 0.16g at the ground level and 0.58g at the crest of dam which looks to be reasonable.

Figure 5.10. Instabilities at upstream slope

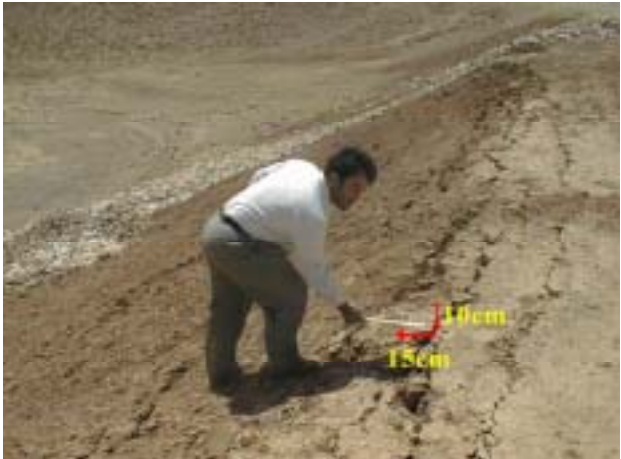
Figure 5.11. Instabilities at down stream slope

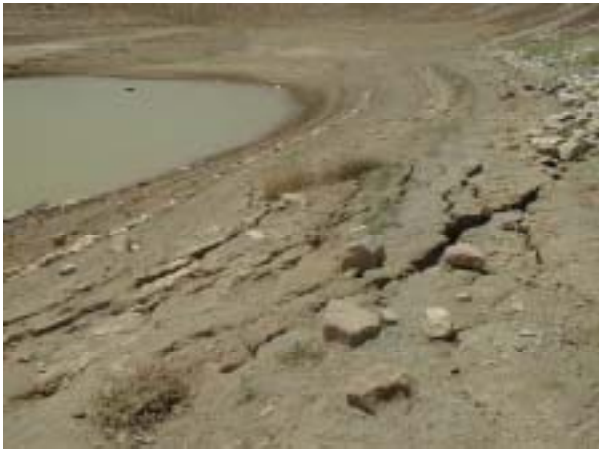
Figure 5.12. Instabilities at upstream slope from a closer view

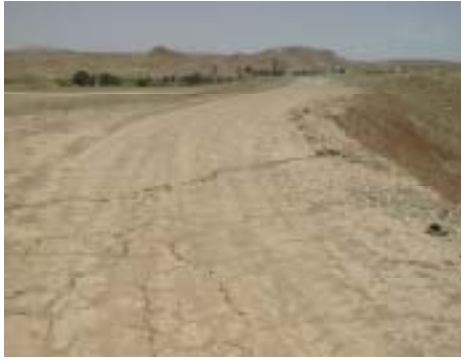
Figure 5.13. Cracks crossing the body of dam near its right abutment

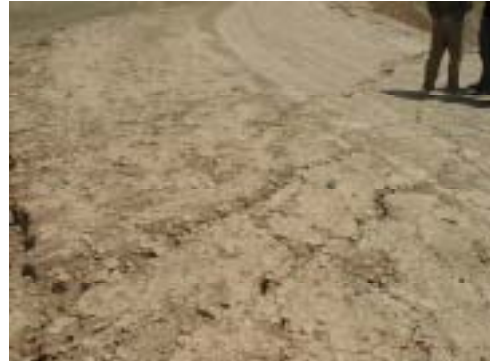
Figure 5.14. Cracks crossing the body of dam at its left abutment

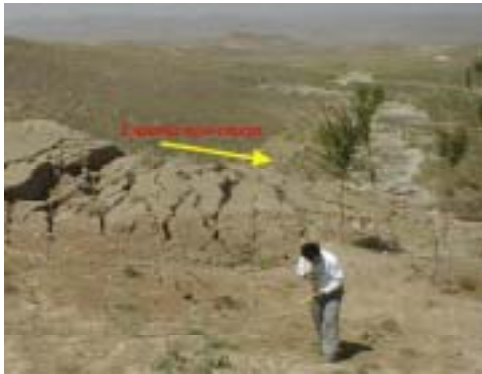
Two other types of failures are observed at two different points in the riverbank of both upstream and downstream sides. The large deformation caused by earthquake at the left bank of river in the downstream part is shown in **Figure 5.15**. A kind of slumping is occurred probably due to softening of the soil caused by reduction of effective stress. The evidence for lateral movement is the clear displacement of trees, which were located at the feet of the bank as is shown in **Figure 5.16**.

Figure 5.15. Slumping of the left bank of river at upstream side

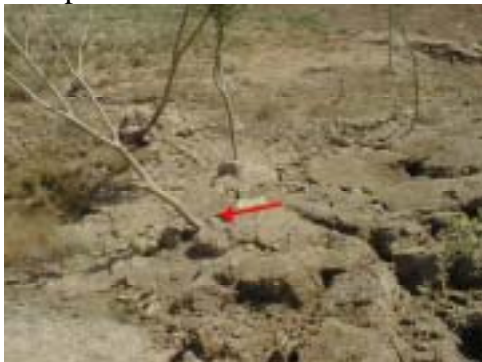
Figure 5.16. The movement of trees indicating lateral displacement of ground

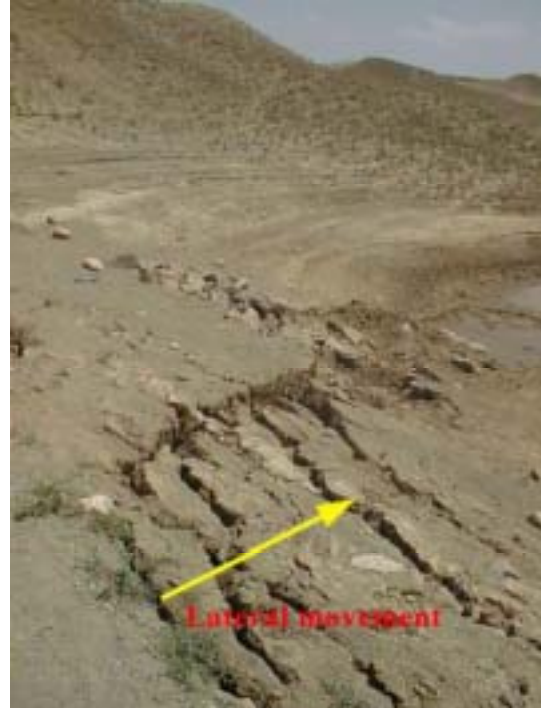
Figure 5.17. Lateral movement of left bank at upstream side

Another failure, somehow similar to that explained above, is occurred at the left river bank in upstream side. **Figure 5.17** illustrates its configuration. As it can be seen in this photograph the soil was wet and probably saturated. The cause for the lateral deformation could be the softening of soil due to reduction of effective stress.
