Japan Society of Civil Engineers

## THE BİNGÖL EARTHQUAKE OF MAY 1, 2003

**Investigated and Prepared by**

July 2003

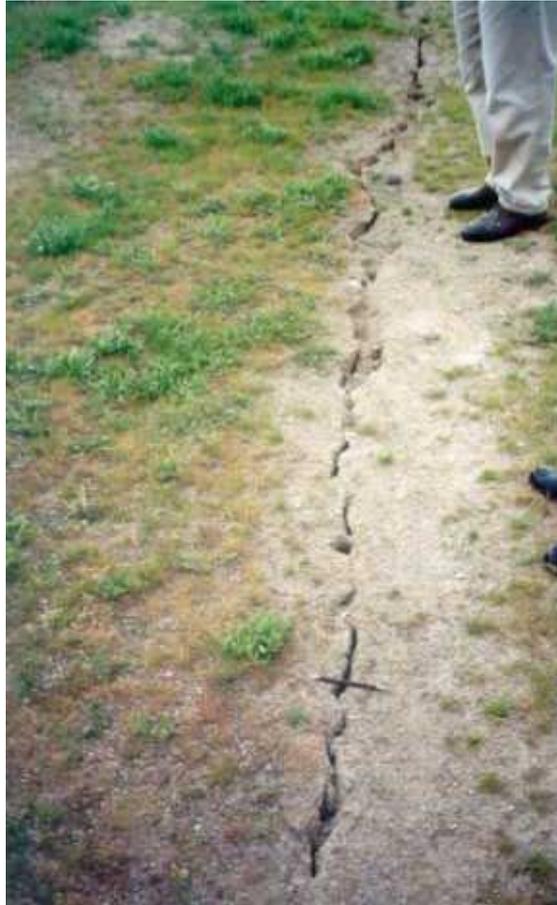
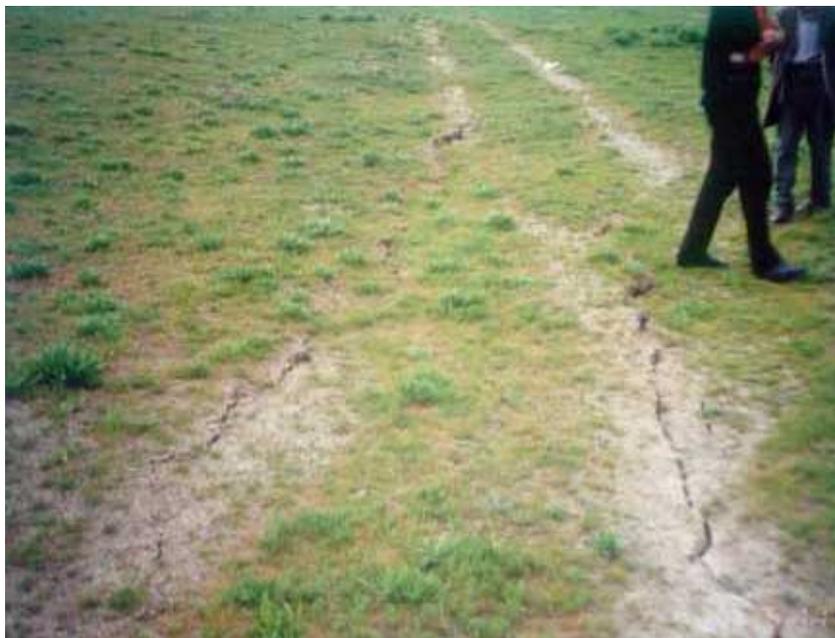
Figure 7.13: Some views of cracks at the site of lateral spread at Hanoçayırı

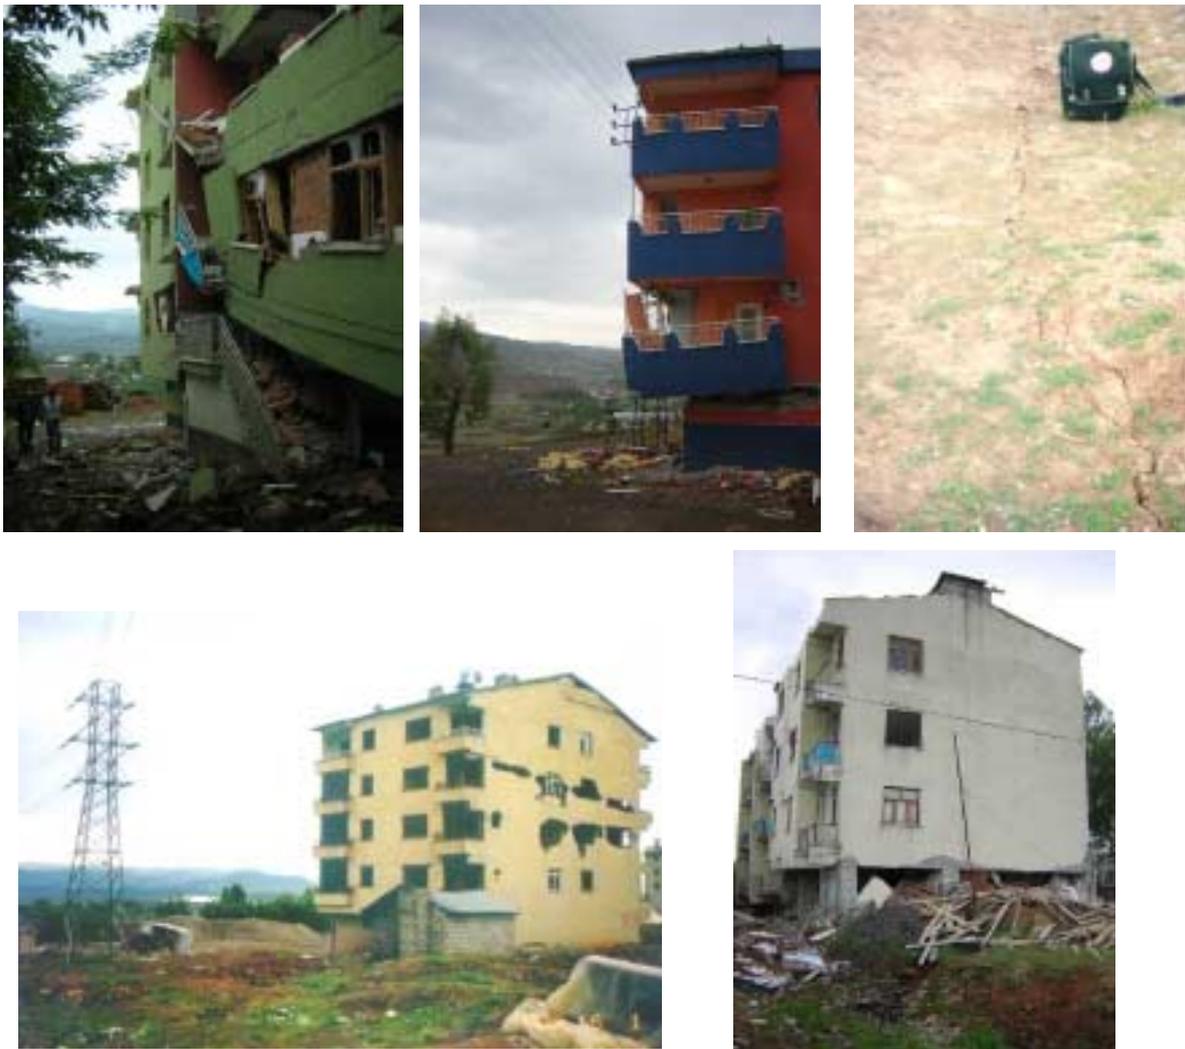
Based on the observations by the JSCE team, collapsed and heavily damaged buildings in Bingöl are also shown in Figure 8.1. These damages (Figure 8.5) are concentrated on the cliff sides of the terraces bounded by the Çapakçur and Gayıt Brooks. This situation suggests a possible amplification at the cliff sides due to topographical effects as presented in Chapter 7 and illustrated in Figure 8.6. These effects may also be responsible from the considerably high peak horizontal ground acceleration values measured at the Bingöl station, which is located close to the cliff side in Düzağaç district adjacent to the Gayıt Brook.

Figure 8.5: Collapsed or heavily damaged RC buildings nearby slope crest in Saray District

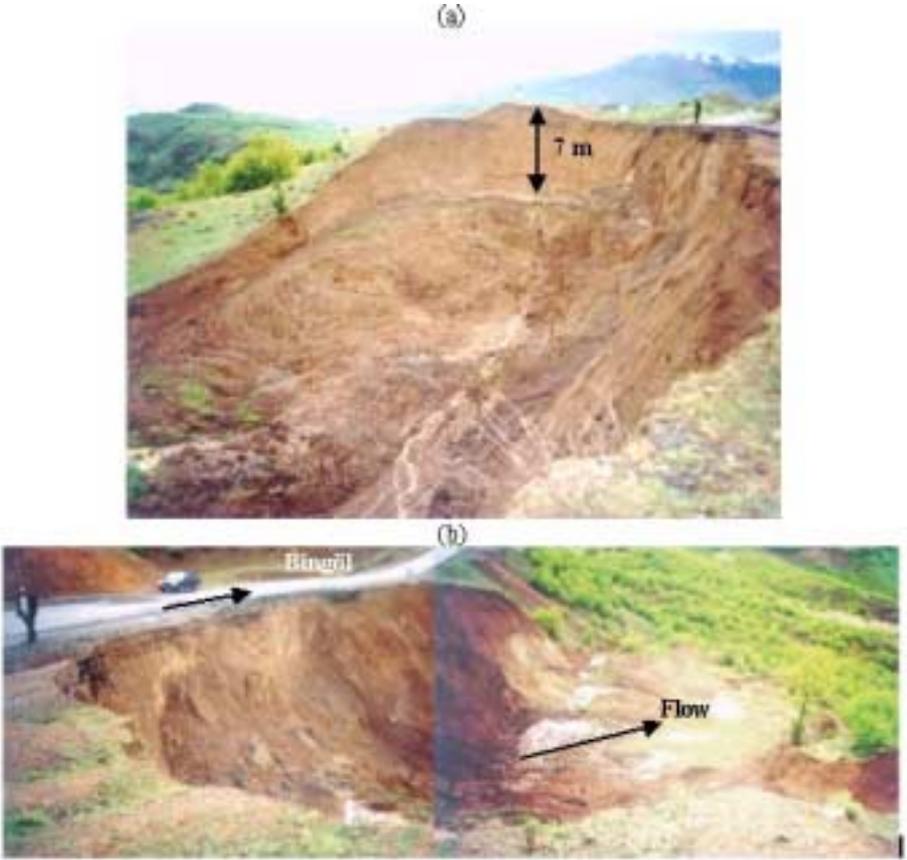
***Soğukçeşme landslide:*** This landslide occurred on the Bingöl-Karlıova road at the NE of Bingöl in very thick weathering products of volcanic rich in silt sized material (Location 1 in Figure 8.10). This rotational failure, which occurred on the SE bank of the Göynük Brook, was transformed into flow type instability extending about 80 m towards west (Figure 8.11a). The failed slope 25m high has an inclination of about  $30^{\circ}$ , and height of the scarp is 7 m. The failure also slightly effected the asphalt pavement of the road as seen in Figure 8.11b.

Figure 8.11: Landslide at Soğukçeşme

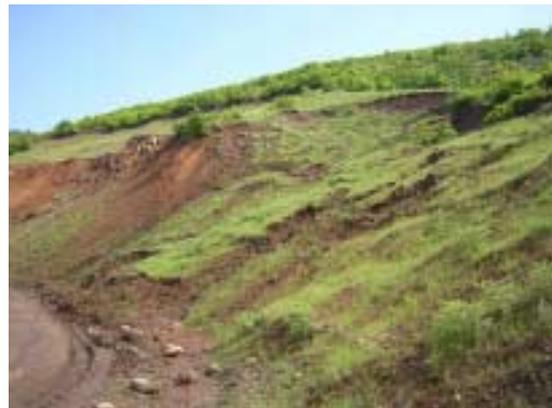
Figure 8.14: Yazgülü slope failure

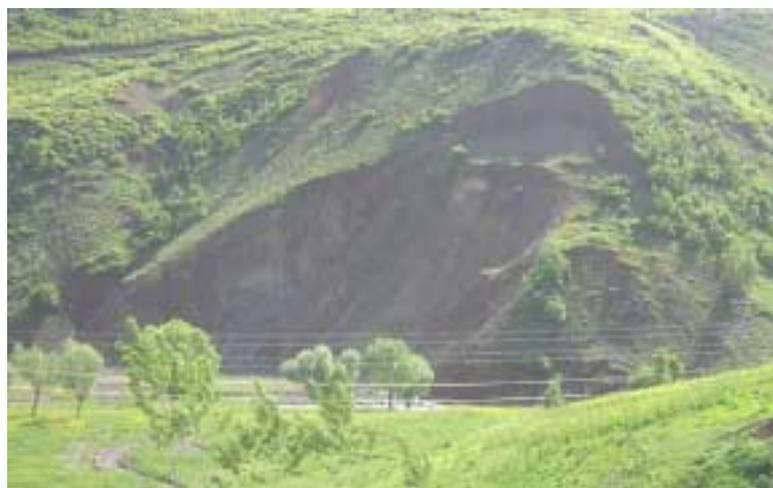
Figure 8.15: Oğuldere slope failure

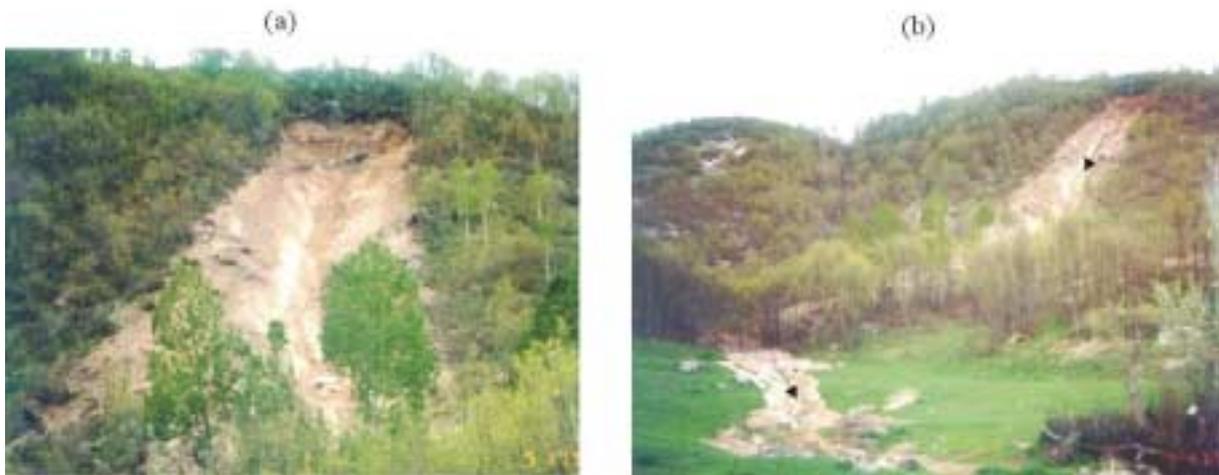
As mentioned in the previous section, a mudflow, which followed a circular failure, occurred at Soğukçeşme (Figure 8.11). Another mudflow was observed in the west of this slide on the eastern bank of the Göynük Brook (Location 14 in Figure 8.10). It was a small-scale mudflow occurred in weathered volcanics along a steep slope.

Figure 8.16: Kurtuluş slope failure and mudflow

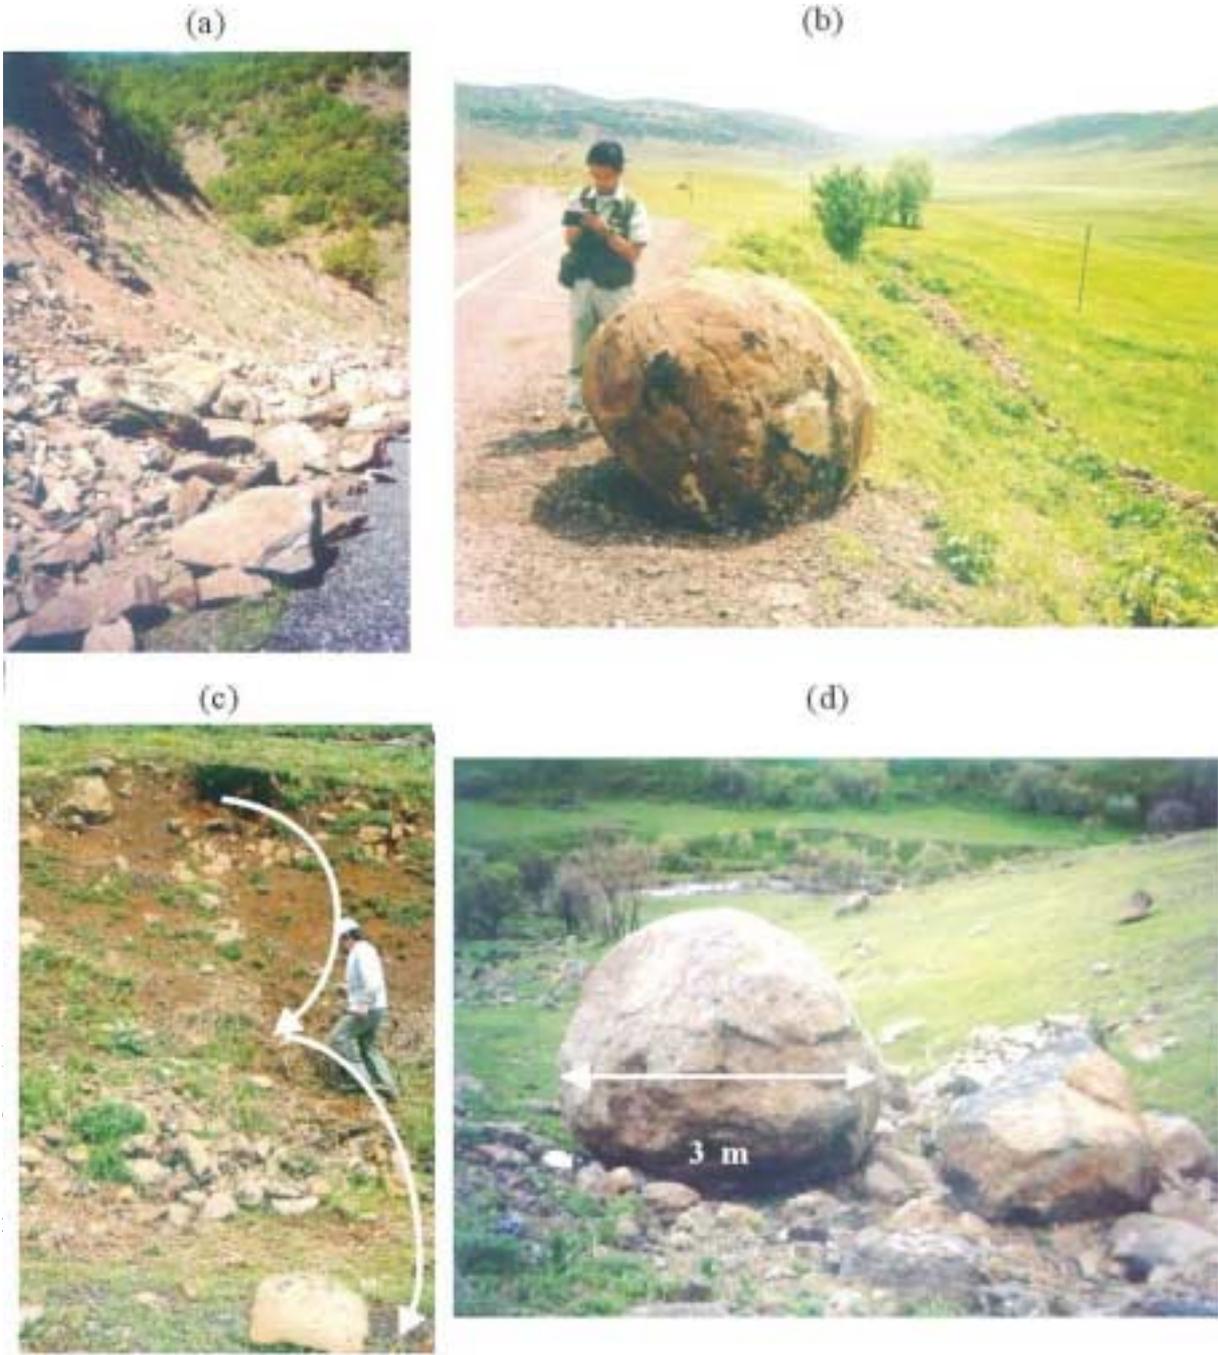
A large basaltic block approximately 1.70 m high and 1 m wide fallen down from the road cut and stopped on the road at the northern exit of Arıclar village (Location 7 in Figure 8.10 and Figure 8.17b, c). Inclination of the slope in 6 m high was  $35^{\circ}$  and the movement direction of the block was S42E. A huge rock block about 3 m in diameter fallen down (Figure 8.17d) from a steep cliff (Location 10 in Figure 8.10) at the NW entrance of Kurtuluş village.

Figure 8.17: Rock falls

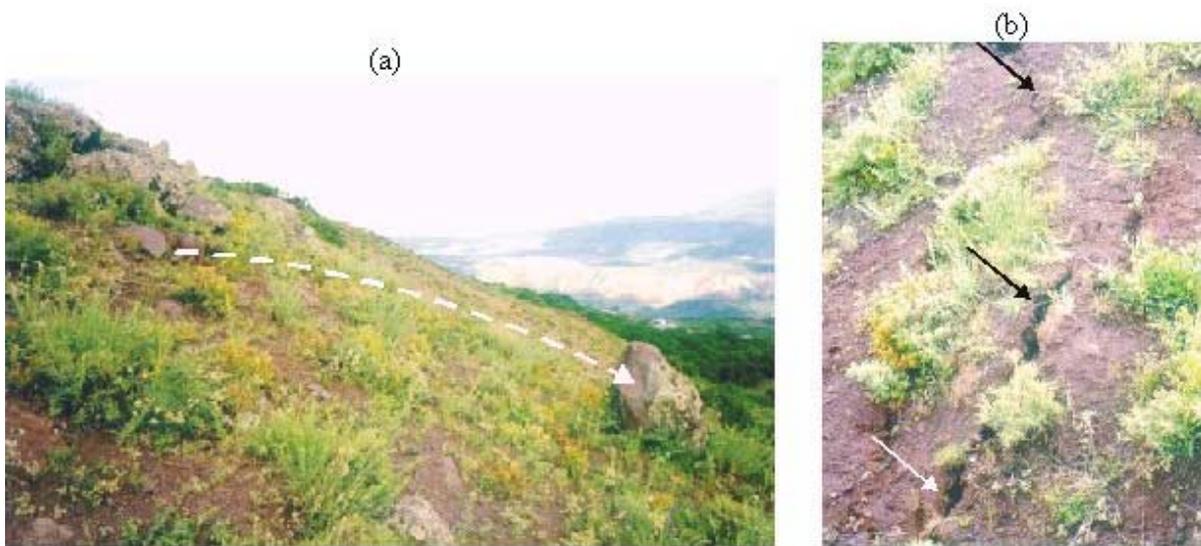
Another place, where rock falls were observed, is Göltepesi village located on the hills at NE of Bingöl (Location 13 in Figure 8.10). The slope surrounding the village from its north is composed of partly weathered blocky andesite, and has an inclination of  $40^{\circ}$ - $50^{\circ}$  towards south. Some local falls of rock blocks with dimensions approximately (90x35x60) cm were observed (Figure 8.18a). Displacement of these rock blocks from their original position was estimated about 2.5-3 m. In addition to rock falls, some cracks trending in E-W direction were evident at the crest of the slope. Their persistence ranged between 5 and 10 m and separation between the walls of these cracks was about 10 cm (Figure 8.18b). These cracks were tension cracks indicating a slope movement towards south. However, they are highly local cracks and the movement could not be transformed into a catastrophic failure.

Figure 8.18: Rock falls behind Göktepesi

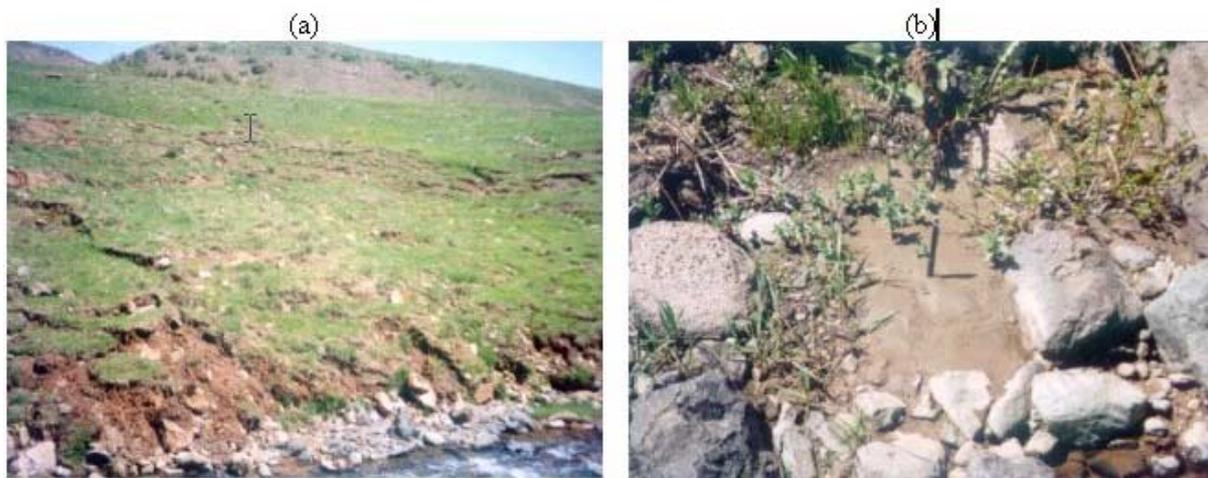
this location, where Uğurboğa Stream 5 m wide flows from west to east, three zones of lateral spreading were identified on the northern bank of the stream (Figure 8.19a). The failure pattern and a sand accumulation very similar to a sand boil on the southern bank of the stream (Figure 8.19b) suggest that this failure can probably be due to a liquefaction-induced lateral spreading. The inclination of the failed stream bank was about  $10^{\circ}$ - $15^{\circ}$ . The displacements due to lateral spreading in these zones were measured as 16.5, 21 and 30 cm, respectively. Width of the zone of ground deformation was 60 m and the sliding material was a dark brown, low plasticity silt-clay-sand mixture.

Figure 8.19: Lateral spread nearby Yaygınçayır village

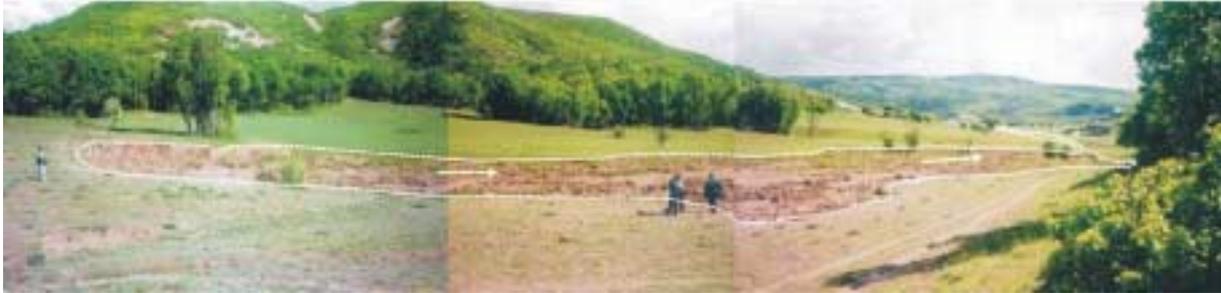
maximum depth of the flow was approximately 600 m, 35 m, and 3 m, respectively. Evident set of ground deformations, which were resulted in 30-35 cm vertical drops (Figure 8.21d) and separations of 10-20 cm in the ground behind the crest and near the flanks of this failure, was observed (Figure 8.21b and c). A total lateral displacement of about 90cm was measured at the crest region of the failure.

Figure 8.20: A view of lateral spreading at Hanoçayırı

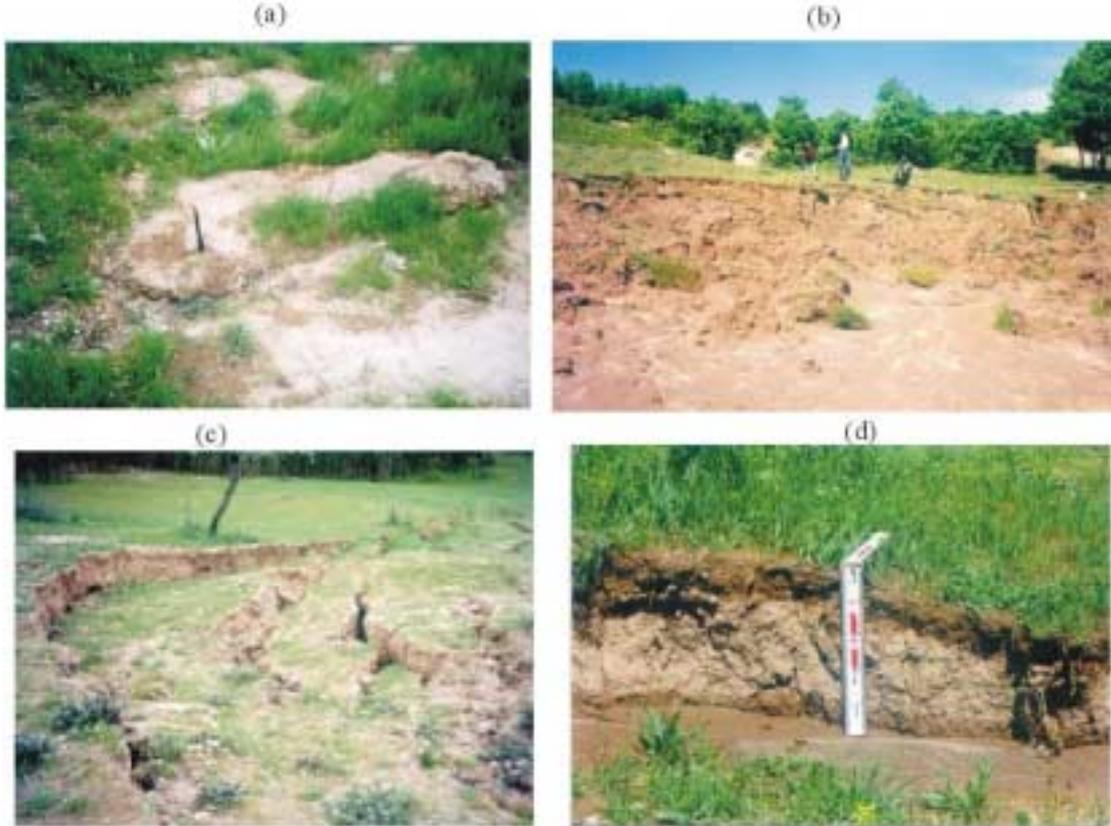
Figure8.21: Some views of lateral spreading phenomenon at Hanoçayırı

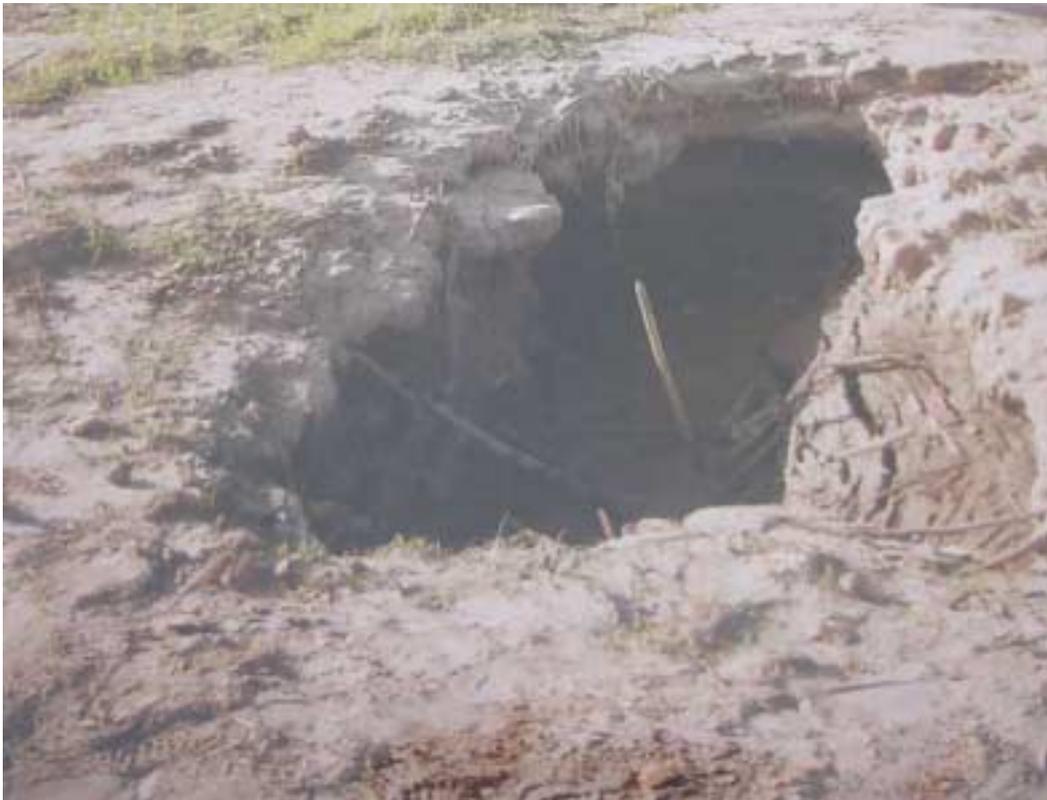
Liquefaction was also observed at Bingöl Plain according to the information provided by N. Bartakuçin who is the Manager of TEDAŞ at Bingöl. As can be seen from Figure 8.10, it occurred at a location between Göynük Brook and Bingöl-Genç road in a farm field. Although the JSCE team and Mr. Bartakuçin spend some effort to find this location one month after the earthquake, it was not possible to find it as it was disturbed by the villagers for farming. However, the photograph showing this sand boiling taken by Mr. Bartakuçin is shown in Figure 8.29. From this figure, sand boiling and sand accumulation are evident, and groundwater table seems to be very shallow. It is also noted that the alluvial sediments carried by Göynük Brook cover this area.

Figure 8.29: Liquefaction in Bingöl Plain (photo by N. Bartakuçin)

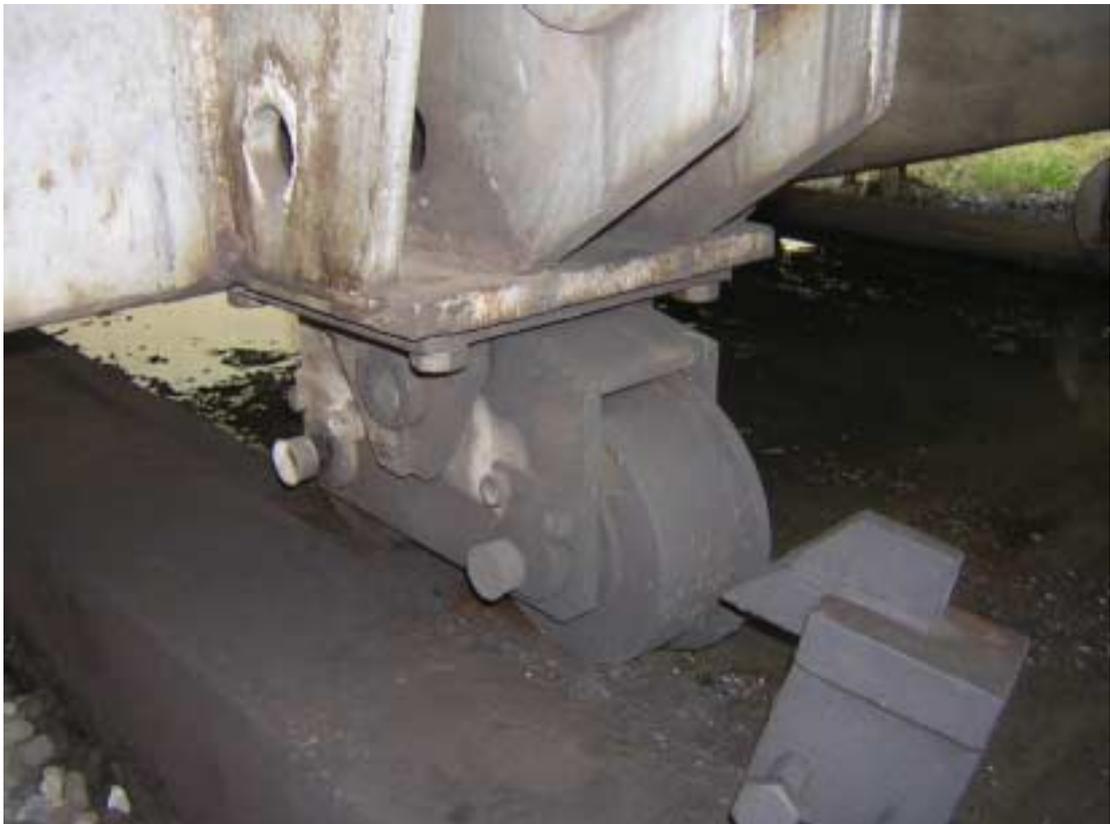
Figure 9.4 Slightly displaced transformer

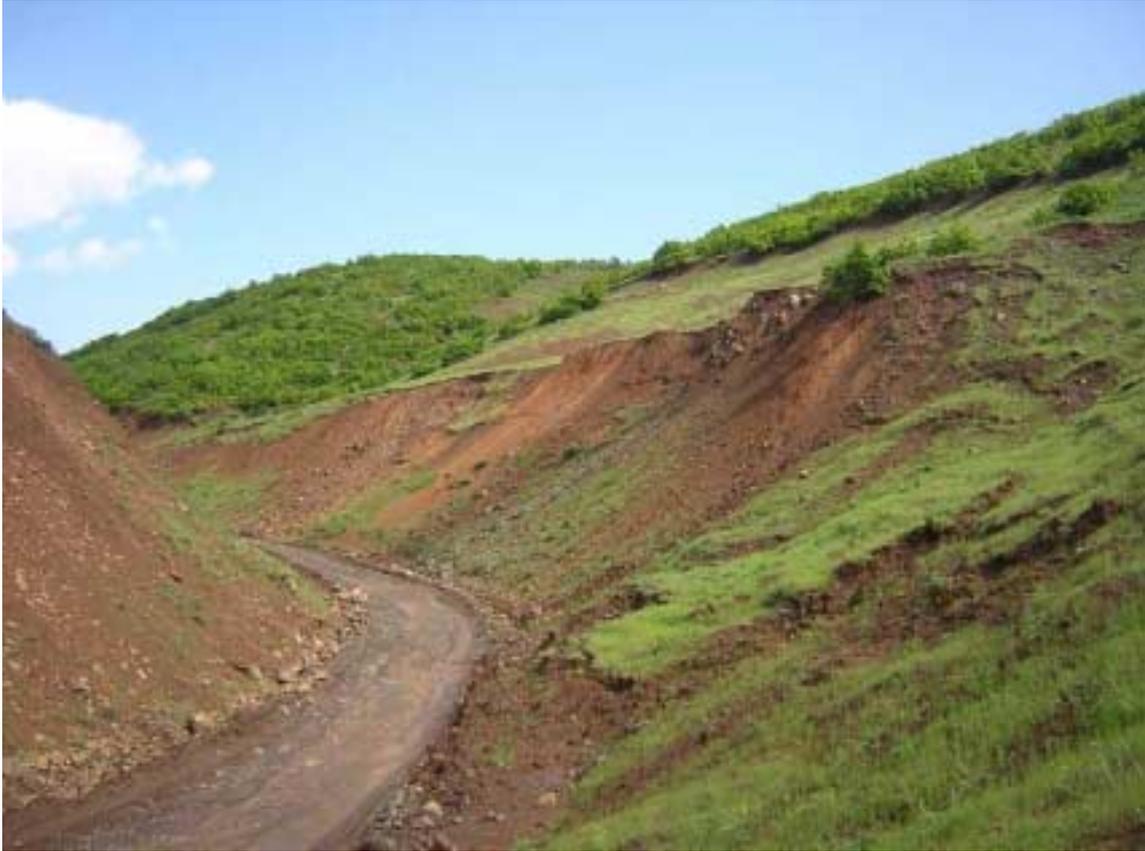
Figure 10.2: Damaged roadway nearby Yazgülü village on Yolçatı-Sancak Roadway

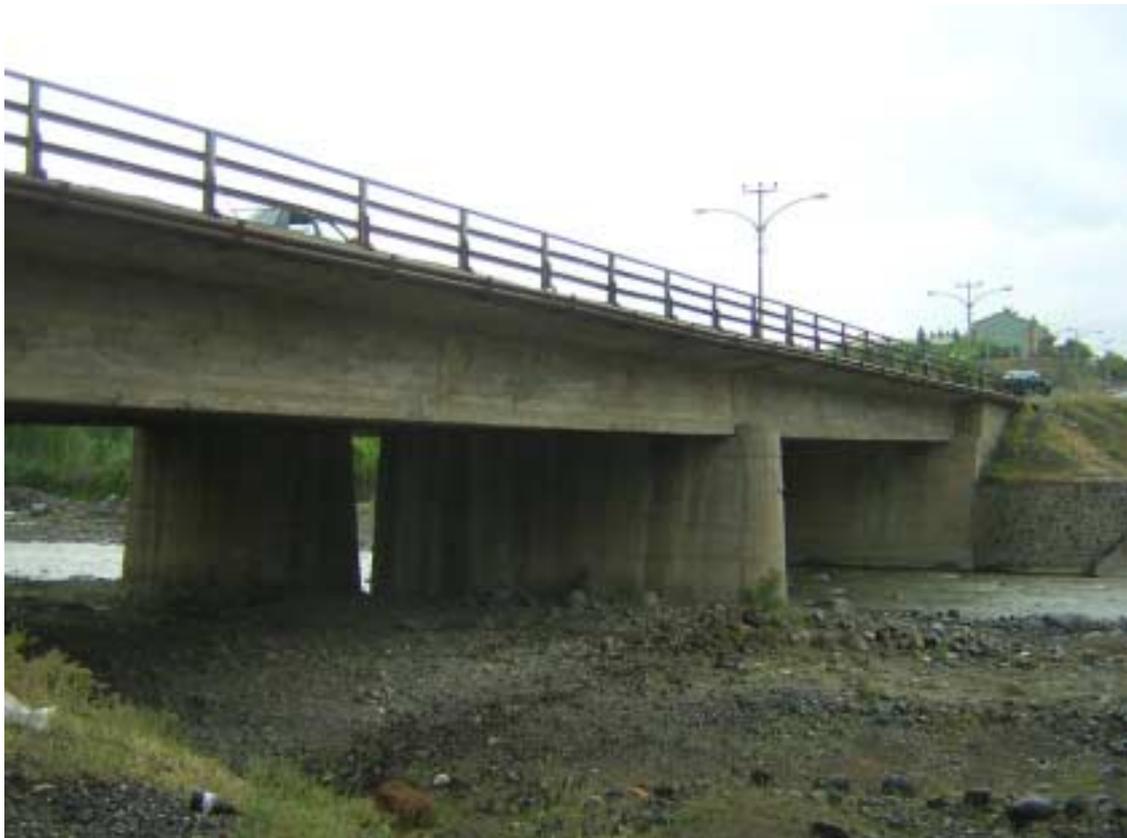
Figure 10.5: Slightly-damaged RC three-span highway bridge on Çapakçur brook

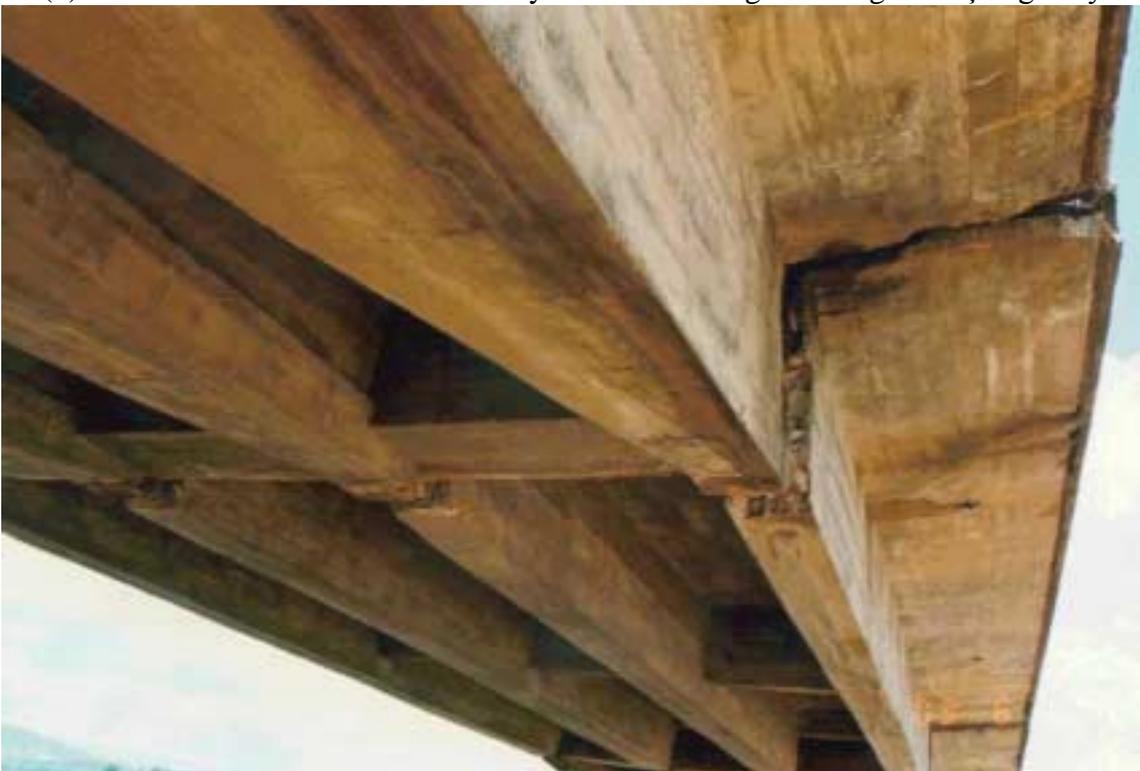
(c) Girder off-set of Gerber-type section of the bridge

Figure 10.6: A view, structural model and damaged section of Göynük Brook Bridge

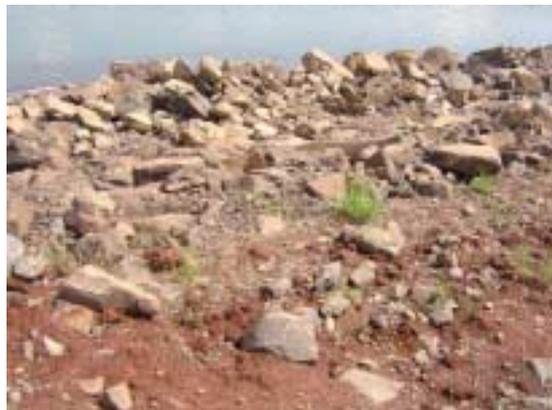
(c) Repaired dam crest

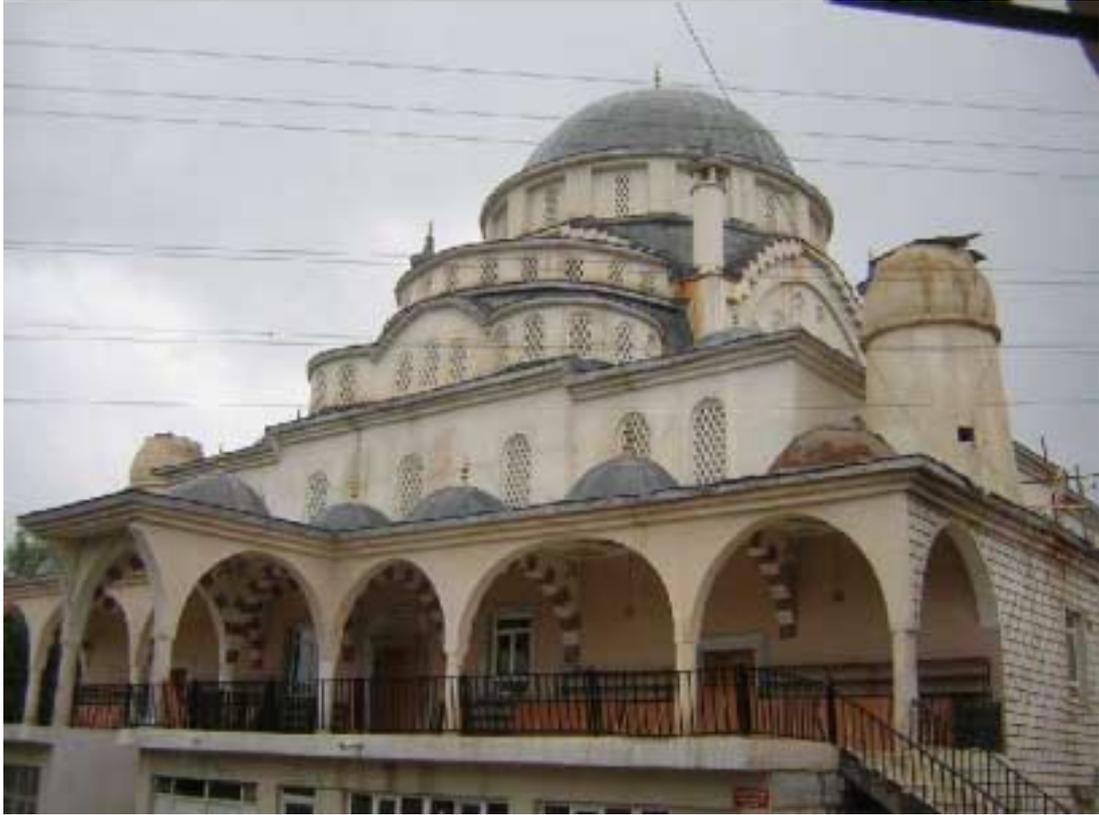
(a) Bingöl Yeni Mahalle Mosque (both minarets toppled)

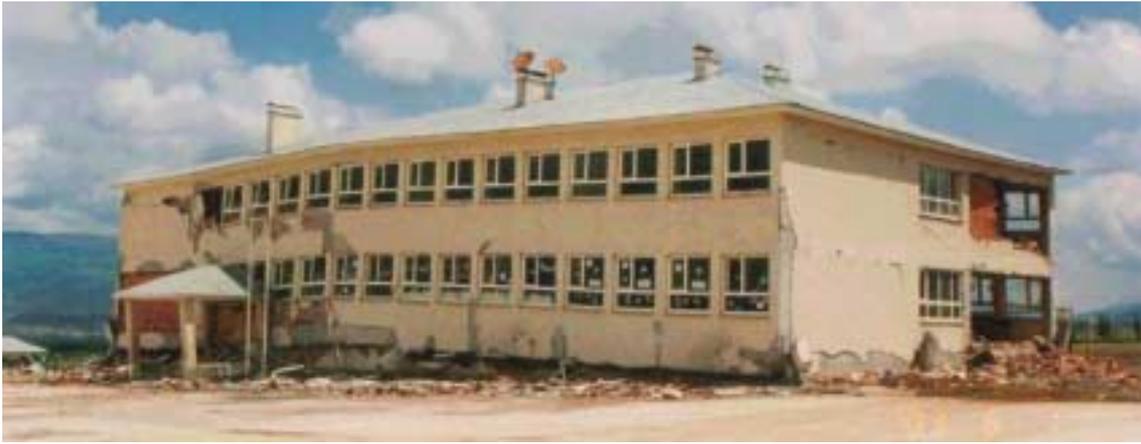
Although the three-story RC student dormitory and school building collapsed at the Çeltiksuyu site, a RC three-story building for teachers and a water tower about 25 m high located at a distance of 40 m from the collapsed buildings were not suffered any damage. By considering this very close distance between the collapsed and non-damaged structures, and

(a) 3 story RC Primary school building at Çeltiksuyu

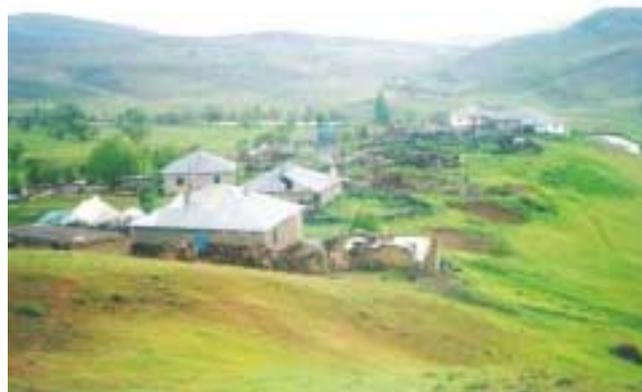
(d) Collapse of houses with heavy earthen roofs  
(note that standing houses have light roofs)
