A RECONNAISANCE REPORT ON THE 2007 SINGKARAK LAKE (SOLOK) EARTHQUAKE WITH AN EMPHASIS ON THE SEISMIC ACTIVITY OF SUMATRA FAULT FOLLOWING 2004 and 2005 GREAT OFF-SUMATRA EARTHQUAKES

Ömer AYDAN

Tokai University, Department of Marine Civil Engineering Shizuoka, Japan

August 2007

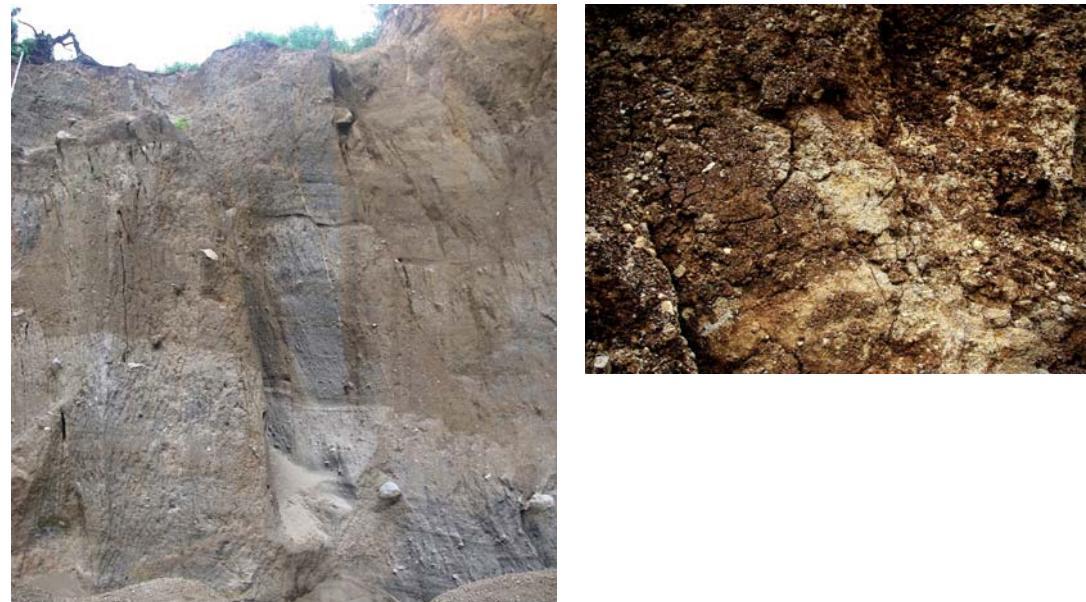
The author did some observation in a quarry just north of Singkarak Lake. Figure 3.3 shows views of the fractures in the quarry and a fault surface with striations. The fractures are almost steeply inclined. However, their dipping direction is about 85°SW. The striations are almost horizontal. Nevertheless, they have slight normal component. In other words, the sense of deformation implies slight trans-tension type movements. Figure 3.4 shows the inferred focal mechanism solution for the striations in the quarry proposed by Aydan (Aydan and Kim, 2002, Aydan 2007b). The strike of the fractures is slightly different from the general trend of the SFZ.

Figure 3.3. Views of the fractures and the striations in Batipuh quarry in the north of Singkarak Lake

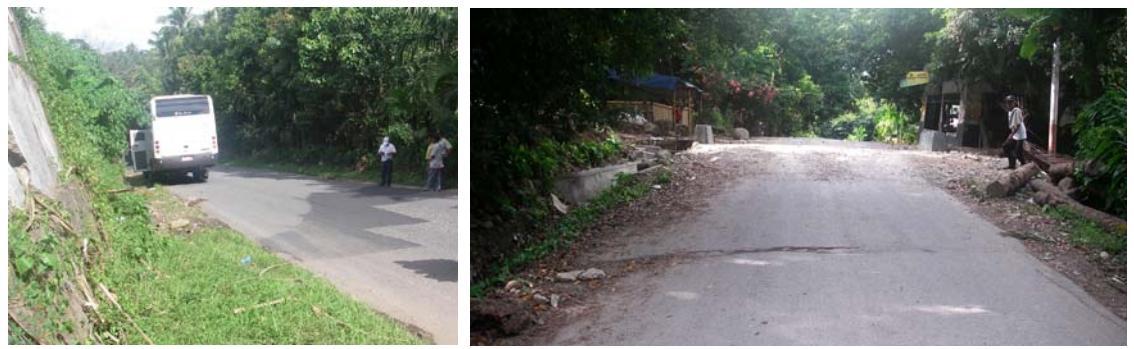
The hypocenter depth of the earthquake is about 30km and the projected epicenter is near the north end of Singkarak Lake. The author noticed two surface ruptures to the north of Singkarak Lake at localities called Batipuh and Sumpur. The strike of these surface ruptures were aligned in the direction of N30-50E. The global strike of Sumatra fault is N35W. The acute angle between the strikes of the Sumatra fault and surface ruptures ranges between 65-85. The two locations of surface ruptures are aligned along N40W direction. Therefore, we expect that surface ruptures are associated with the earthquake faulting and the surface ruptures belong to T-fractures of the fracture zones. Particularly, the surface rupture observed in the village of

Sumpur resembles to that observed between Kavaklı and Hisareyn caused by the 1999 Kocaeli earthquake (Aydan et al. 2000a). This fracture was followed by the author for about 500m and the subdidence of the ground up to 30cm were observed.

(a) Rupture of roadway in Batipuh (b) rupture of roadway in Sumpur Figure 4.3. Surface ruptures

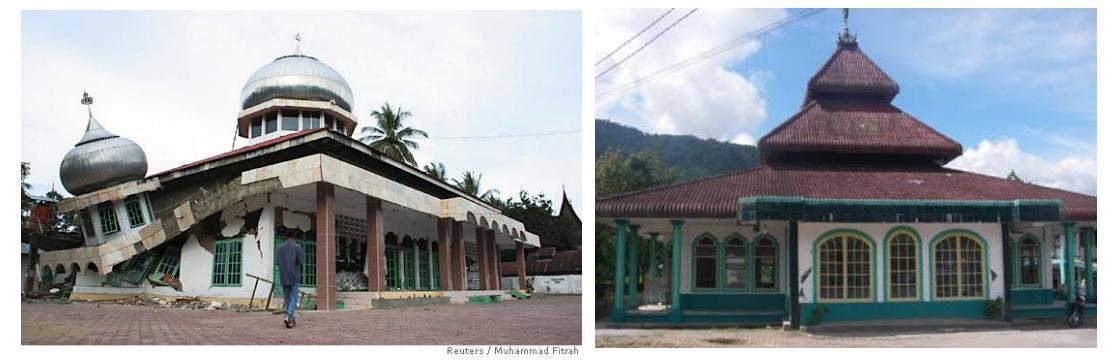
Mosques are semi-reinforced concrete structures. Although reinforced columns and beams are utilized, they are quite small in cross section (15x15 to 20x20cm) and they have 4-6 smooth steel bars with a diameter ranging between 8-12mm. The walls are either hollow cement blocks or bricks. The roof of mosques are generally light. The earthquake caused the failure of outer columns and load-bearing walls at corners and subsequent collapse of roofs (Figure 5.1).

(a) Solok (from Reuter) (b) Padang Pajang Figure 5.1 Damage to mosques

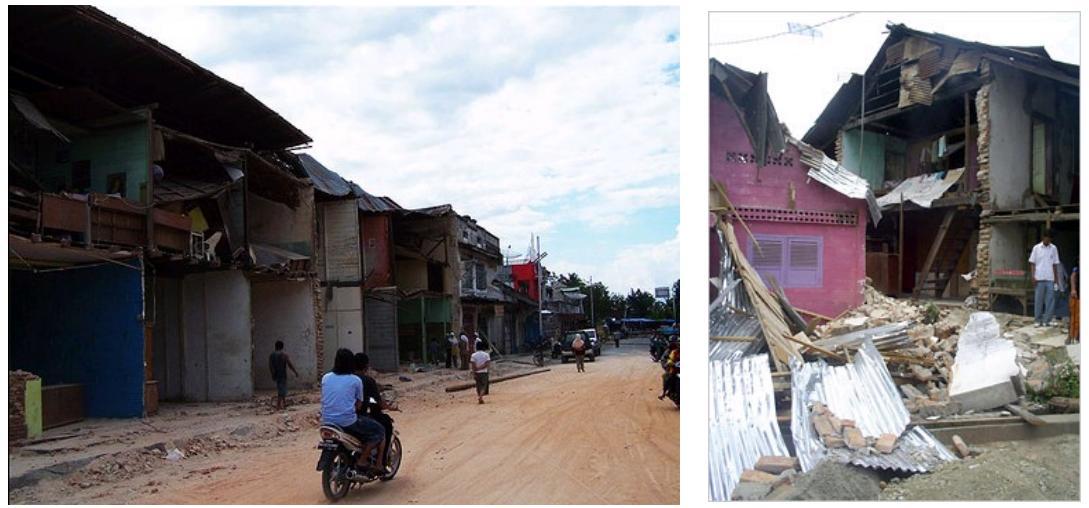
Masonry buildings are generally constructed with bricks and they are either one story or two story buildings. Old masonry buildings has no reinforced concrete slabs and/or columns. Such collapses were observed even in Payakumbuh and Padang, which are relatively far from the epicenter (Figure 5.2) New constructions utilize reinforced concrete slabs and columns. There is no doubt that when such structural elements are integrated with masonry walls they perform better and they prevent the total collapse of the buildings in-spite of some structural damage. The houses or buildings were slightly damaged even they were just on the surface ruptures (Figure 5.3).

(a) Payakumbuh (from Reuter) Padang (from Reuter) Figure 5.2 Collapse of walls of masonry buildings due to out-of-plane loading

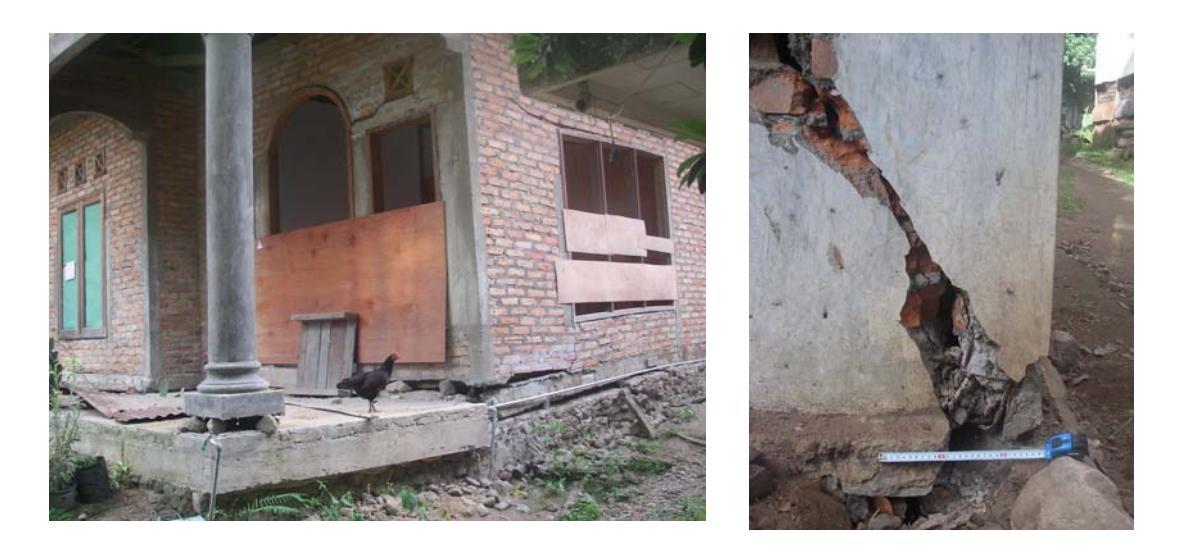
Figure 5.3. Damage induced by surface ruptures to masonry houses with reinforced slabs and columns

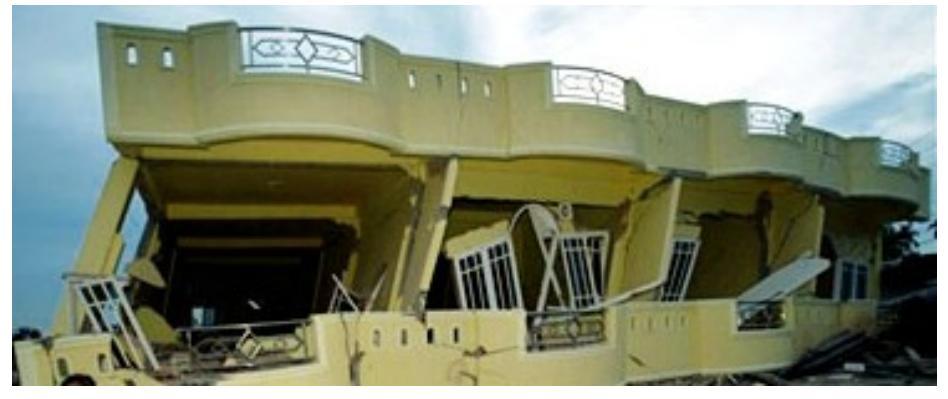
RC buildings with two or three stories suffered heavily from the earthquake. The reinforced concrete structures are framed structures with integrated or non-integrated in-fill walls. The reinforcing bars are generally smooth and infill walls are built with red-burned solid clay bricks using mortar. The floor height in the region ranges between 3 to 4m. The inspections of the reinforced concrete buildings indicated that they are mainly failed in the pancake mode. RC buildings are generally found in cities and large towns. The concrete buildings having 2 or more stories were either collapsed or heavily damaged. The causes of damage to RC buildings are similar to those observed in other recent earthquakes in Indonesia and elsewhere (Figures 5.4 and 5.5). They be re-stated for this earthquake as follows:

- a. Soil liquefaction and lack of the soil bearing capacity (particularly in Solok)
- b. Large ground settlement of ambankments nearby river banks
- c. Fragile structural walls and lack of lateral stiffness,
- d. Poor concrete quality and workmanship,
- e. Plastic hinge development at the beam-column joints,
- f. Lack of shear reinforcement and confinement,
- g. Soft story,
- h. Pounding and torsion and
- i. Ground motion characteristics (i.e. multiple shocks etc.).

Figure 5.4 Pancake collapse of reinforced building in Padang (from Reuter)

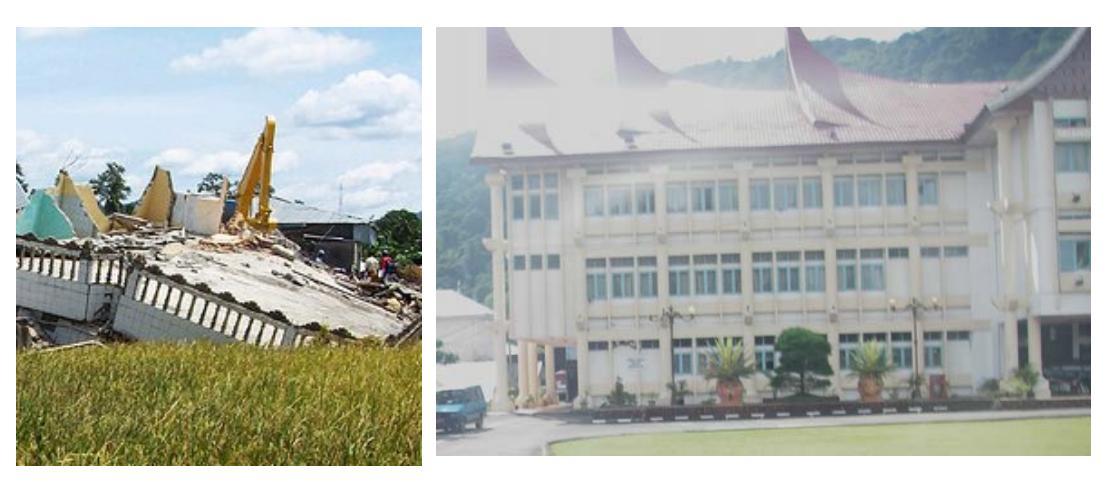
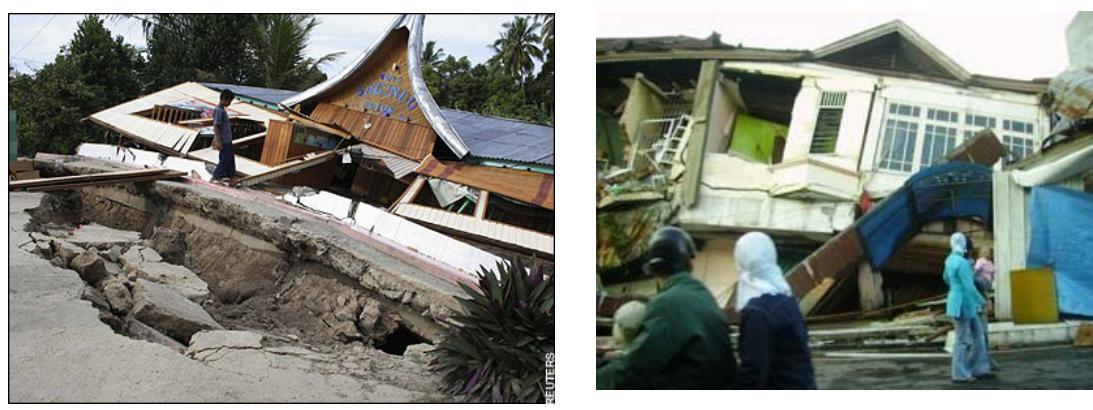
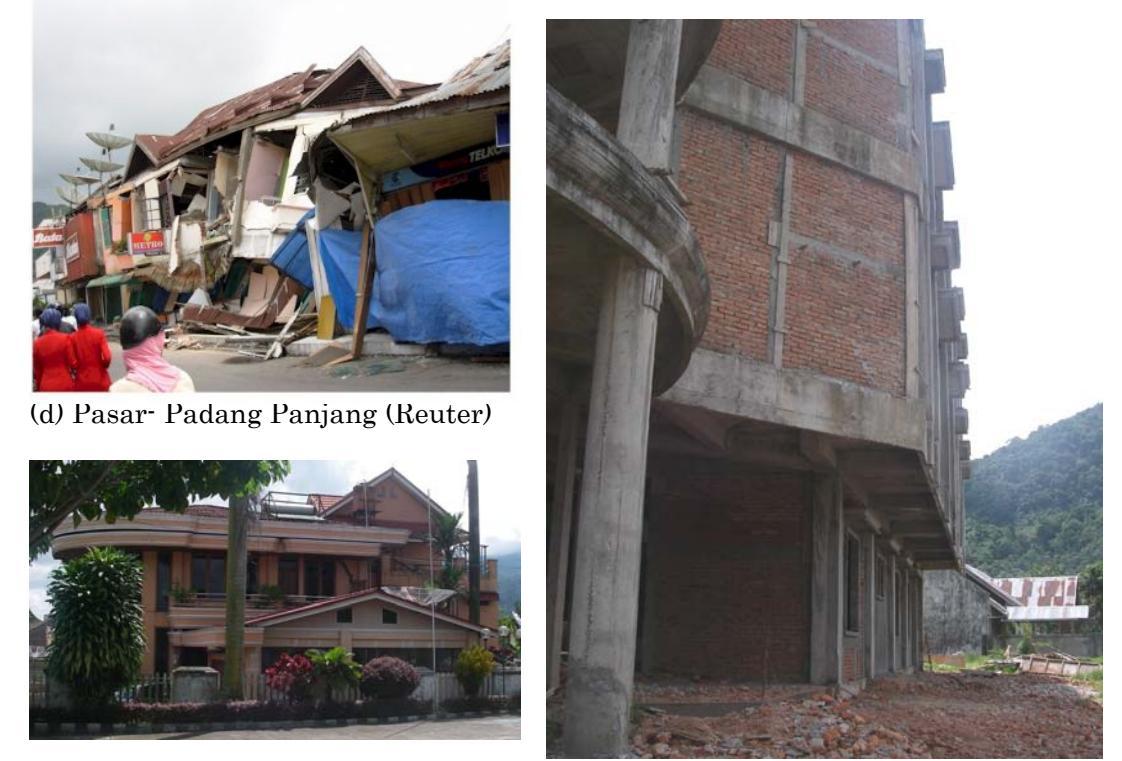
(a) Solok (from Reuter)

(b) Padang Panjang Governor Office

(c) Solok (from Reuter and Internews)

(e) Slightly damaged RC buildings in Padang Panjang Figure 5.5. Some typical damage to RC buildings

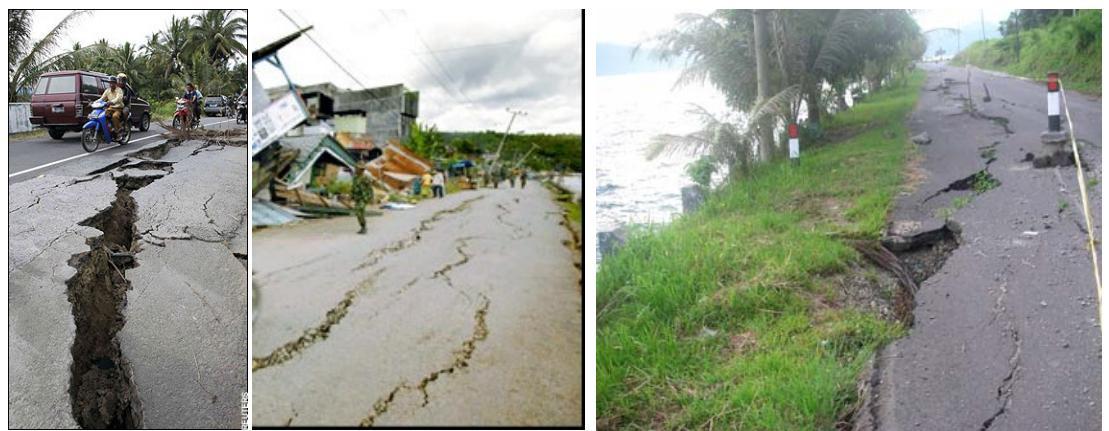
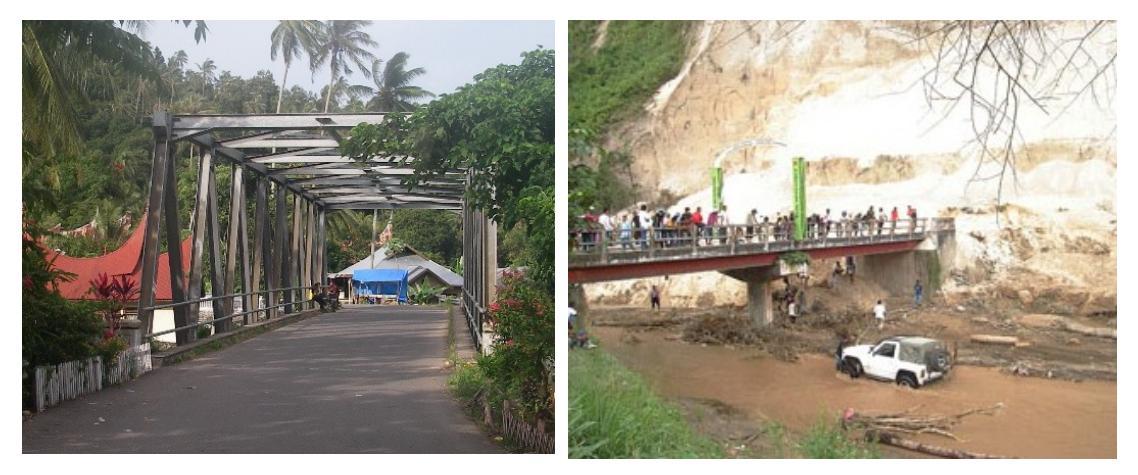
Railway bridges in the epicentral area are truss, arch or simple beam bridges while roadway bridges are of truss or simple beam type. The earthquake shaking did not cause any visible damage to the bridges of railways and roadways even in the nearest location to the epicenter of the earthquake (Figure 6.3). The debris of slope failure in Sianok Valley obstructed a rodway bridge temporarily.

(a) Truss bridge in Sumpur village
 (b) Bridge in Sianok Valley
 Figure 6.3. Views of roadway bridges

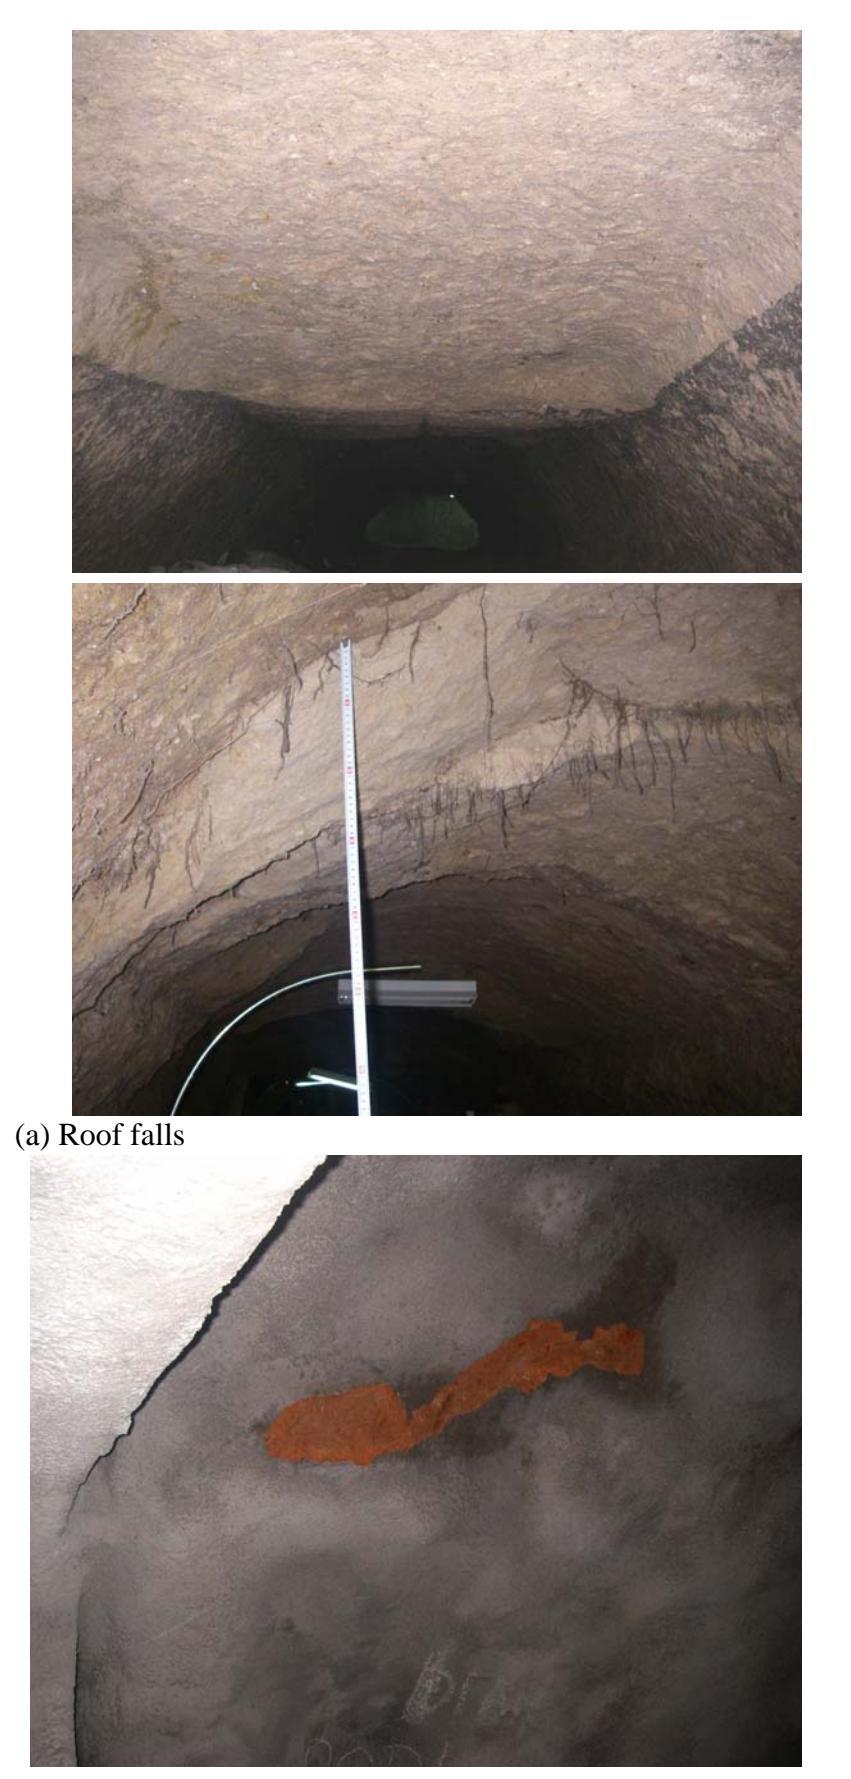
(Location 1)

(b) Spalling at Location 3 Figure 7.5. Some views of the underground shelter and instability locations

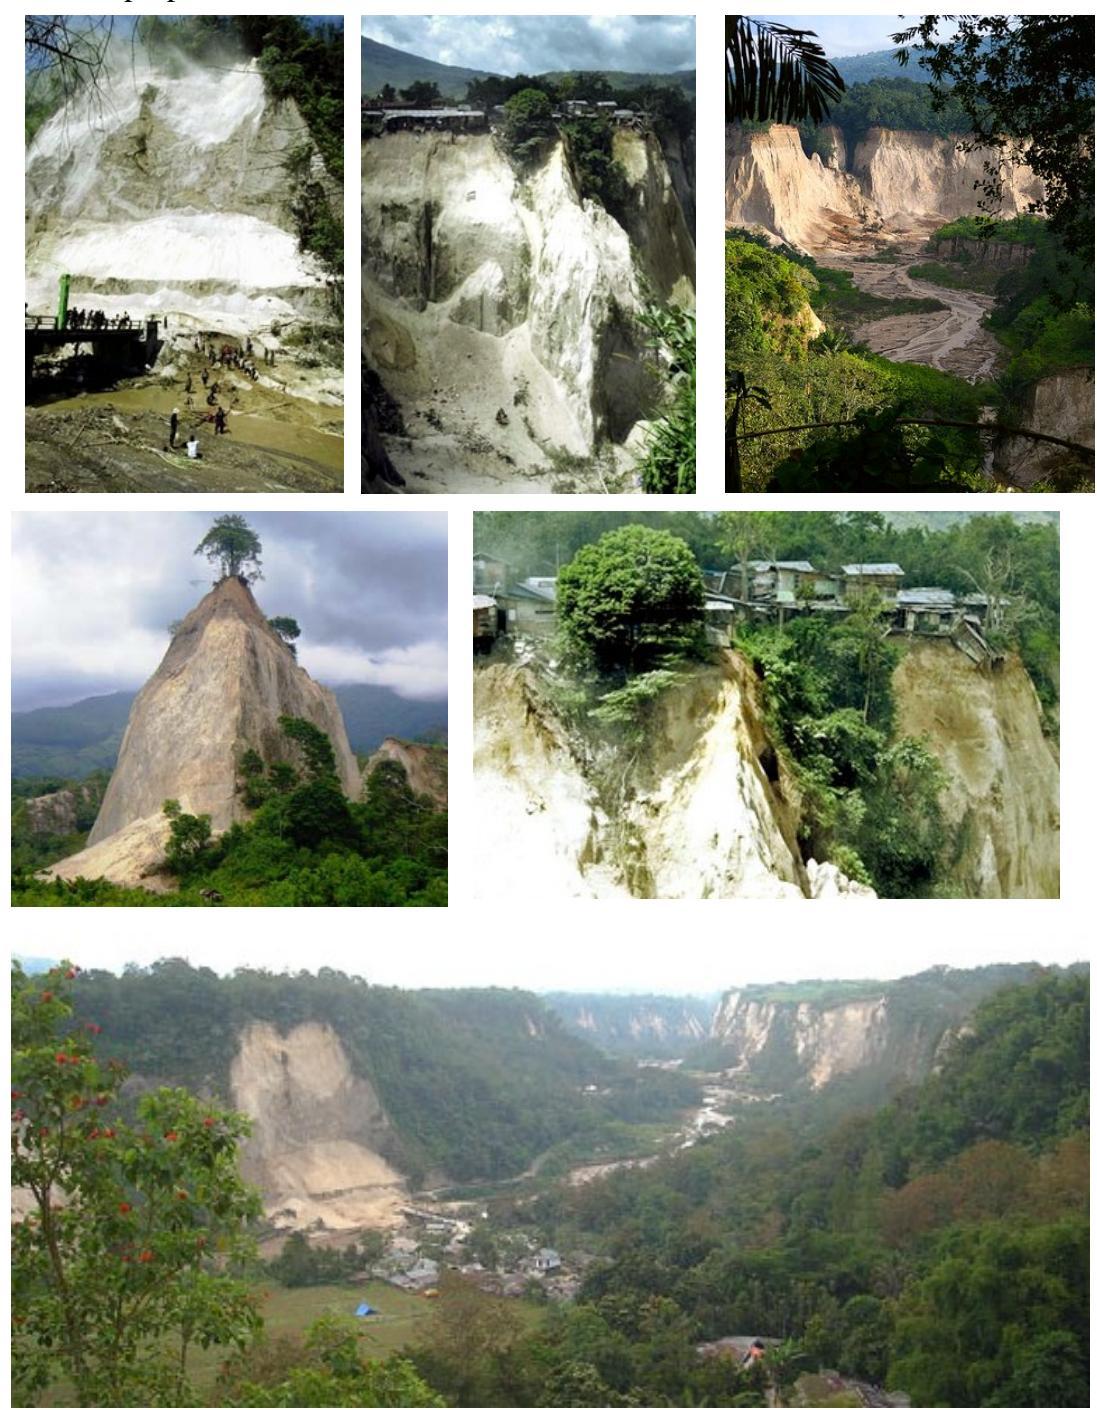
Extensive slope failures observed in Sianok Valley (Figures 8.1 to 8.3). In additon there were also some slope failures and rockfalls in Annai Valley and shore of Singkarark Lake (Figure 8.4). The depth of Sianok Valley is up to 120m and the valley walls are quite steep and the natural slope angles range between 70-80°. The ground mainly consists of pyroclastic flow deposits from nearby Volcanoes as also presented in the previous section. The inclination of the failure plane is about 60° and it is almost planar. The repose angle of the failed ground is about 30°. The material properties of the rock are not well known and it was not measured.

Figure 8.1. Views of slope failues at Sianok Valley in Bukit Tinggi

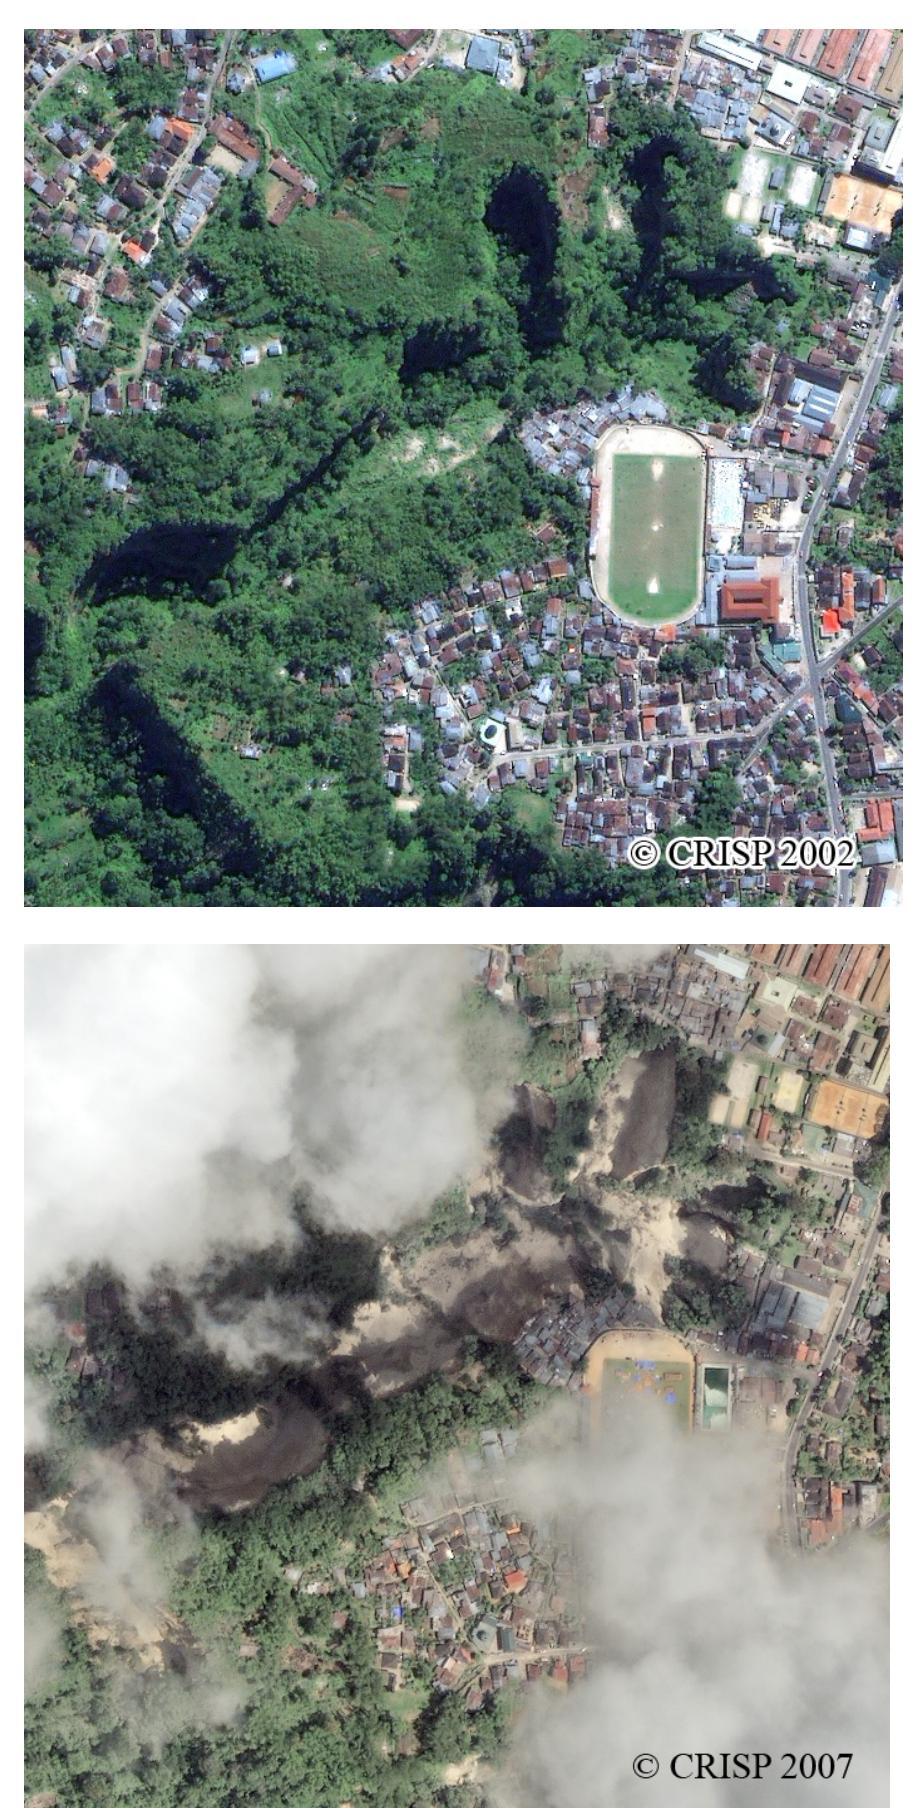
Figure 8.2. Images of Sianok Valley before and after the earthquake

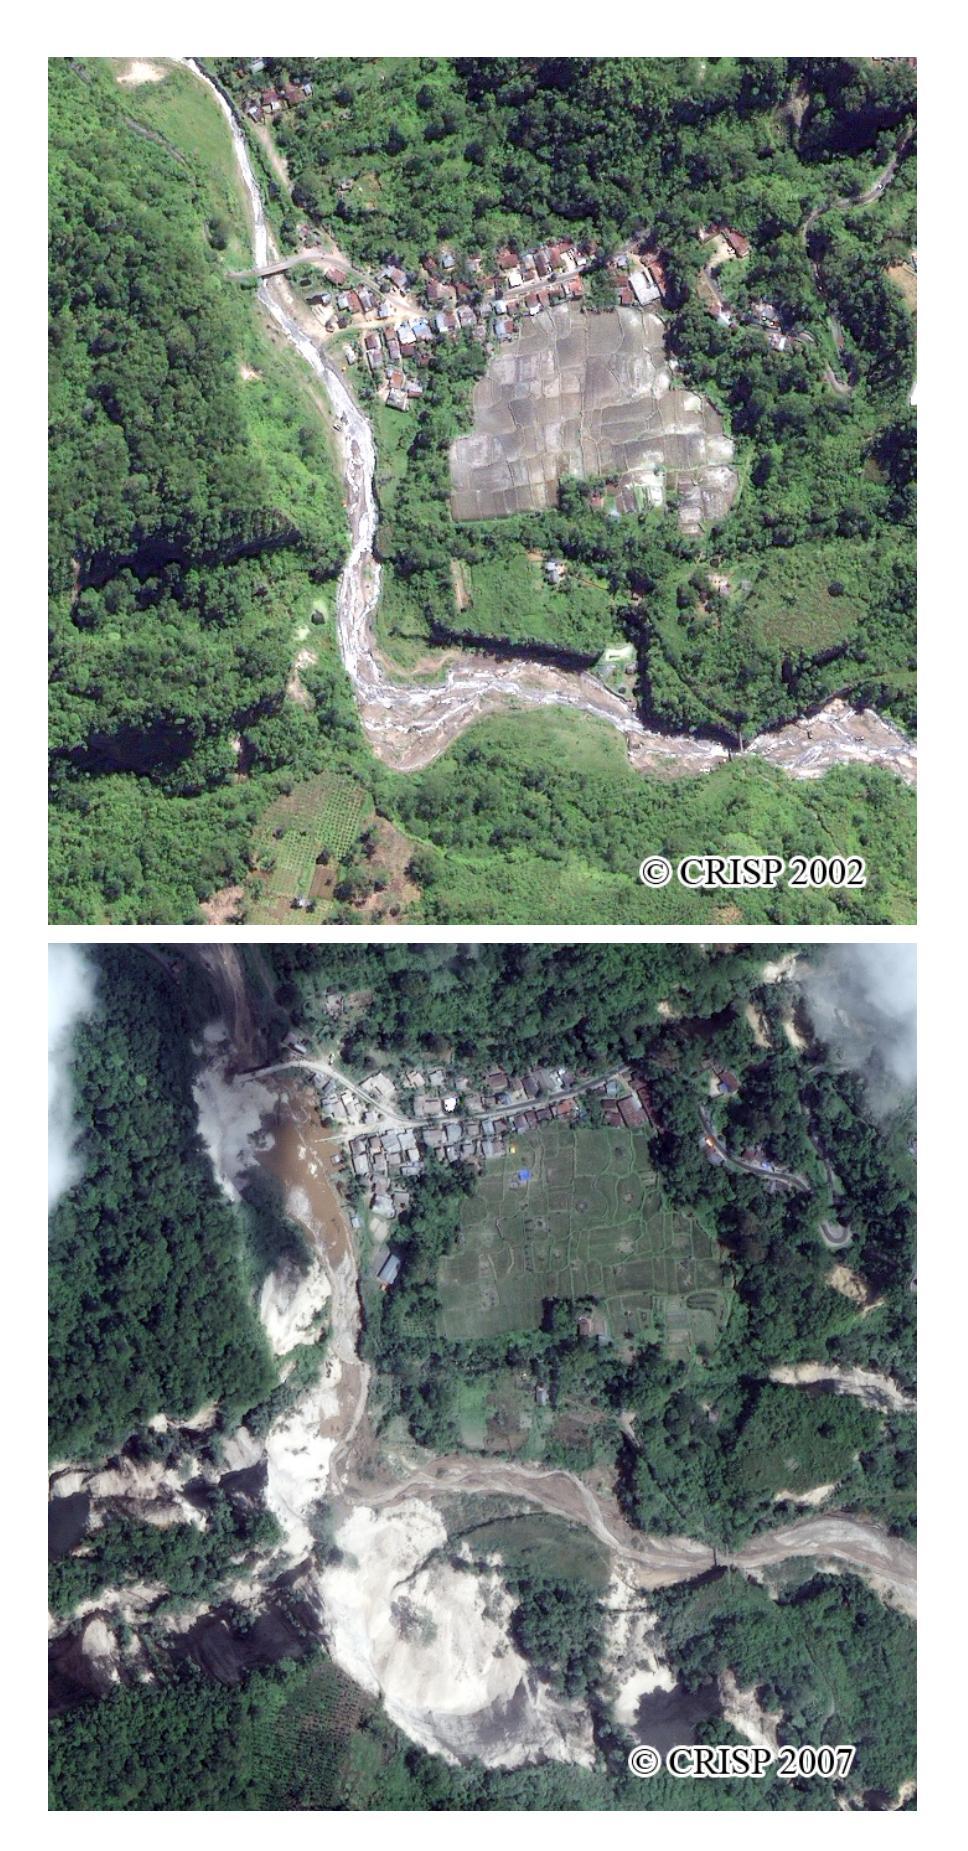
Figure 8.3. Images of Sianok Valley before and after the earthquake

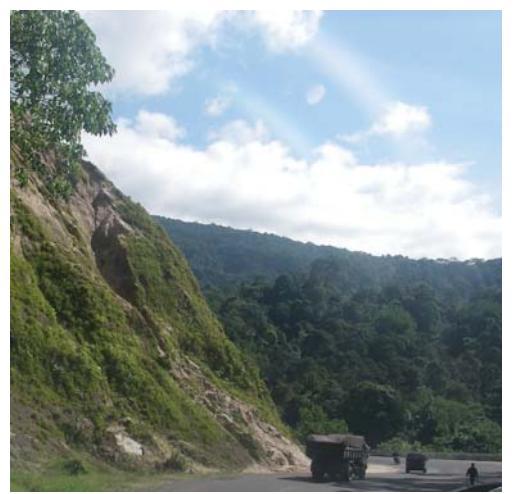
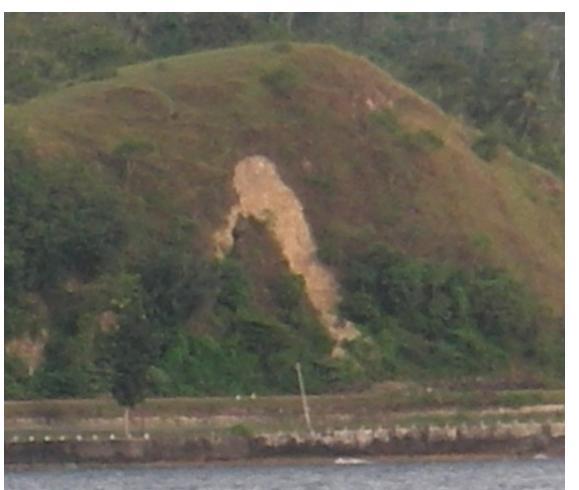
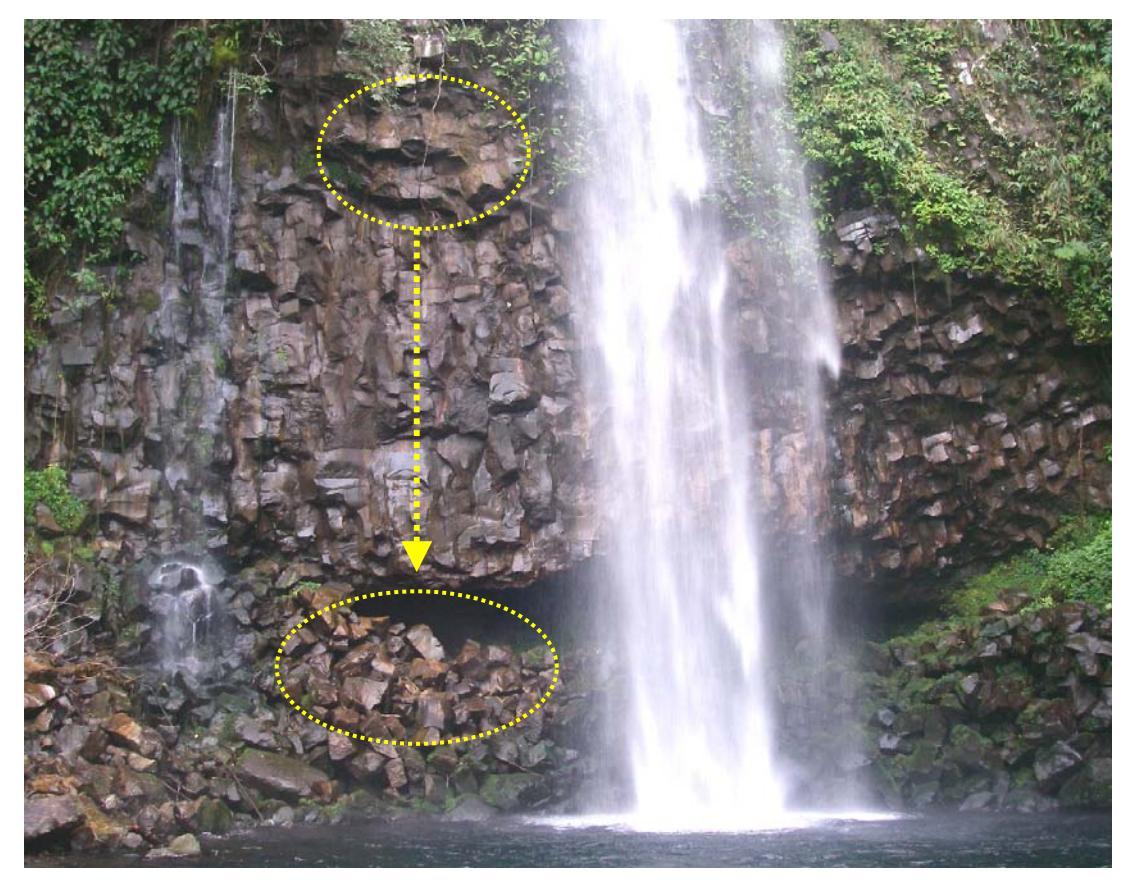
(b) Shore of Singkarak Lake

(c) Rockfall at Annai Water-fall Figure 8.4. Slope failures and rockfalls

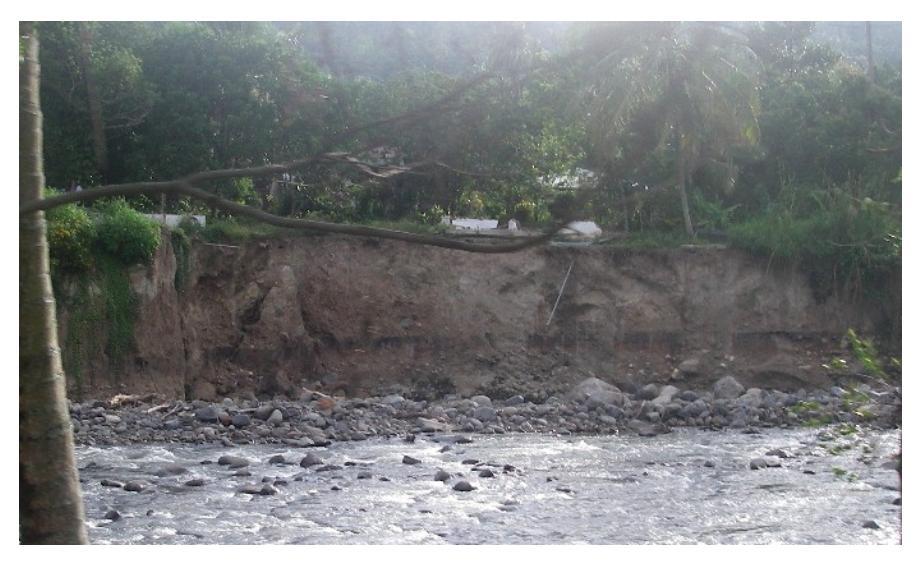
Embankment failures of roadways and rivers were also widespread in the epicentral area (Figures 6.2 and 8.7). The main cause of embankment failures were ground shaking, which resulted in either lateral spreading due to ground liquefaction or curved failure.

(a) Embankment failure at Sumpur Village (the nearest site to the epicenter)

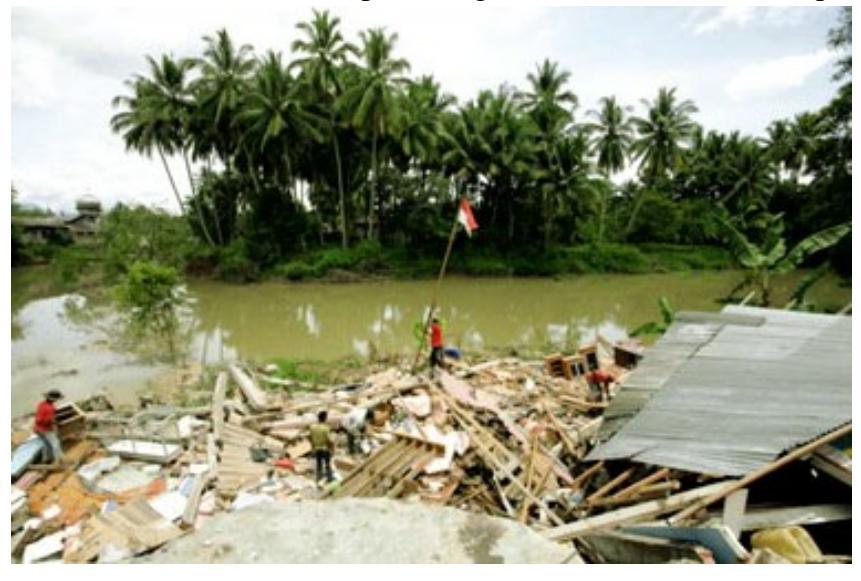
(b) Embankment failure along a river in Solok District Figure 8.7. Some views of embankment failures
