## Chapter 6

## **Strong Motions**

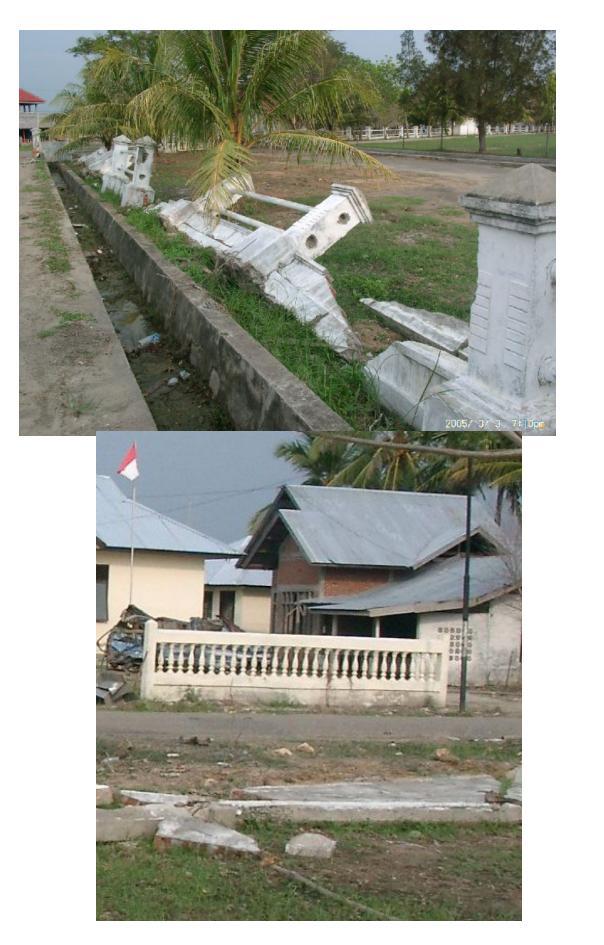
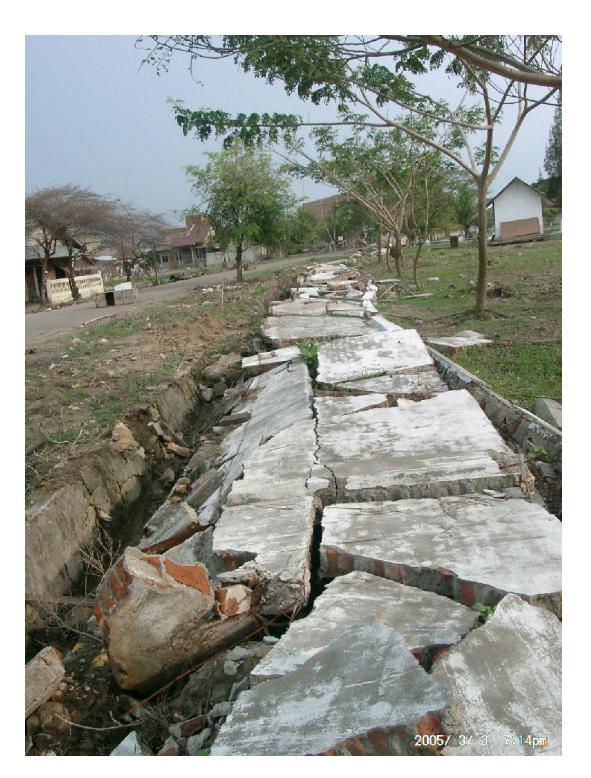
The some of garden walls were toppled during the ground shaking as shown in Photo 6.1. From these observations, the maximum ground acceleration should had been acted almost NS direction, perpendicular to the faulting direction. For NS direction, it should be greater than 200 gals and less than 350gal. As for EW direction, it should be greater than 110 gals and less than 170gal.

Photo 6.1 Earthquake induced wall failure

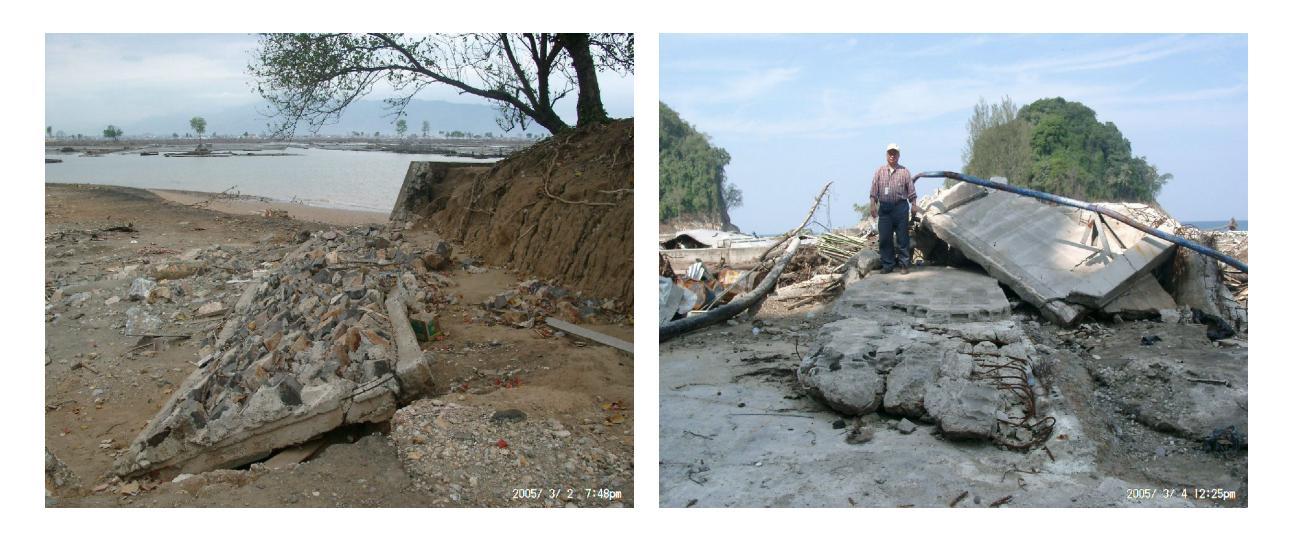
The walls shown in Photo 6.2 were toppled by the tsunami waves. Through some mechanical considerations, these walls may be useful for inferring the impact force of tsunami waves. Photo 6.3 shows pictures of collapsed RC buildings. These buildings were collapsed mainly in NS direction. Although the details of the reinforcement of these columns are not known, a rough estimation would indicate the ground acceleration should be greater than 100gal for the failure of the columns of these buildings.

Photo 6.2 Tsunami induced wall failures

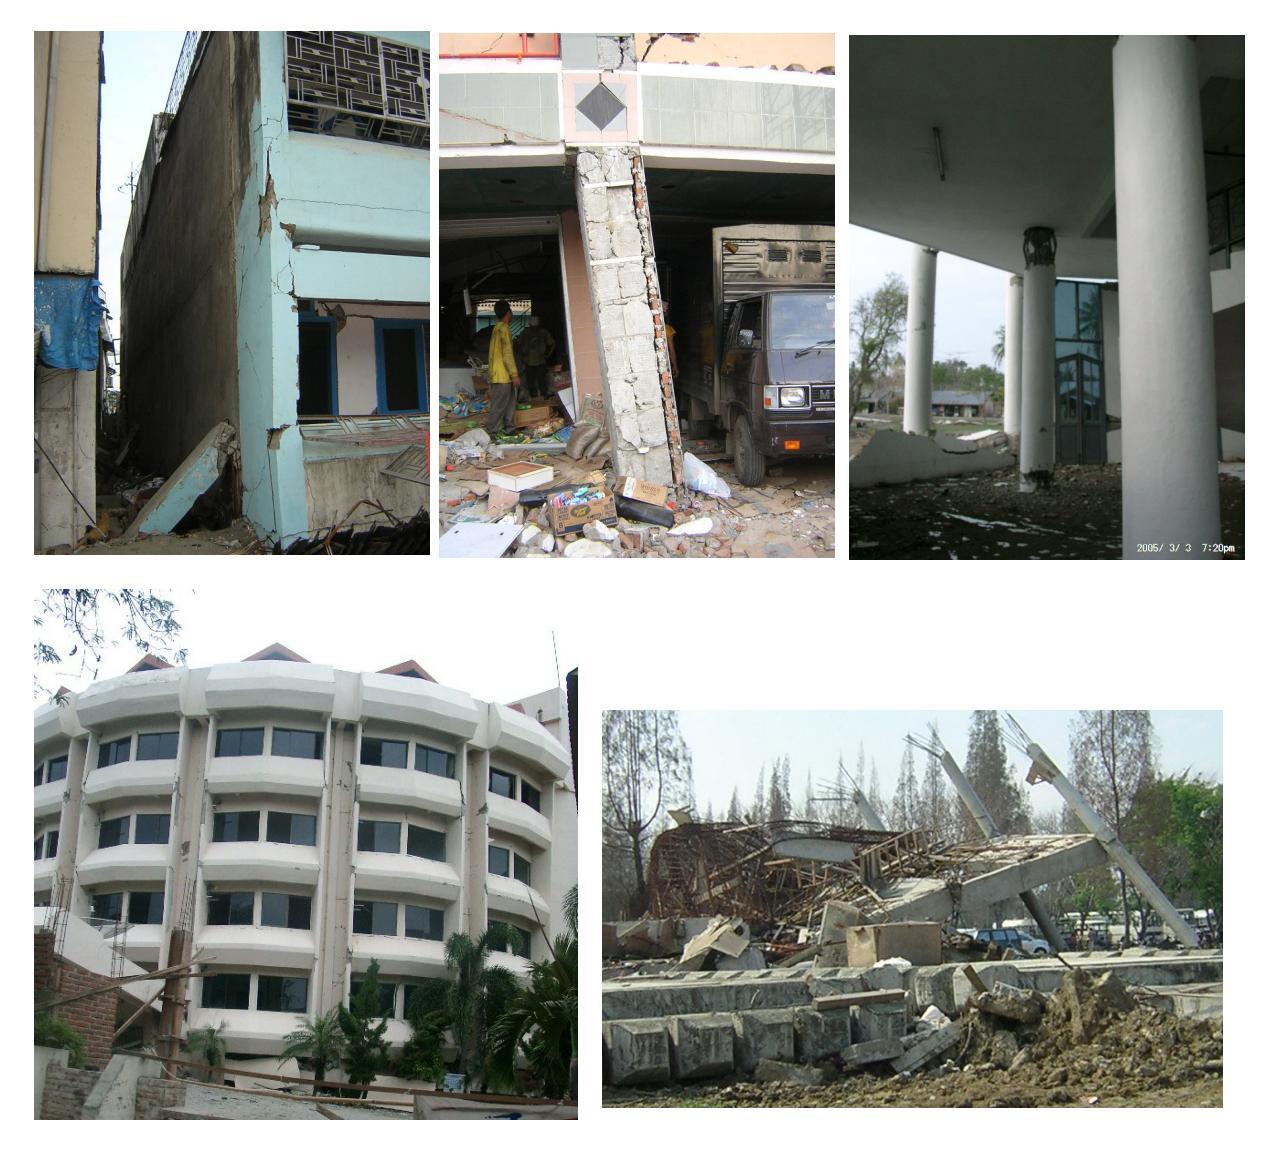
Photo 6.3 Collapsed reinforced buildings in Banda Aceh
