Chapter 8

Geotechnical Damage

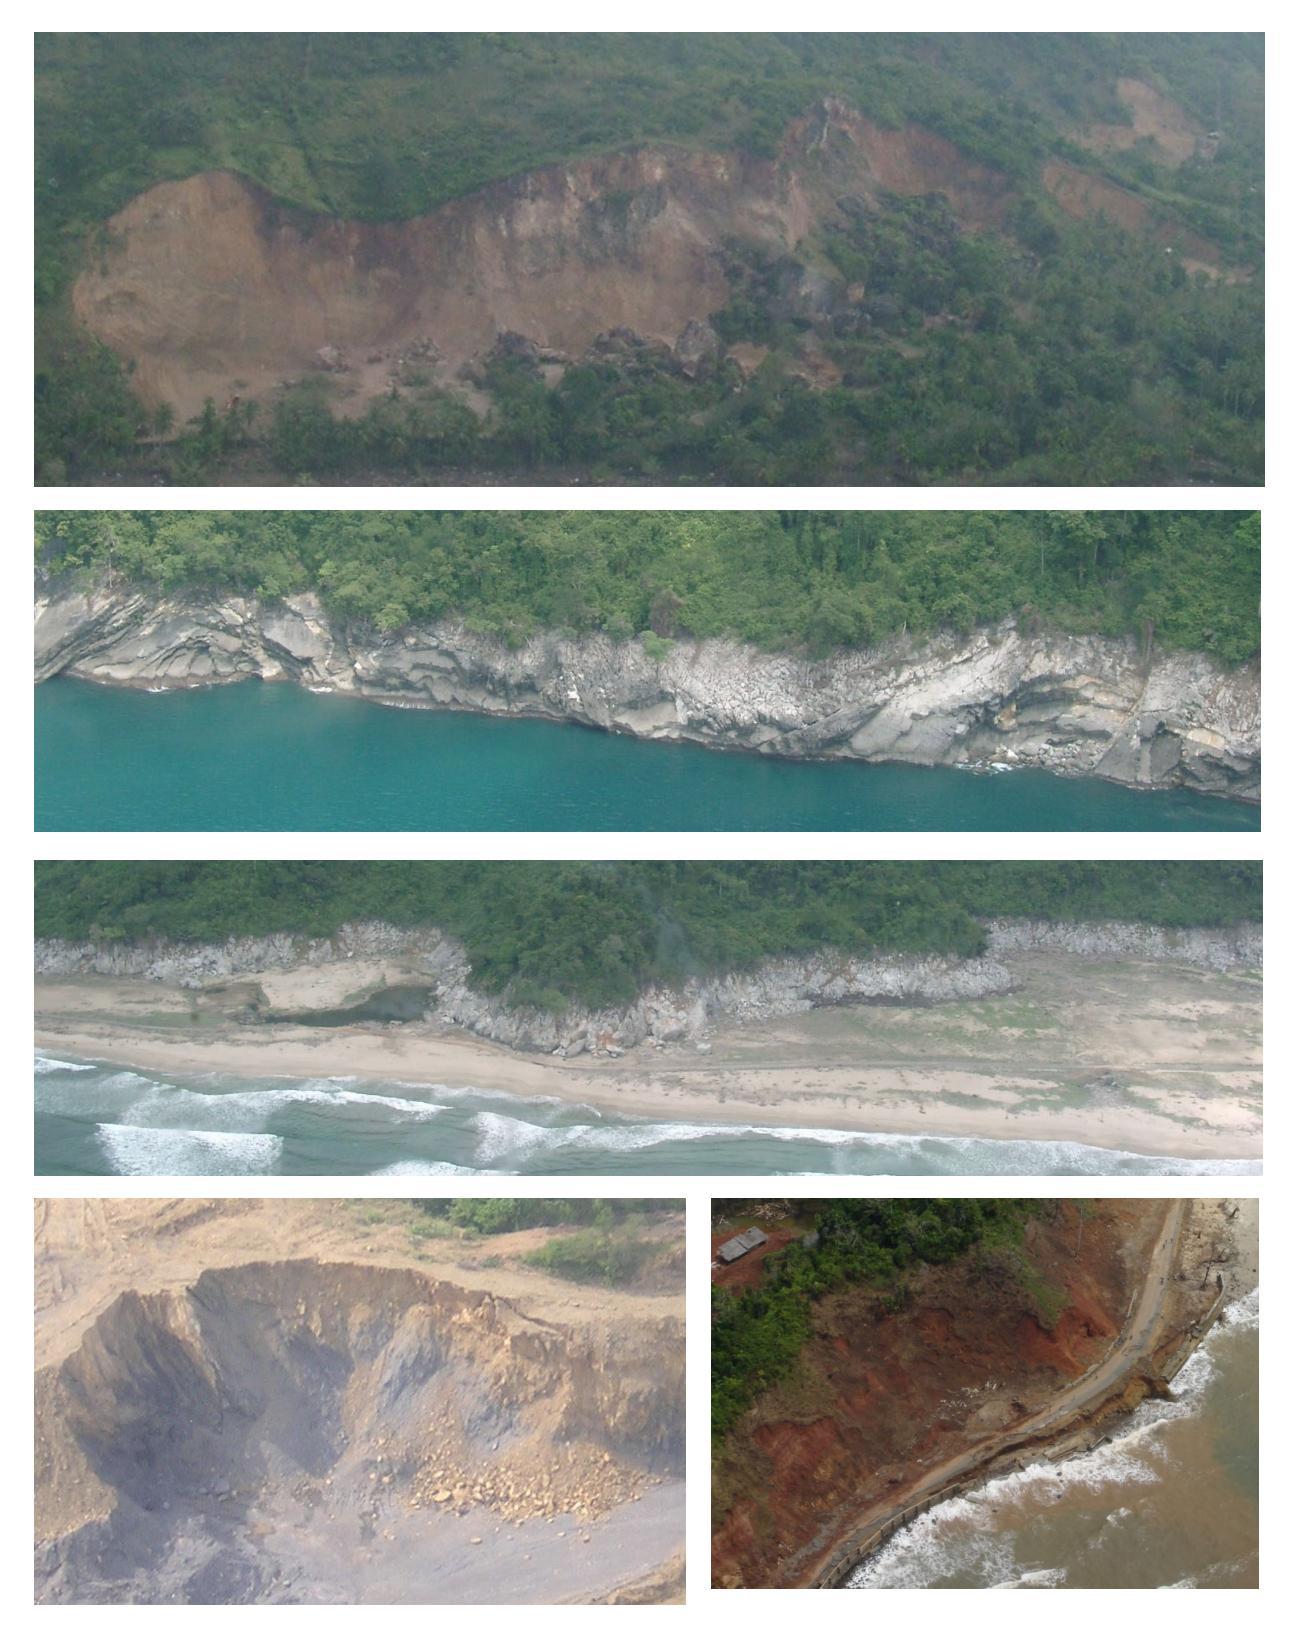
Slope failures were mainly observed in the areas of stone quarries, along roadways and seashores. The seashore between Banda Aceh and Lamno is particularly mountainous and slopes are steeply inclined. Furthermore, the rock layers are folded and are inclined towards the sea. The failure of rock slopes was mainly due to sliding on bedding planes of hard sedimentary rocks and the slopes facing the causative fault plane (Photo 8.1). It is therefore thought that the ground shaking was the main cause of rock slope failures. The weathered material on the rock slopes along the seashore was stripped away for a height of 10-20m by the tsunami waves as seen in Photo 8.2. Rock falls were observed in stone quarries in Lhonga area nearby the cement factory.

Photo 8.1 Rock slope failures and erosion by tsunami

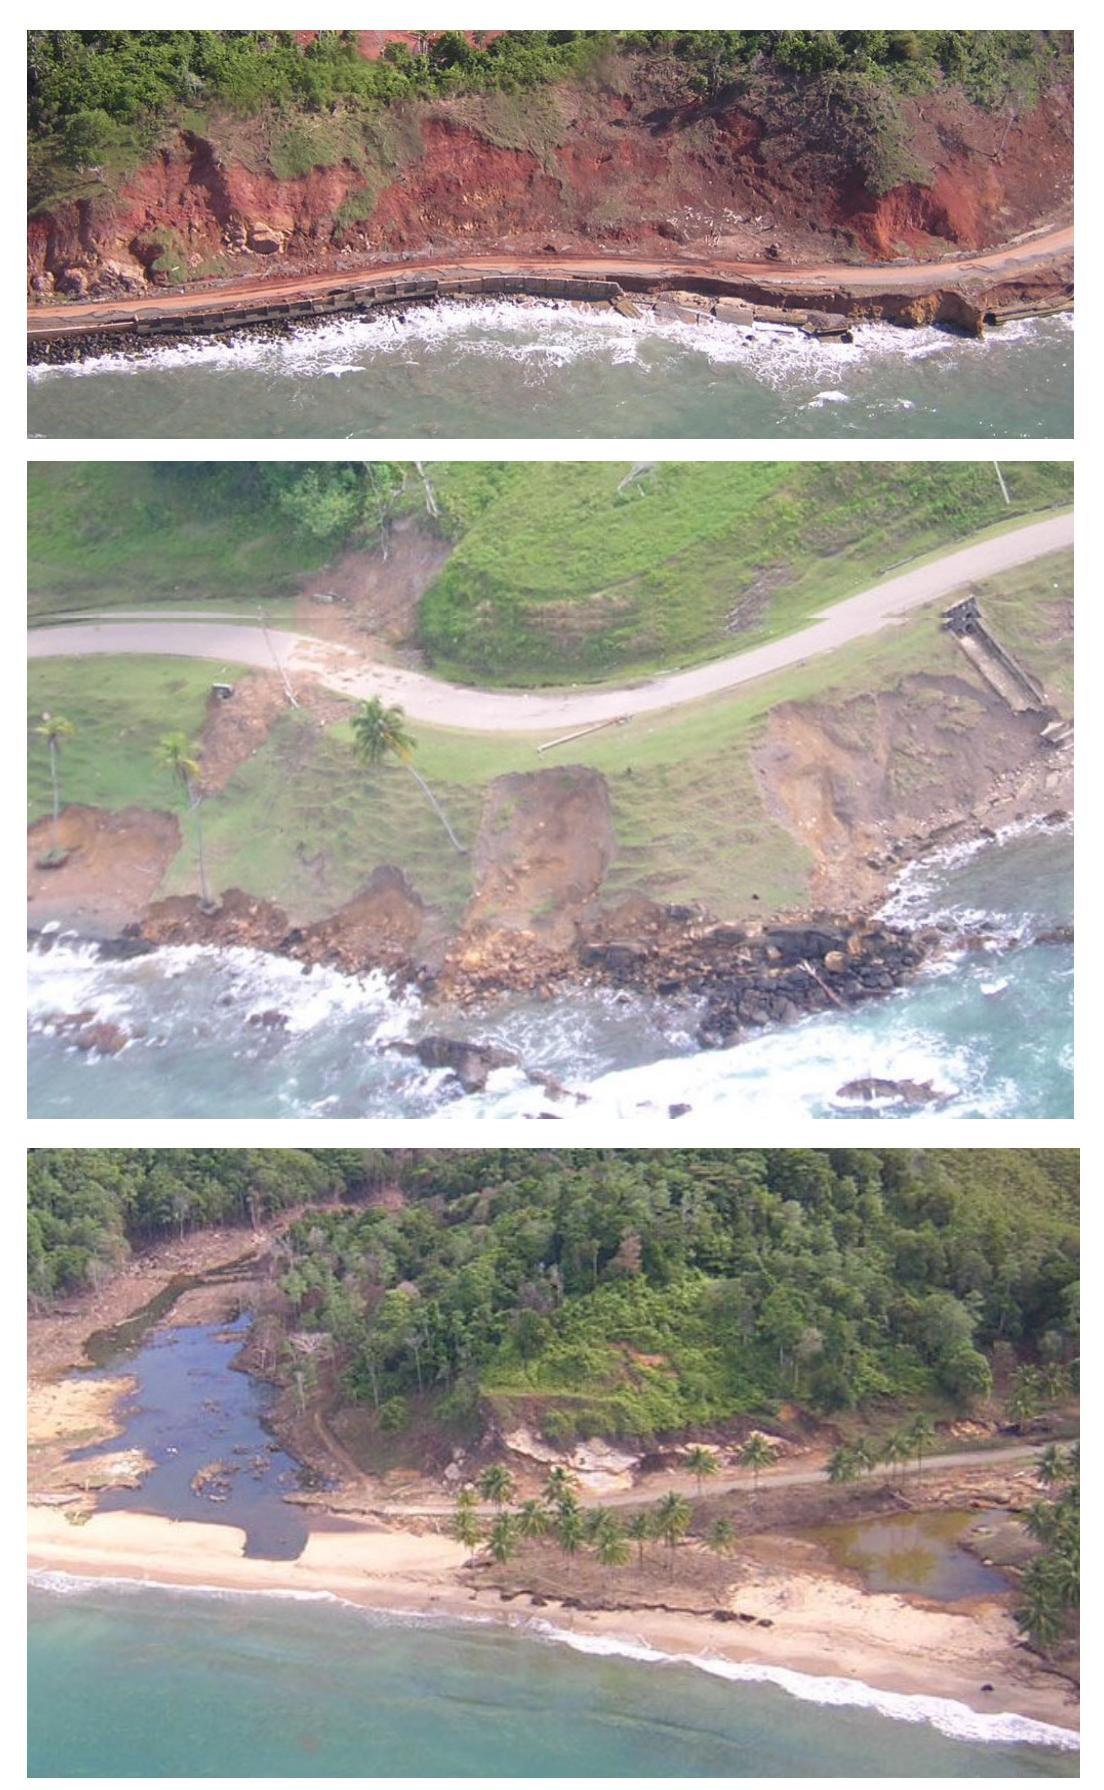
Slopes involving residual soils or highly weathered volcanic rocks were failed in the form of circular sliding. Such failures are observed on slopes on headlands as seen in Photo 8. 2.

Photo 8.2 Soil slope failures and erosion by tsunami

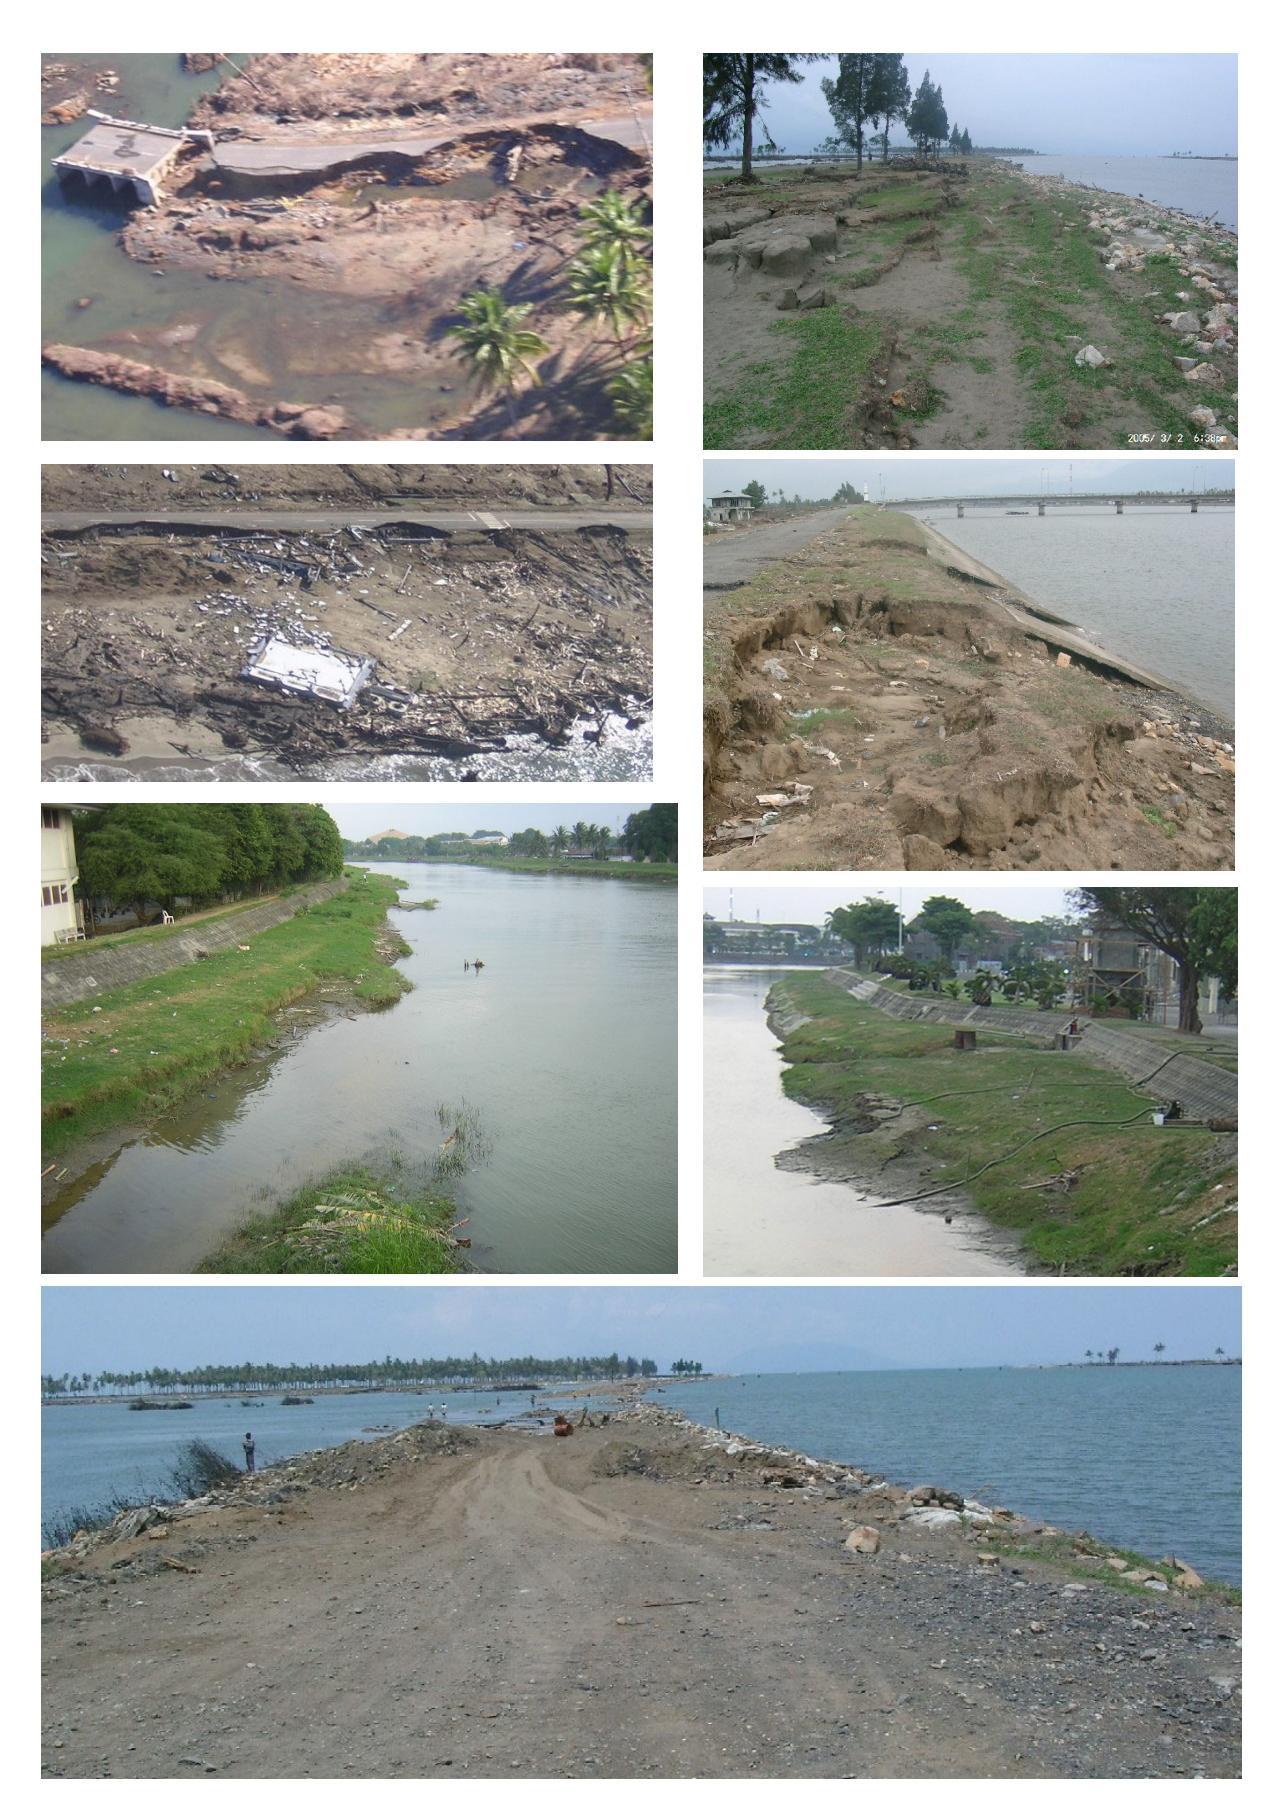
Embankment failures were observed along seashores, rivers and canals and roadways. Some of failures were in the form of typical circular sliding, erosion and liquefaction associated lateral spreading. Photo 8.3 shows some examples of embankment failures.

Photo 8.3 Embankment failures

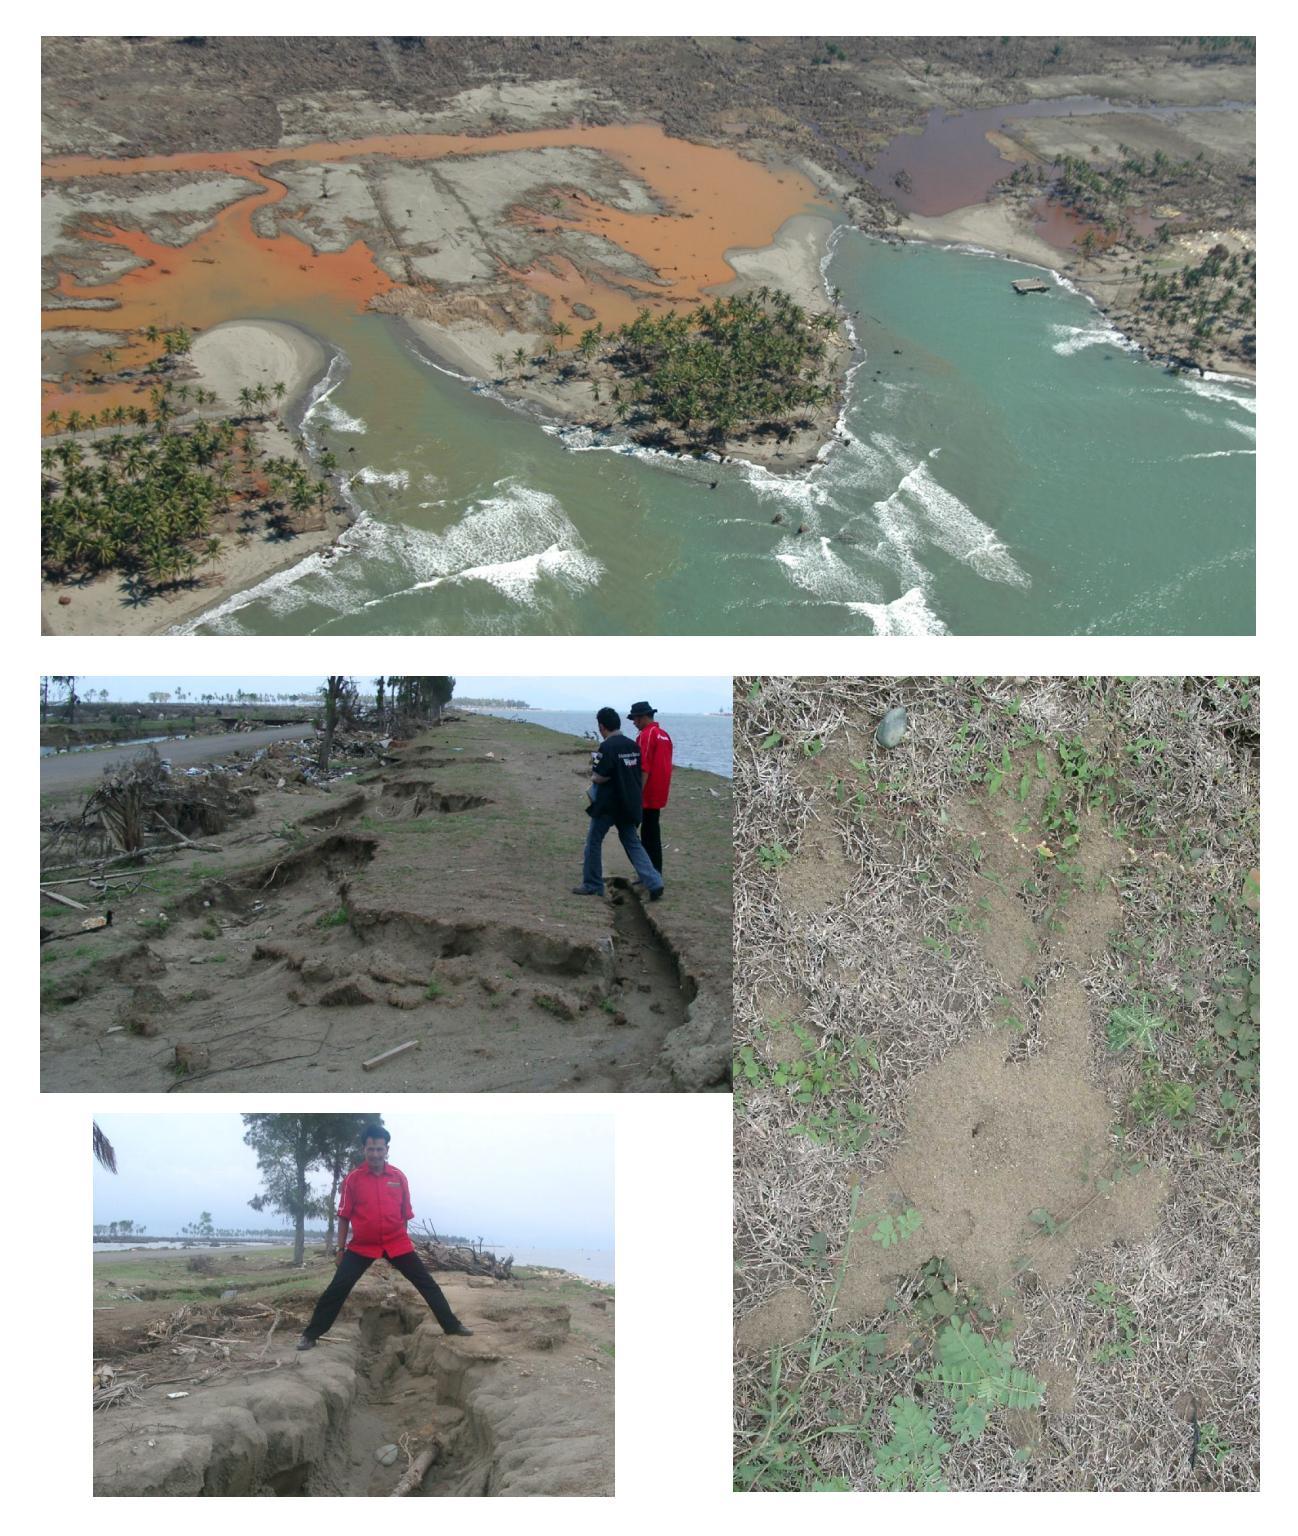
Ground along the western coast of Sumatra Island is mostly sandy soil. Liquefaction can be induced by ground shaking as well as by tsunami. The effects of liquefaction would be ground settlement, lateral spreading and erosion by retreating tsunami waves. The coastal area seems to be settled down and or topsoil is eroded. Photo 8.4 shows some examples of failures induced by liquefaction.

Photo 8.4 Effects of ground liquefaction and erosion
