## Disaster Survey Report:

# Washed Away of Bridge by the Great East Japan Earthquake

*Authors: Dr. Akira HOSODA, Associate Professor, Yokohama National University*

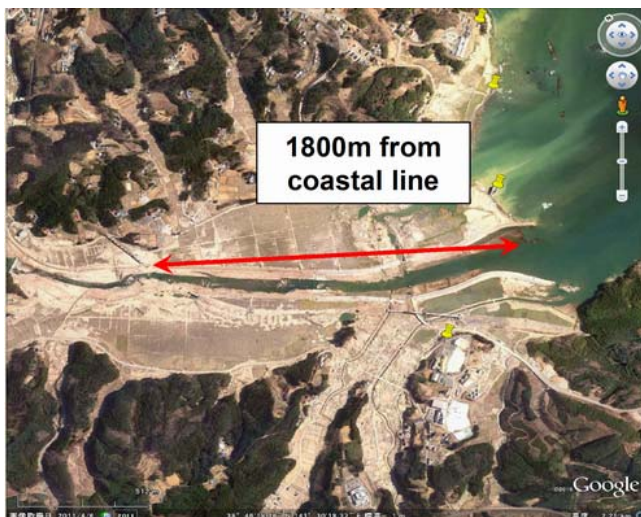
The damage of bridge due to the tsunami shows, of course, different faces. Geometrical feature plays a key role for the run up of tsunami. Fig.2 shows how the area suffered from the tsunami looks like. Two bridges above the river named Tsutanigawa were washed away. The bridge in the upstream is located about 1800m away from the coastal line, but the tsunami came up and washed away PC girders of the bridge (Tsutanigawa bridge: railway bridge). Different from other damaged bridges, RC piers were damaged as shown in Figs.3 and 4. PC girders with 40 length were pushed down and damaged seriously as shown in Fig.5. The reason why RC piers were impaired by the tsunami may attribute to the fact that this bridge had extra devices implemented to prevent falling down of girders after Miyagi-ken-Oki earthquake in 1978. The devices might restrict the horizontal movement of girders, and consequently the force of tsunami taken by girders was transferred to RC piers up to failure or tilt of piers.

Fig.2 Location of Tsutanigawa bridge

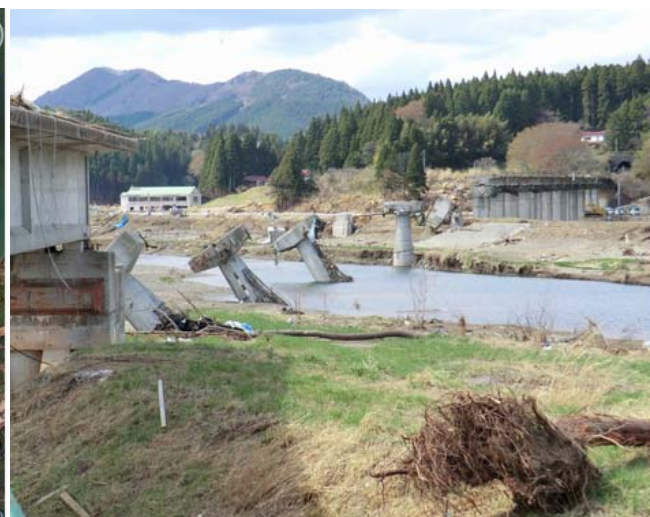
Fig.3 Inclined piers (Tsutanigawa bridge)

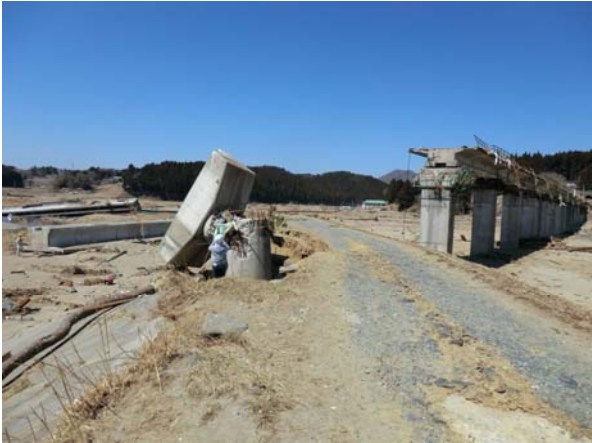
Fig.4 Failed pier (Tutanigawa bridge)

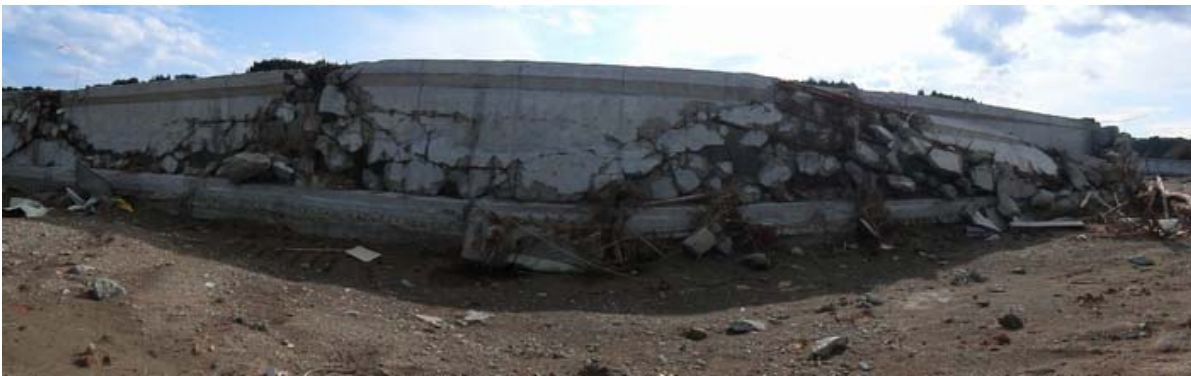
Fig.5 PC girder (Tsutanigawa bridge) washed away and damaged by tsunami

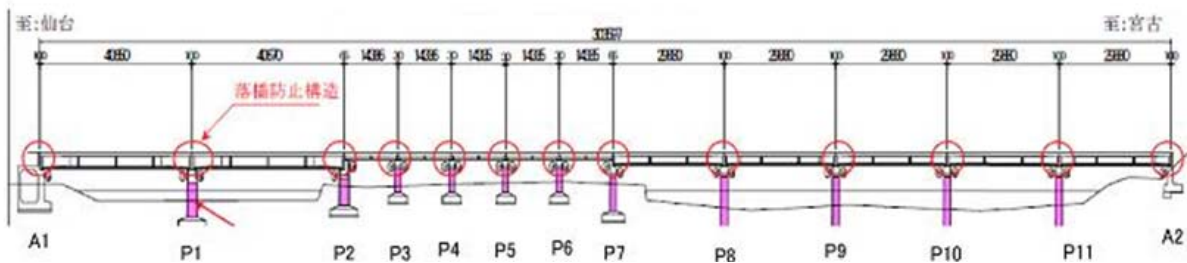
Fig.6 shows the schematic view of Utsu-ohashi bridge (road bridge, national route 45) located 7 km south to Tsutanigawa bridge. Seismic strengthening had been conducted, but was in vain against the tsunami. The PC girders were connected each other to prevent falling down by earthquake (Figs. 7 and 8). Nevertheless, connected PC girders fell down to the ground due to the rupture of the devices (Figs.9 and 10). The seismic strengthened RC piers show almost no damage.

Fig.6 Utsu-Ohashi bridge

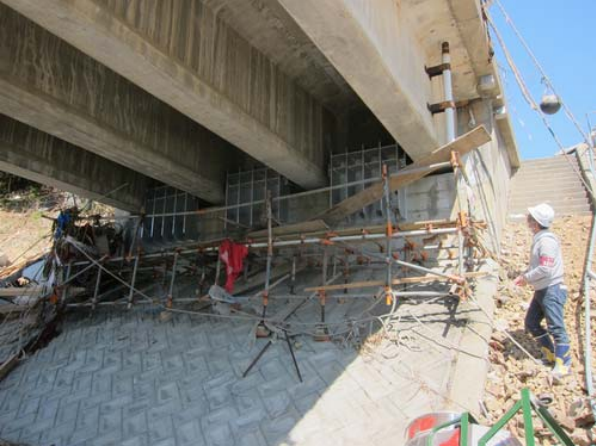
Fig.7 Device to prevent falling down of girders

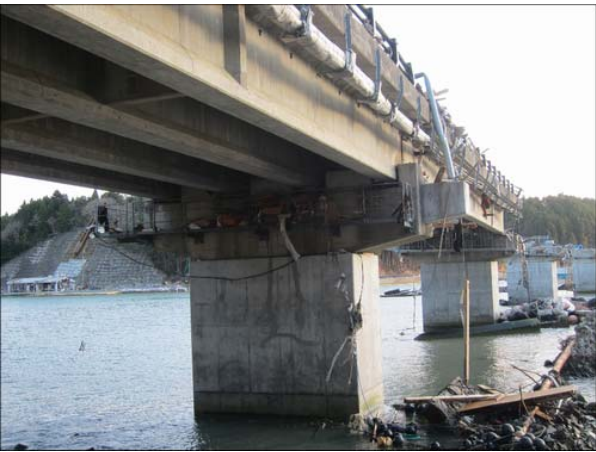
Fig.8 Seismic strengthening of piers (Utatsu-ohashi bridge)

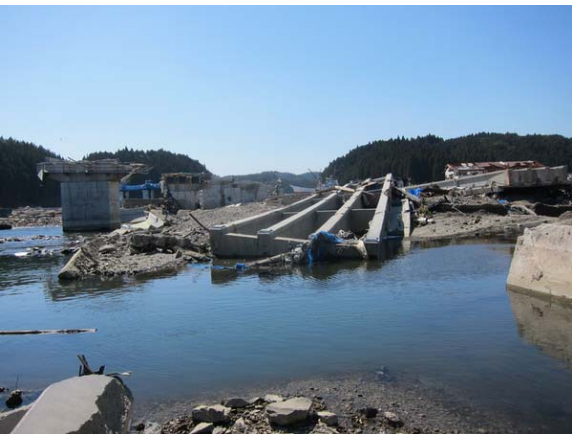
Fig.9 Falling down of PC girders (Utatsu-ohashi bridge)

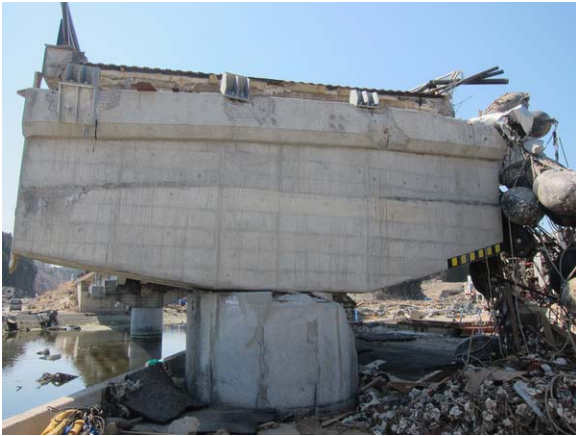
Fig.10 Rupture of devices
