## **Subcommittee on Research of the Old Movable Weir in the Ohkouzu Diversion Channel**

(Subcommittee 272)

The JSCE-272 subcommittee was organized in January 2012. The subcommittee is chaired by Professor Kyuichi Maruyama from the Nagaoka University of Technology. The purpose of the subcommittee is to carry out scientific and technical investigations of the old movable weir and pass down the results to posterity.

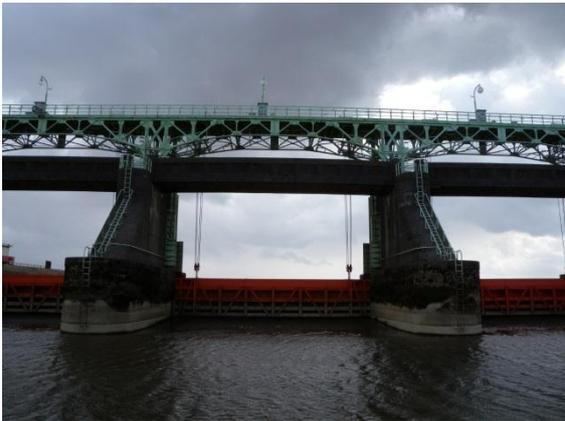
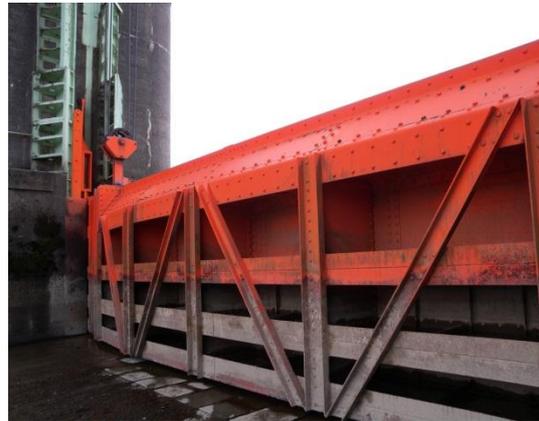
The Stoney-gate of the Ohkouzu movable weir

- From the viewpoint of the structural design, or the design concept, the importance of the Ohkouzu movable weir in the history of modern large-scale river diversion structures in Japan is difficult to accurately determine.
- The Stoney-gate of the Ohkouzu movable weir may be a perfect example of the type of long-span Stoney-gate weir used in the period before the roller-gate weir became popular.
