Activity Report by the Subcommittee on Fatigue Failure of RC Structures  
(Subcommittee 347)

Ichiro Iwaki, Yasuhiko Sato, Satoshi Tsuchiya, Chikako Fujiyama, and Yasushi Tanaka

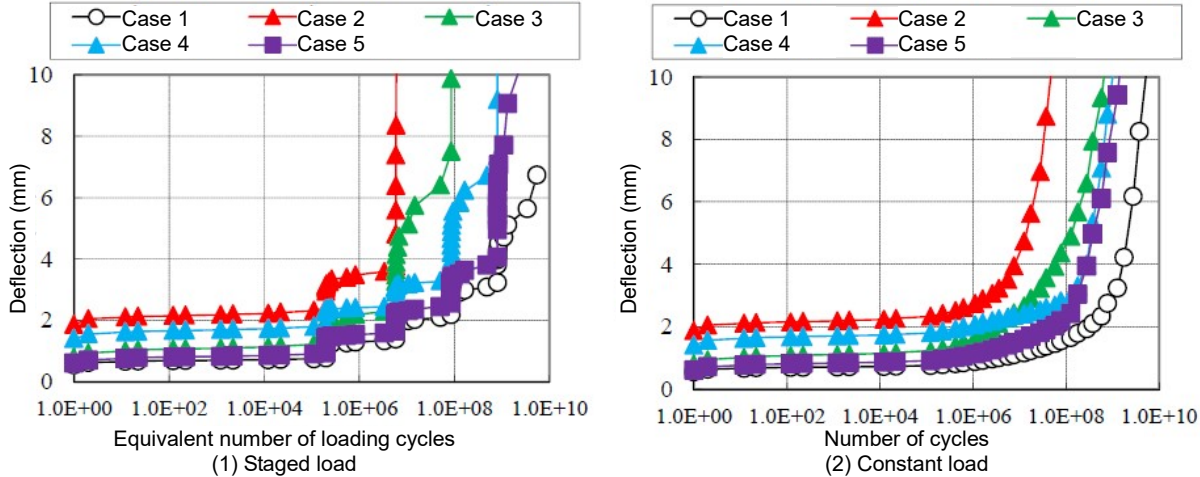
In addition, we also organized the results of the latest experiments and numerical analyses. First, reinforced concrete slabs subjected to fatigue damage were selected as examples of dynamic non-linear response analysis. Figure A shows evaluations of various influencing factors (strength of concrete, loading speed, boundary conditions, etc.) using sensitivity analysis. This study revealed much information about fatigue in reinforced concrete structures that would have been difficult to obtain only through experiments.

Fig. A Examples of deflection analysis of RC slabs under moving loads obtained by 3D non-linear FEM

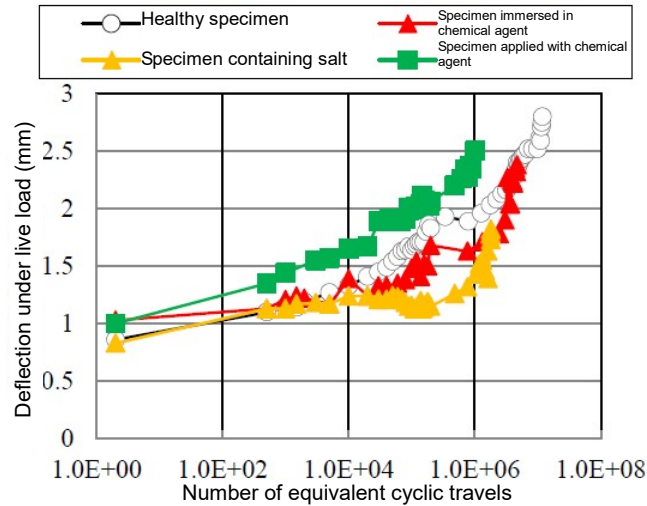
Moreover, the Actual structures are affected by deterioration caused by environmental conditions and material properties, as well as by the effects of fatigue. Figure B shows the results of studies that evaluated the progress of deterioration due to chloride attack or ASR; those coincide with fatigue damage in RC slabs. The study focusing on chloride attack suggests that the performance of an RC slab is influenced by the history of environmental action leading up to corrosion, as well as by the chloride ion content in the concrete and the amount of rebar corrosion. Another study evaluating the failure of reinforced concrete due to fatigue caused by environmental and meteorological actions and the effect of water in cold climates is also introduced. A special experimental study that examined the effects of water and wheel speed is listed together in the report. Further, information about evaluating damage caused by fatigue in RC members that had been repaired and strengthened was revealed

Fig. B Wheel load travel test results under different conditions of corrosion

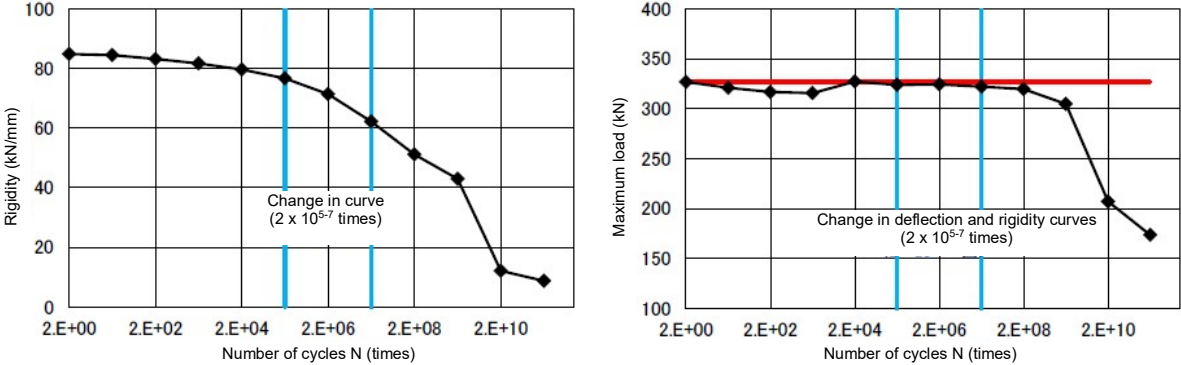
determining residual bearing capacity did not give the expected results for an RC beam that suffers flexural failure; this is possibly because the effect of concrete fatigue damage on bearing capacity is relatively small. In contrast, the reliability of the proposed method was proved in the case of an RC slab that suffers shear failure (Fig. D).

Fig. D Simulation of residual bearing capacity of reinforced concrete slab under the action of wheel load

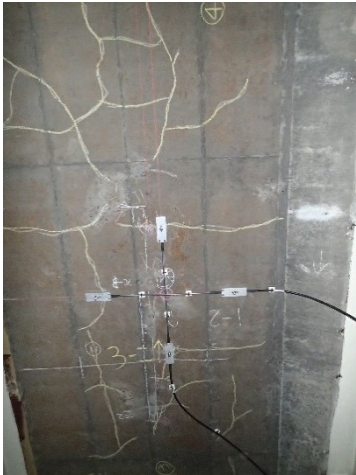
Photo A Grid-like cracking on underside of deck

The WG2 studied the design, construction, and maintenance of the reinforced concrete decks of road bridges with the aim of maximizing their overall performance. Information about recent cases of damage to reinforced concrete decks was collected and measures to prevent such damage were studied. Damage caused by fatigue in road bridge decks has been a problem since the 1960s. Grid-like cracking is noticeable on the decks of road bridges designed to the old standard (Photo A). Revisions of the standard have dealt with the problem of fatigue damage by increasing the minimum slab thickness and the amount of steel reinforcement. However, in addition to increasing the deck strength, the WG suggests improving the design of the girders in order to prevent damage and deterioration. For instance, by taking the number of main girders and their spacing into account along with the vehicle loading positions during the design stage, it is possible to considerably reduce damage to the slabs (Fig. E).

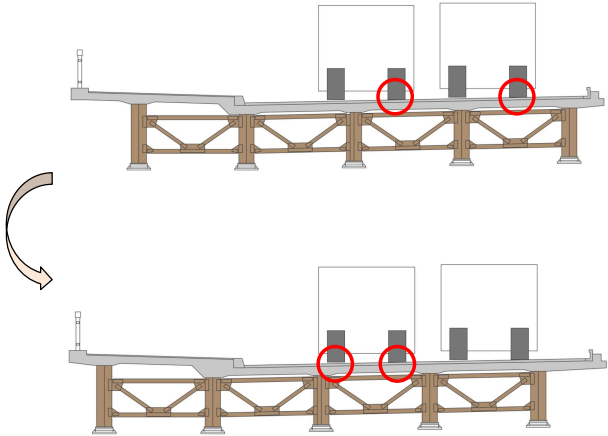
Fig. E Reduction in response value by revised main girder layout (upper: conventional layout; lower: proposed layout)

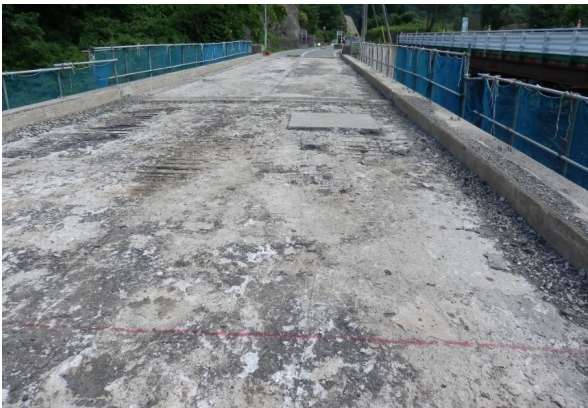
Fatigue failure due to heavy traffic loading is not the sole cause of damage to decks. Concrete on the upper surface of a reinforced concrete deck can fracture and become pulverized (Photo B).

Photo B Pulverized concrete on reinforced concrete deck

The mechanism by which concrete becomes pulverized has not been clarified, but the phenomenon is mostly seen in environments in which anti-freeze agents are used. Previously,

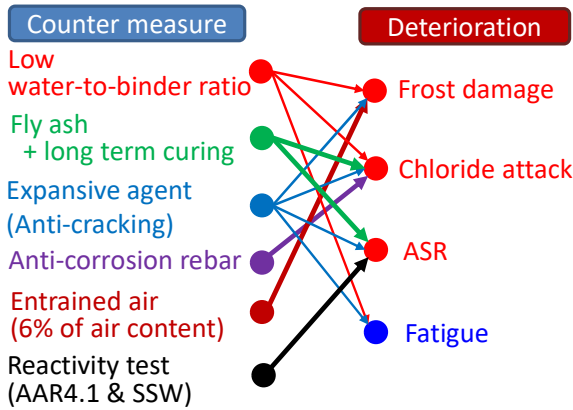
To elucidate the mechanism as a step toward preventing pulverization, a test deck was constructed on a reconstruction road in the Tohoku region of Japan. Measures were implemented against all possible forms of deterioration by considering the combined action of salt in the anti-freeze agent and alkali ions. Furthermore, redundant measures were applied, resulting in a system that prevents deterioration (Fig. G). Fly ash was used in the concrete to inhibit salt damage and the alkali-silica reaction (ASR).

Fig. G Example of highly durable deck design by redundant protection and use of admixture

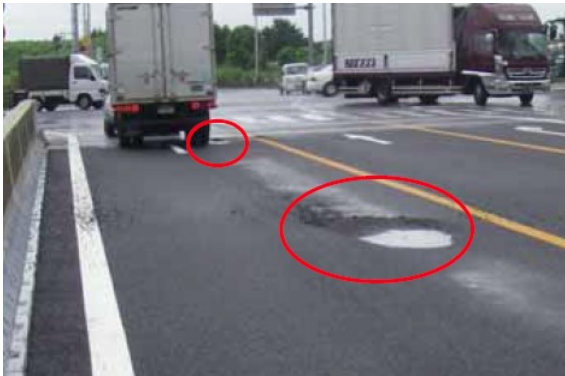
Photo C shows a case of potholes in the asphalt pavement covering a deck slab. Potholes develop when the waterproofing layer between the slab and the asphalt pavement becomes detached. Because some types of finishing agent used during deck construction can reduce the bonding force with the waterproofing system, all materials should be evaluated for compatibility.

Photo C Potholes

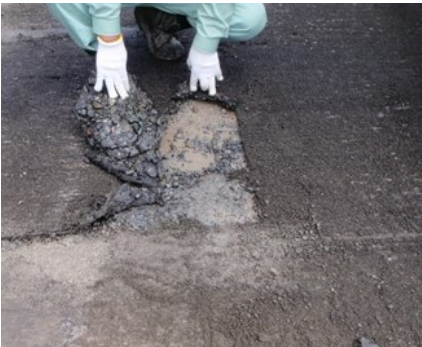
Moreover, if water collects within the asphalt layer, potholes can easily develop. The water easily enters the slab through gaps in the layer and may collect under the layer (Photo D). Water collecting on the upper surface of the reinforced concrete deck significantly reduces fatigue resistance. Hence, decks should be constructed so that they cannot collect water.

Photo D Water collects under waterproofing layer

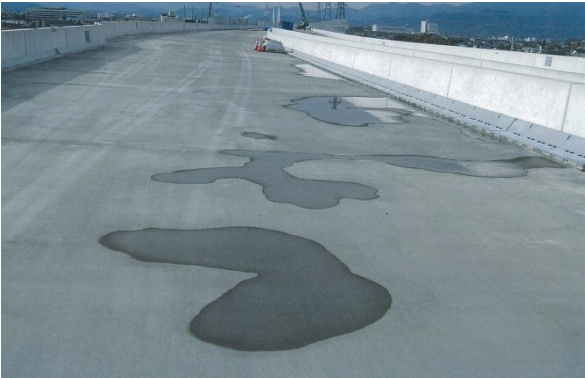
Proper drainage is critical for preventing water from collecting and requires proper planning and upper-surface finishing of a deck to a flat and smooth finish. However, when the surface is manually finished, as is currently done, the surface may be uneven, allowing water to collect after rain (Photo E). To prevent this, the WG has developed technologies to improve the flatness of the surface. Photo F shows a simple finishing machine developed by the WG. Used in the finishing processes, the machine reduces the finishing error to about  $\pm 2$  mm.

Photo E Water collects on deck after rain

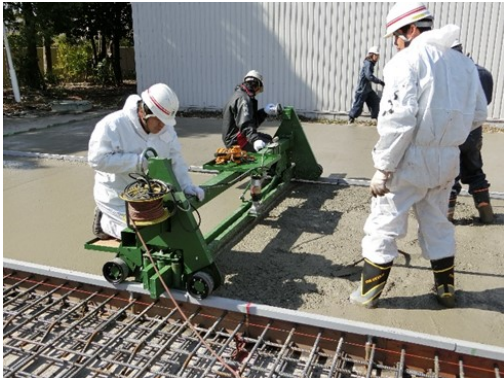
Photo F Simple finishing machine prototype ensures flatness
