# Male' Seawall Project (Maldives)

# 1 Project Background

## 3 Project Features

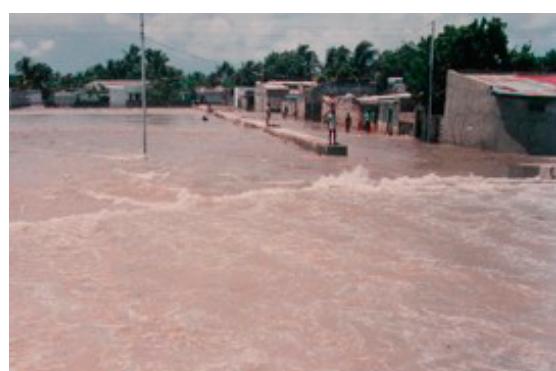
Any serious damage caused by extremely high waves may not have been recorded before 1986 in the Maldives, but from 1986 onward, high waves occurred three times and caused considerable damage in April 1987 and in June and September 1988. From April 10 to April 15, 1987, extremely high waves occurred in Male' (1.6 km long, 1.2 km wide, 1 to 3 meters above sea level) and its neighboring islands and caused damage to seawalls, private houses, airport facilities, etc. The total damage caused by these high waves was estimated to be about US\$ 6 million concentrated along the heavily populated south coast area of Male' Island and at the international airport on Hulhule Island. When high waves occur around Male' Island, flood water remains for considerably long periods, mainly because the island is flat and low-lying and has no adequate drainage system. In 1987, due to a lengthy spell of flooding coupled with high temperatures, an epidemic of diarrhea broke out.

Flooding in 1987

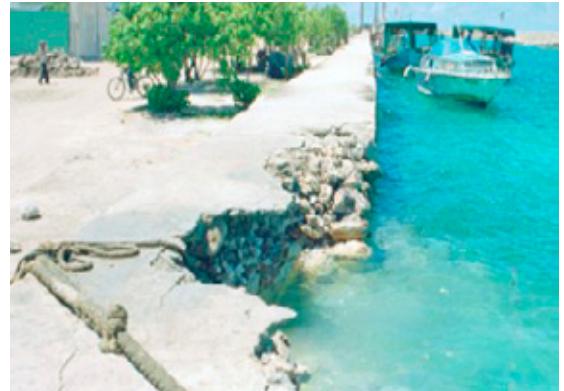
The whole coastal area was constantly washed by swells or waves and the roads behind the existing seawall became flooded due to the effect of water splashing over the seawalls. As the seawalls were not robust in their construction (being constructed of coral boulders 10 to 20 cm in size, capped with cement mortar), there are sections of the seawall that are misplaced/eroded, and therefore the waterfront is neither stable nor safe. In order to prevent such calamities, it is imperative that a permanent and secure seawall be constructed to keep the people of Male' Island free from the ravages of Mother Nature and allow them to have a normal and safe living environment as well as maintain the social and economic base of the Maldives.

Old Coral Seawall

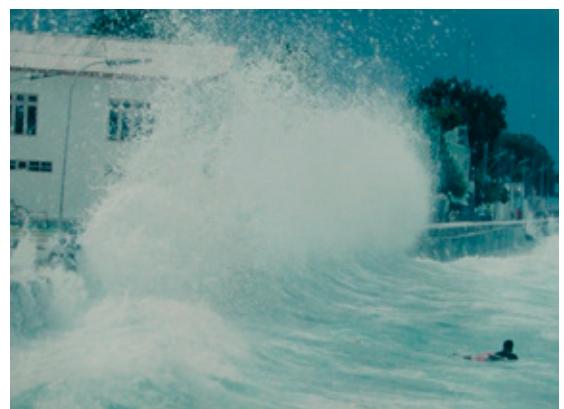
Wave Splashes over the Wall on East Coast in 1991

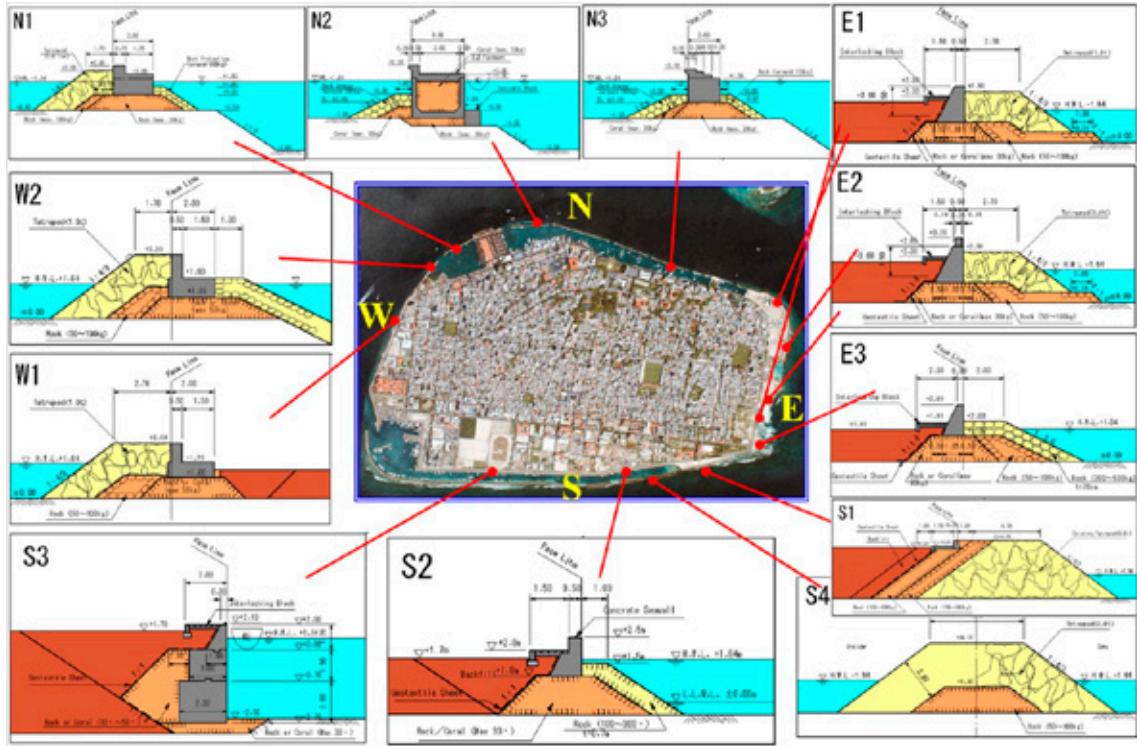
Figure 1: Location and Typical Section of Seawalls

Typical sections of the entire seawall are illustrated below (Figure 1). The seawall structures consist mainly of mounds of

rubble stone, tetrapods, and concrete blocks. Since the Maldives is a coral island, it was impossible to obtain construction materials such as stone, concrete aggregates, cement, etc. This is why all materials were imported from Indonesia by way of barges. Even freshwater for mixing concrete was produced using seawater from a desalination plant.

Based on the recommendations from the feasibility study, it was decided that the seawalls would be designed based on the waves, tide, and height of the seawall as below (Table 1).

Location (Coast)	Offshore Wave Height (m)	Wave Period (sec)	Design Wave Height (m)	Design Tide Level ** (m)	Top Level** of Seawall (m)	Length of Seawall (m)
East	3.0	16.0	1.3	1.64*	2.80 - 3.20	1,266
South	3.0	16.0	0.7	1.64*	2.10 - 2.50	1,508
West	1.2	4.6	1.2	1.34	2.60 - 3.00	774
North	0.6	4.6	0.6	1.34	2.10 - 2.30	1,441

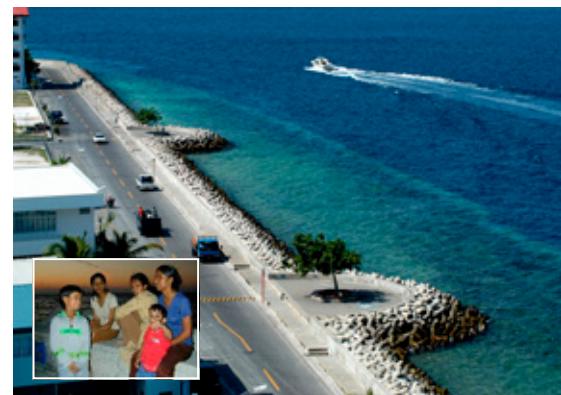
Since the west coast faces inside of the atoll, it suffered no big swell attacks, but wind waves (1.2 meters in height) generated in the atoll would hit the west coast in the monsoon season. The west coast is home to important facilities such as the island's largest hospital, school, and social center, and so building the west coast seawall was the number one priority. There are two detached terraces and a 1.5 meter-long walking path for locals and tourists to enjoy stunning views of the beautiful sunset here.

West Coast Seawalls with Terraces

3. The coastal zone is one of the most important areas in the lives of the local people, so it was very important that the function of each coast be considered carefully when designing the seawalls.
  - a) Two sets of terraces were additionally provided for people to enjoy views of the sunset on the west coast. b) On the east coast, not only an artificial beach

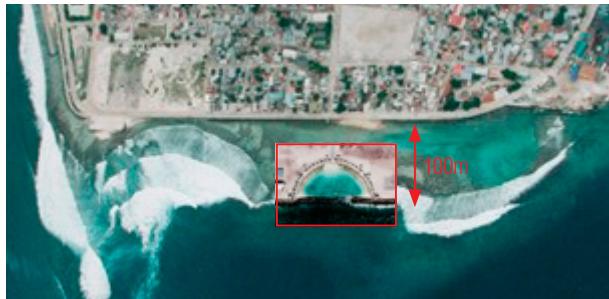
East Coast Before Reclamation

The Government of the Maldives planned to reclaim the shallow reef of the east coast in order to create a place of relaxation and to act as an area for recreation and sports facilities. Taking this into account, PCI proposed that the location of the new seawall along the reclaimed land be located 100

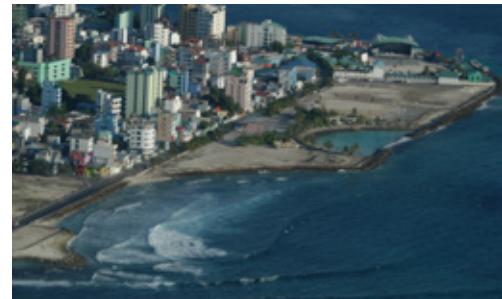
meters seaward from the existing coastline. The Consultant also proposed to create an artificial beach for the Male' people to enjoy swimming safely at any time of day.

East Coast Seawalls

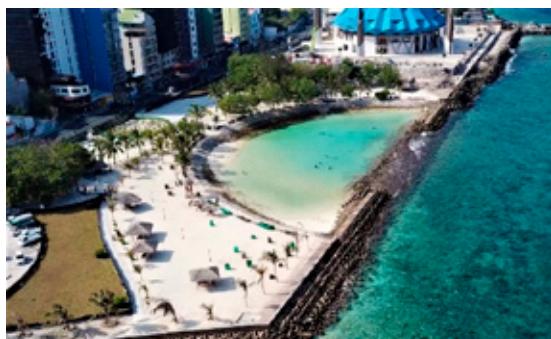
Artificial Beach

which was the last possible area left to realize this idea. For the Government of Maldives to create an artificial beach as a part of the proposed seawall project, the corresponding portion of the seawall was planned with a gentle slope.

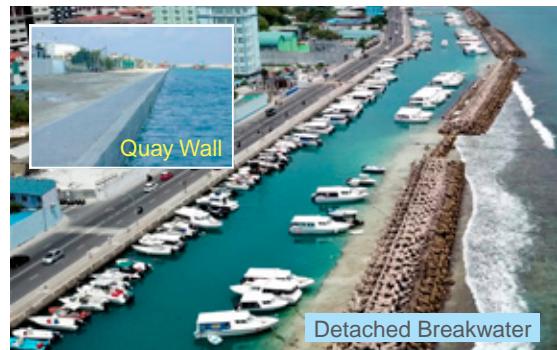
Big swells would constantly hit the south coast from the southern Indian Ocean. After the disaster in 1987, detached breakwaters were constructed in 1990. A calm water area behind the breakwaters was utilized as an anchoring space for pleasure boats or small boats voyaging between Male' and remote islands. This project provided quay walls (water depth of 2.5 meters) as seawalls to enable said boats to moor safely. Now the quay walls are occupied by a lot of boats as shown in the attached photo.

South Coast Seawalls as Berthing Facilities

but also a coastal promenade was set up for the people to enjoy jogging or walking along these scenic areas. c) In order to accommodate plenty of small passenger and cargo boats and pleasure boats safely, a quay wall (about 1,200 meters) with a water depth of 2.5 meters was constructed as seawall facilities on the south coast.

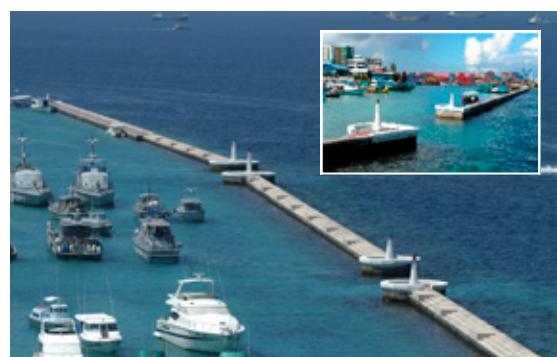
Attractive North Coast Breakwaters

boulders, all the breakwaters were replaced by stone mounds and concrete blocks by this project. At each edge of the breakwaters,

small beacons were installed as navigational aids for entering boats.

d) Many tourists and VIP guests utilize the north coast as it is the only place accessible from the airport. To ensure calm conditions by protecting against waves from the north, 7 sets of detached breakwaters were constructed as part of the seawall project.

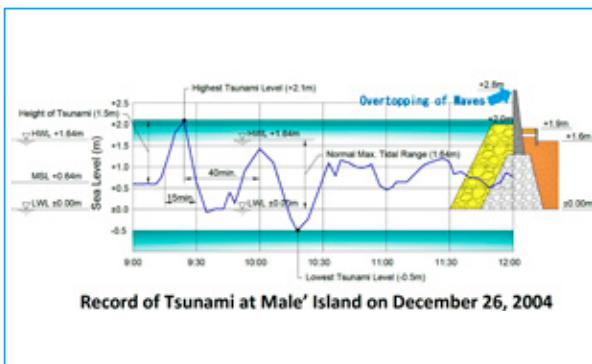
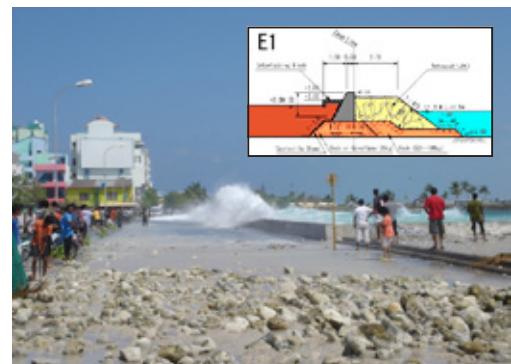
At 9:30 am on December 26, 2004, a huge tsunami attacked Male' Island. The height of the tsunami was about 1.5 meters as shown in the attached figure. Since the tsunami occurred at the time of mean sea level, the top of the seawall was still about 60 cm higher than the height of the tsunami waves. At the time swells (about 1 to 1.5

meters in height) also hit the east coast as shown in the attached photo. Some waves overcame the seawalls and caused flooding on the island. However, fortunately, no serious disaster occurred on Male' island due to the strong seawalls constructed with Japan's ODA.

Wave Splashing Over the Wall during the Tsunami in 2004

1. It was very important to provide strong and maintenance-free seawalls in small low-lying islands in order to avoid a serious disaster due to high waves or a tsunami. The fact that the seawalls protected the people of Male' from a huge tsunami disaster in 2004 proves the importance of constructing shore protection facilities.
2. Considering that concrete blocks (tetrapods) are useful to dissipate and mitigate the threat of high waves but interfere with locals and tourists enjoying themselves by the coast, PCI proposed an artificial beach on the east coast,
