Details of damage in stricken area

Damage caused by storm and tidal surges around Shiranui Town

Characteristics of Typhoon No. 9918 and accompanying storm surge

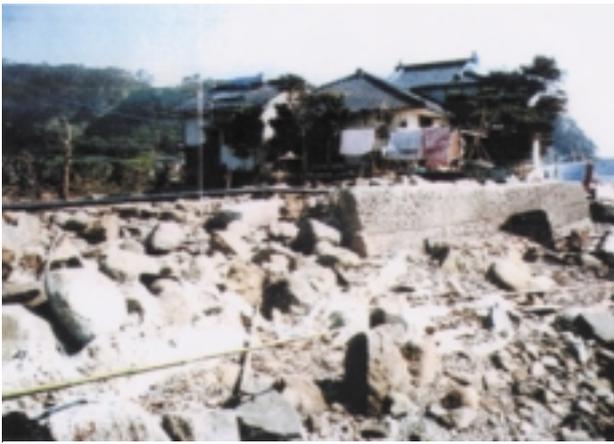
Photo 1. Disaster-hit Einou District

broke into the ground floor of a house in the vicinity of the levee; fortunately the residents had seen the danger and moved upstairs. The levee failed over a length of 137.0 m from a point near this inundated house up to the extremity of the bay (Photo 1). Other damage consisted of 13 houses inundated above floor level and 31 houses below floor level. National Highway 266 was also flooded. The peak of the storm tide in this area was T.P. +4.9-5.6 m.

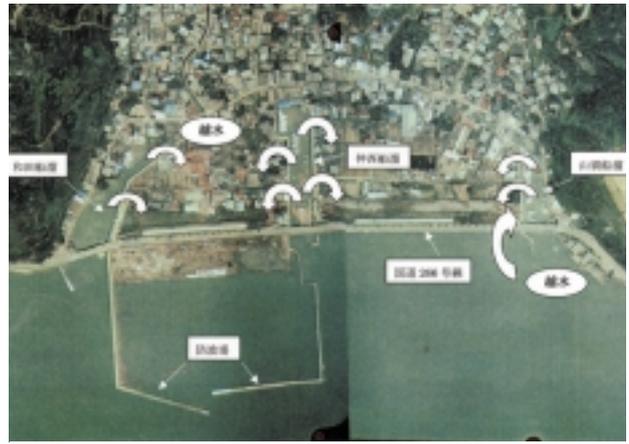
Photo 3. Aerial photo of Matsuai District

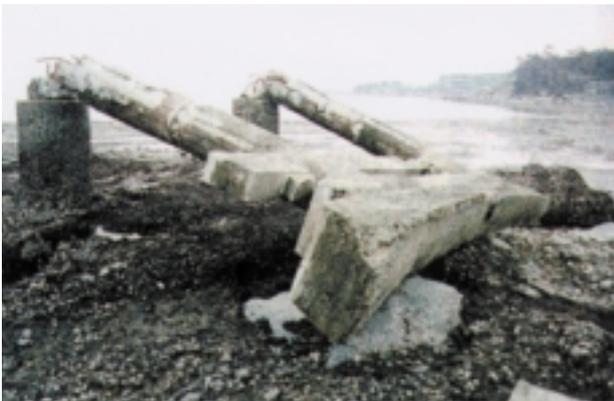
Photo 2. Overturned torii at Einou Shrine (Source: Kumamoto Nichinichi Newspaper evening edition on September 28)

mately 65 m out into the bay from the shrine. The storm tide snapped the 70-cm diameter torii foundations at a point 1.25 m above the seabed, and the structure fell in the direction of the shrine (Photo 2). The torii stood in approximately 2 m of water even at high tide and yet had never been knocked down by a typhoon before.

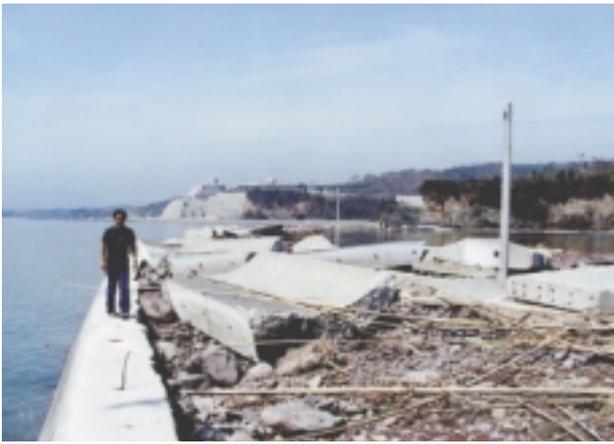
Photo 5. Disaster-hit Teba District

In the Teba District of Misumi Town, located at the southern tip of the Udo Peninsula, sea water began to flow over coastal levees (T.P. +4.5 m) at about 5:30 a.m., causing the levees to collapse over a length of 245.0 m (Photo 5). Prawn farms in the hinterland were closed down and private houses were somewhat distant from the levees. Despite this, water damage was extensive, though there was no injury to humans. One house was inundated below floor level and strawberry farms were damaged. A few spans of a levee on the Matsuai side fell inward while others collapsed outward in the direction of the Shiranui Sea. Further, storm tide traces along the coast in this district showed peak levels of T.P. +4.6-5.7 m, indicating that waves were significant in this area.

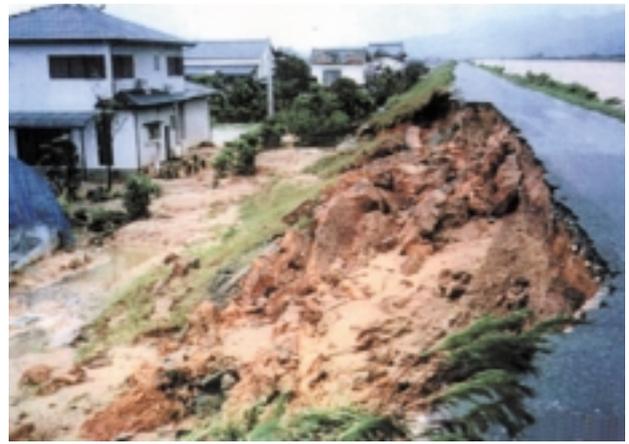
Photo 6. Damaged banks of the river Sunakawa

The survey indicated that the storm tide level in the area reached T.P. +4.1-4.5 m. The results of a survey by the prefecture (as reported later) indicate that the rivers Sunakawa and Hikawa overflowed by T.P. +4.1-4.2 m, causing further damage. These measurements make it clear that the maximum flood level (T.P. +4.5 m) was the highest point of the storm tide.
