## Report of Emergency Survey Group of Usu Eruptive Activity on March 31, 2000

### Detail of volcanic activity, damage caused, emergency communications, And evacuation operations

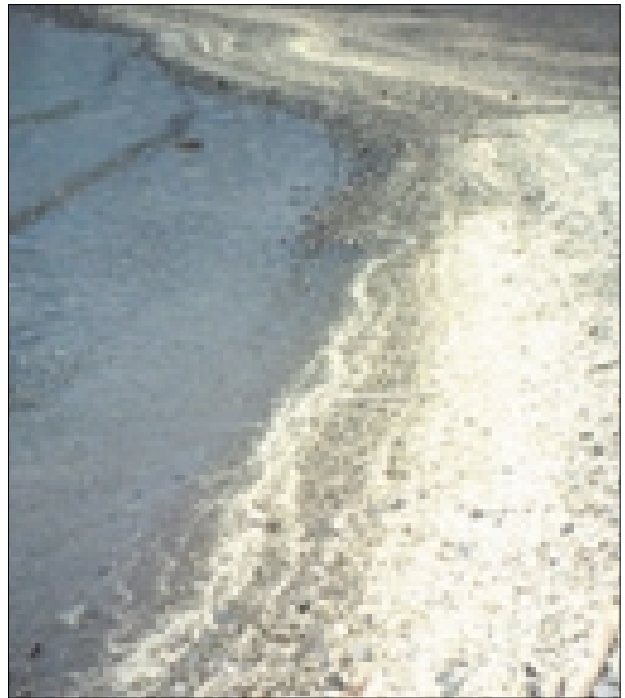
Photo.1 Pumice floating on Lake Toya

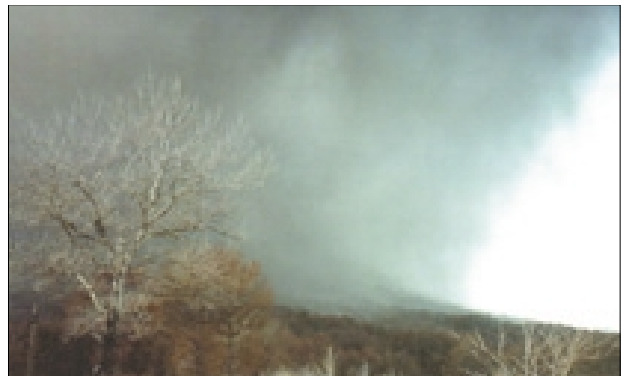
Photo 2. Volcanic ash cloud of eruption at 2:00 p.m. on April 2

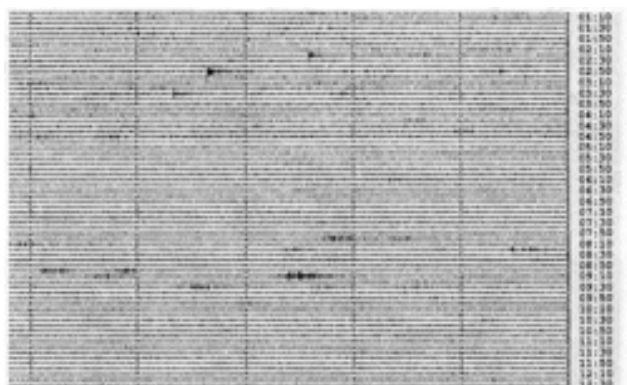
Photo.3 Seismogram recorded on May 12 (by Japan Meteorological Agency)

very few took place near the lake. The hypocenters were mostly 3 to 5 km in depth and there is the characteristics that the shallower their depths, the nearer to Mt. Nishiyama. Photo 3 shows a seismogram recorded on May 12 by JMA, indicated that seismic activity was at a low level.

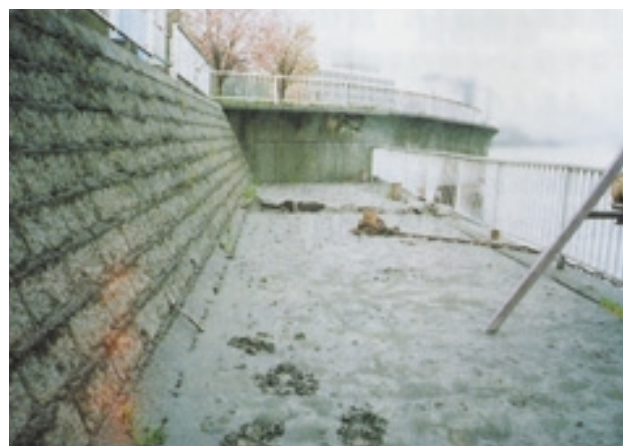
Photo 4. Damaged revetment and volcanic ash deposit at the hot spring resort on Lake Toya

Figure 2 and Photo. 4 show the conditions of the revetments by the lake near the hot spring resort on May 15. The quay wall was pushed toward the lake by earthquakes and lateral movement of the ground was confirmed in some place around there. The volcanic ash fall was 1 to 3 cm thick there and trees in the garden of a near hotel were damaged by the ash fall.

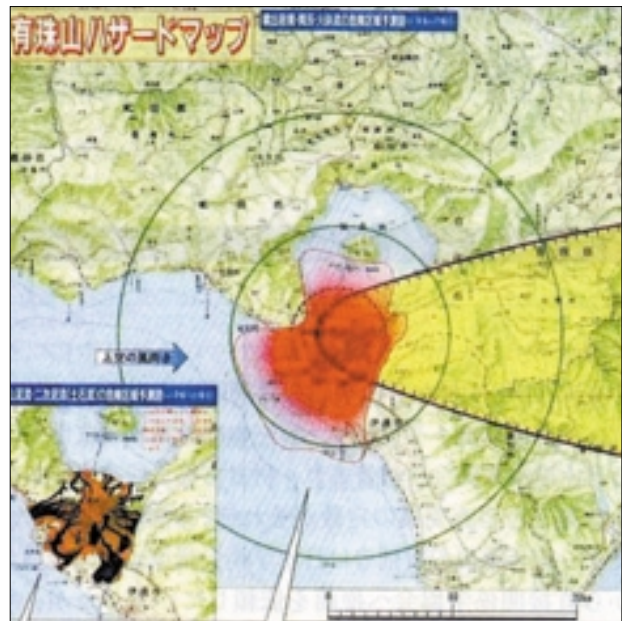
Fig. 3 Hazard map of Usu Volcano  
(Source: Disaster Prevention Map of Usu Volcano)

The representative was a hazard map made in 1995 as shown in Fig. 3, by using the records observed at the last activity 23 years ago as a lesson. This played a significant role in sharing information about damage prevention among researchers, municipality and residents. Considered the hypothetical volcanic activity as inferred from the map, the municipality made an elaborate plan of evacuation and implemented the evacuation drills regularly to develop the awareness of residents, while they had been studying a detailed actions that might need to be taken in case of an emergency. Thus, the residents had deeply understood about the characteristics of eruptive activity of the volcano and were braced for an emergency. Through theses preparatory works, a firm relationship of trust was established between officials and researchers. These ongoing as well as the timely provision of evacuation information led to the problem-free evacuation of residents. This important point should be kept in mind as disaster-prevention efforts continue in the future.
