Year 2002 Flood Disaster Investigation in Europe

Summary Report

March 2003

Year 2002 Flood Disaster Investigation Team to Europe

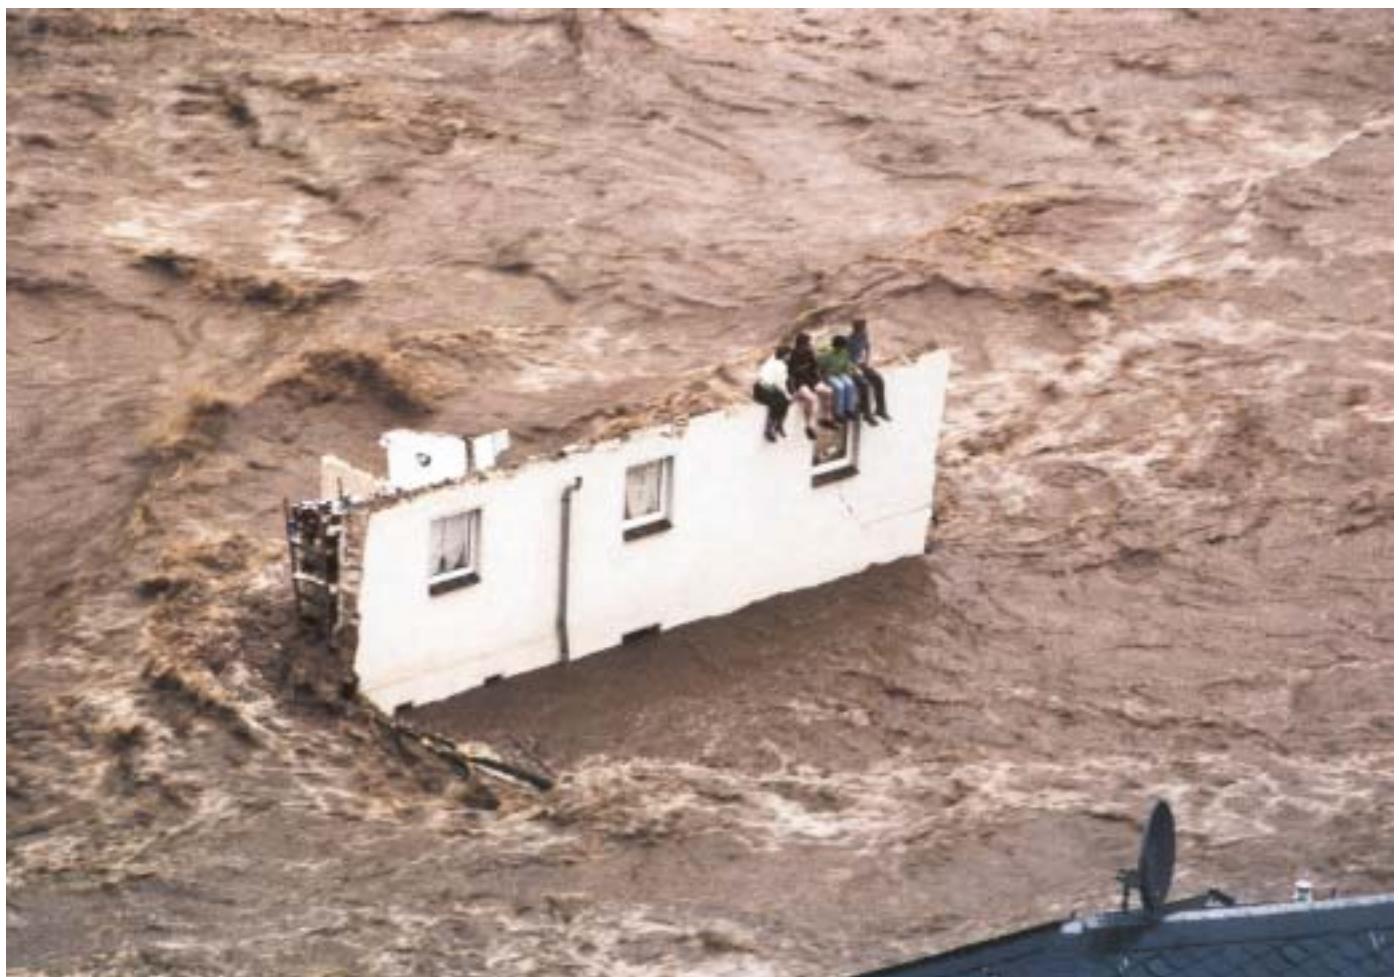
Cover photo: Citizens waiting the rescue team at the Mueglitz River (left tributary of Elbe) (courtesy of Sachsen Municipality Office)

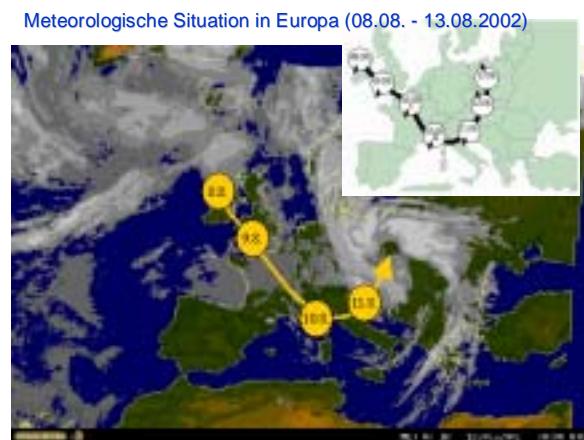
*Figure-1 Center of slow-moving low pressure
(Courtesy of Germany's Federal Ministry of Transport, Building and Housing)*

The low pressure that moved in from the North Sea in early August was blocked by the high pressure that hung over the Sahara – Barth region, slightly changing its course and coming to a near halt (Figure-1).

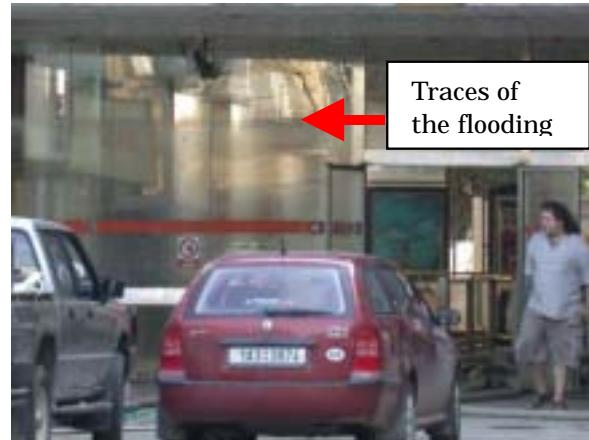
Photo-1 Traces from the flooding at the subway entrance (Prague)

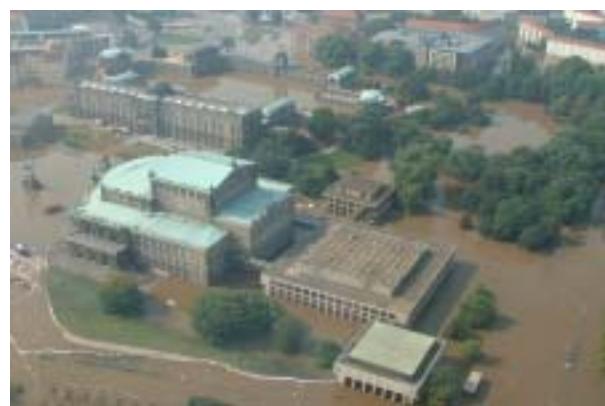
*Photo-2 Flooding in the Dresden city center (Near Zwinger Palace and Semperoper)
(Courtesy of Dresden Municipal Office)*

around the upper main and tributary rivers, it received severe rains of more than 50 – 250mm between Aug. 11 – 13. The rainfall in the area turned out to be two to four times that of average years. Flood disasters broke out on Aug. 13 & 14 in upper main and tributary rivers. The maximum flow in Vltava River along Prague marked $5,300\text{m}^3/\text{s}$, which was the highest since 1828 (Figure-2). The chances for a rainfall of this scale is said to be one in 500 years. The water level in lower parts of the city reached 3 – 4m, flooding the subways (Photo-1). There were no direct casualties within the city since 50,000 people evacuated the city before the flooding occurred. However, in other parts of Czech Republic, a total of 220,000 people took refuge and 15 lives were lost. The cost of the damage is estimated at 3 billion euros. Germany recorded two occurrences of floods attributable to its geological formation surrounding the river basins. The first originated from the heavy rains over the Elzgebirge, where flash floods in the tributary rivers generated flood and sediment disasters along the river on Aug. 12. Floods also occurred downstream along Mulde and other tributary river basins. The second occurrence was from an overflow of the upper mainstream waters of Elbe River. It marked a record high water level in Dresden on Aug. 17 (Photo-2). Because the increase in river water levels served to raise the underground water levels

over a wide area, damages were worsened. The city counts this as the third occurrence of the flood. Fifty 50km² of Dresden was covered with water and 12,000 people had evacuated, 4 lives were lost through accidents and other causes. Downstream, river waters either flowed over or broke past levees, flooding the region. Figure-3 is a satellite photo of the flooding on the right bank in the downstream regions in Torgau. Due to this flooding, a big change in water level was observed between the upstream (Torgau) and downstream (Wittenberg) rivers as shown in Figure-4. The chances of reaching such water levels are estimated as ranging from one in 100 to 1,000 years, depending on the region. The estimate for damage costs in Germany is 9.2 billion euros.

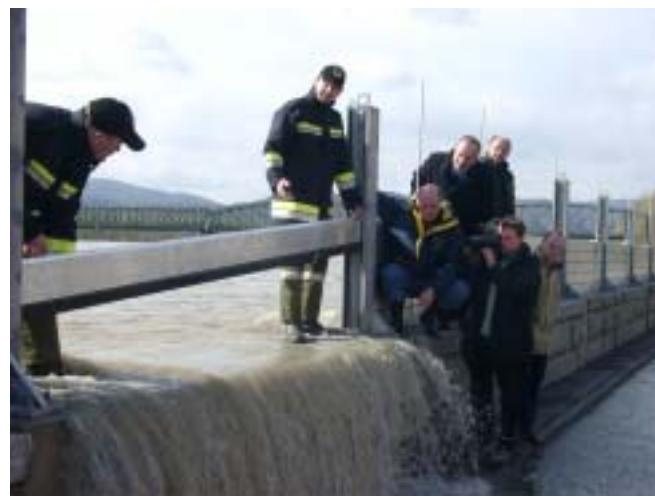
Photo-3 Mobile levees at Krems along Danube River (Courtesy of Municipality of Passau)

In Prague in Czech Republic, there is also a 1/100 plan, but which has not been implemented due to budgetary constraints and from a landscape protection perspective. The current safety level is only 1/20. Nevertheless, sites like ancient city areas declared as world heritage, and other important sites are to be protected with special mobile levees. These levees were installed by the fire department when the floods occurred, which prevented the ancient city

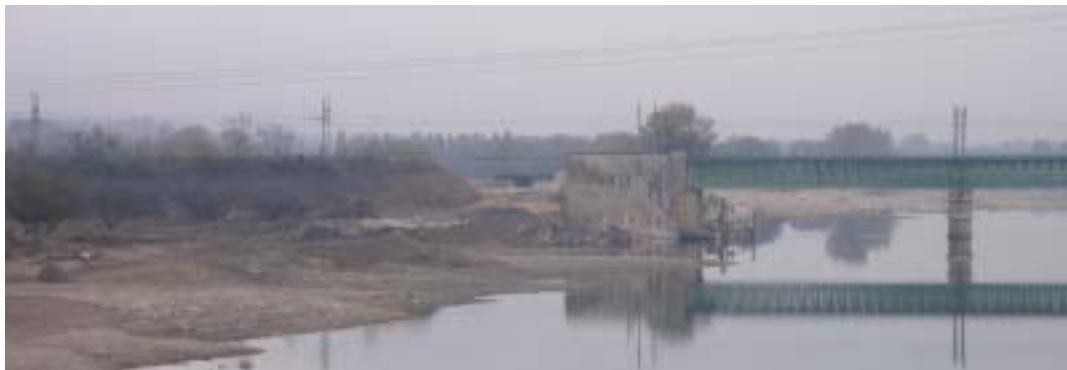
Photo-4 Damages on railroad bridge (fillings around the abutment have been washed away)

southeast region of France, claiming 24 lives, and causing great damage estimated at 1.12 billion euros in total. Especially along the Gard River, a tributary river running right of Rhone River, a concentrated rainfall occurred from the night of Aug. 8 until early morning on Aug. 9. (Anduze, Gard Province recorded a maximum rainfall of 687mm/24hrs). With rapidly increasing water levels, it became the largest flood since 1958. In Ales along the upstream regions of Gard River, and in Aramon located close to where the Gard and Rhone rivers merge, a great number of cars were washed away, houses were isolated, and the bank surrounding the town was broken down, causing considerable damage (Photo-4).

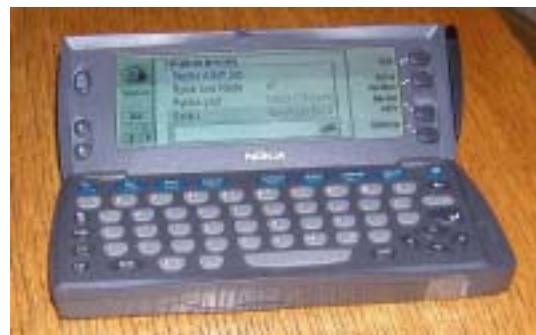
Photo-5 Mobile devices used in Czech Republic

In Czech Republic, mobile device with prioritized telephone numbers were given out to 18,000 government personnel in the time of emergency, which exerted great power. Congestion of phone lines under emergency conditions have been noted in Japan, and measures must be taken quickly to improve related facilities.

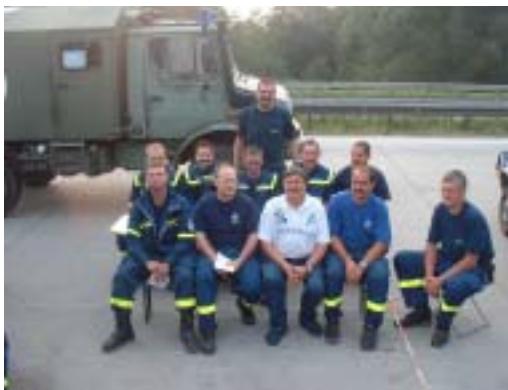
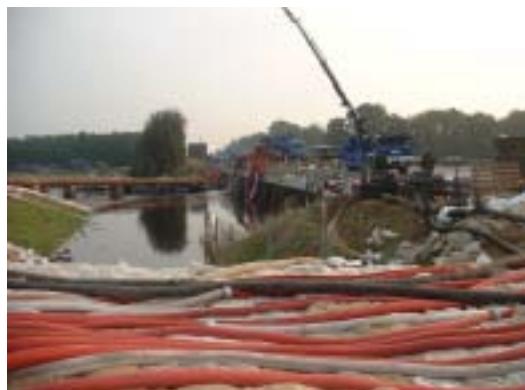
*Photo-6 Technical assistance group dispatched to Sachsen and Anhalt and its draining activities
(Courtesy of states Sachsen and Anhalt)*

Also in Germany, the “technical assistance group,” which is a specialized volunteer organization, played an active part. This organization is under the federal government, but the staff is composed of volunteers, who receive training and play the central role. Their role is similar to that of the Japanese ‘Suiboudan’, flood prevention volunteer, and the system is similar to that of the disaster dispatching system of the Self Defense Forces. They have high-level expert technology, and they receive the same level of benefits as other public employees if dispatched to the field. The power of spontaneous volunteer groups cannot be neglected of course, but the existence of groups with technology and organizational strength as that of this technical assistance group will definitely demonstrate great power. This may serve as a good example for Japan as well.
