10 DAMAGE TO DOMES, MINARETS AND HISTORICAL STRUCTURES

10.1 Domes and Minarets

10.2 Historical Structures

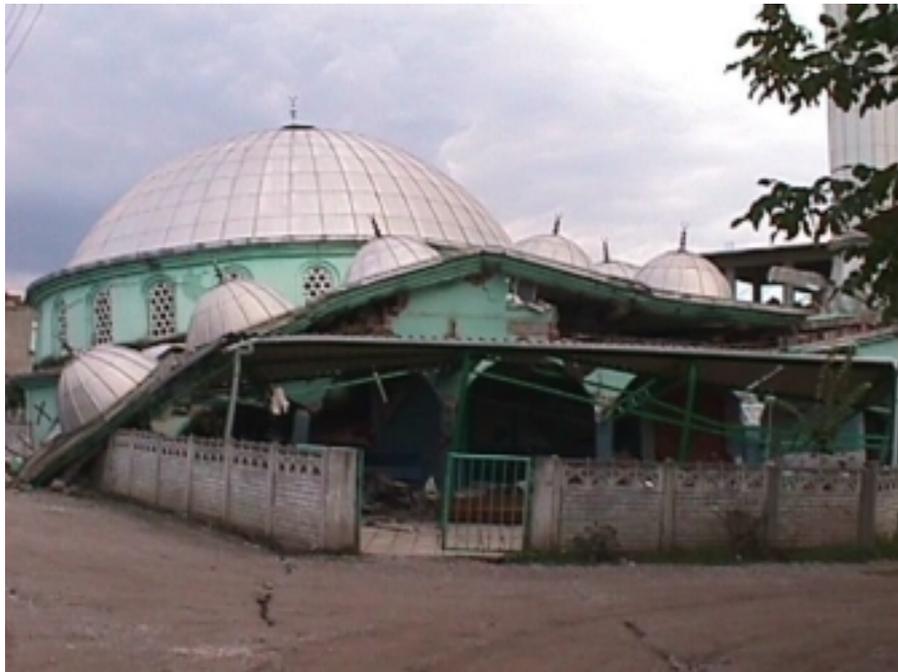
Most of the main compounds of mosques in the earthquake affected region were generally intact or suffered very slight damage (Figures 10.2). The main compounds of mosques generally have single dome or multiple semi-spherical domes and they are structurally symmetric. Maybe for this reason, the main compounds remain intact during shaking. The main compounds of the mosques failed when the faulting occurred right underneath the structure. Figure 10.1 shows such an example in Kavaklı district of Gölcük, which failed due to secondary normal faulting.

Figure 10.1 Totally collapsed mosque at Kavaklı district of Gölcük

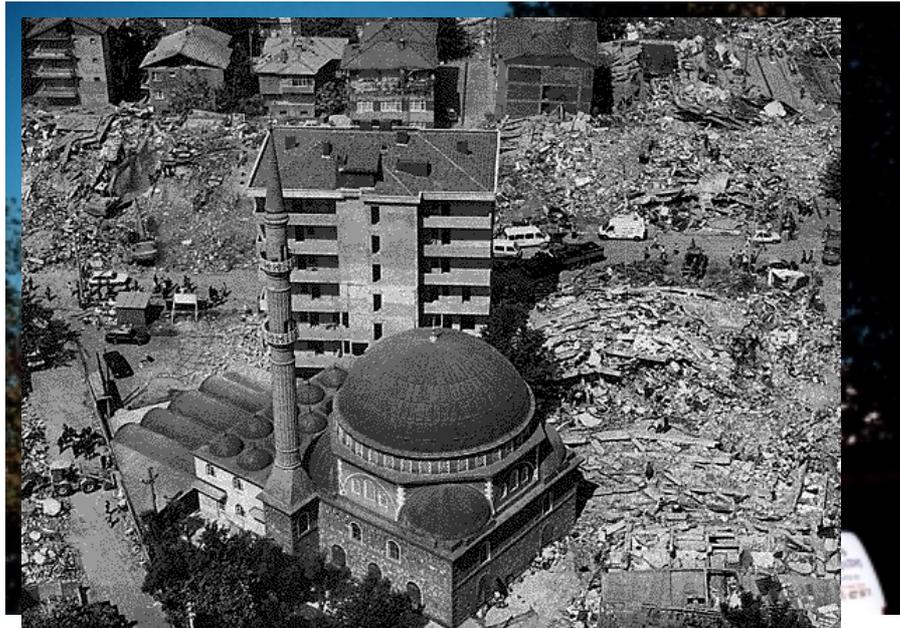
mosque stood with a few other structures amid the rubble of collapsed buildings in the town of Golcuk, 10 miles east of Istanbul.

Figure 10.2 Intact mosque in Gölcük (Hürriyet newspaper)

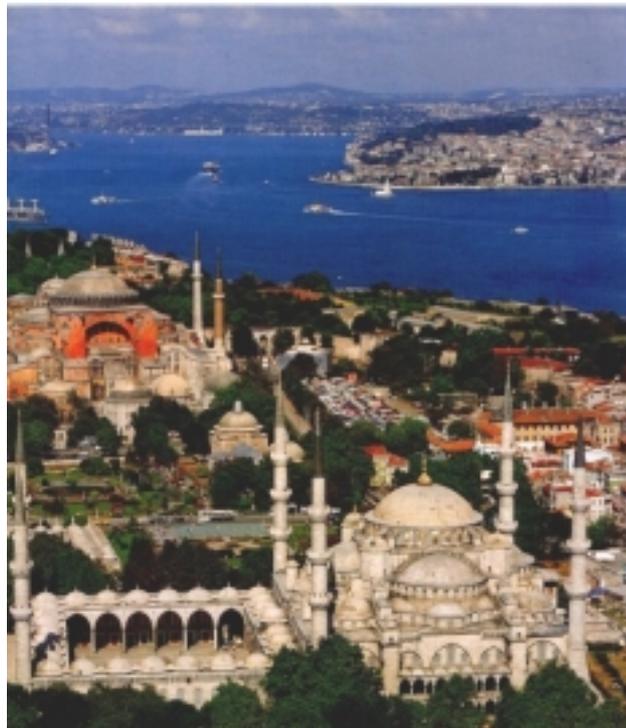
ground and its diameter spans 31 meters. The dome of this structure was partly collapsed in the earthquake of 1766 and it was repaired. A site investigation 7 hours after the earthquake showed no damage to this structure (Figure 10.3. This structure is well instrumented with accelerometers and the measurements on the performance of this structure should be of great value on the preservation as well as the structural stability of historical masonry structures.

Facing St. Sophia stands the supremely elegant, six-minaret, imperial Sultan Ahmet Mosque (Figure 10.3. Built between 1609 and 1616 by the architect Mehmet, the building is more familiarly known as the Blue Mosque because its interior gleams with a magnificent paneling of blue and white Iznik tiles. The cascading domes and four slender minarets of Süleymaniye Mosque dominate the skyline on the Golden Horn's west bank (Figure 10.4. Investigations of these mosques on September 2 indicated no damage.

Figure 10.3 An aerial view of Sultan Ahmet Mosque (foreground) and Ayasofya Museum

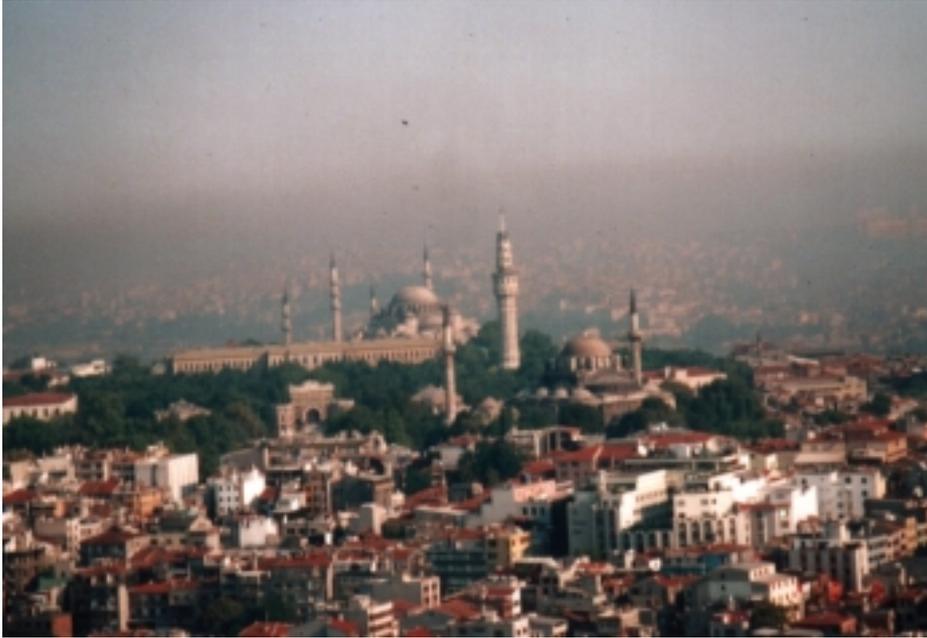
Figure 10.4 An aerial view of Beyazıt Mosque (foreground), Beyazıt Tower and Süleymaniye Mosque

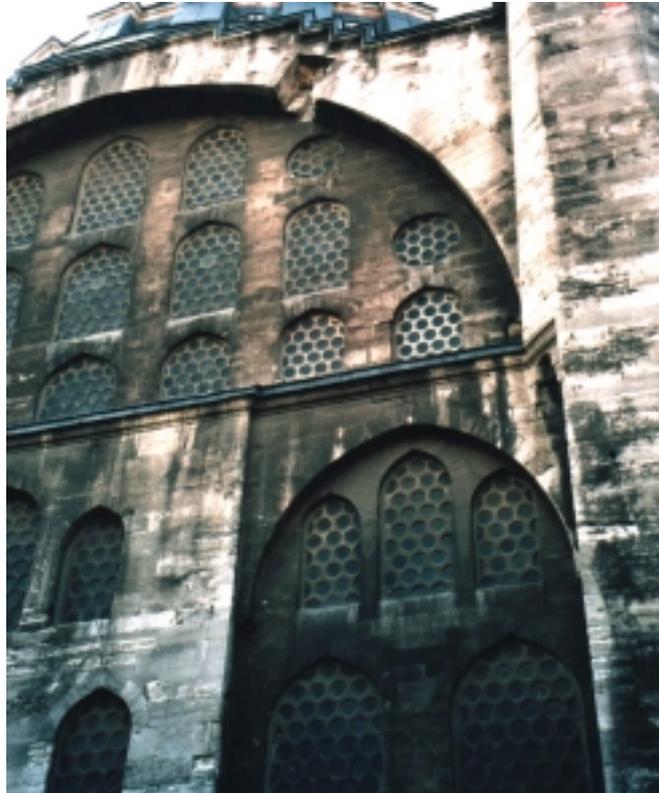
Some light damage was observed at Mihrimah Sultan Mosque. This mosque has one hundred and sixty-one windows, built in 1555. The damage was concentrated at the NE corner of the structure. The separation and relative sliding in this corner resulted in the fall of limestone blocks from the outer arch of the main dome. Nevertheless, the main reason is associated with the settlement of ground at that corner before the earthquake resulted in the loosening of the walls at that specific locations. The ground shaking caused further loosening of the walls which subsequently caused the block walls from the dome (Figure 10.5).

Figure 10.5 A view of damaged Mihrimah Sultan Mosque

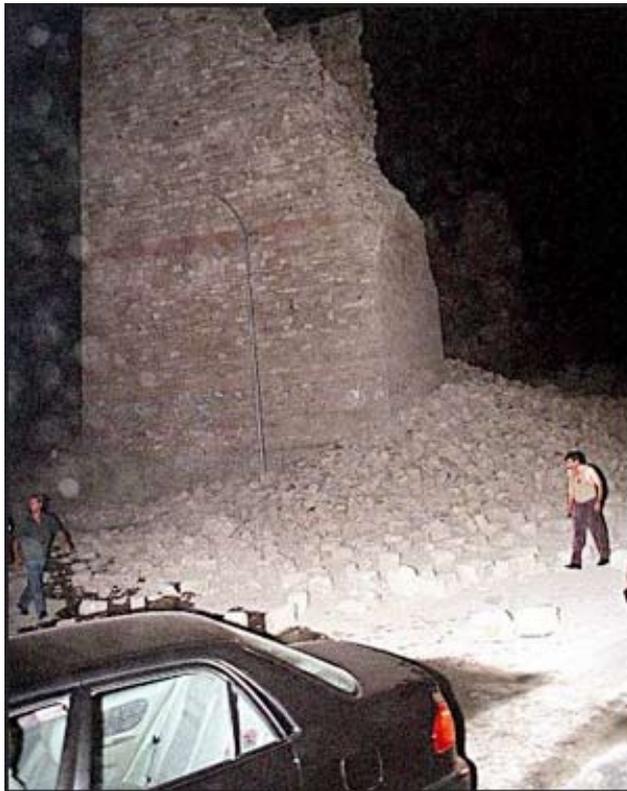
The Istanbul city walls, once an impenetrable fortification, stretch seven kilometers from the Sea of Marmara to the Golden Horn. Restored recently, and many times previously, these walls date from the fifth century and the reign of Emperor Theodosius II. UNESCO has declared the city walls, and the area which they enclose, to be one of the cultural heritages of the world. The walls were heavily damaged in 1766 and 1894 earthquakes and they were repaired. During this earthquake, partial collapses of the walls were observed at several locations (Figure 10.6) .

Figure 10.6 Partial collapse of Istanbul City Wall (Surlar)

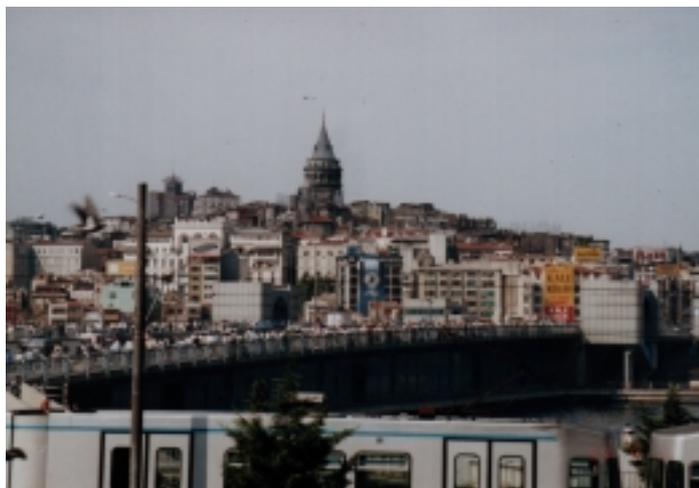
The Galata Tower, a Genoese construction of 1348, rises 62 meters high over the Golden Horn. This tower is one of the landmarks of Istanbul and the site investigation did not indicate any structural damage to this structure (Figure 10.7).

Figure 10.7A view of Galata Tower and Galata Bridge

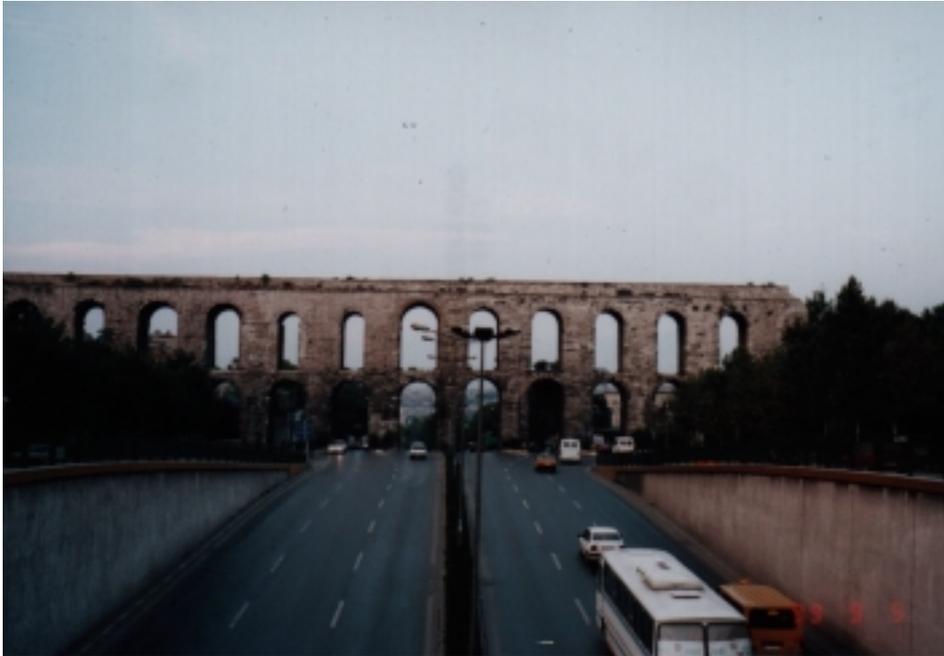
The Bozdöğün-Valens Aqueduct, built in 368 A.D., supplied the Byzantine and later the Ottoman palaces with water. Today part of the remaining 900 meters of double-tiered arches straddle the major highway that runs through the old part of town. No damage was observed during the site investigation of this structure as well as the Ottoman aqueducts such as the

16th Century Moğolova and Sultan Süleyman Aqueducts built both by Sinan (Figure 10.8)

Figure 10.8 A view of Bozdolan Aqueduct

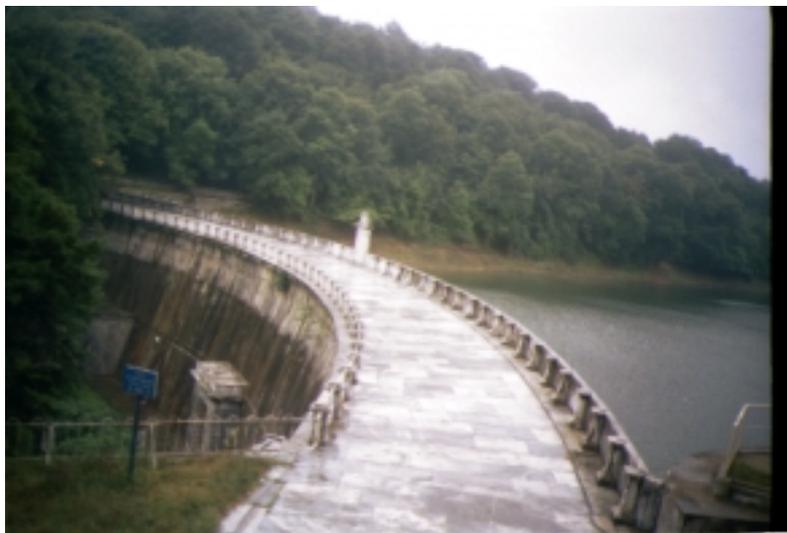
Seven water reservoirs are found in Belgrade Forest (Figure 10.9) The dams of these reservoirs are masonry and no damage was reported for these structures.

Figure 10.9 A view of Valide Sultan Dam in Belgrade Forest
