11 TSUNAMI (HIGH WAVES)

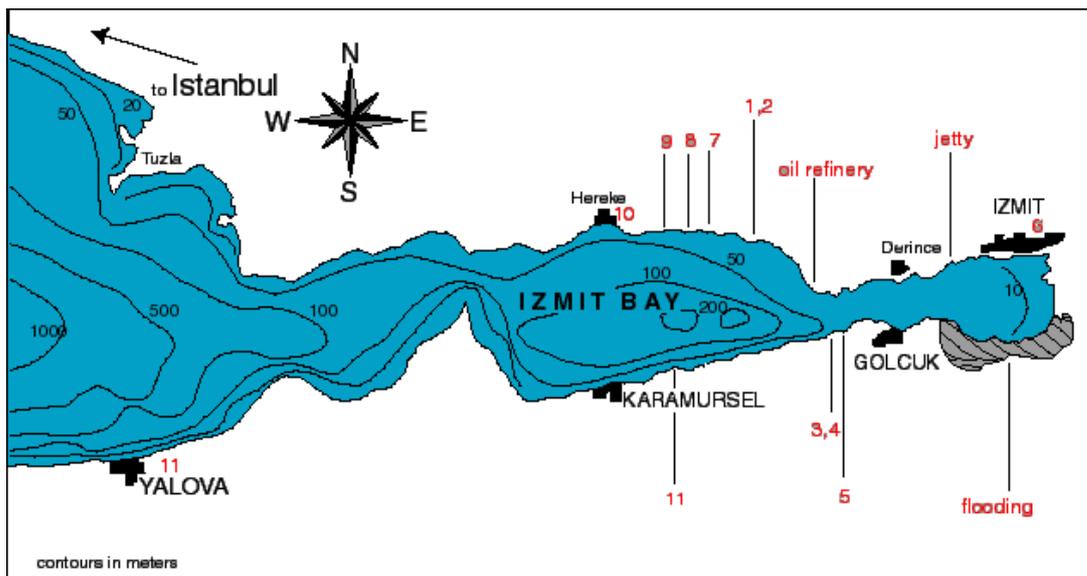
It is well known that many tsunamis occurred during the large earthquakes in Turkey, which took place in Marmara Sea (Soysal 1979). During the site investigations, many people both on the northern and southern shores of İzmit gulf mentioned about high sea waves. The workers interviewed at TÜPRAŞ refinery said that they could see the screws of a ship which was unloading crude oil at the time of the earthquake. According to their statement the height of the sea wave should have been about 7m. In addition they said that the sea retreated for a distance of 100 m soon after the earthquake and the sea returned back with high waves. The people interviewed in Karamürsel, Halıdere, Değirmentepe and Kavaklı said similar things. However, the sea wave height was said to be about 4m. Figure 11.1 shows a compilation of sea wave heights from different sources.

Figure 11.1 Sea-wave height distribution around the İzmit gulf according to local people

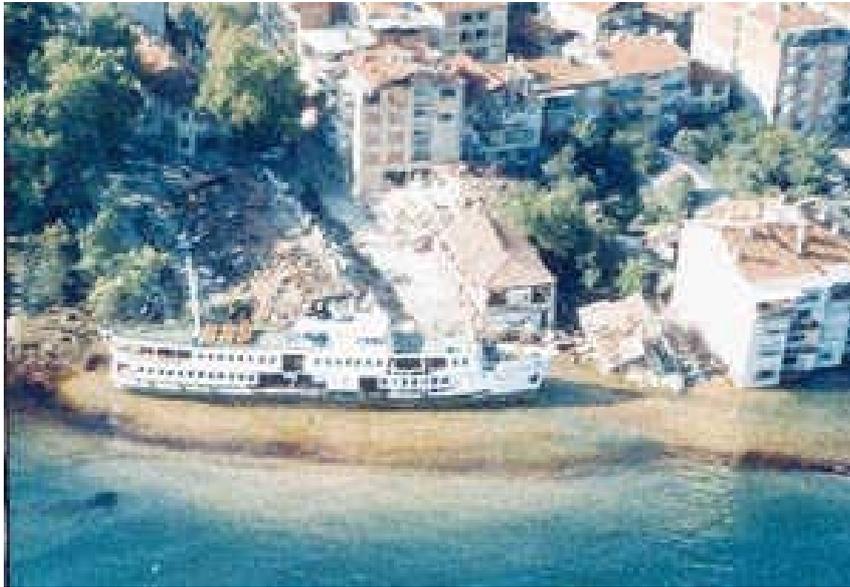
Some ships were thrown onto the land at some locations. Figure 11.2 shows a passenger ship at Değirmentepe port. Another ship at UM shipyard at the eastern side of Gölçük was thrown onto

the land. Observations on the site indicated that the remains of sea shells and sea plants so that the sea must have been climbed onto the land up to a height of 4 m at this particular location.

Figure 11.2 A passenger ship at De ĭrmendere where a submarine landslide took place

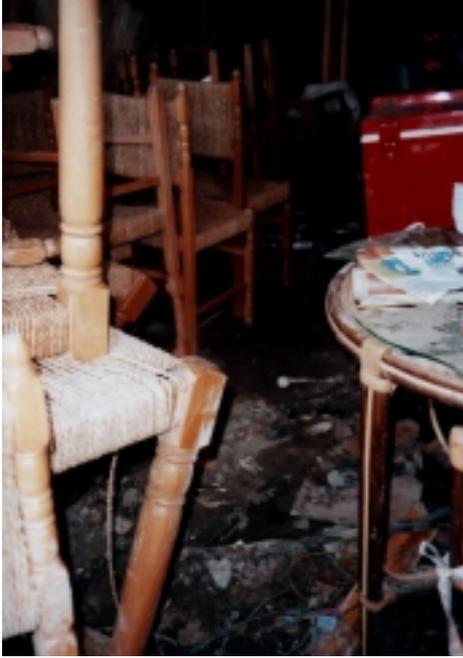
Figure 11.3(a) shows a coffee-shop at De ĭrmendere, which should have been attacked by sea waves since the mud and traces of sea water were still seen two weeks after the earthquake. The windows of a bank next to this shop were broken and similar traces were also seen in the bank. The distance from shore at this particular location is about 12m. Figure 11.3(b) shows a refrigerator thrown by sea wave onto roadway from open-coffee-shop along the shore. The blocks used for the road pavement were all displaced and thrown away for a length of 100 m. Figure 11.4 shows the fountain along the shore of Hal ĭdere. The traces of crude oil could be observed on the back and both sides of this fountain with a height of 1.5m. From the traces, one may estimate the sea wave height to be more than 2.5m at this specific location to the east of De ĭrmendere.

(a) Coffee-shop

Figure 11.3 damaged coffee shop and overturned refrigerator by high sea waves at De irmendere

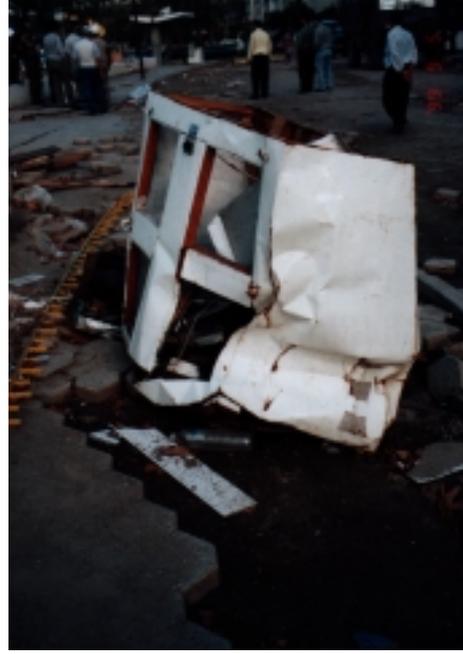
(b) Displaced and overturned refrigerator

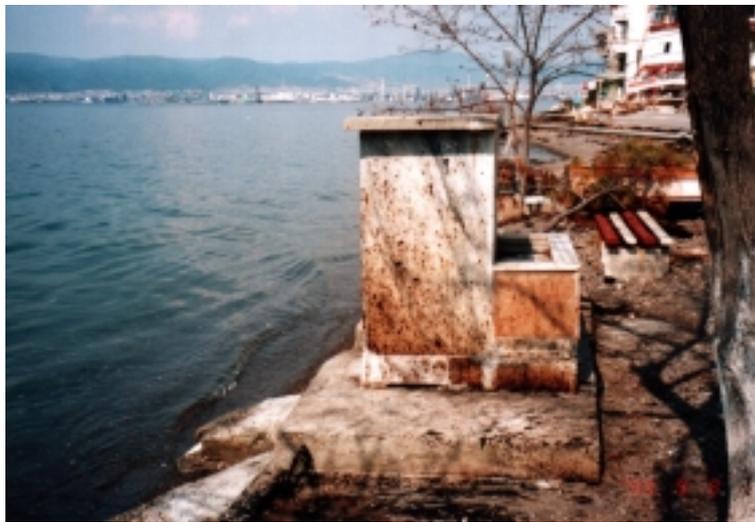
Figure 11.4 Traces of crude oil on the fountain smeared by high sea waves at Hal dere
