## 2.3 OBSERVED SITE EFFECT AND MICROTREMOR MEASUREMENT

The influence of local geologic and soil conditions on the intensity of ground shaking was recognized through this reconnaissance. Local site effects seem to have been responsible for severe damage to dwellings in this earthquake.

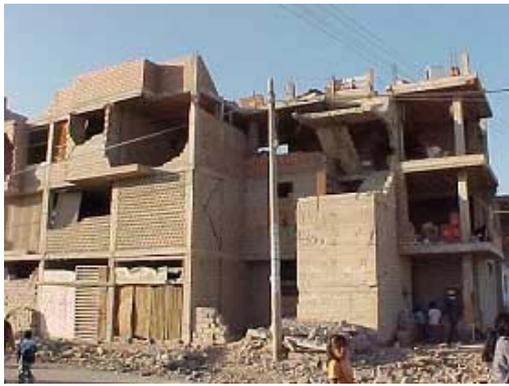
**Figure 2.9**

The northeast area, which has been being developed since 1980's along the northwestern hillside, was the most seriously damaged. Most dwellings there were RC framed with infill walls of mortar blocks and/or bricks (**Figure 2.9**).

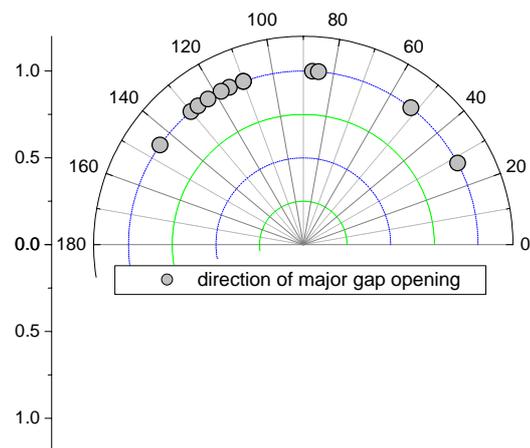
Utility poles (5m tall) are embedded upright in concrete-paved sidewalk. Cracks developing outwardly on the pavement from these poles were mapped. Some poles are very close to the step-shaped edge of the sidewalk. The thin cover concrete thus might have affected the crack pattern. Though the number of the examined utility poles is not sufficient for thorough statistical manipulations, some poles seem to have been forcibly shaken in about Northwest –Southeast direction, transverse direction of the valley (**Figure 2.10**).

**Figure 2.10** Directions of major gap openings at bottom ends of utility poles (Tacna)

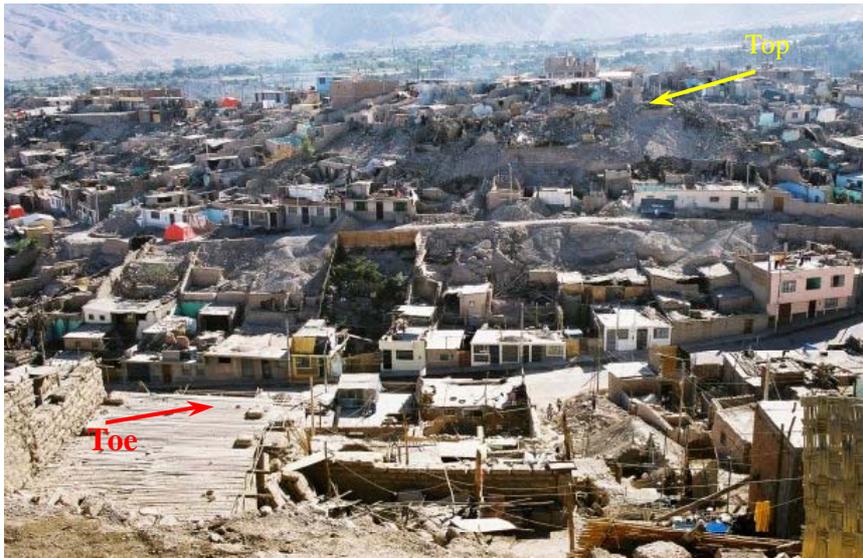
Moquega was the hardest hit city by this earthquake. A number of adobe buildings collapsed in the downtown area and many others sustained heavy damage. A thin mountain ridge, the northeast extension of a sand rock terrace rising behind the central area of Moquegua city, dips gently towards northeast. This ridge is densely covered with adobe dwellings, and the damage to dwellings was the severest there (**Figure 2.11**).

**Figure 2.11** View of the terrace next to San Francisco hill

The square root of the sum of the squares is a good index when fairly flat and horizontally layered sites are considered. However, at hilly sites, it is more meaningful to study the vibration in the directions perpendicular and parallel to the ridge independently. One of the areas most affected by the 2001 Atico Earthquake was San Francisco. Measurements were done at the toe and top of the hill (See **Figure 2.11**). The results of the spectral analysis are presented in **Figure 2.14**.

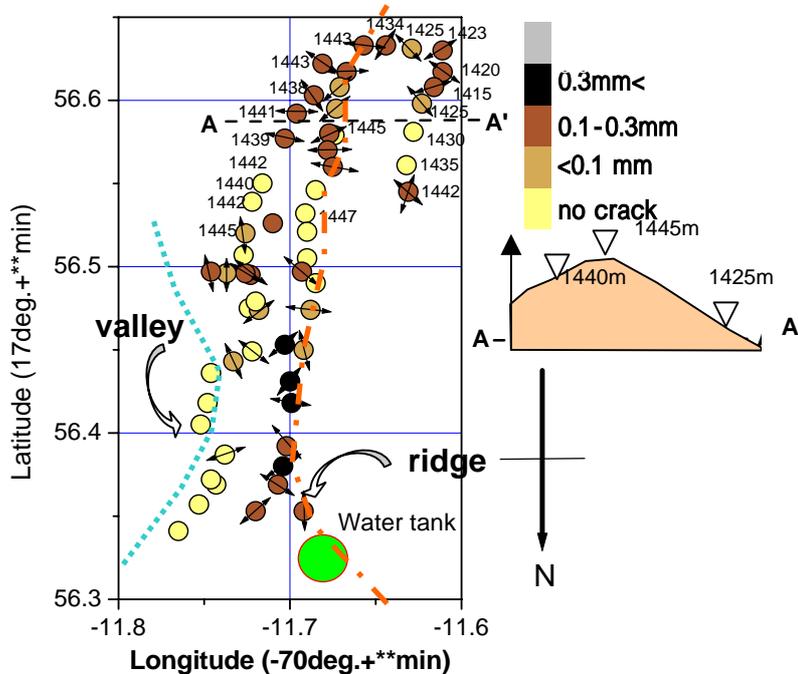
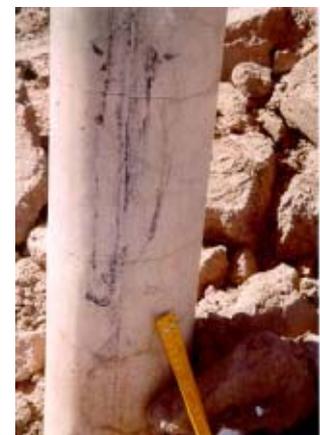
**Figure 2.12.** Distribution of cracked utility poles in San Francisco area, Moquega: Numbers put by circles show elevations of utility poles measured by using a GPS receiver.

**Figure 2.12** shows the observed distribution of crack intensities. Arrows indicate the inferred directions of strong ground motions. In this figure, the first, second and third lines from left to right lined up with the inspected utility poles are streets along a narrow valley, along the ridge and on the other hillside, respectively. It is noted that no utility pole along the valley was cracked while those around the highest peak of the ridge near a water tank (green solid circle) were severely cracked. This contrast suggests that some topographical effect must have been responsible for amplifying ground motions. The arrows along the ridge show that the effect was more pronounced in the transverse direction of the ridge.

Distribution of cracked utility poles is considered to be a good index for discussing possible spatial distribution of intense ground motions. Observed crack intensities on total 59 utility poles were roughly classified into the following 4 groups:

- Group 1:** no visible crack.
- Group 2:** with hair cracks ( $>0.1$  mm)
- Group 3:** with cracks (0.1-0.3 mm)
- Group 4:** with cracks ( $<0.3$  mm) that can be seen at a distance of about 2m

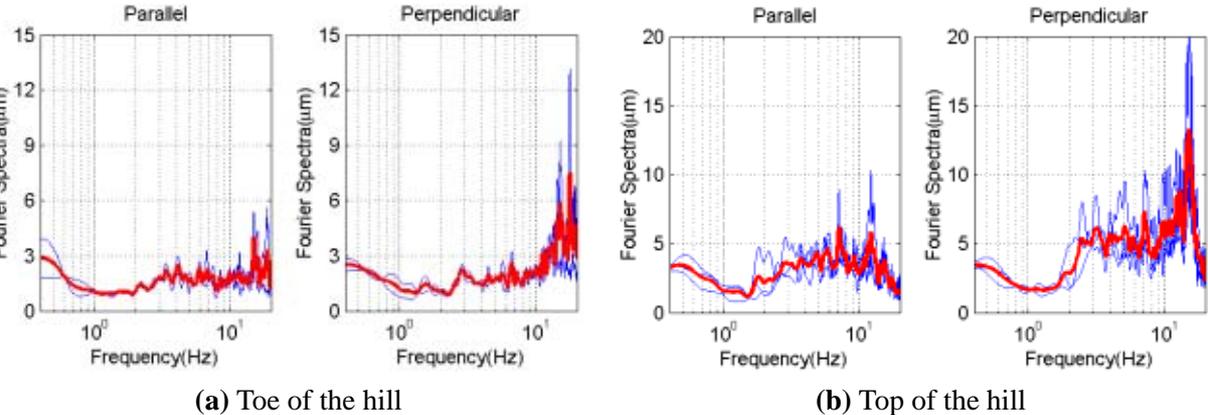
From **Figure 2.14**, it is clear that larger vibrations were recorded on top of the hill, particularly in the direction perpendicular to the ridge. In order to approximately assess the fundamental period of the hill, the microtremor spectra on the top of the hill was divided by the spectra at the toe. The results are shown in **Figure 2.15**.

**Figure 2.14** Fourier Spectra of the microtremor measurements at San Francisco, Moquegua

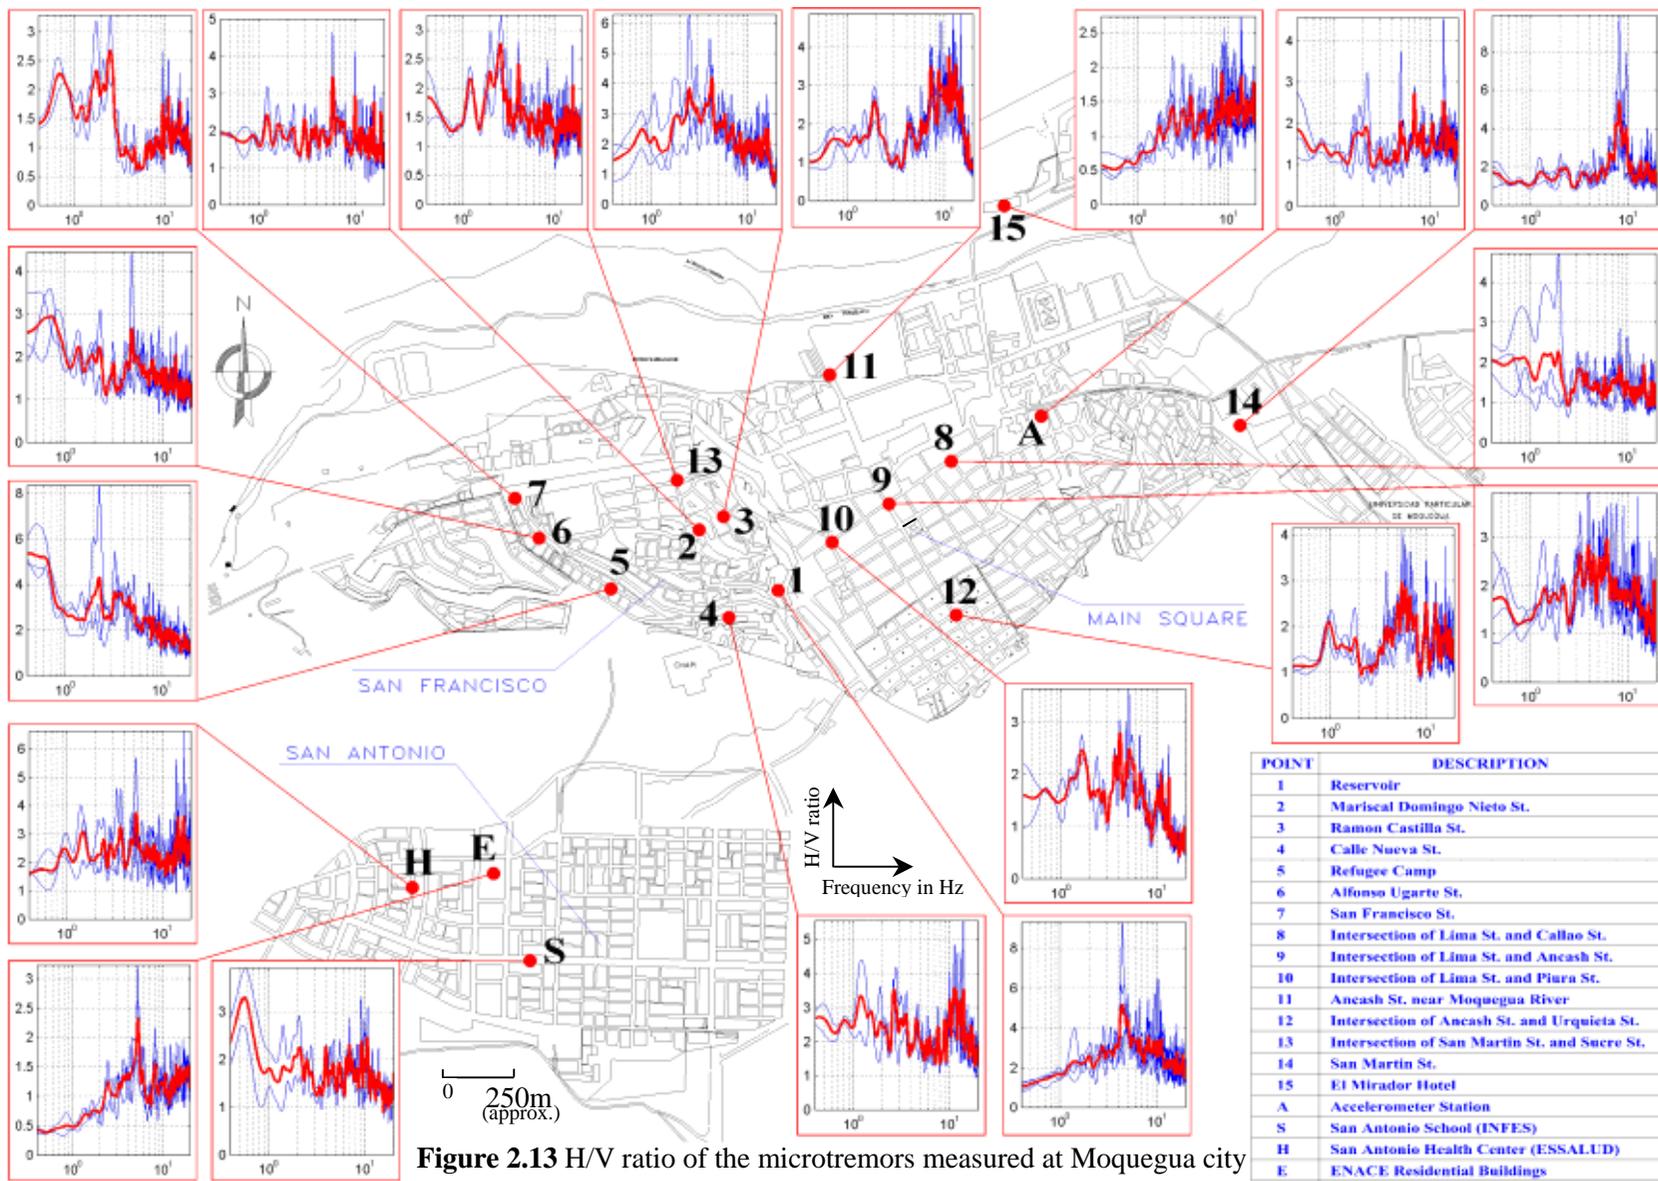
**Figure 2.13** presents the locations where free field microtremors were measured at Moquegua. In order to assess the site predominant frequency, the H/V ratio was used [Nakamura, 2000]. The square root of the sum of the squares of the H/V ratio for NS and EW component is shown at each position. Blue thin curves correspond to a 40.96sec-measurement whereas the thick red curve represents the average of all the measurements. A particularly low frequency site is “S” where the predominant frequency is approximately 0.6Hz. On the other hand, site “14” has a high predominant frequency equal to 8Hz.

Figure 2.13 H/V ratio of the microtremors measured at Moquegua city

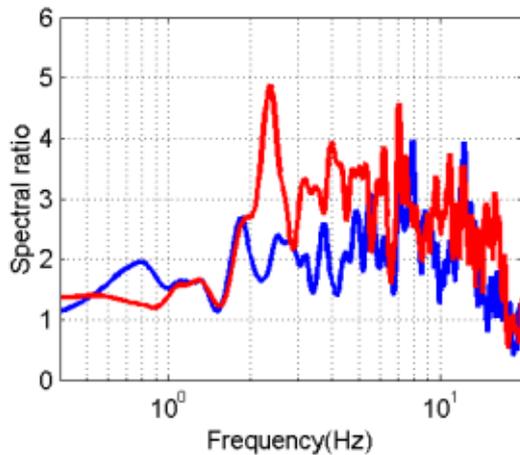
**Figure 2.14** Ratio of the spectra on top and at the toe of the hill. (blue: parallel to the ridge, red: perpendicular to the ridge)

**Figure 2.14** shows that larger amplification is observed in the direction perpendicular to the ridge. Furthermore, the predominant frequency in this direction, approximately 2.5Hz, is lower than the predominant frequency in the direction parallel to the ridge, 7Hz. This is consistent with the hill being more flexible perpendicularly to the ridge.

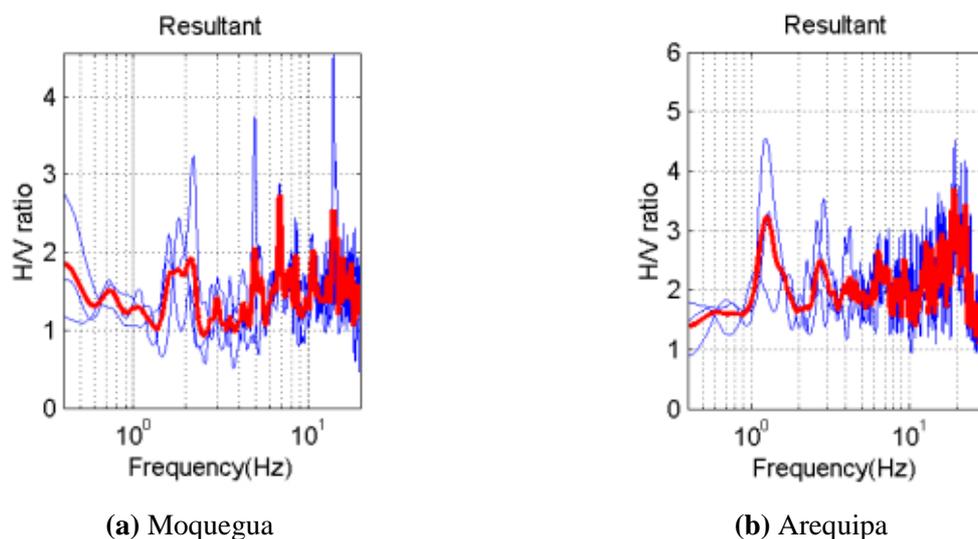
Measurements were also carried out at Moquegua and Arequipa accelerometer stations. **Figure 2.15** presents the results of the spectral analysis, which clearly show predominant frequencies of 7 and 1.1 Hz at Moquegua and Arequipa, respectively. Although there is a peak around 20Hz at the Arequipa station, this component might have been caused by some external source. When comparing this spectrum with other free field measurements in the vicinity of the station, such peak is not observed. In general, amplification at Arequipa station is larger than at Moquegua station. Note that the latter corresponds to the site where the only record of the main shock of the Atico Earthquake was recorded.

**Figure 2.15** Resultant H/V ratio at accelerometer stations

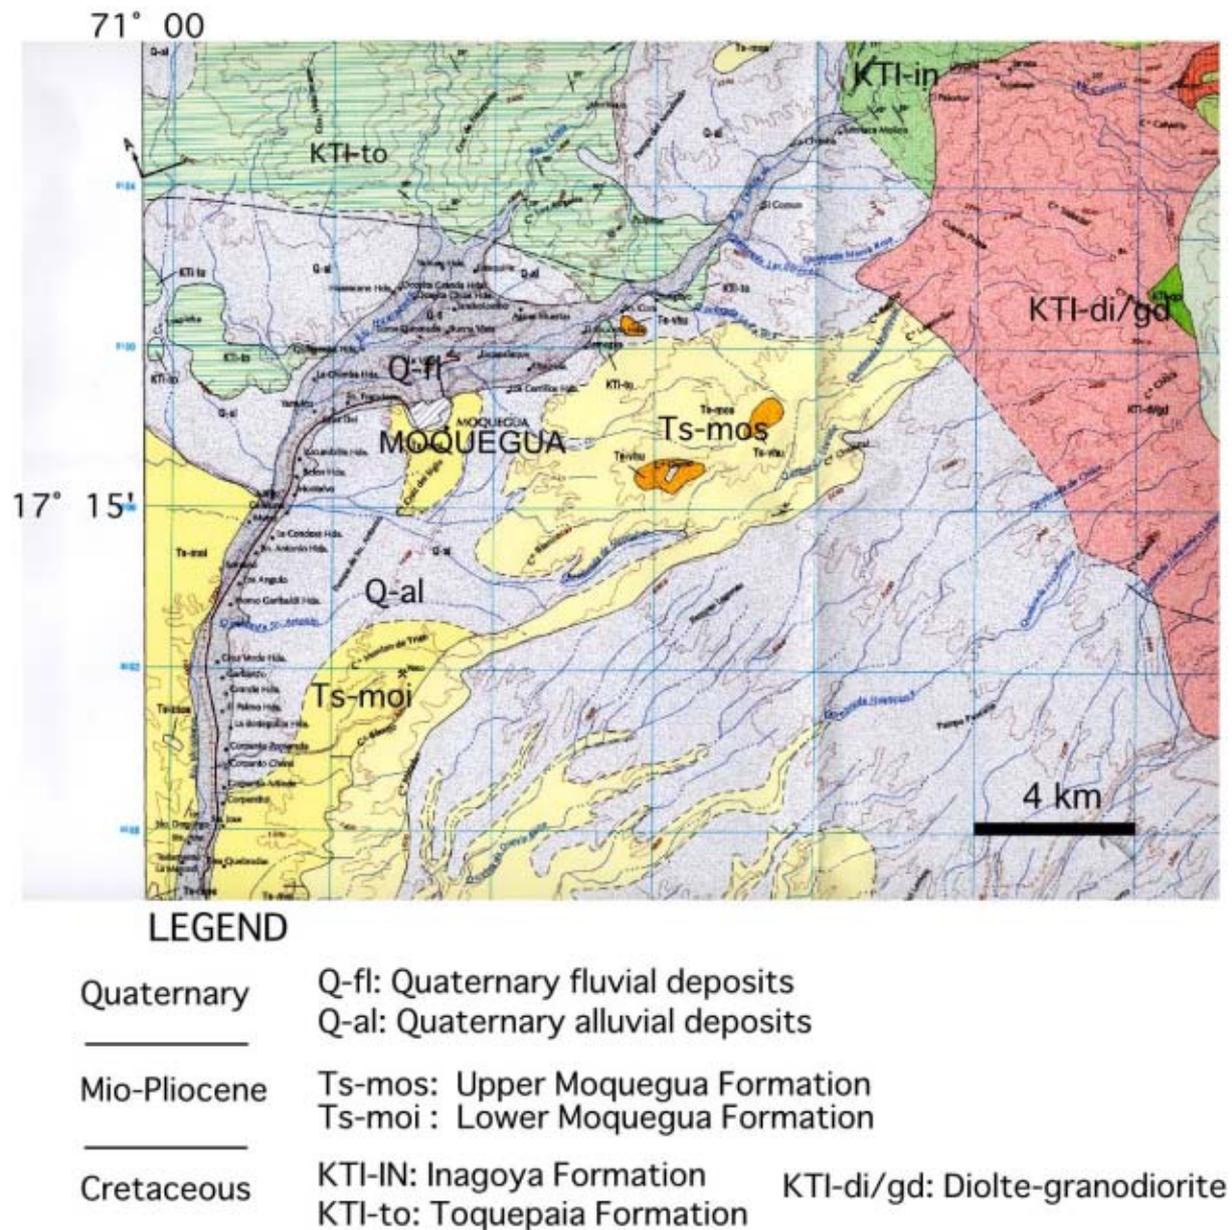
In the northern part of Mogeegua, folded Cretaceous sedimentary rocks (Torquepara and Inagoya Formation) and Cretaceous intrusive rocks are widely cropping out. The Plio-Miocene Moquegua Formation, consist of sedimentary rocks, distributes in the southern part of Moquegua. The Quaternary alluvial and fluvial deposits, unconformably overlying the Moquegua Formation, are distributed in the city of Moquegua. The geologic succession of the city of Moquegua consist of Cretaceous hard rocks with thin younger sediments cover. From geologic point of view, the city of Moquegua has good ground condition against shaking.

**Figure 2.16** Geological Map of Moquegua after Bellido and Landa (1998).

**MOQUEGUA (Figure 2.16: Bellido and Landa, 1998)**

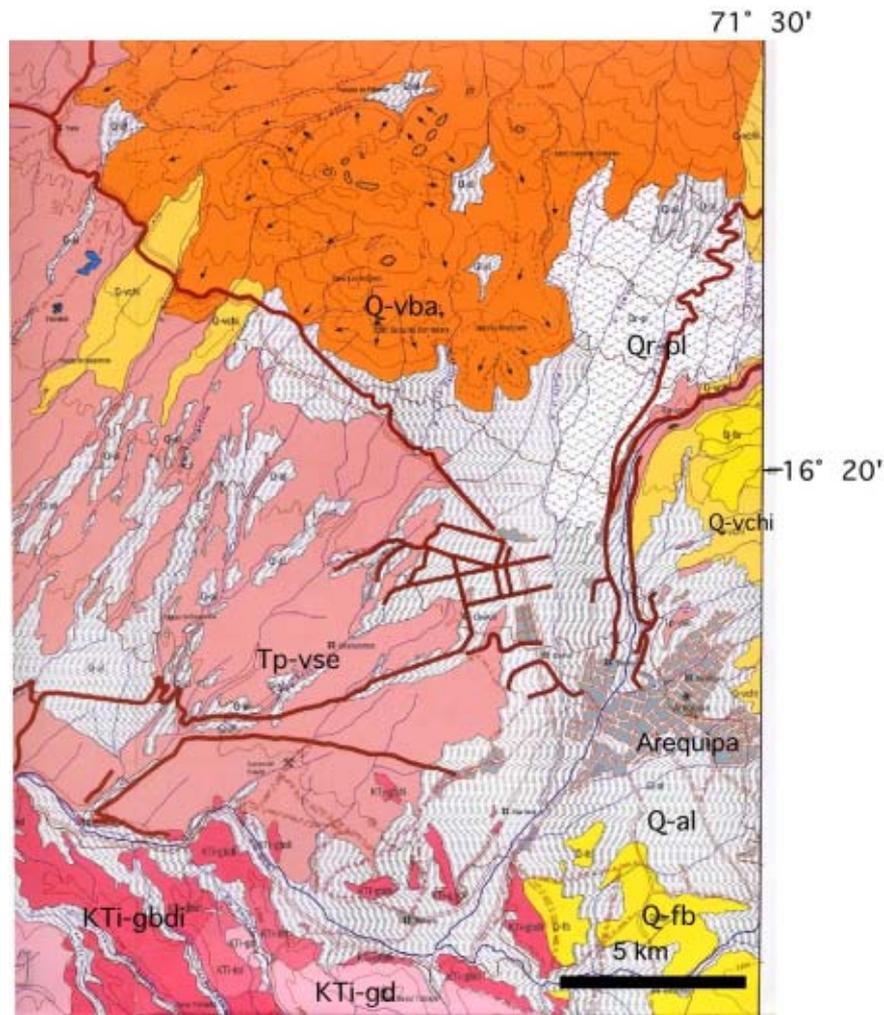
In the south of the city of Arequipa, Cretaceous igneous rocks are widely cropping out forming a seismic basement rocks. Around the city of Arequipa and its northern area, mainly Quaternary volcanic and volcanoclastic sediments are widely distributed. In the northern part of the city of Arequipa, Pliocene felsic tuff (Senca volcanics) is cropping out. Due to the covering of the Pliocene to Quaternary deposits, the actual depth of the Cretaceous rock in the city of Arequipa is not well understood.

Quaternary	Holocene	Q-al: alluvial deposits
	Pleistocene	Q-r-pl: pyroclastic flow deposits
	Pliocene	Q-fb: volcanoclastic deposits
	Cretaceous	Q-vba, Q-vchi: Barroso Group (andesitic volcanic products)
		Tp-vse: Senca volcanic products (felsic tuff)
		KTI-gbdi/KTI-gd: Cretaceous intrusive rocks (granodiorite, gabbro and diorite)

**Figure 2.17** Geological map of Arequipa after Vergus (1970).

**AREQUIPA (Figure 2.17: Vargus, 1970)**
