## 10 DAMAGE TO DOMES, MINARETS AND HISTORICAL STRUCTURES

### 10.1 Domes and Minarets

## 10.2 Historical Structures

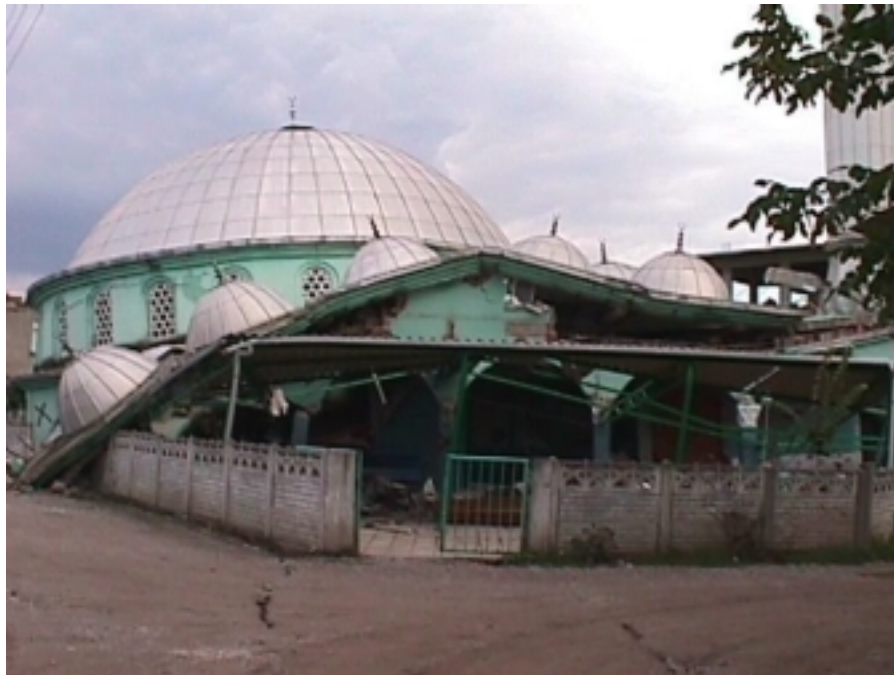
Most of the main compounds of mosques in the earthquake affected region were generally intact or suffered very slight damage (Figures 10.2). The main compounds of mosques generally have single dome or multiple semi-spherical domes and they are structurally symmetric. Maybe for this reason, the main compounds remain intact during shaking. The main compounds of the mosques failed when the faulting occurred right underneath the structure. Figure 10.1 shows such an example in Kavaklı district of Gölcük, which failed due to secondary normal faulting.

Figure 10.1 Totally collapsed mosque at Kavaklı district of Gölcük

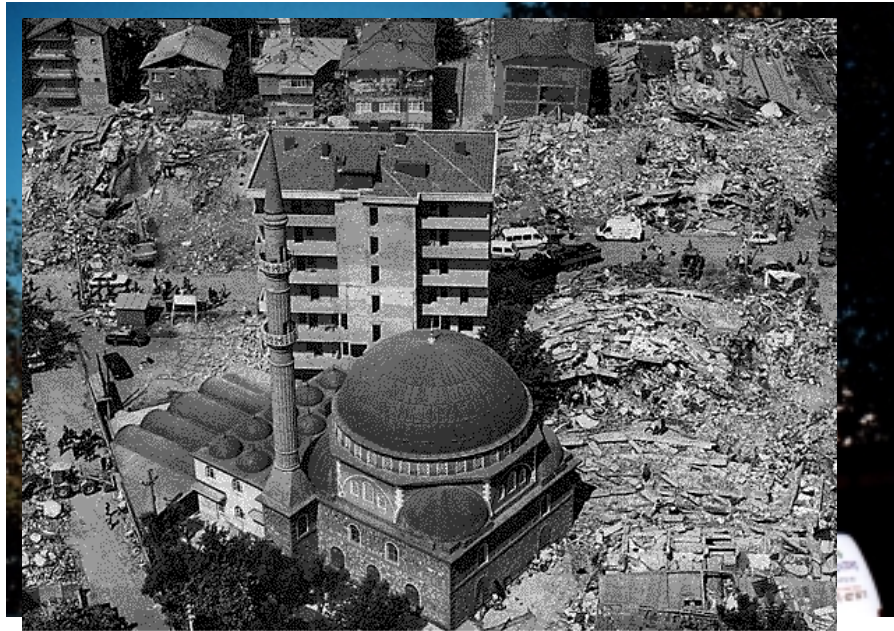
mosque stood with a few other structures amid the rubble of collapsed buildings in the town of Gölçük, 10 miles east of Istanbul.

Figure 10.2 Intact mosque in Gölçük (Hürriyet newspaper)

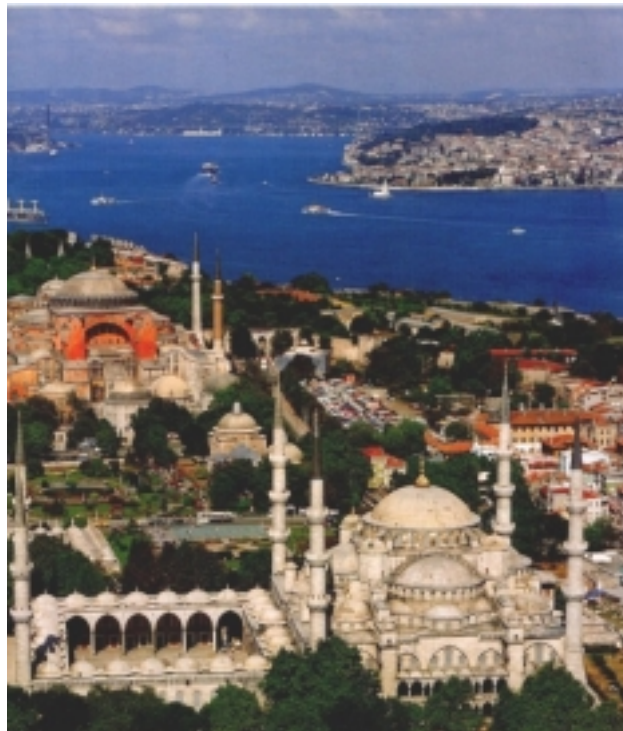
ground and its diameter spans 31 meters. The dome of this structure was partly collapsed in the earthquake of 1766 and it was repaired. A site investigation 7 hours after the earthquake showed no damage to this structure (Figure 10.3. This structure is well instrumented with accelerometers and the measurements on the performance of this structure should be of great value on the preservation as well as the structural stability of historical masonry structures.

Facing St. Sophia stands the supremely elegant, six-minaret, imperial Sultan Ahmet Mosque (Figure 10.3. Built between 1609 and 1616 by the architect Mehmet, the building is more familiarly known as the Blue Mosque because its interior gleams with a magnificent paneling of blue and white Iznik tiles. The cascading domes and four slender minarets of Süleymaniye Mosque dominate the skyline on the Golden Horn's west bank (Figure 10.4. Investigations of these mosques on September 2 indicated no damage.

Figure 10.3 An aerial view of Sultan Ahmet Mosque (foreground) and Ayasofya Museum

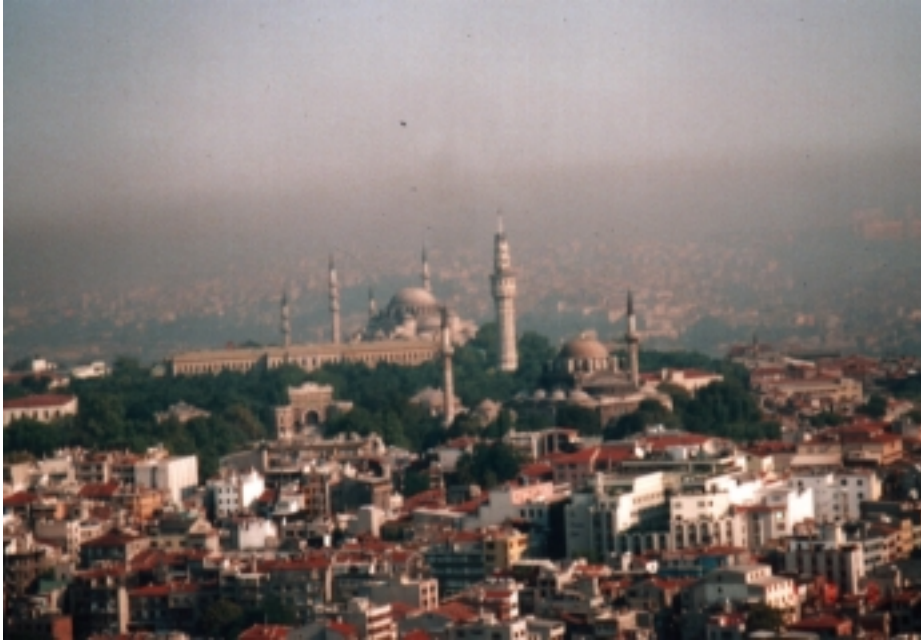
Figure 10.4 An aerial view of Beyazıt Mosque (foreground), Beyazıt Tower and Süleymaniye Mosque

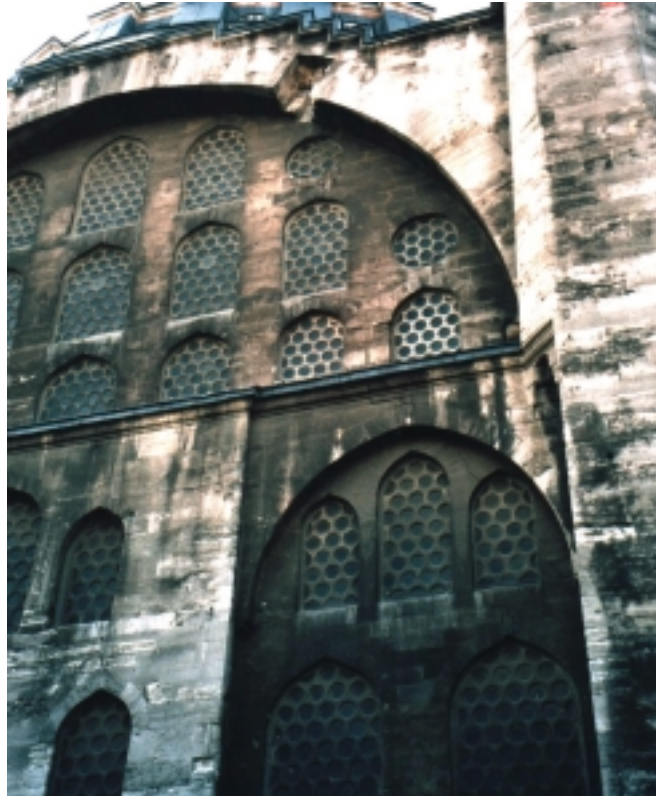
Some light damage was observed at Mihrimah Sultan Mosque. This mosque has one hundred and sixty-one windows, built in 1555. The damage was concentrated at the NE corner of the structure. The separation and relative sliding in this corner resulted in the fall of limestone blocks from the outer arch of the main dome. Nevertheless, the main reason is associated with the settlement of ground at that corner before the earthquake resulted in the loosening of the walls at that specific locations. The ground shaking caused further loosening of the walls which subsequently caused the block walls from the dome (Figure 10.5).

Figure 10.5 A view of damaged Mihrimah Sultan Mosque

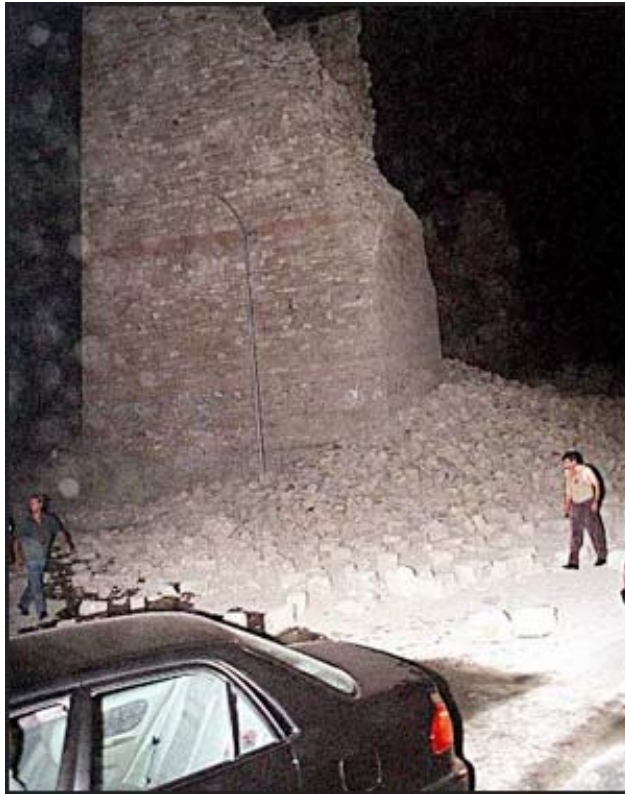
The Istanbul city walls, once an impenetrable fortification, stretch seven kilometers from the Sea of Marmara to the Golden Horn. Restored recently, and many times previously, these walls date from the fifth century and the reign of Emperor Theodosius II. UNESCO has declared the city walls, and the area which they enclose, to be one of the cultural heritages of the world. The walls were heavily damaged in 1766 and 1894 earthquakes and they were repaired. During this earthquake, partial collapses of the walls were observed at several locations (Figure 10.6) .

Figure 10.6 Partial collapse of Istanbul City Wall (Surlar)

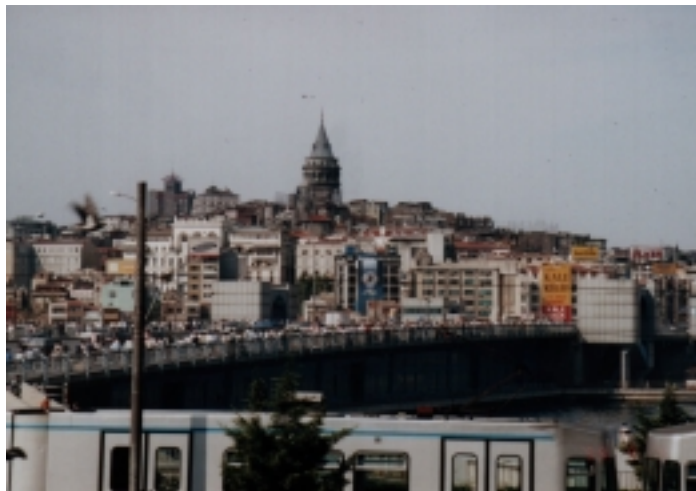
The Galata Tower, a Genoese construction of 1348, rises 62 meters high over the Golden Horn. This tower is one of the landmarks of Istanbul and the site investigation did not indicate any structural damage to this structure (Figure 10.7).

Figure 10.7A view of Galata Tower and Galata Bridge

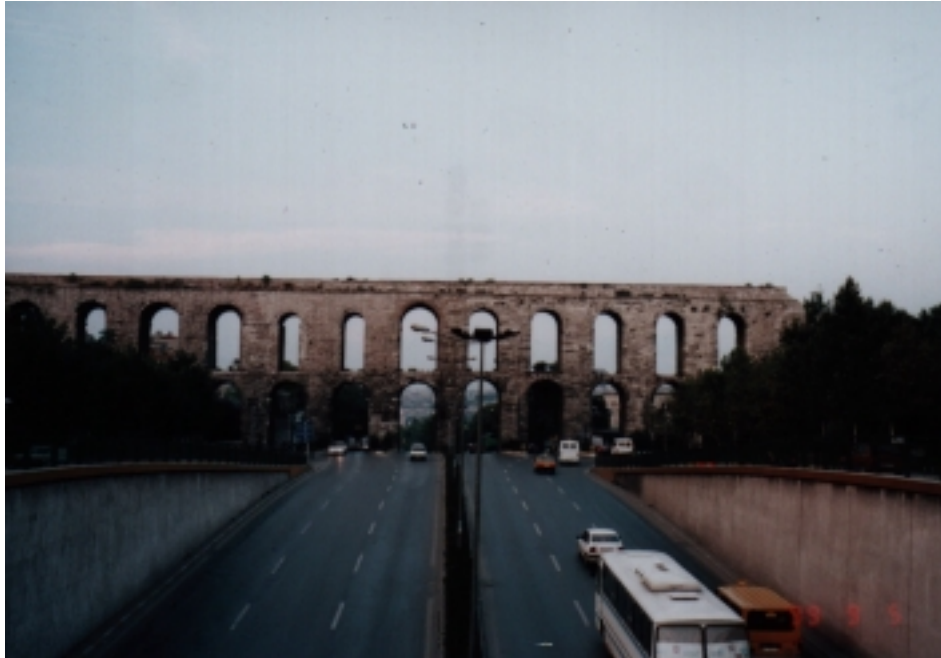
The Bozdoğan-Valens Aqueduct, built in 368 A.D., supplied the Byzantine and later the Ottoman palaces with water. Today part of the remaining 900 meters of double-tiered arches straddle the major highway that runs through the old part of town. No damage was observed during the site investigation of this structure as well as the Ottoman aqueducts such as the

16th Century Moğolova and Sultan Süleyman Aqueducts built both by Sinan (Figure 10.8)

Figure 10.8 A view of Bozdolan Aqueduct

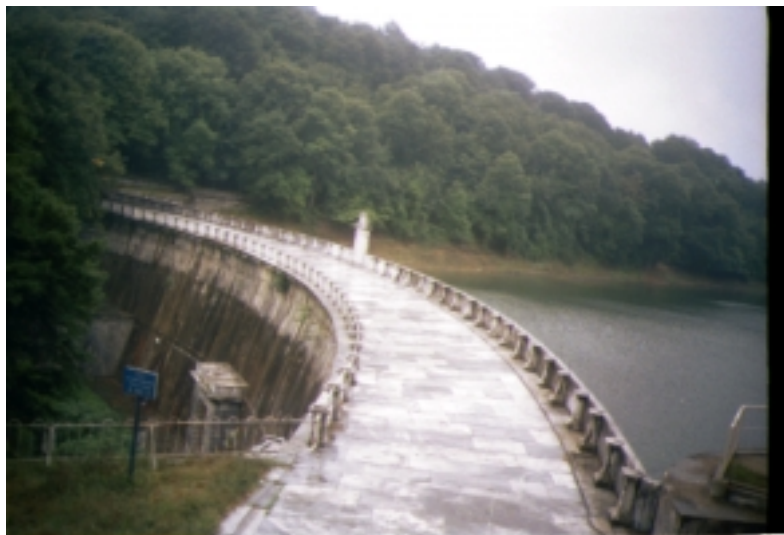
Seven water reservoirs are found in Belgrade Forest (Figure 10.9) The dams of these reservoirs are masonry and no damage was reported for these structures.

Figure 10.9 A view of Valide Sultan Dam in Belgrade Forest
