A RECONNAISSANCE REPORT
ON
THE BENGKULU EARTHQUAKE OF SEPTEMBER 12, 2007

2007 Bengkulu Earthquake Reconnaissance Team

Japan Society of Civil Engineers (JSCE)

Japan Association for Earthquake Engineering (JAEE)

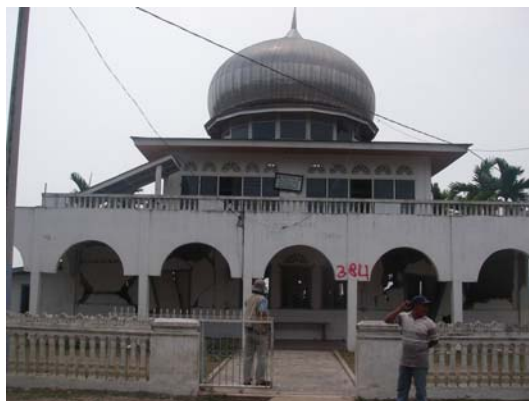
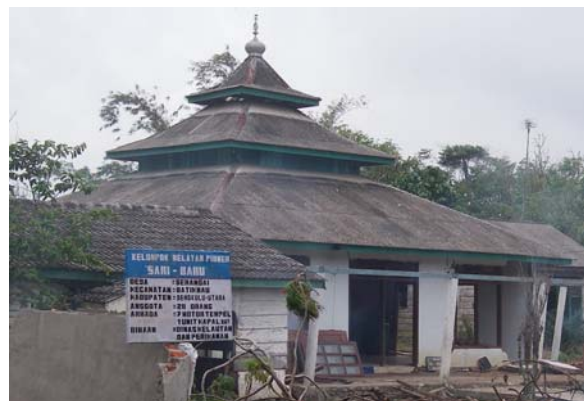
Fig.5.1 Damage to mosques

Mosques are semi-reinforced concrete structures. Although reinforced columns and beams are utilized, they are quite small in cross section (15x15 to 20x20cm) and they have 4-6 smooth steel bars with a diameter ranging between 8-12mm. The walls are either hollow cement blocks or bricks. The roof of mosques are generally light. The earthquake caused the failure of outer columns and load-bearing walls at corners and subsequent collapse of roofs (Figure 5.1).

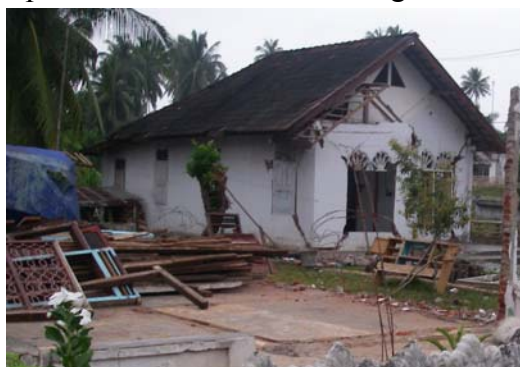
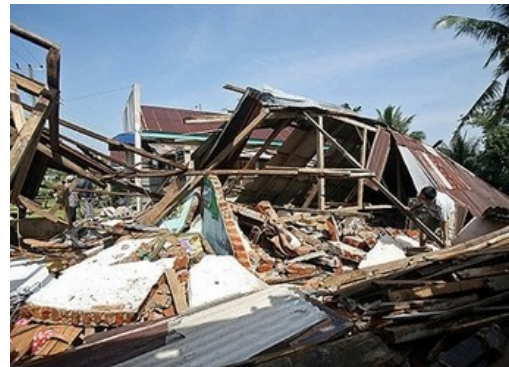
Fig.5.2 Collapsed or heavily damaged brick masonry houses

Masonry buildings are generally constructed with bricks and they are either one story or two story buildings. Old masonry buildings has no reinforced concrete [lintels](#) and/or columns. Such collapses were observed even in areas with high ground acceleration, (Figure 5.2) New constructions utilize reinforced concrete [lintels](#) and columns. There is no doubt that when such structural elements are integrated with masonry walls they perform better and they prevent the total collapse of the buildings in-spite of some structural damage.

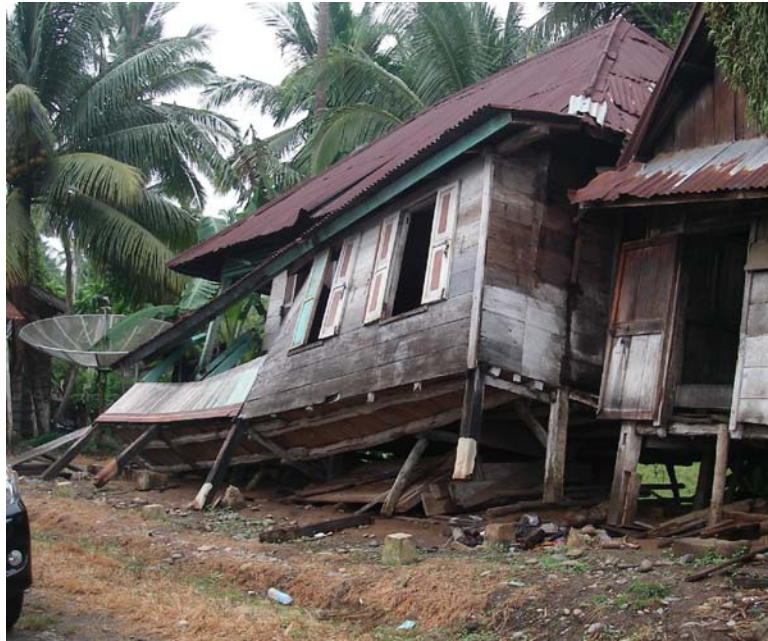
There are many wooden houses. Compared to brick masonry houses with or [without](#) RC [lintels](#) and/or columns, they performed better and there was almost no total collapse due to ground shaking. However, they failed due to the embankment failures as seen in Figure 5.3

Fig.5.3 Total collapse of a wooden house in Pasir Banting due to embankment failure

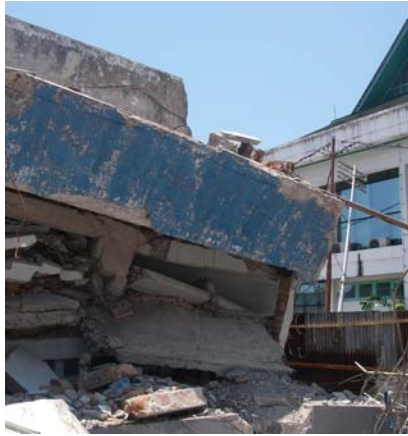
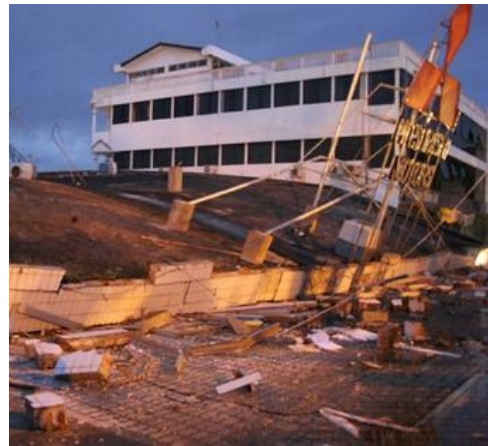
Fig.5.4 Examples of damage to RC buildings

RC buildings with two or three stories suffered heavily from the earthquakes. Many RC buildings either totally collapsed or heavily damaged in Padang City even though they were about 400km away from the epicenter. The reinforced concrete structures are framed structures with integrated or non-integrated in-fill walls. The reinforcing bars are generally smooth and infill walls are built with red-burned solid clay bricks using mortar. The floor height in the region ranges between 3 to 4m. The inspections of the reinforced concrete buildings indicated that they are mainly failed in the pancake mode. RC buildings are generally found in cities and large towns. The concrete buildings having 2 or more stories were either collapsed or heavily damaged. The causes of damage to RC buildings are similar to those observed in other recent earthquakes in Indonesia and elsewhere (Figures 5.4). They may be re-stated for this earthquake as follows:

- a. Soil liquefaction and lack of the soil bearing capacity (particularly in Padang)
 - b. Large ground settlement of embankments nearby river banks
 - c. Fragile structural walls and lack of lateral stiffness,
 - d. Poor concrete quality and workmanship,
 - e. Plastic hinge development at the beam-column joints,
 - f. Lack of shear reinforcement and confinement,
 - g. Soft story,
 - h. Pounding and torsion and
- Ground motion characteristics (i.e. multiple shocks etc.).

(a) Padang

(d) Mitsubishi showroom

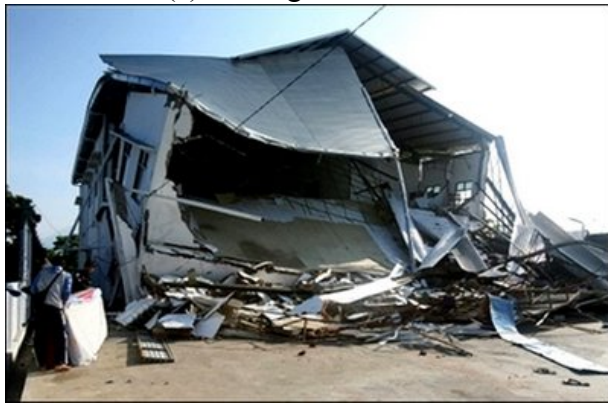
(c) Collapsed show room in Argamakmur

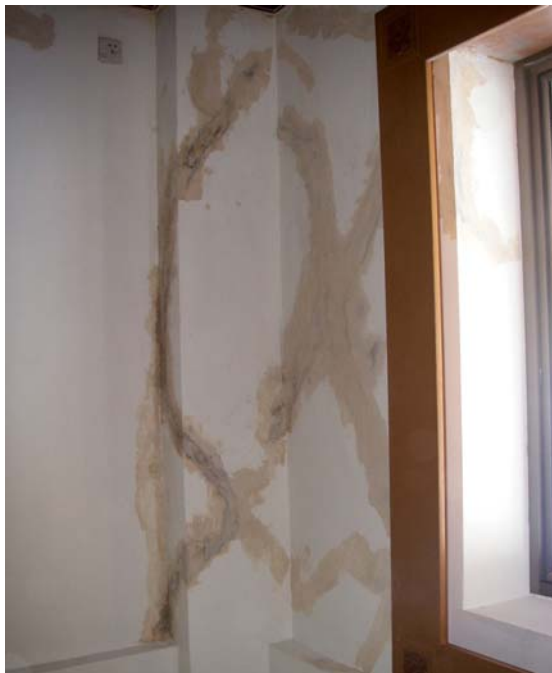
Many RC buildings suffered some damage and repairs implemented are just to [re-plaster the cracks](#) caused by the ground shaking ([Figure 5.5](#)). These buildings are probably the most vulnerable to collapse during a next strong earthquake.

Fig.5.5 Re-Plastered columns of an RC building used as an hotel in Padang

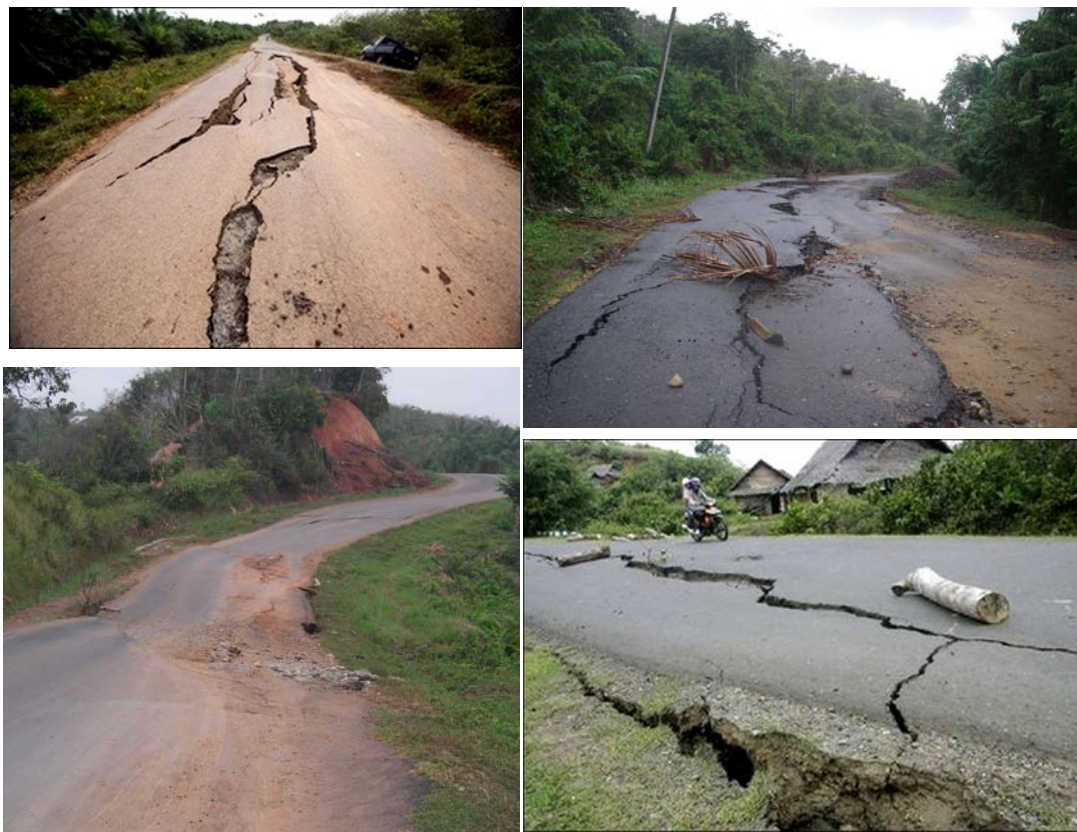
Embankment failures of roadways and rivers were also widespread in the area where the ground motions were high. The embankment failures at infilled sections of the roadways were quite severe and the general trend was quite similar to those observed in Noto Toll Road (Figures 5.8). Since the ground was more resistant and

ground shaking was mild, the translational movements did not cause the total collapse of the embankments. Furthermore, the approach embankments of bridges were severely damaged by settlement and lateral spreading of ground at their base.

Fig.5.8 Some examples of failures of embankments of roadways

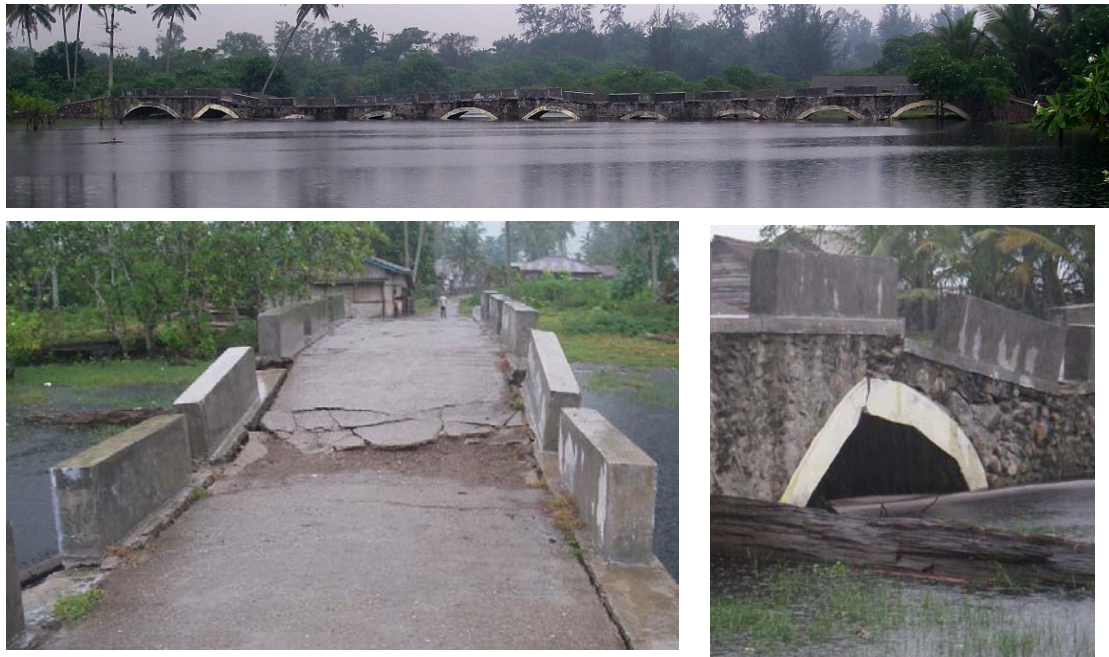
Bridges in the epicentral area are truss, arch or simple beam bridges. The earthquake shaking did not cause any **major** damage to the bridges of roadways even in the nearest location to the epicenter of the earthquake (Figure 5.9) except the newly built arch bridge at Pasir Ganting. The damage to bridges were caused by the failure of approach embankments and uneven settlement of piers (Figure 5.10 and 5.11). However, almost all bridges were open to traffic with some speed limitation.

Fig.5.9 Damage to the arch bridge at Pasir Ganting due to ground liquefaction

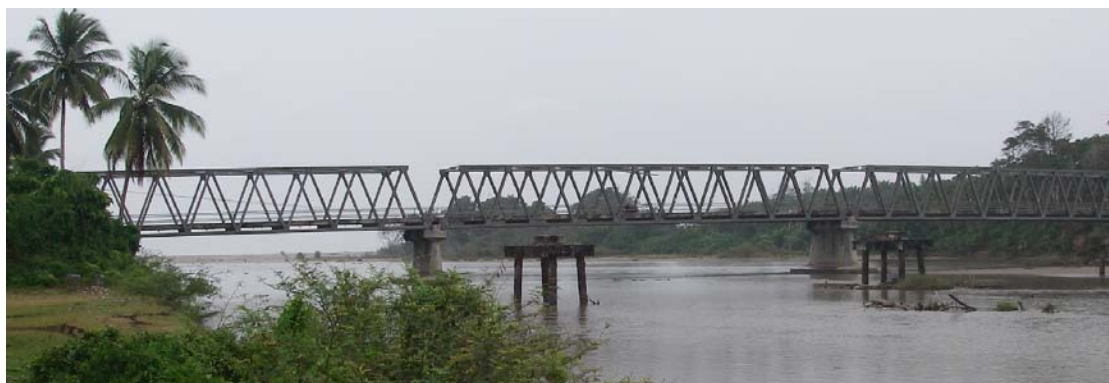
Fig.5.10 Slight damage to Seblat River Bridge due to uneven settlements

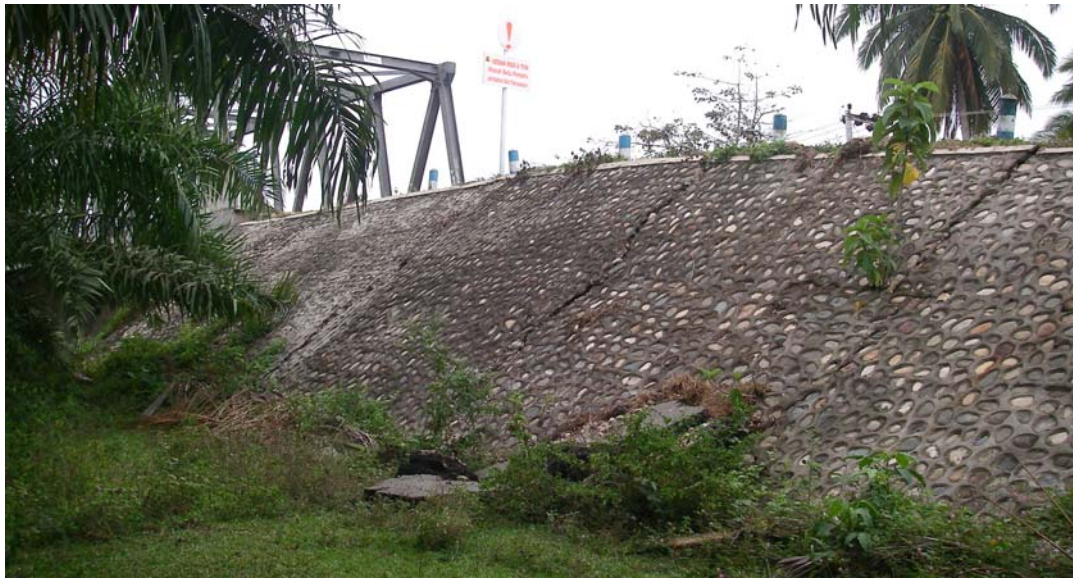
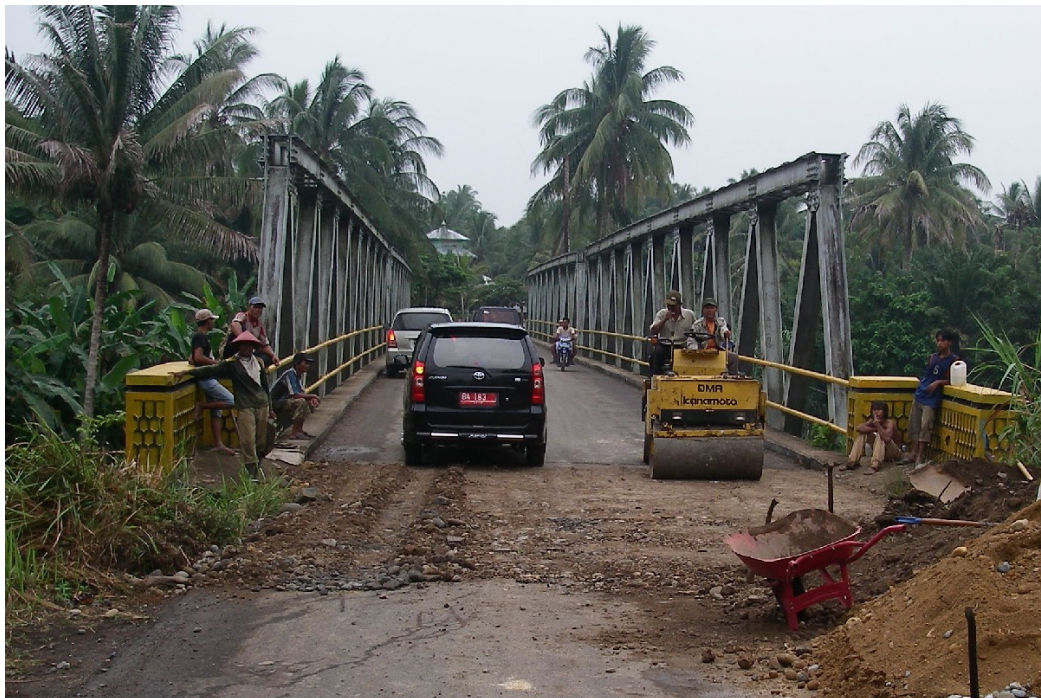
Fig.5.11 Damage to approach embankments of bridges

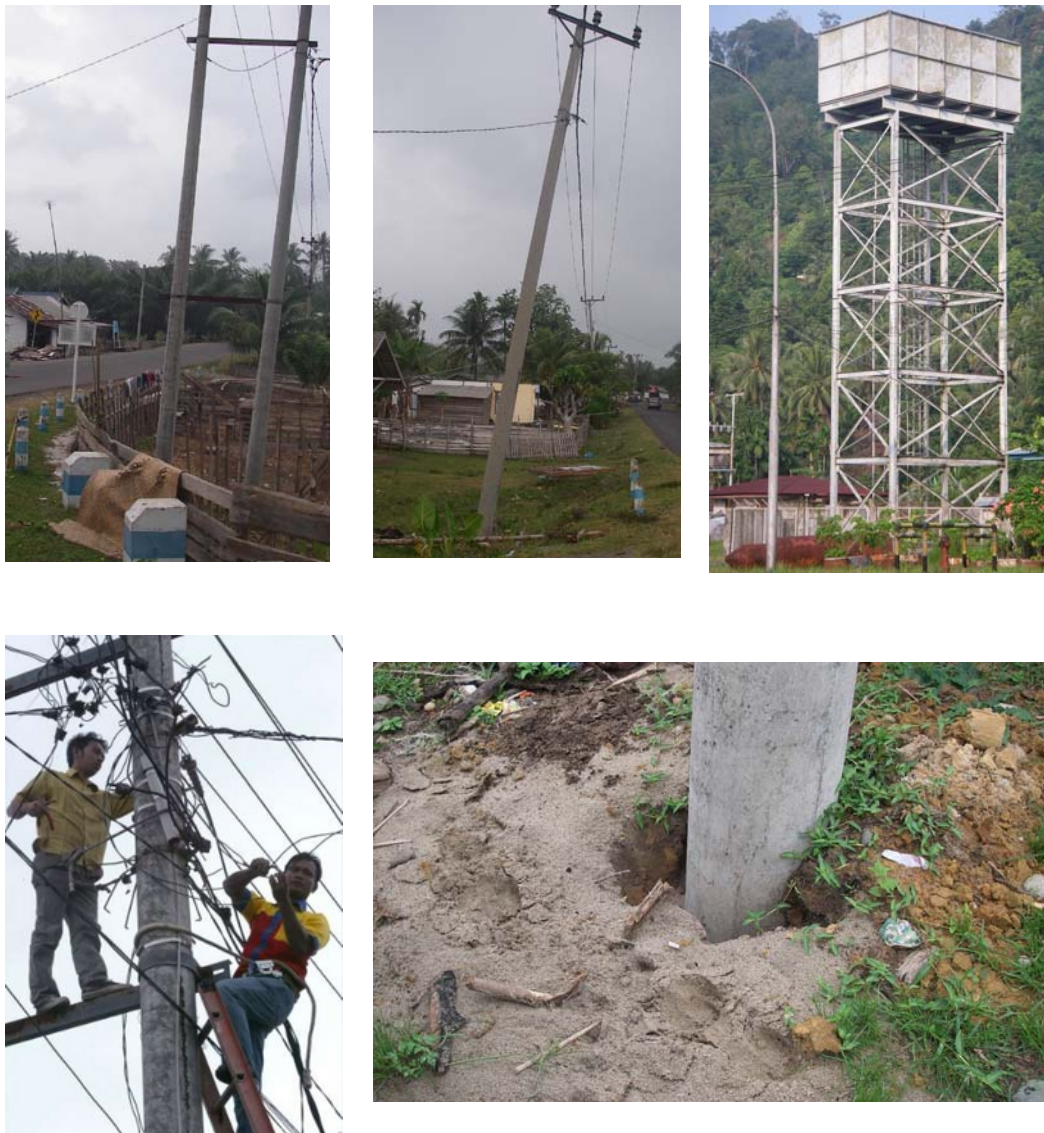
Power lines and communication were cut in the affected region following the earthquake (Figure 5.12). In some areas, electricity has returned to normal soon after the earthquake. At some locations, where shaking or geotechnical damage was heavy, some power lines were damaged. The electricity was fully recovered in the next day.

Fig.5.12 Views of some damage to utility poles and a non-damaged elevated water tank

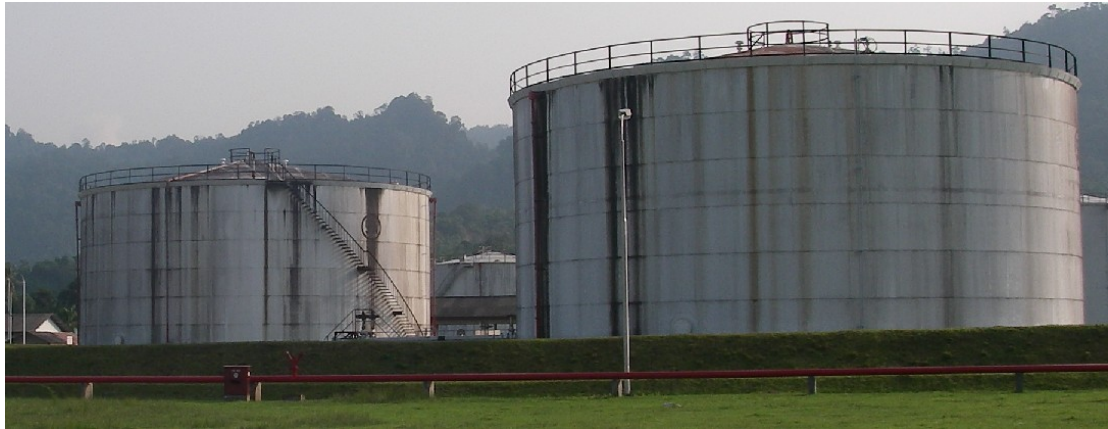
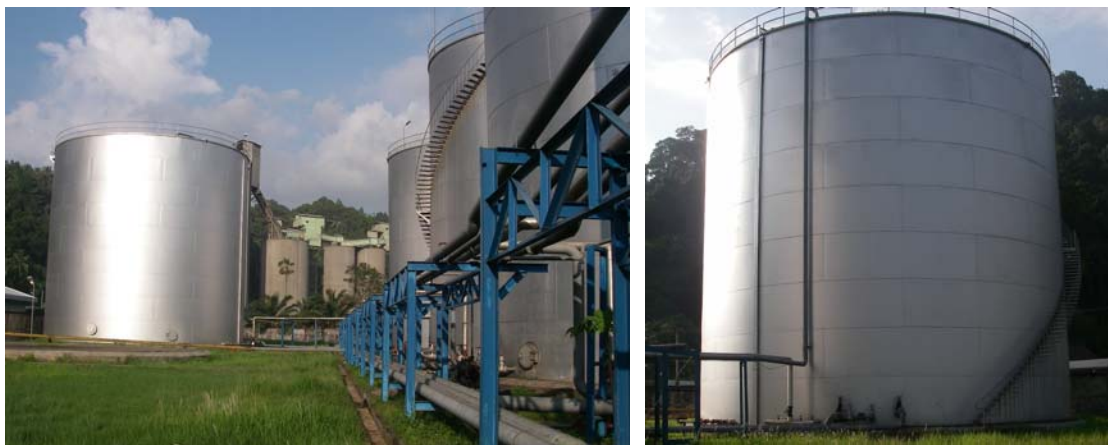
Most of industrial facilities are located in Bengkulu City of Bengkulu Province and in Padang City and Teluk Bayur Port of West Sumatra province. The inspection of some industrial plants between Padang and Bengkulu indicated that the earthquake did not cause any major damage to industrial facilities except some small scale damages to connections and rollers etc. (Figure 5.13 and Figure 5.14)

Fig.5.13 Tank yards in Teluk Bayur Port of Padang Ciity and Painan City

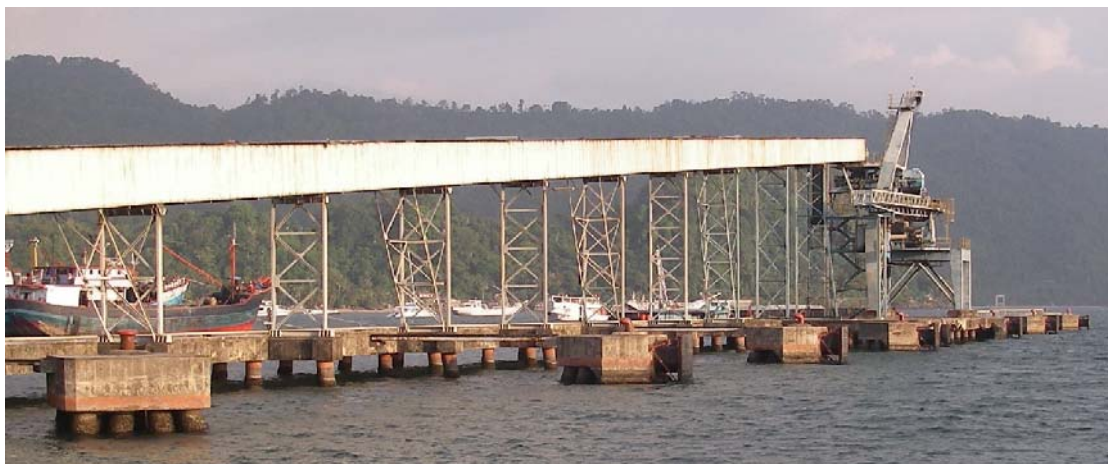
Fig.5.14 Slightly damaged Conveyor of loading facility at Teluk Bayur Port

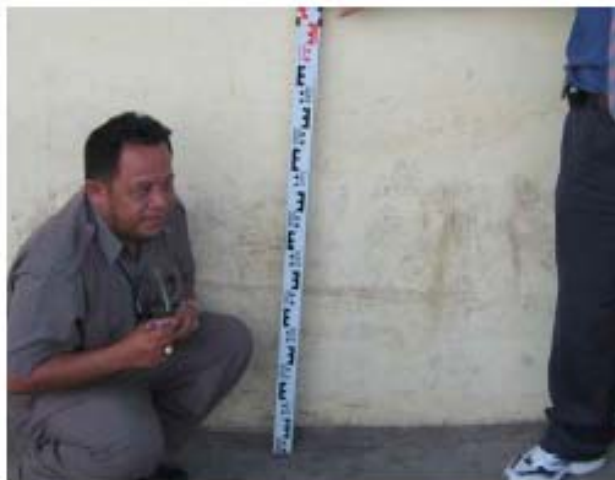
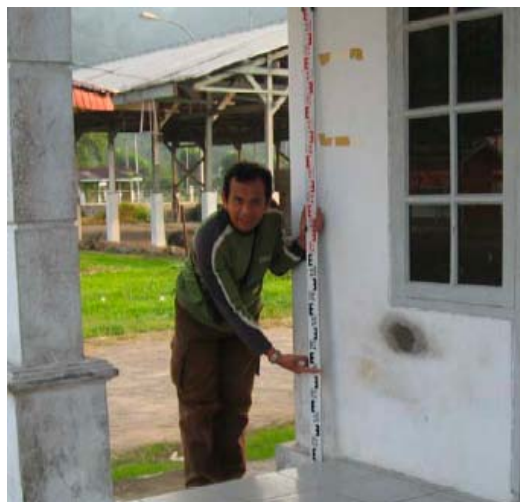
Fig.6.8 Measuring tsunami height of water marks on the wall above the ground

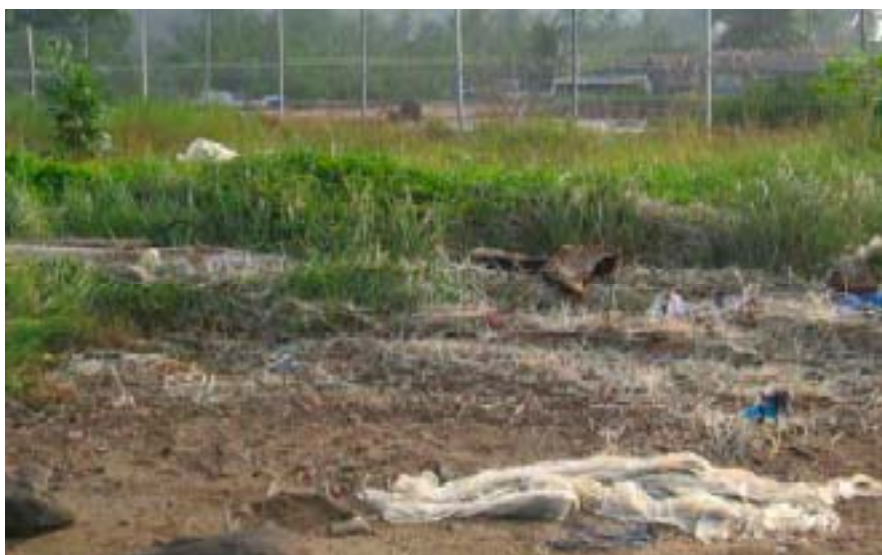
There are several damage due to a tsunami, which can be divided into direct and indirect damage. The first is human loss, houses and infrastructure damage by the inundation or destructive wave force. The second is floating material, oil spread, and no use of harbor facility. The process and mechanism of each damage due to an impact of a tsunami should be investigated and studied for evaluation and mitigation in the future. The traces and evidences of tsunamis as shown in Figure.6.9 are very important item for the field investigation.

Fig.6.9 Example of the tsunami trace

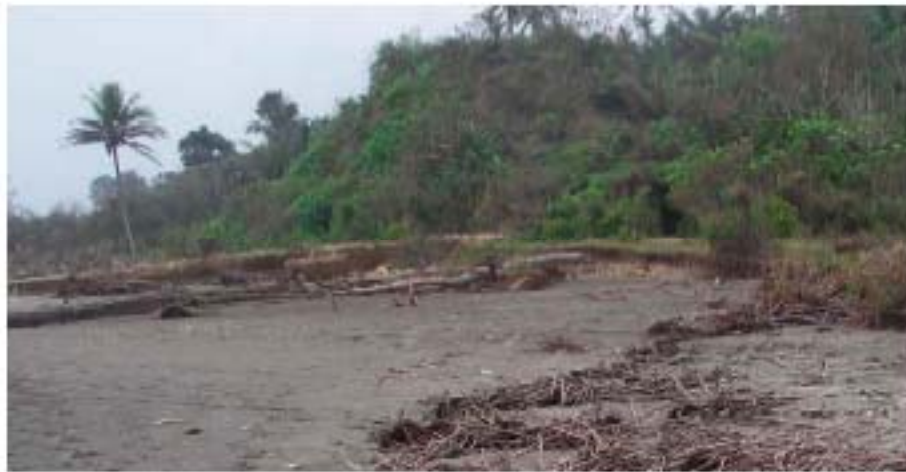
Fig.6.10 Example of tsunami erosion along the coast at Seblant, Koto-bani

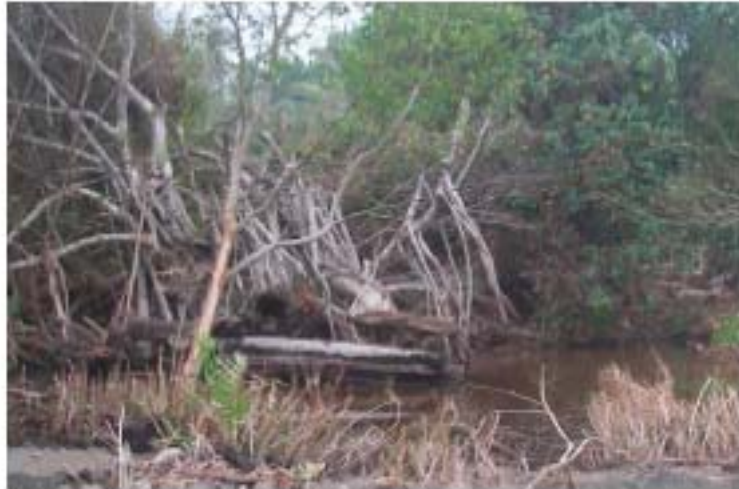
In this event, at Serangai there is green belt composed of the Mangrove along the coast, which could stop the floating material of timbers moved by the tsunami from

coast. However, the houses behind the green could not be survived and completely destroyed. Because there are so many timbers on the sea, which can be not trapped. And wave force of the tsunami should be so strong that the green rule is not enough to reduce them. The width of the green would be small at this area. This suggests the limitation of the green belt to reduce the tsunami impact force.

Fig.6.12 Floating timbers trapped by the Mangroves on the shore

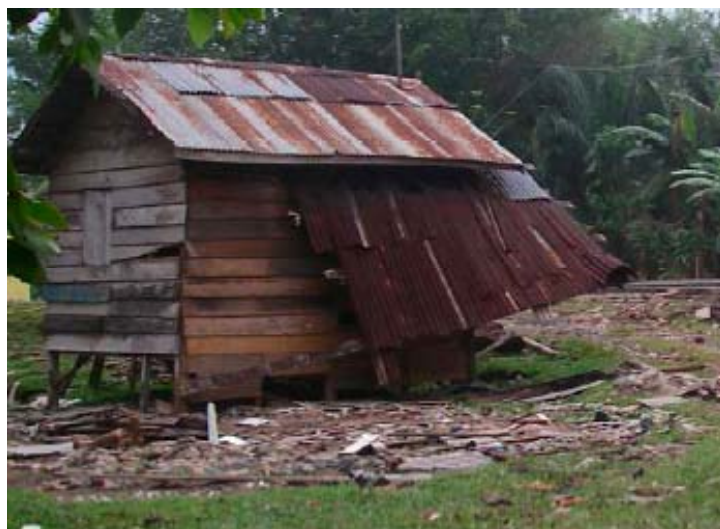
Fig.6.13 The house damaged and moved by the tsunami

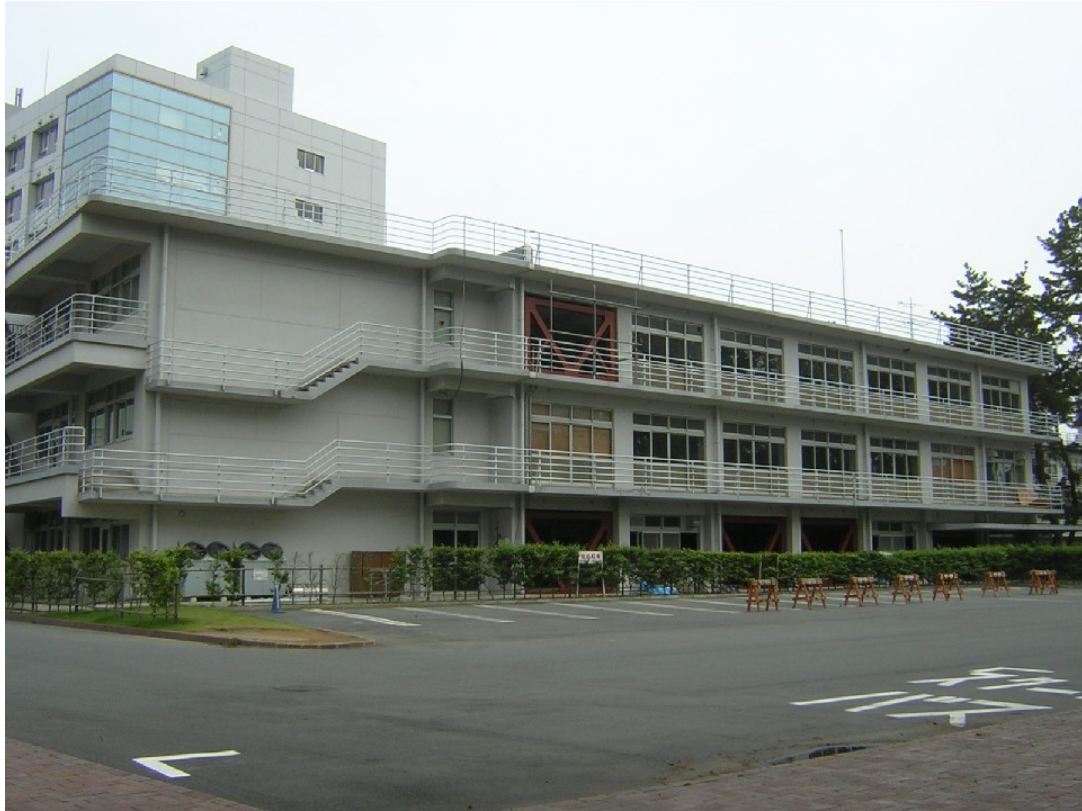
Fig.8.2. Buildings of Shoyo High School of Tokai University Education System in Miho Peninsula in the tsunami-prone area of the expected Tokai earthquake

The existing buildings in Padang City and elsewhere in Sumatra Island and the rest of Indonesia are generally very vulnerable against ground shaking. There were even some collapses of RC buildings in Padang city, which was about 400km away from the epicenter of the South Sumatra Earthquake of 2007. Furthermore, many RC buildings suffered some damage and repairs implemented are just to re-plaster the cracks caused by the ground shaking. These buildings are probably the most vulnerable to collapse during a next strong earthquake. **The existing buildings must be retrofitted against strong ground shaking and they should be equipped with terraces and stairs for the vertical evacuation in tsunami-vulnerable areas (Figure 8.2).**

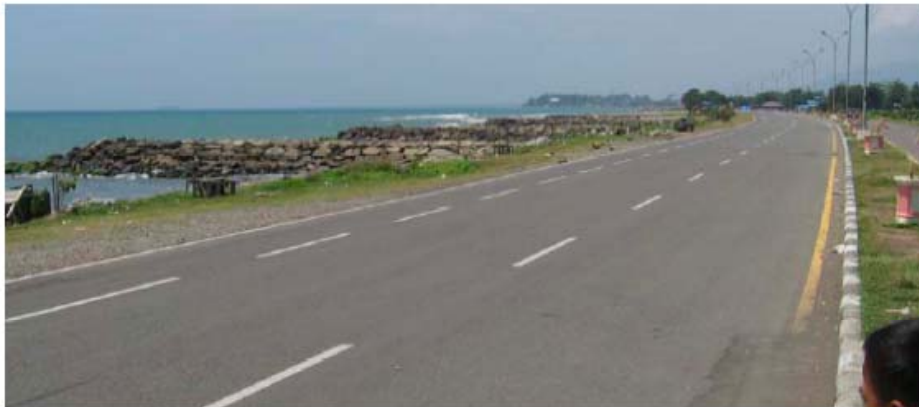
Fig.8.5 Sea dike with the height of 2-3 m at Padang, which prevent a small tsunami and stop the inundation.

Building dykes, **elevated tsunami shelters**, gates and water breaks and planting trees along the coast line can be also implemented as hardware measures against tsunami disasters (Figure 8.5).
