THE OFF-OKINAWA ISLAND EARTHQUAKE OF FEBRUARY 27, 2010

Naohiko TOKASHIKI  
Ryukyu University, Department of Civil Engineering  
Nishihara, Okinawa, Japan

Ömer AYDAN  
Tokai University, Department of Marine Civil Engineering  
Shizuoka, Japan

August 2010

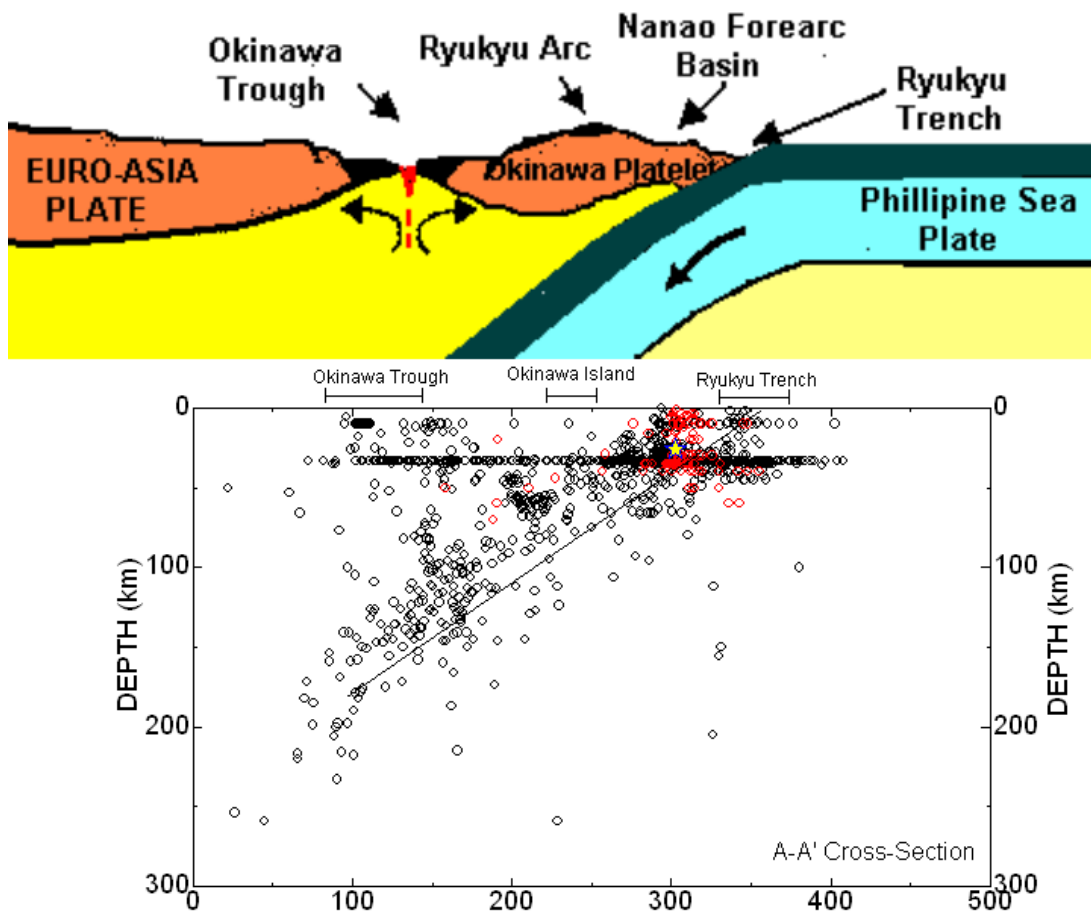
Figure 6: A cross-section of the earth-crust in the vicinity of Okinawa Island and associated seismicity together with aftershock activity

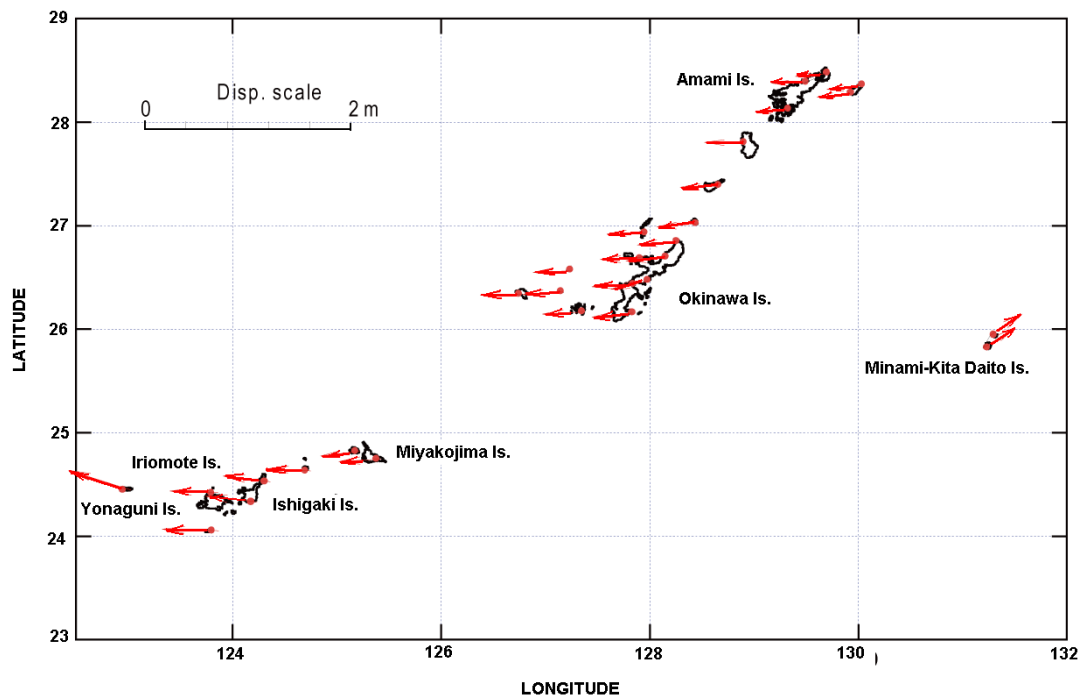
Figure 7. Crustal deformation of Ryukyu Islands between 1997 and 2008

The authors have been using the deformations measured from GPS network of GEONET of Japan (Figure 7) to obtain current crustal straining and stress changes. Although the GPS stations are sparsely located, it is possible to obtain information on the current situation of crustal straining and stress changes of Ryukyu Islands. The authors have been using the method proposed by Aydan. This method utilizes the principles of Finite Element Method (FEM) to obtain incremental strain and stress changes. Figure 8 shows the stress changes obtained from deformations between 1997 and 2008. As noted from the figure stress changes are not uniform along the Ryukyu Islands.

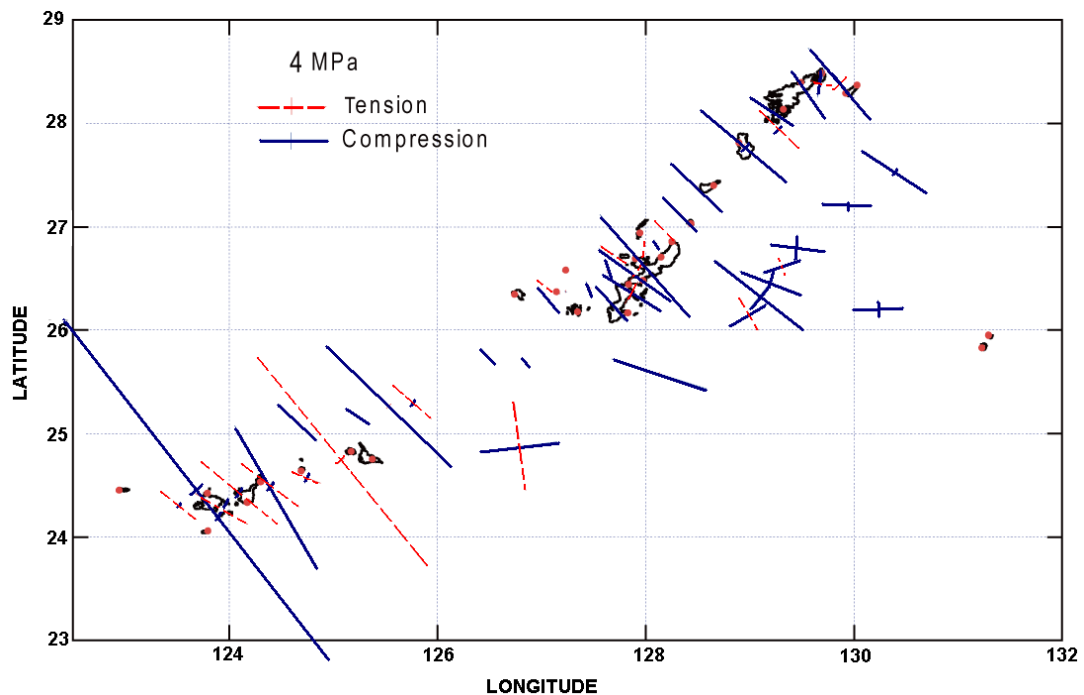
Figure 8. Stress changes of Ryukyu Islands between 1997 and 2008.

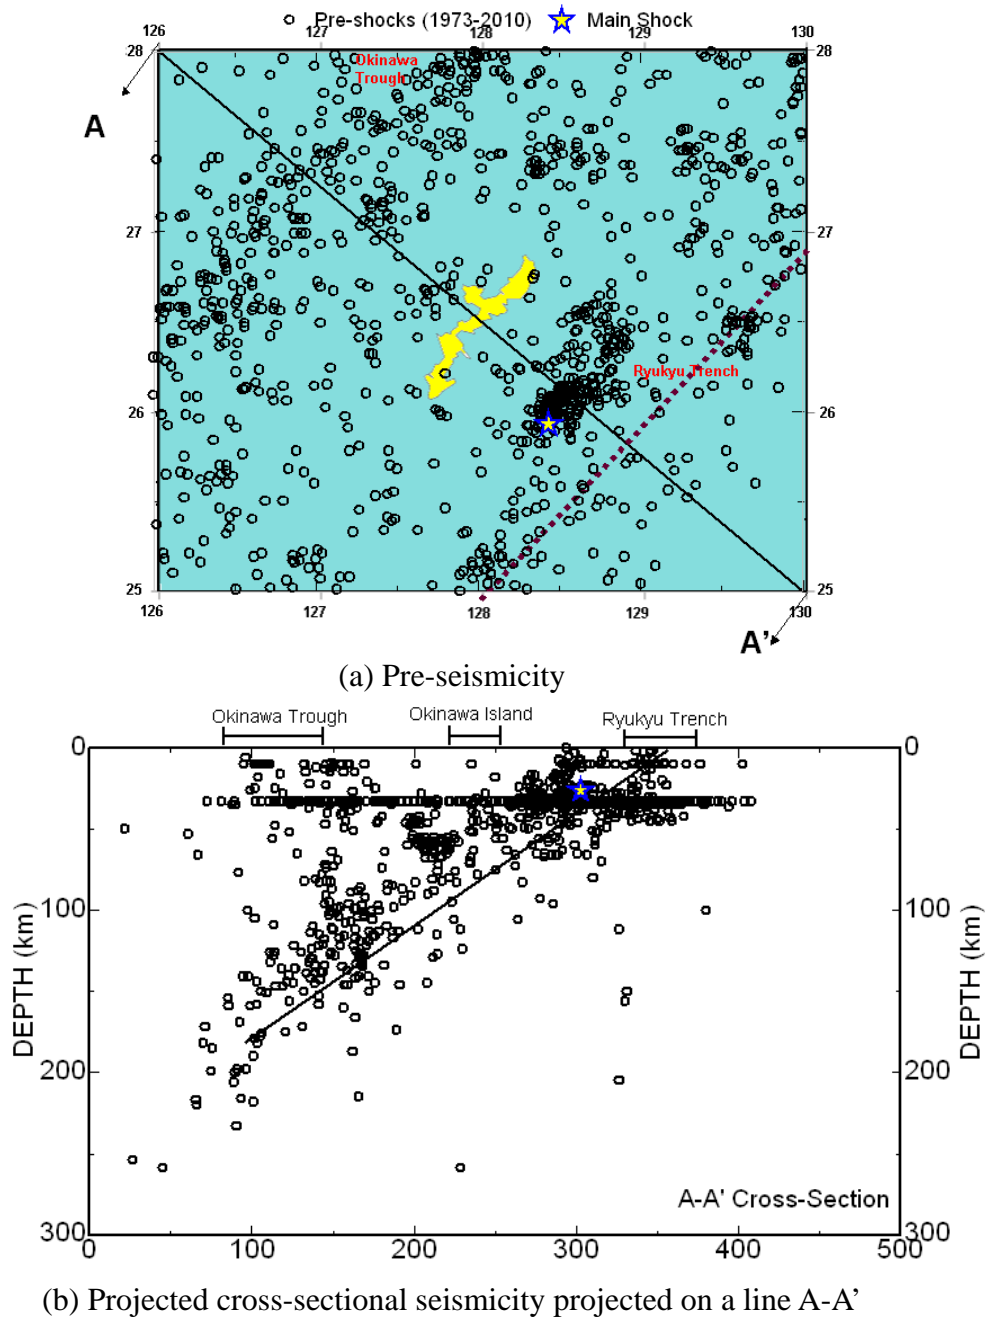
Figure 10: Pre-seismicity of the earthquake affected area.

Figure 10 shows the pre-seismicity of the earthquake-affected area together with the main shocks. It is interesting to note that the high seismicity is observed in the close vicinity of the hypocenter. The depth of the earthquakes extends up to 250 km below Okinawa Trough. The seismic activity mainly concentrated in the Okinawa trough, Ryukyu Trench and the upper zone of the subducting Philippine Sea Plate.

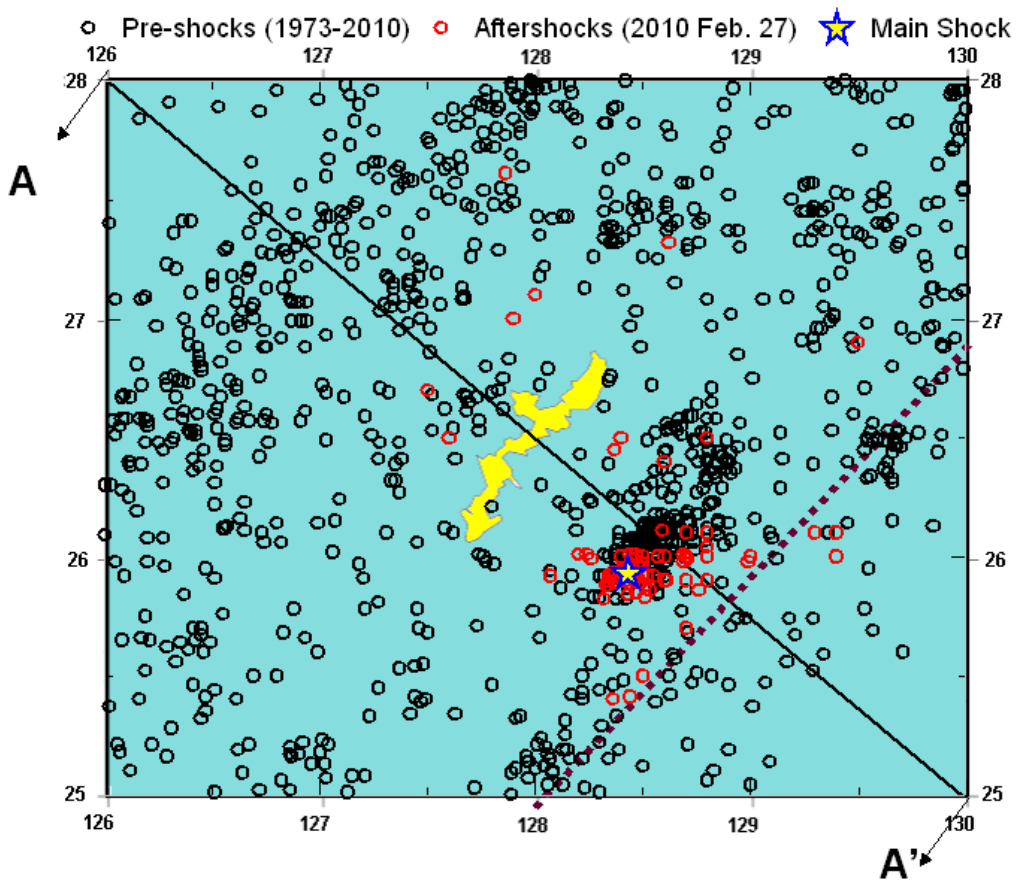
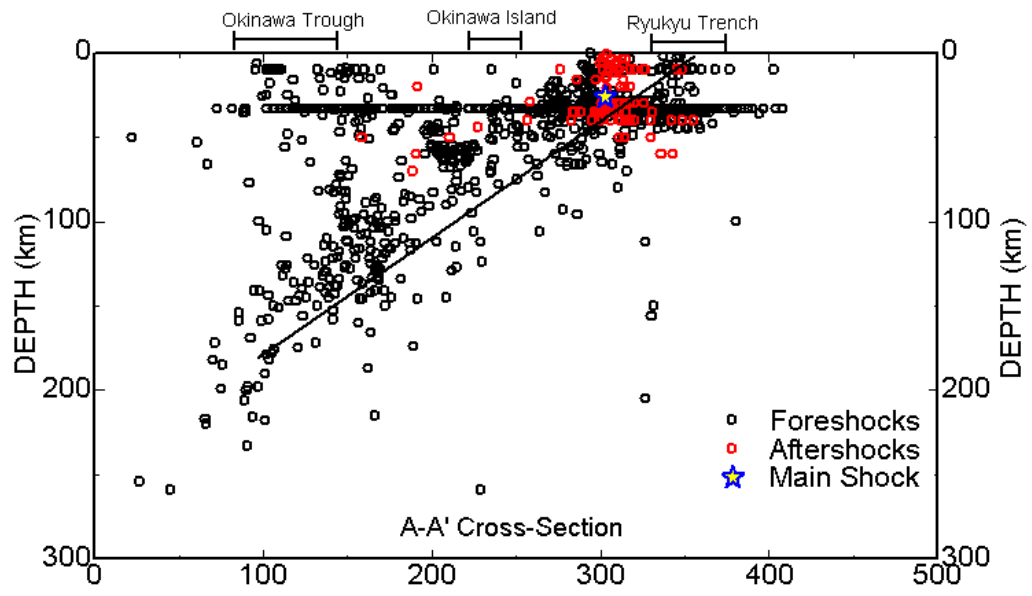
(a) Foreshock and aftershock activity

(b) Projected foreshock and aftershock seismic activity along line A-A'

Figure 14: Foreshock and aftershock activity in the earthquake-affected area

Various seismological institutes estimated the characteristics of the main shock on Feb. 27, 2010 as given in Table 1 and as shown in Figure 13. The estimated parameters are very close to each and they implied that the earthquake occurred by strike-slip faulting. The Harvard solution estimated the duration of the earthquake as 15s. The authors utilized the relations proposed Aydan (2007) to estimate the size of the fault plane and duration of the earthquake for a moment magnitude of 7.0 and the results are also given in Table 1. As usual, focal mechanism solutions imply two possible fault planes. The fault plane striking almost E-W is expected to be the causative fault plane in view of aftershock activity following the main shock as seen in Figure 14. The aftershock activity is observed on an 80 km long and 40 km deep cross-sectional area.

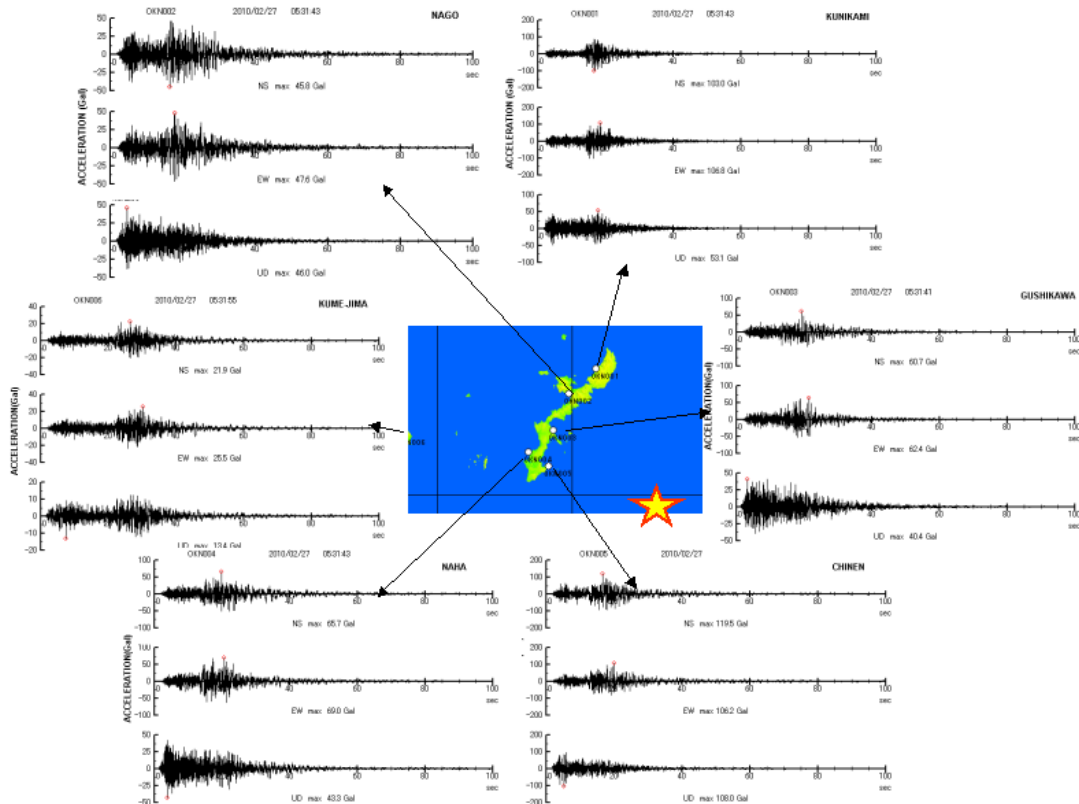
Figure 15: Acceleration records at strong motion stations in Okinawa and Kume Islands

There are 5 K-NET strong motion stations owned by the National Research Institute for Earth Science and Disaster Prevention (NIED). The nearest strong motion to the epicenter is Chinen (Re=90 km) and the maximum ground acceleration was 123 gals. Figure 15 shows the ground accelerations in Okinawa and Kume Islands. The second highest ground acceleration were observed at Kunigami. The shear wave velocity of ground up to a depth of 5 m in all stations ranges between 150-250 m/s. The attenuation of maximum ground acceleration and velocity data are compared with some of empirical relations proposed by Aydan (2001, 2007) as shown in Figure 16. The empirical relations proposed by Aydan consider the directivity effect and type of faulting and the type of earthquakes. It was assumed that the earthquake was an intra-plate strike-slip earthquake. As noted from the figure good correlations are observed between estimations and measured values. Figure 17 shows the acceleration response spectra for strong motion records shown in Figure 15. The acceleration response spectra imply that Nago and Gushikawa records indicate some long-period effects. This may be related to the existence of relatively thick sedimentary deposits at these stations.

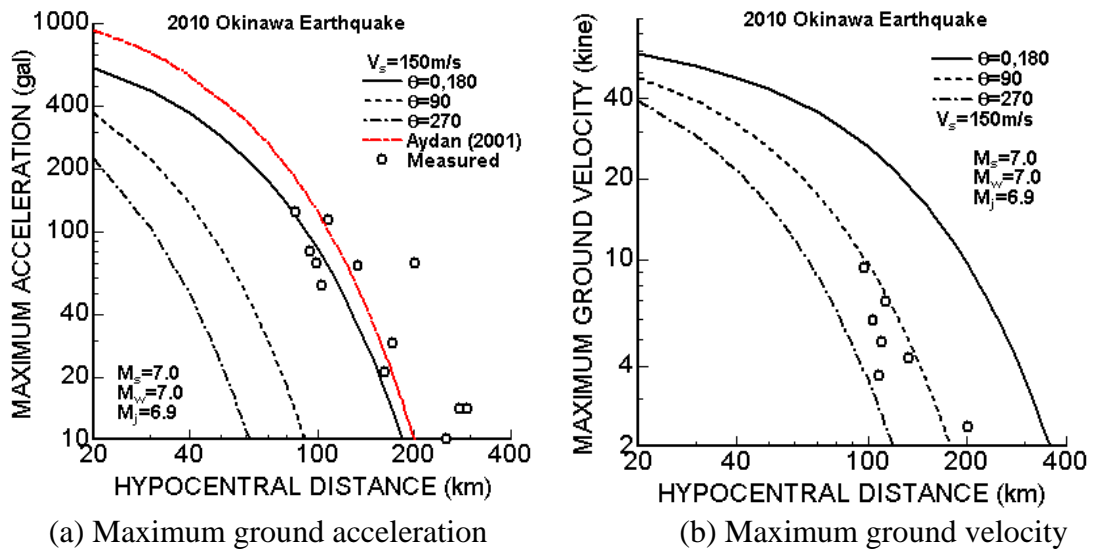
Figure 16: Attenuation of maximum ground acceleration and velocity with distance

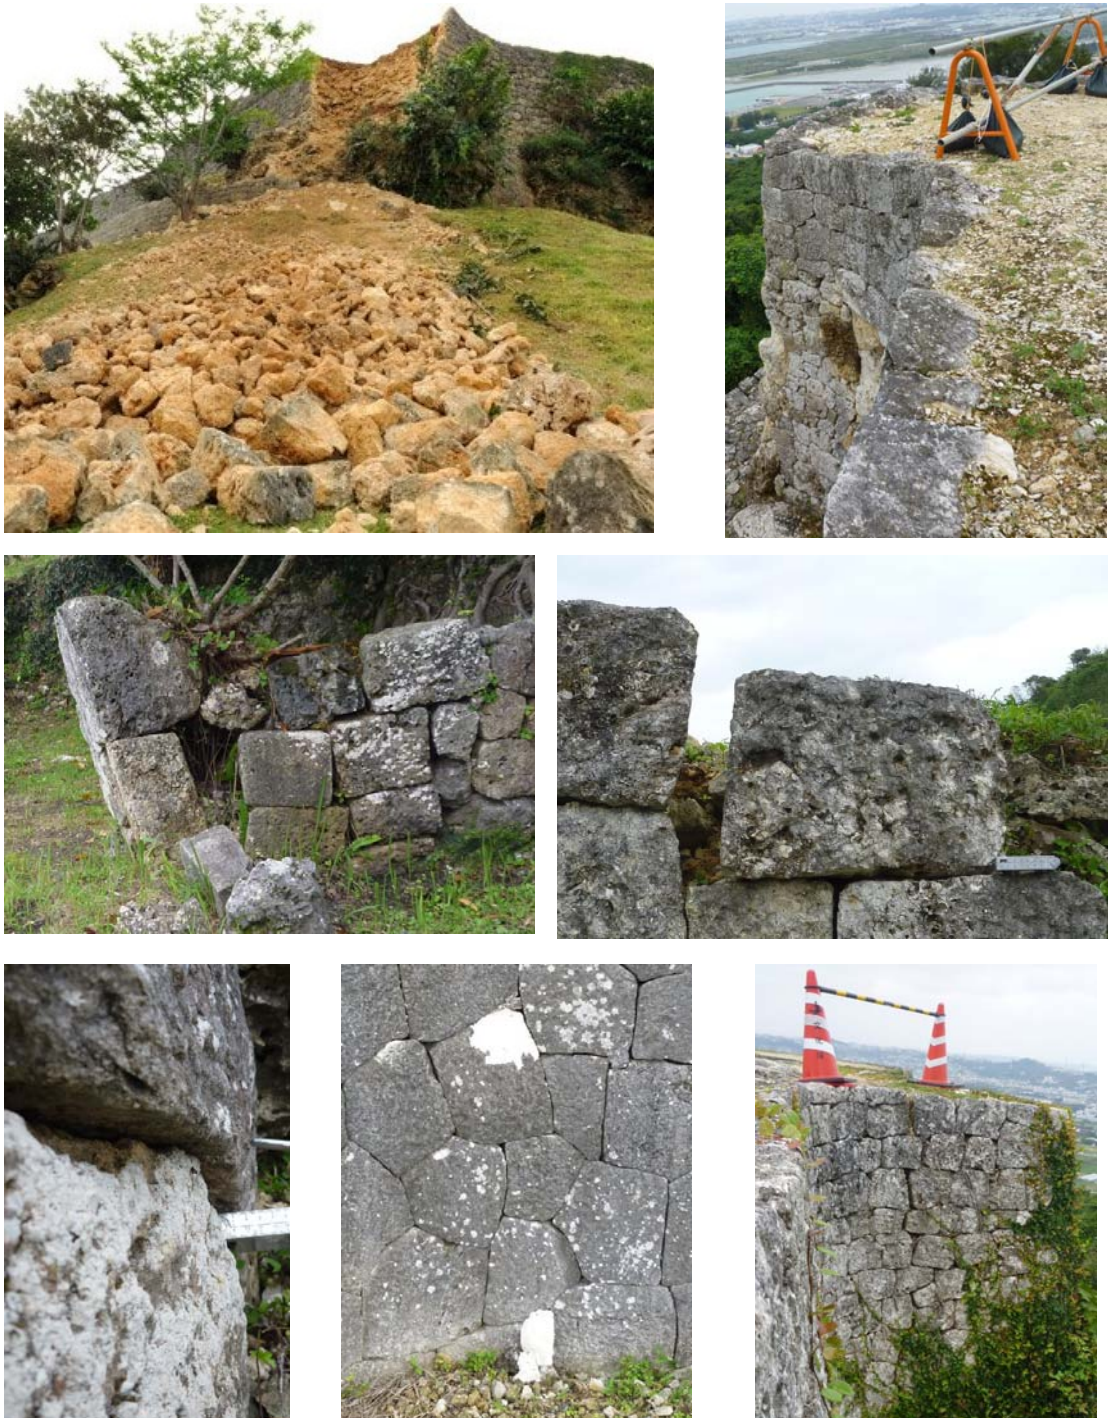
The collapse of some of castle walls at Katsuren Castle, which is designated as a world heritage site, occurred. The castle is located over a hill in Uruma City and the nearest strong motion station of the K-NET strong motion network is Gushikawa. The NW corner of the castle wall with a height of 4m collapsed and there were numerous dislocations blocks and rotation of blocks in the castle as seen in Figure 19.

Figure 19: Collapse of the castle wall and dislocation or rotation of blocks and walls

Although the Ryukyu Archipelago is a seismically active part of the world, the general impression is that the Archipelago is not seismically active. The earthquake on 2010 Feb. 27 showed that the importance of the consideration of seismicity in Ryukyu Islands. As the earthquake was at least 90 km away from the populated areas, the ground motions were that high to cause major damage. However, castle walls are collapsed, toppling of water tanks, rupture of water pipes and embankment and slope failures occurred. There are many stone masonry historical remains in Ryukyu Islands and they are very vulnerable to earthquakes as seen in Katsuren Castle remains.. The seismic stability of these masonry structures should be re-evaluated.

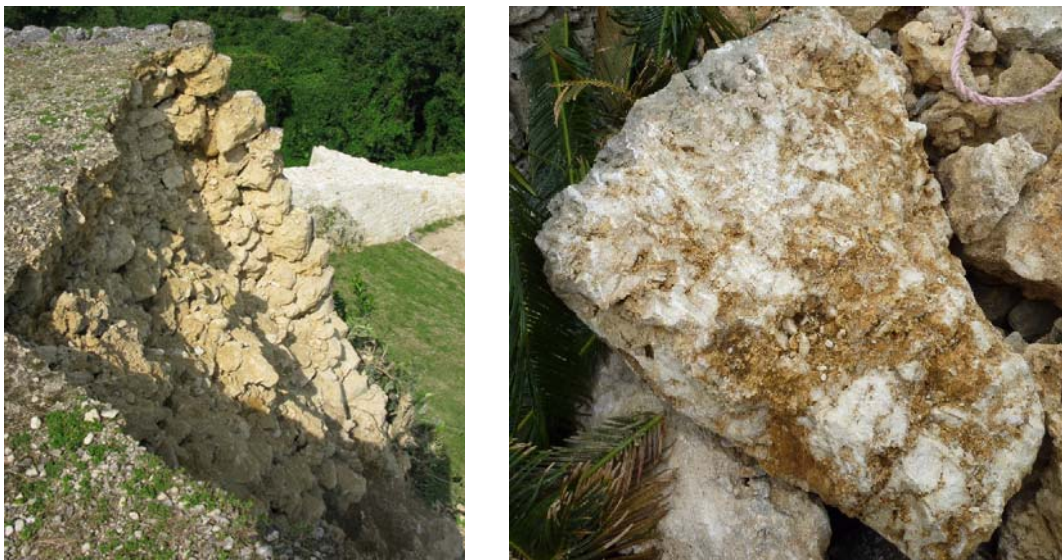
The authors carried out a series of analyses using the acceleration records at Chinen and Gushikawa strong motion stations of the K-NET strong motion network. The typical size of the blocks ranges between 50 to 60 cm as seen in Figure 20. The authors used their method (Tokashiki et al. 2008) to back-analyze the collapse of the wall using the strong motion records at Gushikawa and Chinen. The wall is stable against toppling mode for strong motions at Gushikawa and Chinen. If the records taken at Gushikawa are used, the relative sliding can not be greater than 10cm, which implies that the wall should be stable although some slip might take place. However, if the records taken at Chinen are used the relative sliding can be greater than 60 cm for  $\theta = 5^\circ$ , which exceeds the half size of the block and this implies that the wall should collapse (Figure 21). The bulging of the wall and inclination of the foundation rock strongly supports that this condition would be prevailing at the location of the collapse. As the castle is situated on the top of the hill, it is likely that ground motions were amplified.

Figure 20: Close-up views of the collapsed wall and typical rock block

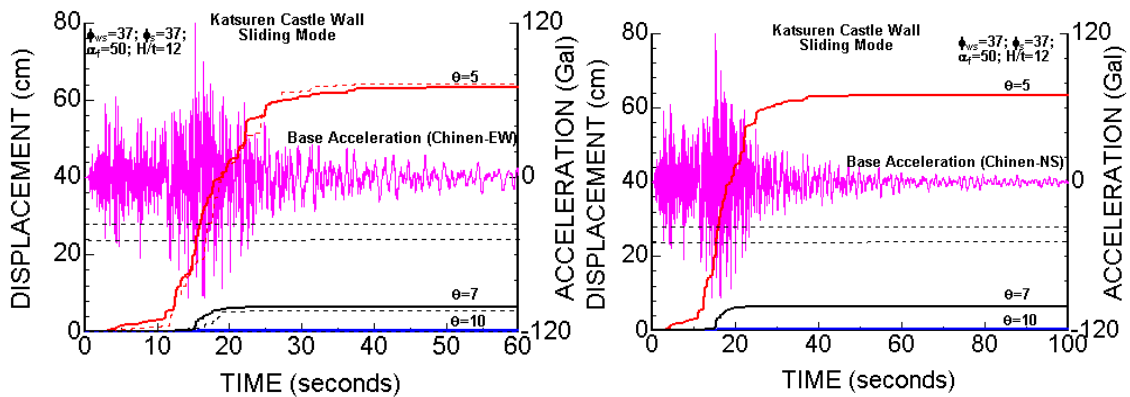
Figure 21: Sliding responses of the castle wall for Chinen record.

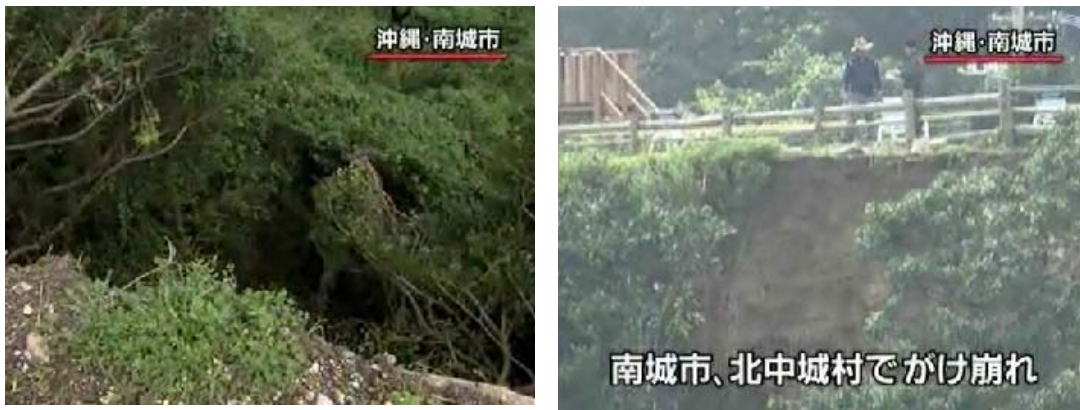
Slope failures occurred in Nanjo City and Nakagusuku (Figure 22). The authors also found that embankment of roads to Nakagusuku Castle were also partially failed (Figure 23).

Figure 22: Slope failure in Nanjo City (from mass media)

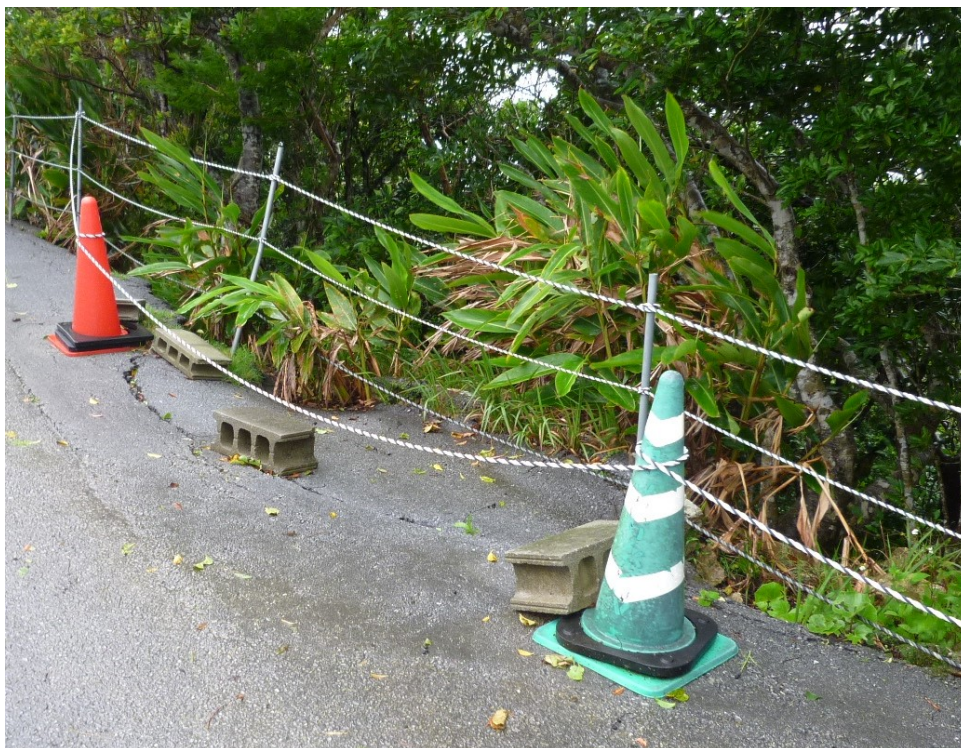
Figure 23: Partial failure of road embankment near Nakagusuku

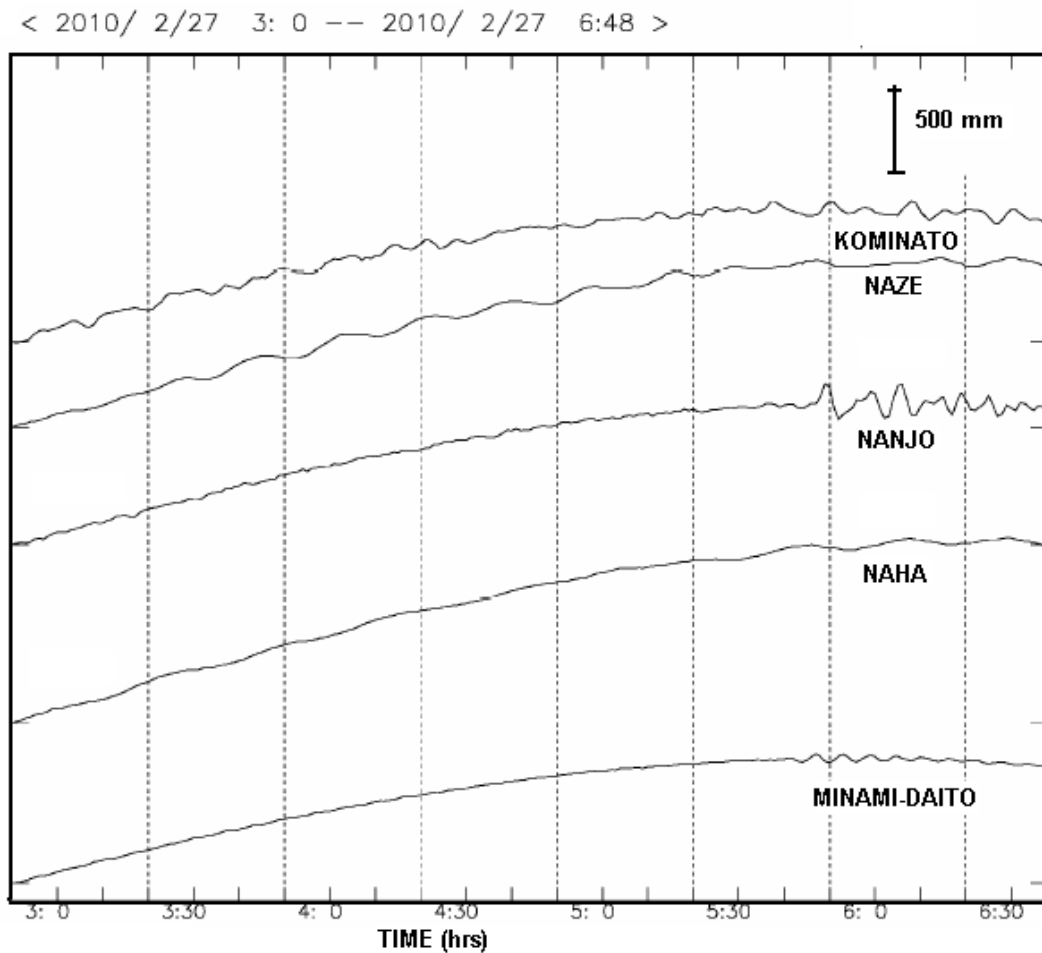
The character of the earthquake was strike-slip faulting with a small thrust component. As expected from the character of the earthquake, tsunami is very unlikely. The earthquake caused very small tsunami waves. The highest tsunami wave was observed in Nanjo City and Minami-Daito island after about 15 minutes. The tsunami wave height was about 10 cm in Nanjo City while it was much less in Minami-Daito Island. Figure 24 shows the tidal wave observations at several observation points.

Figure 24: Tidal wave records at several ports in the earthquake-affected area

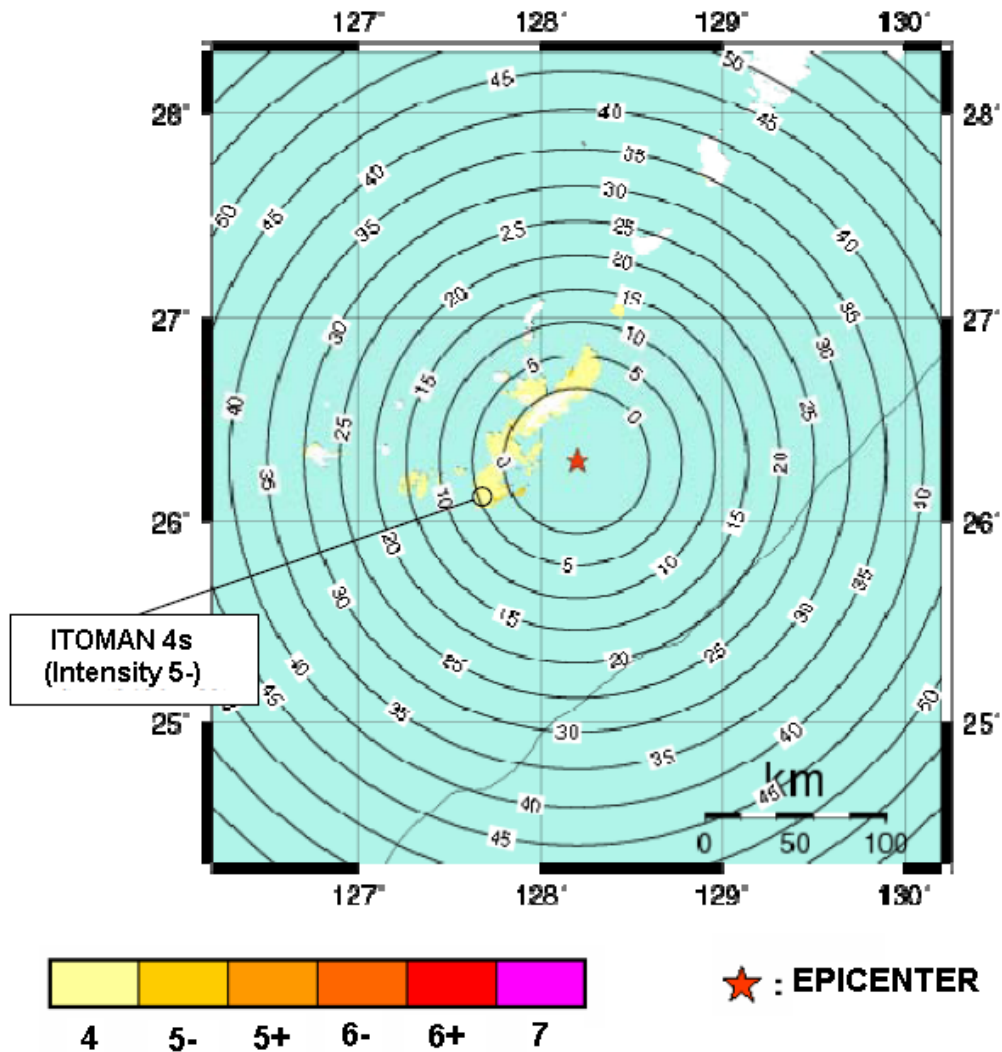
Japan Meteorological Agency introduced a new system of early warning system for earthquakes. Figure 25 shows the warning time around the epicenter issued for the 2010 Off-Okinawa Island earthquake. The system was successful for issuing warnings for the given specified conditions. Nevertheless, this system was of no use for people in the close vicinity of the earthquake epicenter, who were waken up by the intense ground shaking and falling objects. Although the system may be useful for stopping the operation of large industrial plants, power plants and trains and roadway traffic in areas with a warning time period of more than 10s, it is practically useless for people, who were directly hit by the earthquake.

Figure 25: Warning time contours around the earthquake epicenter
