5. DAMAGED AREA ESTIMATION BASED ON DMSP/OLS NIGHTTIME IMAGERY AND AERIAL RECONNAISSANCE

The January 13, 2001 Off the Coast of El Salvador Earthquake

5.6 AERIAL RECONNAISSANCE

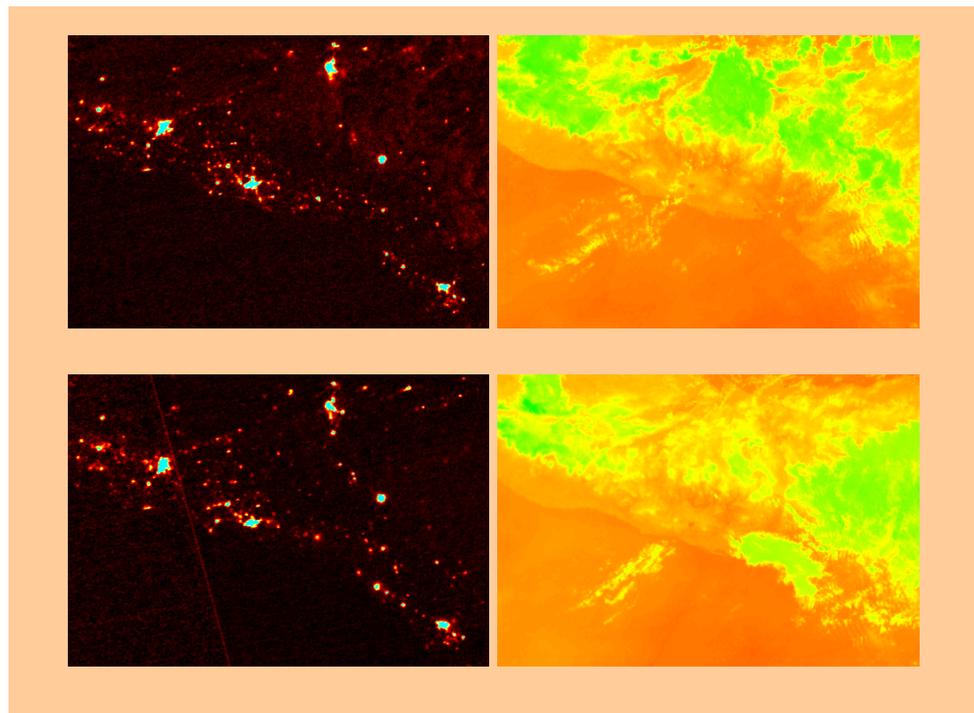
VNIR and TIR images of El Salvador on January 12
before the earthquake (above) and on January 13
after the earthquake (below)

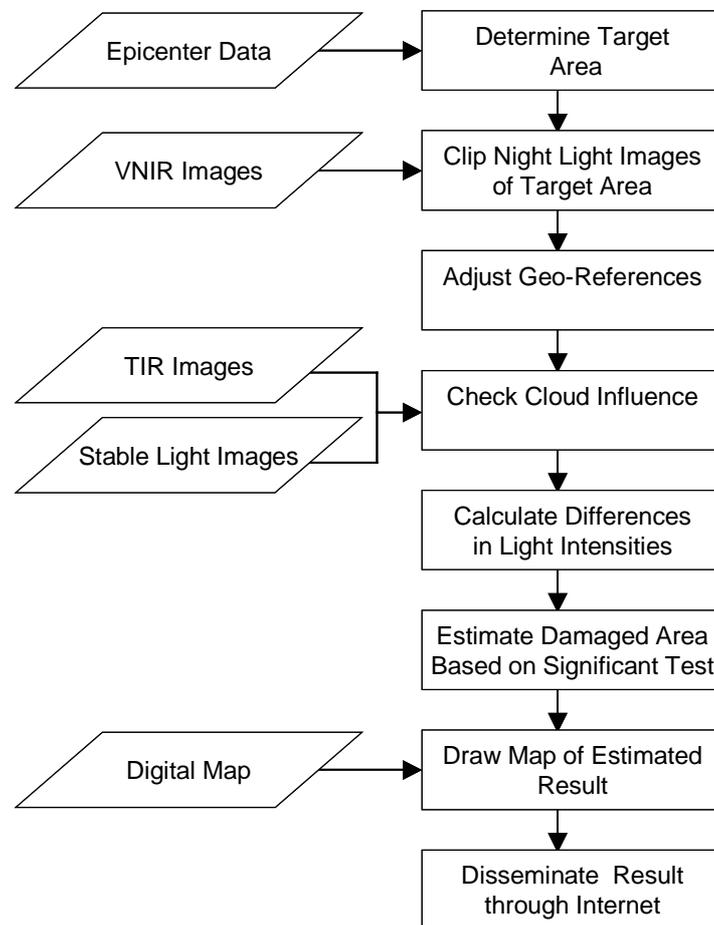
Figure 5.1 Flowchart of damaged area estimation.

The steps of damaged area estimation are shown in **Figure 5.1**. Each pixel in the visible-near infrared (VNIR) images has digital number (DN) ranging from 0 to 63. We calculated the differences of DNs on a pixel basis between before and after the earthquake in the sampled area. The cloud influences were checked using the thermal infrared (TIR) images and the stable light images. Based on the histogram of the differences, the areas that show the reduction in nighttime lights with $p > 0.995$ were determined as significant reduction due to the earthquake disaster (**Figure 5.2**).

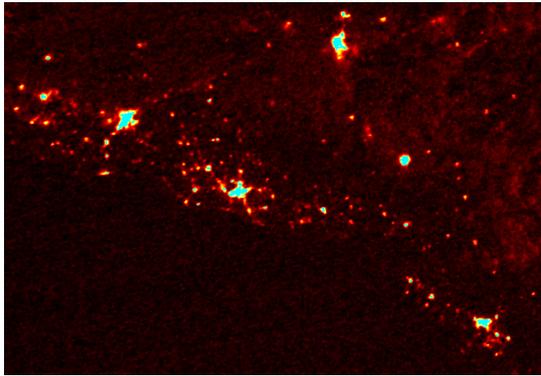
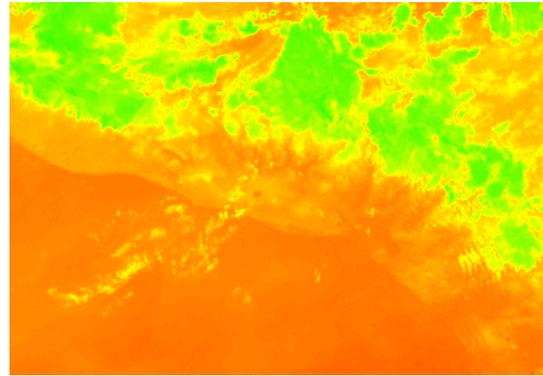
Figure 5.3 VNIR and TIR images on January 12 before the earthquake

We estimated the possible impacted areas of the earthquake disaster. The DMSP/OLS images in this region were provided from National Oceanic and Atmospheric Administration's National Geophysical Data Center (NOAA/NGDC). The nighttime VNIR and TIR images on January 12 (before the earthquake), January 13 and 14 (after the earthquake) are shown in **Figures 5.3, 5.4** and **5.5**, respectively. The histogram of digital number differences between two VNIR images on January 12 and 13 is shown in **Figure 5.6**. The similar figure between January 12 and 14 is shown in **Figure 5.7**. The thresholds of $p > 95\%$ and 99% are used to estimate damaged areas. The estimated impacted areas based on Figure 6 (between January 12 and 13) and on **Figure 5.7** (between January 12 and 14) are shown in **Figure 5.8** and **5.9**, respectively.

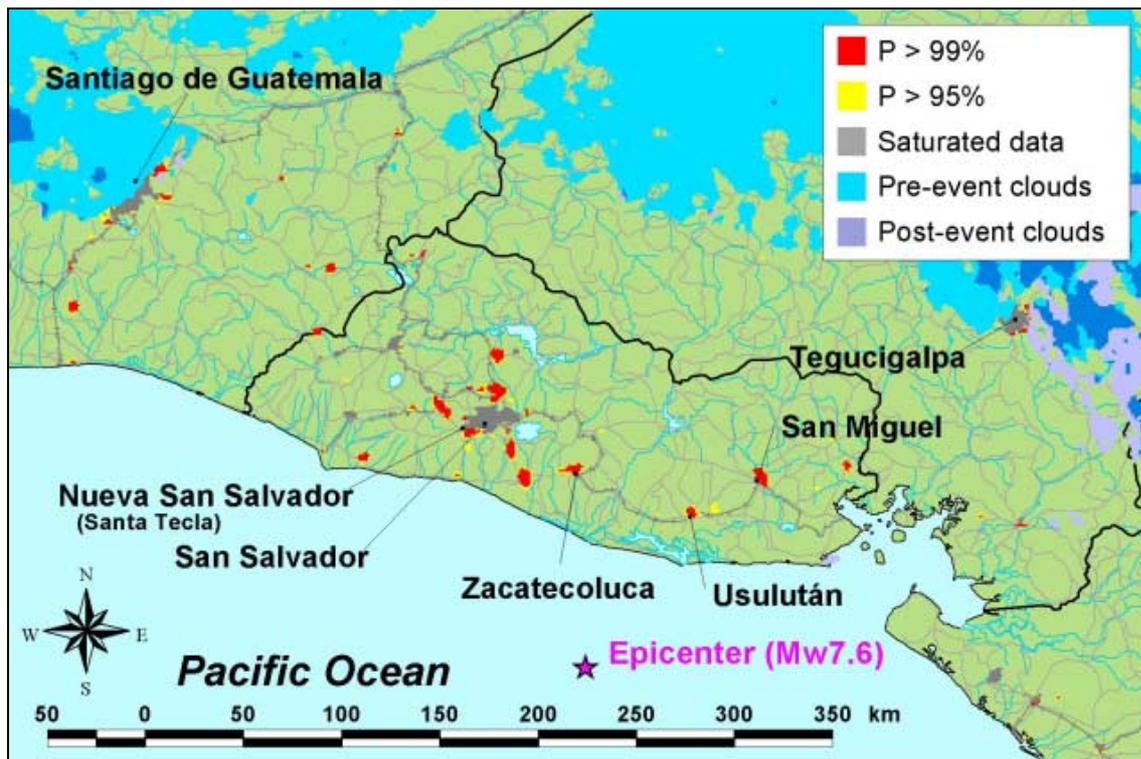
Figure 5.8 Estimated damaged area using two images on January 12 and 13.

The estimated impacted areas spread around San Salvador and eastern area including Usulután and San Miguel widely in **Figure 5.8**. In a few days after the earthquake, there was a countrywide power cut due to the damage of the transmissions and sub-stations facility (see chapter 5) so that the decrease in light intensity in the post-event images seems to reflect that influence. Because of recovery of electric power, the estimated impacted area including Usulután and San Miguel decrease after 2 days (**Figure 5.9**).

Hundreds of houses were buried due to a large landslide in Nueva San Salvador. The damage was estimated based on January 13 (**Figure 5.8**), on the other hand, the area could no be estimated because of the data saturation. It is difficult for this method to estimate the damage in highly populated area such as Nueva San Salvador.

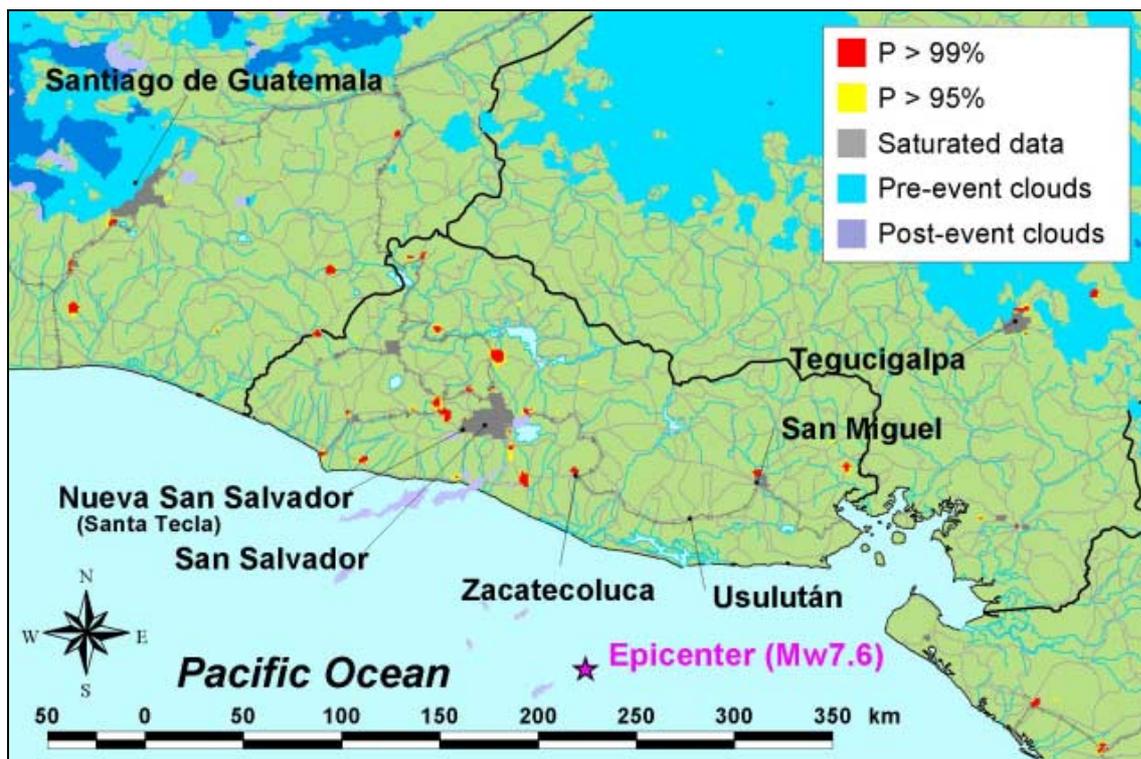
Figure 5.9 Estimated damaged area using two images on January 12 and 14.

The disaster damage reported by COEN (Comité de Emergencia Nacional, 2001) is shown in Table 1. The map of prefectures in El Salvador is shown in **Figure 5.10**. The number of collapsed buildings in La Libertad, La Paz, Sonsonate, Usulután and San Salvador was over 10,000. These prefectures contained most of the estimated damaged cities in **Figure 5.9**. The estimation result showed with a high degree of correspondence with the real damage distribution.

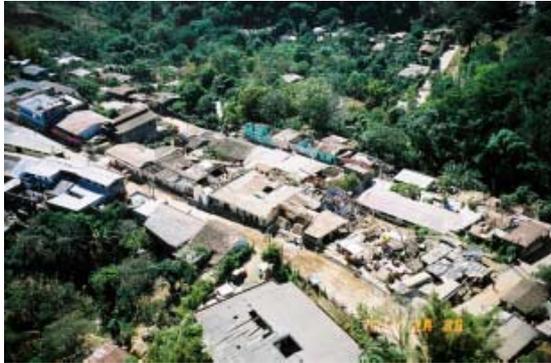
- 1) In western area of San Salvador, dwellings at small mountain villages such as Tepecoyo, Jayaque, Talnique and Comasagua in La Libertad suffered serious damages due to strong ground motion and landslide (**Figure 5.12**).
- 2) Las Colinas landslide destroyed hundreds of houses and killed over 500 people in Nueva San Salvador (**Figure 5.13**).
- 3) In eastern area of San Salvador, dwellings at towns such as San Juan Nonualco and Zacatecoluca in La Paz suffered slight damages of roofs and walls (**Figure 5.14**).
- 3) San Marcos Bridge on Lempa River was slightly damaged with subsidence of back fill soil behind the abutment. The girder of the old railway bridge close to San Marcos Bridge fell down due to the horizontal displacement of the riverside ground (**Figure 5.15**). The cracks and sand boils were shown in some places along Lempa River (**Figure 5.16**).

Figure 5.12 Collapsed houses at Jayaque village in La Libertad

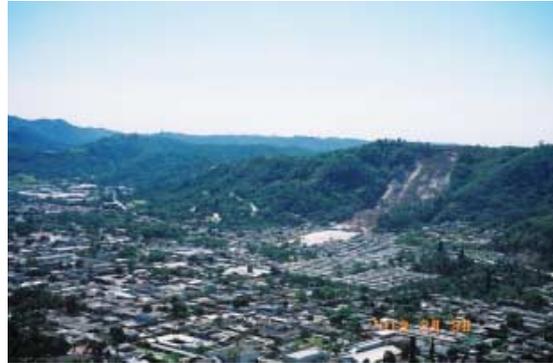
Figure 5.13 Las Colinas landslide in La Libertad

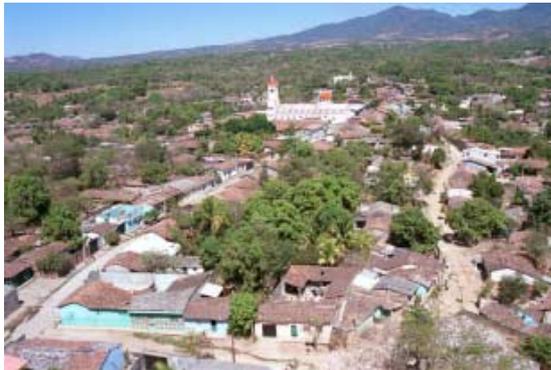
Figure 5.14 Damaged houses at San Juan Nonualco in La Paz

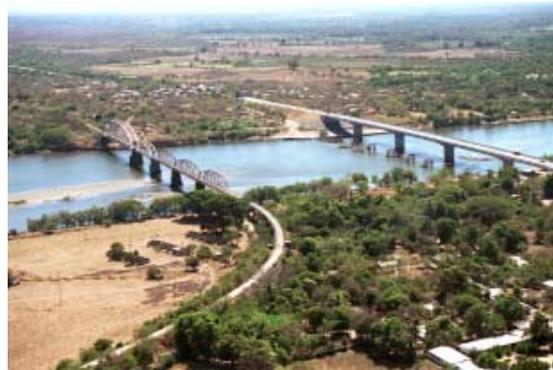
Figure 5.15 Damaged bridges on Lempa River

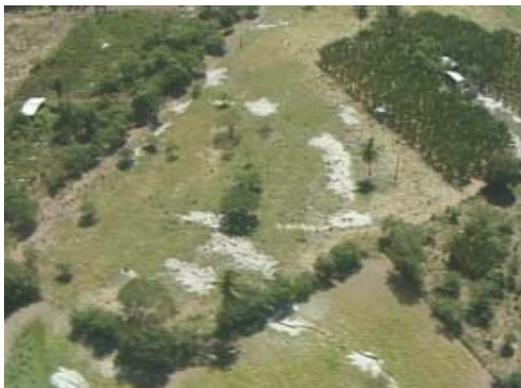
Figure 5.16 Liquefaction-induced sand boils along Lempa River

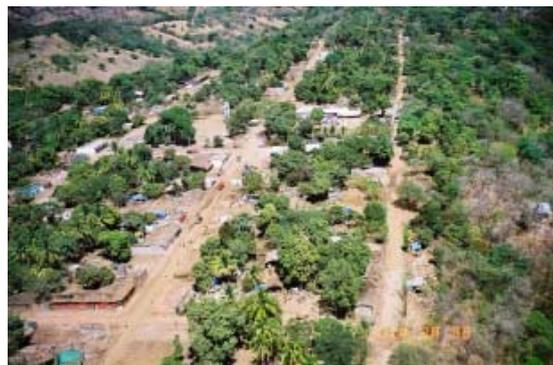
- 4) Dwellings at mountain villages such as San Augstin and Santiago de Maria in Usulután suffered damages (**Figure 5.17, Figure 5.18**). Especially, most of dwellings such as unreinforced adobe and bahareque houses were collapsed at San Augstin.
- 5) No major damages were observed in San Miguel City, which is one the largest city in eastern area (**Figure 5.19**).

Figure 5.17 Collapsed houses at San Augstin in Usulután

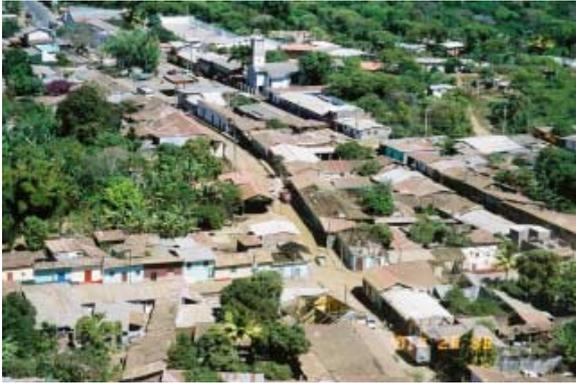
Figure 5.18 Damaged houses at Santiago de Maria in Usulután

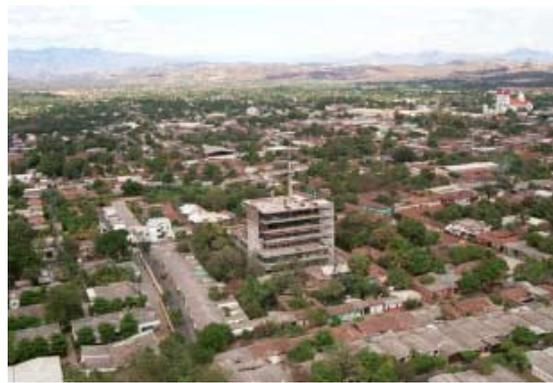
Figure 5.19 No major damage in San Miguel City
