6. SUMMARY AND RECOMMENDATIONS

The January 13, 2001 Off the Coast of El Salvador Earthquake

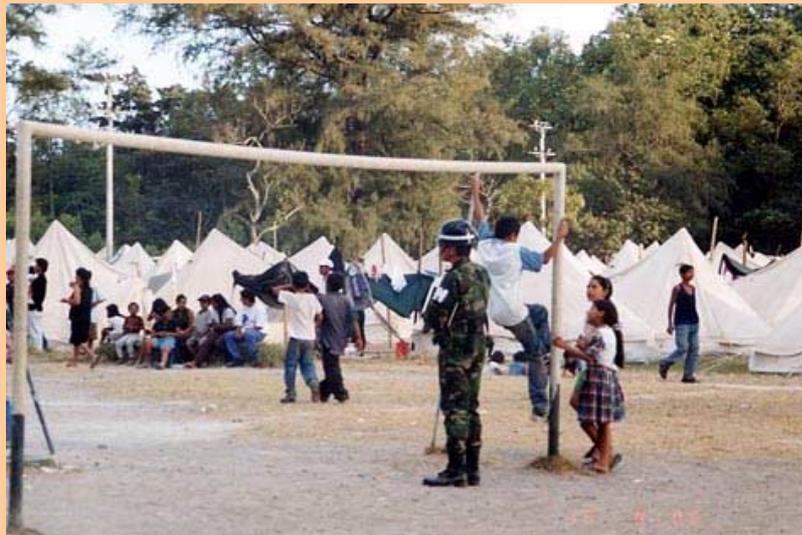
A week after the earthquake, the number of residents evacuated from the zones exposed to the menace of possible landslides reached 14,000, and as of Feb. 3, about 4,000 refugees were still being forced to live in tents (Nueva San Salvador).
