## 2. LANDSLIDES

The January 13, 2001 Off the Coast of El Salvador Earthquake

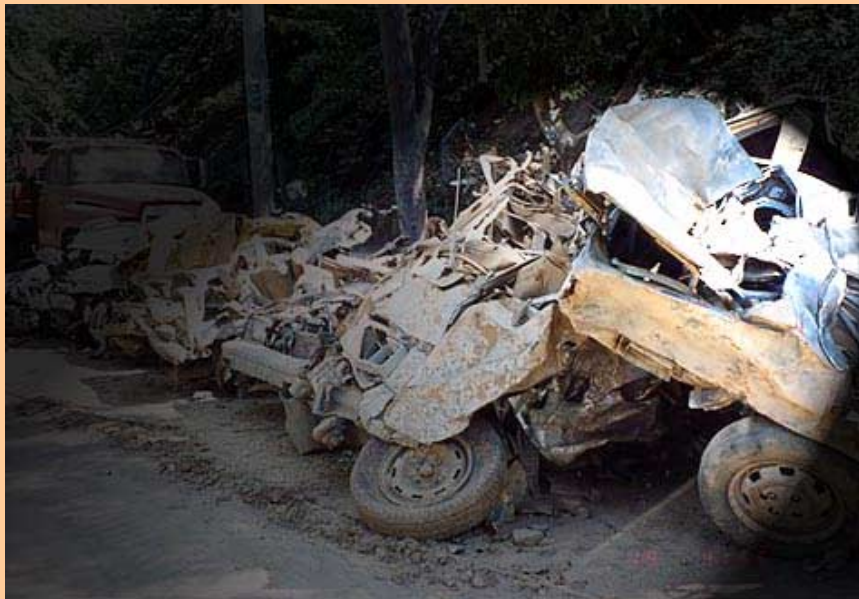
Cars destroyed in the slid soil mass, Las Colinas

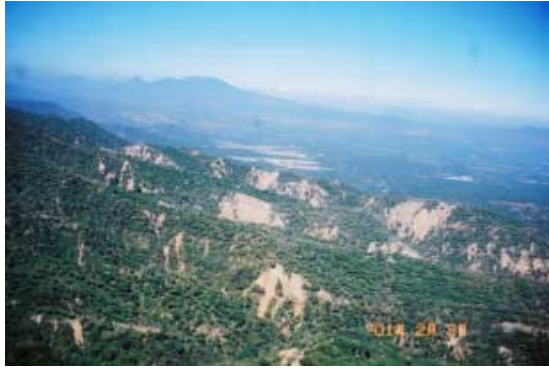
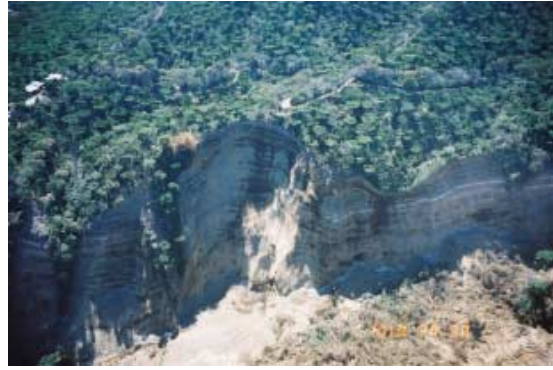
1. Sonsonate: Small slides of rock and soil occurred around the Lake Coatepeque in a crater to the east of the Santa Ana Volcano.
2. La Libertad: Many landslides including Las Colinas landslide occurred around the San Salvador volcano and other mountains (**Figures 2.6** and **2.7**). Traffic on mountain roads leading to small towns was suspended by these slope failures. The western stretch of the Pan American Highway from San Salvador was blocked at several points in Los Chorrros. **Figure 2.8** shows the Las Colinas landslide, which was responsible for the loss of more than 500 lives. Details of the Las Colinas landslide will be described in the next section.

**Figures 2.6 (left) and 2.7 (right).** Landslides on mountain slopes, La Libertad

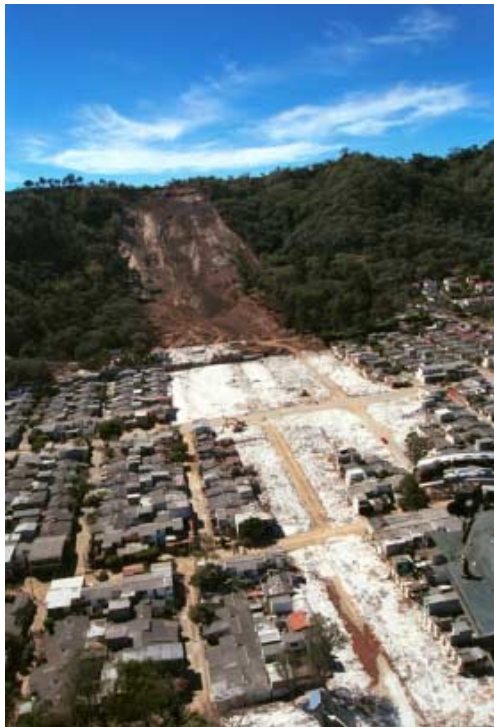
**Figure 2.8** Las Colinas landslide, La Libertad

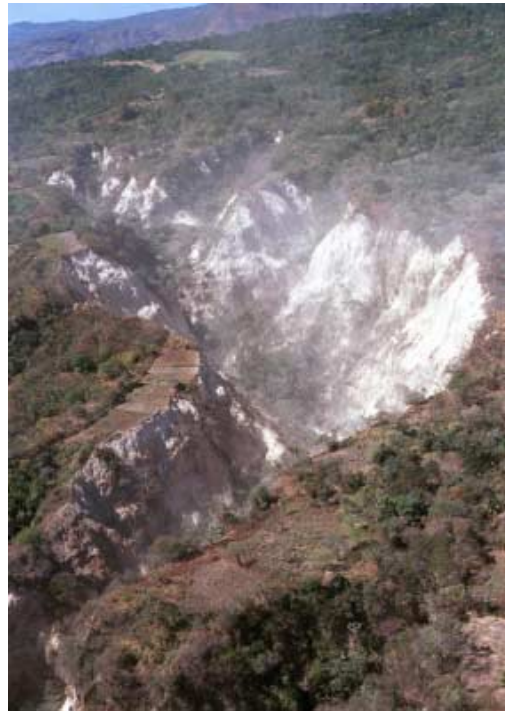
3. Cuscatlán: Young pyroclastic deposits ("tierra blanca") slid down steep crater walls of Lake Ilopango (**Figure 2.9**).
4. San Vicente: A great amount of soil mass blocked the Pan American Highway (**Figure 2.10**). Bulldozers were removing the slipped soil mass.

**Figure 2.9** Steep slope failures around Ilopango Lake, Cuscatlán

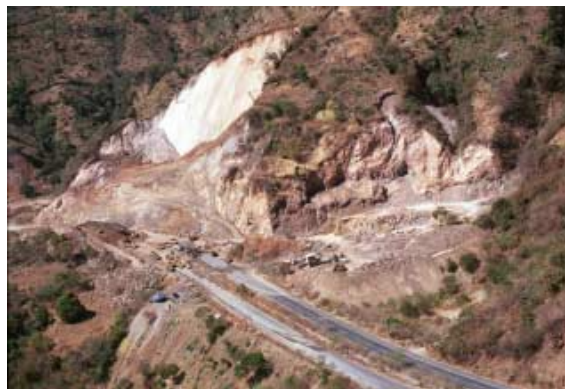
**Figure 2.10** Blocked PanAmerican Highway, San Vicente
